Montana Department of Transportation
Research Program
June 2006

POST-WINTER EVALUATION REPORT

Detectable Warning Devices (Truncated Domes) for use by the Visually Impaired

Project No.: STPU 5201(11), 6th St. N. W.

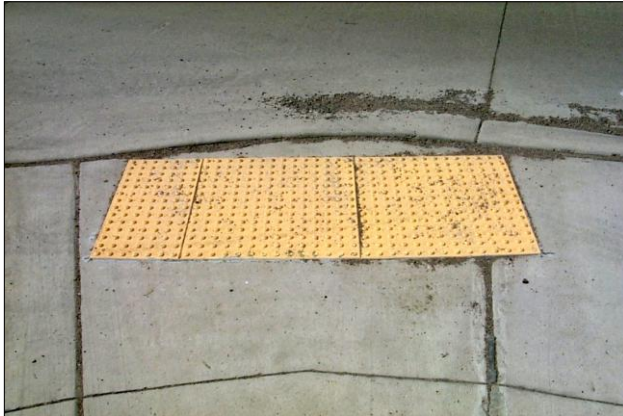
Installation 1A: Located on the northeast corner at the intersection of the east entrance to the Expopark adjacent to 5th Ave. N. W.

Adhesion fair. Interior seams beginning to curl up. Loss of domes on leading edge of mat due to blade damage. Minimum wear on domes. Color good.

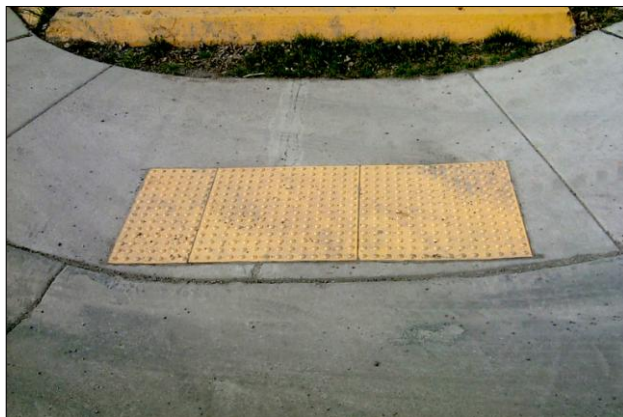
Installation 1B: Located on the southwest corner of the intersection 4th Ave. N. W. & 6th St. N. W.

All three site installations were in fair condition at the time of this inspection. Minimum wear on domes. Continued loss of adhesion was observed with the interior seams of treatment 1C & 1B. The following images are the individual treatments with comments.

Adhesion fair. West interior seam continues to curl and accumulate debris. Perimeter seam still tight. Color good. Minimum wear on domes.

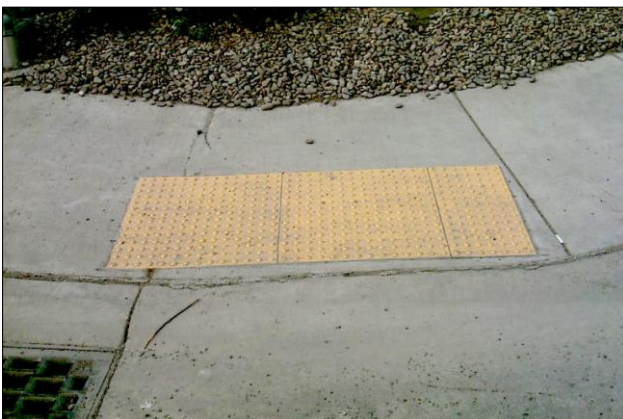
Installation 1C: Located on the southwest corner of the intersection 5th Ave. N. W. & 6th St. N. W. This treatment connects the east-west pedestrian walkway.

Same condition as 1B.

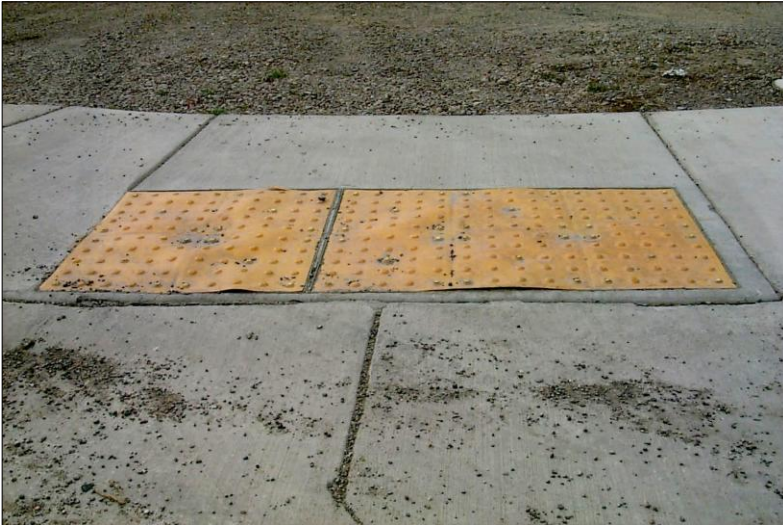
Installation 2: Located on the southwest corner at the intersection of 6th Ave. N. W. and 6th St. N. W.

Most all treatments exhibited some form of distress during the winter months. The worst performer was the Disability Devices Wet Anchor Box System, which has failed and has been removed. Note that the Wet Anchor Box was improperly installed that led to the premature failure of the glue. However there was substantial loss of dome relief due to blade damage.

This treatment performed poorly since construction. Approximately 35% of dome relief has been lost through use of a shovel or blade apparatus during the 2004-05 winter. Domes are wearing rapidly. The edges within the treatment and perimeter are beginning to lose adhesion. The tactile response is spongy, substantial air pockets beneath the mat, severe loss of adhesion. The setting pins are breaking off. Color is good. This treatment has been determined as a trip hazard and has been removed. Note that this device was improperly installed and most likely led to its premature failure.

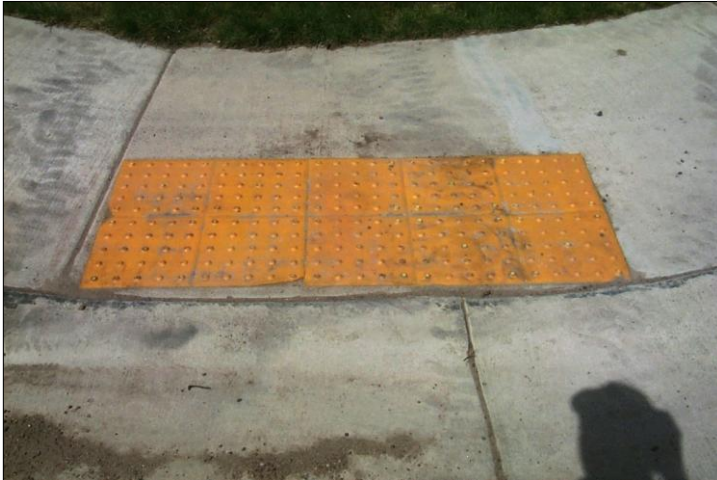
Installation 3A: Located on the northwest corner of the intersection of 5th Ave. N. W. and 6th St. N. W.

Installation 3A was in poor condition at the time of this inspection. Additional loss of domes due to suspected blade damage. Continued loss of adhesion at panel edges and interior seams. Color remains good. Many of the plastic setting pins have broken off. Evidence that an individual has taken a knife and cut the off the edges of the panel where it had lost adhesion. Installation 3B has failed and been removed.

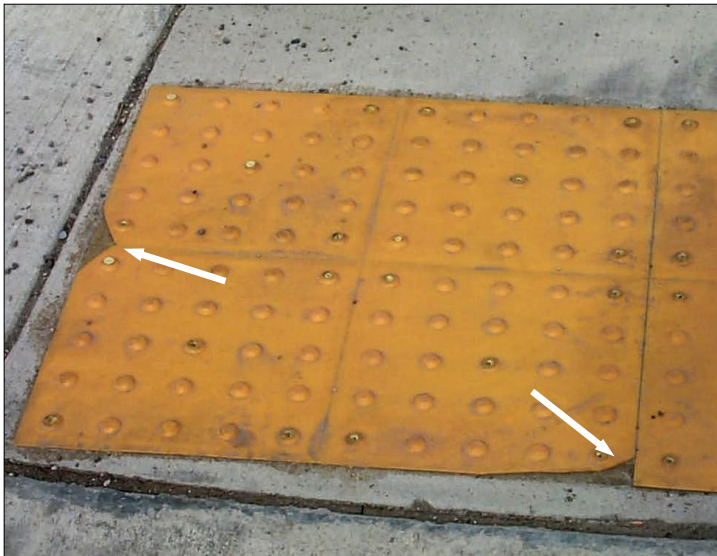
Installation 3A: Close-up of edges that have been cut away.

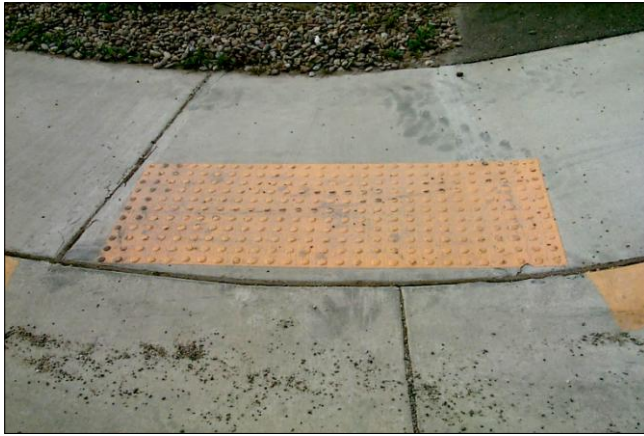
Installation 4A: Located on the southwest corner of 5th Ave. N. W. and 6th St. N. W.

All installations were in fair condition at the time of inspection. Color good. Treatment 4A displayed no deterioration. Treatment 4B & 4C have cracked at the mortar sidewalk joint, not associated with the performance of the product. Treatment 4C has lost one dome documented in the spring 2004 report.

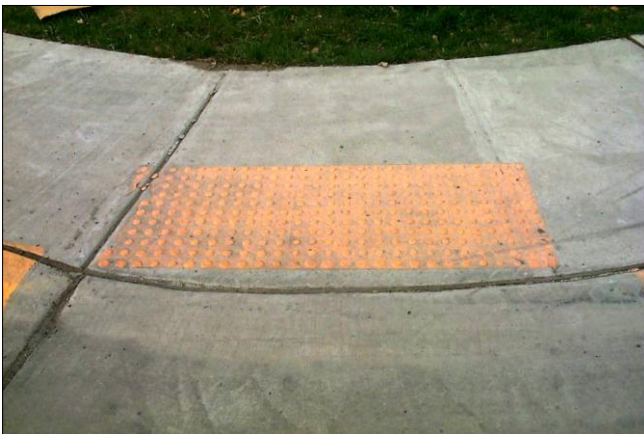
Installation 4B: Located on the northwest corner of 5th Ave. N. W. and 6th St. N. W.

South end of treatment deteriorating at mortar joint.

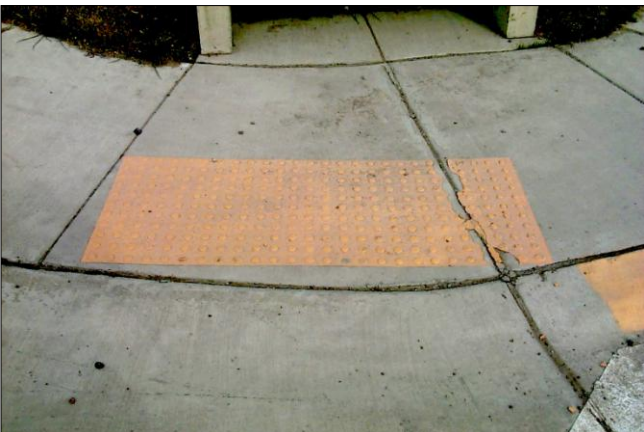
Installation 4C: Located on the northwest corner of 2nd Ave. N. W. and 6th St. N. W.

East mortar joint failing.

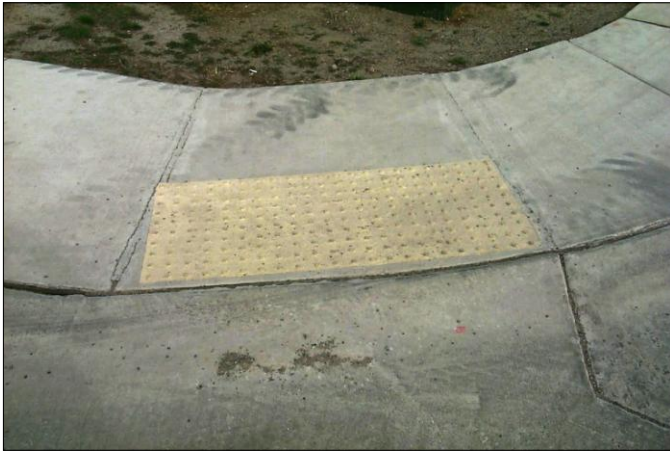
Installation 5A: located at northwest intersection of 1st Ave. N. W. and 6th St. N. W.

These installations have performed poorly, Substantial dome loss since last inspection, due to apparent blade damage. Adhesion is good. Color retention is fair.

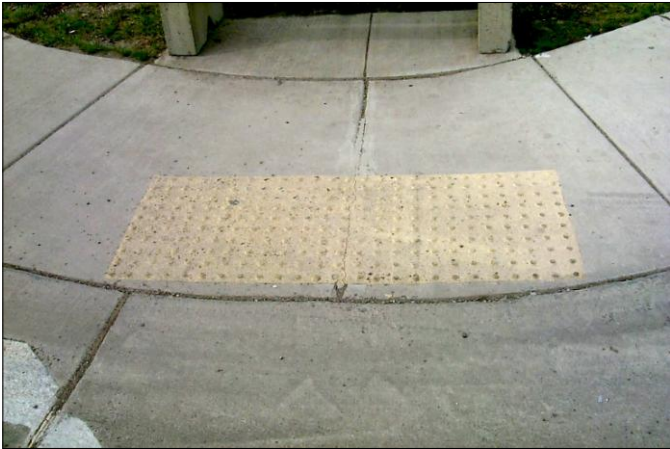
Installation 5B: Located at the southwest intersection of 3rd Ave. N. W. and 6th St. N. W.

Treatment displays substantial dome loss due to blade damage.

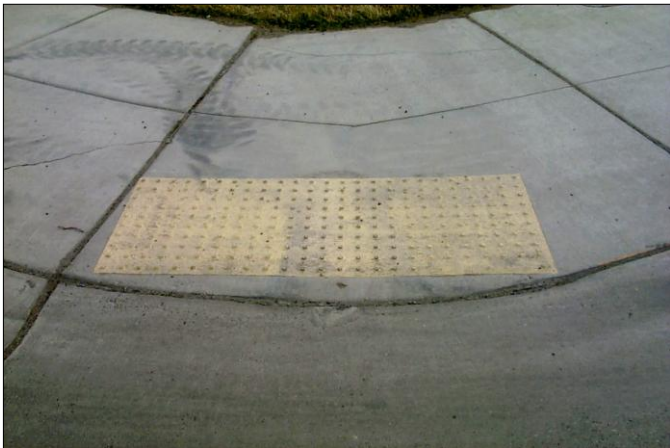
Installation 5C: Located on the southeast corner of the east Expopark entrance and 6th St. N. W.

Treatment displays dome loss since last inspection

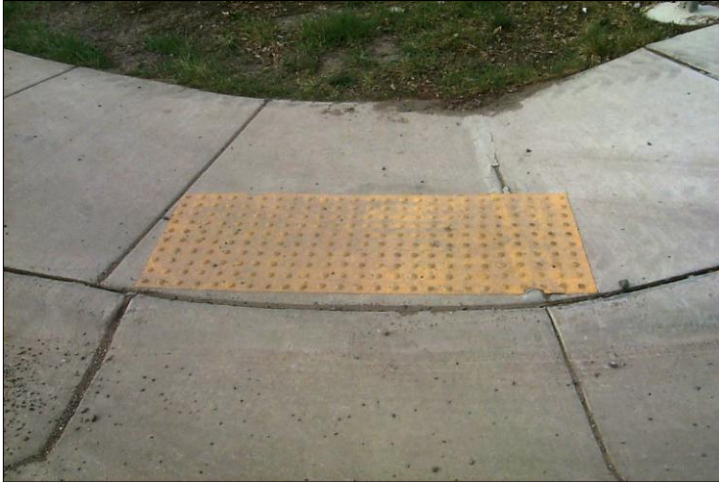
Installation 6A: located on the southwest corner of the intersection 2nd Ave. N. W. and 6th St. N. W.

All installations were in poor condition at the time of inspection. Treatment 6A is continuing to lose adhesion around the edges of the mat. The anti-skid coating over the top of the rubber domes with treatment 6A & 6B is continuing to flake off. It is unclear if this is a result of blade damage, sunlight deterioration or through the action of freeze-thaw.

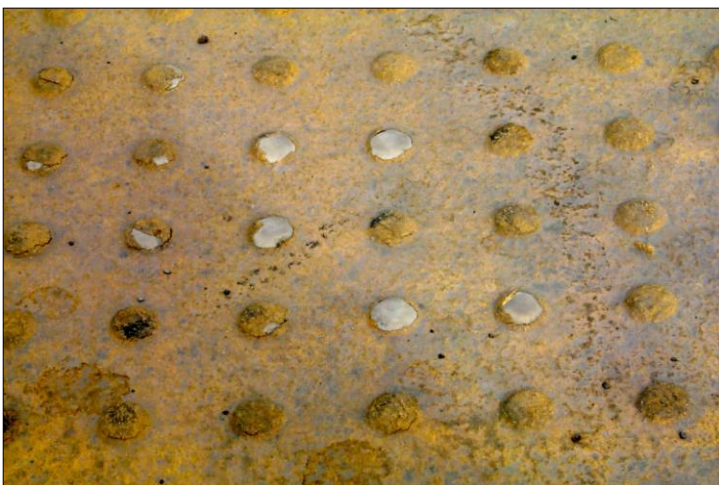
Installation 6B: Example of delaminating and cracking surface application of the rubber domes.

Although not seen as a slip hazard, this will facilitate future loss of domes.

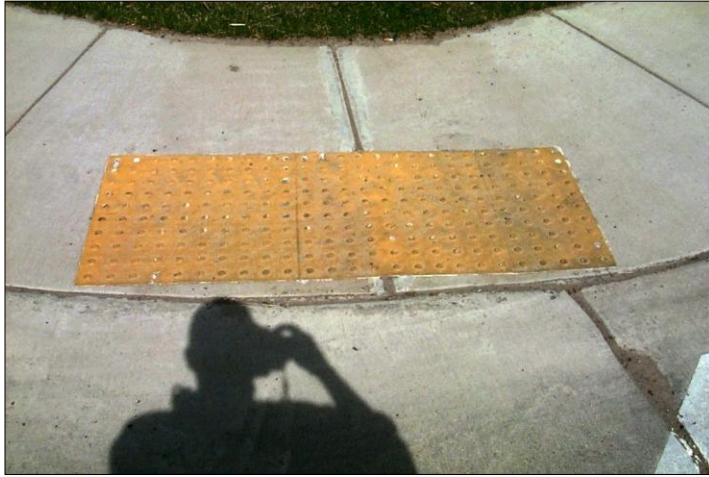
Installation 7: Located on the northwest corner of the intersection of 3rd Ave. N. W. and 6th St. N. W.

This treatment is failing rapidly. The surface of the mat has continued to rip and tear. There is additional dome loss since the pre-winter evaluation. Edges are losing adhesion. Color is fair. At this time it is not a trip hazard.

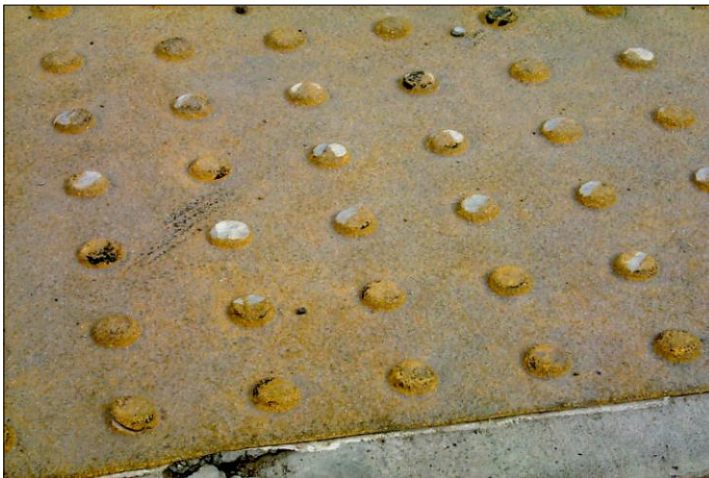
Installation 7: Close-up of damaged mat. Loss of domes and torn surface.
