Montana Department of Transportation
Research Program
October 2004

PRE-WINTER EVALUATION REPORT

Detectable Warning Devices (Truncated Domes) for use by the Visually Impaired

Project No.: STPU 5201(11), 6th St. N. W.

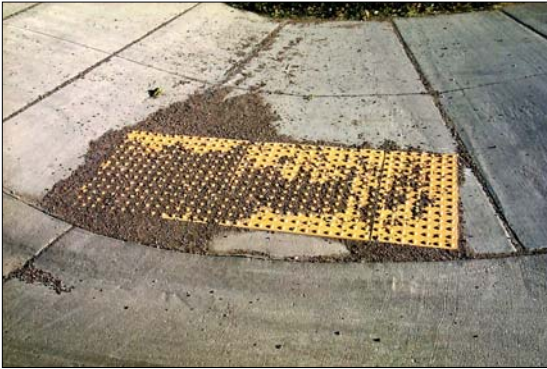
Installation 1A: Located on the northeast corner at the intersection of the east entrance to the Expopark adjacent to 5th Ave. N. W.

Adhesion tight. No dome loss. Minimum wear on domes. Color good. Abnormal accumulation of material on and around mat. This could minimize the tactile function of the DWD.

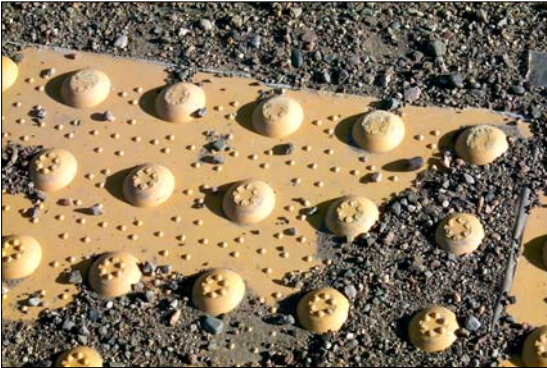
Installation 1A:

Example close-up of dome wear. Not considered at this time to be a detriment regarding resistance to slipping.

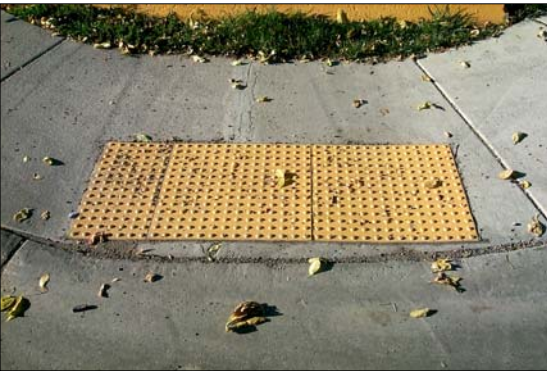
Installation 1B: Located on the southwest corner of the intersection 4th Ave. N. W. & 6th St. N. W.

Adhesion fair. West interior seam beginning to curl and accumulate debris. Perimeter seam still tight. Color good. Minimum wear on domes.

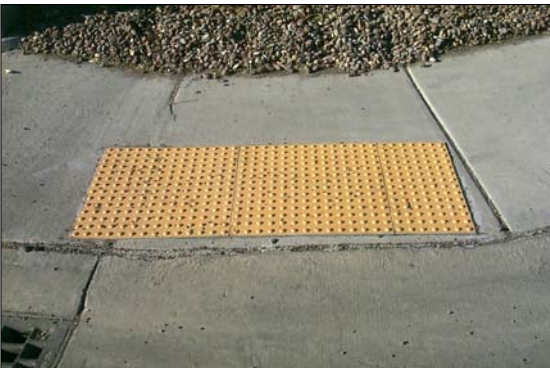
Installation 1C: Located on the southwest corner of the intersection 5th Ave. N. W. & 6th St. N. W. This treatment connects the east-west pedestrian walkway.

Same condition as 1B.

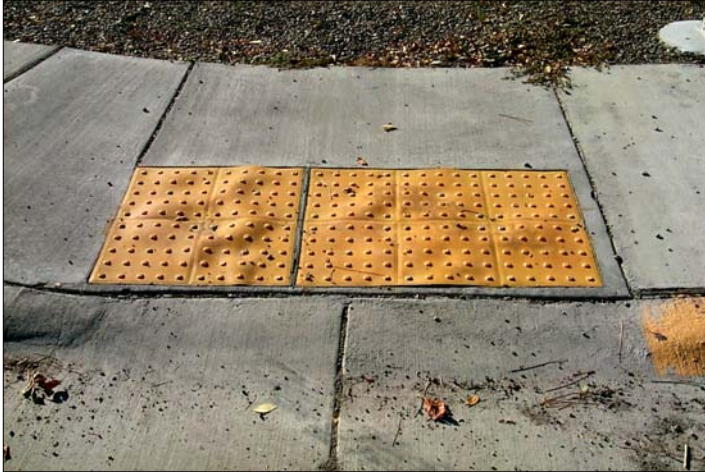
This treatment performed poorly since construction. Approximately 25% of dome relief has been lost through use of a shovel or blade apparatus during the 2003-4 winter. Domes are wearing rapidly. The edges within the treatment and perimeter are beginning to lose adhesion. The tactile response is spongy, substantial air pockets beneath the mat, severe loss of adhesion. The setting pins are breaking off. Color is good. Research will monitor this product closely during the winter in case it becomes a trip hazard to the public.

Installation 2: Located on the southwest corner at the intersection of 6th Ave. N. W. and 6th St. N. W.

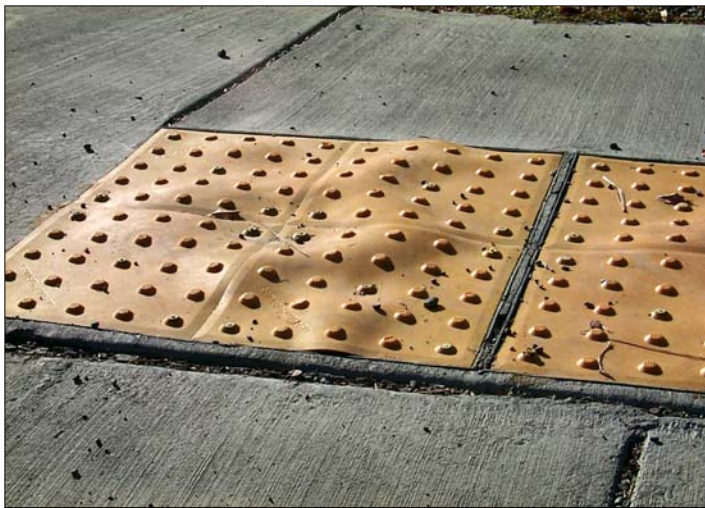
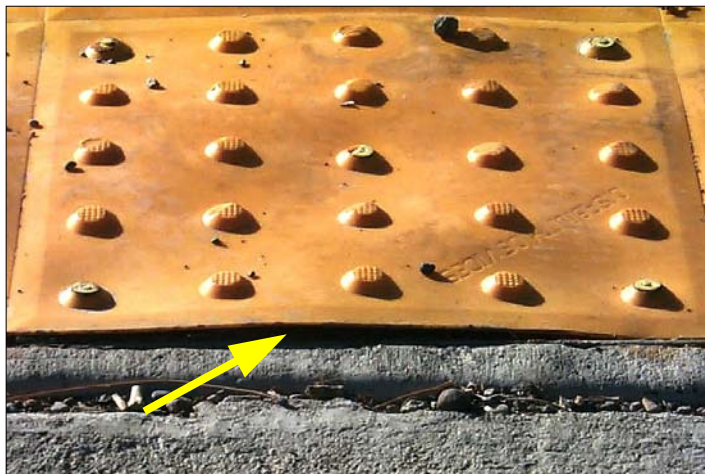
Installation 2: Close-ups of lost adhesion under mat at and edges.

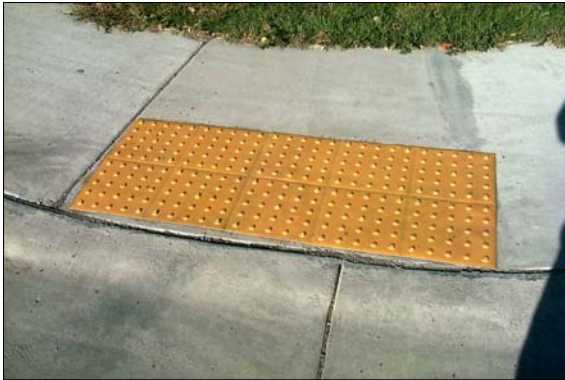
Installation 3A: Located on the northwest corner of the intersection of 5th Ave. N. W. and 6th St. N. W.

This treatment connects the north-south pedestrian walkway.

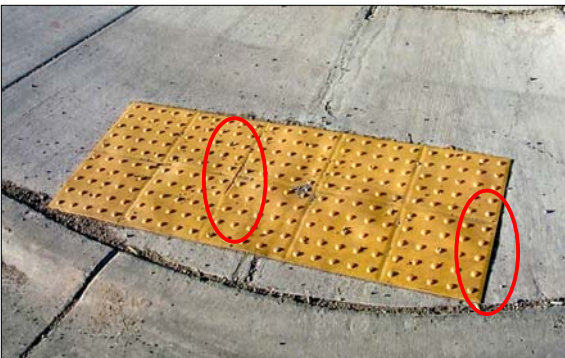
Installation 3B: Located on the southwest corner of the intersection of 1st Ave. N. W. and 6th St. N. W.

Severe loss of adhesion of panel to sidewalk. Gaps large enough at interior seams to be a trip hazard (red circles).

Installation 3A was in fair condition at the time of this inspection. No additional loss of domes. Minor adhesion loss at panel edges and interior seams. Color good. Many of the plastic setting pins have broken off. Installation 3B has failed and become a trip hazard to the public. Research has asked for the panel to be removed.

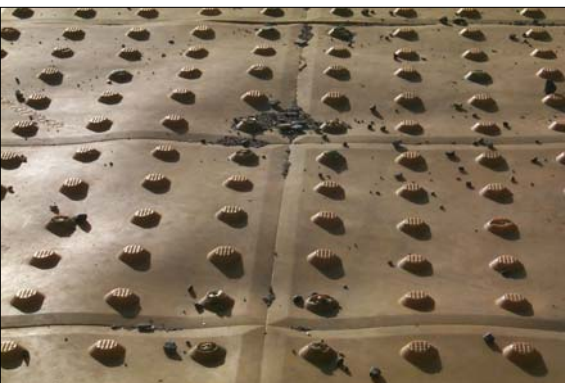
Installation 3B:

Example image of loss of adhesion to sidewalk.

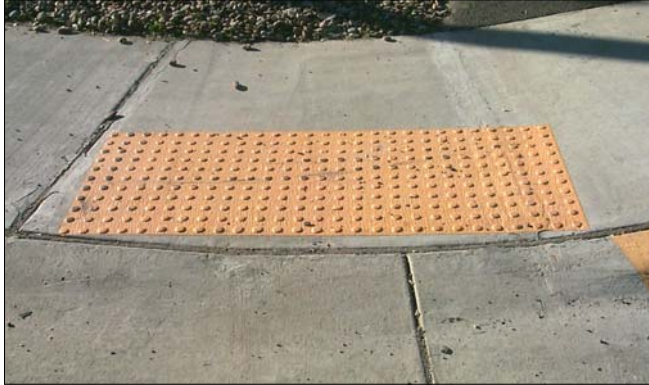
Installation 4A: Located on the southwest corner of 5th Ave. N. W. and 6th St. N. W.

This treatment connects the north-south pedestrian walkway.

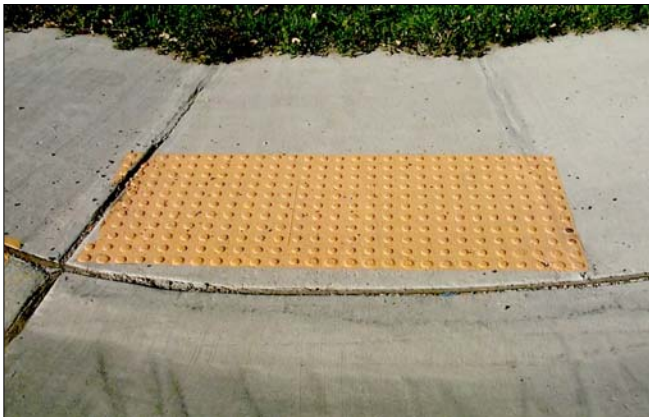
Installation 4B: Located on the northwest corner of 5th Ave. N. W. and 6th St. N. W.

South end of treatment deteriorating at mortar joint.

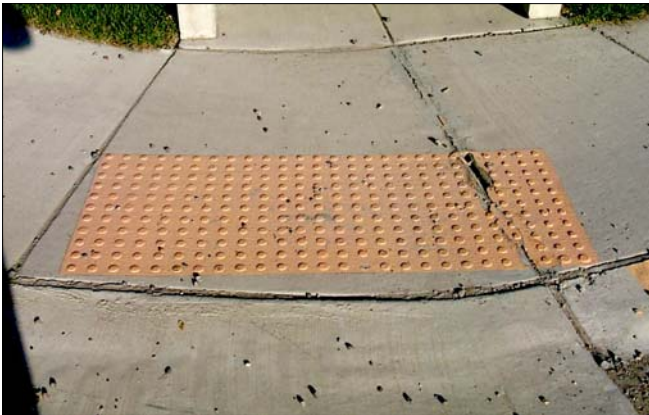
Installation 4C: Located on the northwest corner of 2nd Ave. N. W. and 6th St. N. W.

East mortar joint failing.

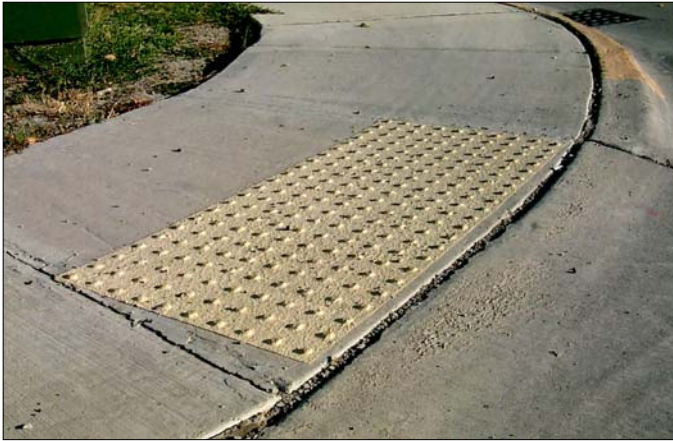
Installation 5A: located at northwest intersection of 1st Ave. N. W. and 6th St. N. W.

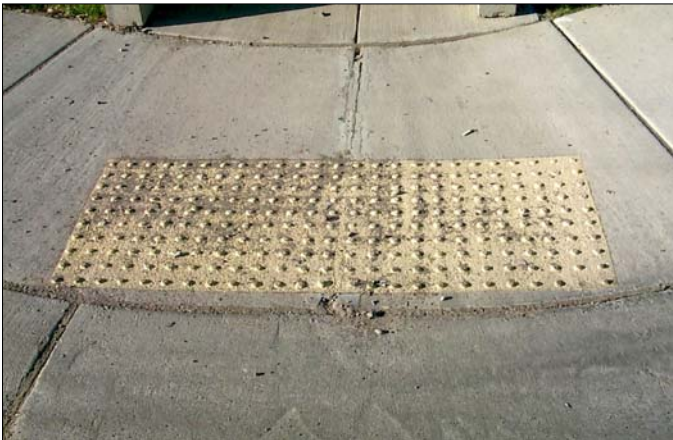
Installation 5B: Located at the southwest intersection of 3rd Ave. N. W. and 6th St. N. W.

Note accumulation of debris.

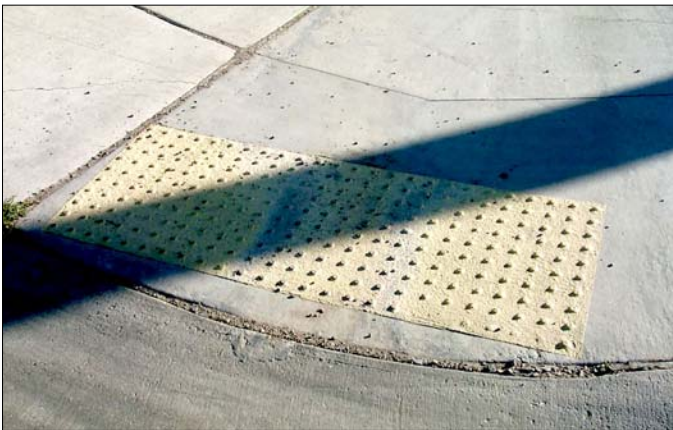
Installation 5C: Located on the southeast corner of the east Expopark entrance and 6th St. N. W.

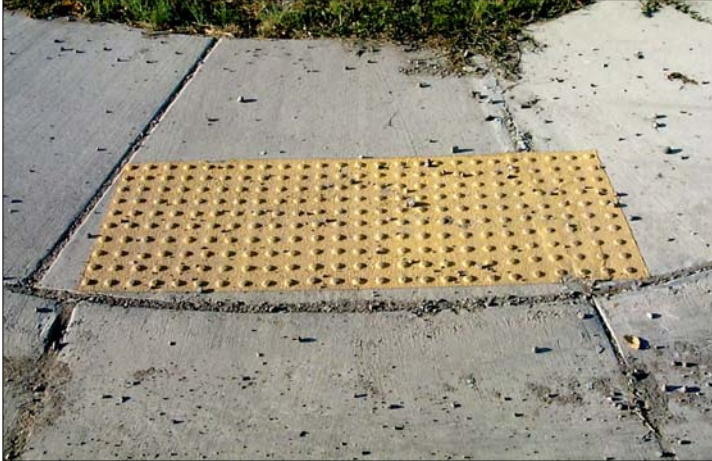
Installation 6A: located on the southwest corner of the intersection 2nd Ave. N. W. and 6th St. N. W.

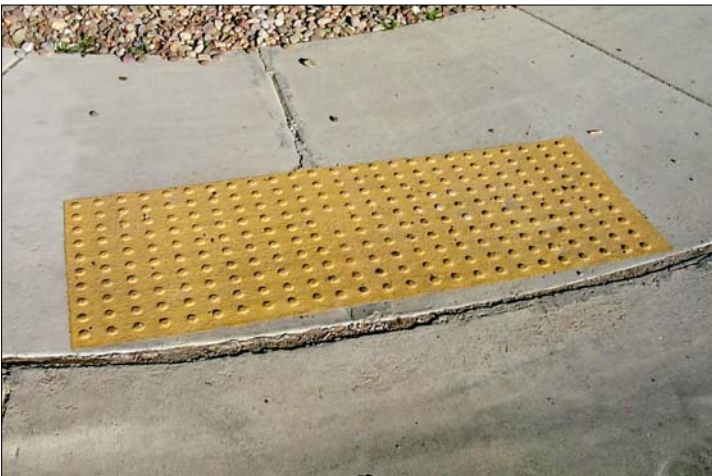
Installation 6B: located on the northwest corner of the intersection 4th Ave. N. W. and 6th St. N. W.

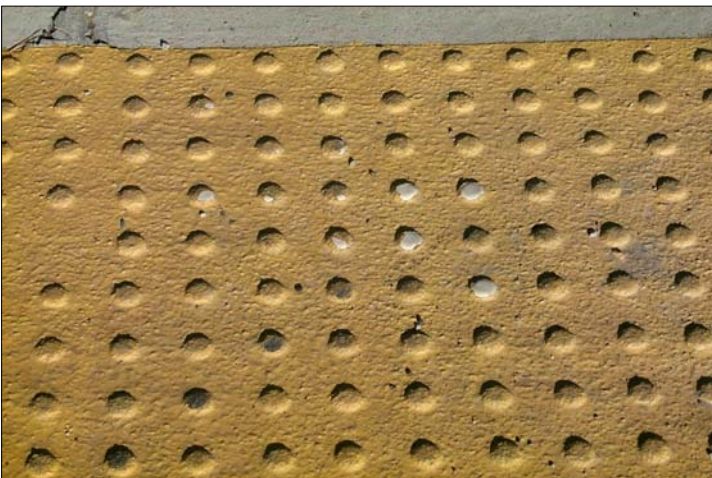
All installations were in fair to poor condition at the time of inspection. Treatment 6A is continuing to lose adhesion around the edges of the mat. The anti-skid coating over the top of the rubber domes with treatment 6B is continuing to flake off. It is unclear if this is a result of blade damage, sunlight deterioration or through the action of freeze-thaw.

Installation 6B: Example of delaminating and cracking surface application of the rubber domes.

Although not seen as a slip hazard, this will facilitate future loss of domes.

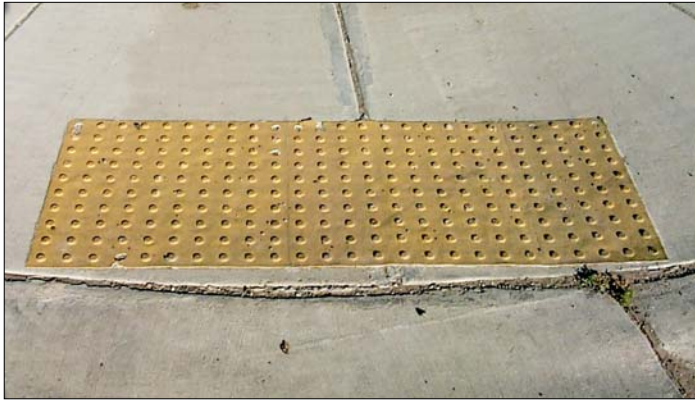
This treatment is failing rapidly. The surface of the mat has continued to rip and tear. There is additional dome loss since the spring evaluation. Edges are losing adhesion. Color is fair. At this it is time not a trip hazard.

Installation 7: Located on the northwest corner of the intersection of 3rd Ave. N. W. and 6th St. N. W.

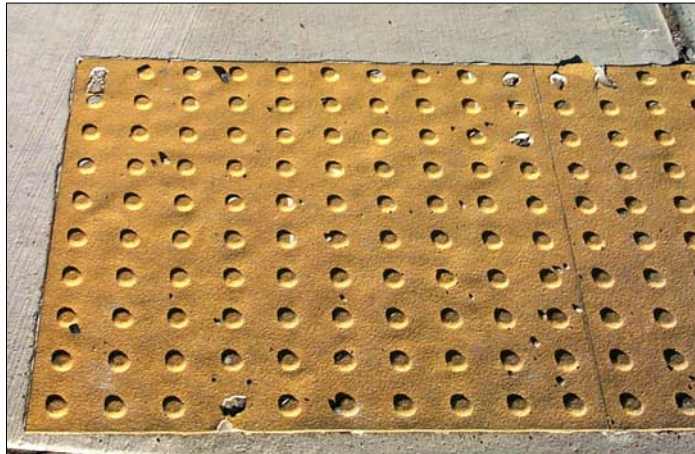
Installation 7: Close-up of damaged mat. Loss of domes and torn surface.
