# FRA/Volpe Center Task Force Observation of Operations at TVE Transrapid Test Facility October 15 to December 17, 1992

DOT-VNTSC-RR393-PM-93-1  
April 1993

Prepared by the Federal Railroad Administration/Volpe National Transportation  
Systems Center High Speed Guided Ground Transportation Safety Task Force

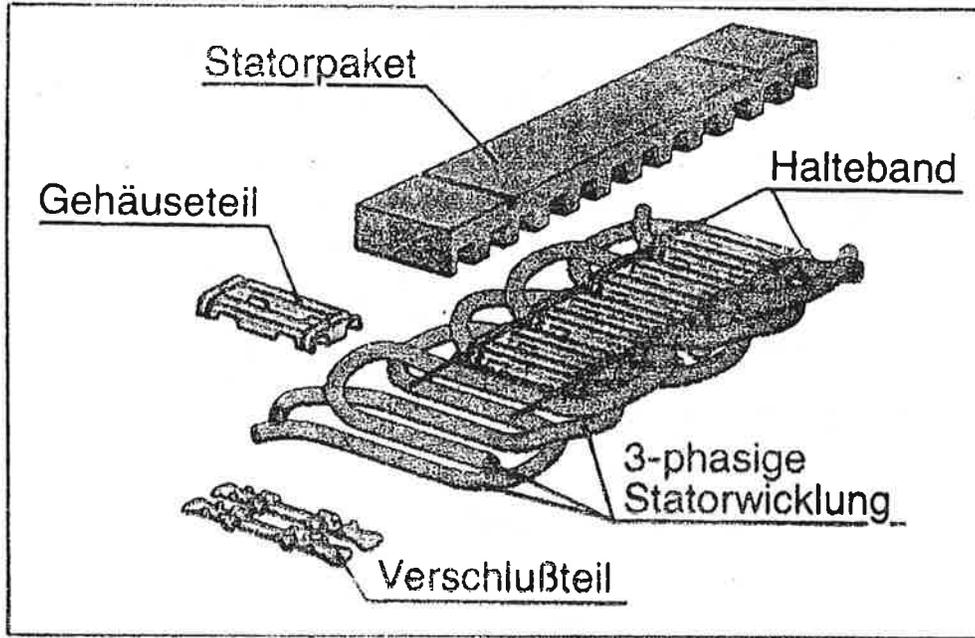
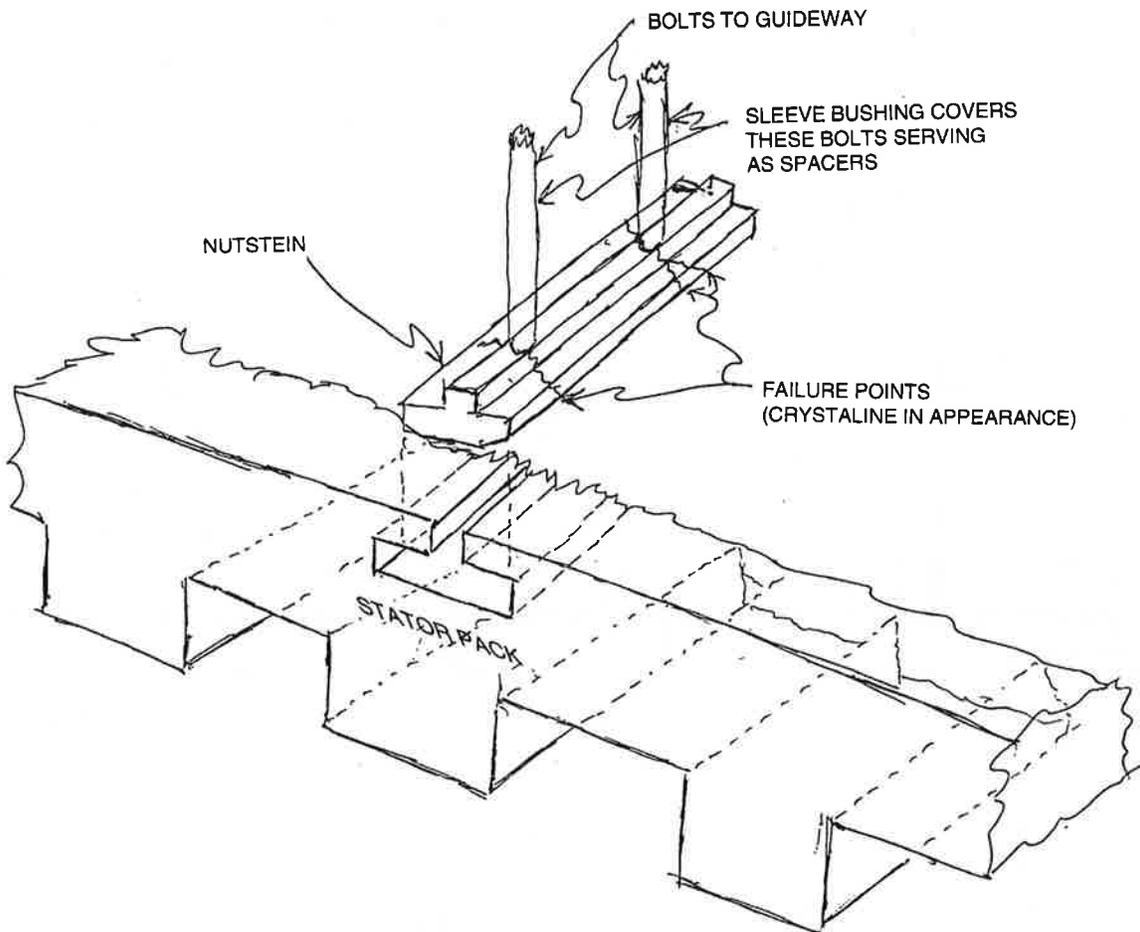
Figure 6. Stator Pack and Nutstein Failure

Fasteners	The "nutstein" is a channel-shaped piece that slides in a retaining groove of the stator pack. There are two nutsteins per stator pack. They are a critical non-fault-tolerant part of the fastener assembly that holds the stator pack to the guideway using four guideway mounting bolts. Fracture type failures have been discovered in several stator pack/guideway attachment assemblies.
"Vergussmortproblem"	This issue involves premature failure of the special epoxy-bonding or "casting mortar" in the stator pack fastener assembly sleeve in concrete spans.

Concern was expressed about the condition of the stator pack fastening bolts in the northern loop. Because of the design, portions of the bolts were under no tension despite being properly installed, causing uneven loading on the bolts. Thus, the performance life of these bolts could be lower than that of bolts in other areas of the guideway, and it is unknown how long they will last. Additionally, each pass of the TR07 vehicle results in 150 loading cycles on each load-bearing bolt (one per magnetic pole), not the single cycle as originally thought, thereby potentially shortening the performance life still further.

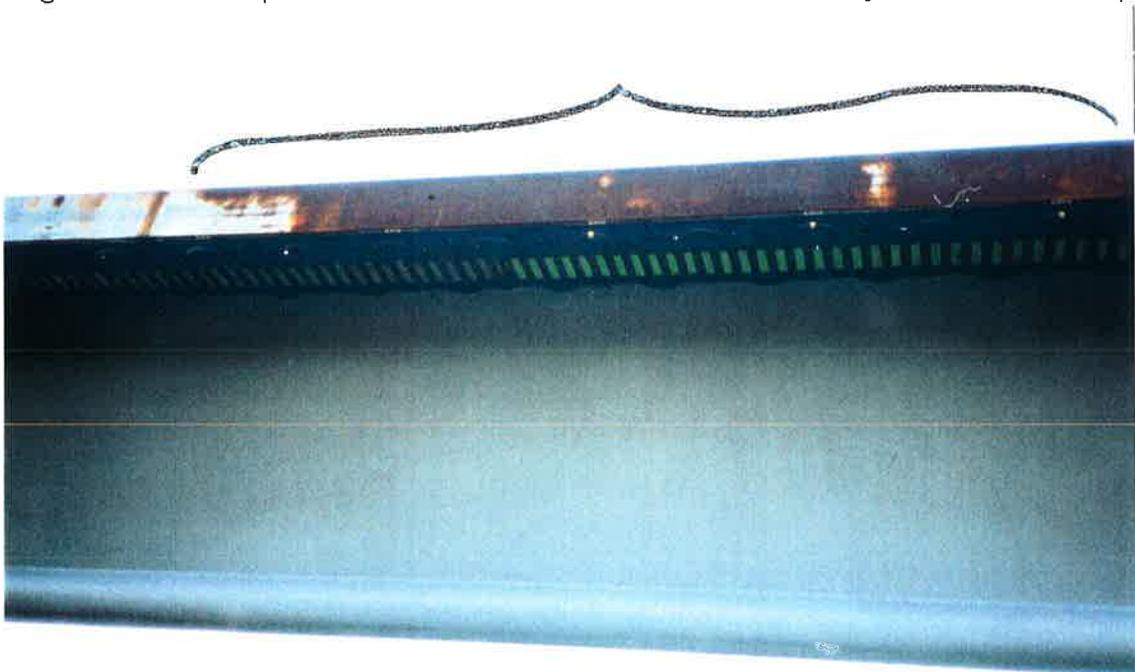
Figure 12. Example of Surface Condition of Steel Guideway in Northern Loop

Another issue related to the bolts is the status of the bolts on the steel section of the northern loop. The bogies on the TR07 vehicle have been modified so that contact between a stator pack and a vehicle section will no longer be a safety issue, thereby limiting damage to the section. To address the bolt fatigue problem, Thyssen Henschel wanted to use this portion of the guideway to test some of the possible modifications to the bolts and/or fixture. However, the guideway in question is on private land, and TÜV, which is responsible for ensuring the safety of the public, has concerns about such testing. One of the issues under discussion between Thyssen and TÜV is the statistical risk for such test operations and the implications of the risk.
