**Federal Railroad  
Administration**

## **Alternative Occupied Volume Integrity (OVI) Tests and Analyses**

| 4. TITLE AND SUBTITLE<br>Alternative Occupied Volume Integrity (OVI) Testing and Analyses | | | 5. FUNDING NUMBERS<br>RR28A1/JG343<br>RR28A2/JL649<br>RR28A2/KL649 | |
| 9. SPONSORING/MONITORING AGENCY NAME(S) AND ADDRESS(ES)<br>U.S. Department of Transportation<br>Federal Railroad Administration<br>Office of Research and Development<br>1200 New Jersey Avenue, SE<br>Washington, DC 20590 | | | 10. SPONSORING/MONITORING<br>AGENCY REPORT NUMBER<br>DOT/FRA/ORD – 13/46 | |

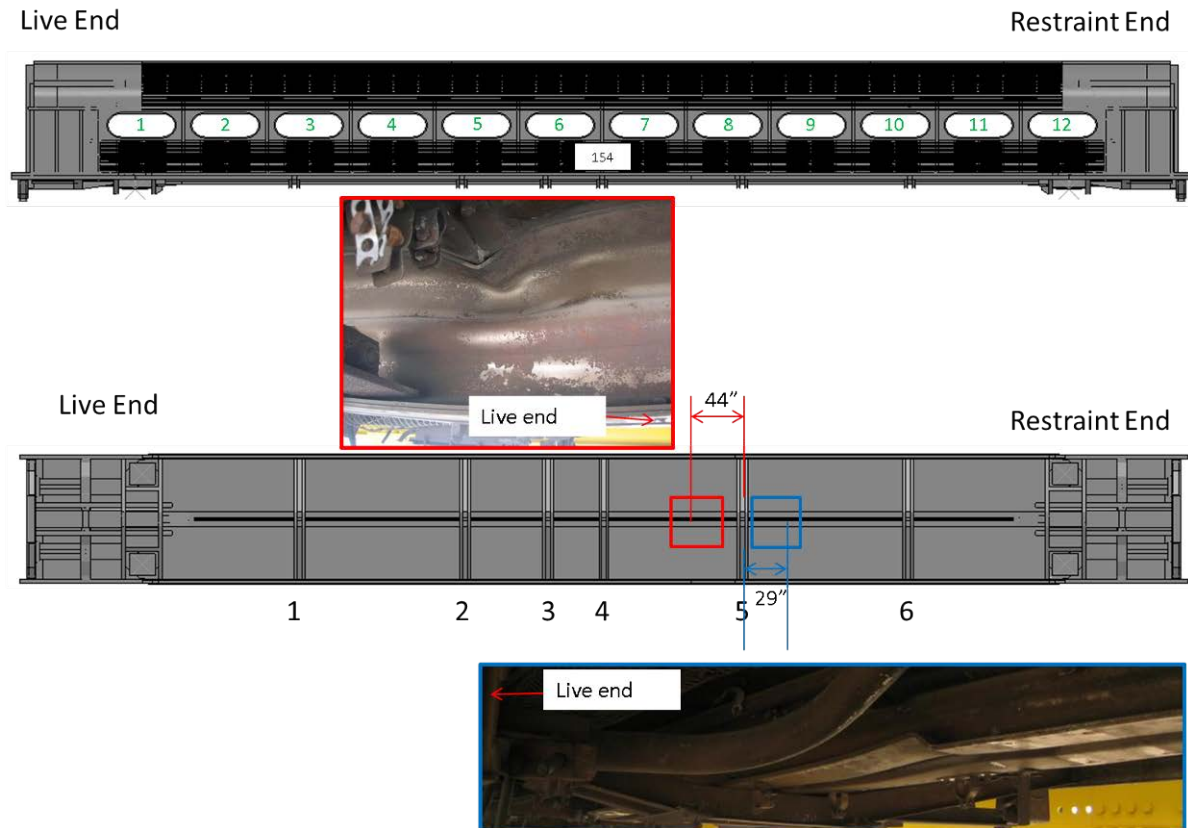
Damage occurred on the center sill and both side sills of Car 248. Because of the limited-instrumentation applied to this car during the shakedown test, it is unclear in what sequence the damage occurred. On the center sill, buckling was found to have occurred in two locations. The first location was approximately 44 inches toward the live end from the centerline of cross-bearer 5. This buckle occurred in the top half of the web of the center sill. A second buckle was found approximately 29 inches toward the restraint end, measured from the centerline of cross-bearer 5. This buckle was in the lower flange of the center sill. Both of these buckles are shown in Figure 47.

**Figure 47. Damage to Underframe of Car 248**

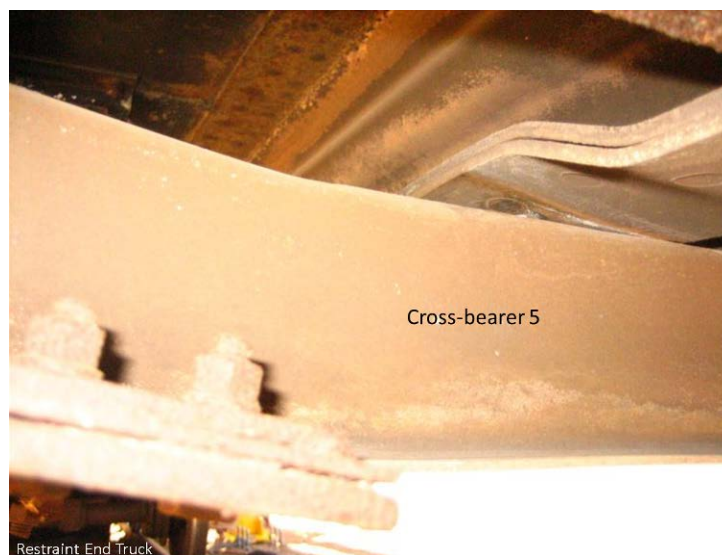
A third area of damage was observed on the center sill of car 248. A small buckle and failed welds were observed at the intersection of the center sill and cross-bearer 5. This area of damage is shown in Figure 48.

**Figure 48. Buckle and Failed Welds in Center Sill at Cross-Bearer 5, Car 248**

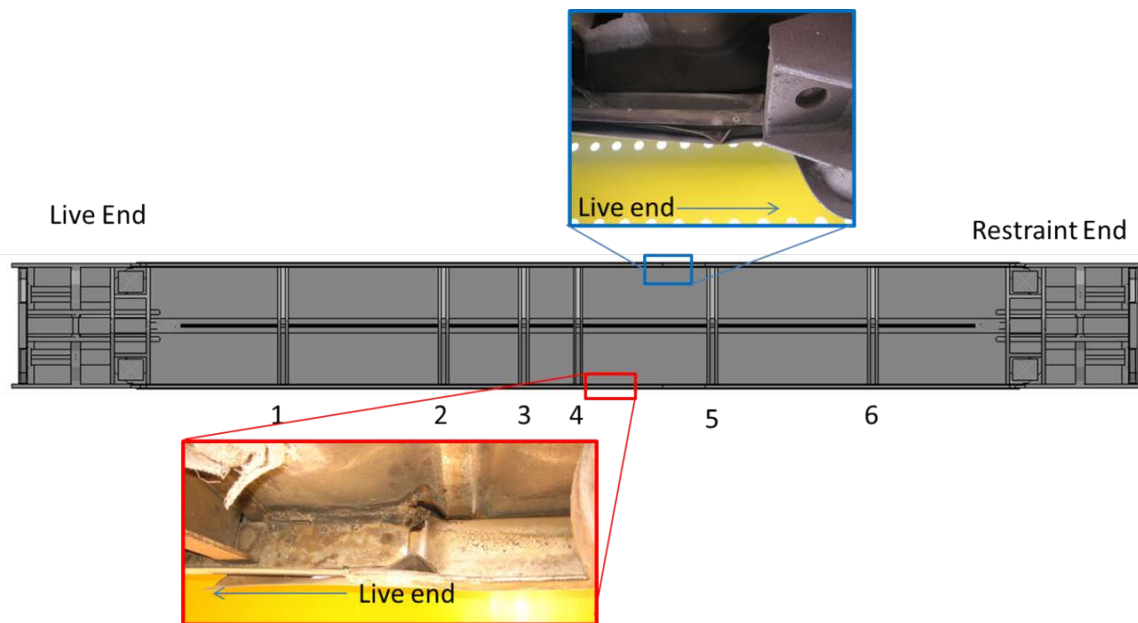
**Figure 49. Damage to Sides Sills of Car 248**

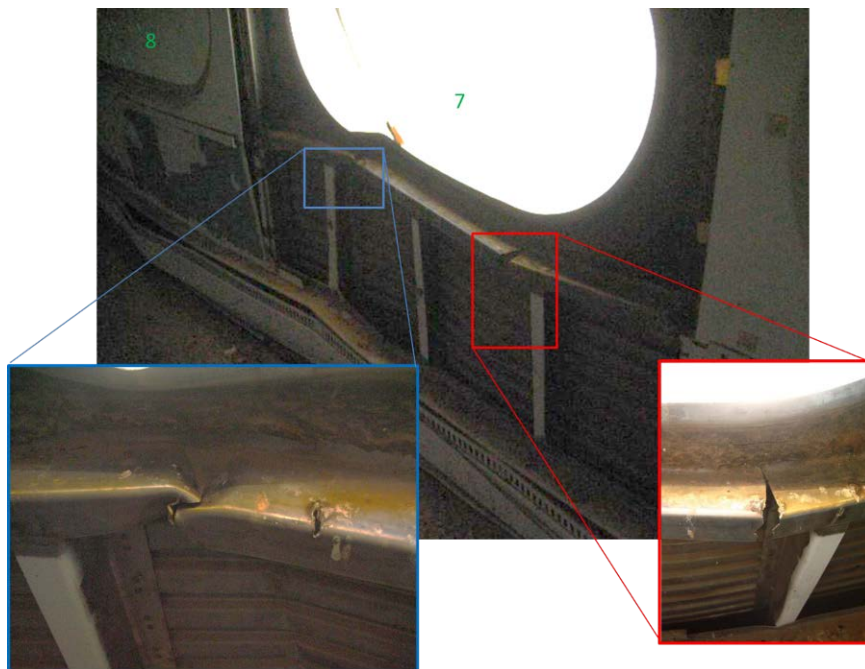
**Figure 52. Fractured Left Belt Rail, Car 248**

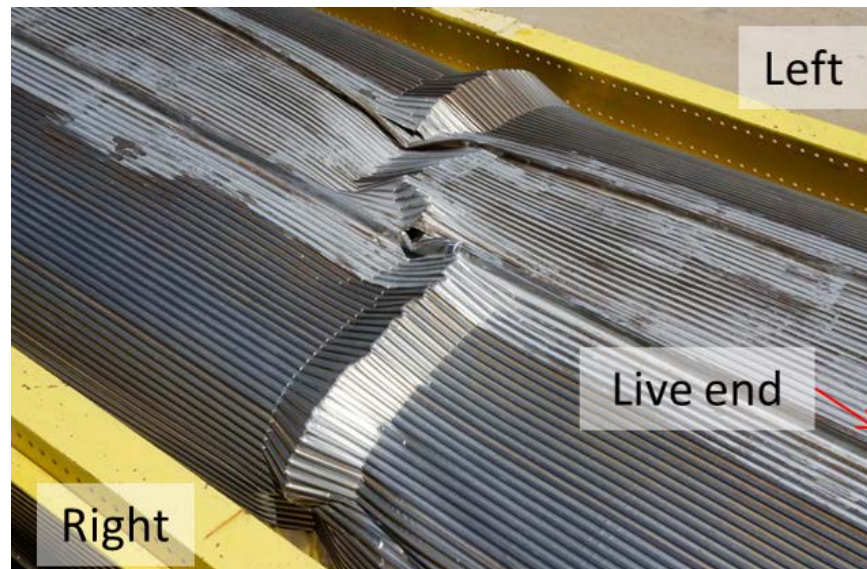
**Figure 53. Buckled Roof, Car 248**

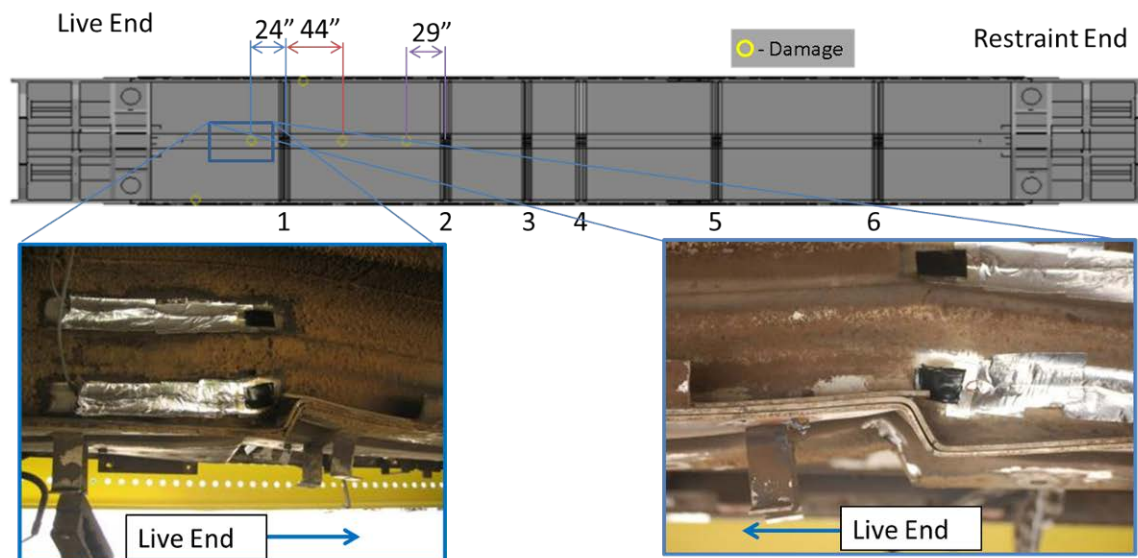
**Figure 59. Damage to Car 244 Center Sill (1)**

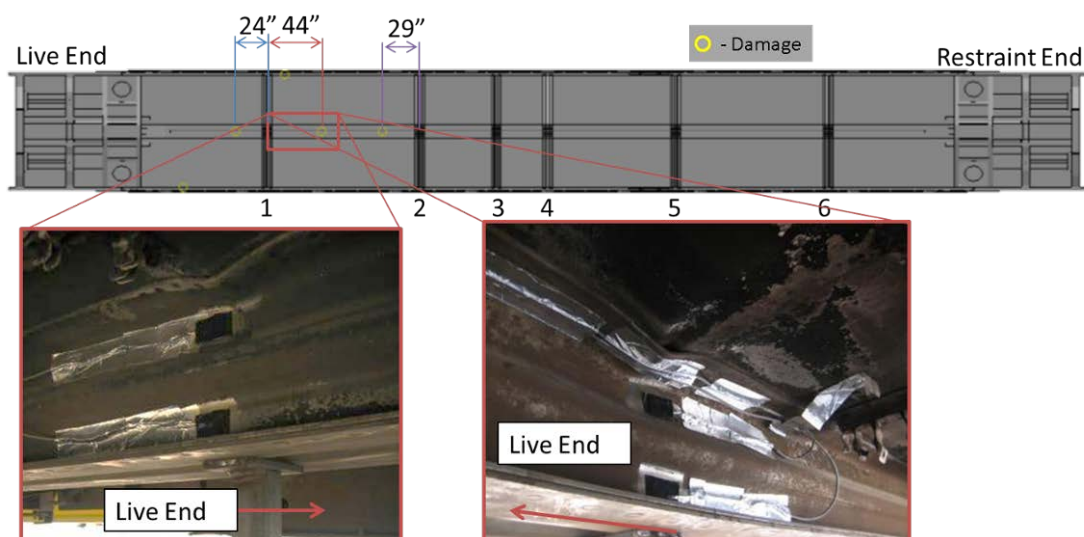
**Figure 60. Damage to Car 244 Center Sill (2)**

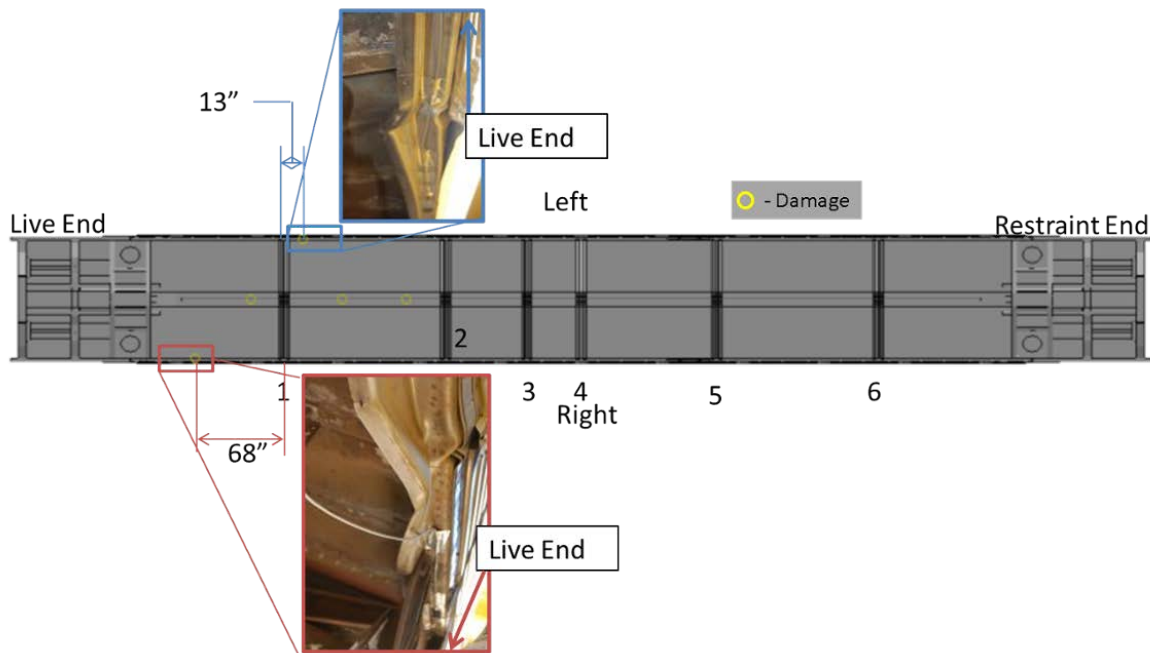
**Figure 61. Damage to Car 244 Side Sills**

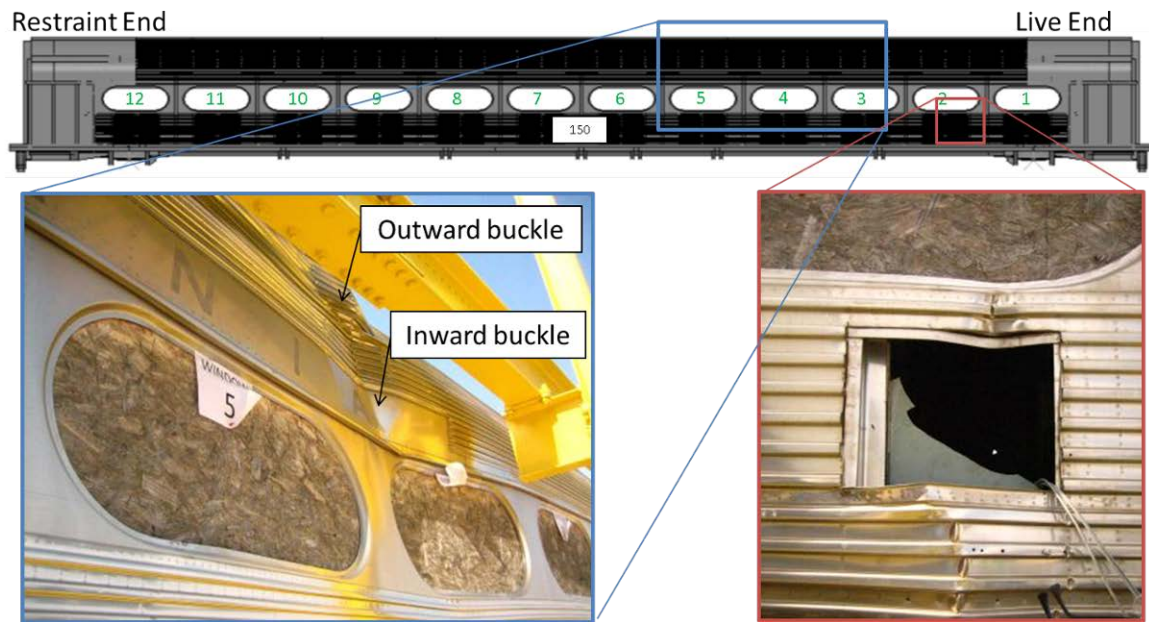
**Figure 62. Damage to Right Side of Car 244**

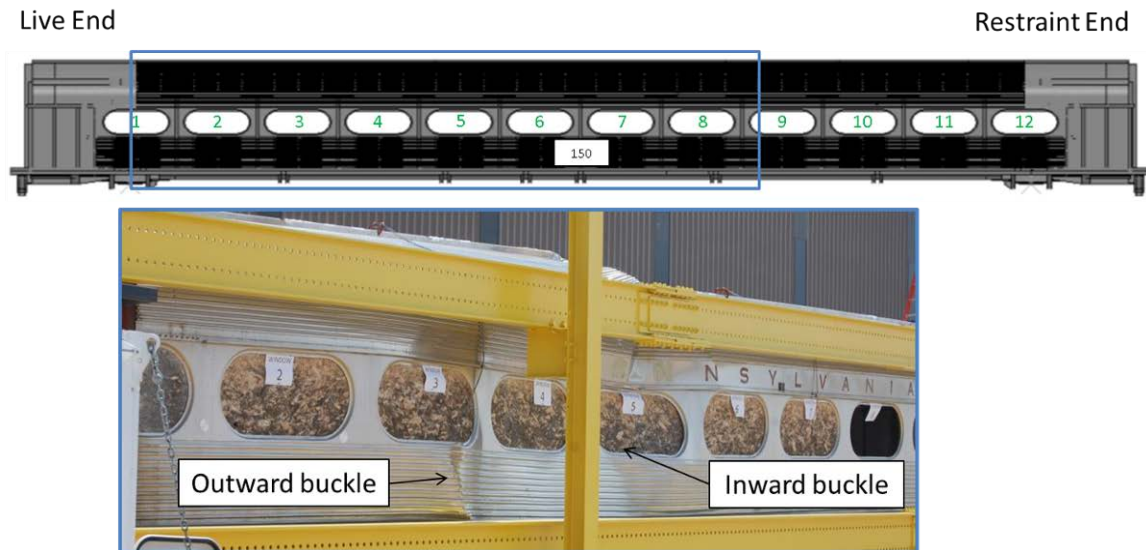
**Figure 64. Damage to Left Side of Car 244**

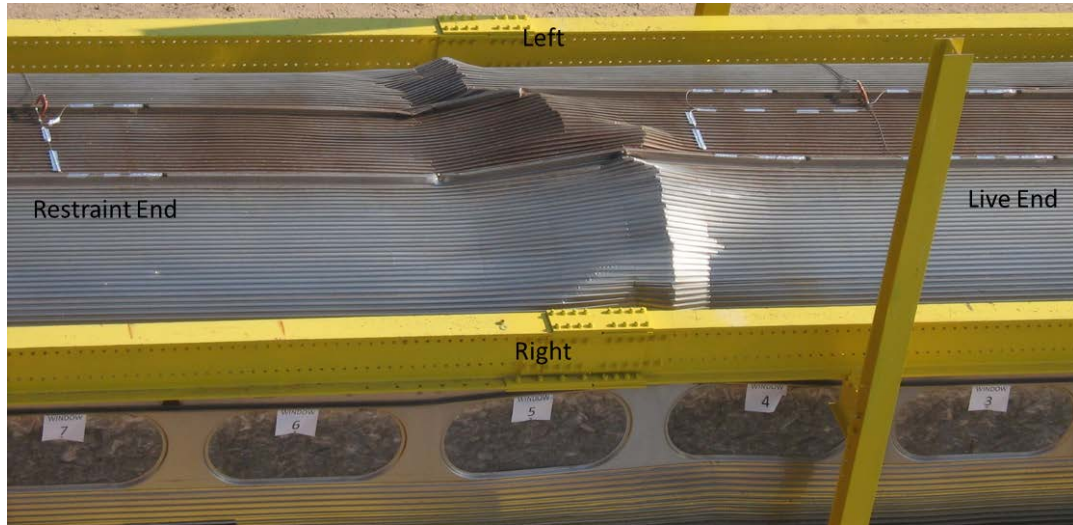
**Figure 66. Roof Buckle in Car 244**

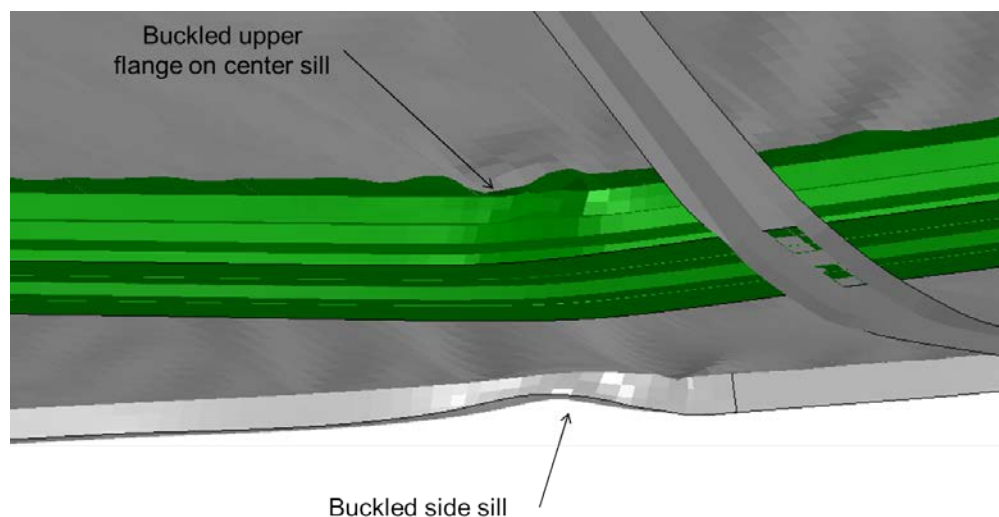
**Figure 79. Detail Showing Buckled Center Sill and Side Sill in FEA**

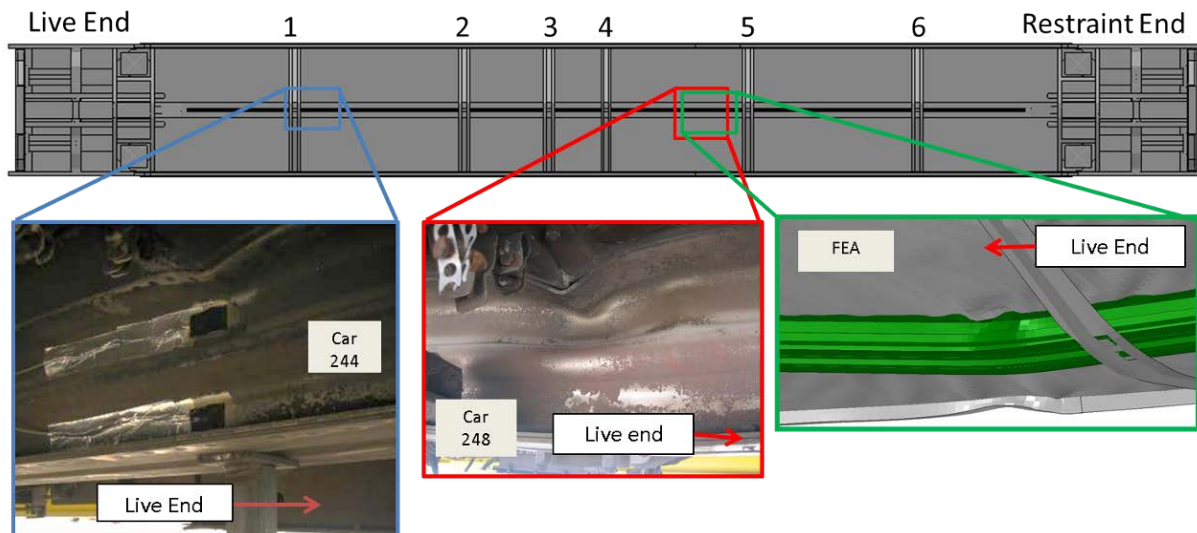
**Figure 80. Center Sill Upper Flange Buckle in Car 244, Car 248, and FEA Result**
