SOME PRELIMINARY OBSERVATIONS ON RETREAD MANUFACTURING PRACTICES

Irving Litant
Transportation Systems Center
Kendall Square
Cambridge, MA 02142

DECEMBER 1972
PRELIMINARY MEMORANDUM

1. Report No. DOT-TSC-NHTSA-72-5		2. Government Accession No.		3. Recipient's Catalog No.	
4. Title and Subtitle SOME PRELIMINARY OBSERVATIONS ON RETREAD MANUFACTURING PRACTICES				5. Report Date December 1972

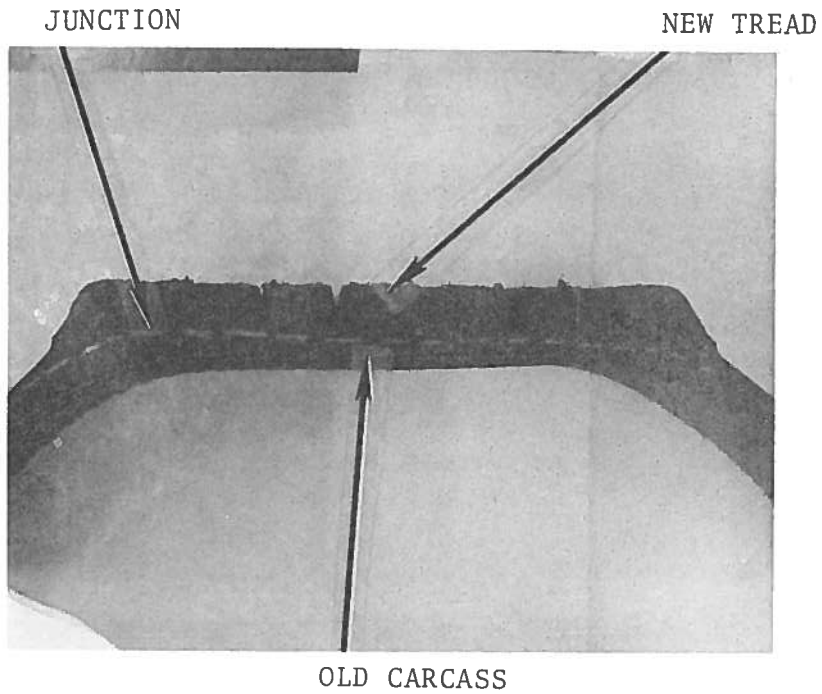
Non-uniform buffing was the most common anomaly observed. Retread shops that were visited had templates corresponding to the different tire sizes and styles which are supposed to be used as guides to provide for even removal of the old tread. The templates appeared to be seldom used. The cross section of the tire shown in Figure 3-1 is an example of this.

Non-uniform buffing results in non-uniform application of the new rubber, and although the final thickness of the tread may be uniform around the tire, the differences in modulus and resiliency in different parts of the tread would be emphasized, contributing to instability.

Figure 3-1. An Example of Non-Uniform Buffing

- a. Buffing machines with templates that would be set for specific tire dimensions that would not operate without the guidance of the template, or, as an advanced alternative, a device that would guide the buffer by continuous determination of rubber thickness by ultrasonics. A device of this type should be developed for this application.

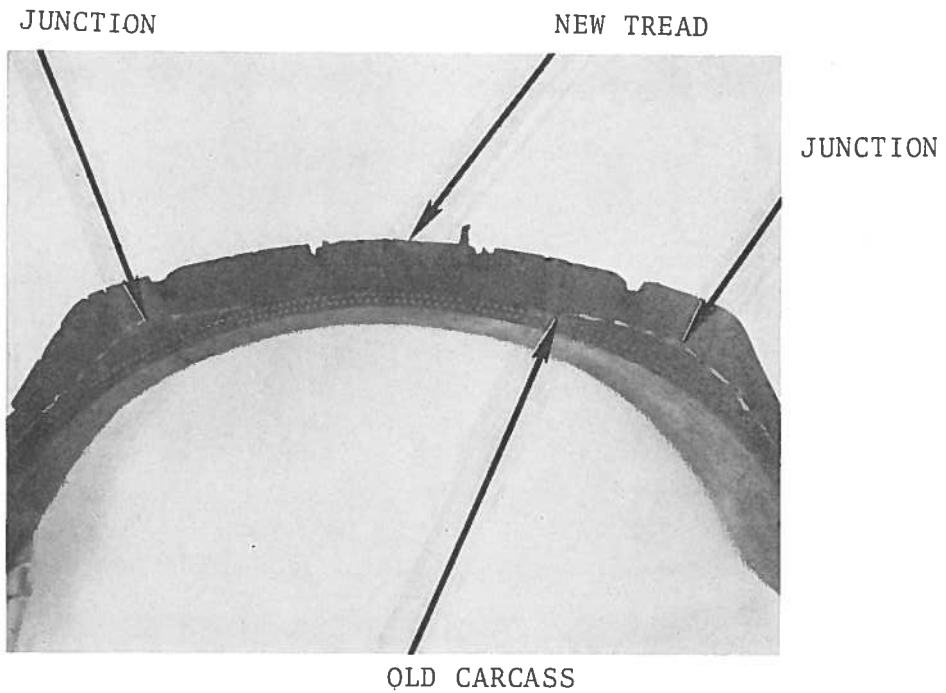
This is a special case of non-uniform buffing. When the buffer misjudges and buffs into the fabric, he is likely to damage the cords. On sectioning a tire which was buffed through the tread, the junction line is seen to disappear into the outer cord ply, as shown in Figure 3-2. To verify damage to the cords, the tread was stripped from this specimen. Figure 3-3 shows some of the abraided cord appearing through the rubber. A radiograph of the

Figure 3-2. Buffing into the Cord Ply

- b. Strict observance of the regulation concerning the unacceptability of exposed fabric. If, with the proper template in place, fabric is exposed, this may indicate undue warping of the carcass and would constitute sufficient reason for rejection.

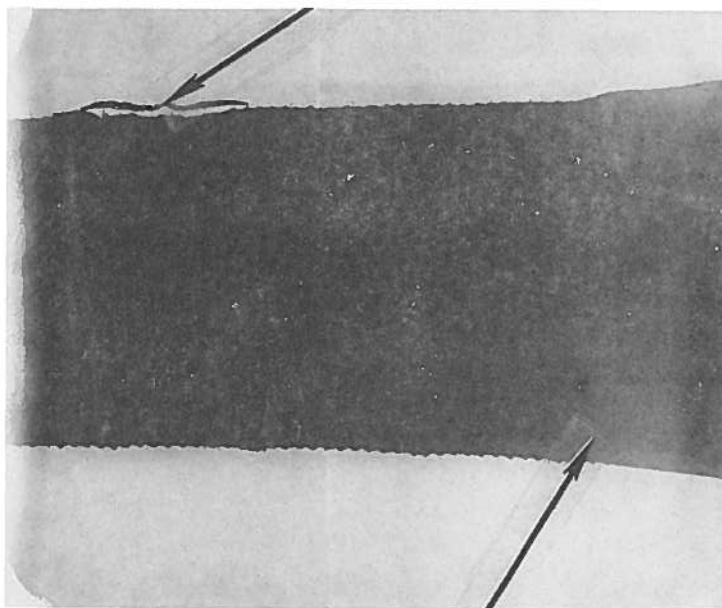
BUFFED ABRAIDED CORD

Figure 3-3. Buffed Cord Showing through Rubber

Motor Vehicle Safety Standard 117, Section 5.2.1 states, "No retreaded tire should be manufactured with a casing on which cord fabric or bead wire is exposed either before or during processing". This regulation was promulgated specifically to prevent damage to the cord and weakening of the fabric.

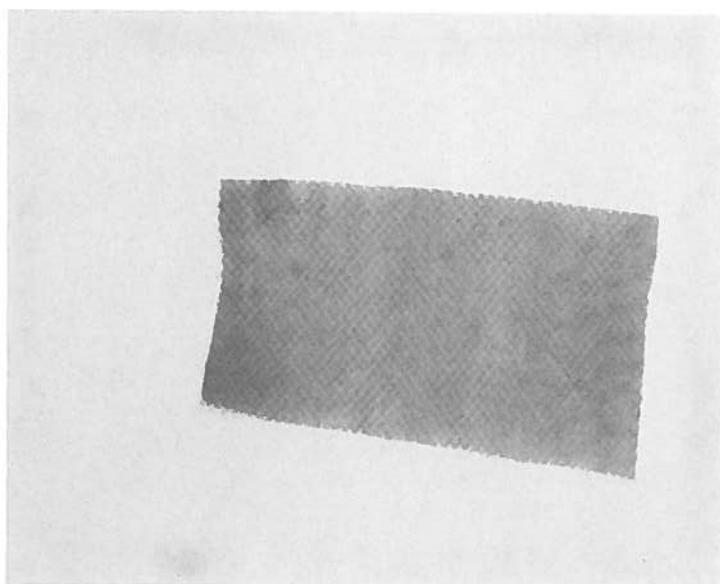
Figure 3-4. Radiograph of Section of Tread in Figure 3-3.
Faint or Missing Cords Have Been Buffed

specimen shown in Figure 3-4 indicates cords which were partly removed by buffing.

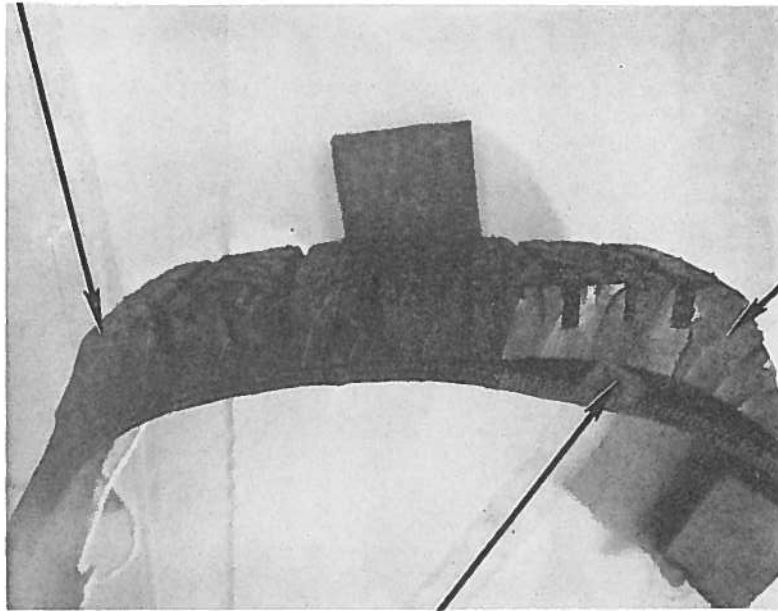
Another common anomaly is the variation in thickness from one shoulder to the opposite shoulder in the same tire. Figure 3-5 shows one such tire with a one quarter inch difference in the two shoulders. This differs from the situation described in 3.1 in which the overall thickness has been adjusted. The uneven distribution of rubber in the tread can have an adverse effect on lateral stability and could have caused the large separation created in this tire.

Figure 3-5. Shoulders Differ in Thickness by One Quarter of an Inch

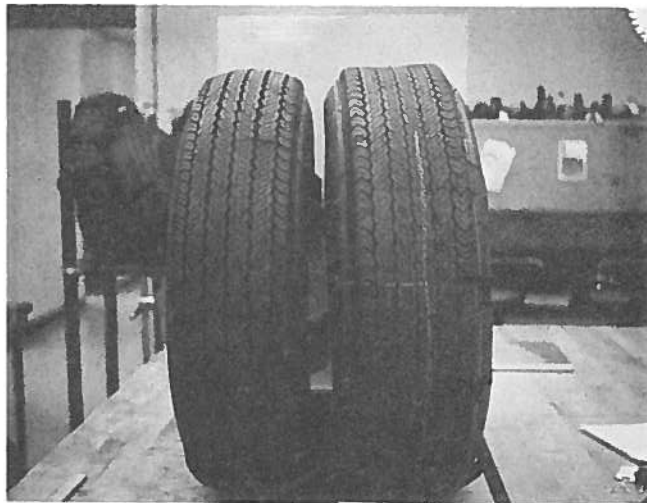
Many retreaders use a standard tread matrix design to retread all tires within their individual size categories. Thus, a tire originally designed and built with the new wider tread may be remolded with a narrow tread, and a snow tire reappears as a regular passenger tread. These retreads may now flex in a manner and in locations for which they were not originally designed, possibly resulting in unusual hysteresis heating and degradation. Figure 3-6 shows two tires of different sizes that were probably retreaded in the same mold. Figure 3-7 is a portion of a former snow-treaded tire that was remolded as a regular tread and appears to have torn itself apart.

Figure 3-6. Tires of Different Size Retreaded and Cured in the Same Mold

- c. Strict adherence to the use of the proper matrix size in retreading as dictated by measurement of the carcass, and a ban on the retreading of snow tires as regular tires.

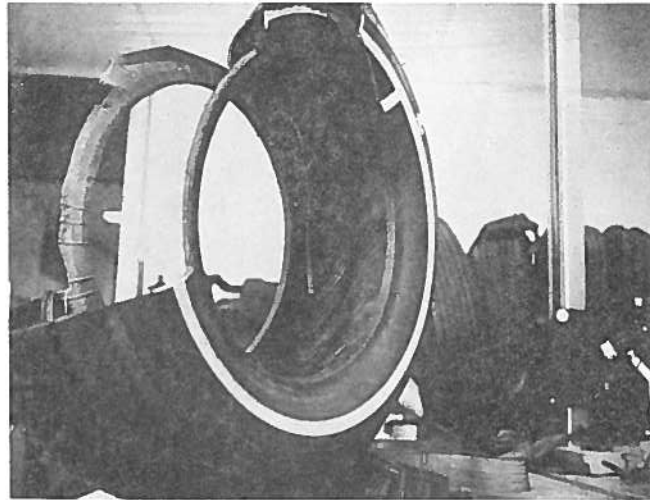
Figure 3-7. Tire Failure Resulting from Improper Remolding

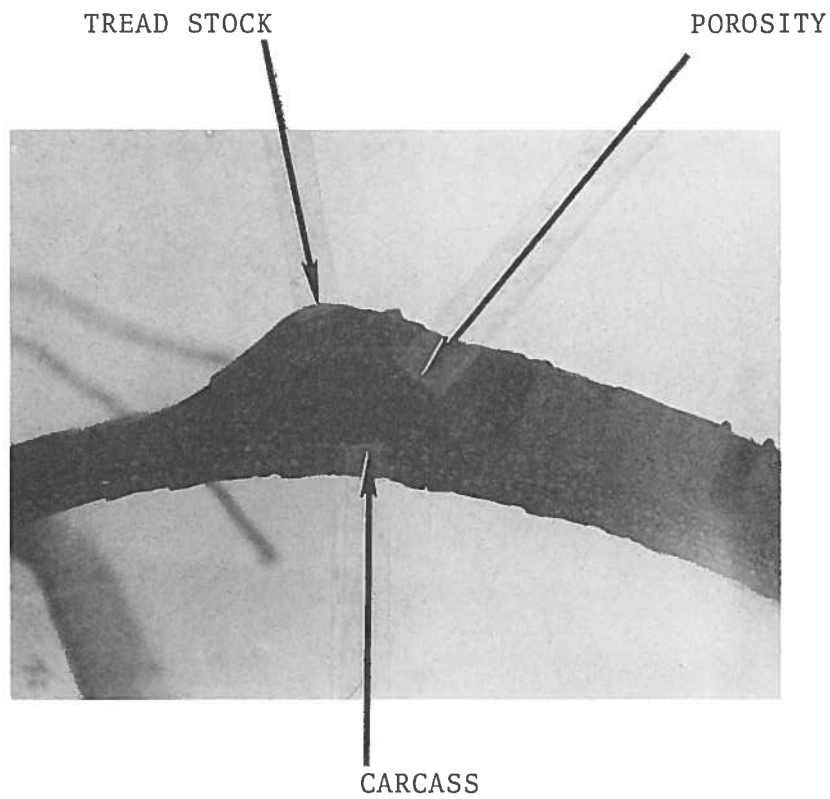
Separations were often found in the junction (interface) region between the new and old tread stock. Even more frequently, the junction was porous and relatively easy to peel. Figure 3-8

Figure 3-8. Severe Porosity in Rubber and Junction Area

shows one extreme example of junction and tread stock porosity. This problem can be caused by: 1) the use of a poor adhesive; 2) incomplete filling of the mold; 3) allowing the buffed surface to become contaminated with oil or dirt; 4) insufficient pressure applied to the inner surface while in the mold; or 5) inadequate mold temperature.

- d. With the use of a new matrix or a new batch of rubber or adhesive, examination of the first tire produced for adhesion of new stock to old, and for porosity at the interface.

- e. Greater reliability in maintaining the proper temperature and pressure in equipment, and in cleanliness of the buffed surface.
