MA 82-18

Air Conditioning Modifications for the GMC RTSII Series 01 Coach (Model TH-8201)

October 1982
Final Report

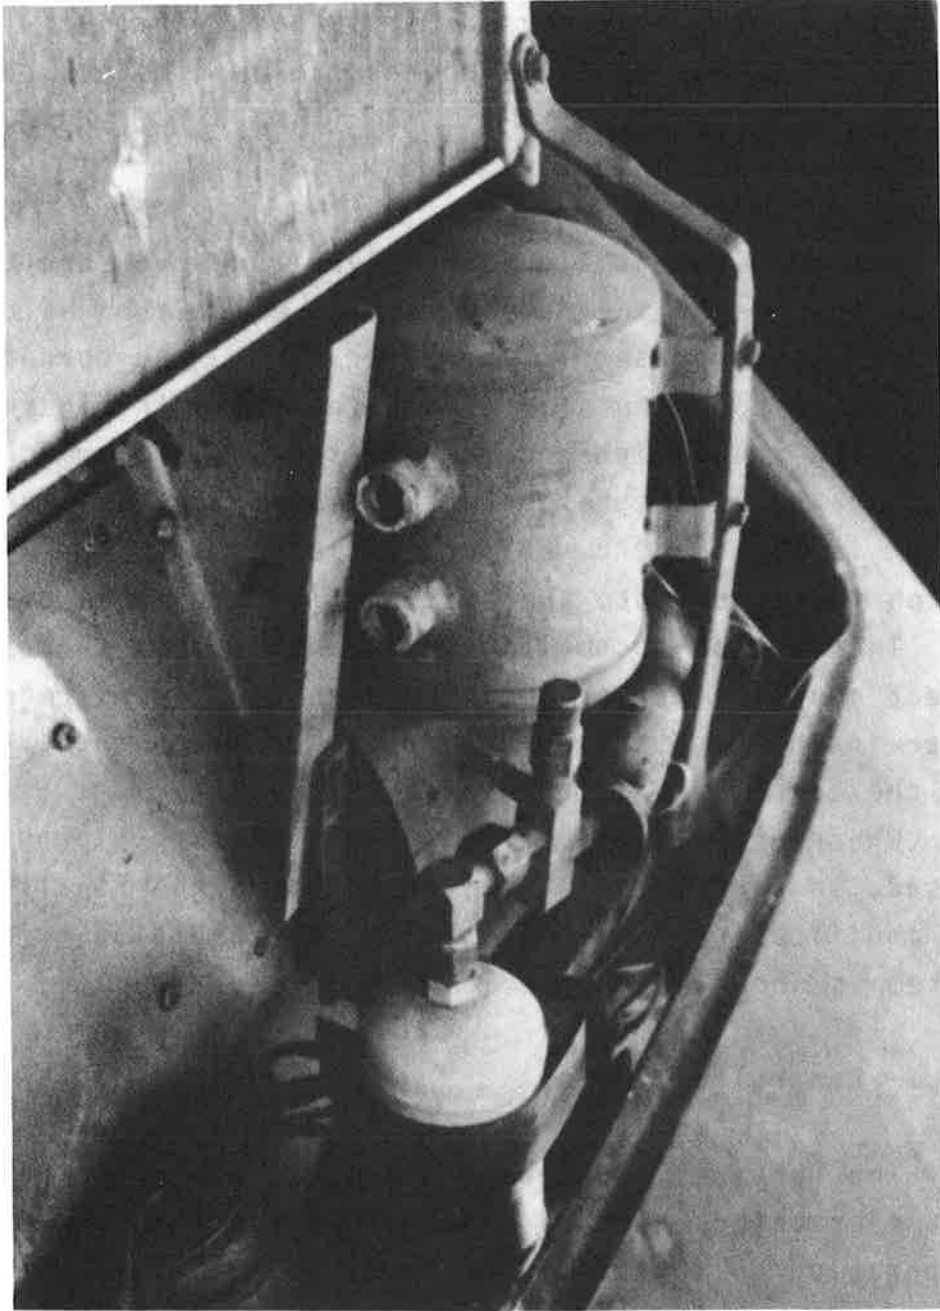
FIGURE 14

The refrigerant liquid receiver and dryer are both relocated from the engine compartment to a location below the replacement condenser in the upper right rear corner of the bus. These components are shown installed in Figure 14.

Relocated Liquid Receiver and Dryer

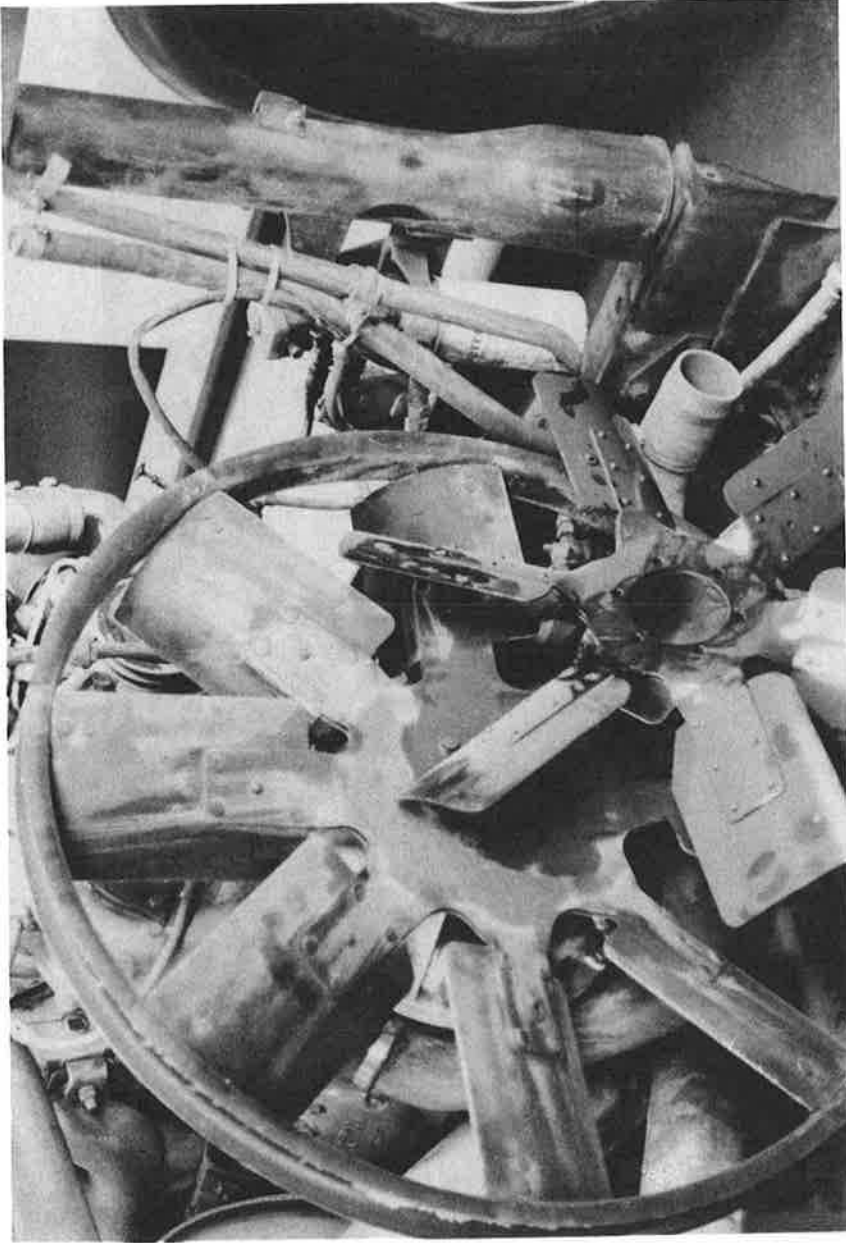
The engine cooling fan is replaced with one of smaller diameter (26 inches) than the original fan (34 inches). The new fan, a stock item, reverses the direction of air flow through the radiator, blowing the heated air out the left side of the coach. The fan has six blades, two fewer than the larger fan. The two fans are shown in Figure 18.

FIGURE 18
Eight-Blade Original and Six-Blade Replacement
Engine Cooling Fans

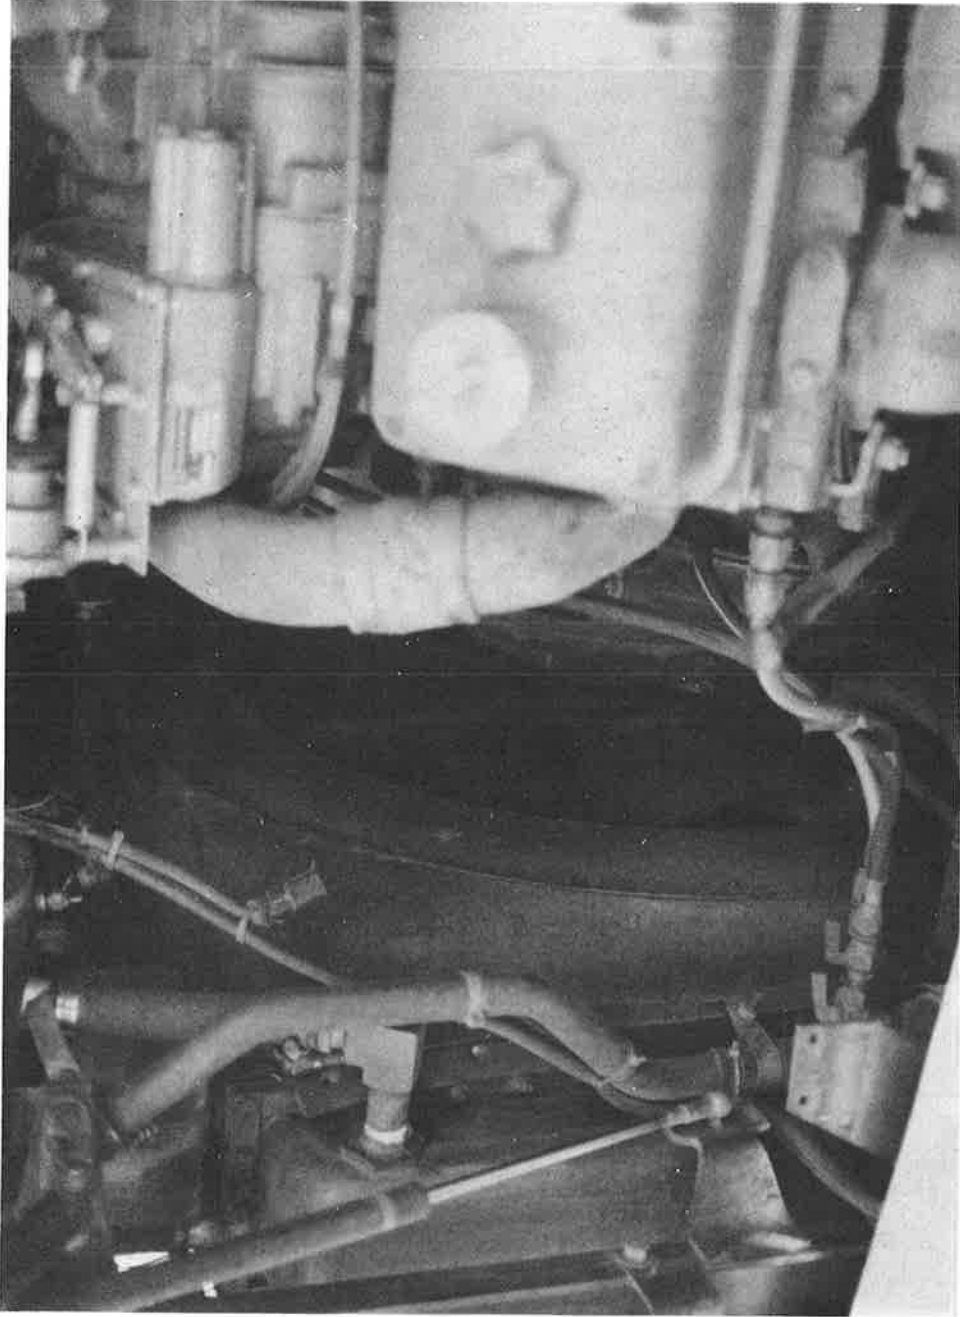
FIGURE 19
Modified Engine Cooling Fan Shroud

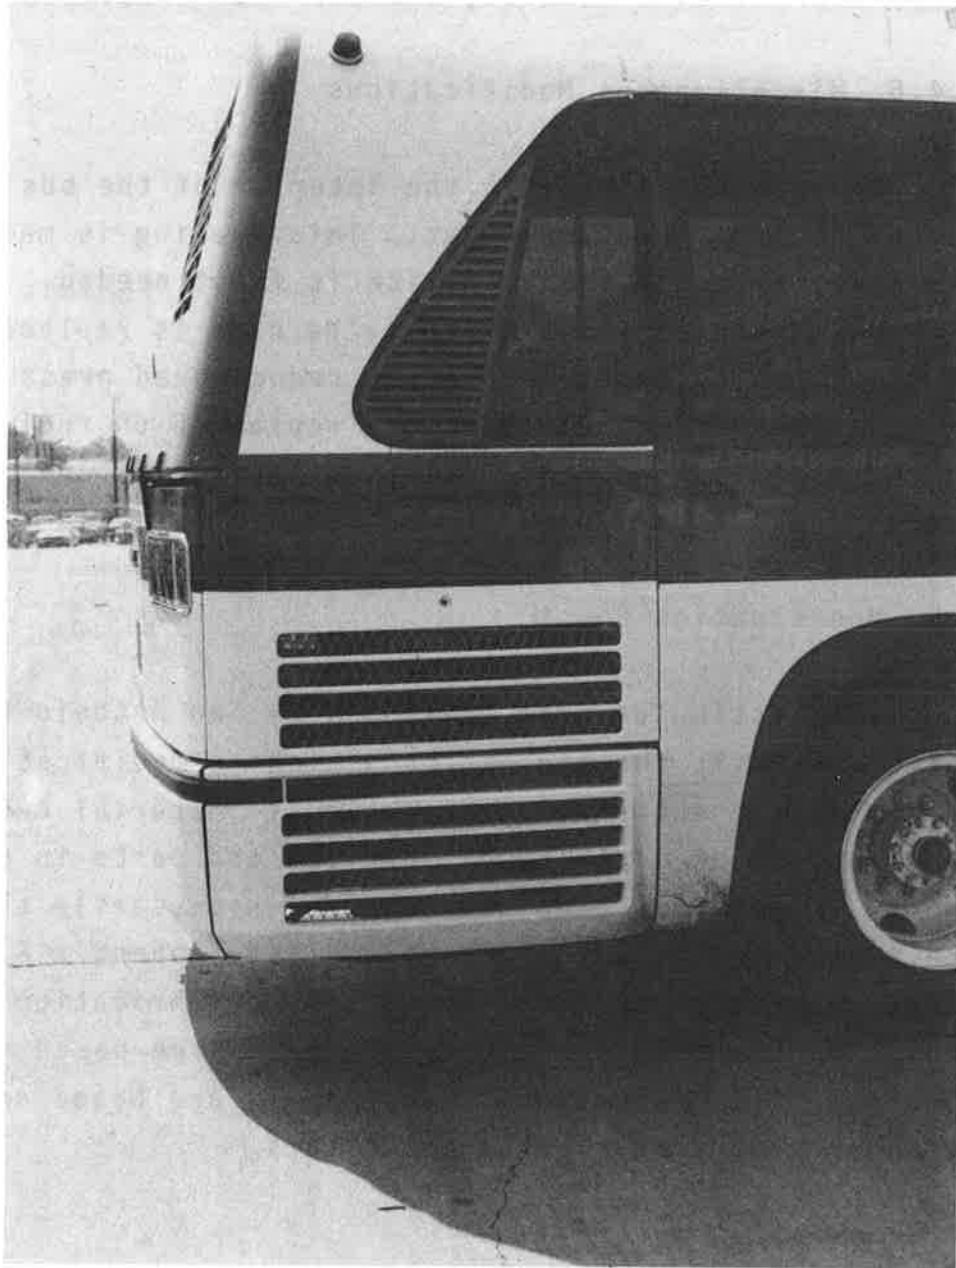
engine compartment past the transmission and the air conditioning compressor. The metal plate(s) are replaced with an expanded metal grill, shown in Figure 20. Noise levels are reduced because of the combined effects of decreased fan size, thermostatic control, and air flow direction.

FIGURE 20
Modified Right Side Air Intake Vents

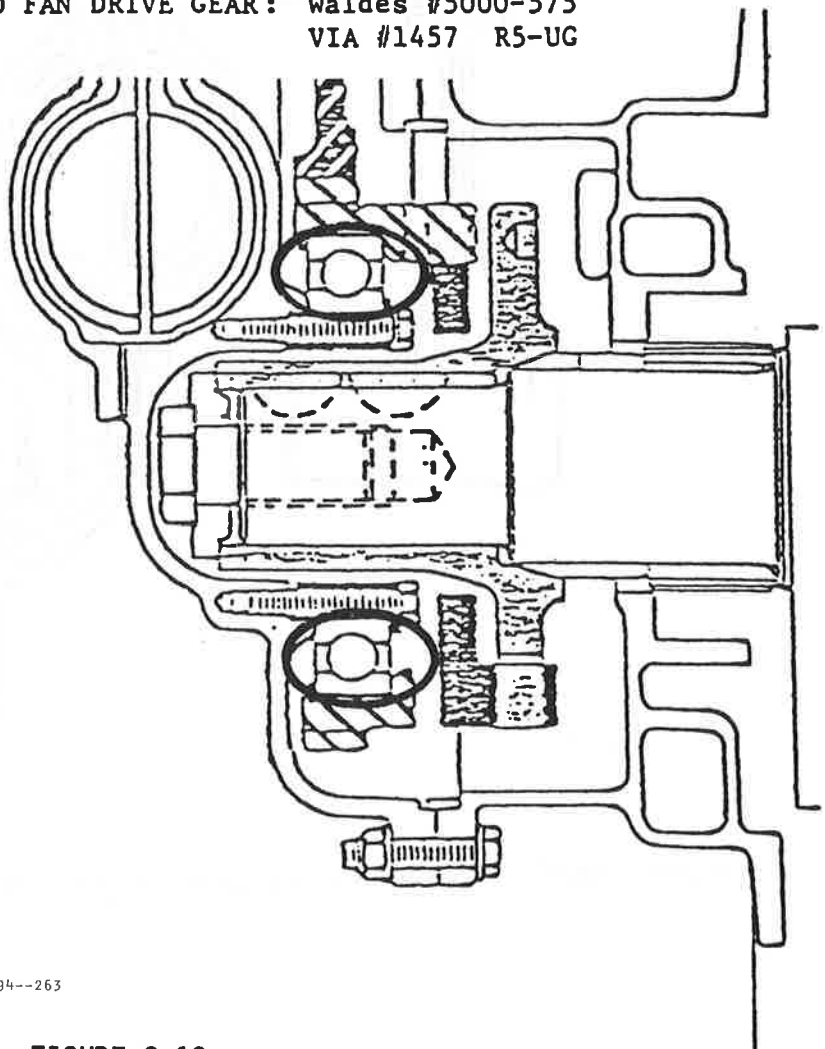
FIGURE C-13

Figure C-13: Experiencing a high failure rate with spiral snap ring P/N 2050680, the drive gear P/N 2033519 is modified as follows using a Waldes snap ring #5000-575. Machine gear as follows:

BEARING WIDTH = .940"

SNAP RING FLUID FAN DRIVE GEAR: Waldes #5000-575
VIA #1457 R5-UG
