# RECYCLING ASPHALT PAVEMENTS

Pavement Surface Recycling

Parks Highway

Project RF-F-035-1(24)

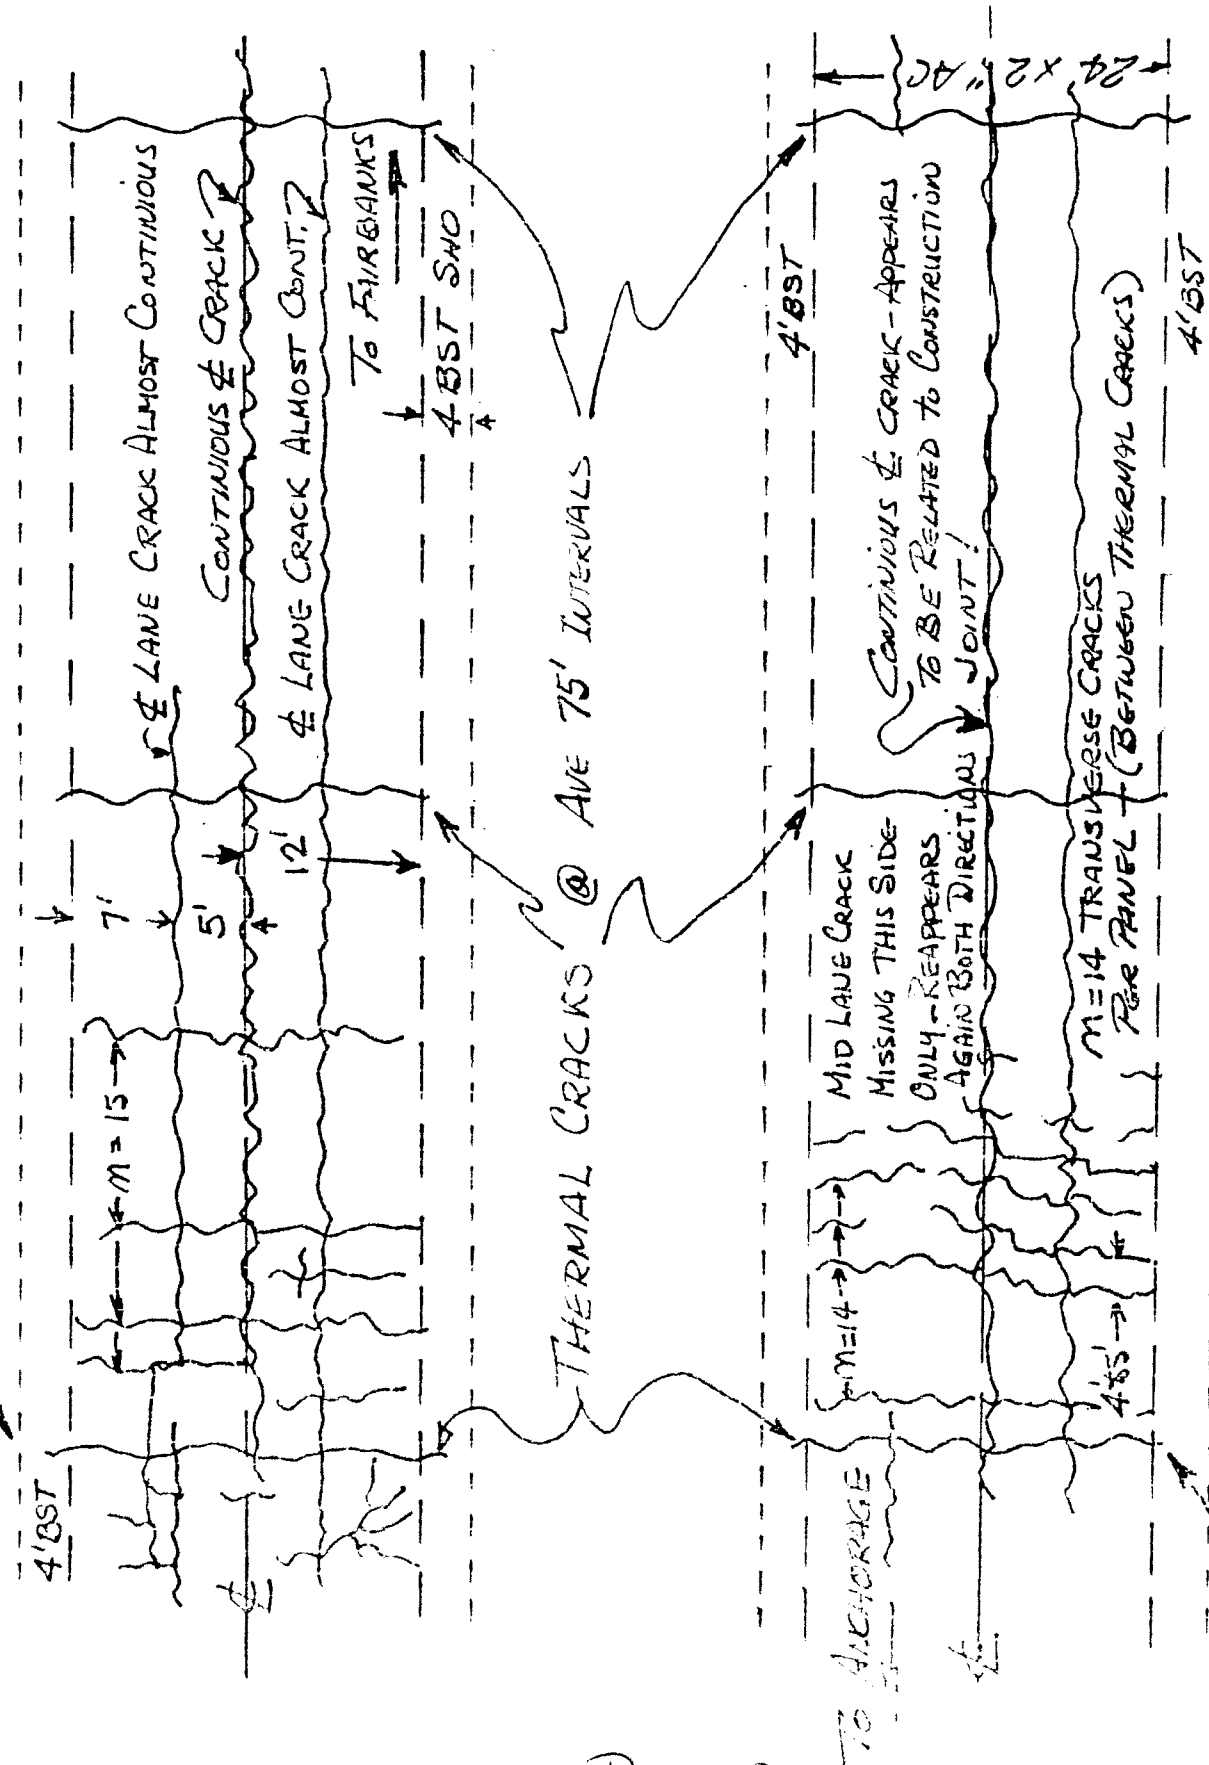
THERMAL CRACKS @ AVE 75' INTERVALS

CRACK RECORDED

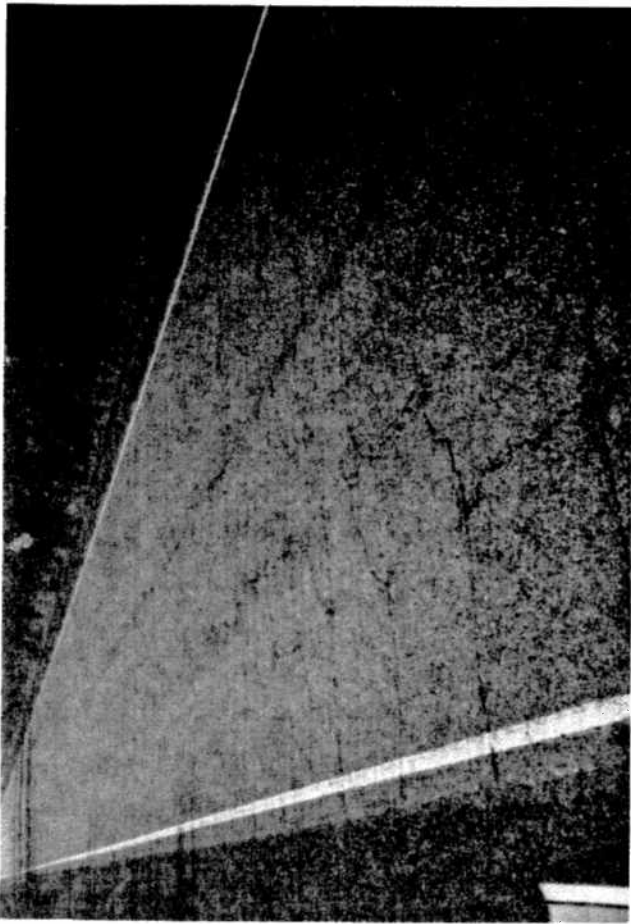
TYPICAL BLOCK CRACKING

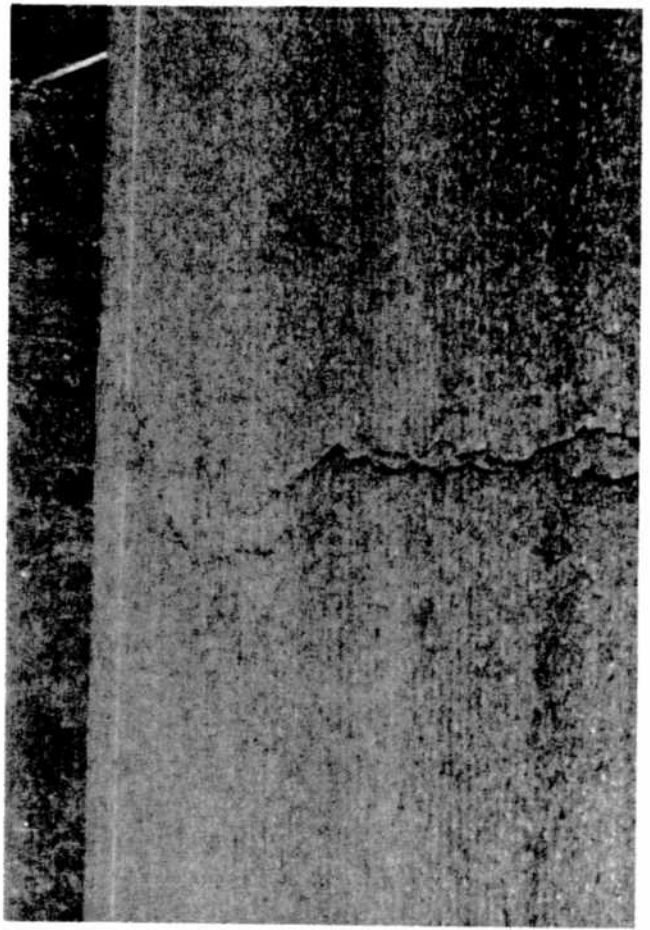
TYPICAL THERMAL CRACK

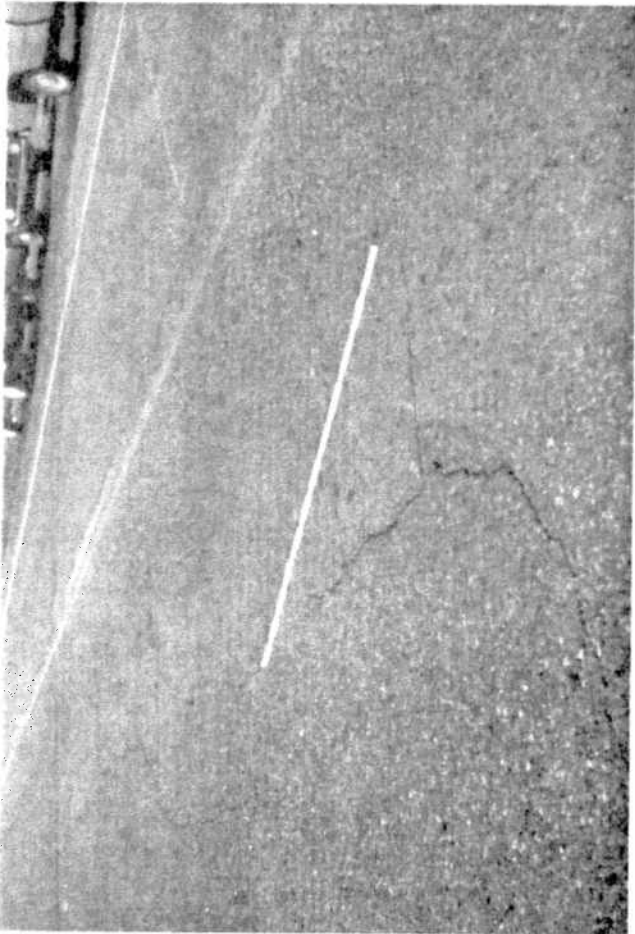
TYPICAL BLOCK CRACKING

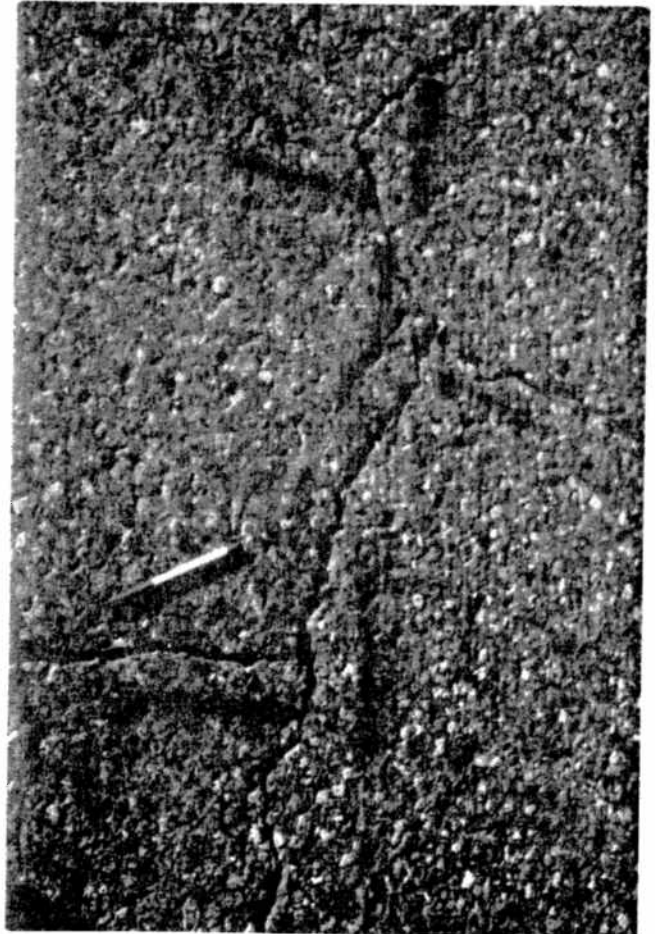
CLOSE UP OF CRACKING & RAVELING

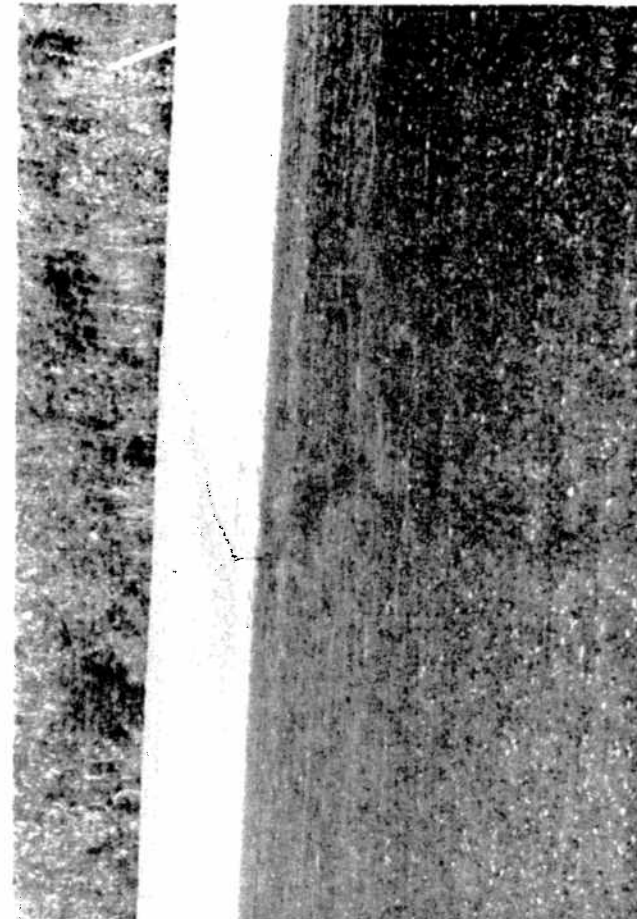
THERMAL CRACK AFTER TREATMENT

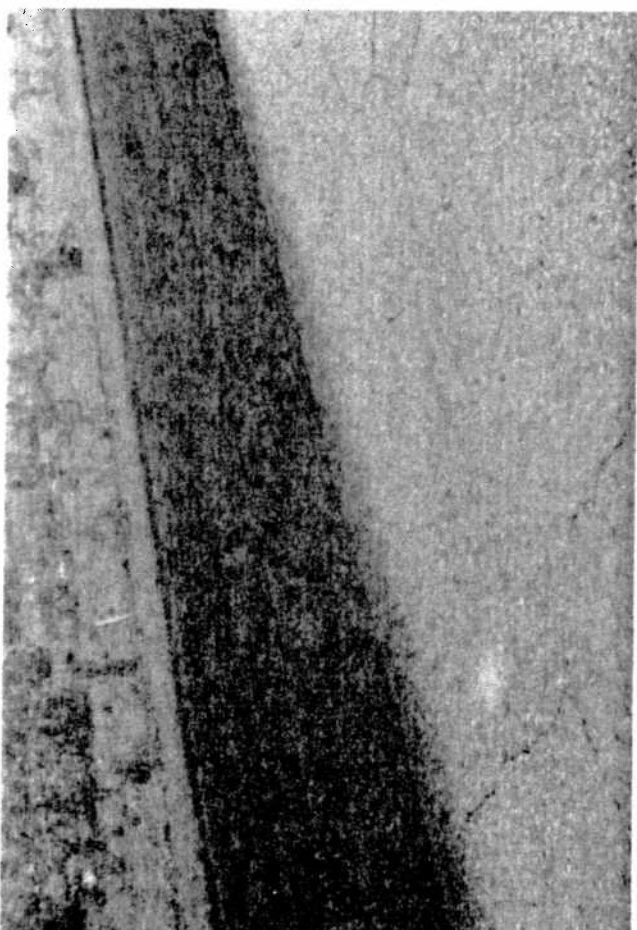
FAR LANE TREATED--NEAR LANE STILL CRACKED

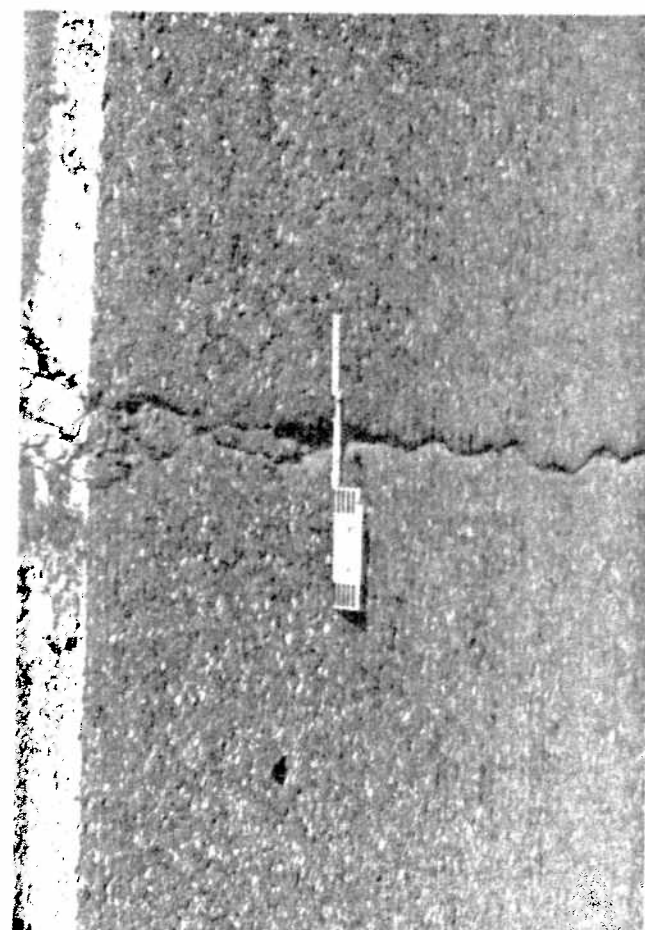
THERMAL CRACK SPALLING
