DOT-TSC-UMTA-83-33

Updated Reliability Evaluation of V730 Transmission

Prepared by:
Transportation Systems Center
Operations Assistance Division

July 1983

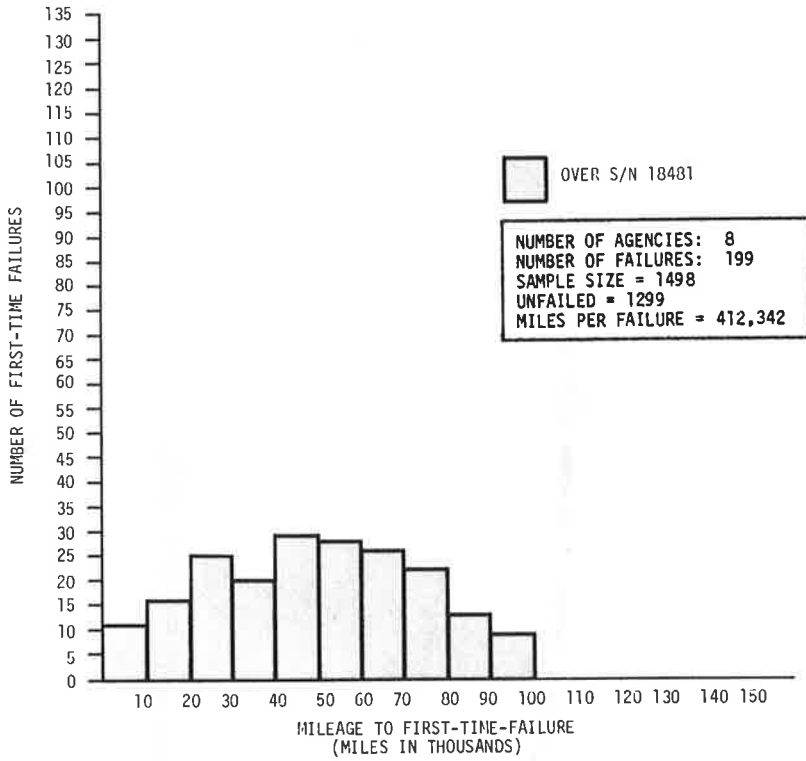
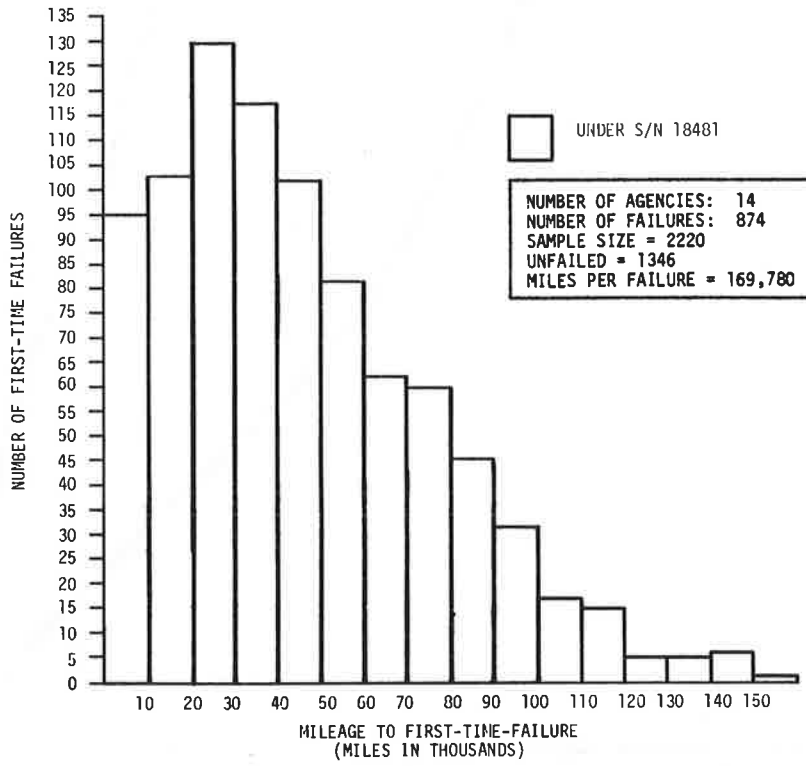
FIGURE 1. DISTRIBUTIONS OF ACTUAL V730 MILEAGES ALL AGENCIES COMBINED

It is evident from comparisons between the two histograms of Figure 1 that not only do earlier transmissions show first failures peaking at rather low mileages, but about 40% of the transmissions appeared to have failed by the 100,000 mile point. It is obvious from Figure 1 that the earlier units tend to have their first failures at lower mileages; a substantial percentage of such transmissions first-failed at 10,000 miles or below.

It can also be seen from Figure 1, that the miles per failure $\left[\frac{\text{unfailed miles} + \text{failed miles}}{\text{failures}} \right]$ of the over-serial-number 18481 units show a better than two-to-one improvement, showing slightly over 400,000 miles per failure. At about corresponding points in fleet maturity the older product had 61% transmissions still running while the newer product shows 87% still running.

Transmissions with serial numbers above 18481 show a much reduced incidence of early life failures. Low serial number transmissions showed that 10.9% of the failures mentioned above had occurred at or below 10,000 miles. Higher serial numbered transmissions have had only 5.5% of their total failures to date at 10,000 miles or below. Thus, the number of early failures (under 10,000 miles) is not present to the degree that it was in earlier V730 product.

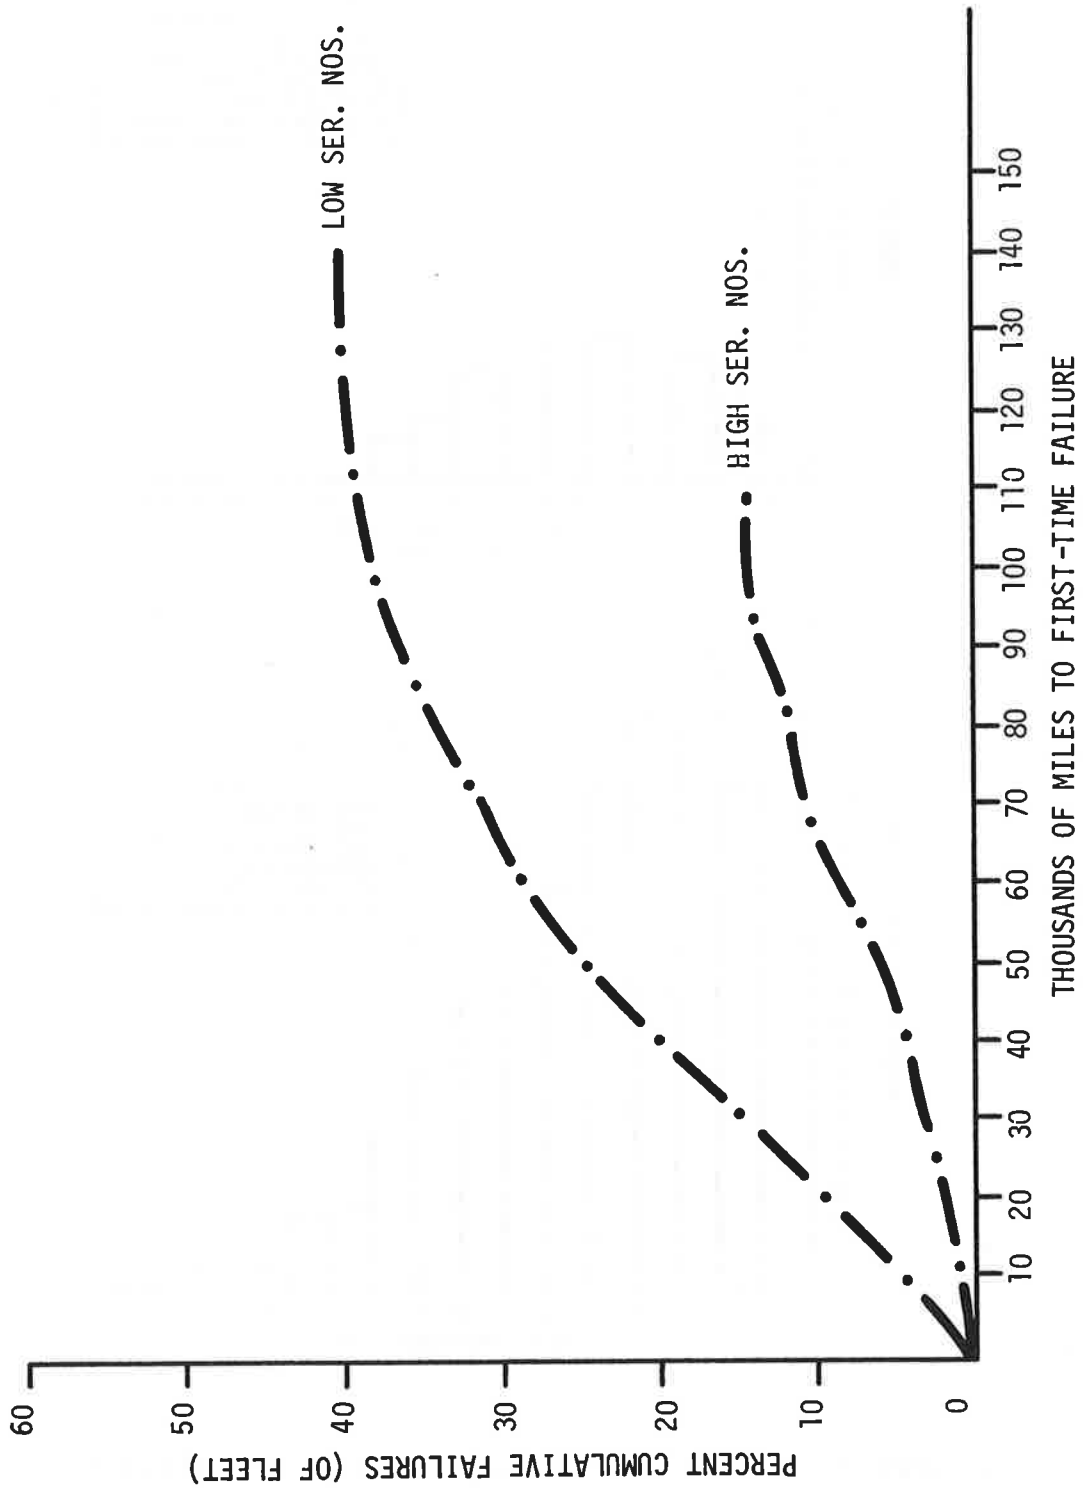
FIGURE 2. FAILURES AS PERCENT OF FLEET

The cumulative failure profiles (percent of fleet) are represented in Figure 2. These curves are based on the successive addition of the failures represented in the histograms of Figure 1. The improvement attributable to the higher serial number transmissions is self evident.

It can be seen that the cumulative failure curves of Figure 2 do not start upward again which, if this did, would imply a wear-out situation.

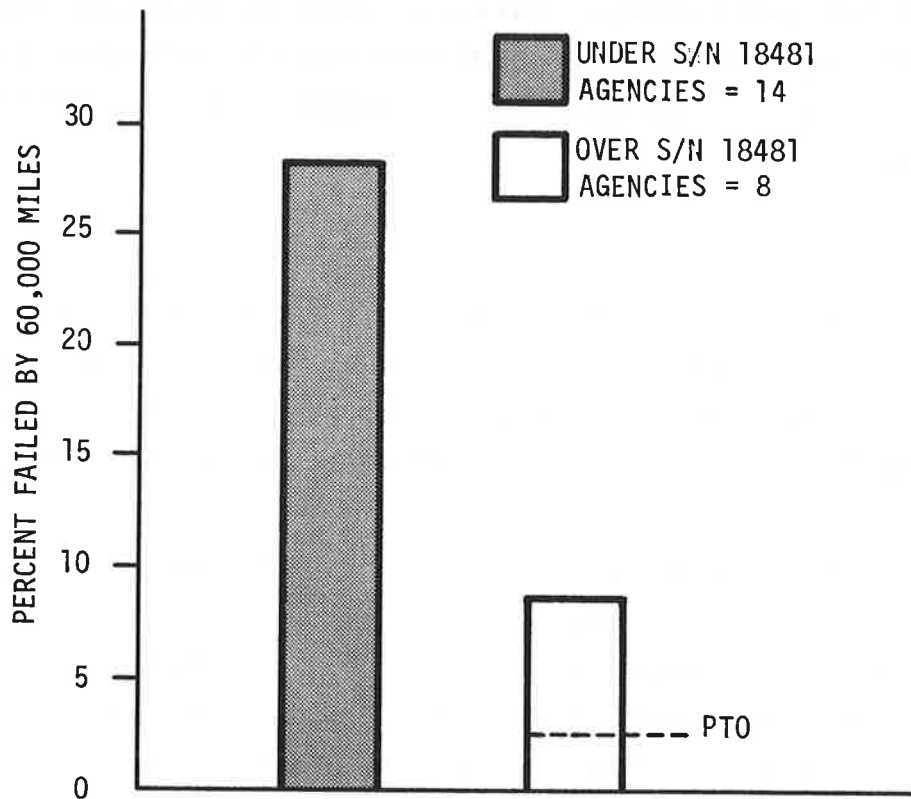
FIGURE 3. PERCENTAGE OF FLEET FAILED BY 60,000 MILES

The average bus of the high serial number fleet has achieved 60,000 miles. At this point, the older fleet (February 1982 report) had failed 28.3% of their lower serial number V730 transmissions. Only 8.8% of the newer transmissions, including those with power-take-offs have failed; the numbers range from zero to a maximum of 12% (at SCRTD). This contrast is shown by Figure 3. Sufficient mileage has been accumulated for those higher serial numbered transmissions to warrant a reasonable degree of confidence in these results.

The power take off problem has long been recognized as a large part of the V730 difficulties. Figure 3 shows that of the 8.8% high-serial-number transmission failures, 2.5% were PTO related. Thus, DDA has placed a high priority on resolution of this particular problem.

DDA is incorporating a viscous damper attached to the air conditioning compressor pulley to smooth out the damaging vibrations generated by certain compressors and their supporting "system" such as belts, platforms, cushions, brackets, clutch, etc. DDA found that the compressor system was setting up a "clatter" (vibration) in the PTO drive train, especially around 1000 rpm. This speed, of course, is a very common engine speed (fast idle) necessary whenever the bus is parked with its engine running to maintain air conditioning. The viscous damper has been tested in the laboratory and on a few operating coaches. More significantly, forty dampers were installed in Miami and operated throughout the summer of 1982. No PTO problems were experienced. The point to be noted is that a quantity of the devices have shown effectiveness over a reasonable period of time.

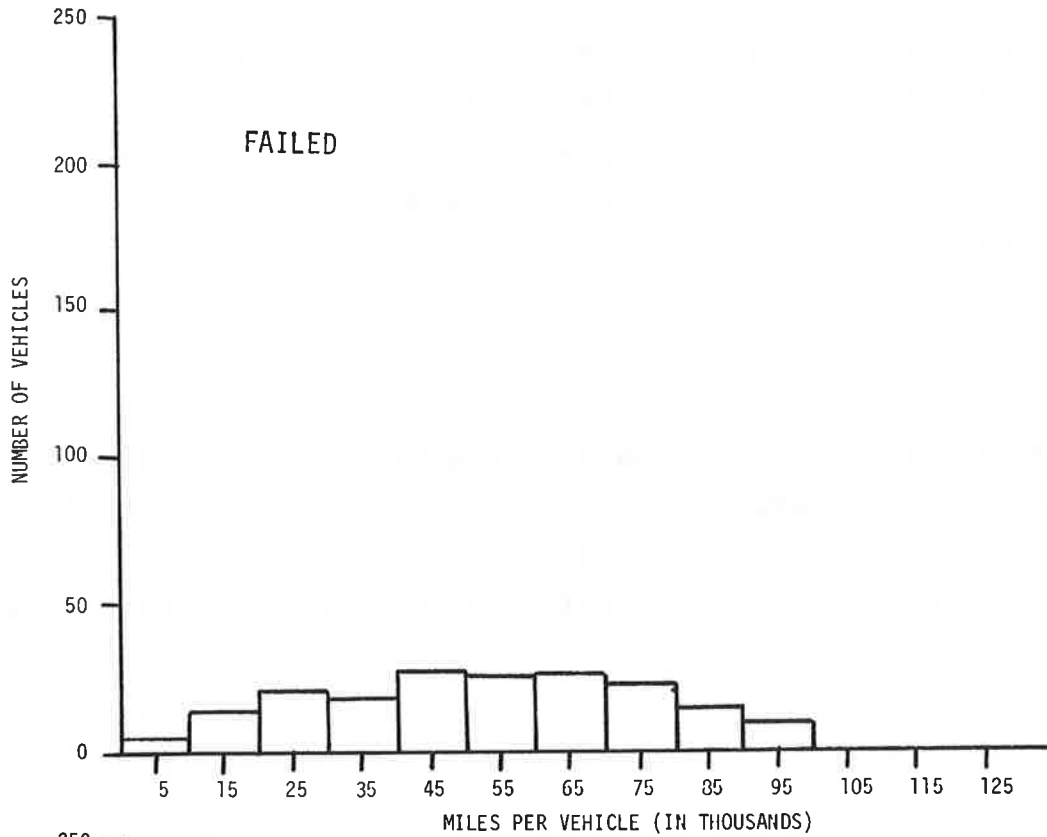
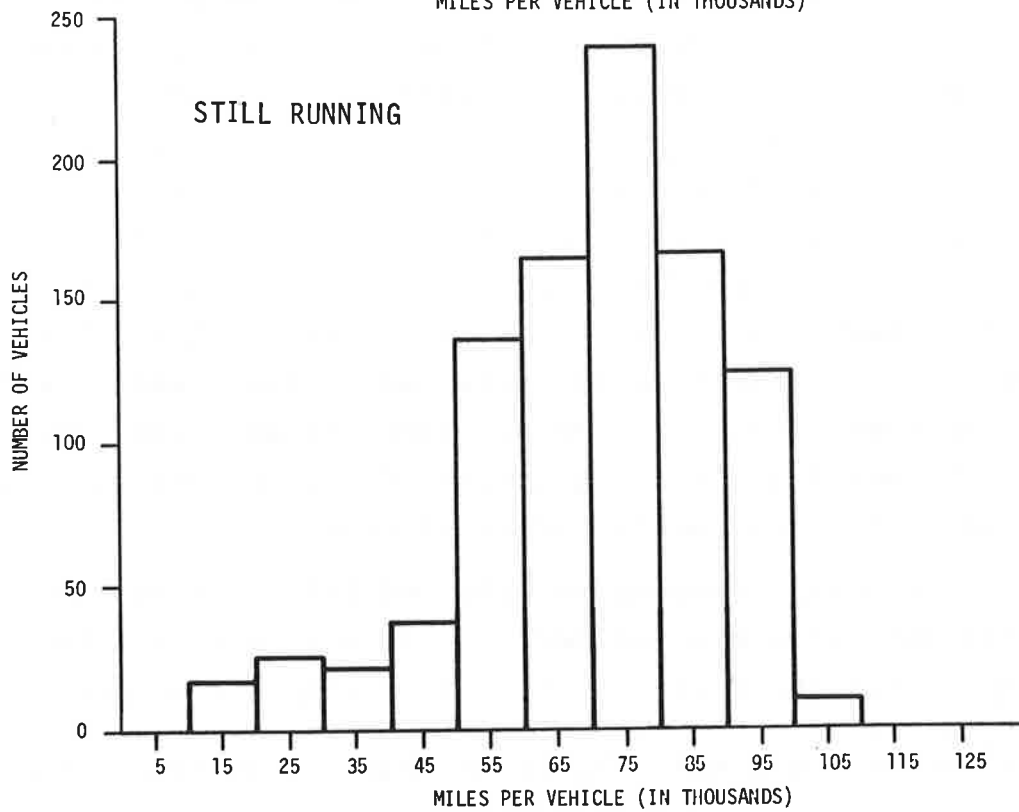
FIGURE 4. SCR TD FLEET MILEAGE DISTRIBUTION FOR V-730'S ABOVE S/N 18200 AS OF AUGUST, 1982

The SCRTD V730-equipped coach data covers a relatively large fleet with a high proportion of high-serial-number transmissions. The combination warrants a reasonably high degree of confidence in the resulting "old versus new." SCRTD data is separately identified in Figure 4.

Figure 4 shows both the failed and still-running portions of the 940 vehicles with transmission serial numbers above 18200. Of the 181 failed transmissions, only 25-30 are between serial number 18200 and the "turning point", serial number 18481. Thus, it is fair to maintain, that the 940 SCRTD units constitute a valid high-serial-number fleet.

The 940 coach fleet is averaging 75000 miles per coach. Figure 4 also shows that about 81% of this fleet is still operating without first transmission failures. The remaining 19% failures are primarily PTO problems. Of the 181 total failures, 75 are PTOs and these failures increased as the Los Angeles weather warmed up. The 181 failures were as follows;
