REPORT NOS. DOT-TSC-NHTSA-79-51

# CORRELATION BETWEEN ULTRASONIC NONDESTRUCTIVE INSPECTION AND WHEEL TEST OF 34 RETREADED TIRES

NOVEMBER 1979

FINAL REPORT

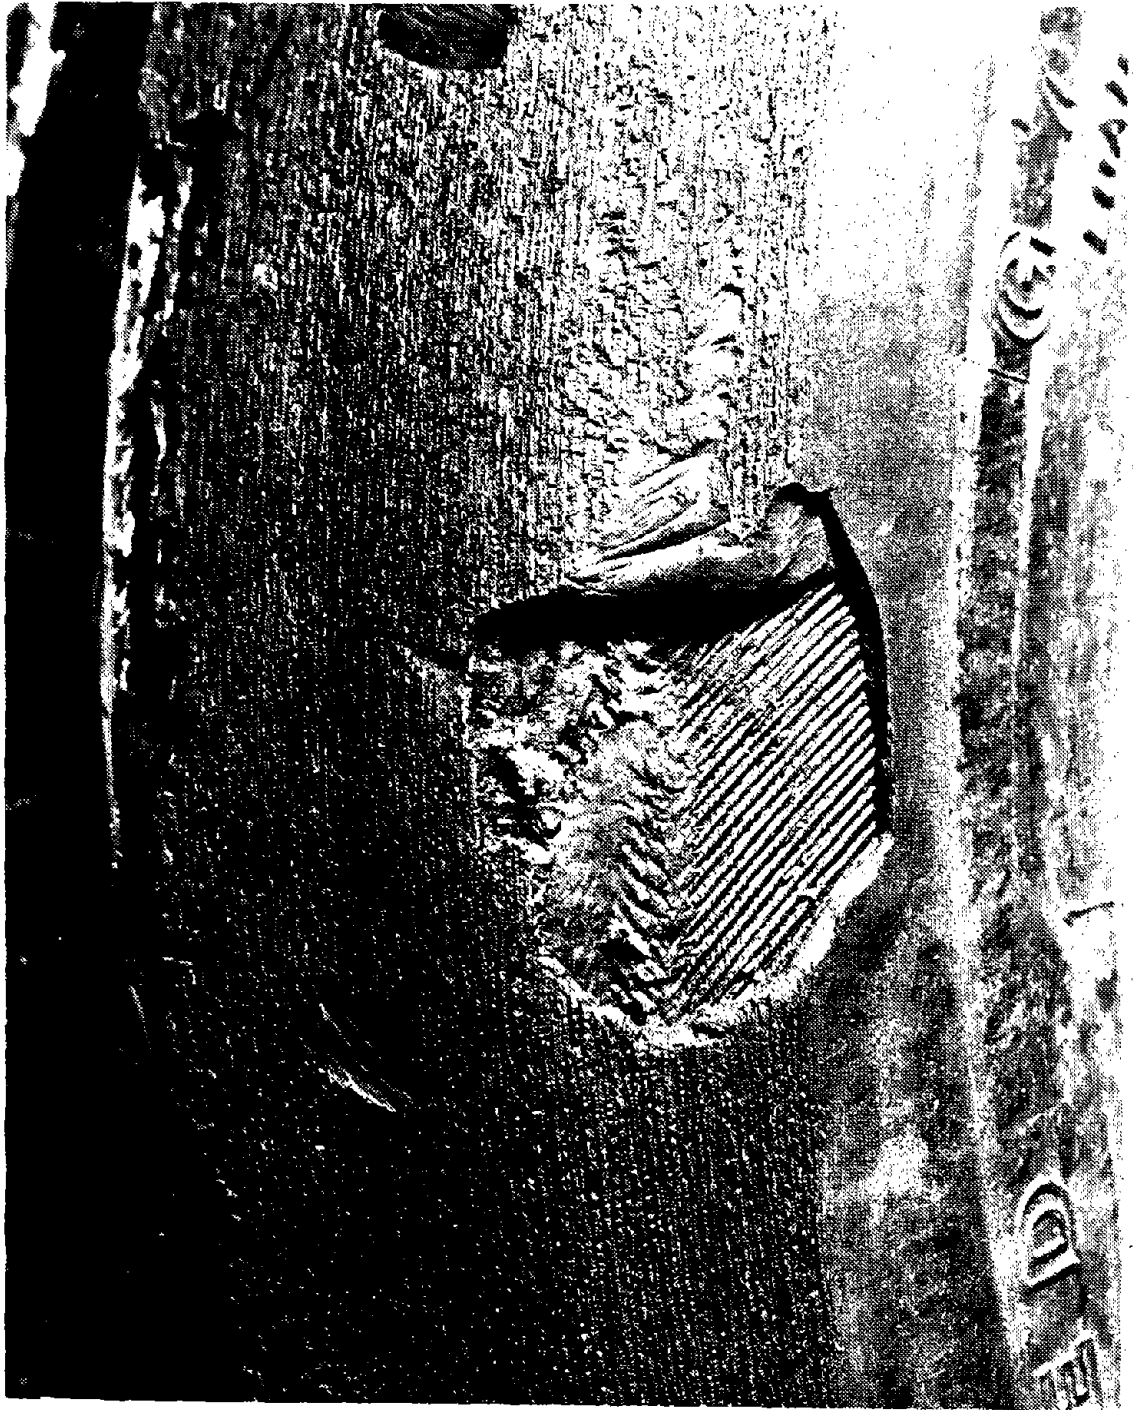
It is commonly accepted that separations above one-half inch in size, if located at critical sites, will eventually cause failure of a tire. This criterion seems to be true whether the tire is new or retreaded. The rate of degradation of a tire with a separation is highly dependent on the location of the separation and appears to be different for new and retread tires. It is generally thought that belt edge separation is one of the most common and destructive causes of tire failure. These separations seem to occur in most radial tires after a period of service but, if the tire is properly built, they remain small and only achieve accelerated growth toward the end of wear-out. However, for retreaded radial tires, belt edge separations appear to be the principal cause of failure. A typical example of this is shown in Figure 2-1.

FIGURE 2-1. BUFFED INTERFACE AND BELT EDGE SEPARATION T5X 1223

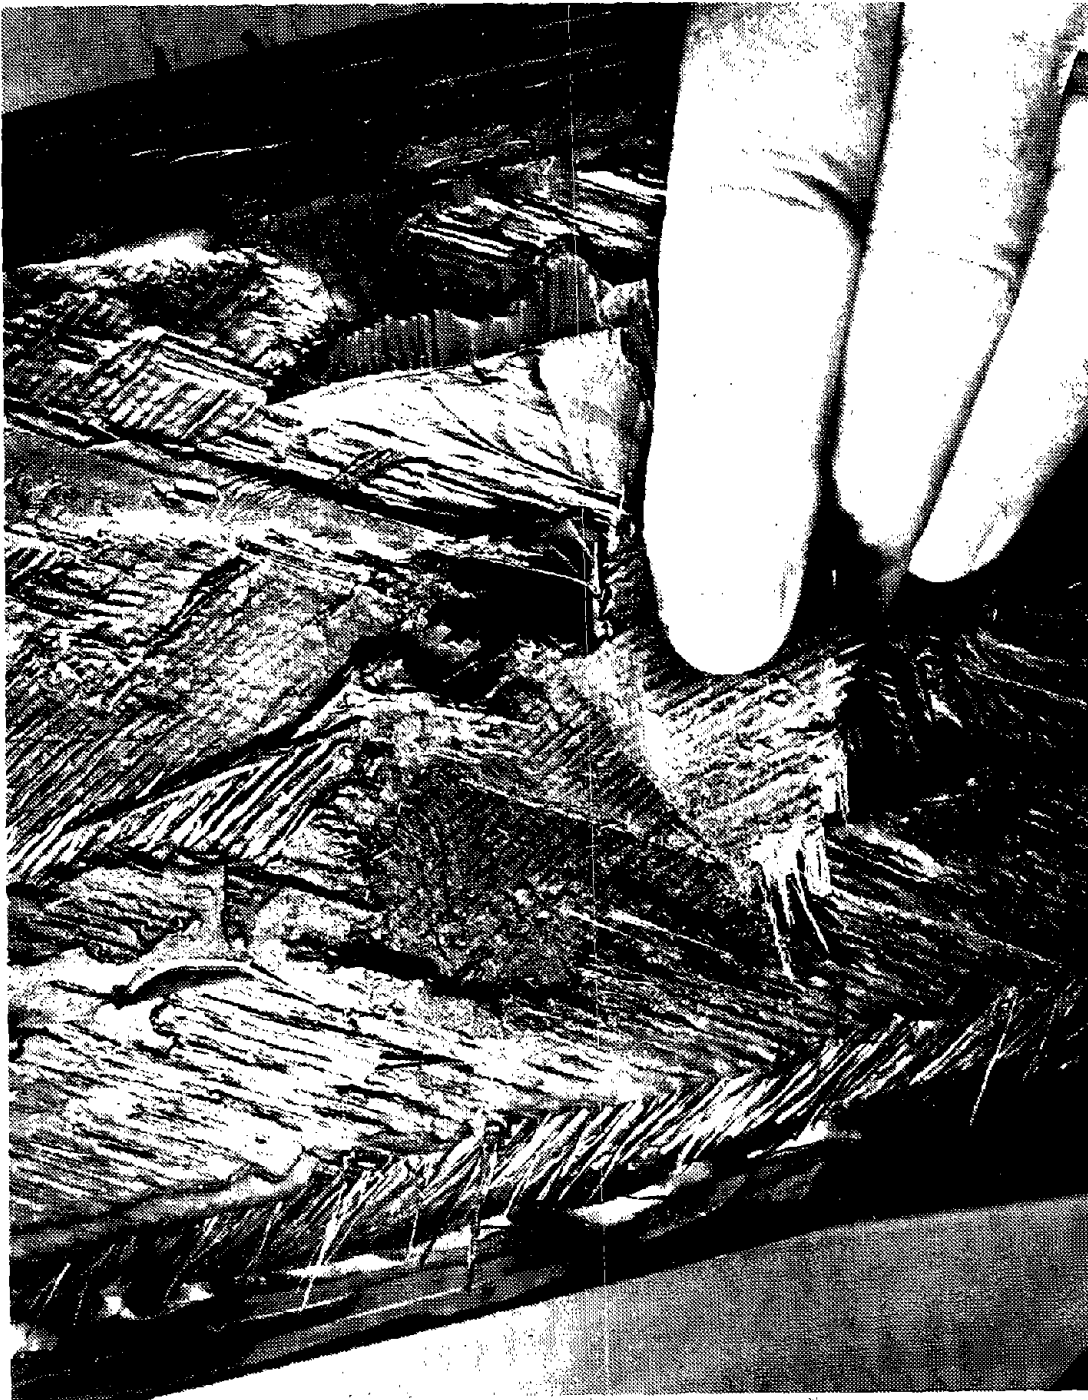
Belt breakage, shown in Figure 2-2, is far more prevalent in retreads than in new tires. Although new green tires are sometimes "trapped" in a mold in such a way that the expanding

FIGURE 2-2. SEVERE BELT BREAKAGE AND FAILURE AREA T5X 1183

mold bag will break the belt during curing, this is a rare phenomenon. Belt breakage usually occurs either as a result of marginal design practice on early glass belted tires, or by abuse or road hazard damage during the service life of the tire.

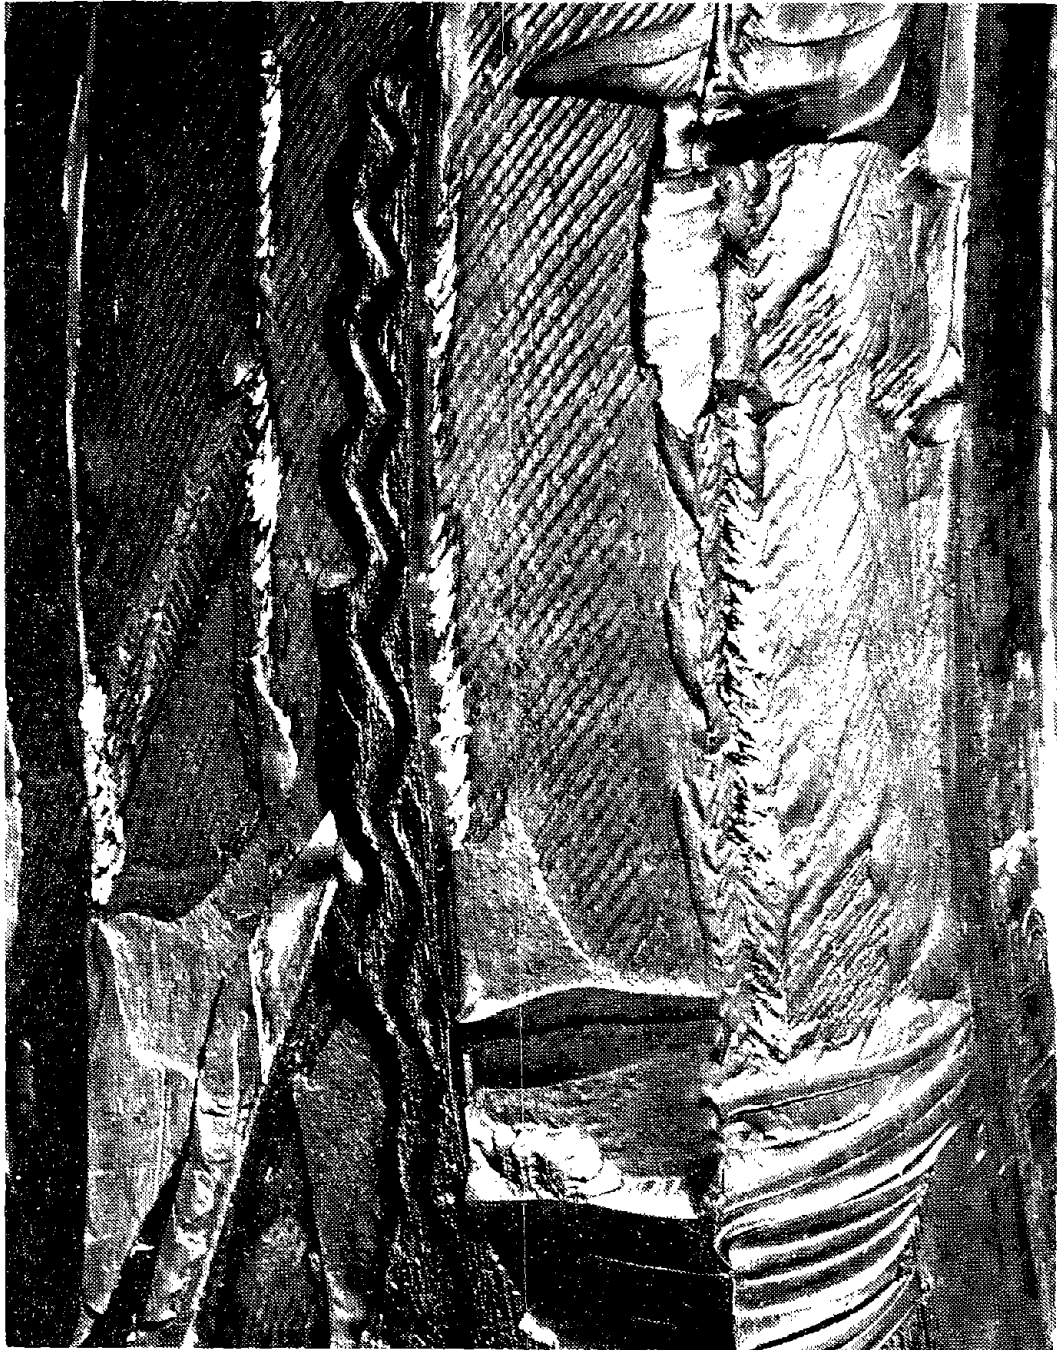
A principal cause of the early failure of retreads and a problem in new tire manufacture is the amount of tread thickness between the groove bottom and the outer ply of the belt. Figure 2-3 is a picture of the condition as found in one of the tires in this study. The groove bottom is nearly in contact with the outside belt and the result is a burned groove bottom and a failed tire.

FIGURE 2-3. BURNT MOLD GROOVE LINE T5X 1223

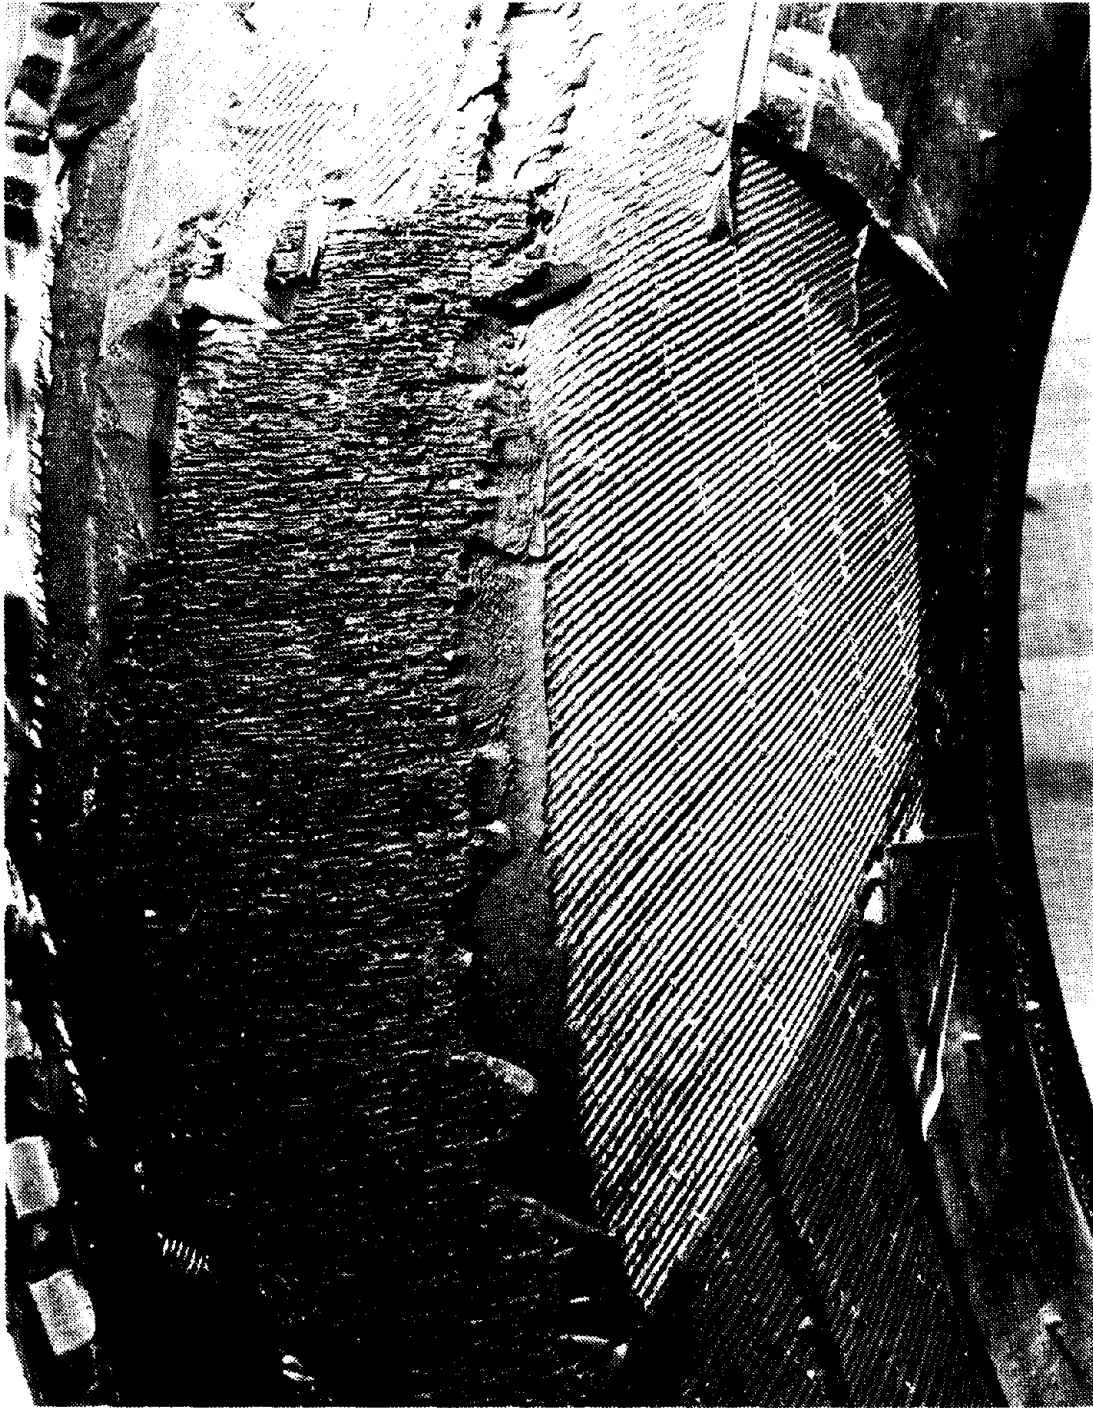
the relationship between overbuffing and failure, modern retread practice considers overbuff a harmful condition. Figure 2-4 is a clear representation of many of the major problems of the modern retreader. This casing selected by a casing supplier and inspected several times prior to retreading had in it an area which was in an incipient failure mode, probably from the beginning of the tire's life. Careful use had permitted the tire to run through one service life with an area of poor adhesion in the tread and sidewall. However, when the tire was subjected to the thermal wheel test, the old problem became aggravated, resulting in heat buildup and causing an adhesion failure in the buff line.

FIGURE 2-4. SIDEWALL SEPARATION AND AREA OF POOR RUBBER ADHESION T5X 1161

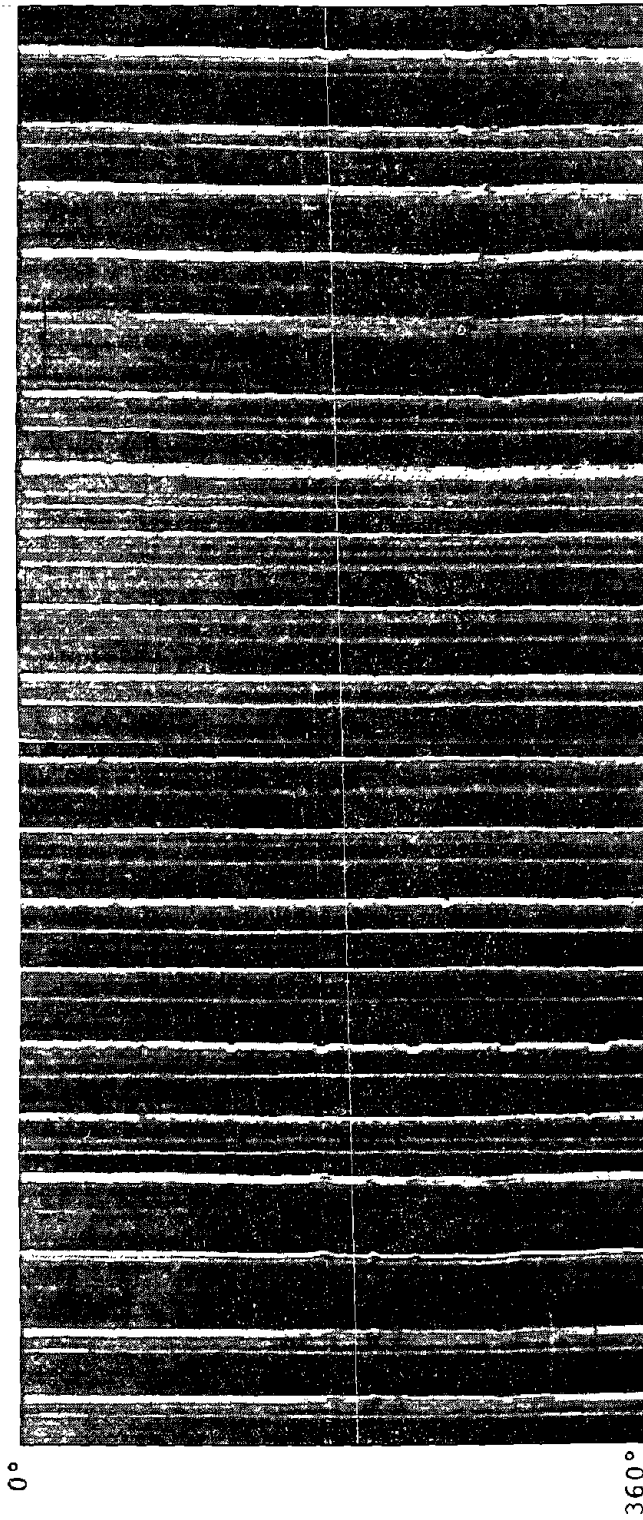
FIGURE 3-3. TIRE T5X 1172R

Although this tire passed the wheel test, Figure 3-3 shows evidence of some abuse in the white sidewall shoulder. Channel 17 (trace in rectangle) is indicative of belt edge separation. The anomalies in channel 7 are generally caused by bagmarks in the liner and are not considered abnormal. The anomaly in Channel 9 would have been considered if it did not look so much like those in channel 7. Inspection of the tire showed nothing that would account for these conditions.

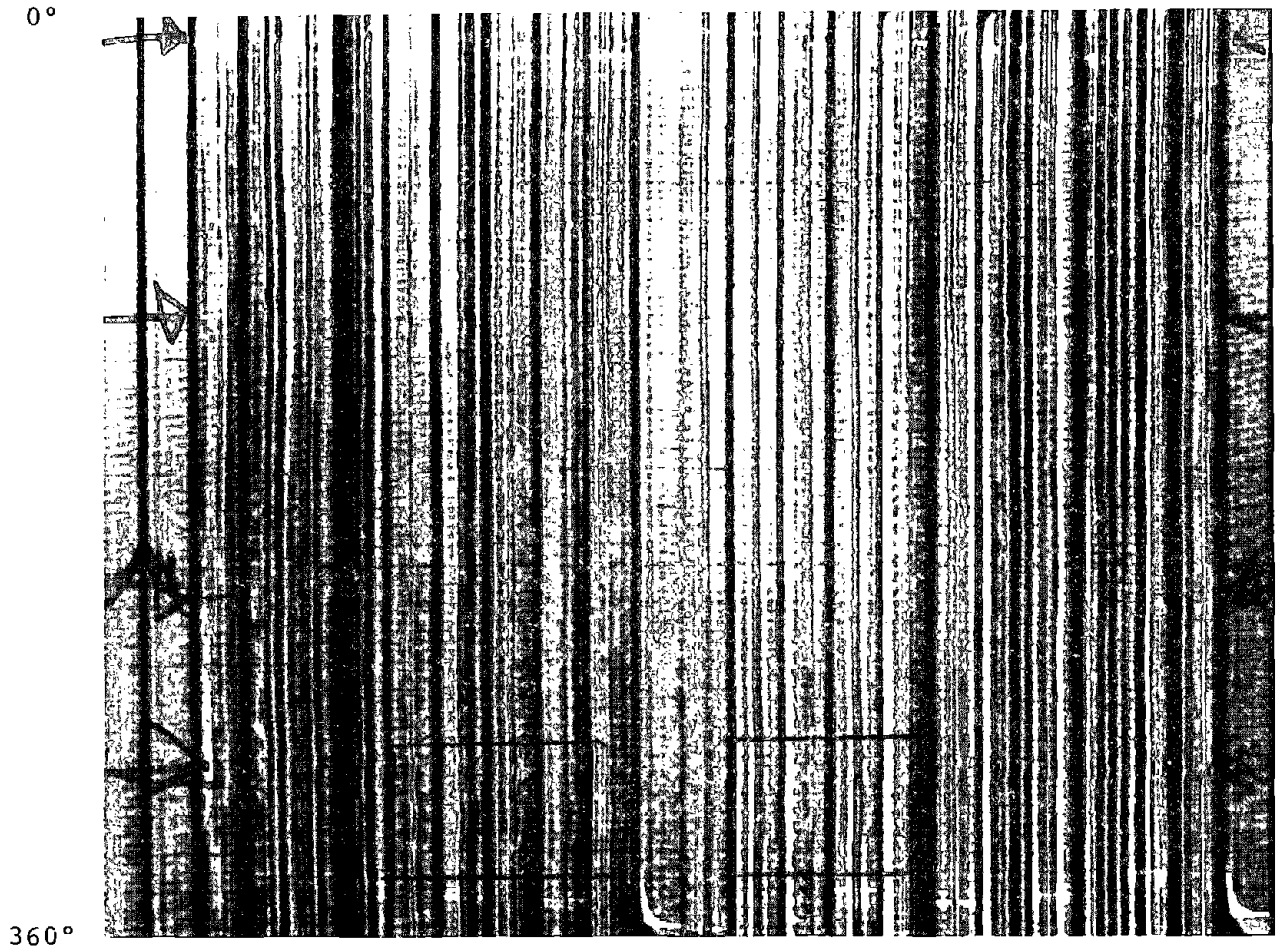
FIGURE 3-9. TIRE T5X 1239 BEFORE RETREADING

It is instructive to review the data from this tire since it is indicative of the types of conditions which can occur. Figure 3-9 is an early reflection trace of the tire prior to retreading. Channels 8,9,10,15 and 16 indicate substantial runout from a heavy splice. This appears only in the liner and

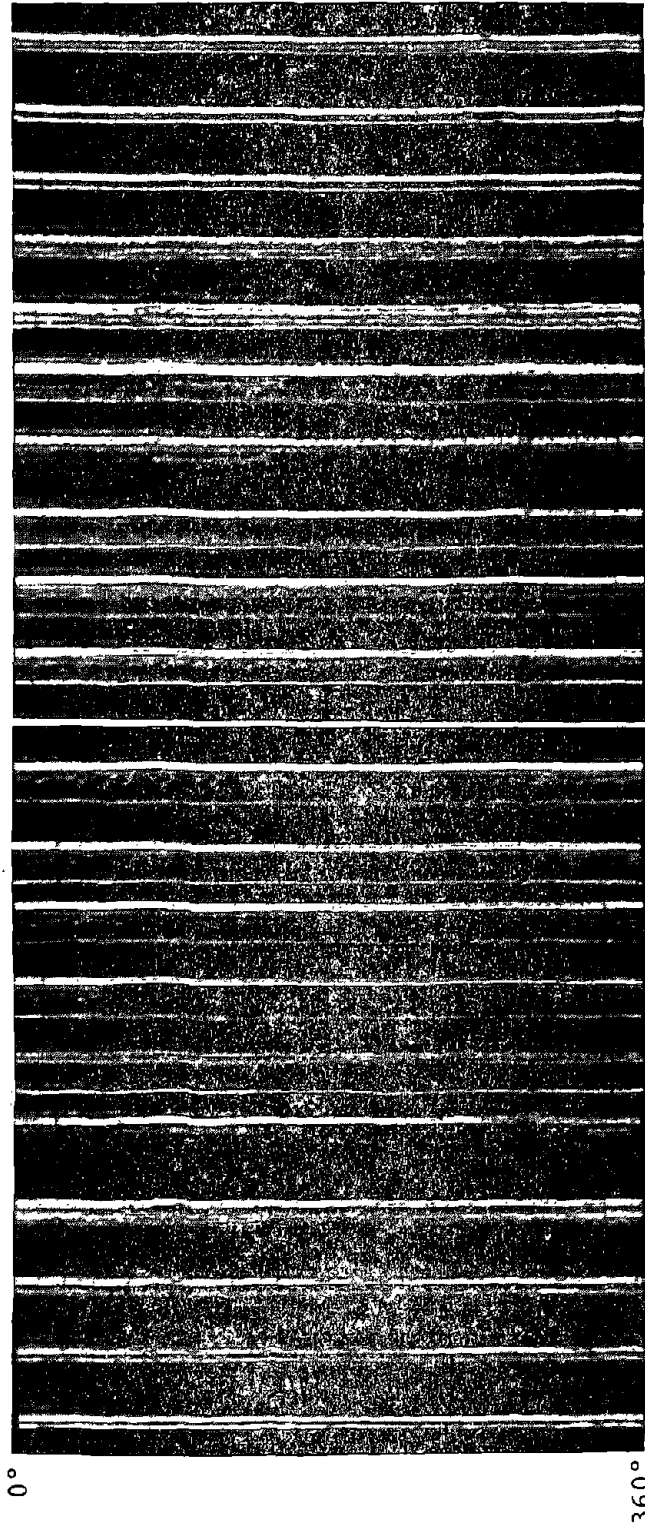
FIGURE 3-10. TIRE T5X 1239R AFTER RETREADING

not on the tread surface. Figure 3-10 is a trace of the tire after retreading. It shows no evidence of this condition and indicates that, in this tire at least, the retreading has helped the balance situation.

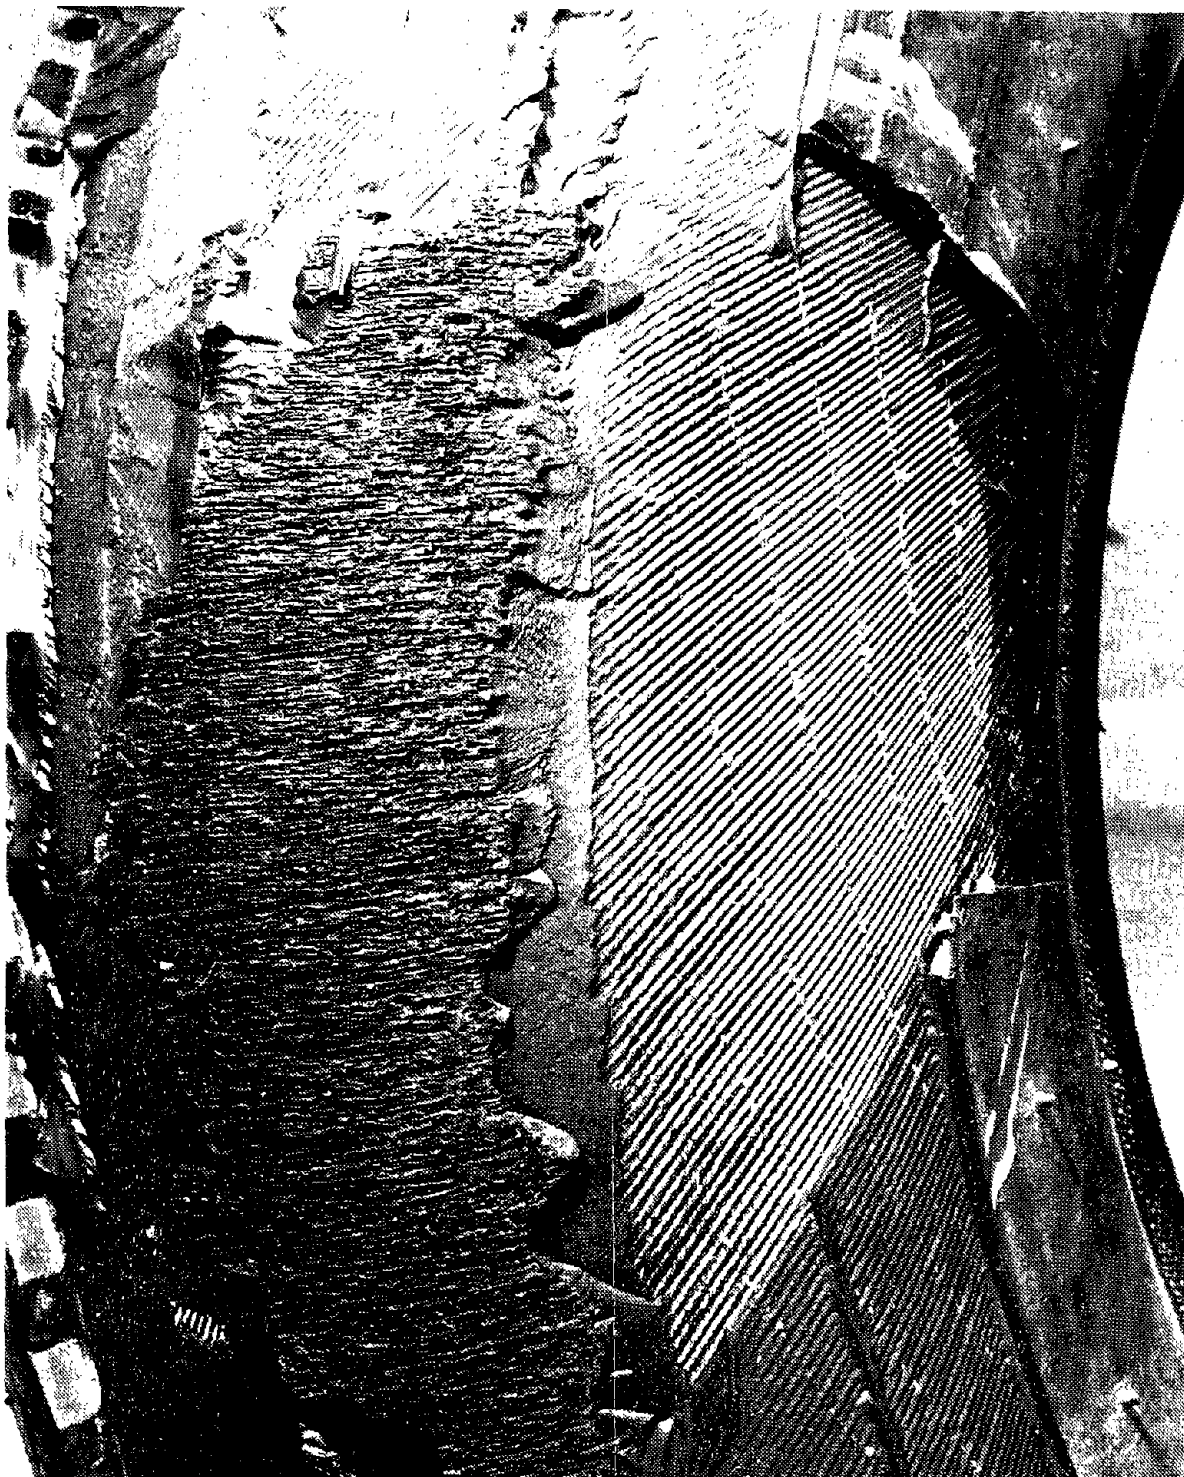
1. Tire Analysis T5X 1161 - A large separation and bubble centering at  $\theta=300$ ,  $\phi=190-280$  (NDT ultra-sonic inspection had shown separations at both  $\theta=270$  and  $300$  and  $\phi=270$ ) was the immediate cause of failure. Figure 1 shows the separation area at  $\theta=300^\circ$ , and especially an area of no rubber adhesion to the sidewall. The ply-cords in this area also contained detritus (black) between individual yarn plies and no cord adhesive remained on the surface of each yarn. The ply-cord surface was not abraded to any degree; thus indicating that the separation or an area of no adhesion was present prior to re-capping. Also the original tire has an aspect ratio of about 83% and was molded in a G78-15 (or 78% aspect ratio) re-cap mold. This situation would cause abnormal sidewall and shoulder distortion in a tire to the point where sidewall buckling is promoted which would very likely cause a separation at any area of weak adhesion between cord ply and carcass rubber.

The separation area at the buffed interface under the re-cap tread is caused from the heat generated from the original separation bubble having been pressurized.

Figure 1. Sidewall Separation and Area of Poor Rubber Adhesion T5X 1161

1. The tire was really too old to be subject to re-capping.
2. The tire had a severe separation or area of poor carcass-rubber adhesion that became distorted when the 83% aspect carcass was re-capped and molded in a 78% aspect mold.
3. Failure occurred when the separation became pressurized, bubbled and then generated high heat levels which failed the carcass rubber.

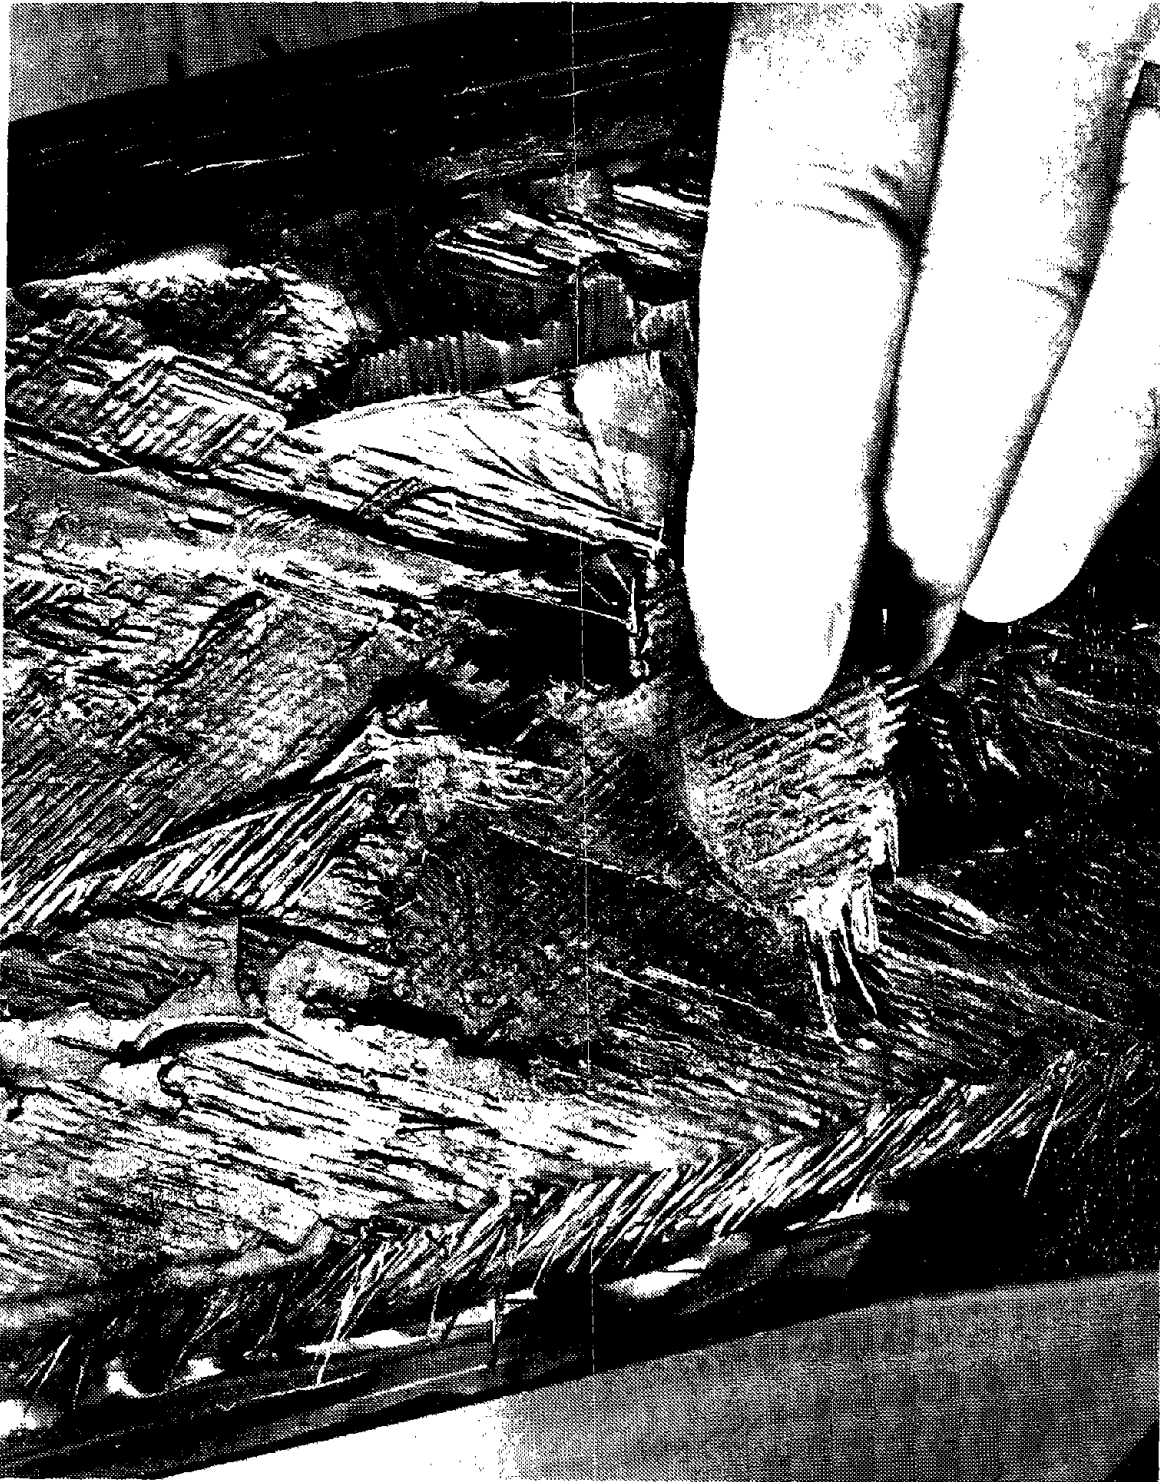
2. Tire Analysis T5X 1183 - This glass belted tire had failed when parts of the tread separated. Inspection of the tire under the tread showed massive belt breakage throughout the tire. Actual tire failure was initiated primarily at  $\theta=80^\circ$ ,  $\phi=180^\circ$  where there was a large separation in the carcass directly under an area of severe glass belt breakage. Figure 2 shows the area of severe glass belt breakage and the failure separation beneath the belt. Also a larger sidewall separation was found at  $\theta=45^\circ$ ,  $\phi=250^\circ$ . The sidewall/shoulder rubber had separated from the carcass fabric and the carcass fabric had buckled (reverse curvature). Figure 3 shows this separation and buckle. This buckling is an artifact occurring during the re-capping operation when the tire does not fit the mold very well. With the severe glass belt breakage, the tire was probably considerably over-size in circumference which would cause the sidewall to buckle when the tire was placed in the re-cap mold and there is an area of poor adhesion. The sidewall separation at  $\theta=45^\circ$ ,  $\phi=250^\circ$  extends from the bead to well into the shoulder. Also there is another sidewall ply separation at  $\theta=50^\circ$ . Both glass belts are essentially completely disintergrated from  $\theta=70^\circ$  to  $120^\circ$ . There was no evidence that the carcass buffing prior to re-capping had touched or otherwise

Figure 2. Severe Belt Breakage and Failure Area T5X 1183

damaged the glass belts. Also the broken ends of glass were completely blackened and in some cases covered with burnt rubber, definitely indicating that the tire had been running for a relatively long time with broken glass belt cords.

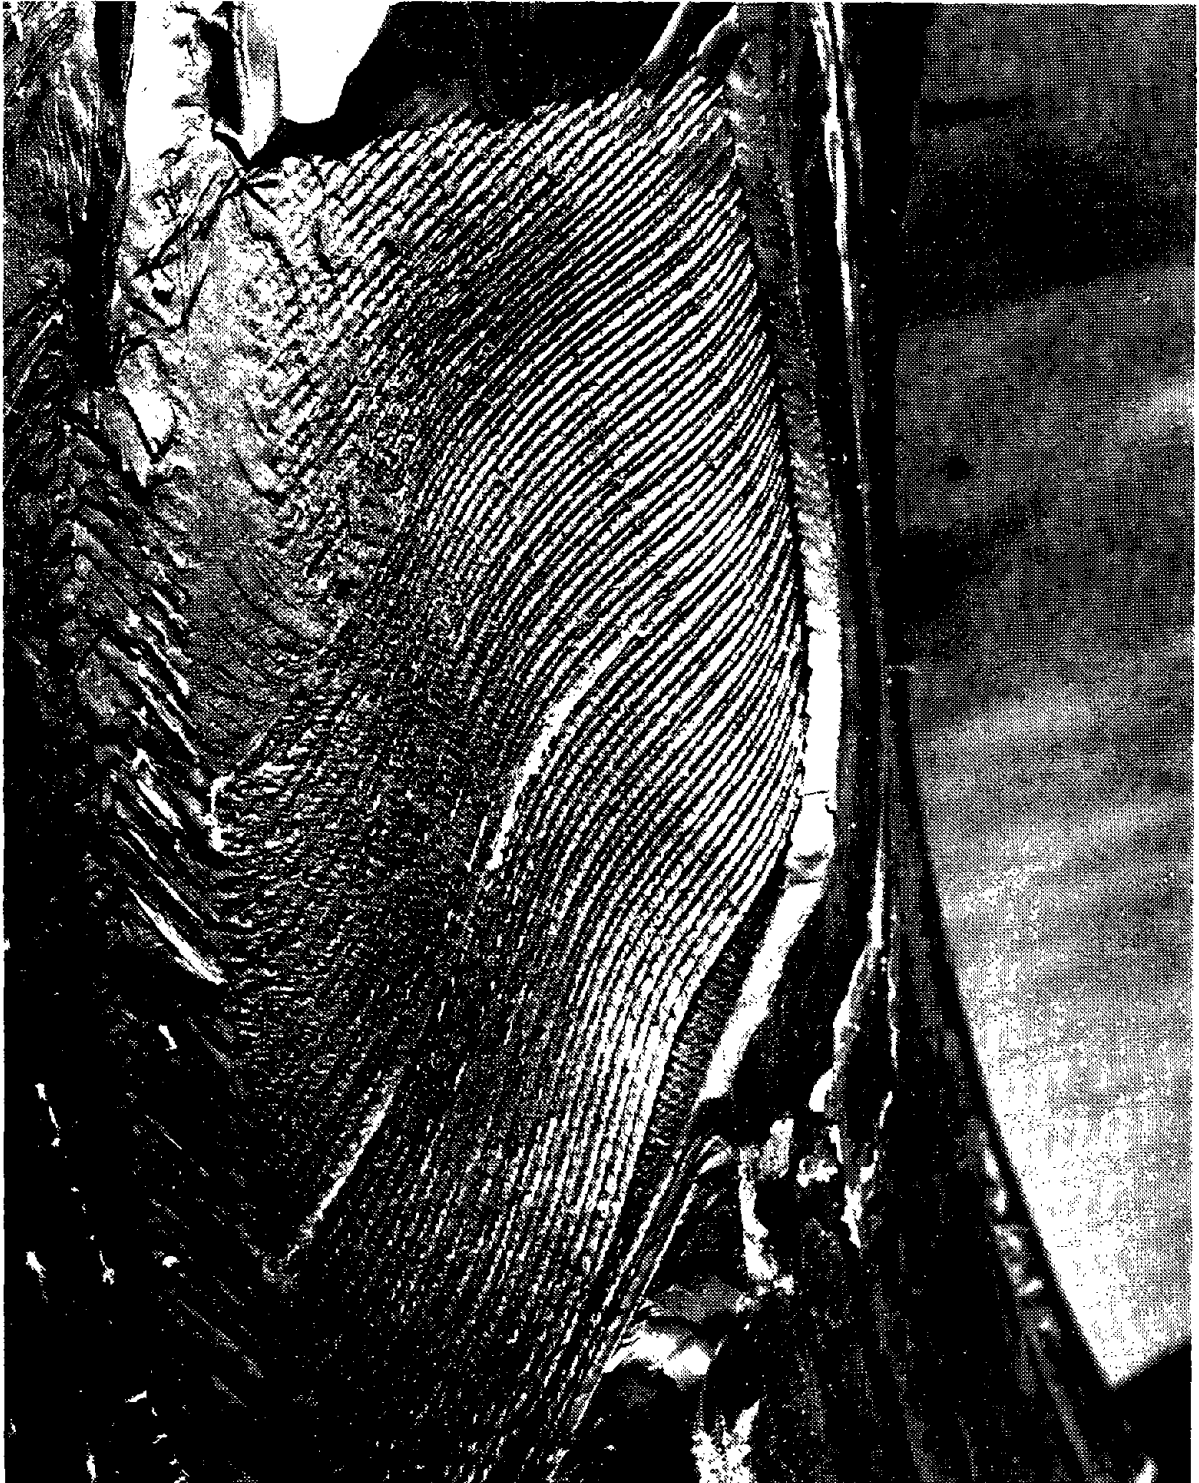
Figure 3. Sidewall Separation and Buckling T5X 1183

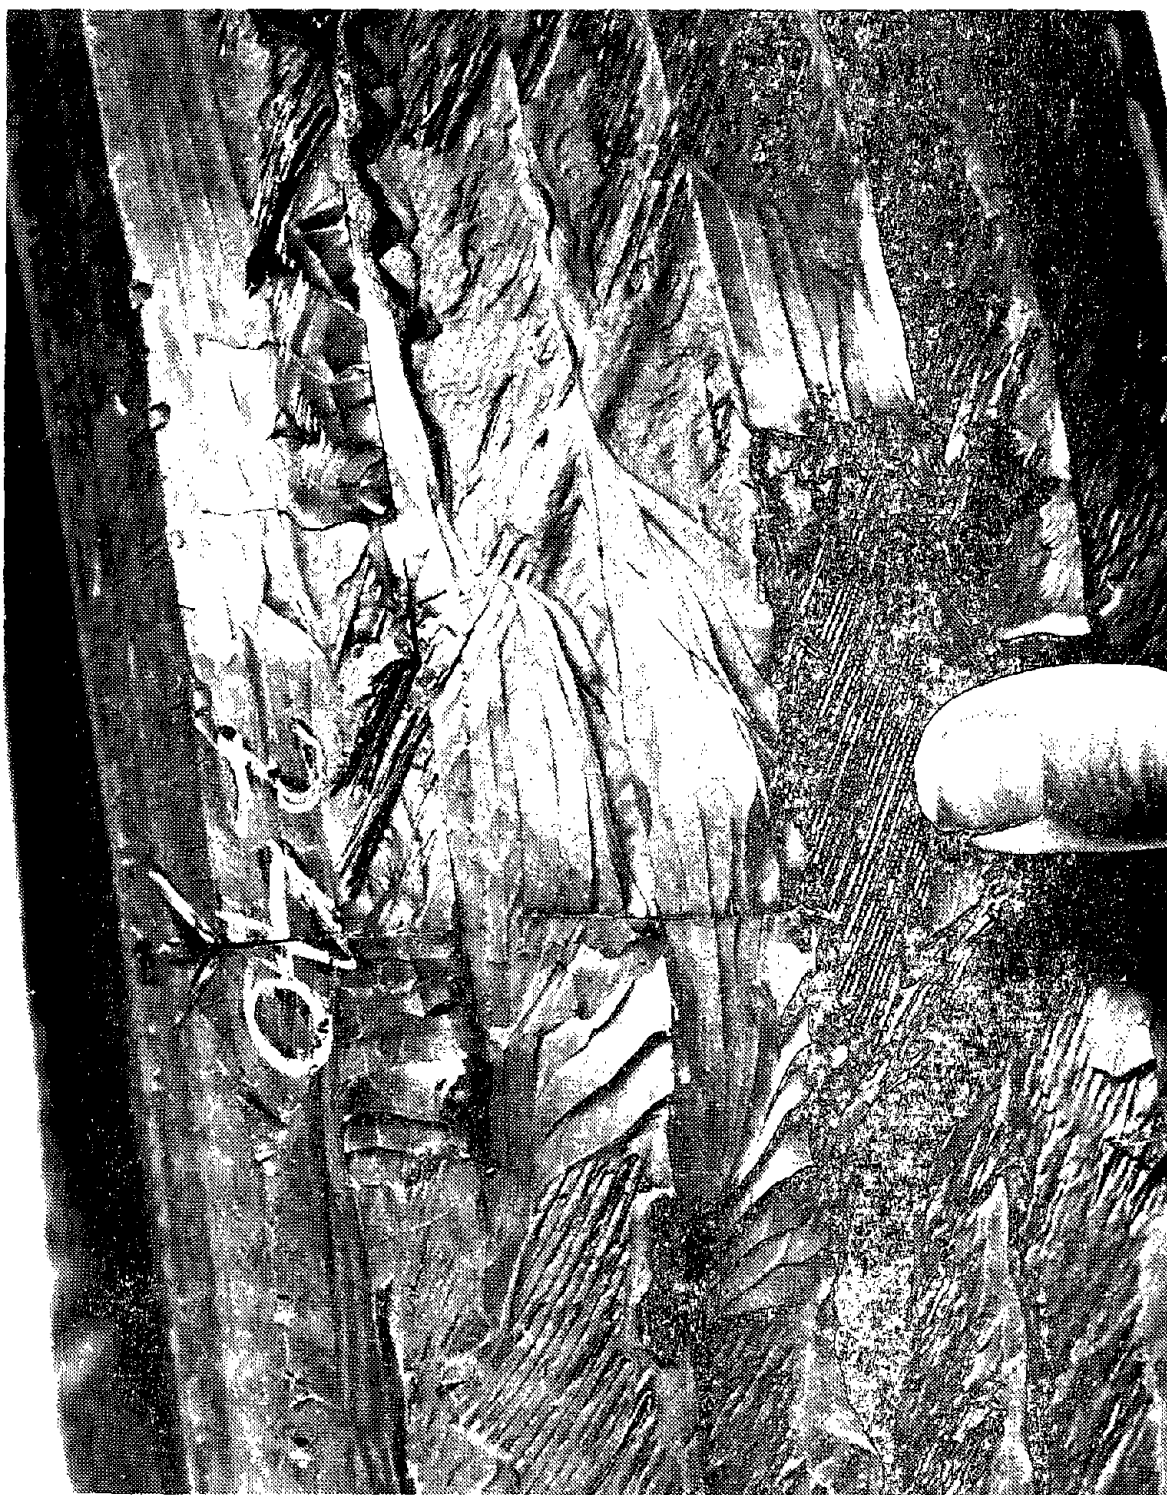
Dissection and inspection of the glass belt showed the glass yarns to be badly broken. Figure 4 is a photo of the failure area showing the severe glass breakage and the separation. The separation also shows a heavy loss of carcass rubber with black detritus having penetrated into the carcass cord, indicating the separation had been present for a long time. The glass belt was badly broken throughout and especially severe breakage was noted at  $\theta=200-210^\circ$  and  $\theta=270^\circ$ , and another belt separation was found at  $\theta=270^\circ$ . Also a belt edge separation was found at  $\theta=220^\circ$ ,  $\phi=250^\circ$ . IR scans were made of the pyrolysis products of the tread and liner rubber. Both the tread and liner rubber outside the failure area showed little degradation from either age or heat. The rubber from the failure area was burnt and was oxidized (according to IR analysis) indicating that the tread splitting was caused by excessive heat buildup when the separation became pressurized. Ply-cord adhesion averaged about 4.3 lbs/cord. This adhesion is low for the 3 ply, 3600 denier polyester cord used in this tire. Cord strength was 45.2 lbs which is normal for this cord. The low cord adhesion is probably an accelerated aging effect caused by the tire having been overloaded or underinflated during its earlier life.

Figure 4. Severe Belt Breakage and Separation in Failure Area T5X 1204

Conclusions - T5X 1204 - This tire had severe belt breakage and at least two belt separations at the time of re-capping and was essentially a failed tire prior to re-capping.

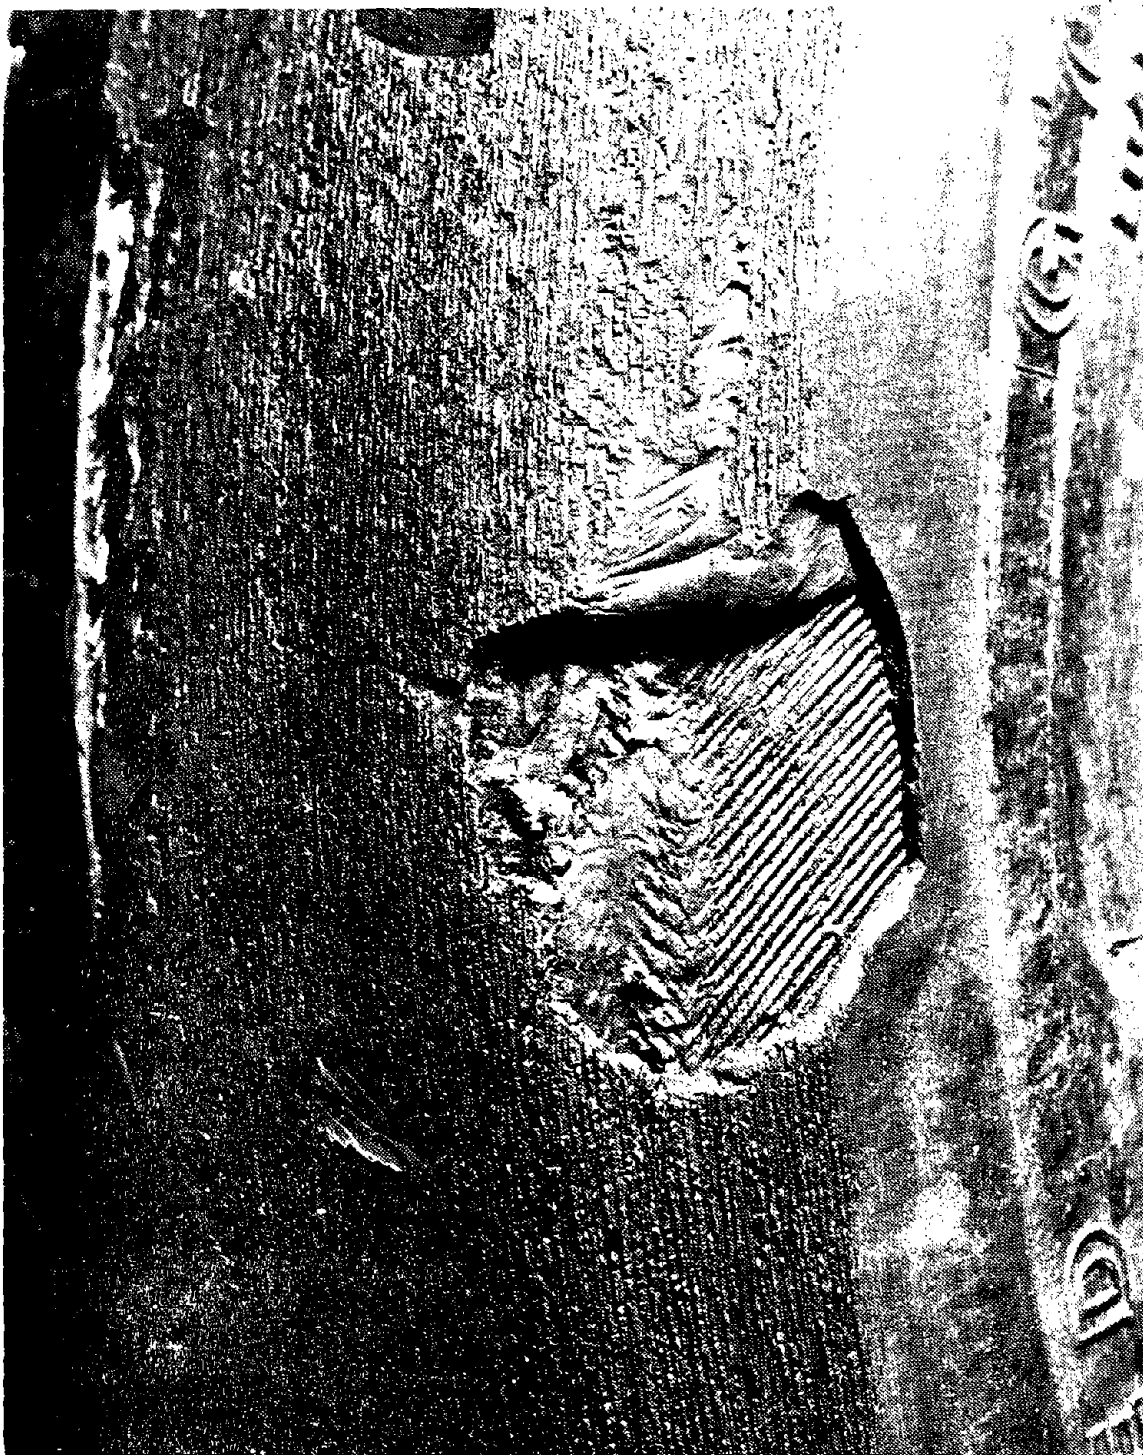
The re-capping was also of poor quality especially along the edges of the re-cap when the stitching was poorly done with many areas of loose edges, one of which was next to the separation at  $\theta=270^\circ$ .

Figure 5. Buffed Interface and Belt Edge Separation T5X 1223

Conclusions - T5X 1223 - This tire failed because of a re-cap separation present in the tire right after the re-capping. Also the tire became over-heated in the re-cap mold which promoted deterioration. The presence of the belt edge separation at this point also caused local over-heating and a bump in the tire during the wheel testing. Again the tire should not have been re-capped. However, the poor re-capping job and a hot spot in the mold were the immediate cause of failure.

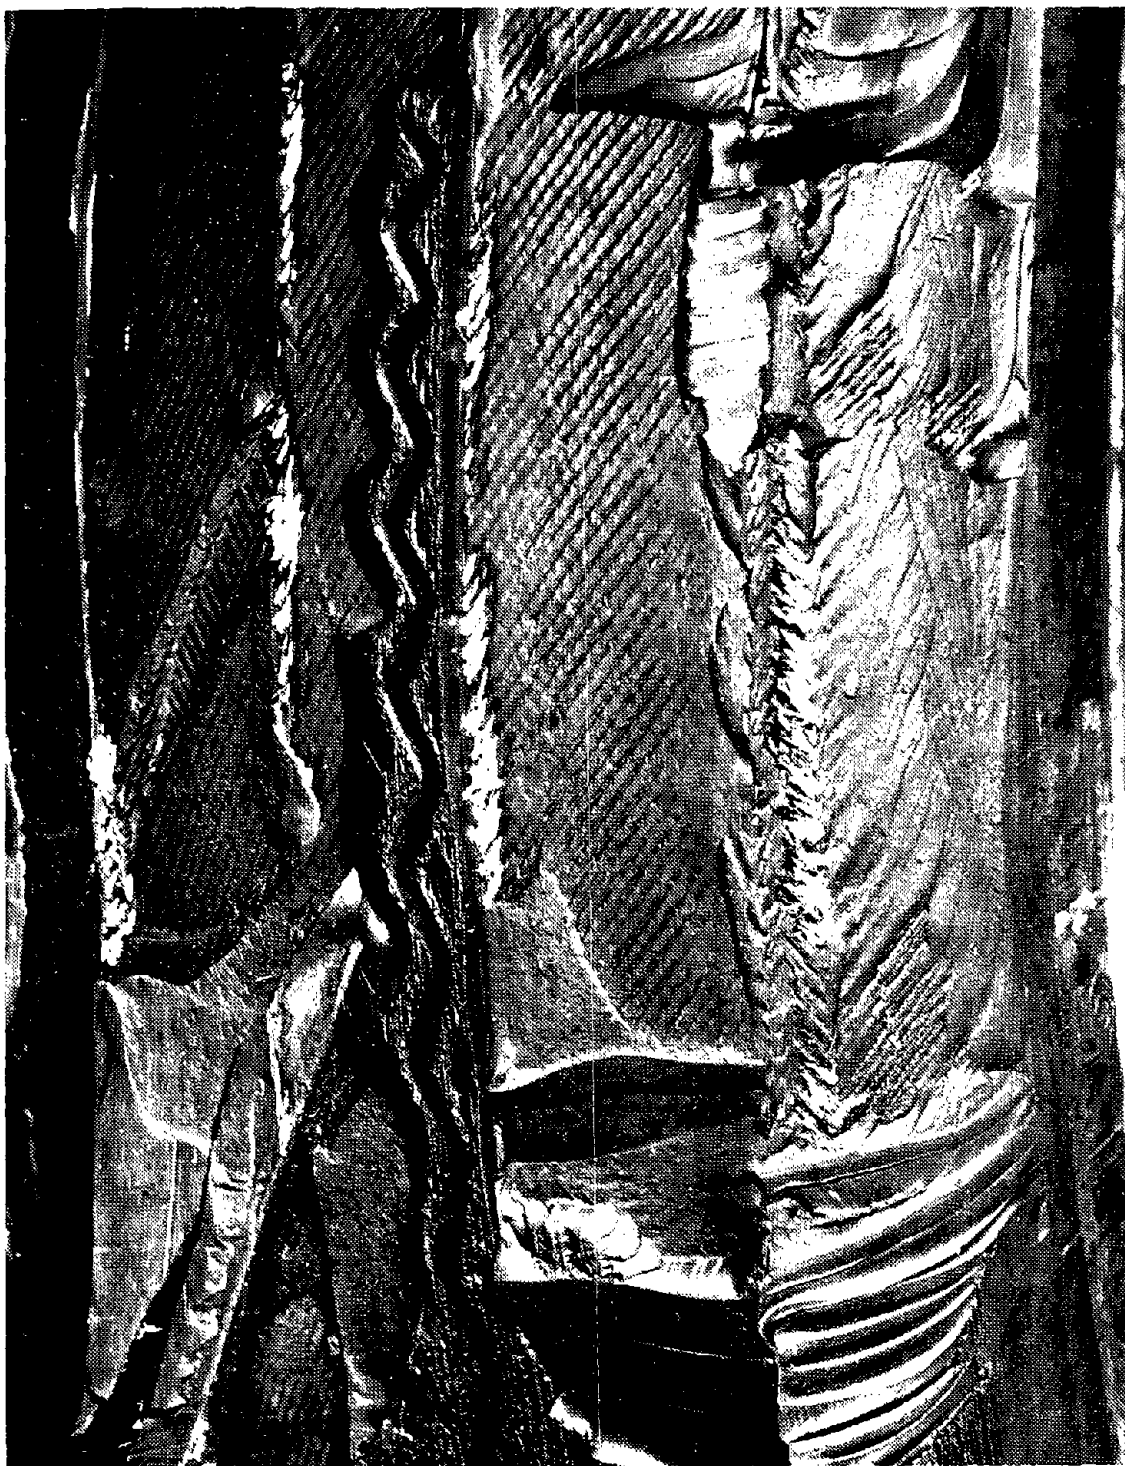
Figure 6. Burnt Mold Groove Line T5X 1223
