REPORT NOS. DOT-TSC-NHTSA-79-51

# CORRELATION BETWEEN ULTRASONIC NONDESTRUCTIVE INSPECTION AND WHEEL TEST OF 34 RETREADED TIRES

NOVEMBER 1979

FINAL REPORT

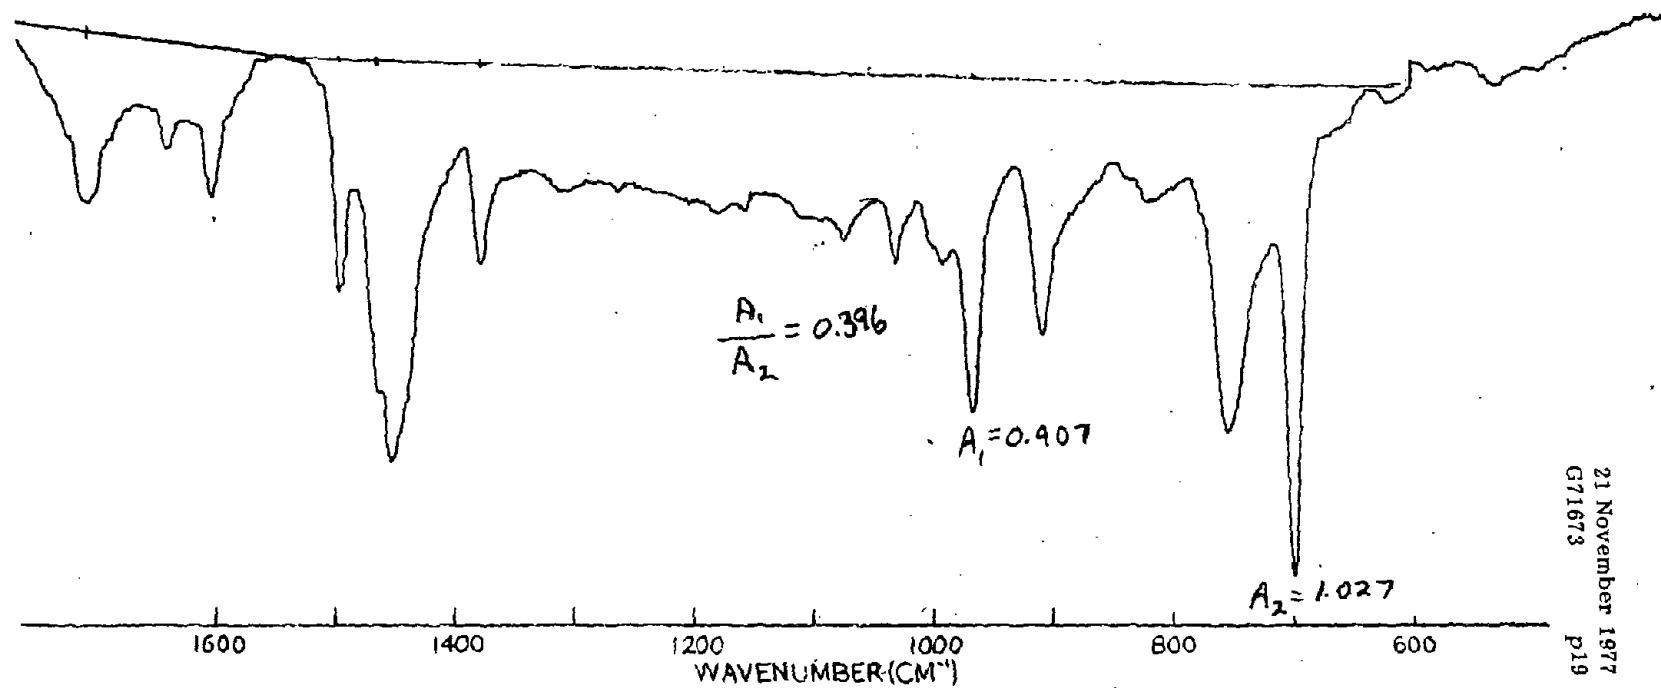
Figure 7. IR Scan - Pyrolyzed SBR Tread Rubber - Little Oxidation-Degradation T5X 1161

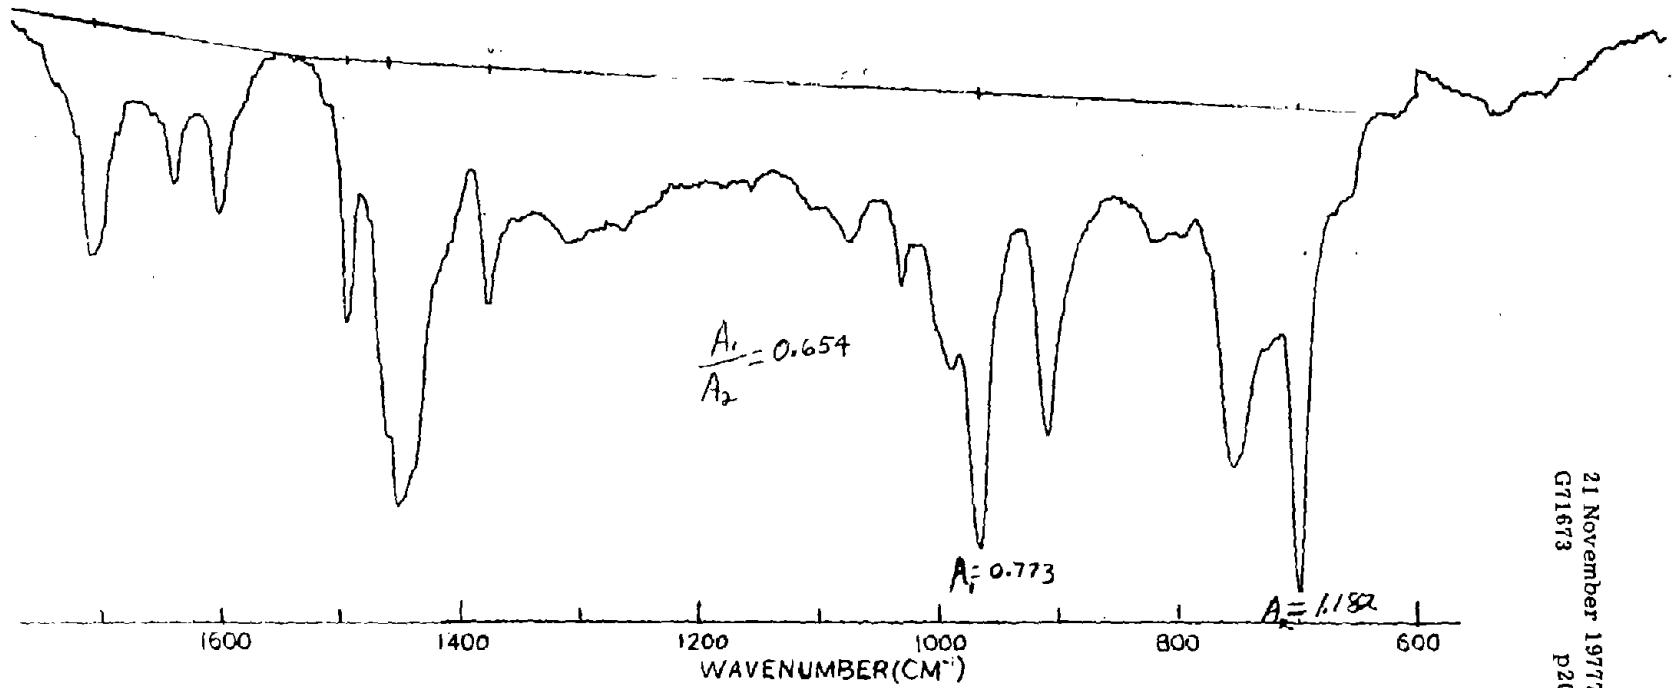
Figure 8. IR Scan - Pyrolyzed SBR Tread Rubber - High Oxidation-Degradation T5X 1223

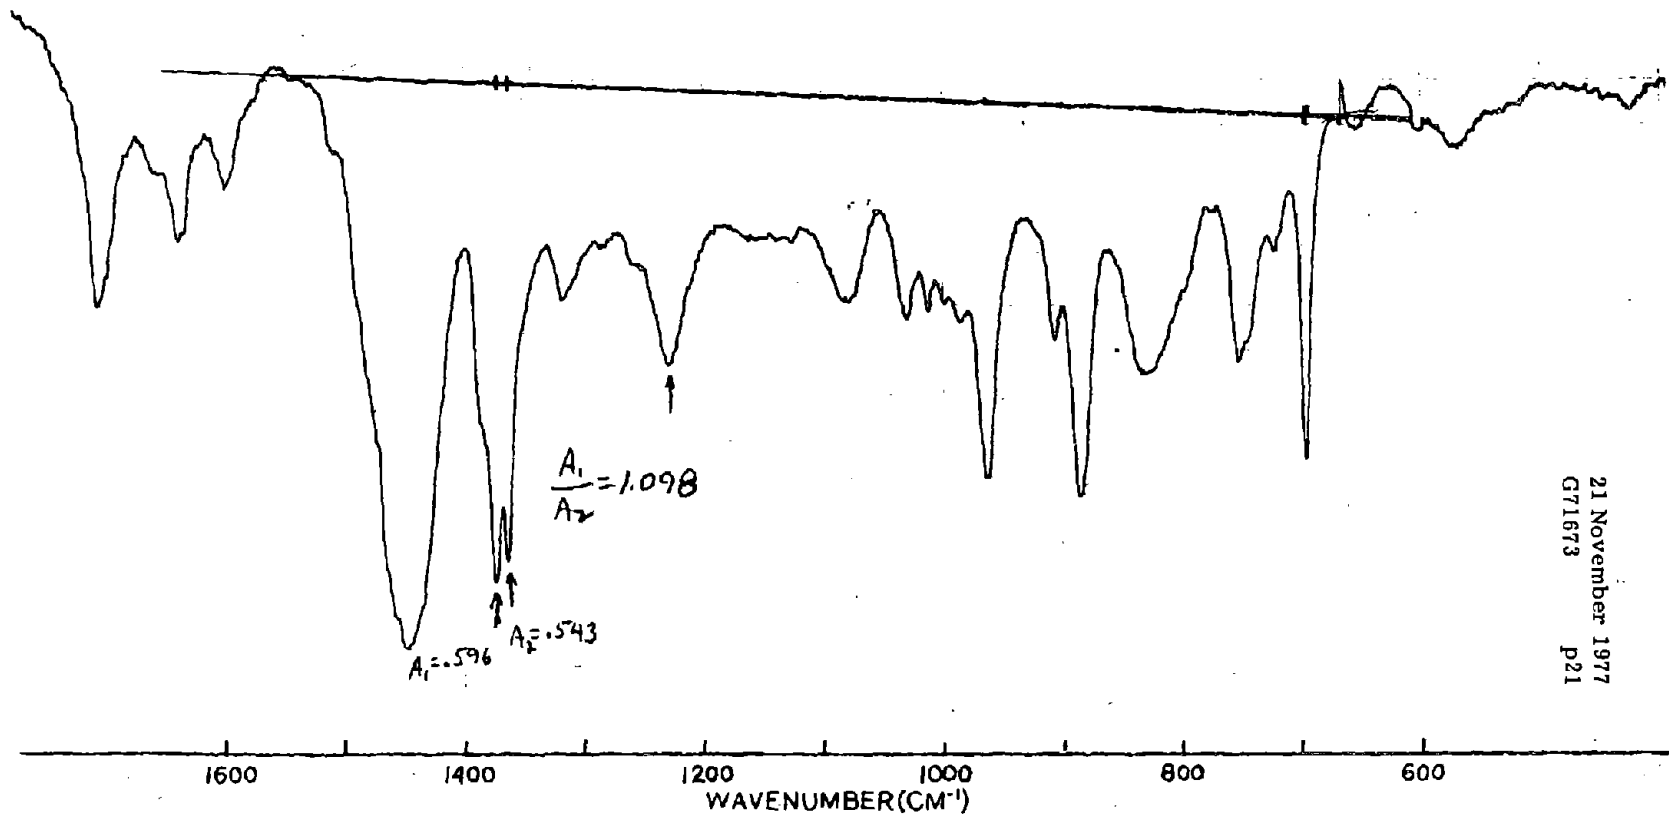
Figure 9. IR Scan - Pyrolyzed Liner Rubber - Little Oxidation-Degradation (Butyl) T5X 1204

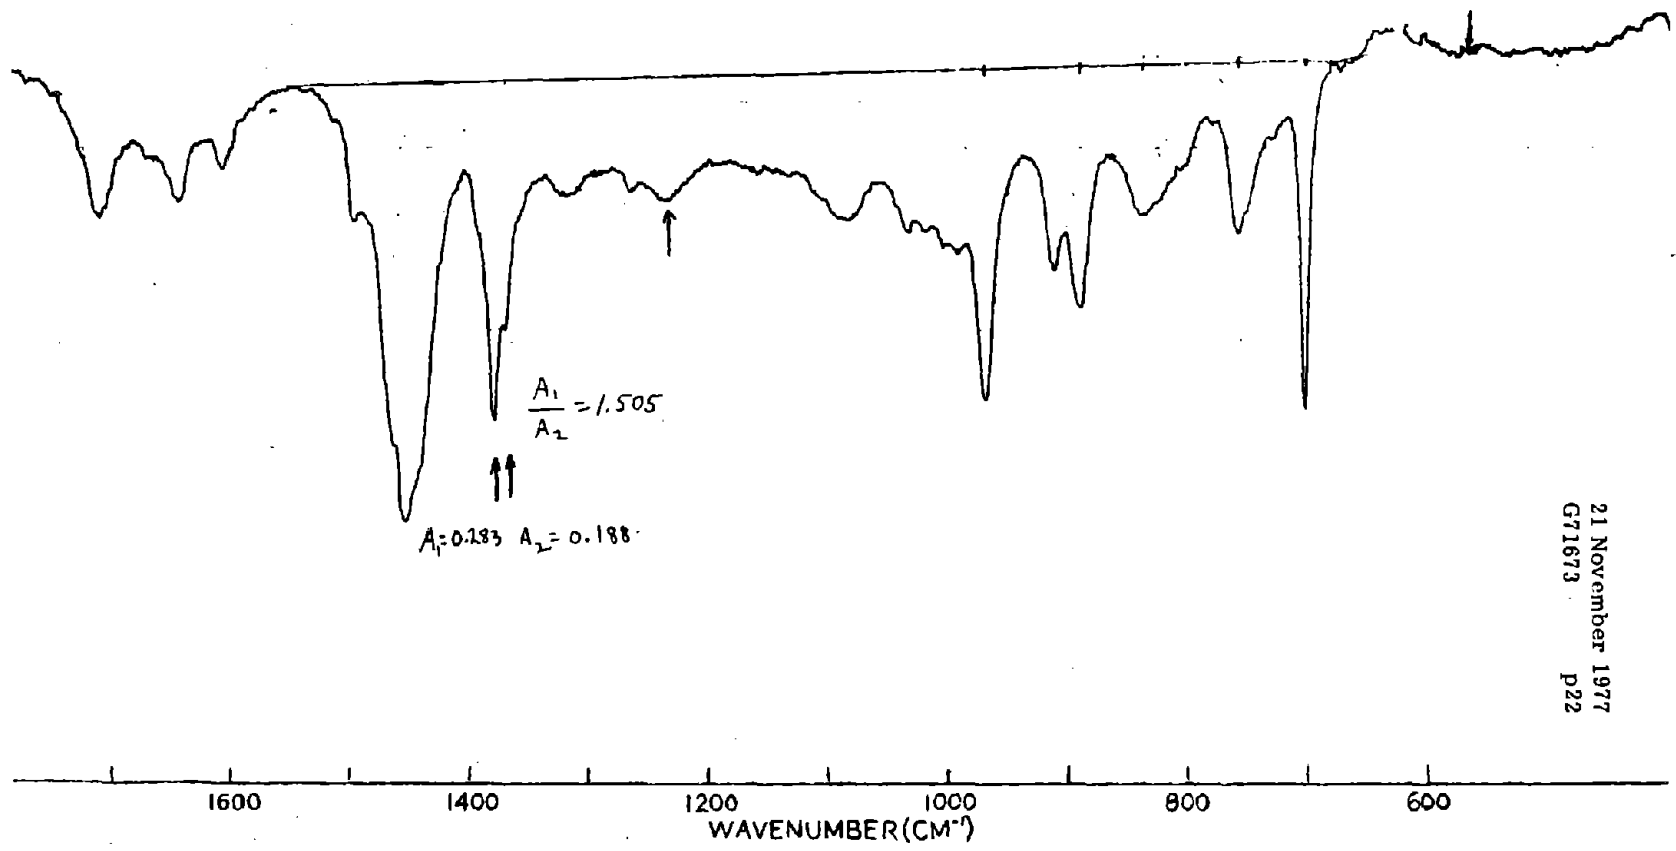
Figure 10. IR Scan - Pyrolyzed Liner Rubber - High Oxidation-Degradation (Butyl) T5X 1223
