1. Report No. FRA/ORD-81/26		2. Government Accession No.		3. Recipient's Catalog No. <b>PB83 110577</b>	
4. Title and Subtitle RAILCAR ROLLER BEARING FAILURE PROGRESSION TESTS				5. Report Date April 1982

16. Abstract This report describes the laboratory endurance test of six railcar roller bearings that had previously suffered physical damage or were otherwise degraded as a result of actual railroad service. Two different onboard impending bearing failure sensors were also physically evaluated. The objectives of the tests were to obtain a better understanding of the railcar roller bearing failure process(es), the manner in which bearing defects progress, and the effectiveness of the impending failure warning devices. A 150 hour test with 26,250 pounds radial load (equivalent full car load) at 528 rpm (equivalent to approximately 52 mph) was planned for each bearing. Only one bearing actually failed to complete the 140 hour test. All bearings exhibited further measurable degradation of defect progression during the course of the tests. Neither warning device actually gave warning of the one failure experienced.

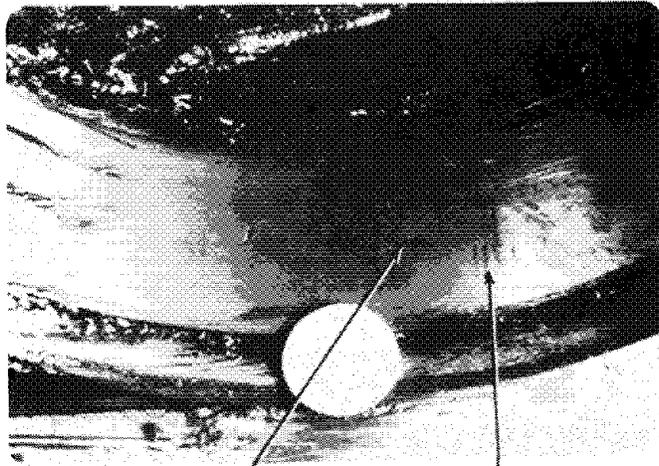
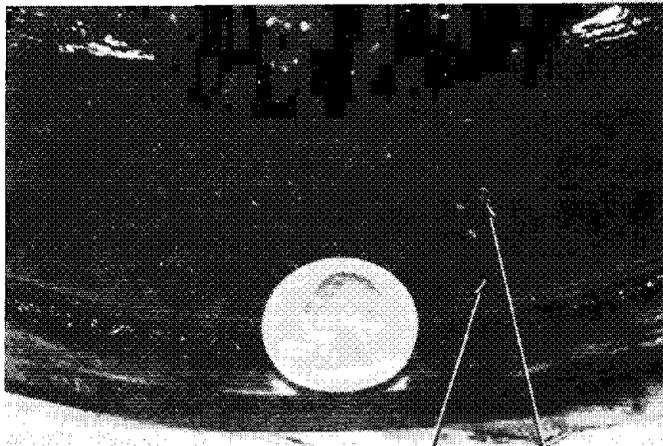
SPALLS

WATER ETCH

INCREASED SPALL  
SIZE AND AREA

"DISTURBED" AREA  
AROUND SPALL

FIGURE 10. BEARING FP-8 SHOWING INCREASED SPALL SIZE AND MEASUREMENT

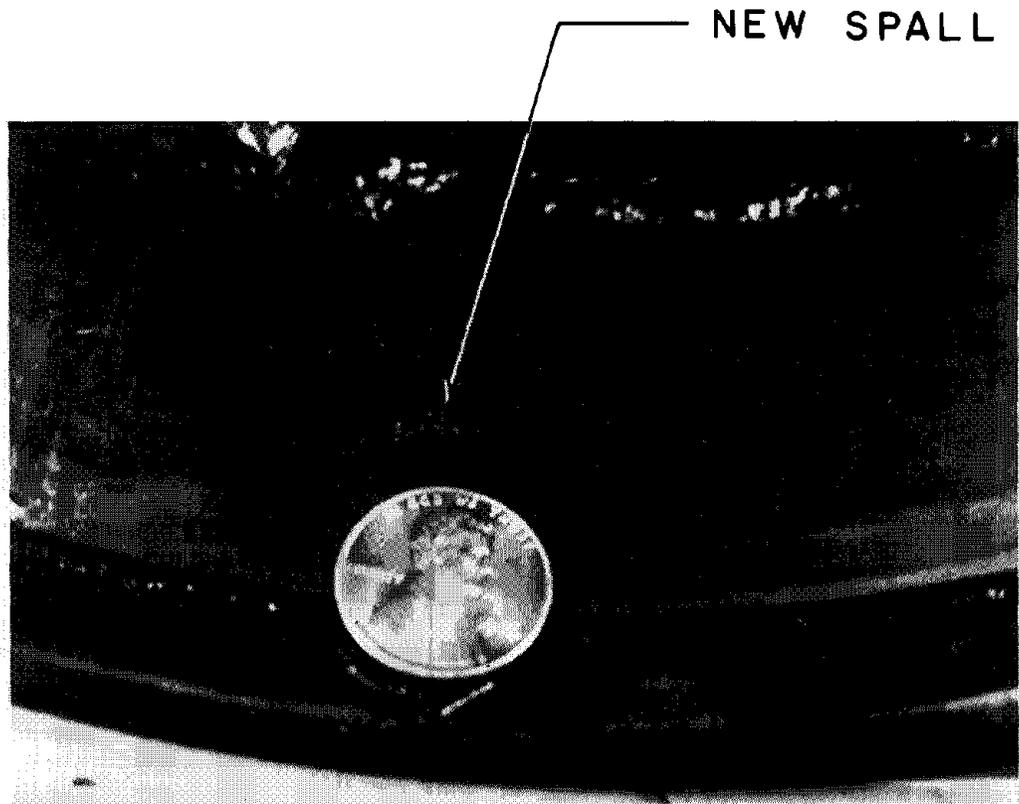
FIGURE 11. BEARING FP-8 AFTER 150.1 TEST HOURS SHOWING NEW SPALL

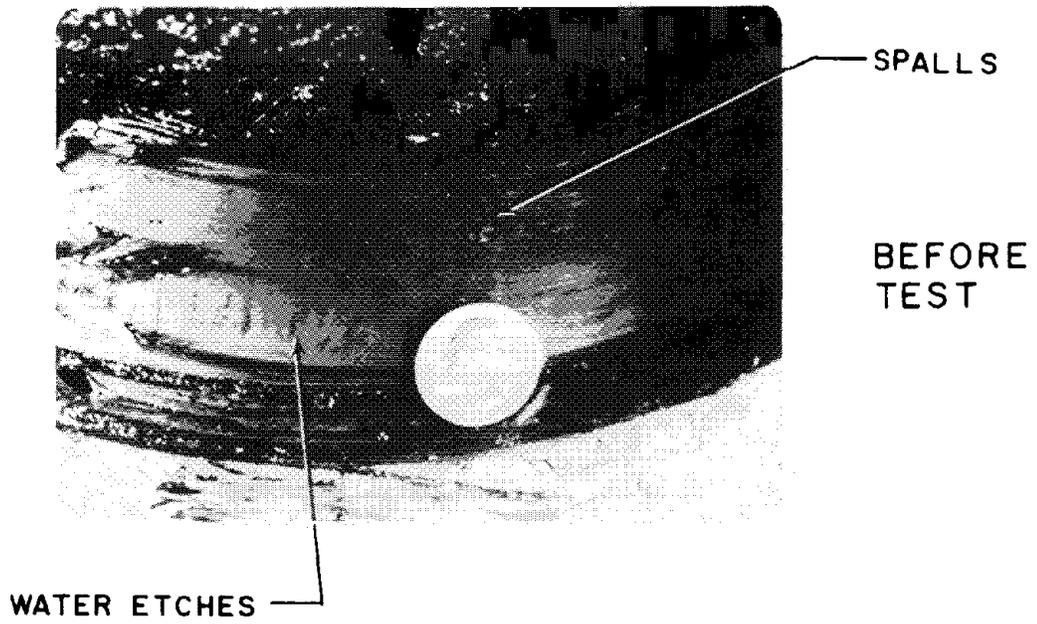
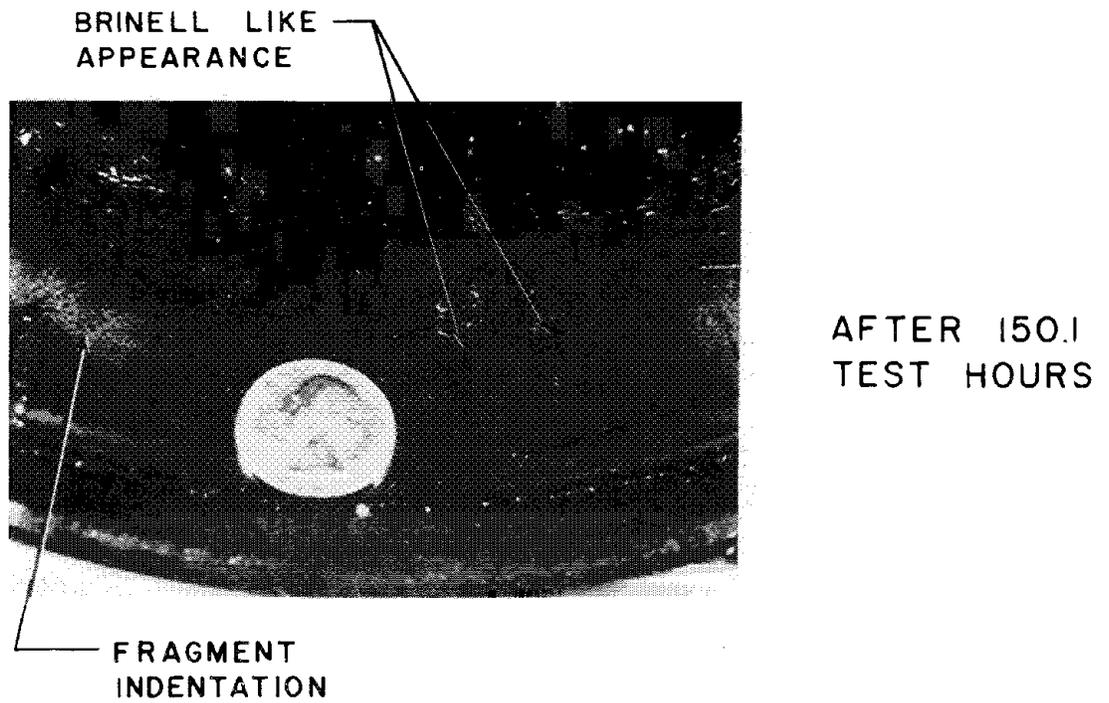
FIGURE 12. BEARING FP-8 SHOWING INCREASED FRAGMENT INDENTATION

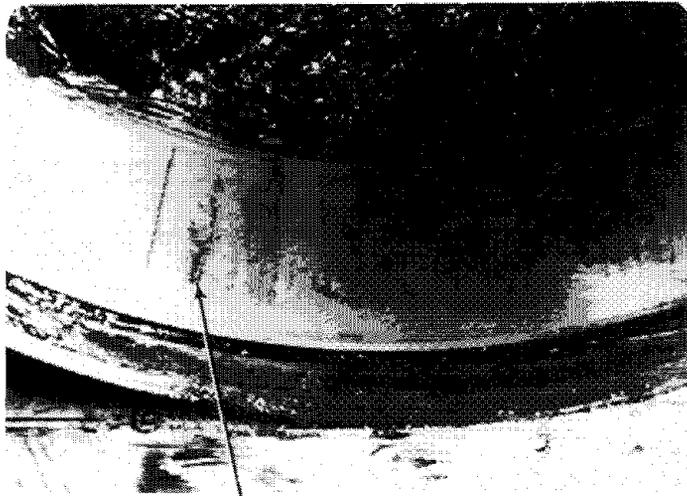
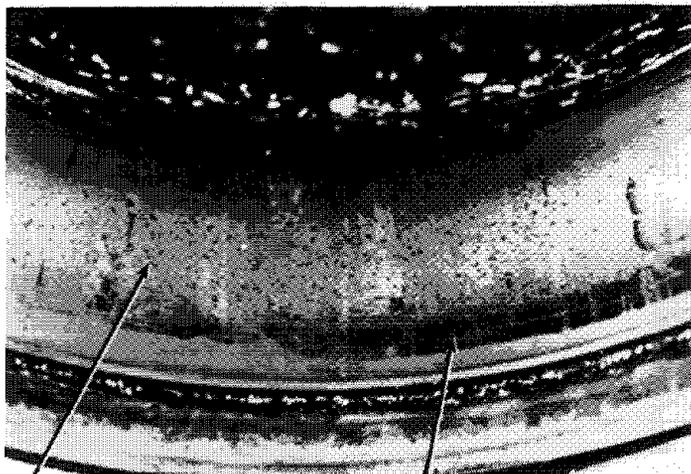
RUSTY LIKE WATER  
ETCHES

FRAGMENT  
INDENTATION

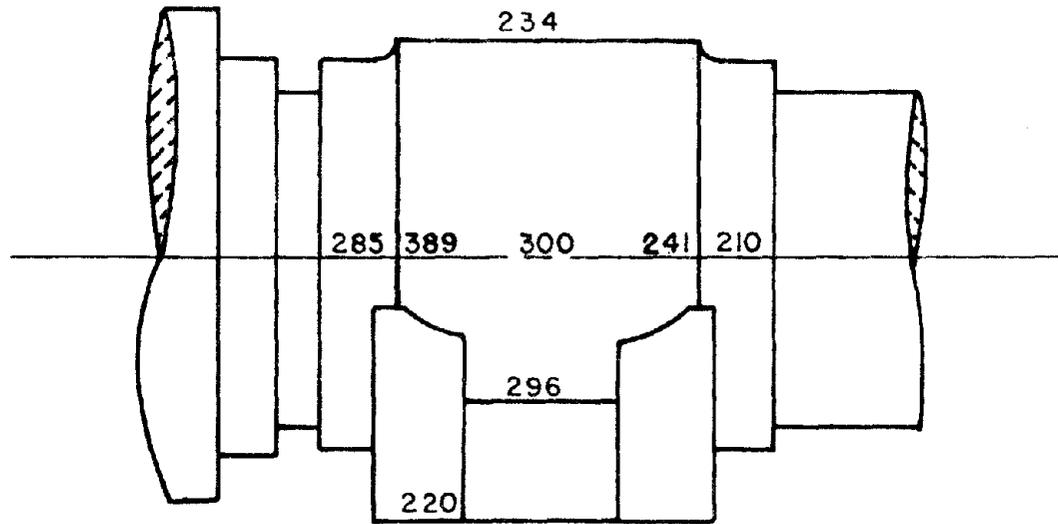
The cup temperatures as recorded on the multipoint chart recorder just before "failure" (390<sup>o</sup>F shutdown point) are shown in Figure 15. Unfortunately, the thermocouple at the center of the bearing was the one being computer-monitored, and it reached the 300<sup>o</sup>F tape recorder trip point only a few seconds before the highest temperature reached the rig shutdown temperature of 390<sup>o</sup>F. Thus, no meaningful magnetic tape recorded data was produced during the final failure process.

FIGURE 15. FP-6 CUP TEMPERATURES JUST BEFORE AUTOMATIC SHUTDOWN

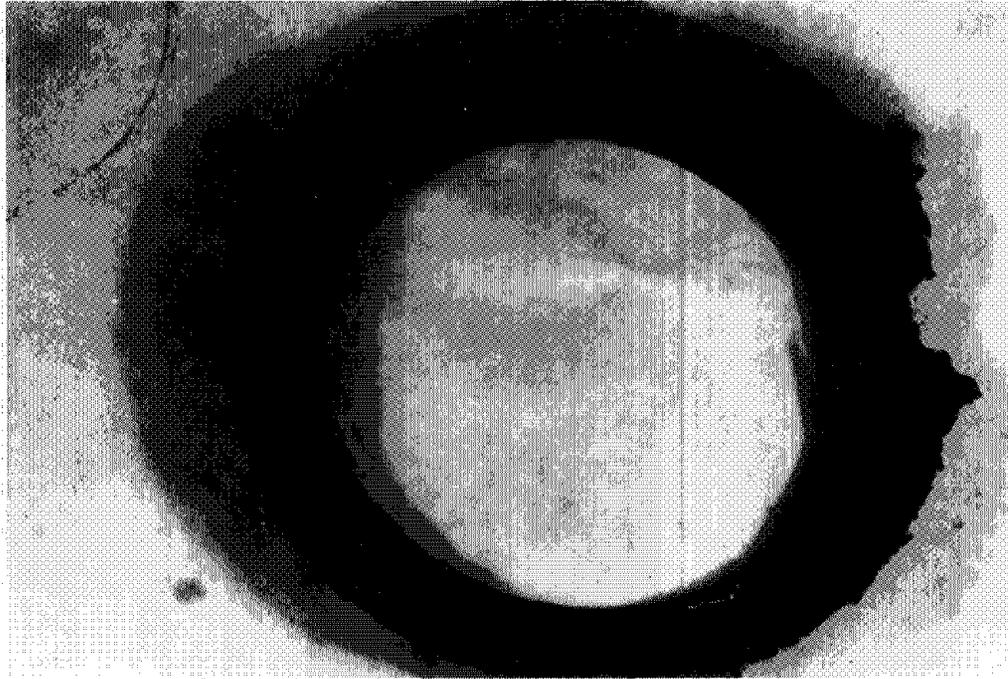
FIGURE 17. OUTBOARD SEAL FROM BEARING FP-6 SHOWING DRIED AND BURNT GREASE

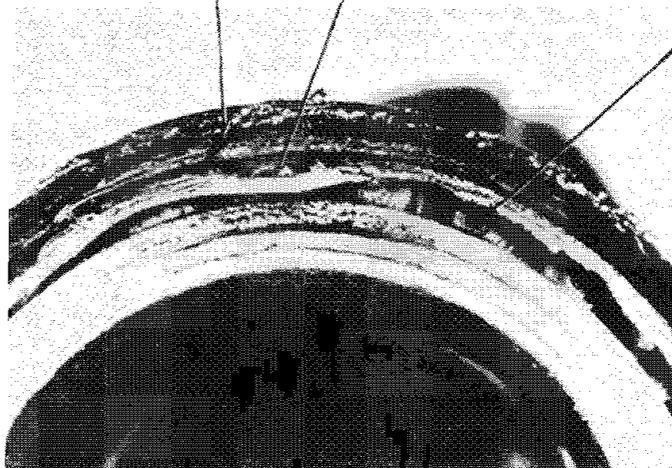
LARGE  
DENT

DRIED AND BURNT  
GREASE

BLUED AND WORN  
ROLLER ENDS

FIGURE 18. BEARING FP-6 SHOWING HEAT DAMAGE

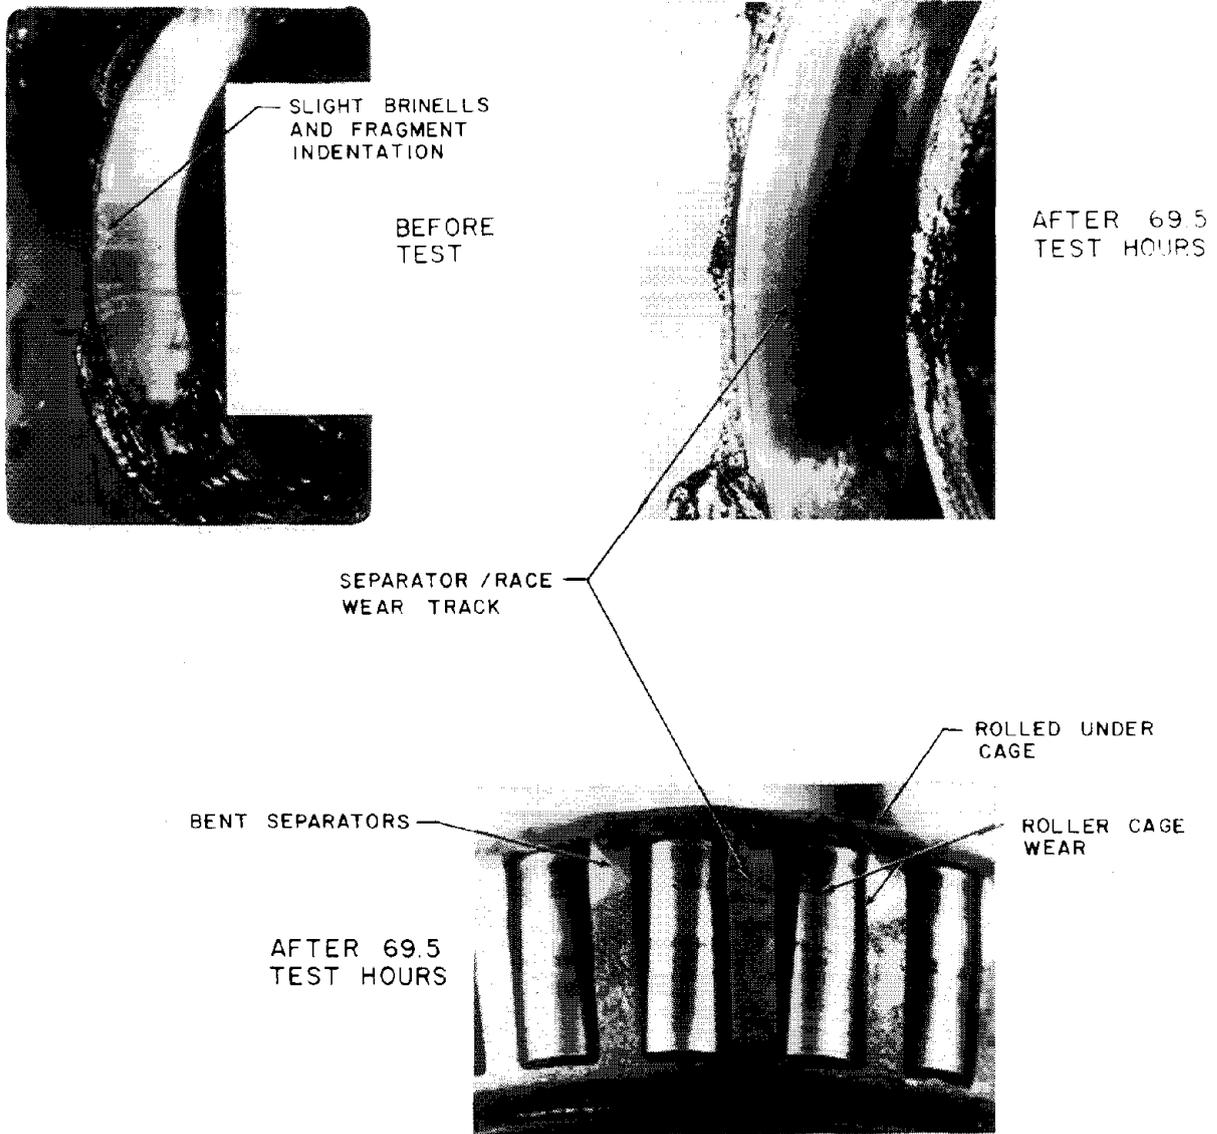
FIGURE 19. BEARING FP-6 SHOWING EFFECTS OF BENT AND ECCENTRIC CAGE

ROLLED UNDER CAGE  
(CAUSED BY PREVIOUS  
ACCIDENT)

CAGE WEAR (OCCURRED  
DURING TEST)

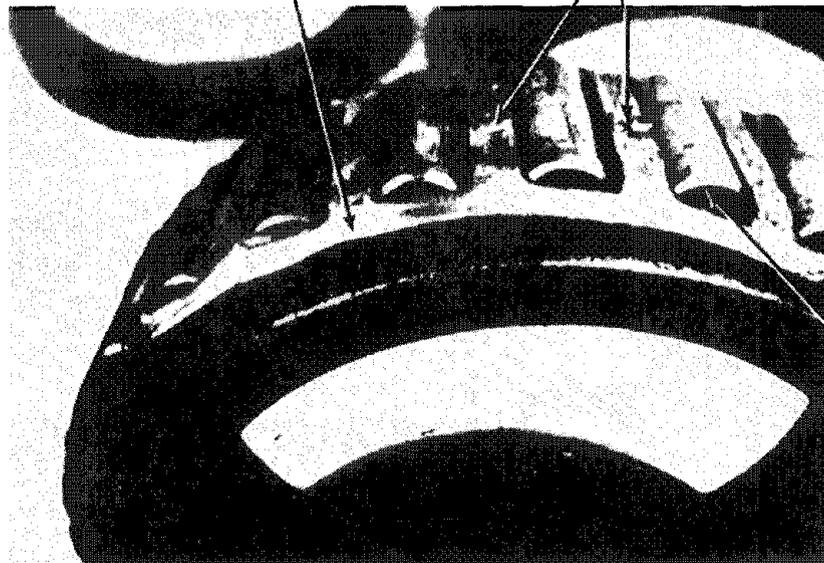
ROLLER WEAR (OCCURRED  
DURING TEST)

FIGURE 20. BEARING FP-6 AFTER 69.5 TEST HOURS SHOWING OUTBOARD CONE DAMAGE

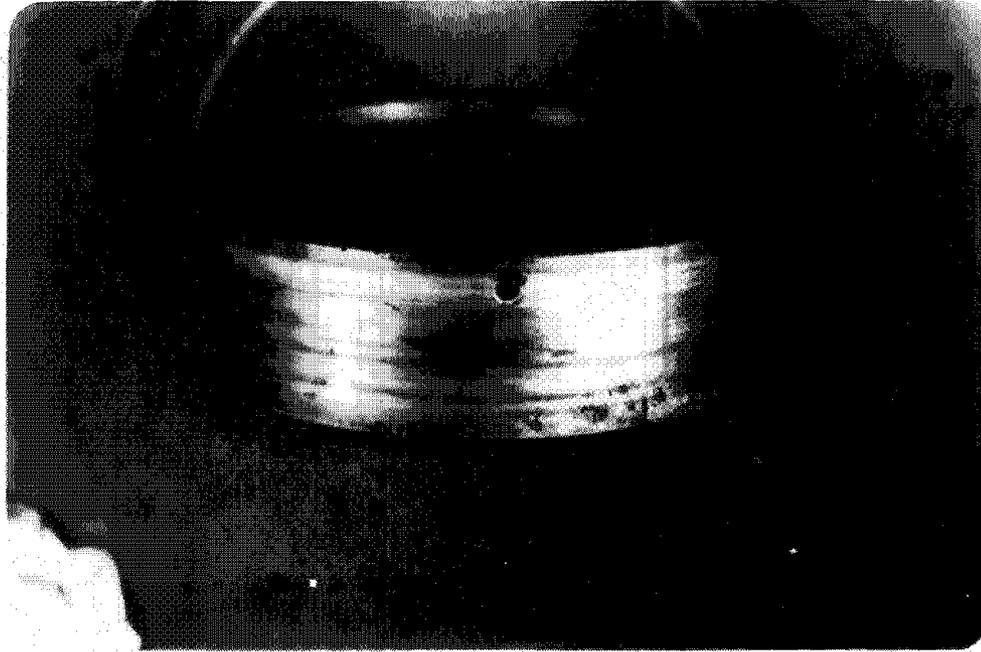
FIGURE 21. BEARING FP-6 AFTER 69.5 TEST HOURS SHOWING CRACKED OUTBOARD END WEAR RING

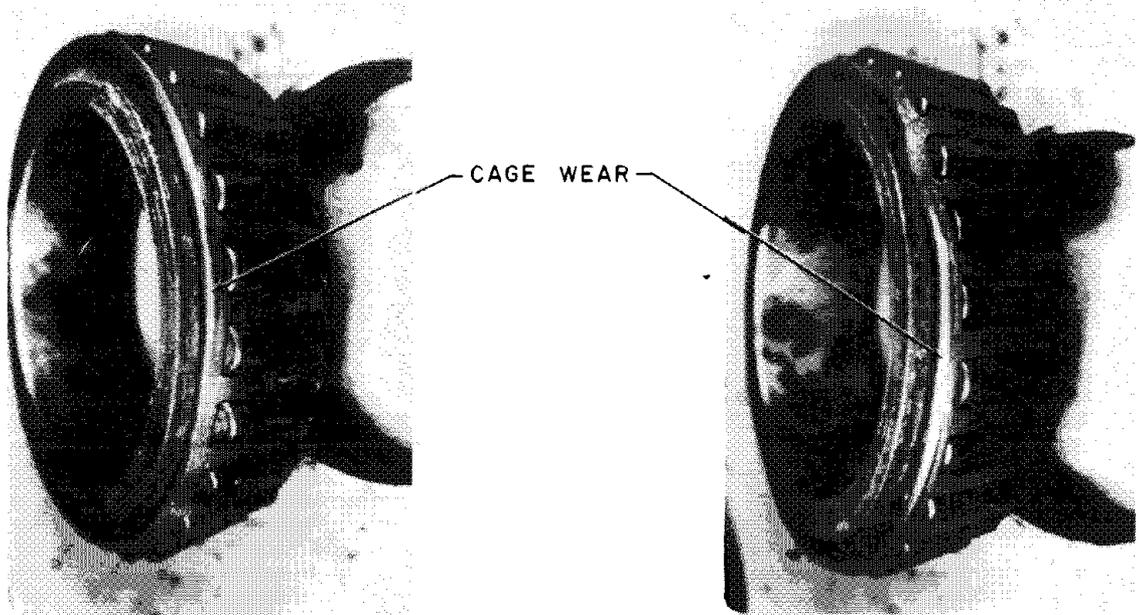
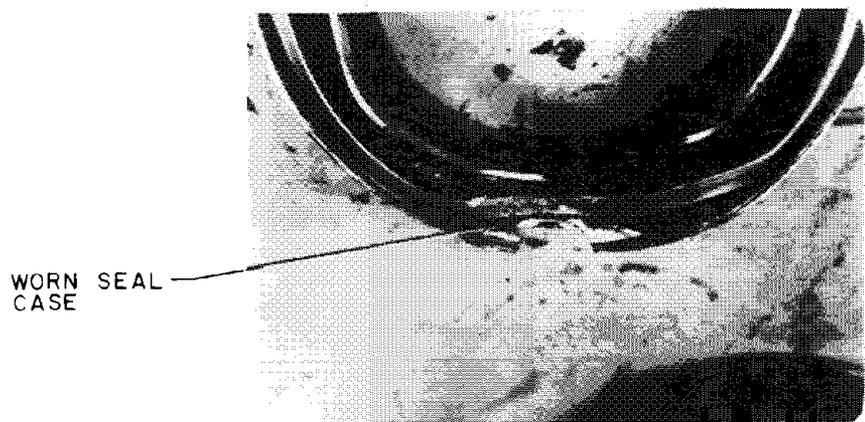
FIGURE 22. BEARING FP-6 AFTER 69.5 TEST HOURS SHOWING SEAL CASE AND CAGE WEAR WHICH CAUSED ECCENTRIC CAGE OPERATION

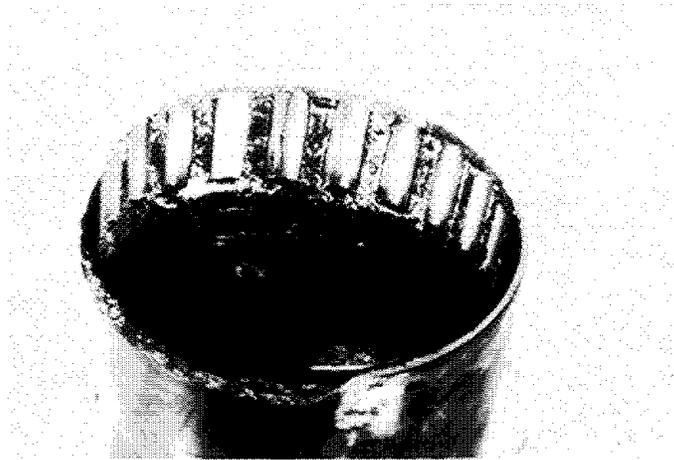
FIGURE 23. BEARING FP-6 AFTER 69.5 TEST HOURS SHOWING THAT INBOARD END WAS NOT SIGNIFICANTLY AFFECTED BY THE HIGH OUTBOARD END TEMPERATURE

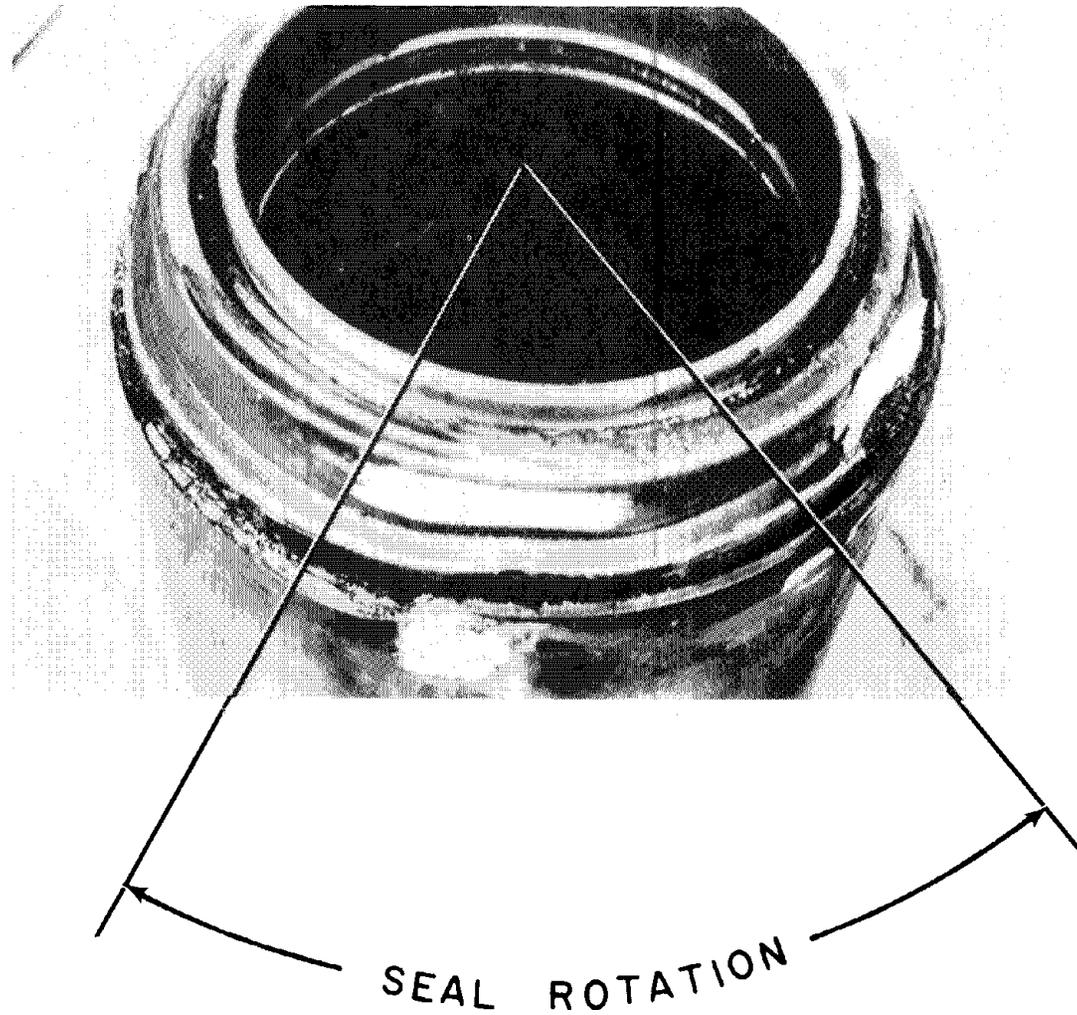
FIGURE 24. BEARING FP-6 AFTER 69.5 TEST HOURS SHOWING ROTATED AND COCKED SEAL

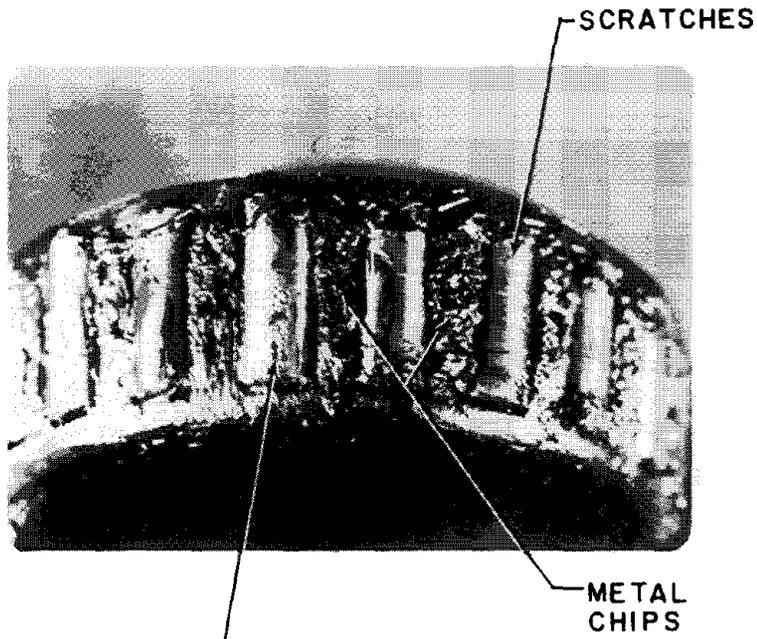
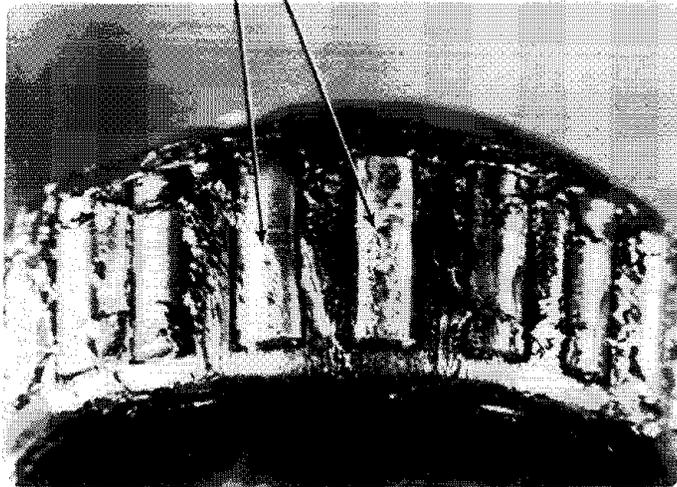
SPALLS

FIGURE 26. BEARING FP-7 AFTER 150.5 TEST HOURS SHOWING OUTBOARD CONE

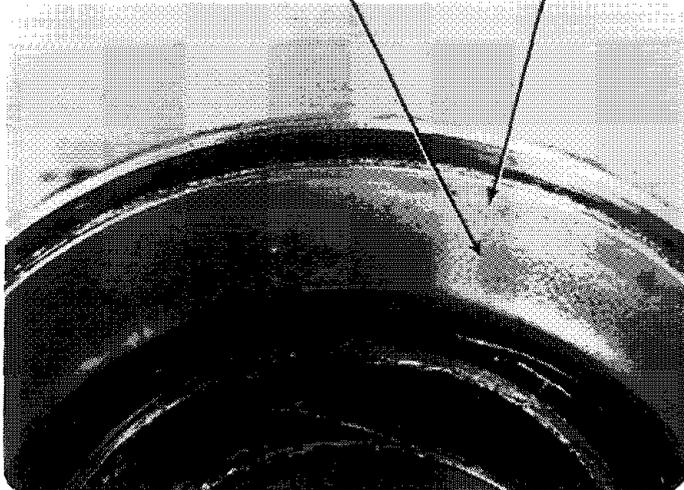
FIGURE 28. BEARING FP-7 AFTER 150.5 TEST HOURS SHOWING INBOARD SIDE CONDITION

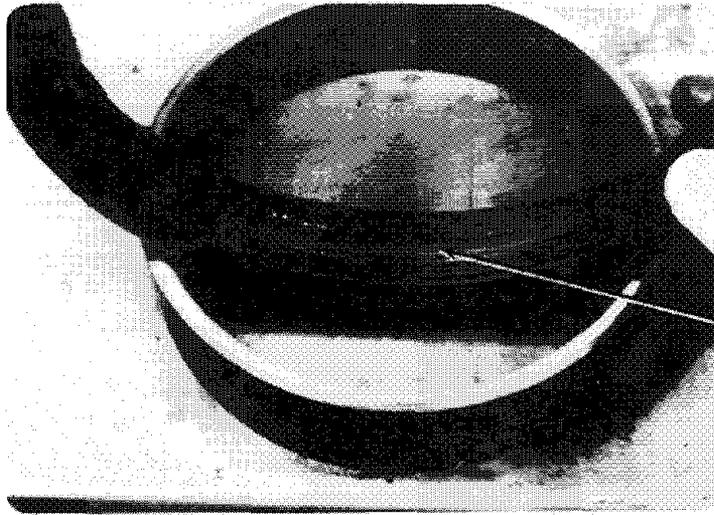
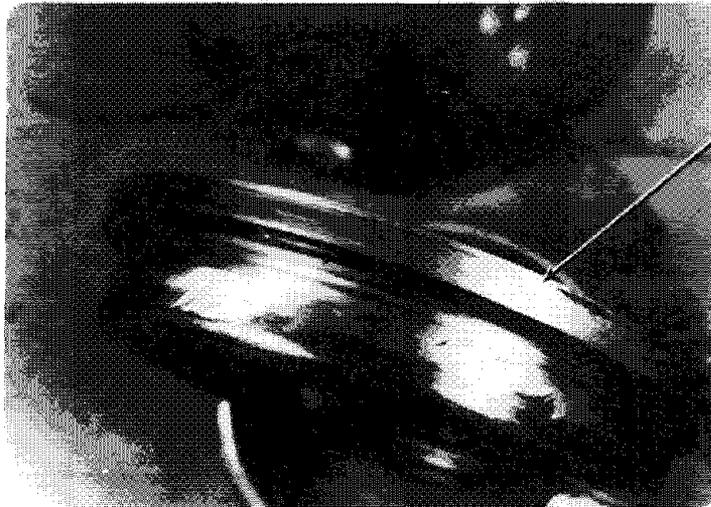
WORN SEAL LIP  
(SMOOTH WEAR)

WORN AND SHARP  
EDGED SEAL CASE

FIGURE 29. BEARING FP-7 AFTER 150.5 TEST HOURS SHOWING SEAL CONDITION

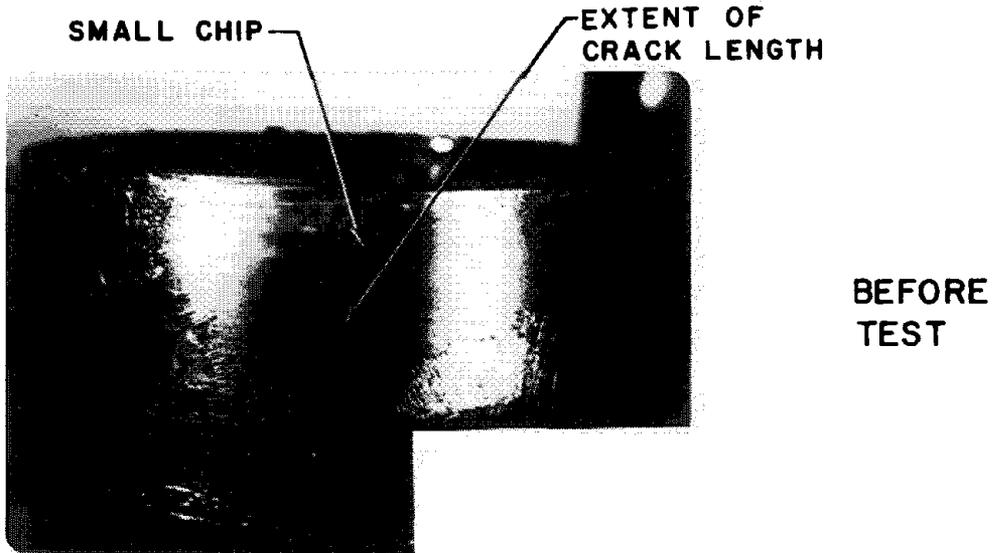
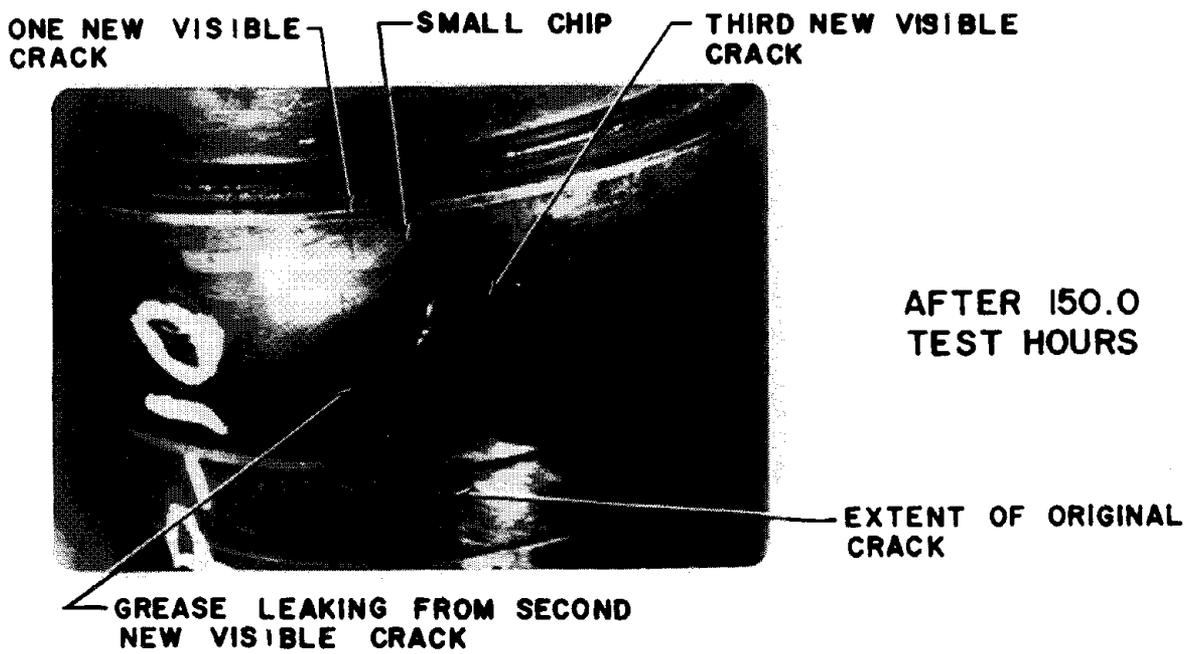
FIGURE 32. BEARING FP-10 SHOWING CRACK GROWTH ON INBOARD END

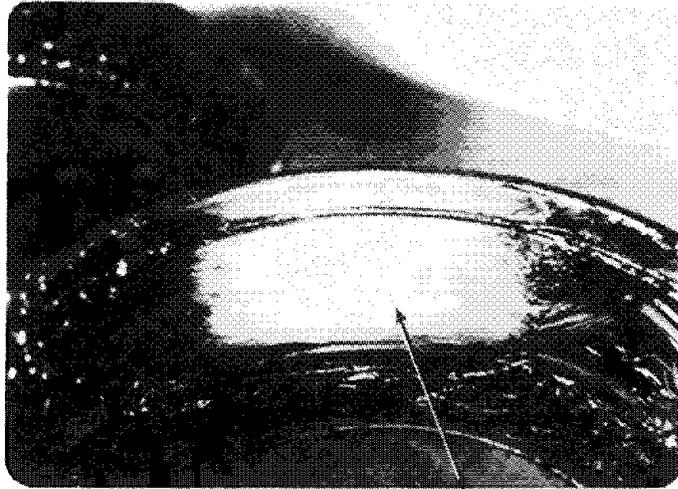
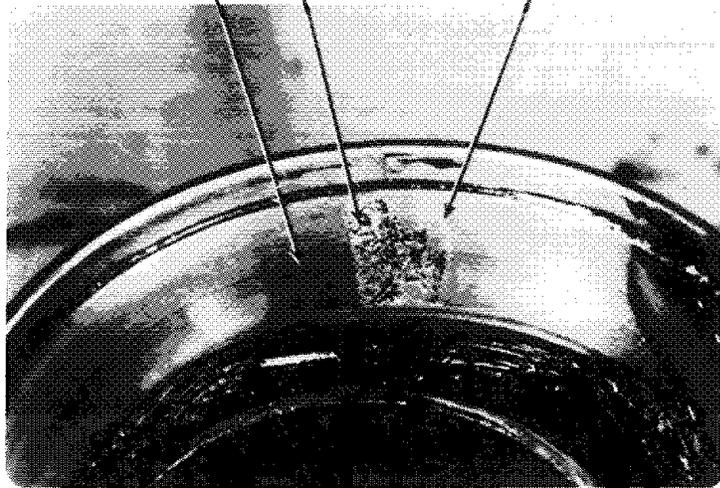
DENTED  
APPEARANCE

SPALL

STRINGER CRACKS

FIGURE 33. BEARING FP-10 SHOWING DEGRADATION OF INNER RACE ON INBOARD END

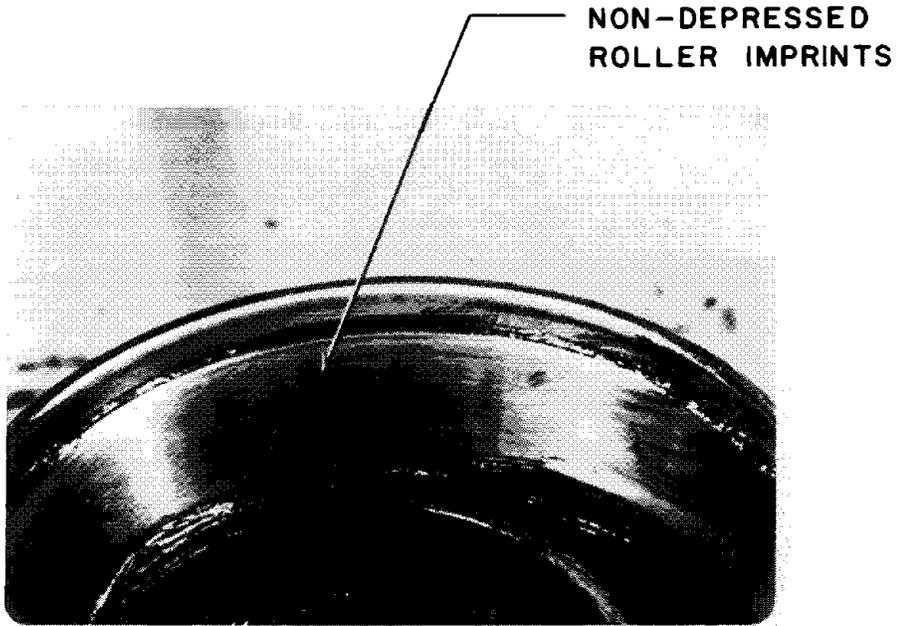
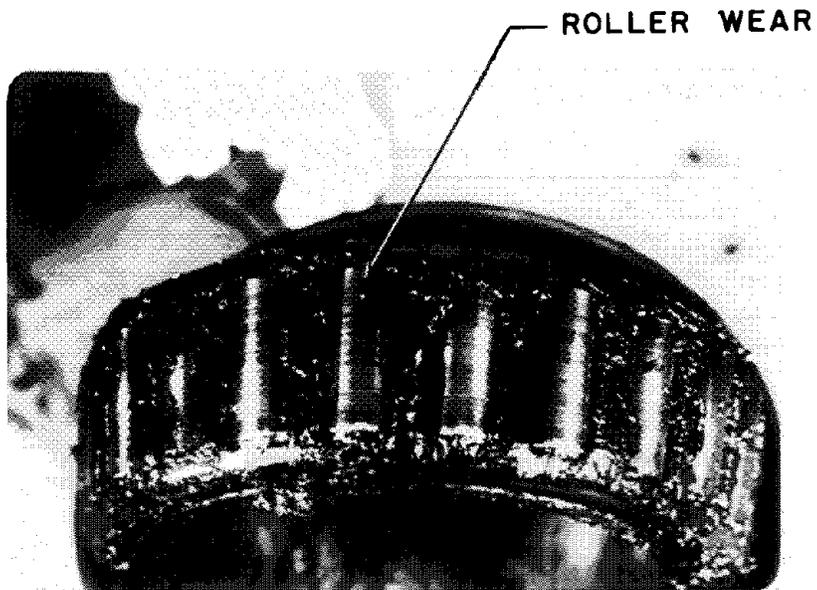
FIGURE 34. BEARING FP-10 AFTER 150.0 TEST HOURS SHOWING ROLLER WEAR AND "IMPRINTS" ON INBOARD END

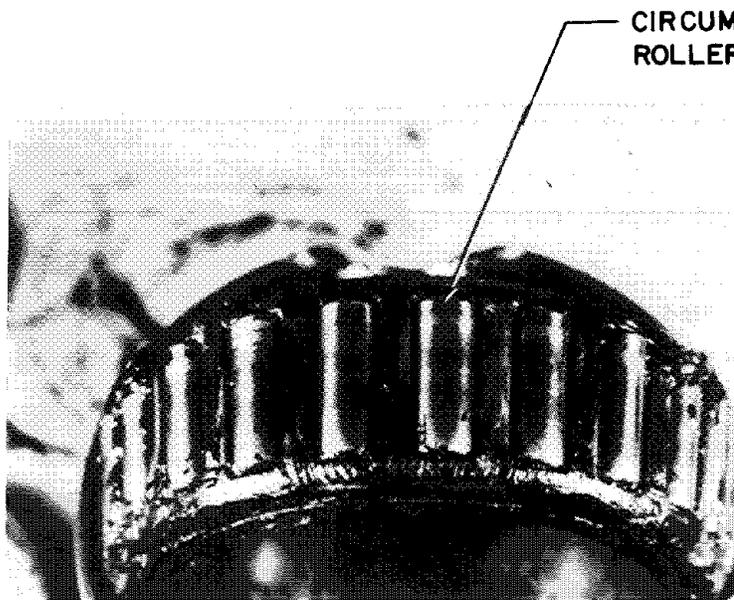
FIGURE 36. BEARING FP-10 SHOWING ROLLER WEAR IN AREA OF  
BROKEN CUP ON OUTBOARD END

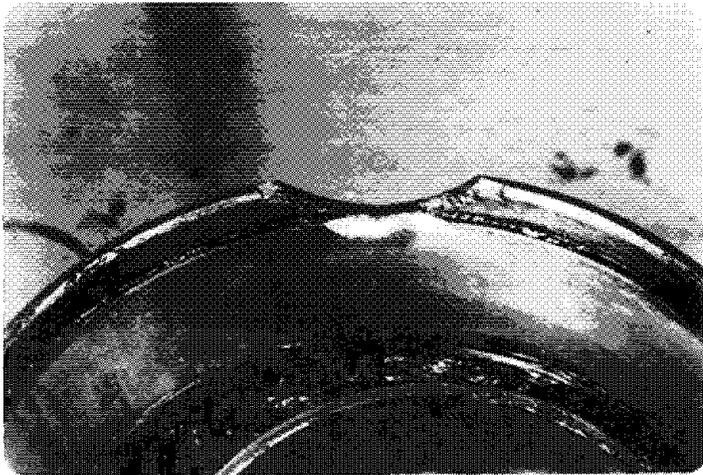
FIGURE 38. BEARING FP-11 SHOWING OUTBOARD END BROKEN CUP

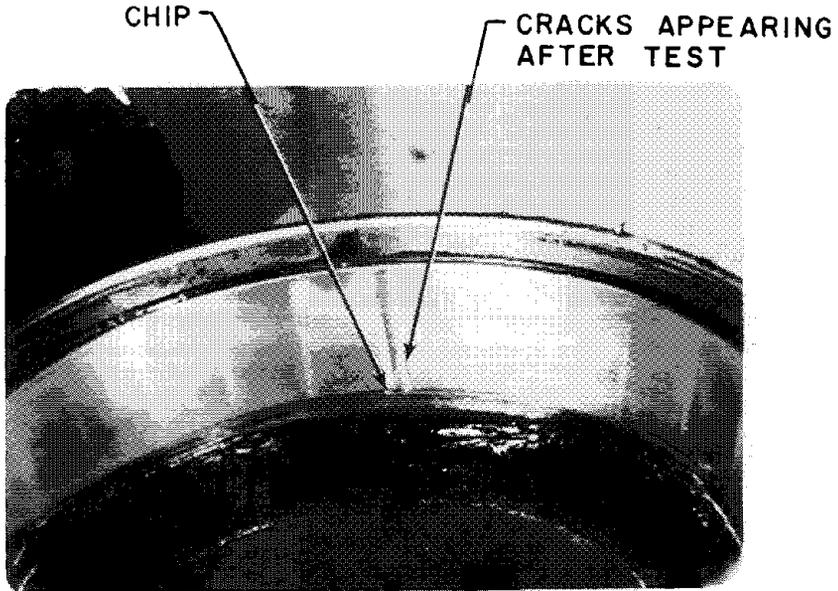
FIGURE 40. BEARING FP-11 SHOWING INBOARD END BRINELL AND CRACKS

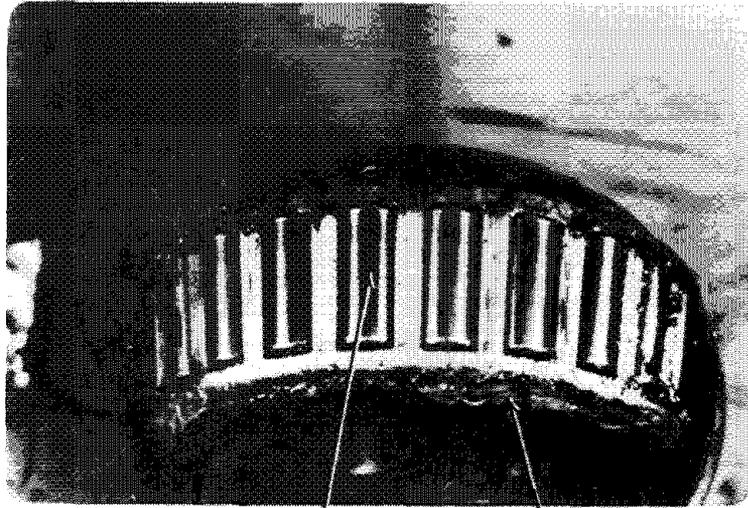
SLIGHT WEAR  
TRACKS

CLEAN GREASE

FIGURE 45. BEARING LB-1 (TEST BEARING END) AFTER 676.8 HOURS AT TWICE RATED LOAD

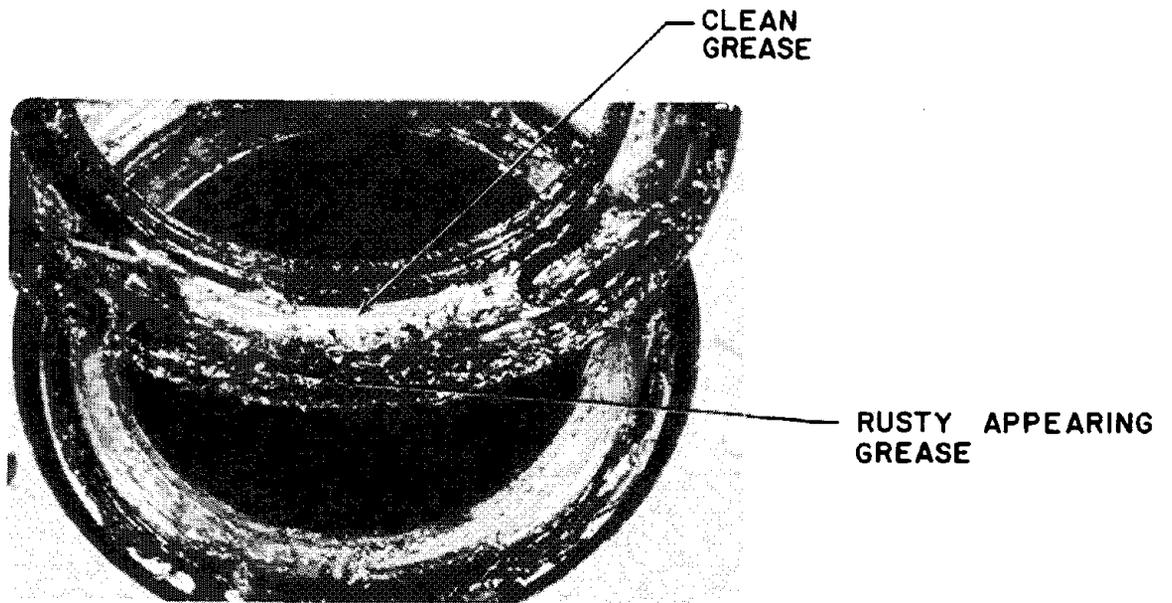
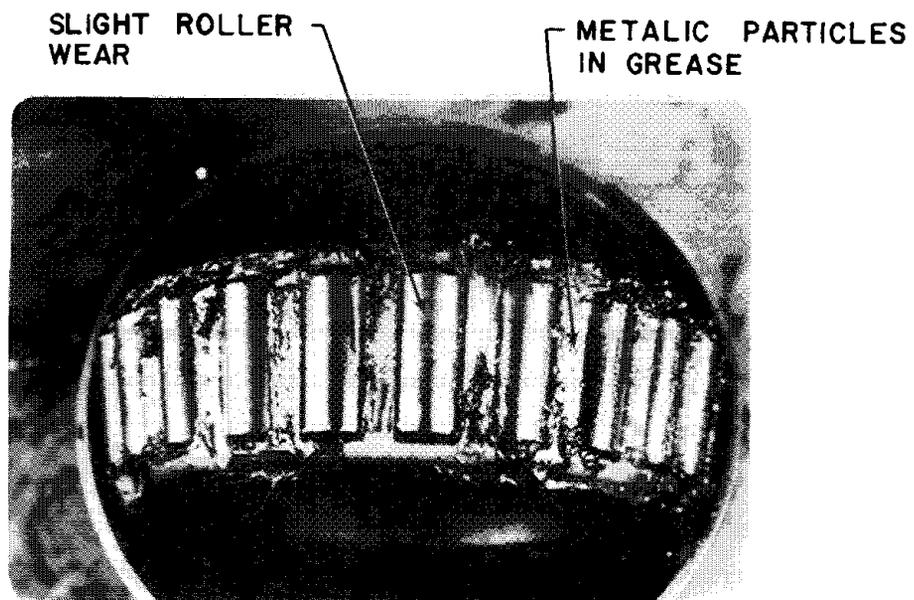
Instead, it is postulated that the method of applying load through the cooling jacket was the cause of the spalling problems. The standard adapter is designed so that the side frame load is picked up on two raised and crowned ribs and then distributed in a near uniform fashion over a relatively wide circumferential area of the cup as is shown pictorially in Figure 49a. When the cooling jacket was placed between the bearing and the adapter, the load was uniformly distributed over the contact area of the cooling jacket. However, the cooling jacket was too stiff to accommodate the clearance between the jacket bore and bearing O.D., as is shown in Figure 49b. This resulted in the load being concentrated along a line on the cup instead of being distributed over a wide area.

FIGURE 46. BEARING LB-2 (TEST BEARING END) AFTER 308.3 HOURS AT TWICE RATED LOAD

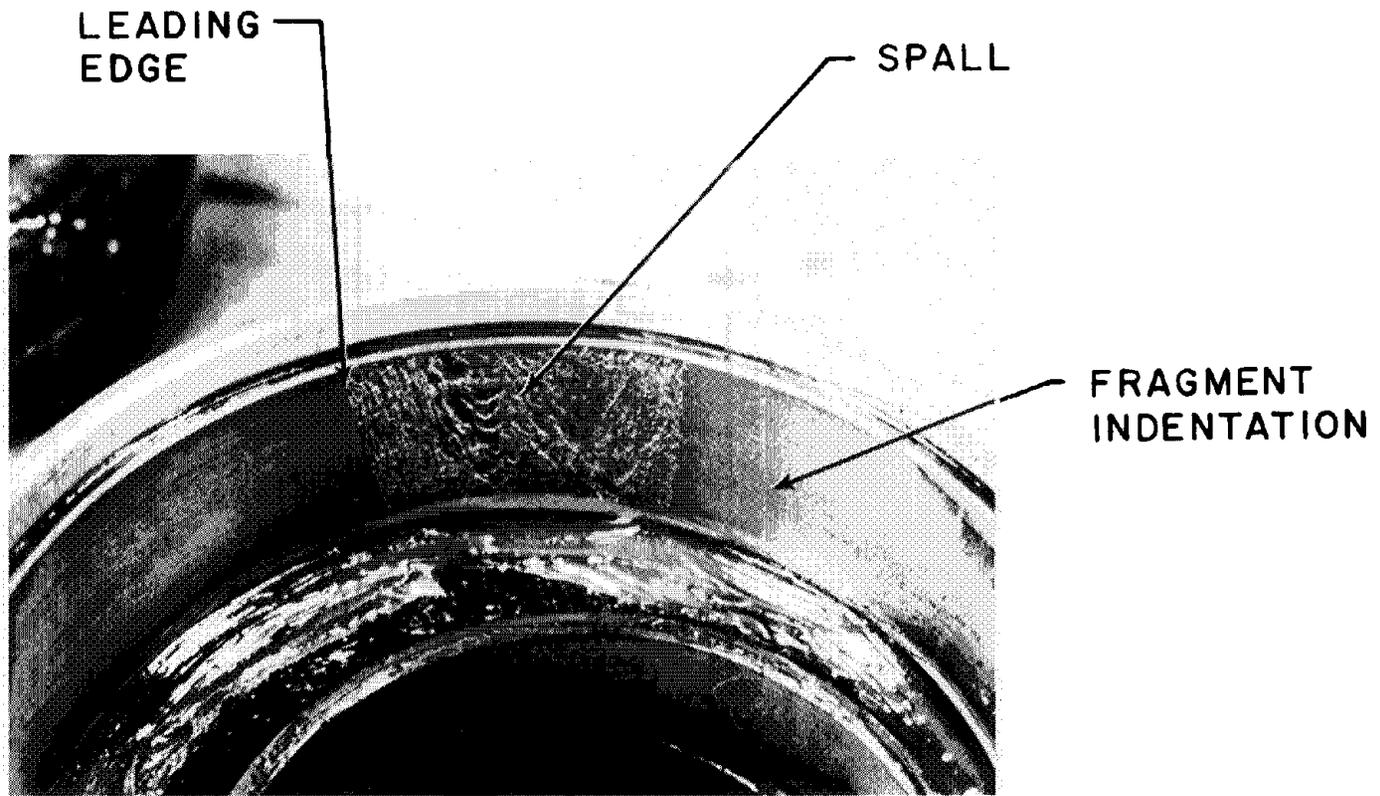
FIGURE 47. BEARING LB-2 (TEST BEARING END) AFTER 308.3 HOURS AT TWICE RATED LOAD

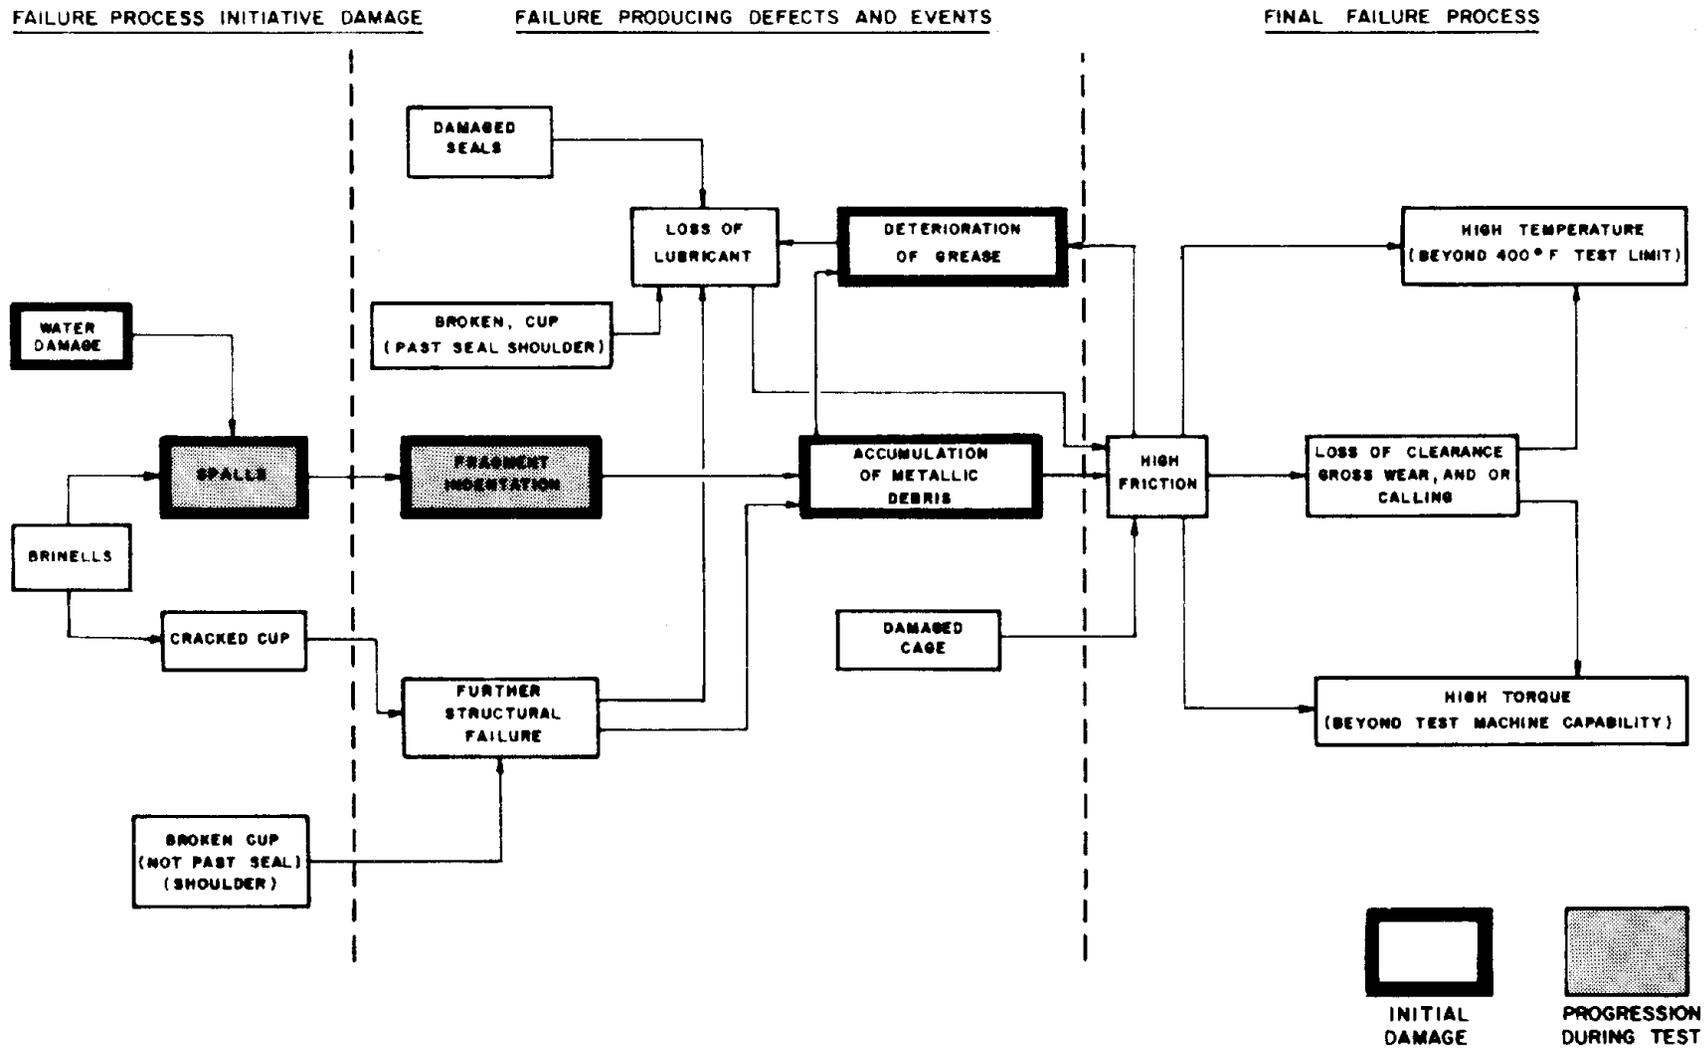
FIGURE 57. DEFECT PROGRESSION, BEARING FP-8
