1. Report No. FRA/ORD-81/26		2. Government Accession No.		3. Recipient's Catalog No. <b>PB83 110577</b>	
4. Title and Subtitle RAILCAR ROLLER BEARING FAILURE PROGRESSION TESTS				5. Report Date April 1982

16. Abstract This report describes the laboratory endurance test of six railcar roller bearings that had previously suffered physical damage or were otherwise degraded as a result of actual railroad service. Two different onboard impending bearing failure sensors were also physically evaluated. The objectives of the tests were to obtain a better understanding of the railcar roller bearing failure process(es), the manner in which bearing defects progress, and the effectiveness of the impending failure warning devices. A 150 hour test with 26,250 pounds radial load (equivalent full car load) at 528 rpm (equivalent to approximately 52 mph) was planned for each bearing. Only one bearing actually failed to complete the 140 hour test. All bearings exhibited further measurable degradation of defect progression during the course of the tests. Neither warning device actually gave warning of the one failure experienced.

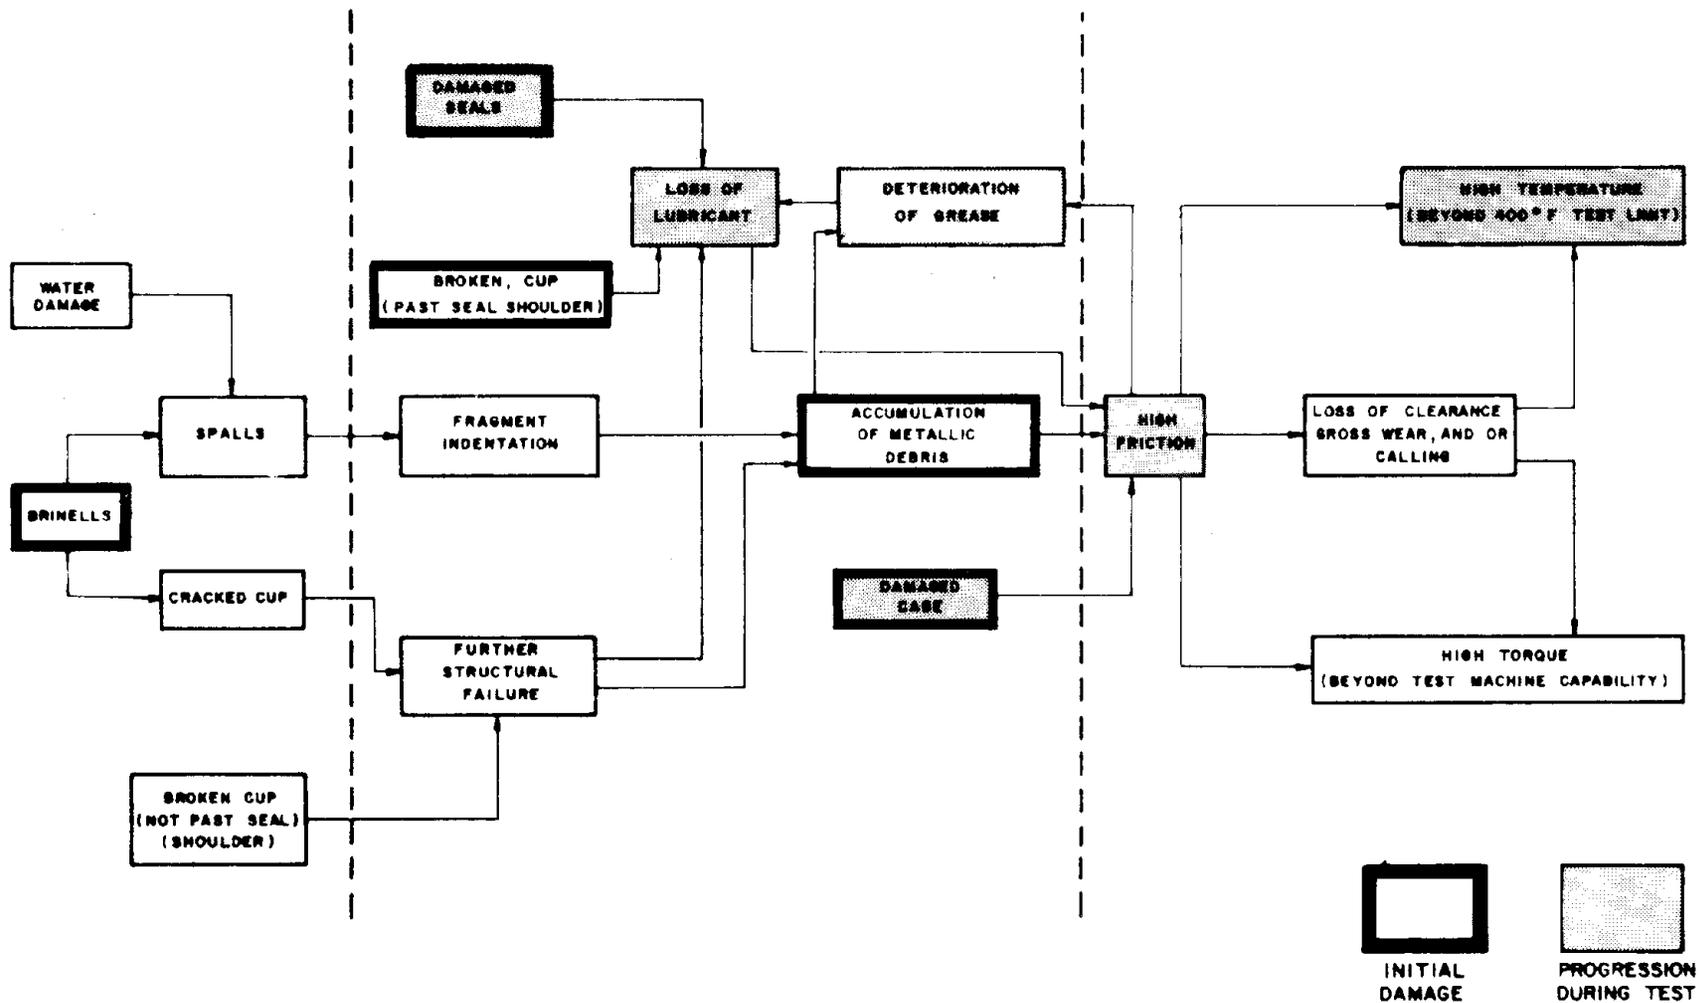
FIGURE 58. DEFECT PROGRESSION, BEARING FP-6

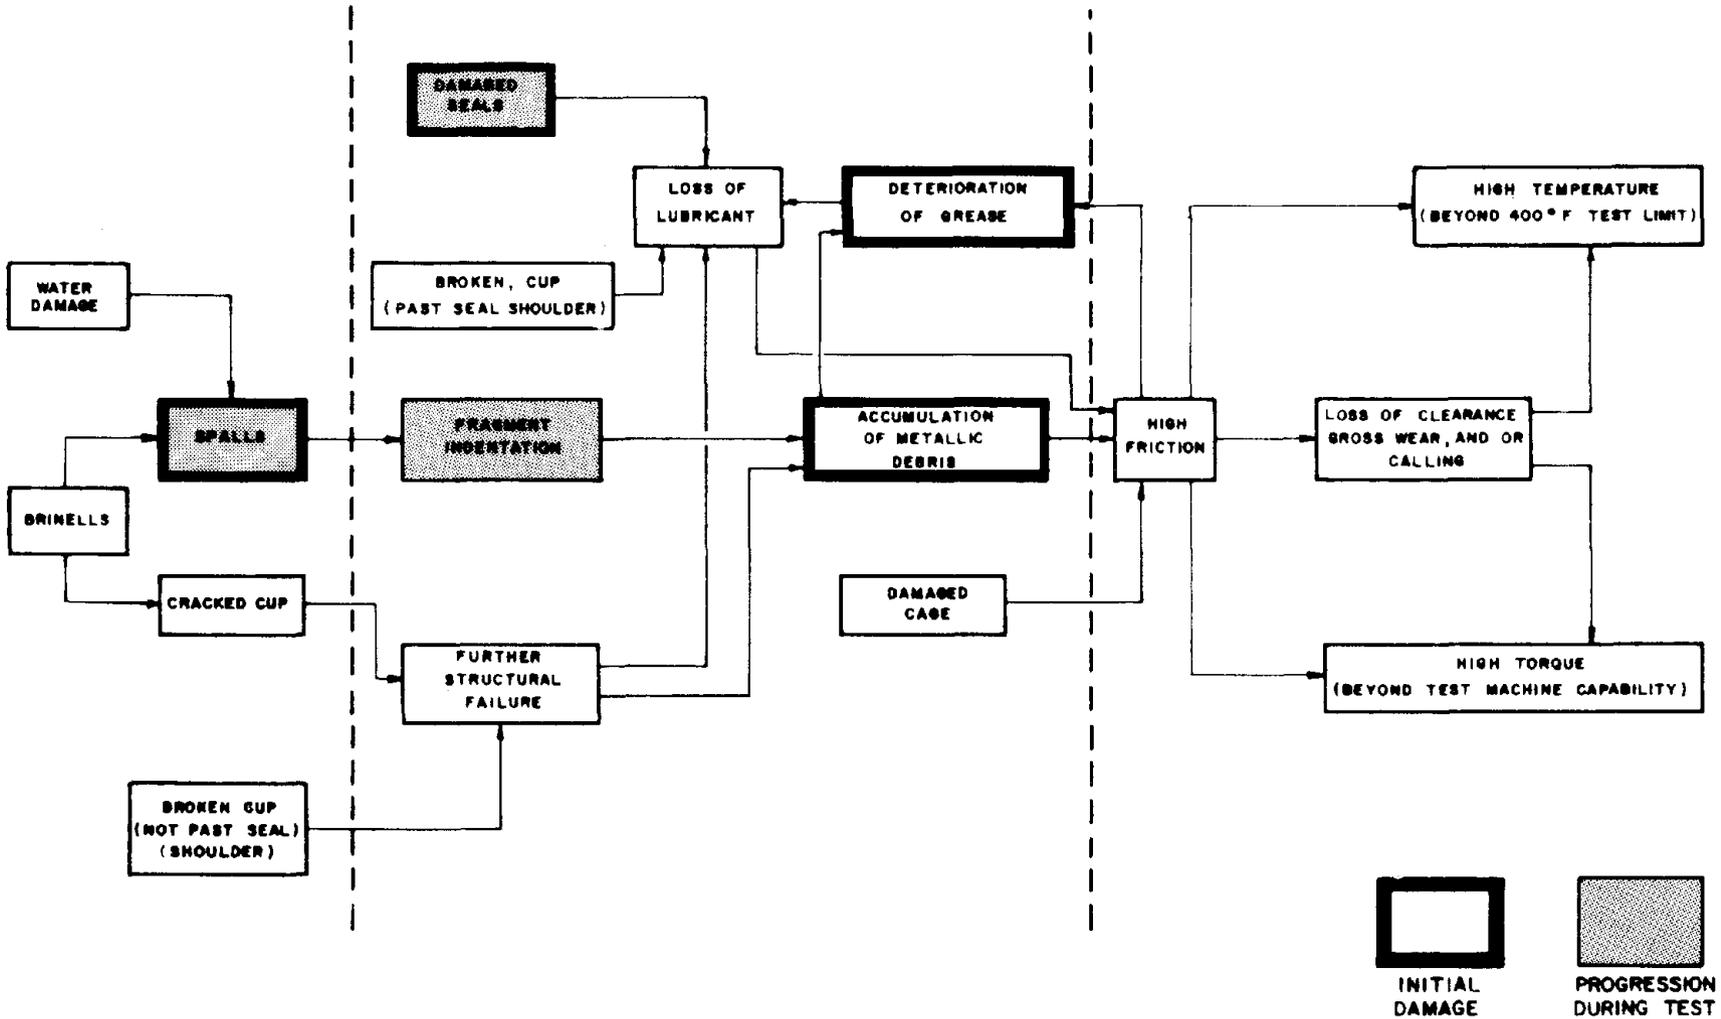
FIGURE 59. DEFECT PROGRESSION, BEARING FP-7

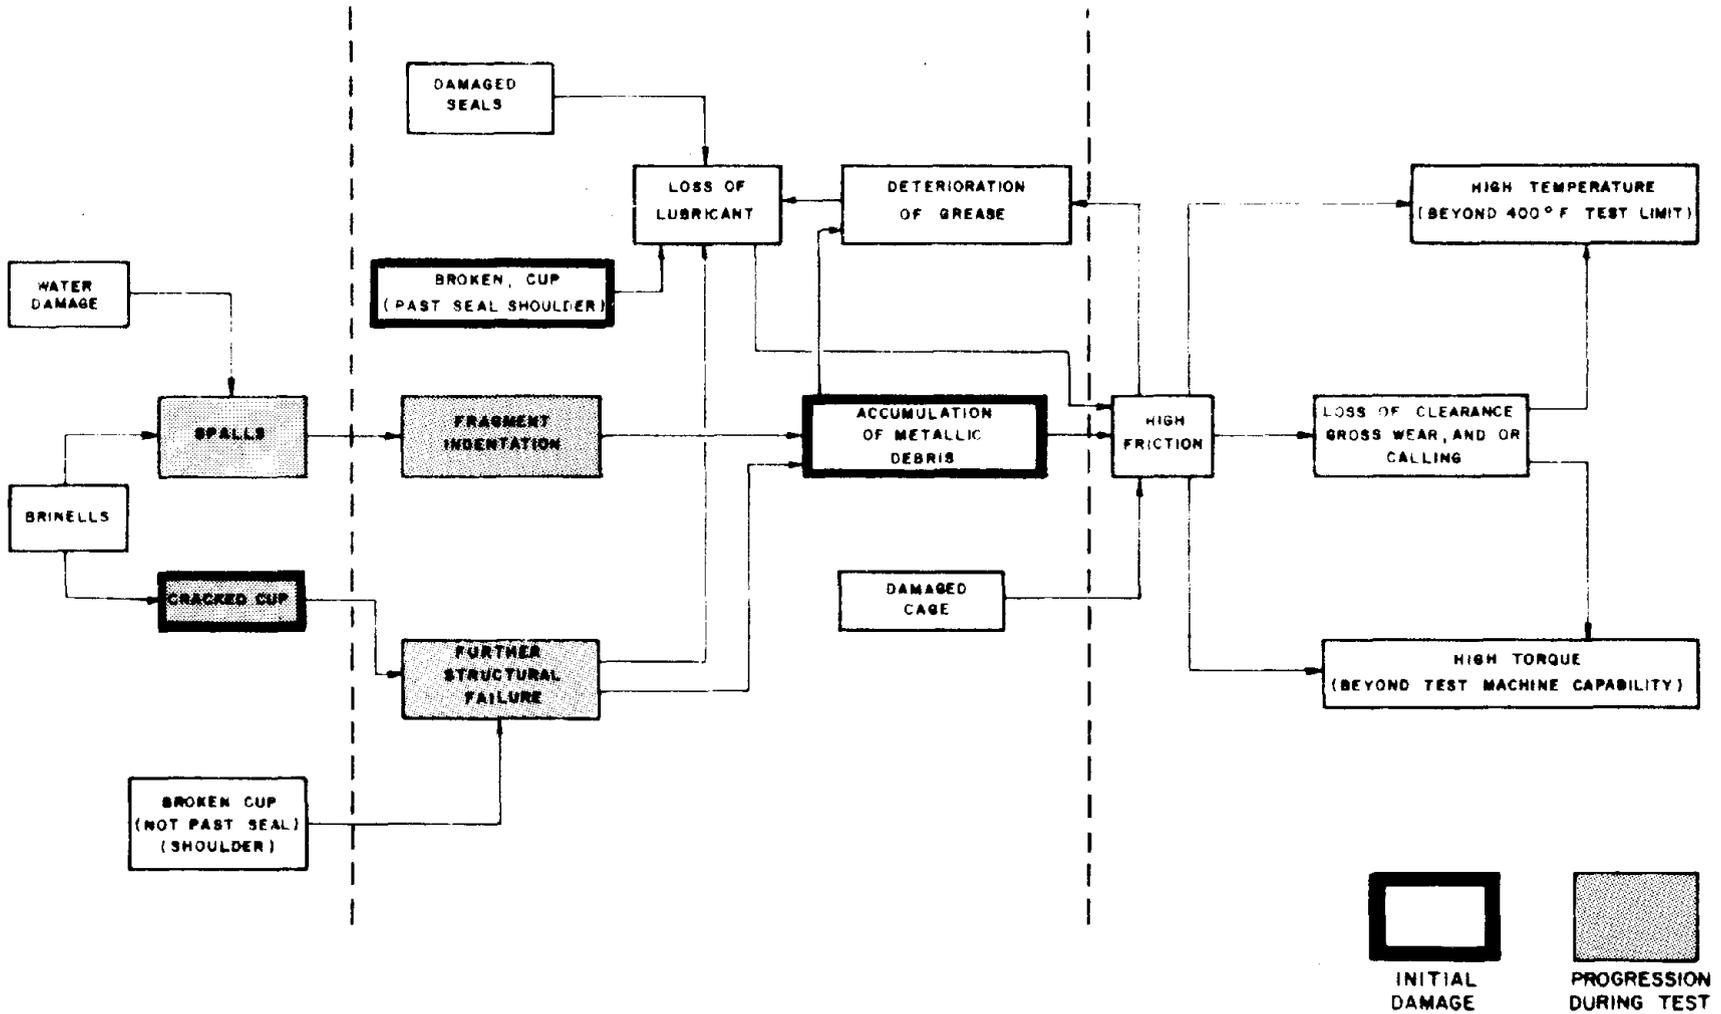
FIGURE 60. DEFECT PROGRESSION, BEARING FP-10

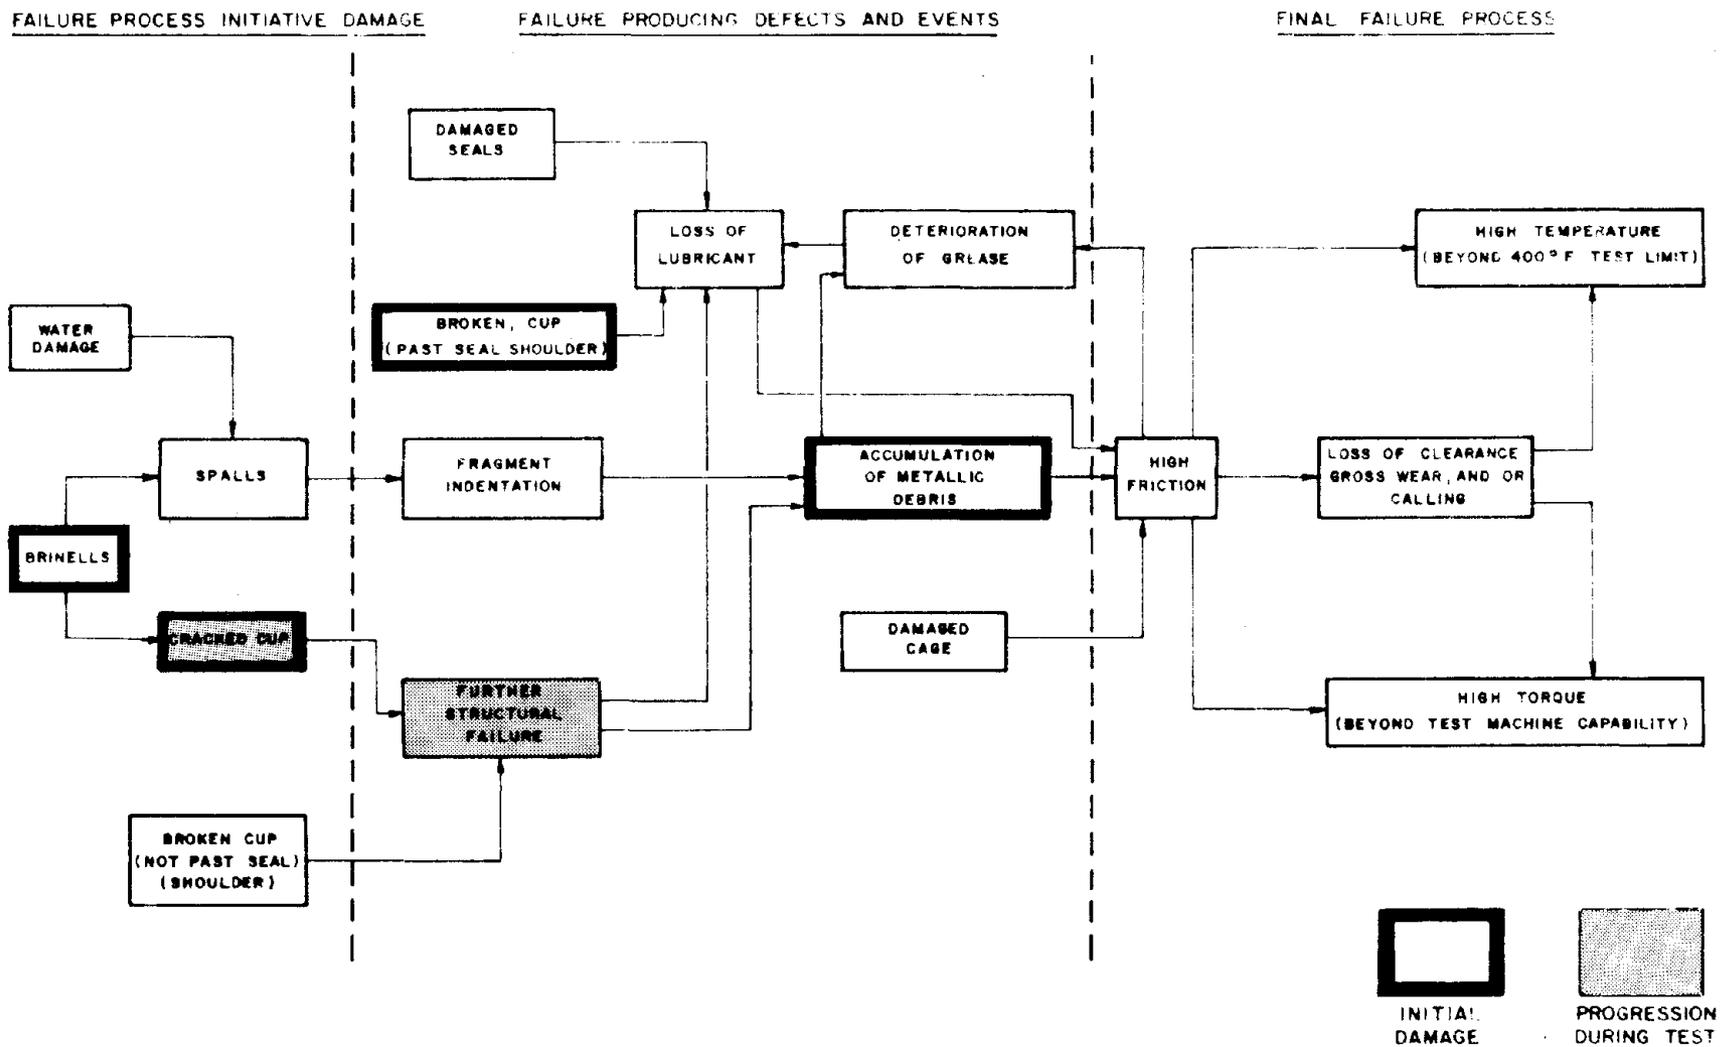
FIGURE 61. DEFECT PROGRESSION, BEARING FP-11

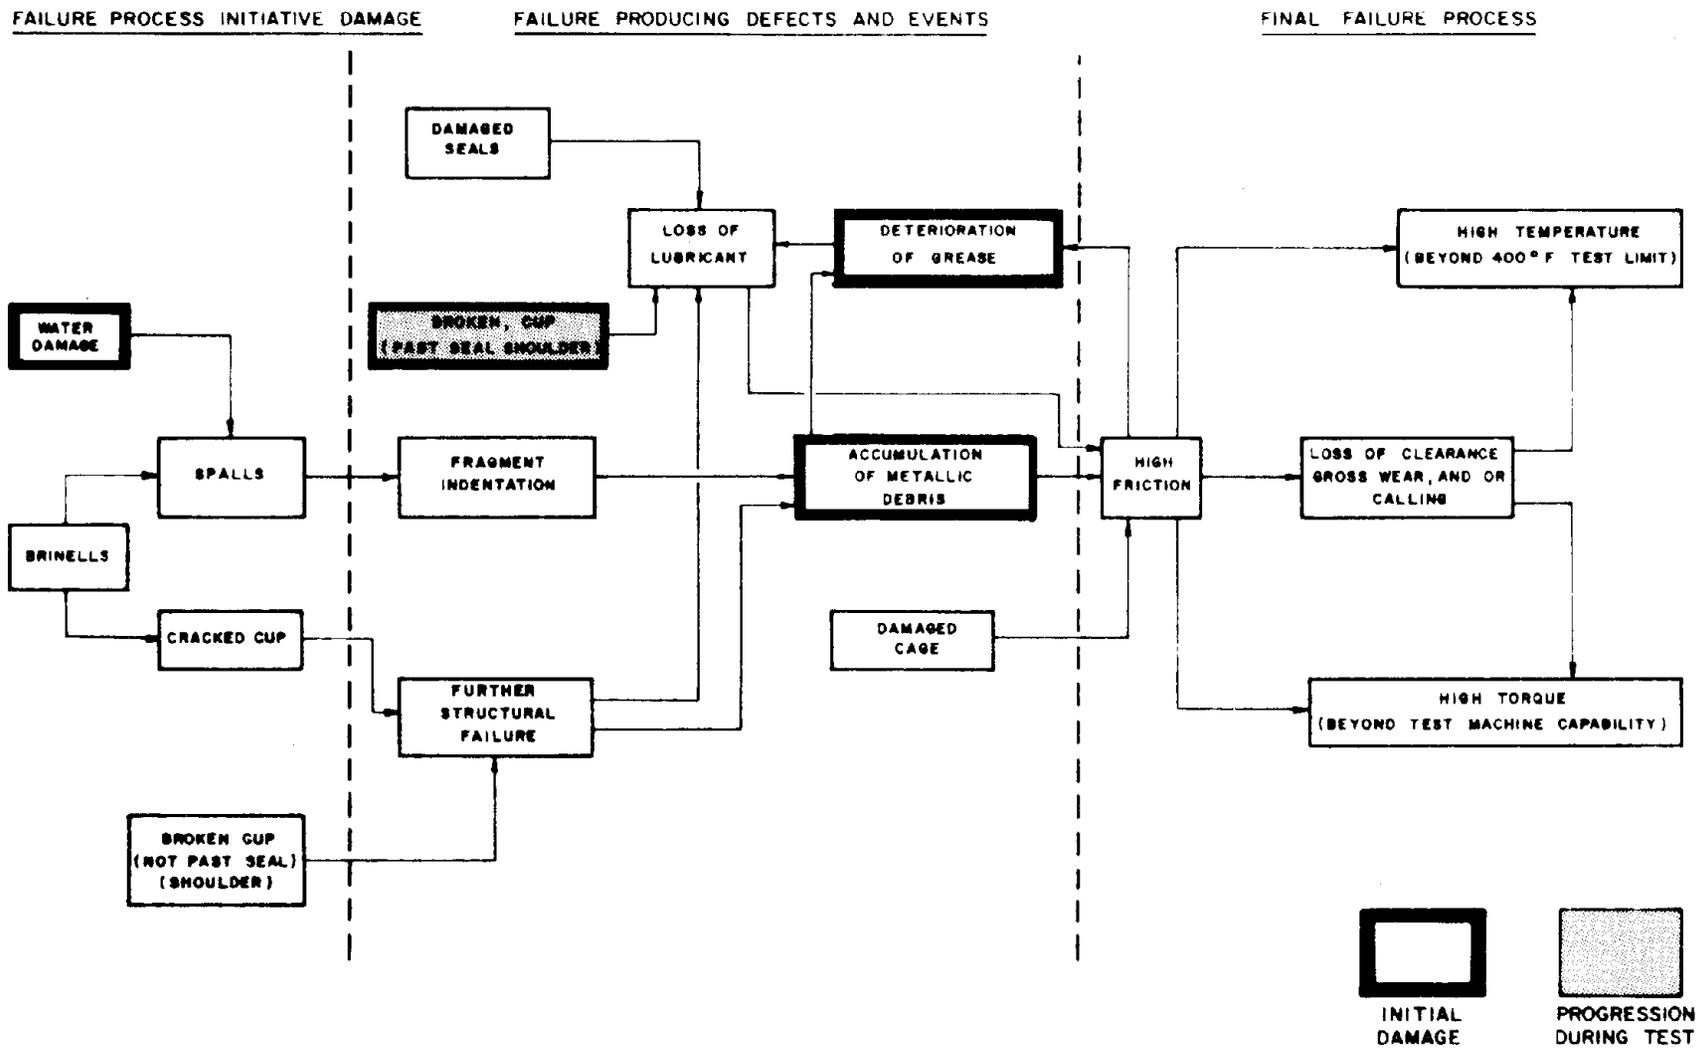
FIGURE 62. DEFECT PROGRESSION, BEARING FP-12
