REPORT NO. FRA-OR&D-76-03

# LOCOMOTIVE TO AUTOMOBILE BASELINE CRASH TESTS

R. L. Anderson

AUGUST 1975  
FINAL REPORT

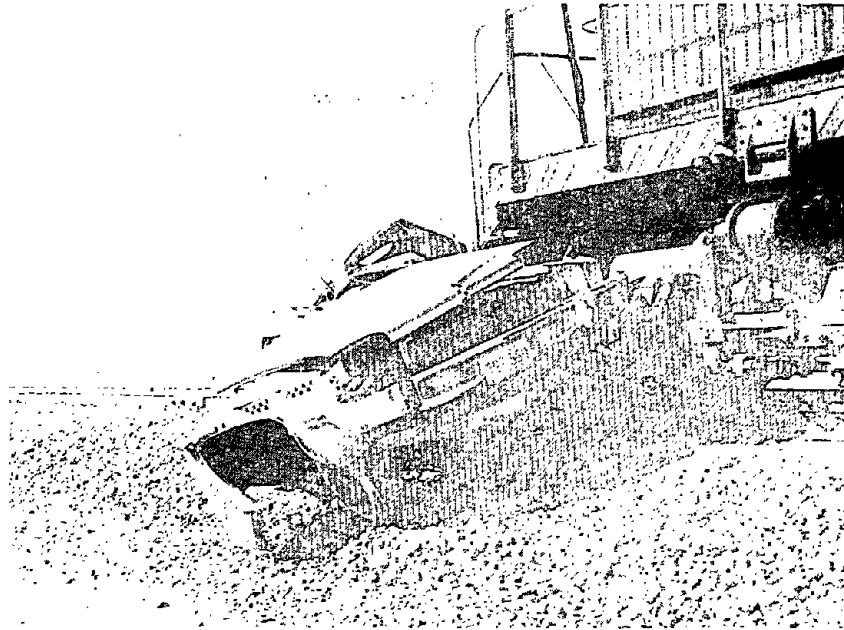
Figure 14. Post-test View of Automobile Front Section (Test TGB-1).

Figures 11 and 12 are overall and close-up views of the pre-test impact orientation for Test TGB-1. Figures 13 and 14 are post-test views of the locomotive and automobile. The coupler penetration is illustrated in Figures 15 and 16. During the impact, the fuel tank was damaged, causing a steady flow of the dyed water from near the top of the tank. The deformed tank is shown in Figure 17. During impact, the rear axle contacted the front plate on the train and was driven against the fender on the opposite side of the car. Figure 18 shows the deformation on the passenger side of the automobile due to the rear axle. The front section of the automobile from the firewall forward was broken loose, as mentioned earlier, but remained connected by the left front fender. Figure 19 shows how the engine compartment was opened up and how the transmission penetrated into the ballast at the side of the track during the stop. The front of the locomotive suffered significant deformation. The front plate was bent back as much as 11 inches at the lower right corner. The locomotive steps, which were part of the support of the front plate, sheared with permanent set are seen in Figure 20. Figure 21 shows a close-up of the broken pipe on the front of the locomotive. The post-test condition of the front of the locomotive is illustrated in Figure 22. The imprint of the left rear wheel can be seen on the lower left-hand side of the plate.

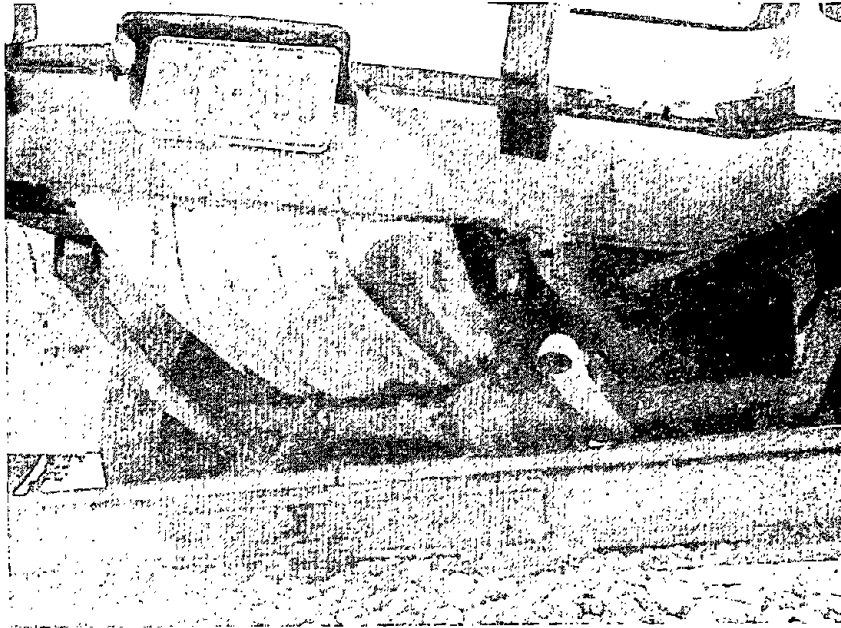
Fuel tank was ruptured

Figure 17. Post-test View of Fuel Tank (Test TGB-1).

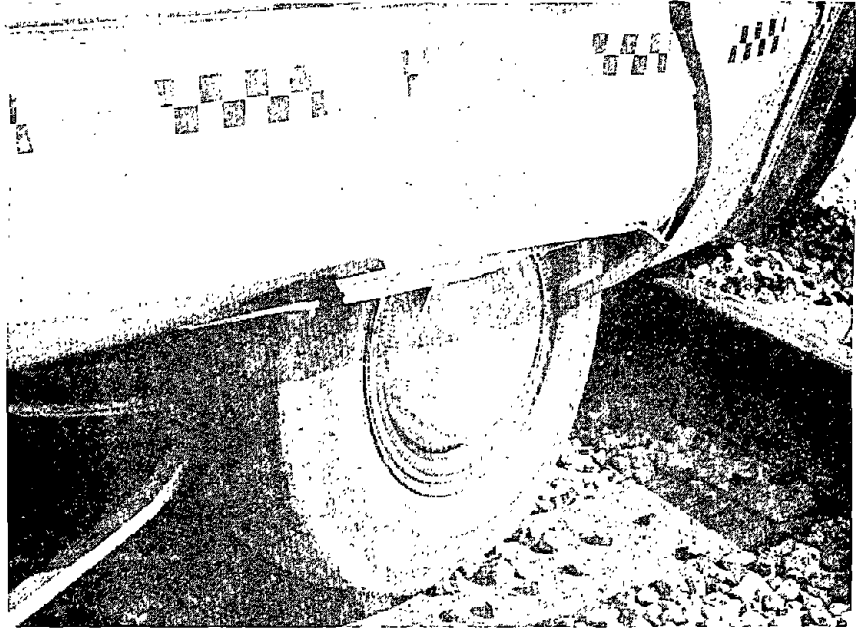
Imprint of rear wheel was observed on locomotive front plate

Figure 18. Deformation on Right Side of Automobile Due to Rear Axle Striking Locomotive Front Plate (Test TGB-1).

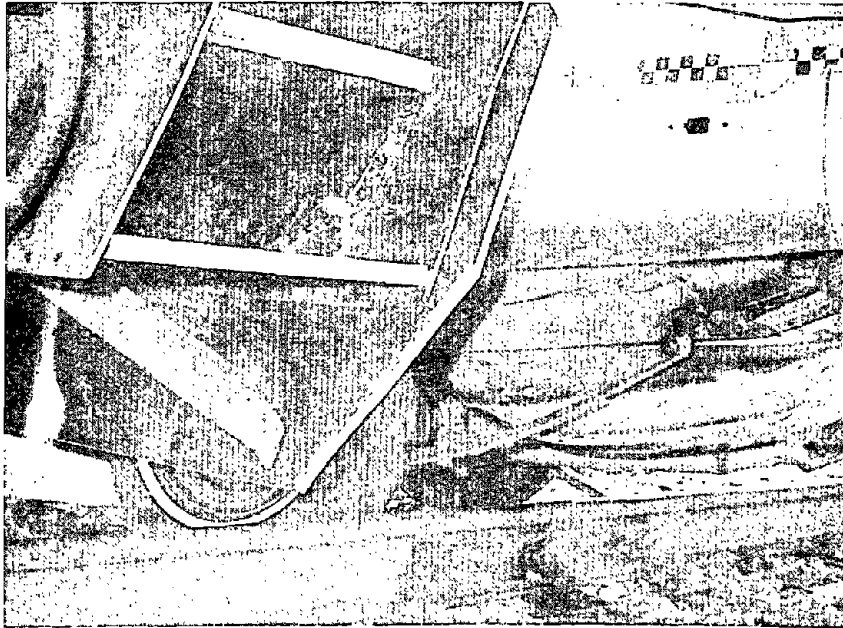
Figure 20. Permanent Set in Locomotive Steps After Test TGB-1.

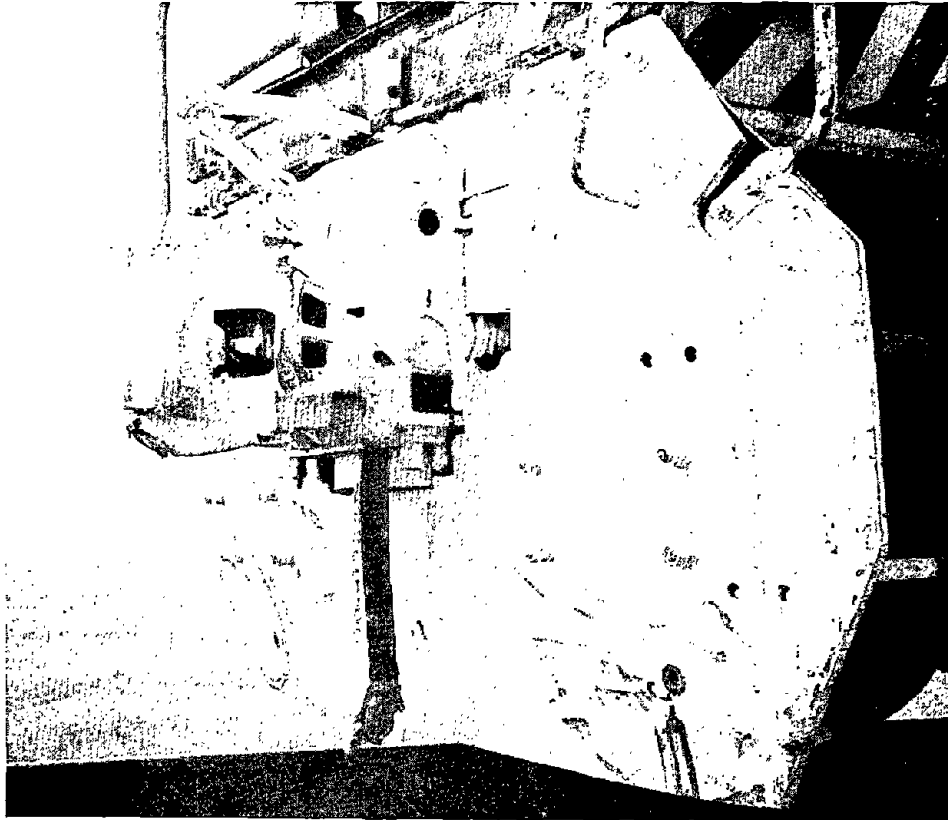
Figure 22. Post-test Condition of Locomotive Front  
(Test TGB-1).

While the automobile and locomotive remained in contact during the post-impact travel, the locomotive was easily separated from the automobile by simply backing away.

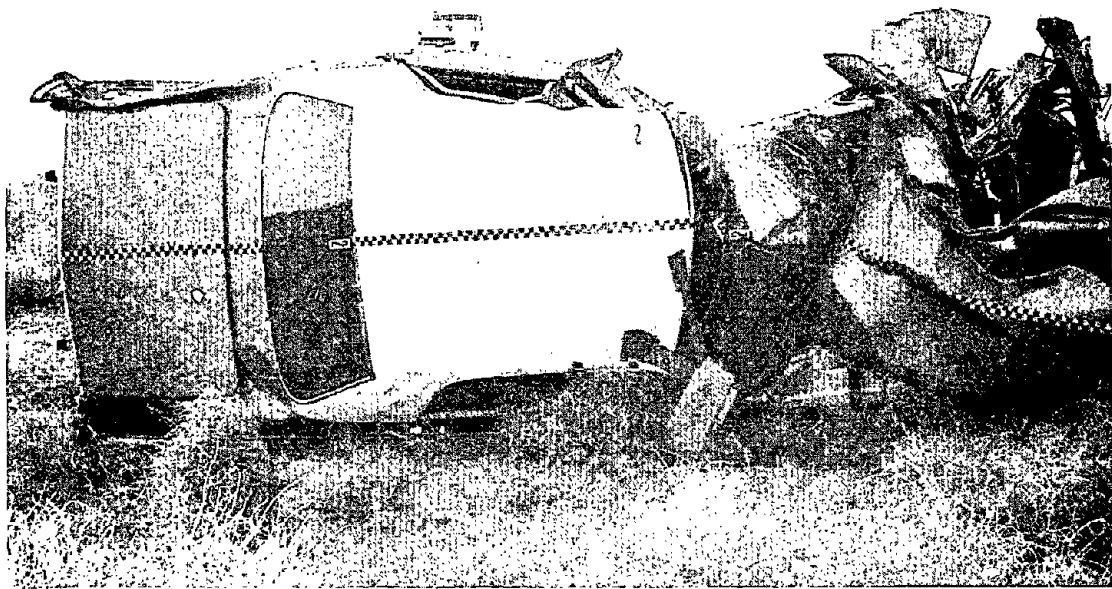
Figure 26. Post-test View of Top of Automobile (Test TGB-2).

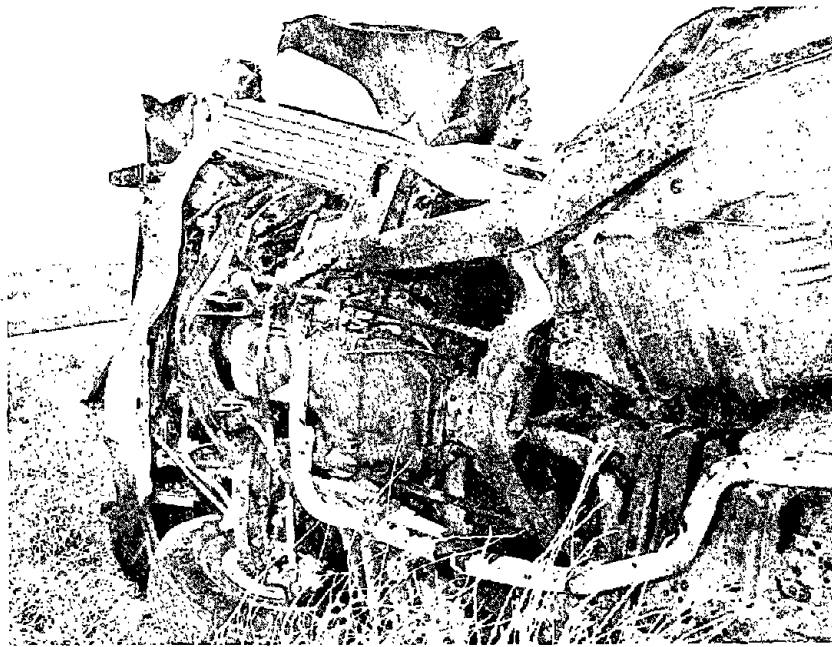
Front cross frame under engine front was buckled  
Battery was on ground  
Radiator hose was on ground  
Carburetor was broken in two  
Left front fender was separated  
Front windshield was crushed - retained on bottom and lower right side  
Rear window was partially separated near roof dent on right side  
Right rear fender was bent inward  
Front seat was buckled up on left side  
Glove box door had opened  
Left valve cover was off of engine  
Fuel tank was dented but only leakage was from around cap  
Entire left rear fender was bent up  
Transmission housing was cracked  
Rear cross frame for transmission support had buckled  
Right front torsion bar had pulled out  
Both stub frames were bent but still attached  
Drive shaft was out  
Tunnel had collapsed back to rear seat area - left floor under rear seat had buckled  
Rear spring clip was gone - front right - rear left  
All engine mounts were broken

Figure 27. Post-test Underside View of Front Section of Automobile (Test TGB-2).

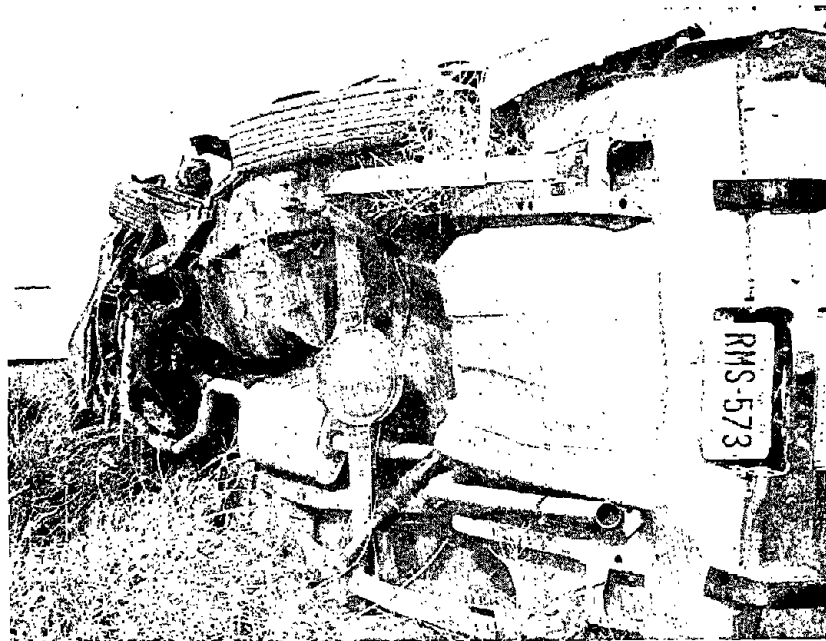
Figure 28. Post-test Underside View of Automobile (Test TGB-2).

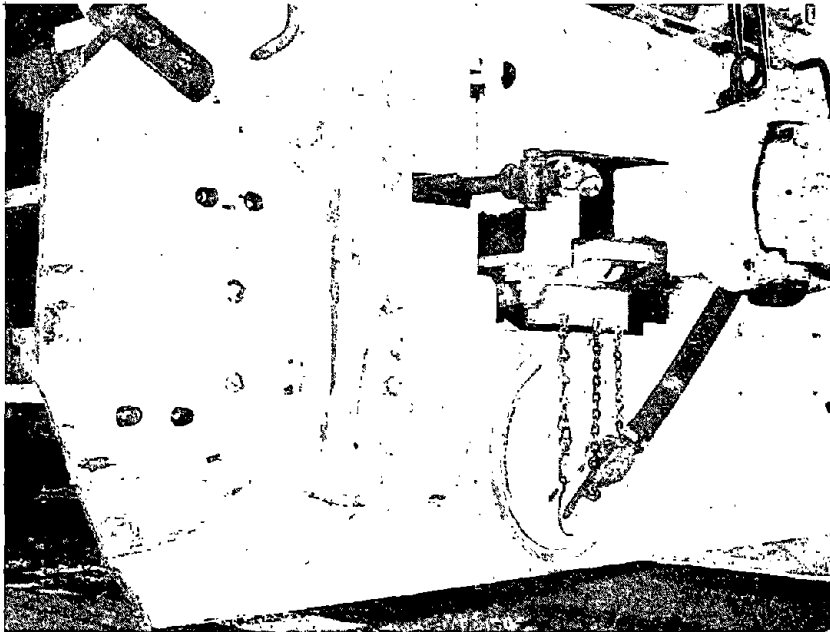
The imprint of the automobile on the locomotive front plate is shown in Figure 30. The automobile caused minor damage to the side of the locomotive when the left rear fender rotated into its side, as shown in Figures 31 and 32.

Figure 30. Post-test View of Locomotive Front Plate Showing Automobile Imprint (Test TGB-2).

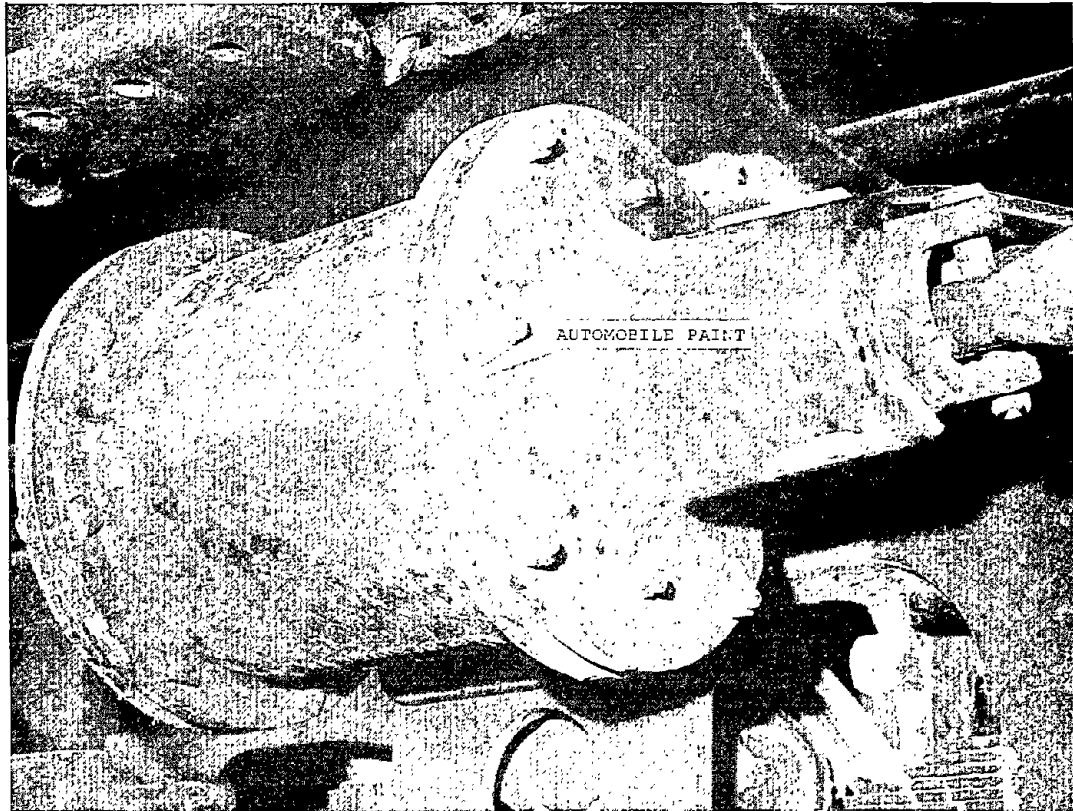
Since the impact force was ahead of the center of mass of the automobile, the automobile rotated into the locomotive. The rear portion of the automobile actually briefly moved in an up-track direction. The left rear fender impacted the side of the locomotive leaving paint on the brake cylinder and causing minor damage to the bearing box cover.

Figure 32. Post-test View of Locomotive Brake Cylinder With Automobile Paint Visible Around Front Collar.

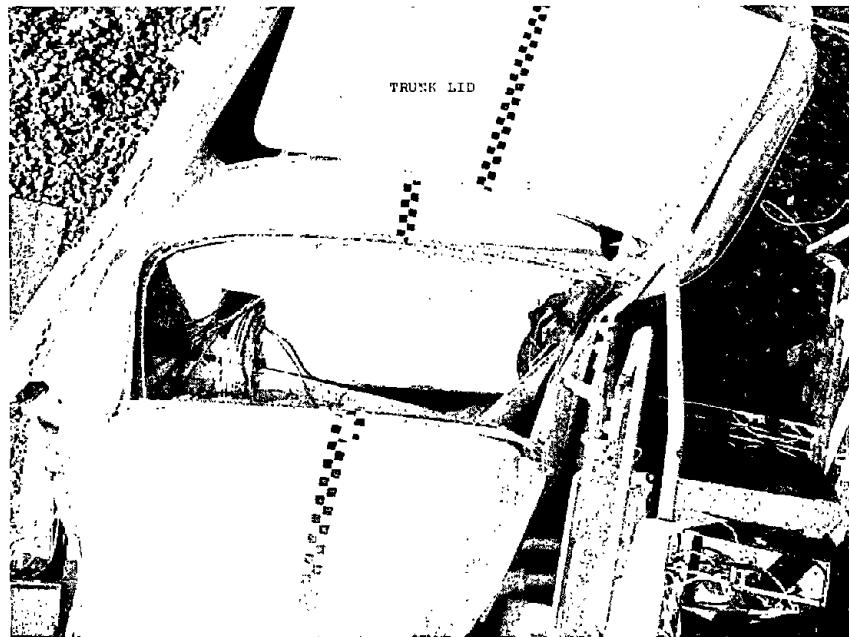
37, and 38 are post-test overhead views of the center, front, and rear sections of the automobile showing how the automobile is wrapped around the locomotive front plate and coupler.

Figure 38. Post-test View of Rear Section of Automobile (Test TGB-3).

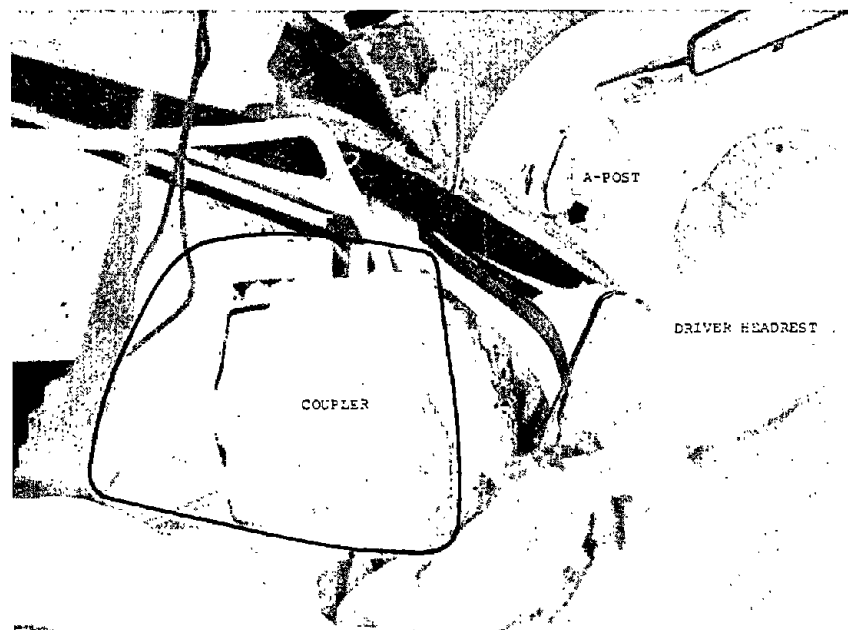
Figure 39 is a view of the coupler through the right rear door, showing the intrusion into the occupant space of the automobile. Figure 40 is a post-test view of the dummy in the driver area. The dummy retained its structural integrity with no apparent permanent damage, even though the loads experienced during the impact would have been fatal for a human, as will be discussed later. After the front section of the automobile was pulled back, the locomotive was simply backed away from the automobile leaving an imprint as shown in Figure 41.

Figure 39. Intrusion of Coupler Into Occupant Compartment (Test TGB-3).

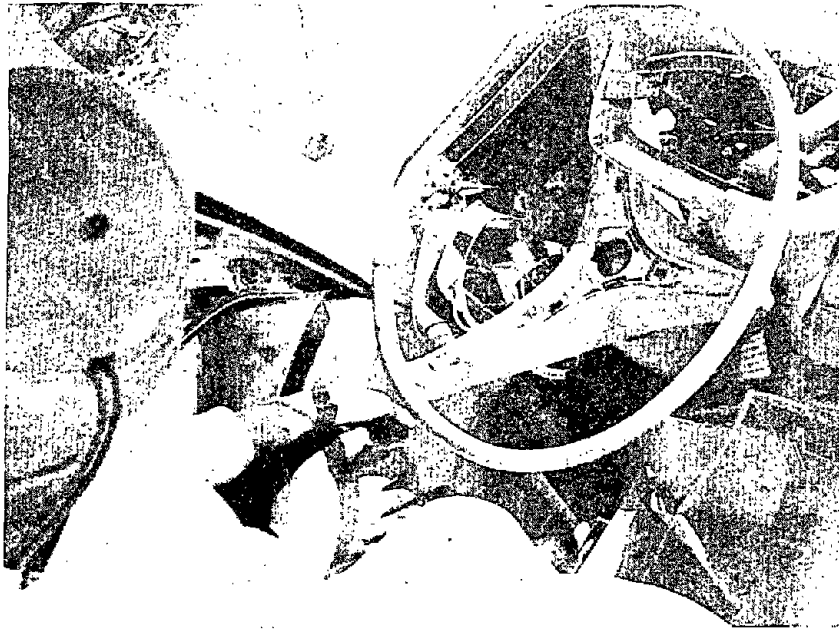
Figure 40. Post-test View of Dummy and Driver Area (Test TGB-3).

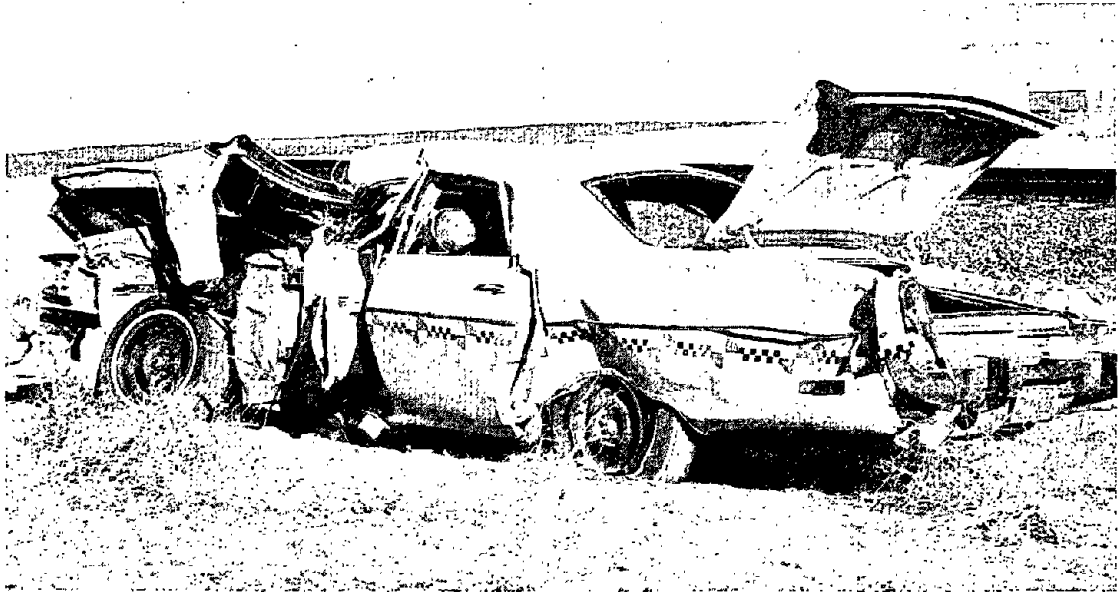
Figure 54. Post-test View of the Left Side of the Automobile (Test TGB-4).

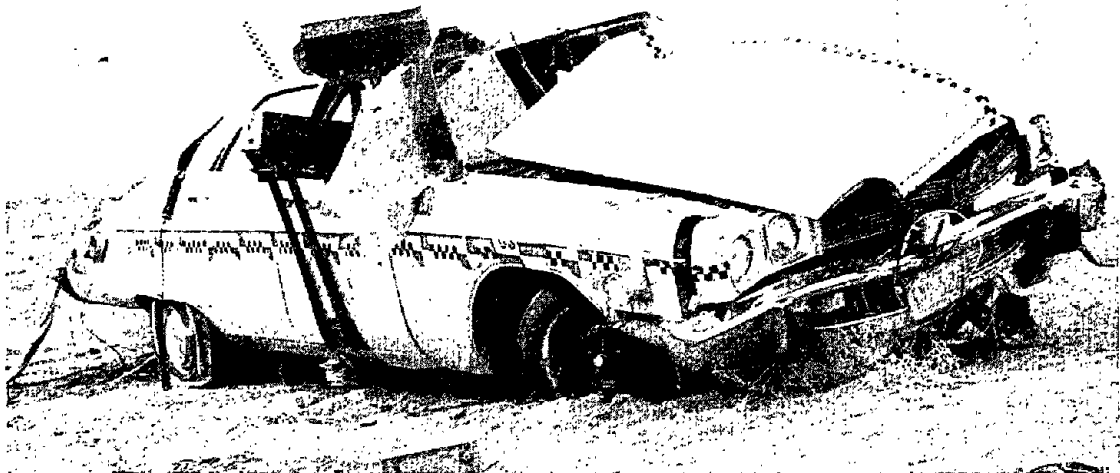
Figure 55. Post-test View of the Right Side of the Automobile (Test TGB-4).

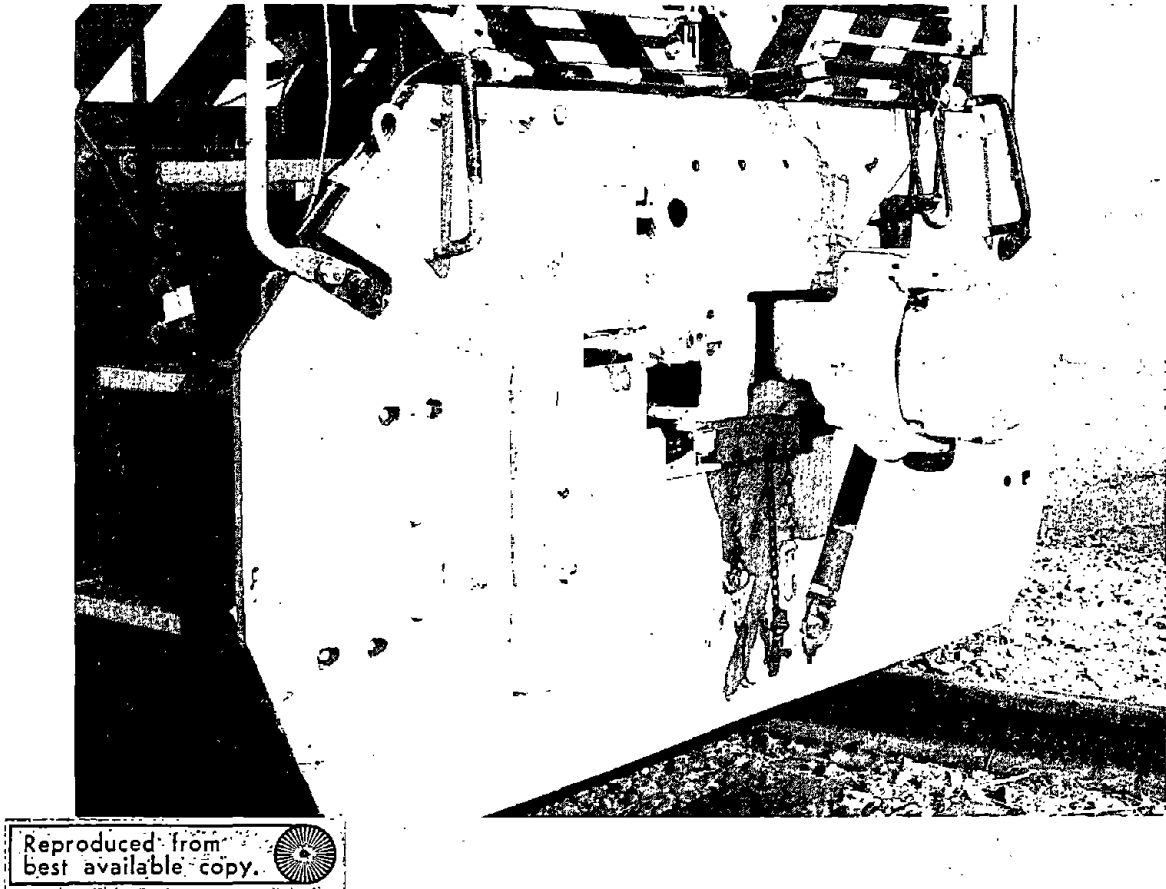
The front of the locomotive was undamaged except for broken brake pipes, as can be seen in Figure 58, which also shows the imprint of the left front wheel on the front face.

Figure 58. Post-test View of Locomotive Front Plate (Test TGB-4).
