# Evaluation of Immediate Actions Taken to Deal with Cracking Problems Observed in Wheels of Rail Commuter Cars

DOT/FRA/ORD-93/15  
DOT-VNTSC-FRA-93-3

Final Report  
July 1993

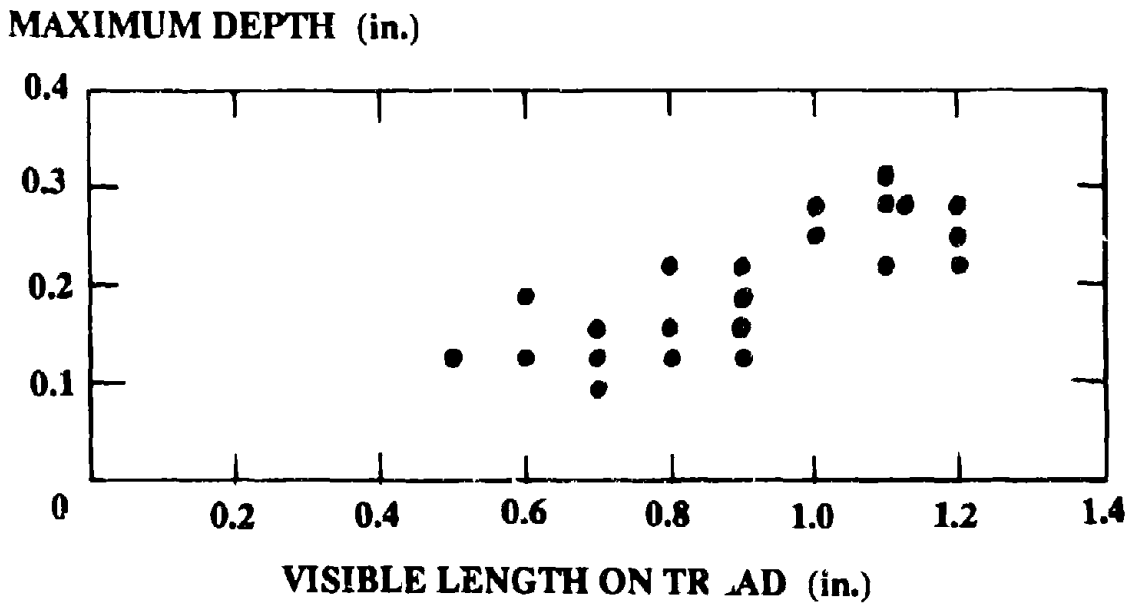
Figure 4. Visible Length Versus Maximum Depth.

located in a band centered at 2.96 inches from the front rim face. All cracks were visible on the tread surface, and the visible length of each crack was also its maximum length. The cracks were well distributed around the circumferences of both wheels, although the car #1419 wheel had one 12-inch sector with no cracks. Heat checks, such as described in the 1984 edition of the AAR interchange rules (see Section 1.2) were generally visible between the thermal cracks. The combined populations included cracks with visible lengths ranging from 0.5 inch<sup>4</sup> to 1.15 inches. From the combined populations, 22 cracks marked and measured in the "peeling" process exhibited a rough proportionality between visible length and maximum depth, with no crack depth exceeding 1/3 inch (Figure 4).

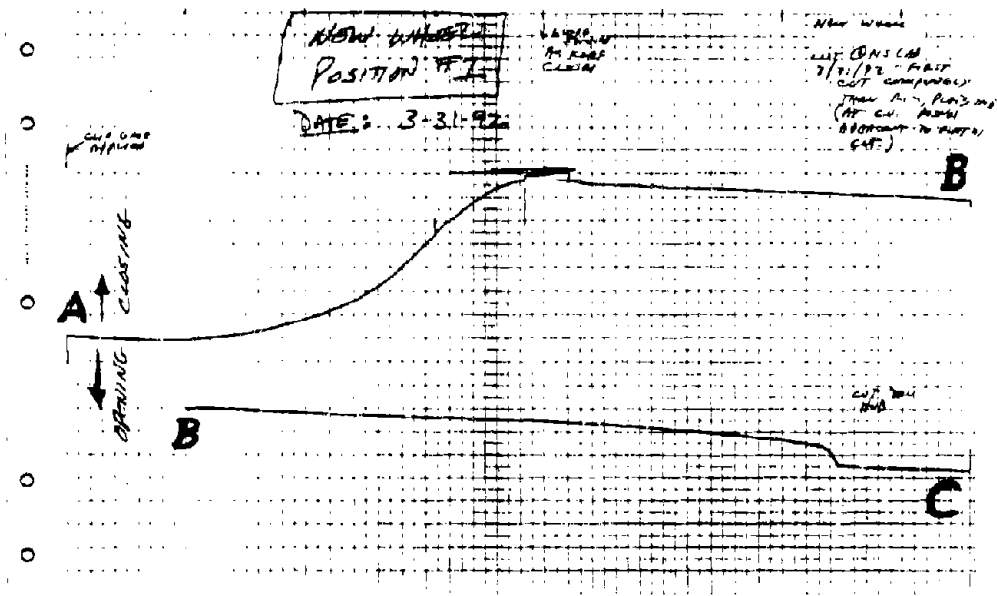
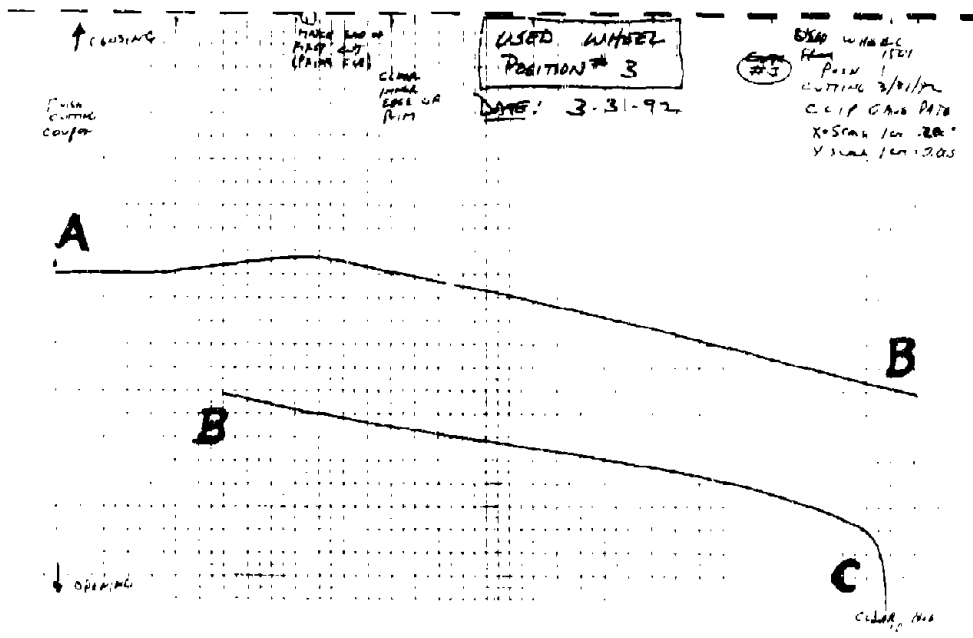
Figure 5. Clip-Gauge Curves from New and Cracked Wheels [4].

When a wheel is radially cut, the kerf either opens or closes, depending upon whether the cut is passing through material which is under tensile or compressive hoop stress. The basic procedure for determining the wheel condition, established by the railroad industry, relies on a clip-gauge extensometer to measure the kerf opening or closing at the tip of the flange, as the cut is being made. The movable part of the saw table is also instrumented, with a linear voltage-displacement transducer (LVDT), to measure the radial depth of the cut. The cut depth and kerf response are recorded as a "clip-gauge curve" on an XY plotter.

Moire applied to the flat areas on the front and back rim faces of each wheel was used to measure the kerf displacement profiles when the cut was stopped at roughly two thirds of the way through the rim thickness. A three-dimensional finite element model was prepared for each wheel<sup>6</sup> and was used to reconstruct the rim hoop stress. Steep gradients were found, with maximum compressive stresses (at the tread surface) of 42 ksi in the new wheel and 28 ksi in the car #1501 mate wheel. The retention of some compression in a used wheel was encouraging, since compressive stress tends to close and delay the growth of cracks. However, the saw cut tests did not provide the data necessary to reliably determine the depth below tread at which a crack would encounter tensile hoop stress.

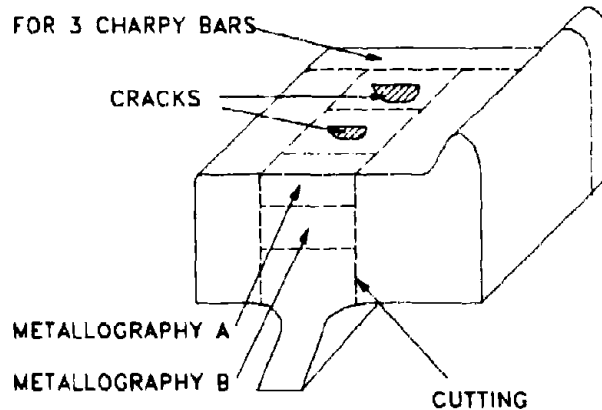
Figure 6. Specimen Locations (Car #1501 Mate Wheel) [6].

One of the car #1501 mate wheel rim blocks was examined at the Massachusetts Institute of Technology (MIT) [6]. Two specimens, each containing a center tread thermal crack, were cut from the outer region of one of the rim blocks and broken in liquid nitrogen to expose the crack propagation surfaces. Adjacent specimens were cut from the same block for metallography and fracture toughness testing (Figure 6).

Charpy bars were machined from a specimen of the car #1501 mate wheel rim block (see Figure 6) and tested at room temperature to provide data for estimation of the wheel steel fracture toughness. The fracture toughness of carbon steel alloys can be estimated from the empirical formula [9]:

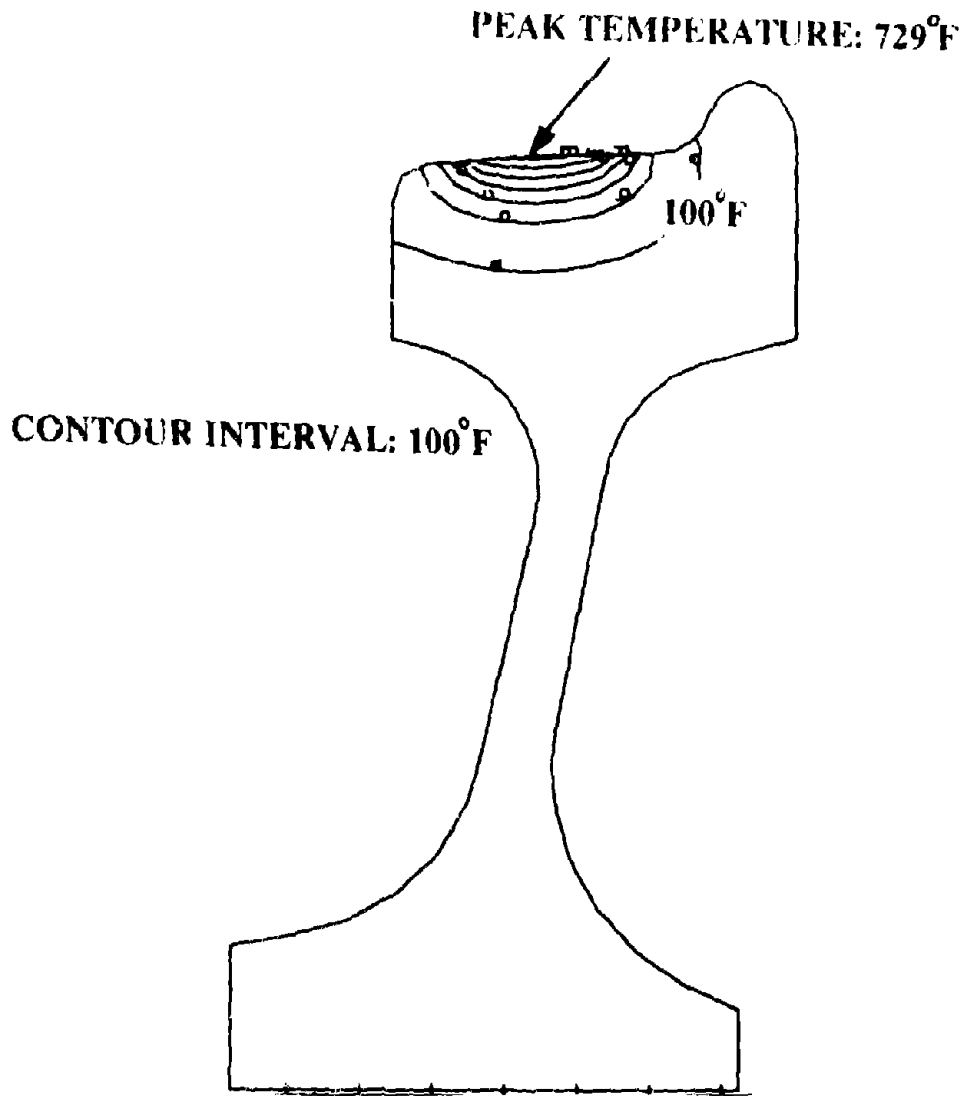
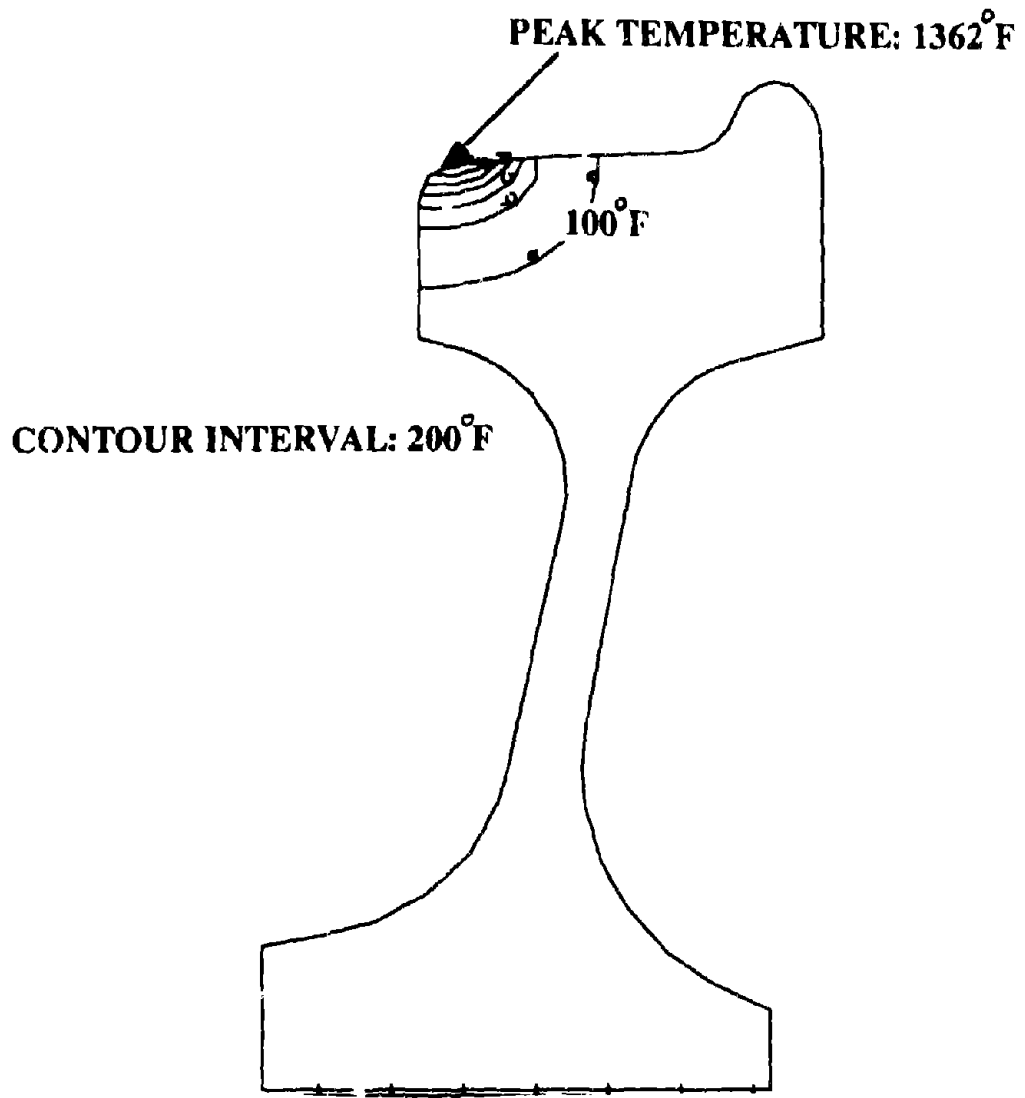
Figures 15 and 16 illustrate the computed temperature distributions at the respective times when the peak tread temperatures are attained. Note that the peak value for the overhanging case is almost twice the nominal value. Note also that the overhanging case leads to temperatures which, according to the metallurgical investigation results, are high enough to spheroidize the microstructure.

Figure 15. Temperatures Attained with Shoe Correctly Aligned.

Figure 16. Temperatures Attained with Overhanging Shoe.
