Water Intrusion Problems in Transit Tunnels

P. Parks
J. Francis
A. Gorlov
E. Gorlova
J. D. Guertin, Jr.

Paul Parks and Associates, Inc.
Engineering & Management Consultants
100 Boylston Street
Boston MA 02116

September 1986
Final Report

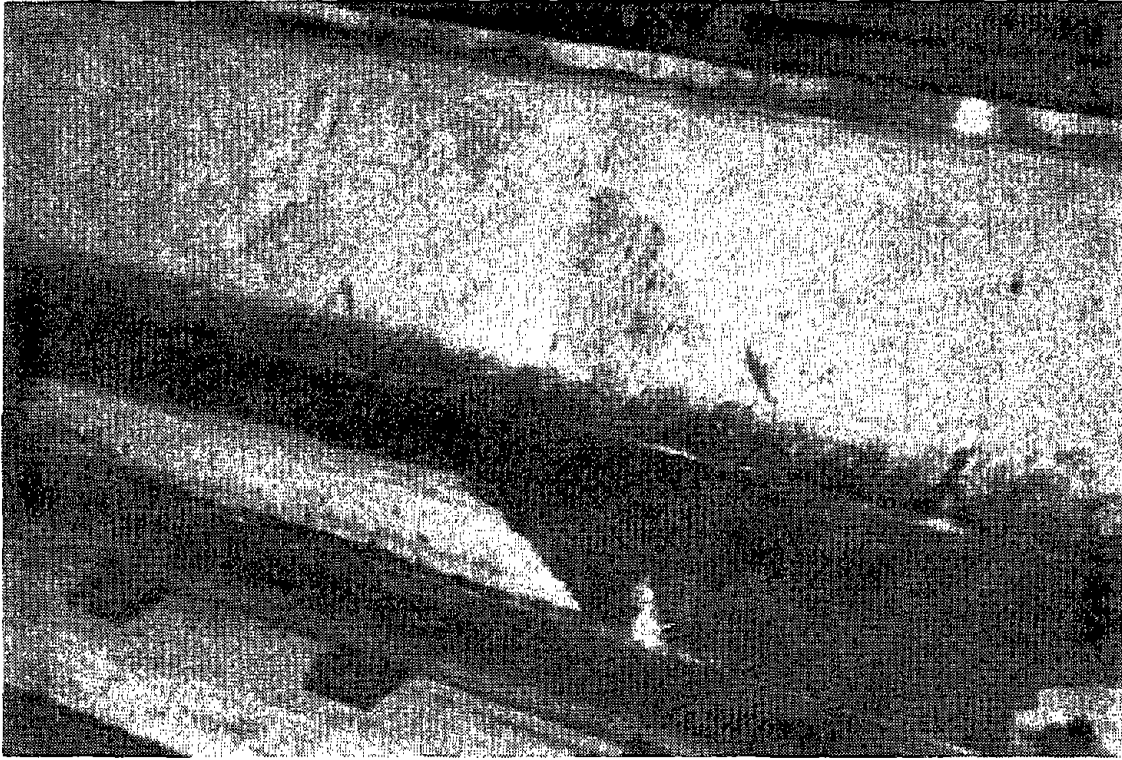
FIGURE 5.3 LEAKS ONTO TRACKBED

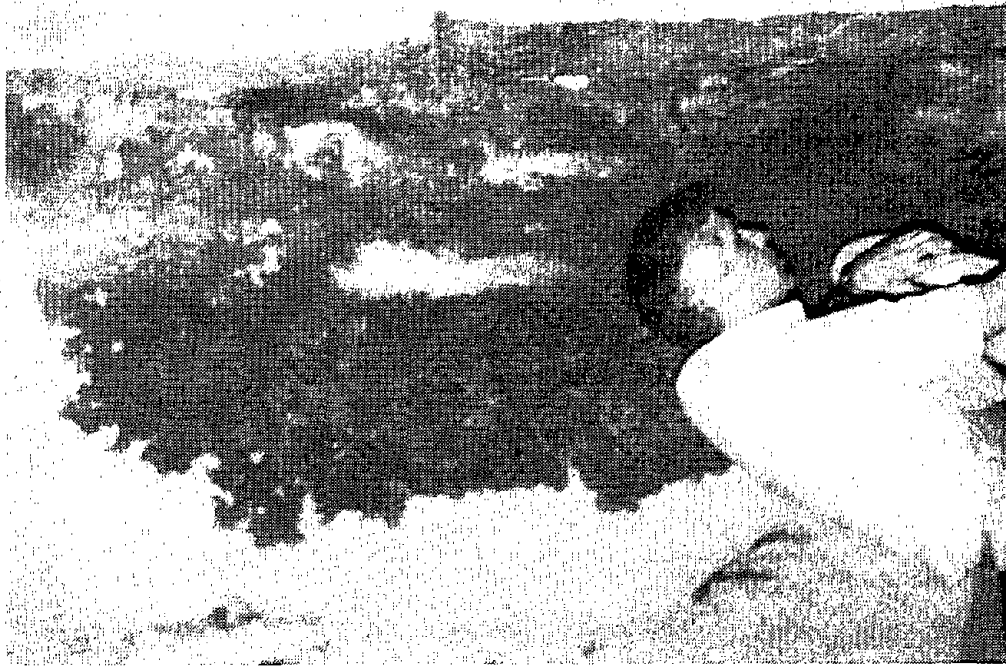
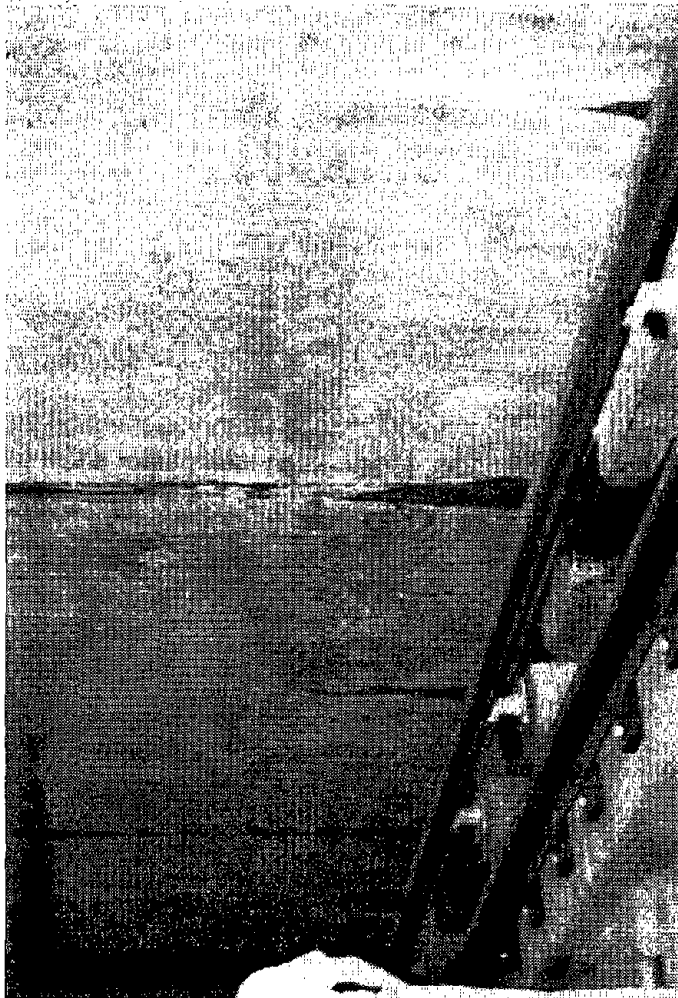
FIGURE 6.4 WATER INFILTRATION THROUGH THE WALLS

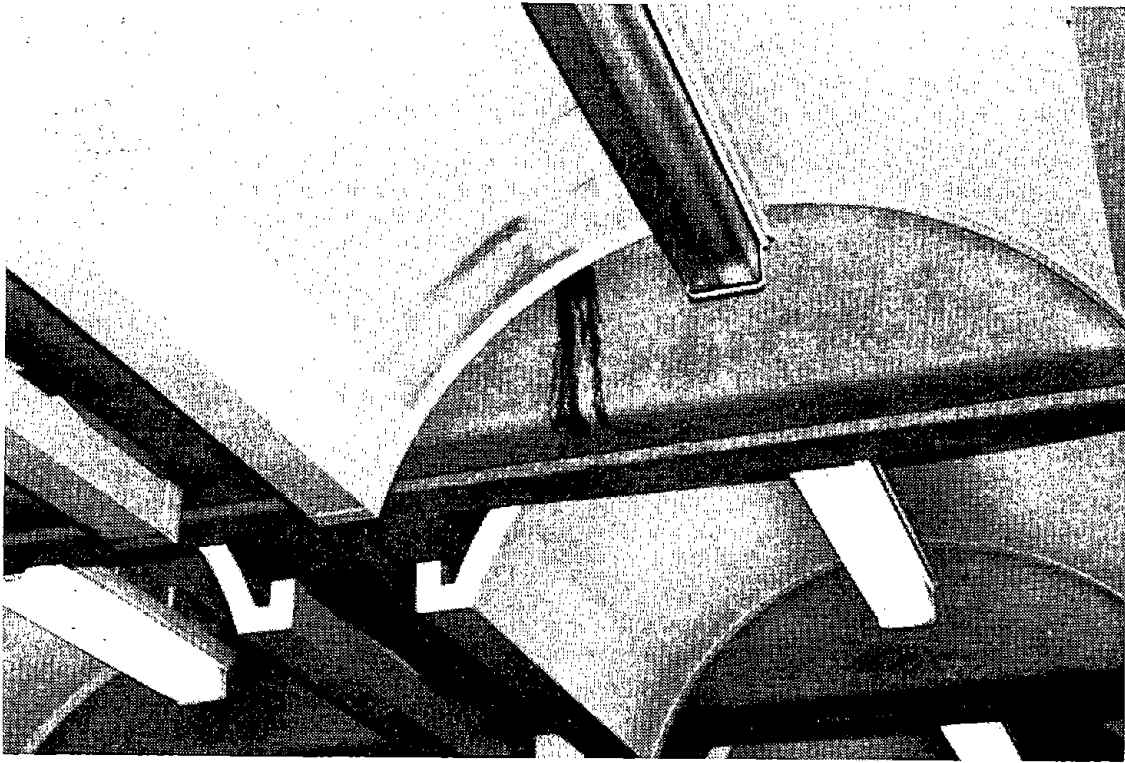
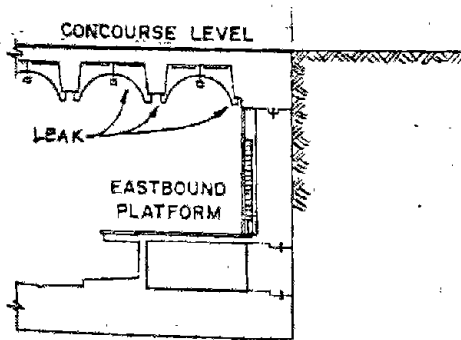
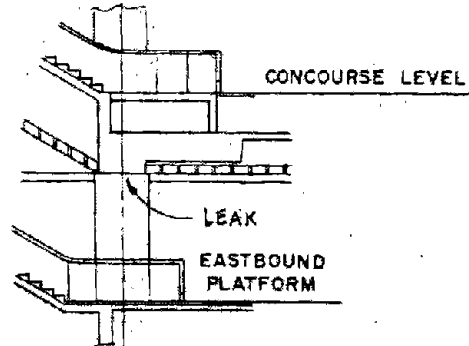
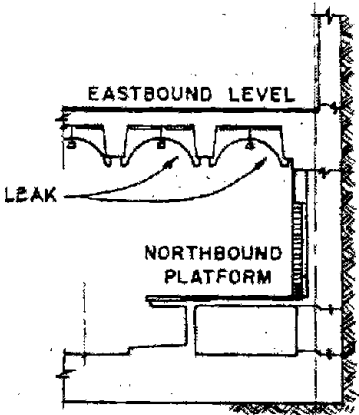
Figure 6.5 demonstrates typical leaks through the station roof. This type of leakage results in significant deterioration of both structural and architectural elements of the stations. It also has a deteriorative effect on functional components of a subway system. For example, the stray currents seek the path of water or dampness, thereby concentrating electrochemical attacks on rails, which results in severe corrosion of rail structures.

The steel inserts which are embedded in the concrete second pour, and which hold the direct fixation fasteners (DFF) in place, were rusting badly. These inserts would be almost impossible to replace.

FIGURE 6.5 WATER INFILTRATION THROUGH THE STATION ROOF

The fasteners themselves were also rusting badly along with their bolts and rail clips. The rails were rusting prematurely. At some locations, the intruded water had a high sulphate content (determined in a subsequent water analysis of that location) which caused the deterioration of the concrete.

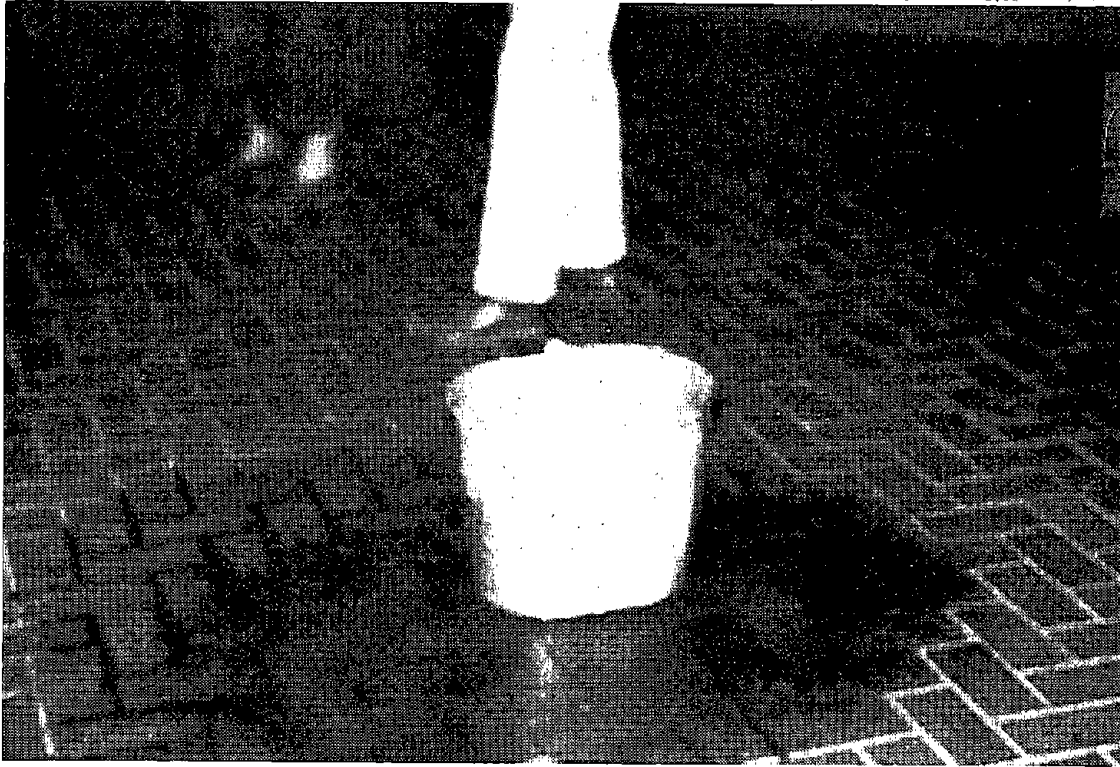
FIGURE 6.6 SAFETY HAZARD DUE TO WATER INTRUSION THROUGH STATION CEILING

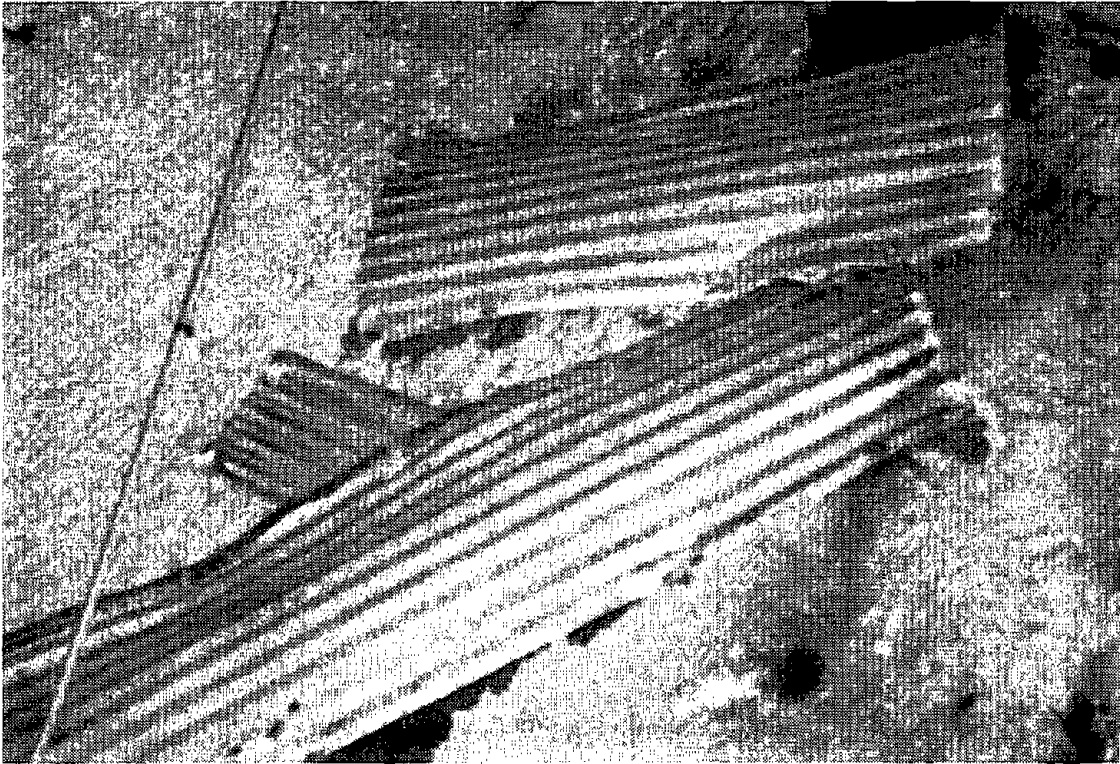
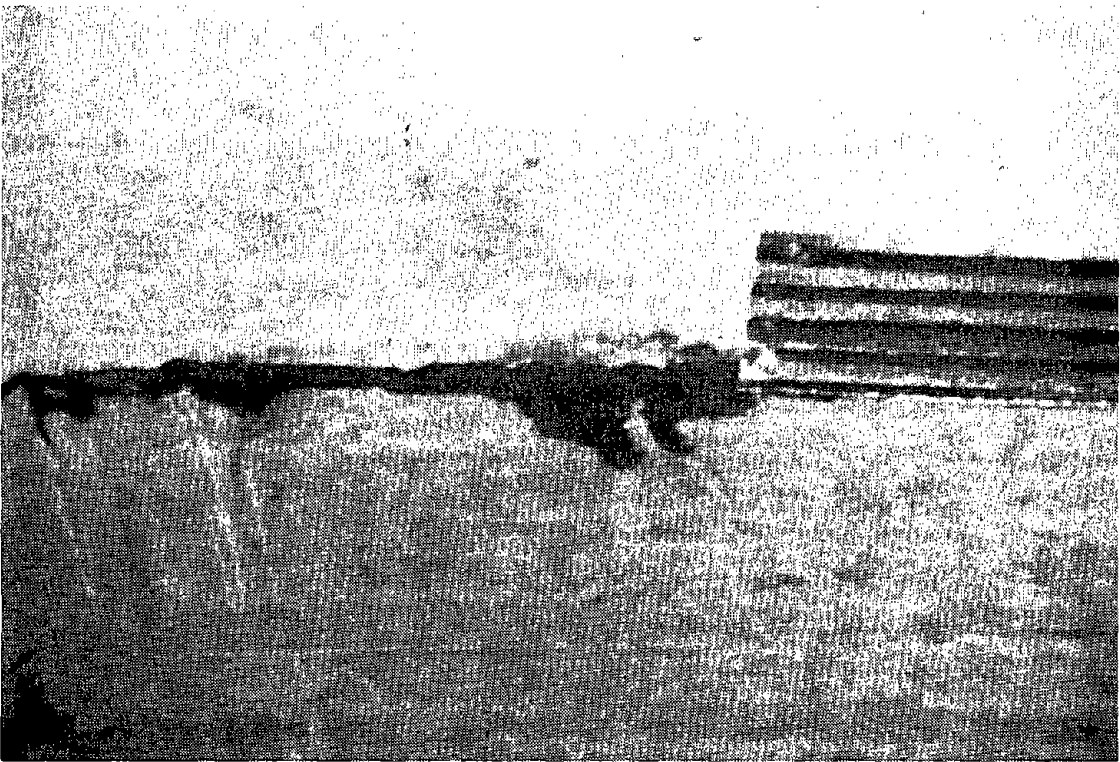
FIGURE 6.7 LEAKS AT FIVE POINT STATION

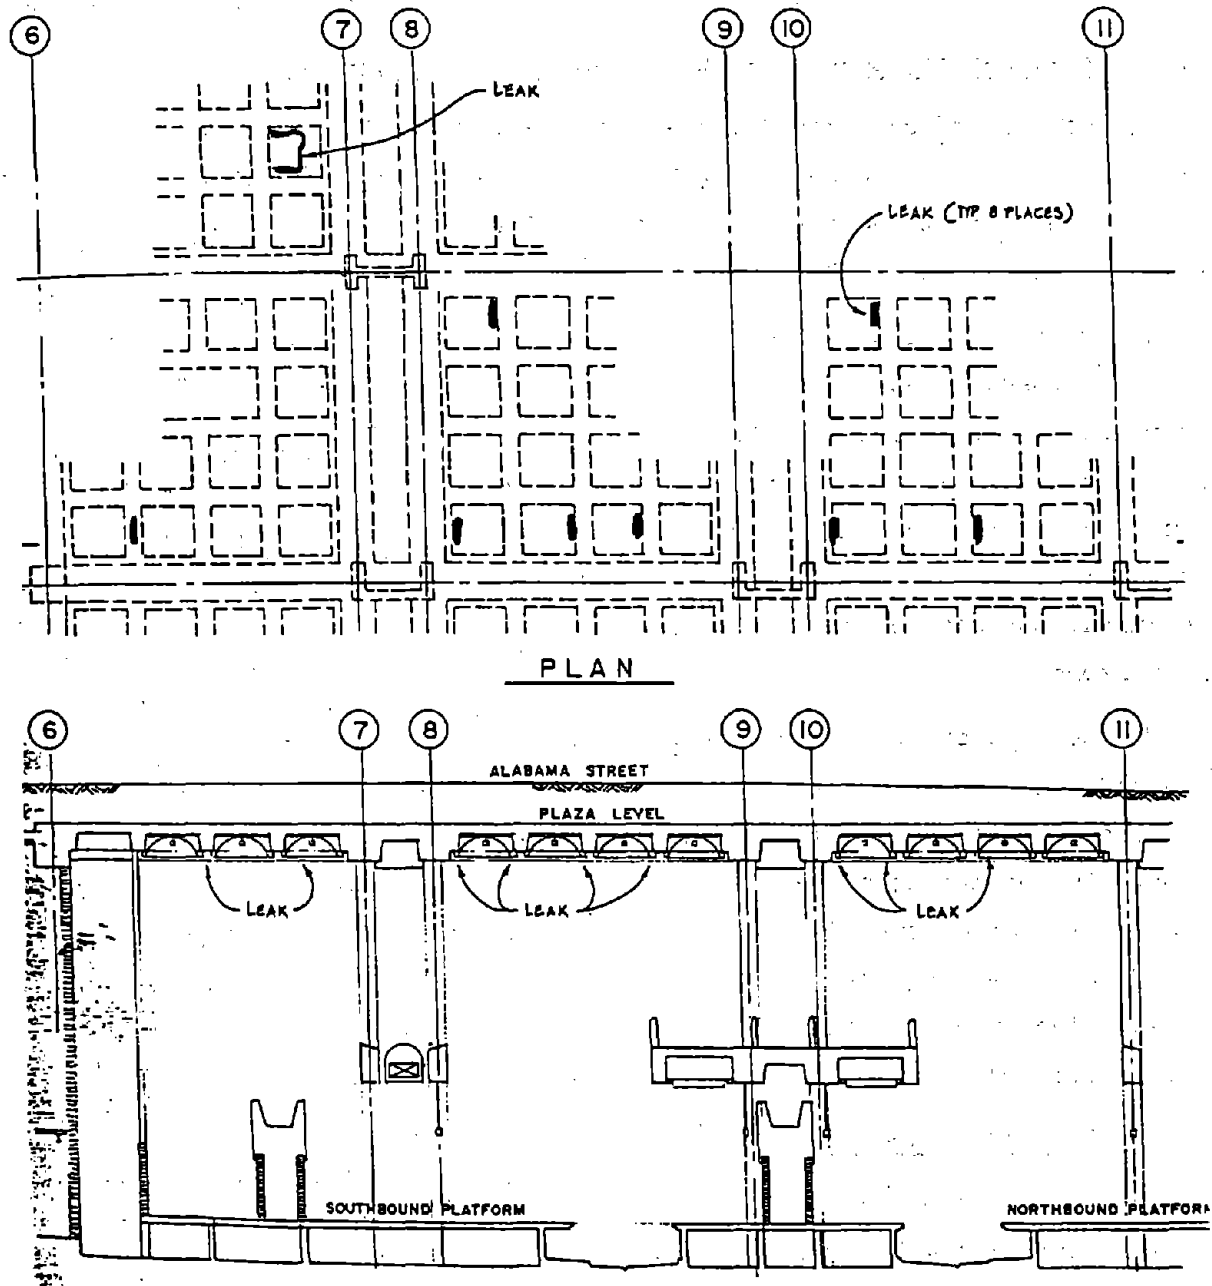
FIGURE 6.9 INTERCEPTING OF LEAKAGE (REMEDIAL MEASURES)

- o Intercepting and collecting the water flow and channeling it to the pumps by means of galvanized steel plates installed directly against water leaks, thereby diverting wall and ceiling water leaks from rail structures;
- o Installation of steel lining consisting of concrete arches with steel pans, for diverting the water (this measure was taken at construction time as well as during post-construction maintenance);
- o For many leaks that were emerging from the base of the emergency cat walk, "toe bench cutting" was used. This procedure entails cutting a small trough adjacent to all second pours that were lower than the

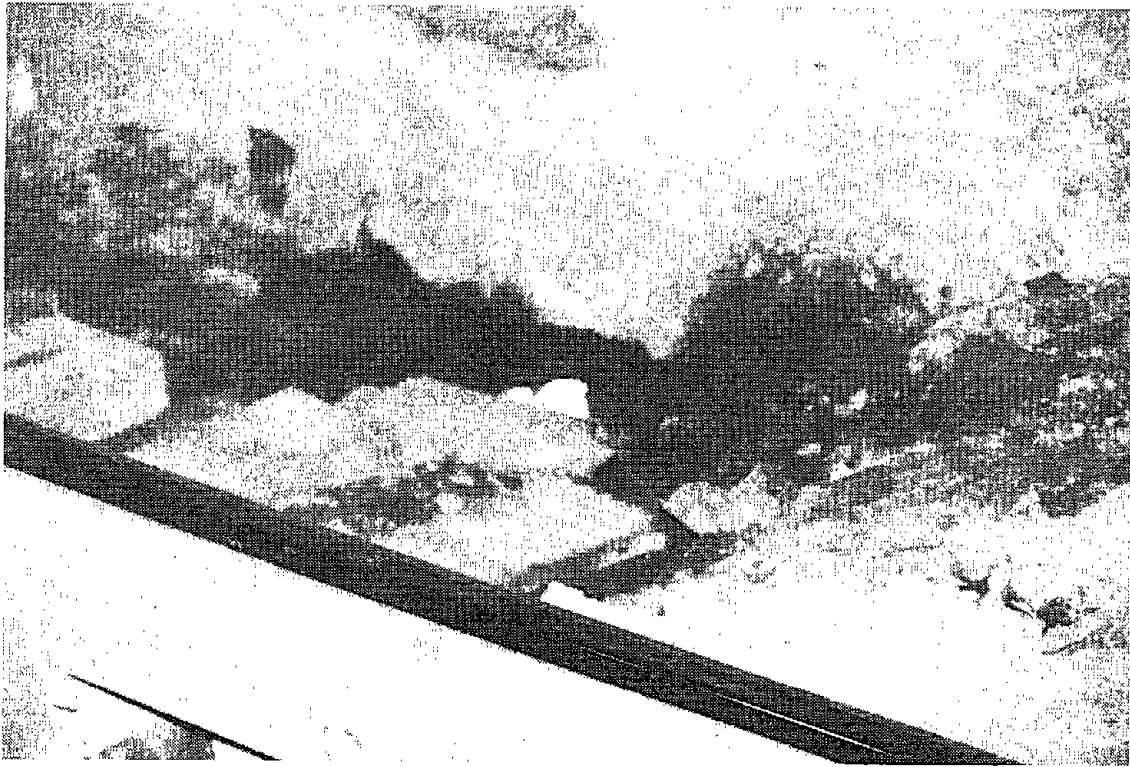
Leakage such as water streams emerging from the base of the track bed creates a specific problem by washing ballast away, as can be noted in Figures 7.2 and 7.3, where large segments of the washed-out ballast are shown.

FIGURE 7.2 BALLAST WASHED OUT BY STREAMS OF RUNNING WATER
(RED LINE, SOUTH STATION)

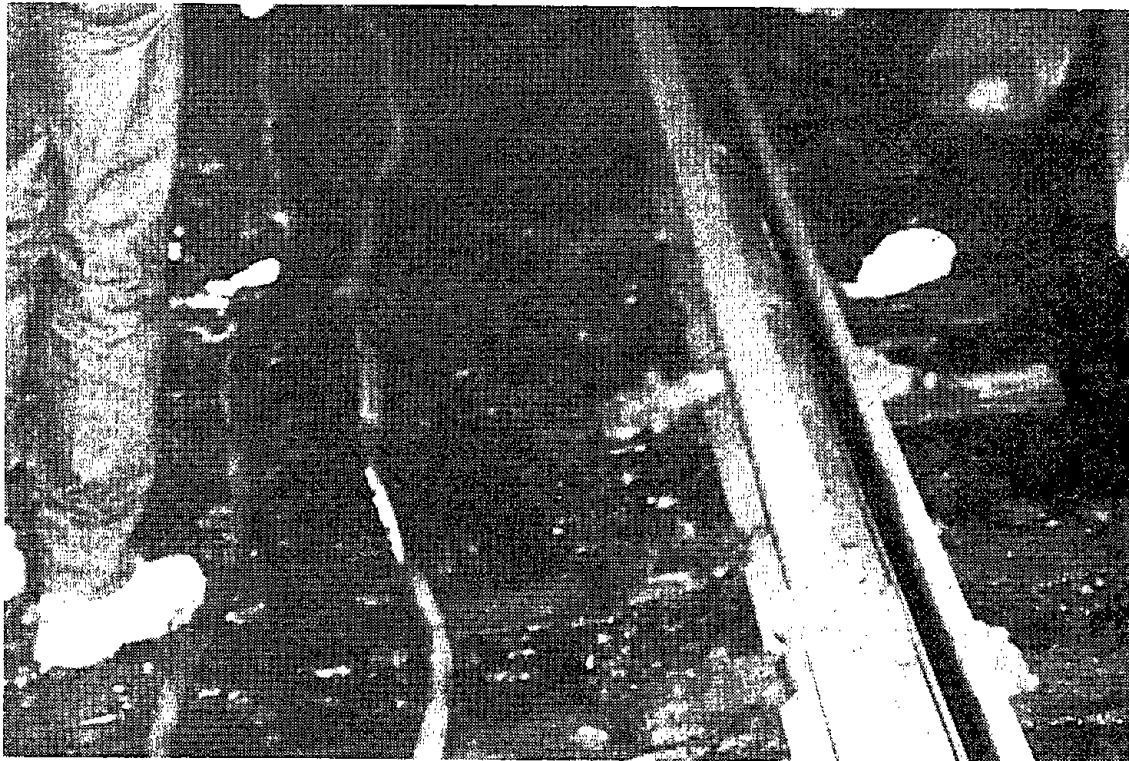
FIGURE 7.3 STANDING WATER IN THE TRACKBED (RED LINE, SOUTH STATION)

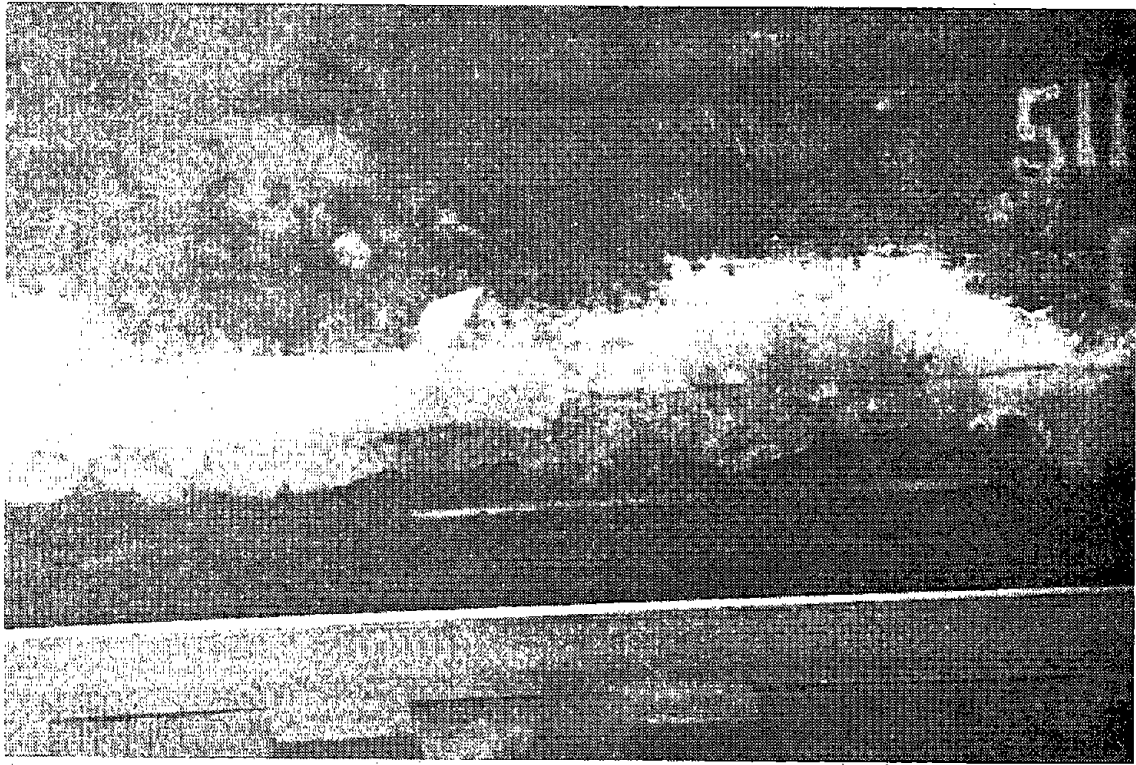
Figure 7.4 shows a wide area of calcification around shrinkage cracks in concrete. The calcification was caused by water leaks which also resulted in standing pools of water in the track area.

FIGURE 7.4 CALCIFICATION AROUND A SHRINKAGE CRACK (RED LINE, SOUTH STATION)

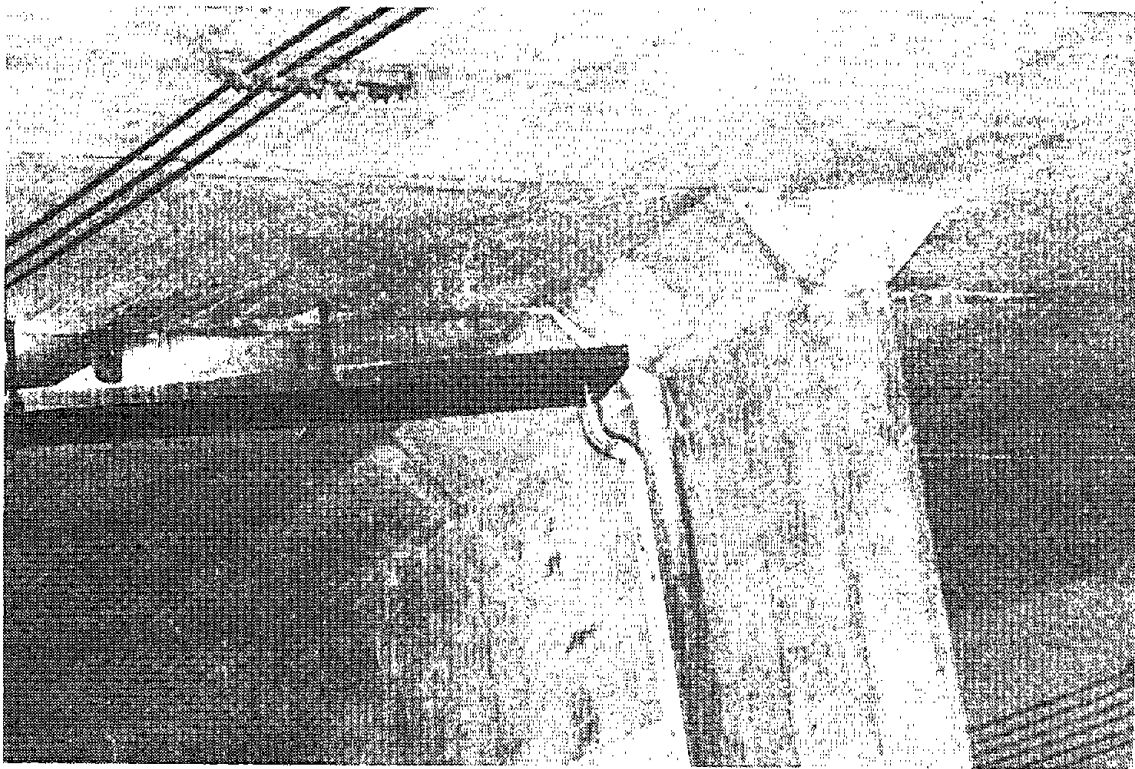
FIGURE 7.5 CHANNELING OF THE WATER (RED LINE, SOUTH STATION)

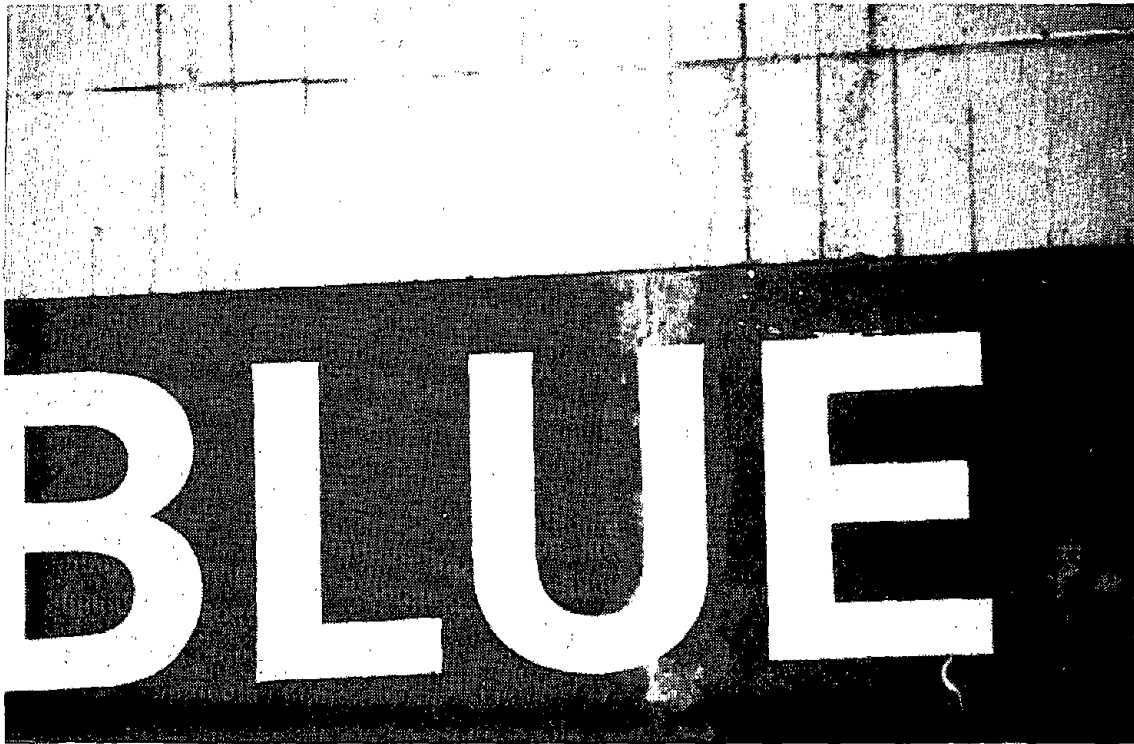
FIGURE 7.6 DETERIORATION OF PAINT (BLUE LINE, AQUARIUM STATION)

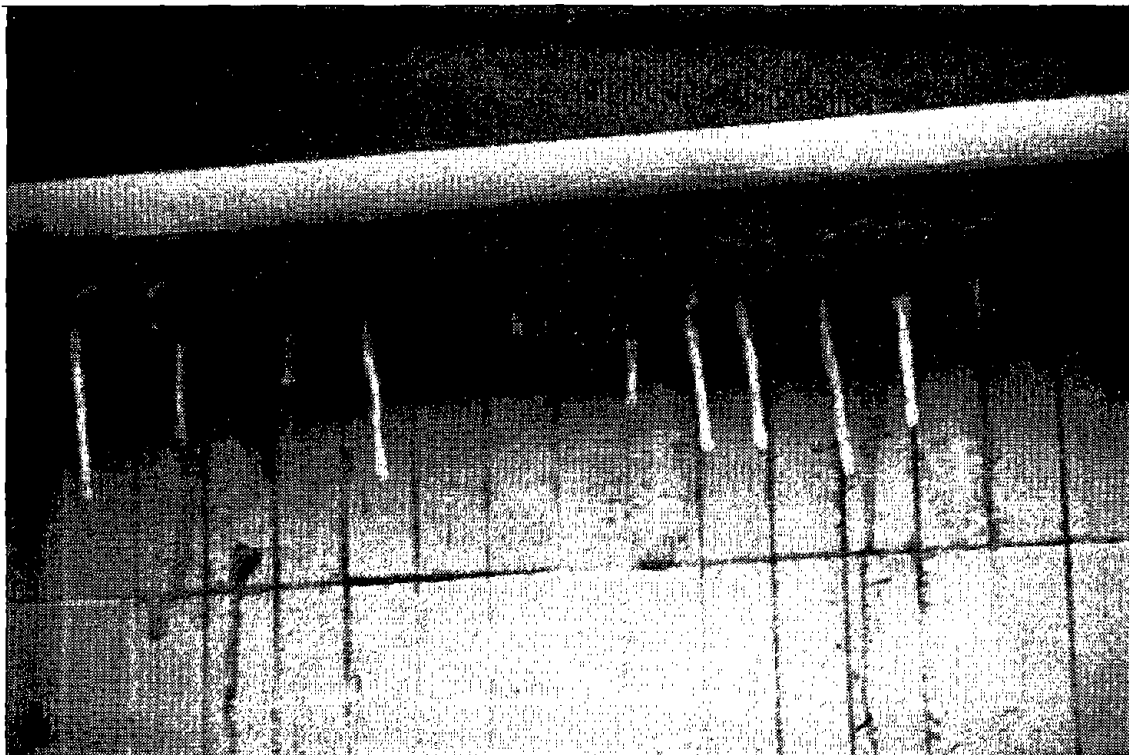
FIGURE 7.7 STALACTITES GROW (BLUE LINE, AQUARIUM STATION)

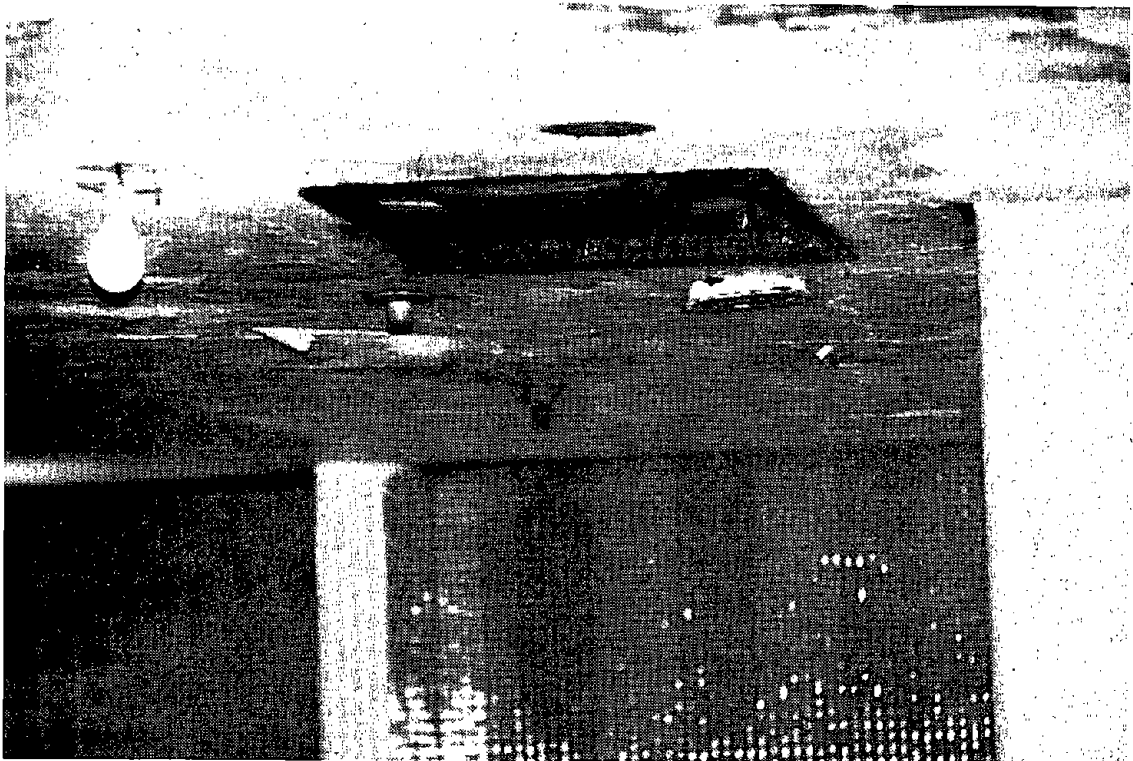
FIGURE 7.9 CEILING SECTION REMOVED FOR INVESTIGATION OF MAIN ROOF LEAKS (BLUE LINE, AQUARIUM STATION)

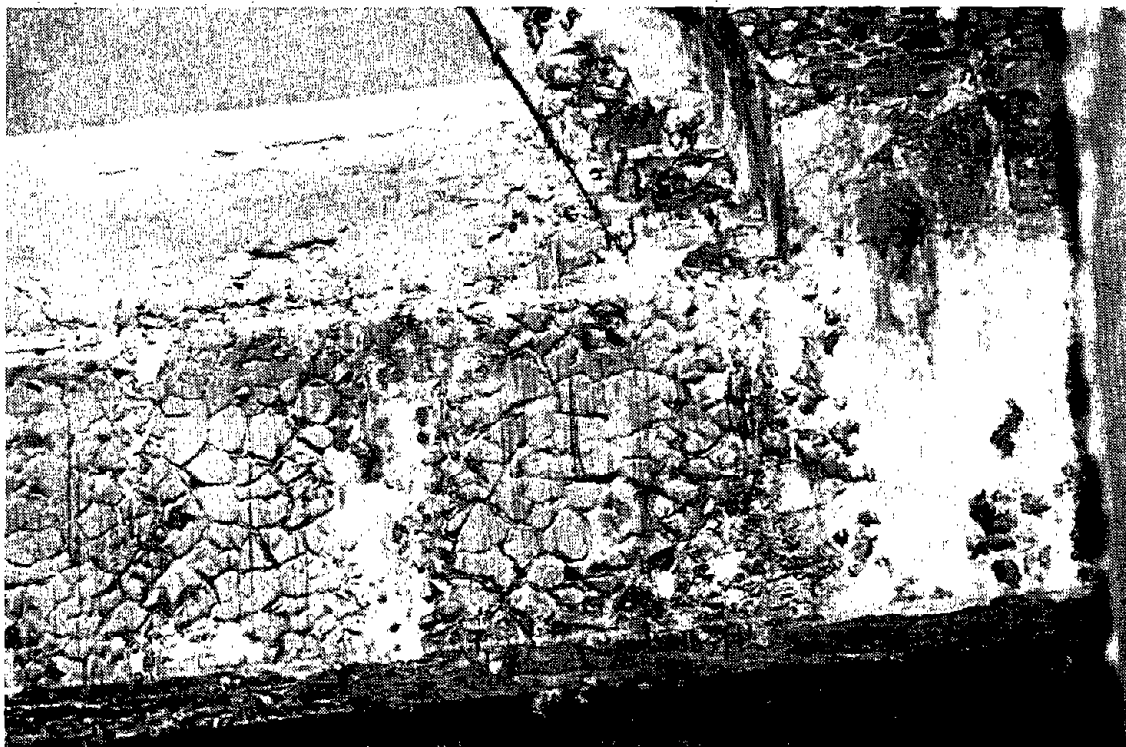
Figure 7.10 shows a large area of calcification on the wall finish caused by the water infiltrating through the walls and ceiling of the concrete lining. Such structural and architectural deterioration requires extensive repair work.

FIGURE 7.10 CALCIFICATION OF THE WALL FINISH (BLUE LINE, AQUARIUM STATION)

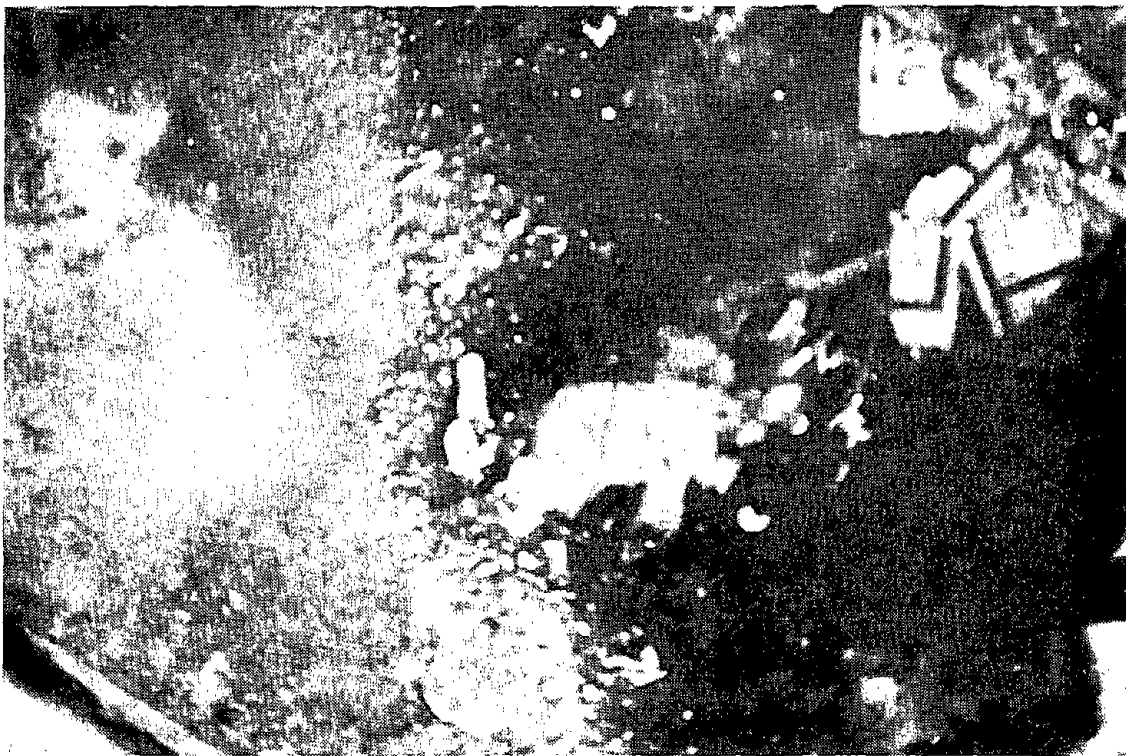
FIGURE 7.11 STANDING POOL OF WATER WITH FLOATING DEBRIS IN TRACKBED AREA (BLUE LINE, AQUARIUM STATION)

Figures 7.11, 7.12, and 7.13 also depict the deteriorative effect of water on the trackbed. There are some zones where ballast has been completely washed out.

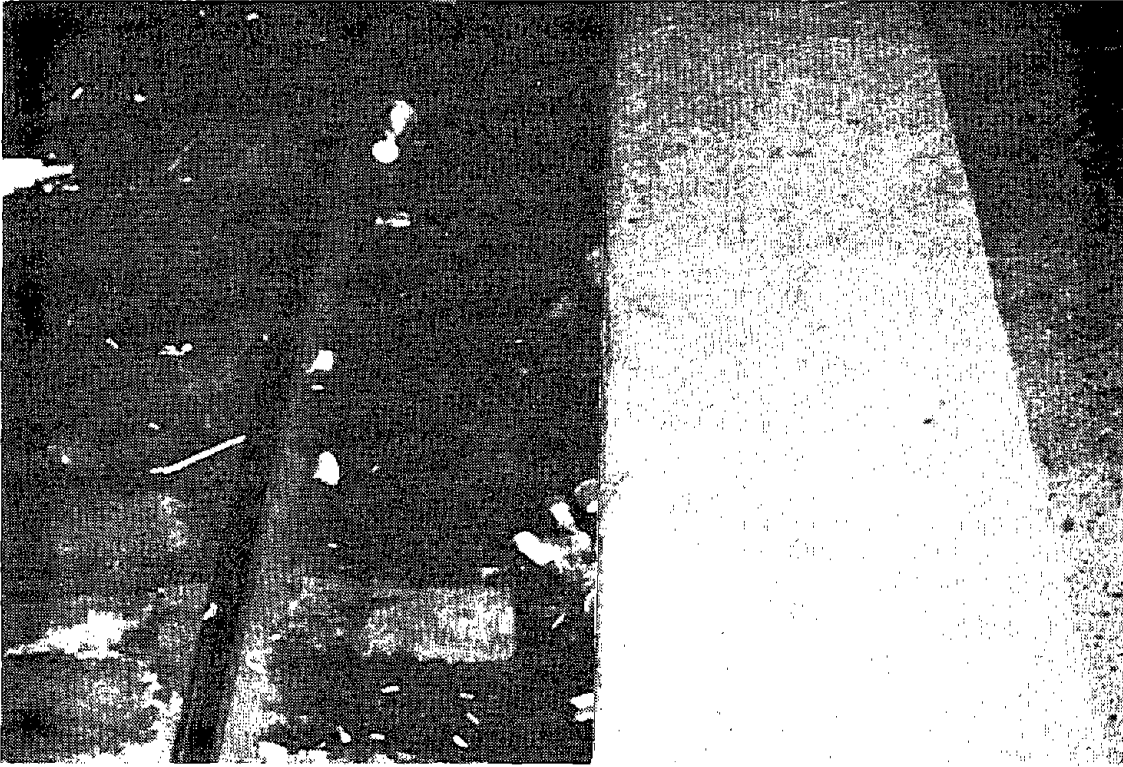
FIGURE 7.12 WATER STREAM IN TRACKBED (BLUE LINE, AQUARIUM STATION)

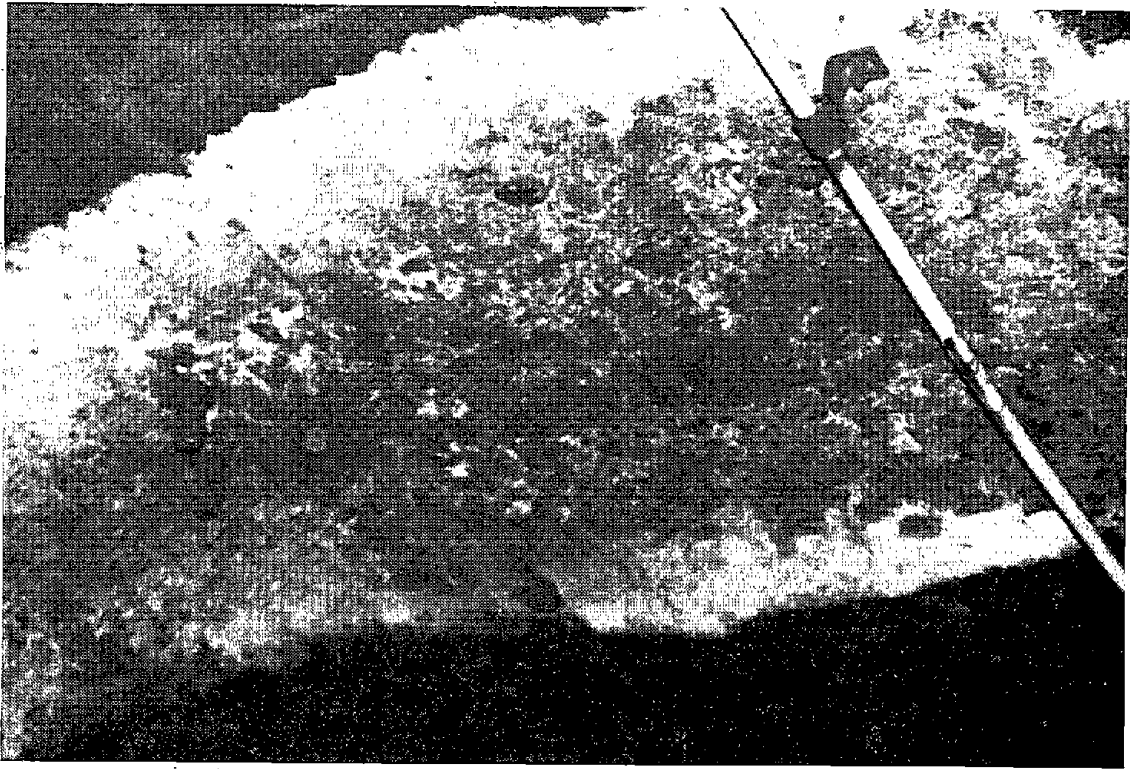
FIGURE 7.14 ZONE OF CALCIFICATION AND STALACTITES AROUND A CRACK
(GREEN LINE, BOYLSTON-ARLINGTON TUNNEL)

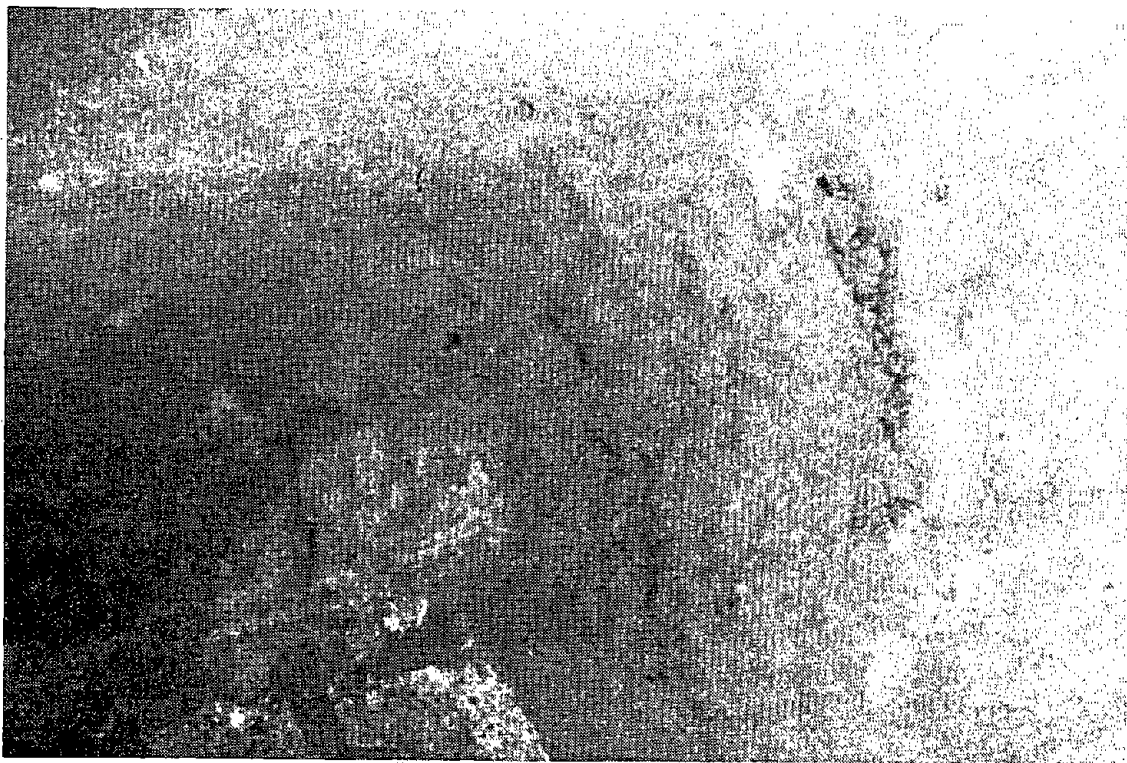
FIGURE 7.15 AREA OF MASSIVE CALCIFICATION (GREEN LINE, BOYLSTON-
ARLINGTON TUNNEL)

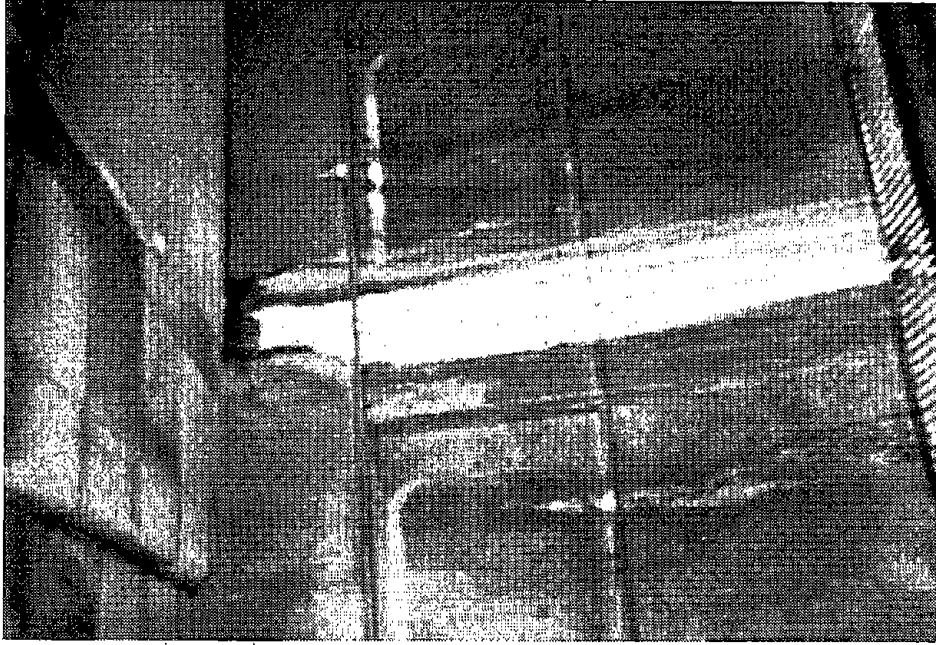
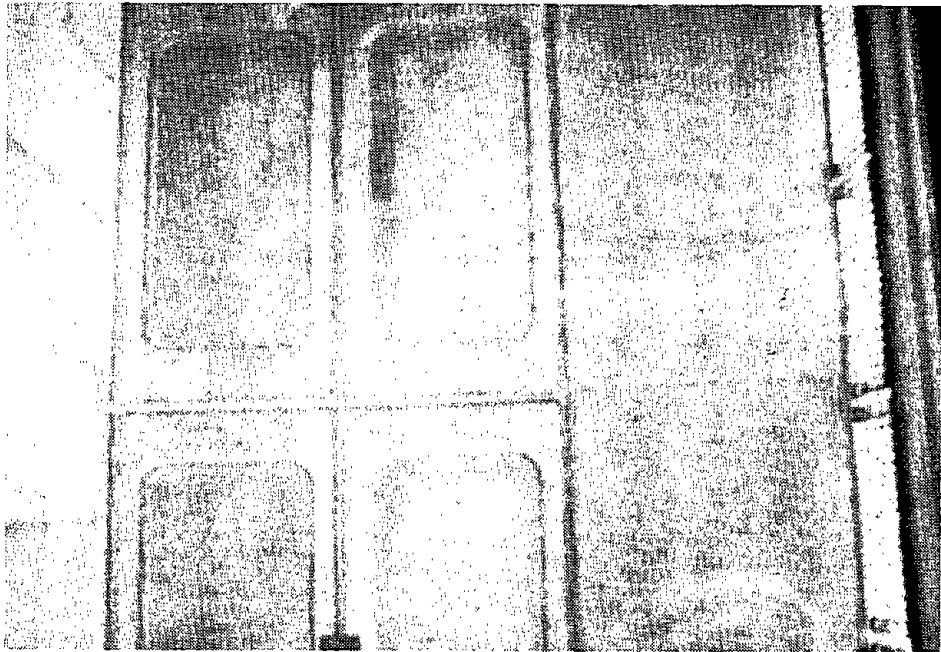
FIGURE 8.3 STONE WALLS DAMAGED BY WATER INTRUSION

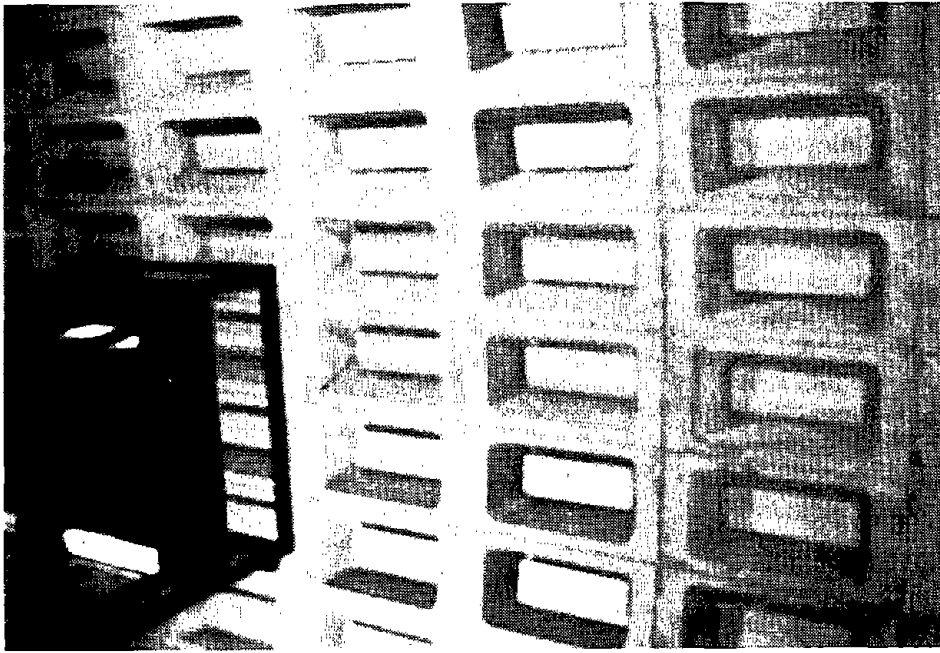
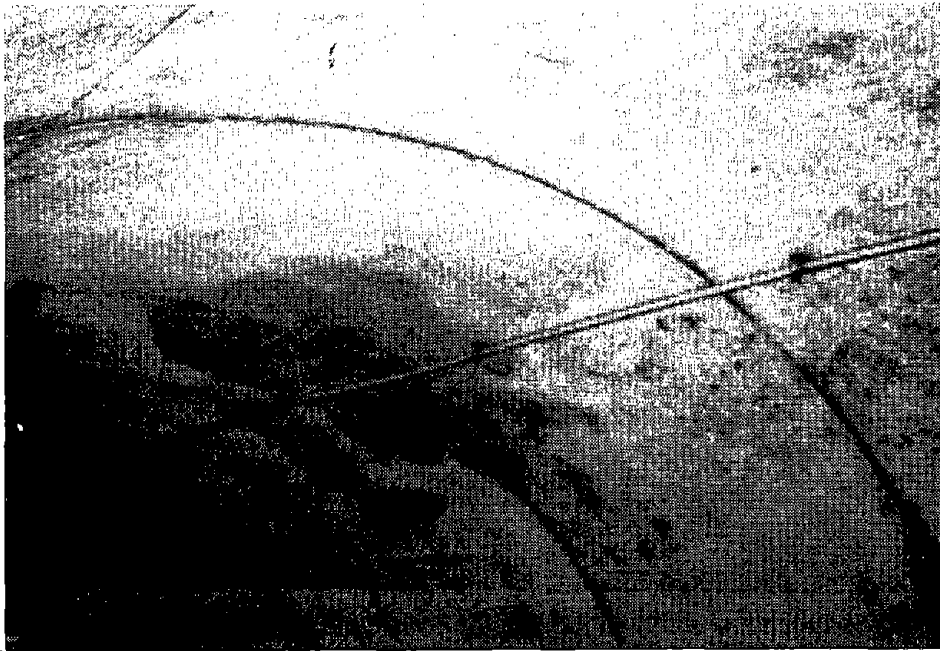
FIGURE 8.4 LEAKS THROUGH PRECAST AND CAST-IN-PLACE CONCRETE WALLS

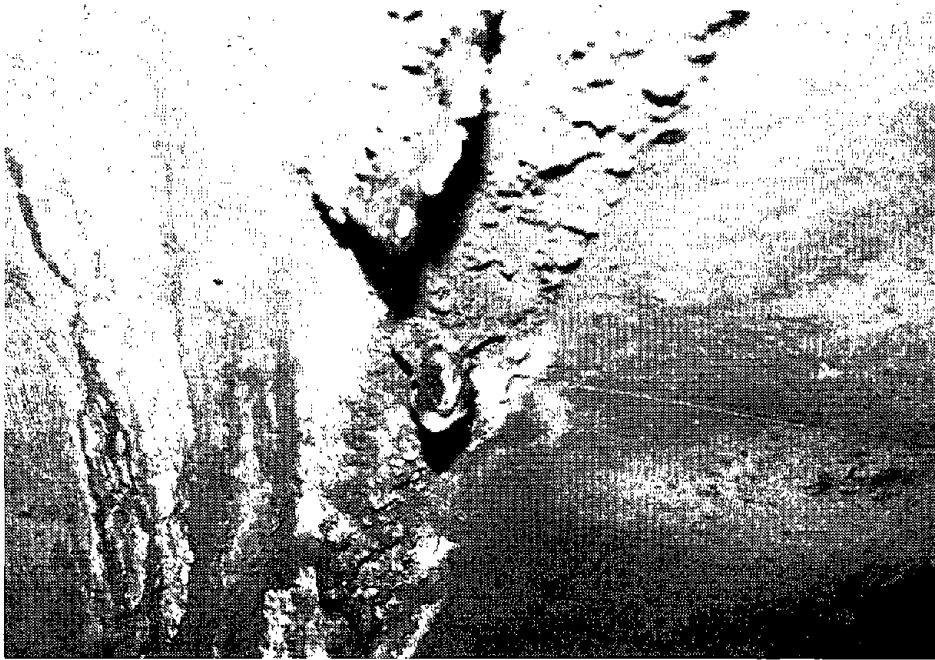
FIGURE 8.5 CALCIFICATION AND PRECIPITATIONS CAUSED BY LEAKING WATER
