Water Intrusion Problems in Transit Tunnels

P. Parks
J. Francis
A. Gorlov
E. Gorlova
J. D. Guertin, Jr.

Paul Parks and Associates, Inc.
Engineering & Management Consultants
100 Boylston Street
Boston MA 02116

September 1986
Final Report

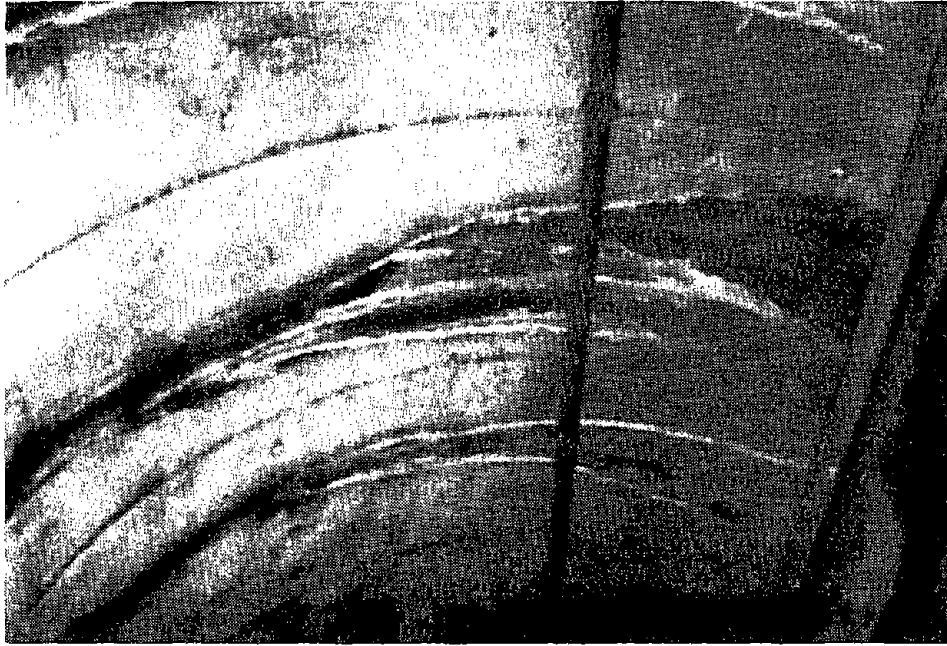
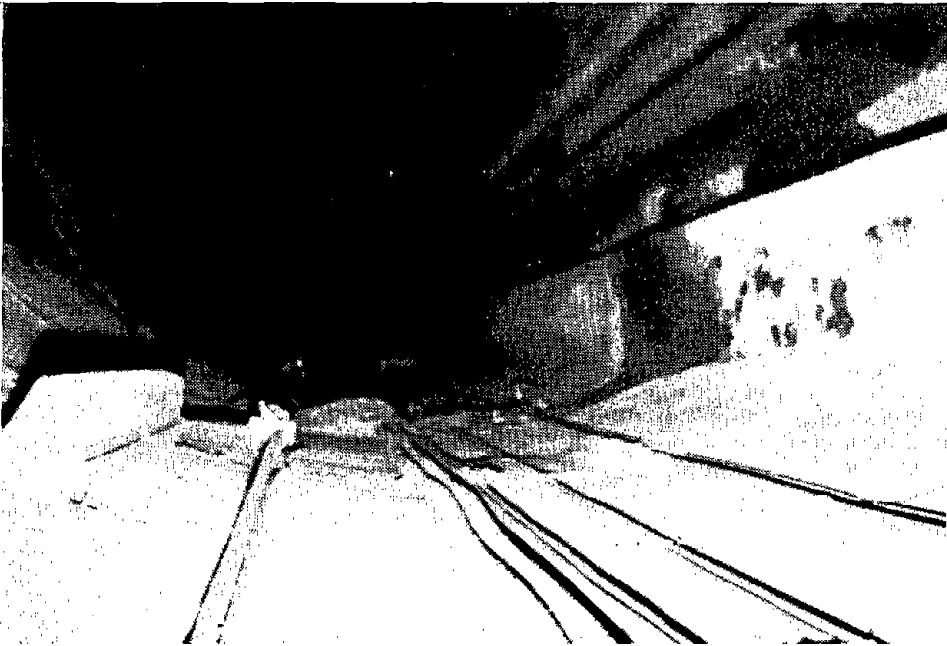
FIGURE 8.6 SHRINKAGE CRACKS IN CONCRETE LINING

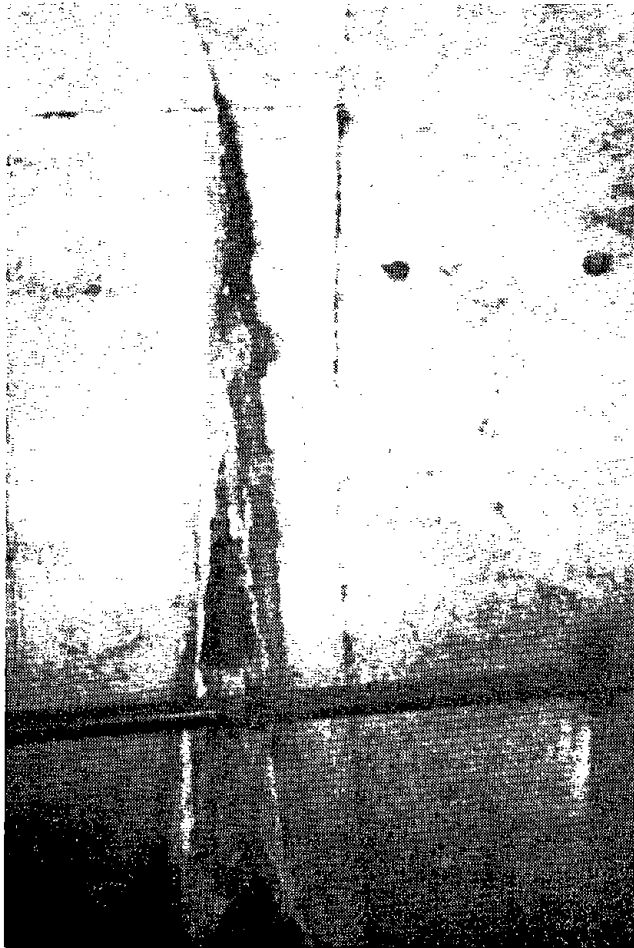
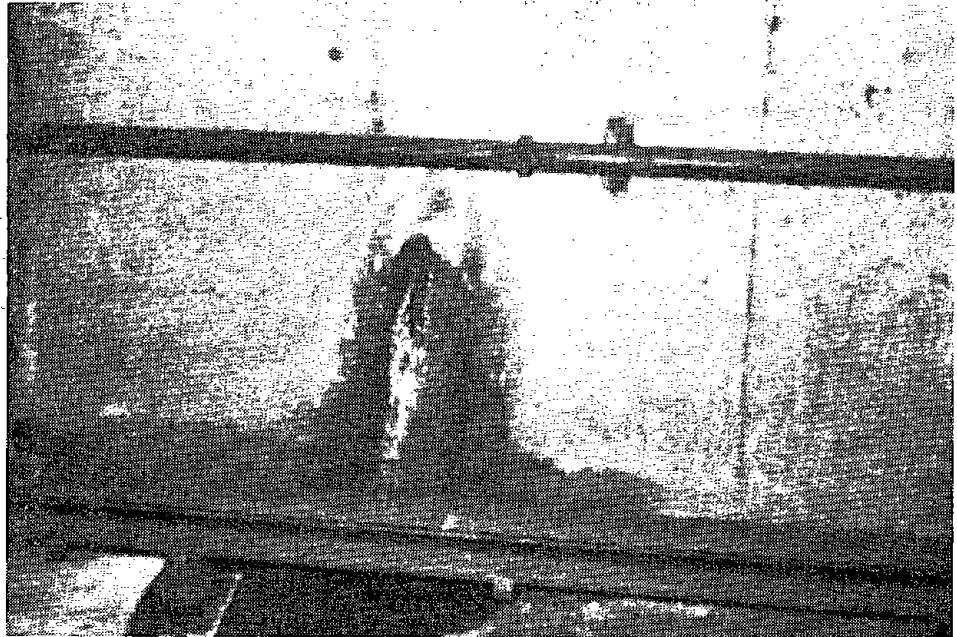
FIGURE 8.7 LEAKS THROUGH THE SHRINKAGE CRACKS IN CONCRETE LINING

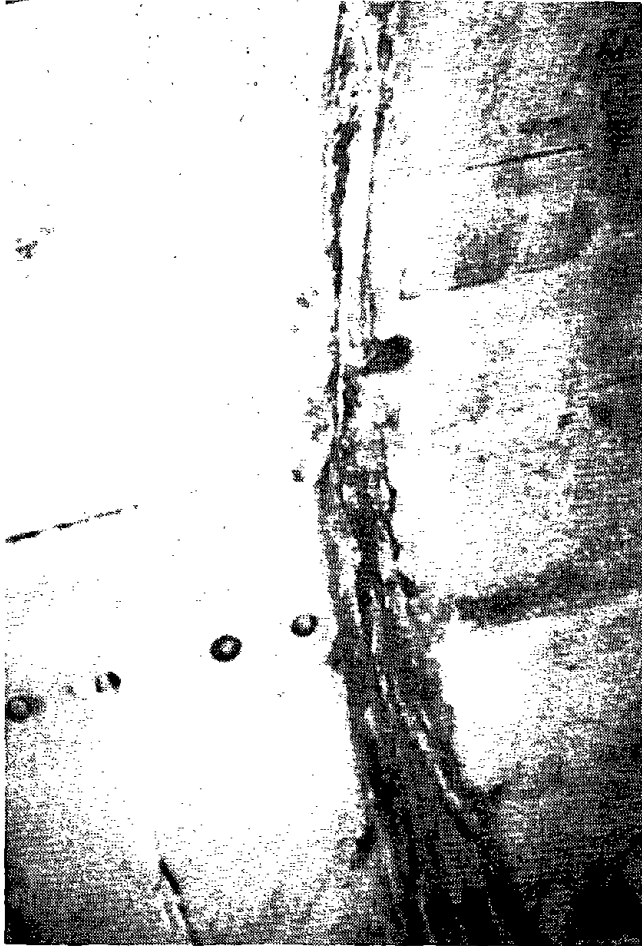
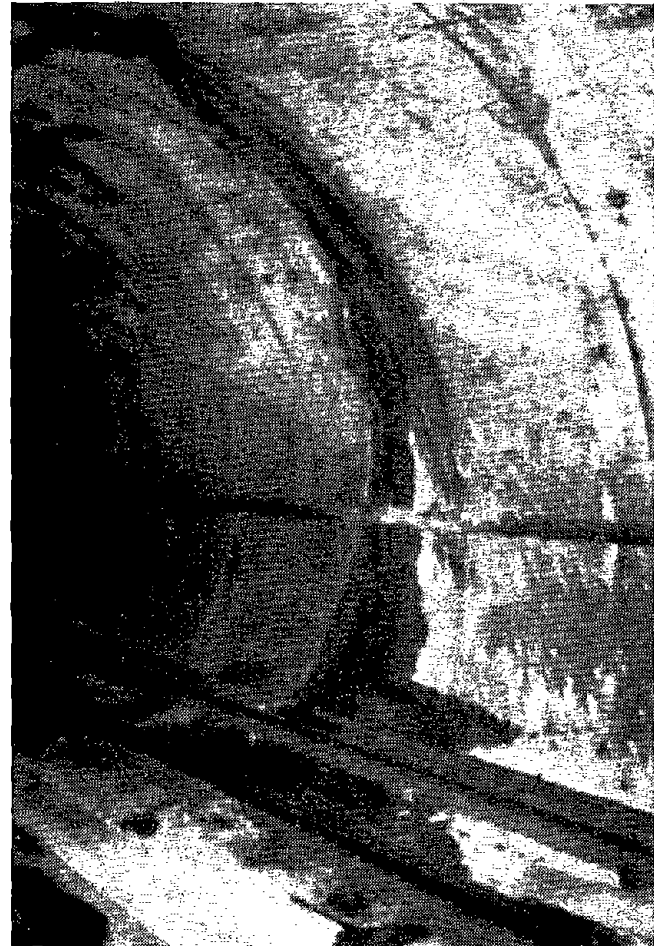
FIGURE 8.8 LEAKS THROUGH THE STRUCTURAL JOINTS IN CONCRETE LINING

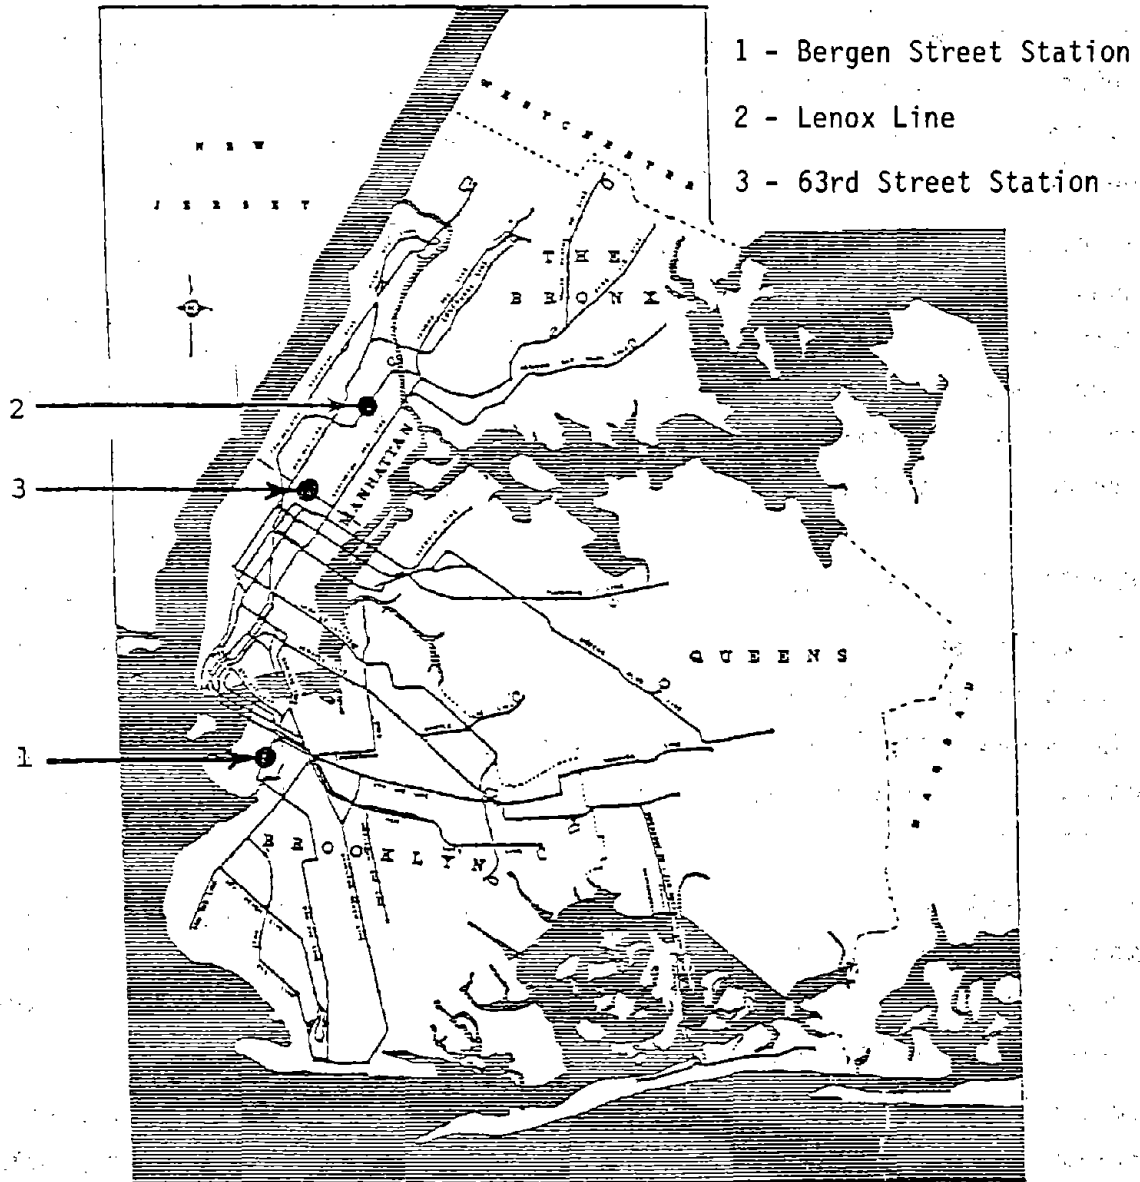
The general scheme of the NYCTA Subway System is shown in Figure 9.3. Figure 9.3 also shows the sites of the most intensive water leaks. Arrows 1, 2, and 3 point to the underground subway site locations that were visited by the site-visit team. Those sites are the most affected and are undermined by the infiltration of ground water.

FIGURE 9.3 SITES OF INTENSIVE WATER LEAKS

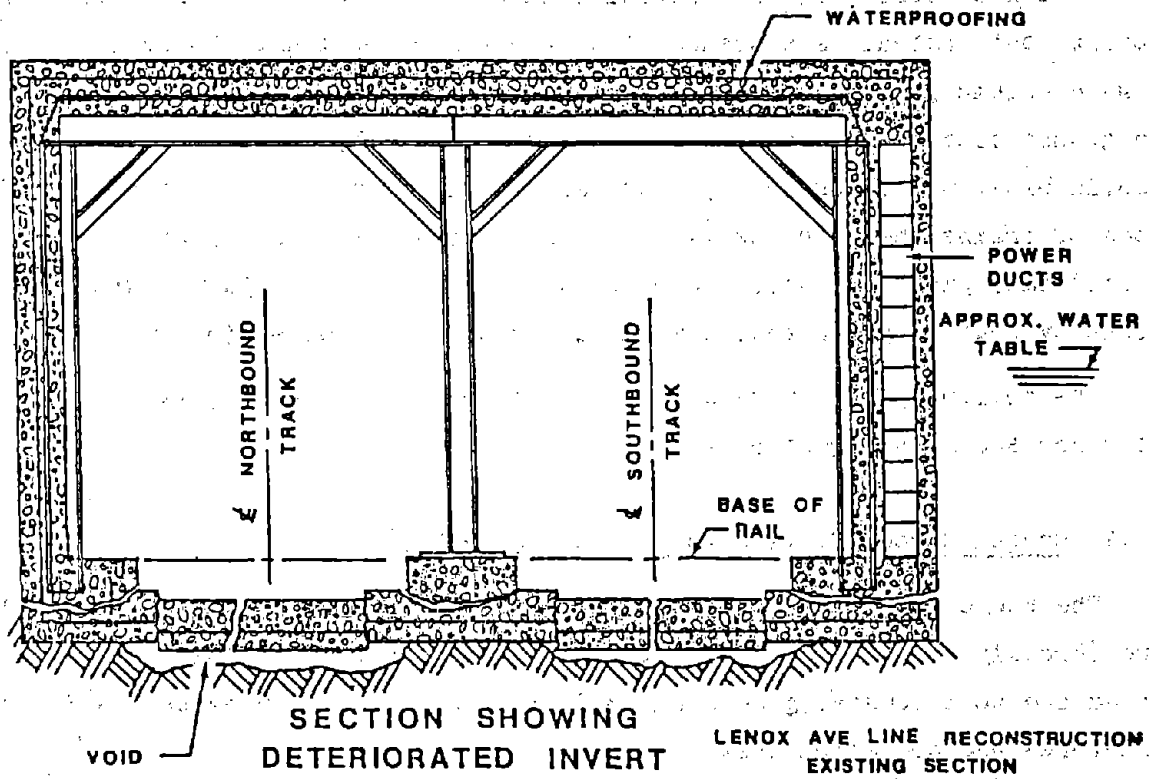
There are also a number of leaks along the ventilation system and sewer lines. However, the most extensive and dangerous type of leakage in tunnels occurs when the water can infiltrate through partially destroyed tunnel concrete walls and floors, as previously described. Figure 9.6 shows an example of such deteriorated structures.

FIGURE 9.6 WATER INFLOW BETWEEN THE BLOCKS OF DESTROYED TUNNEL FLOOR

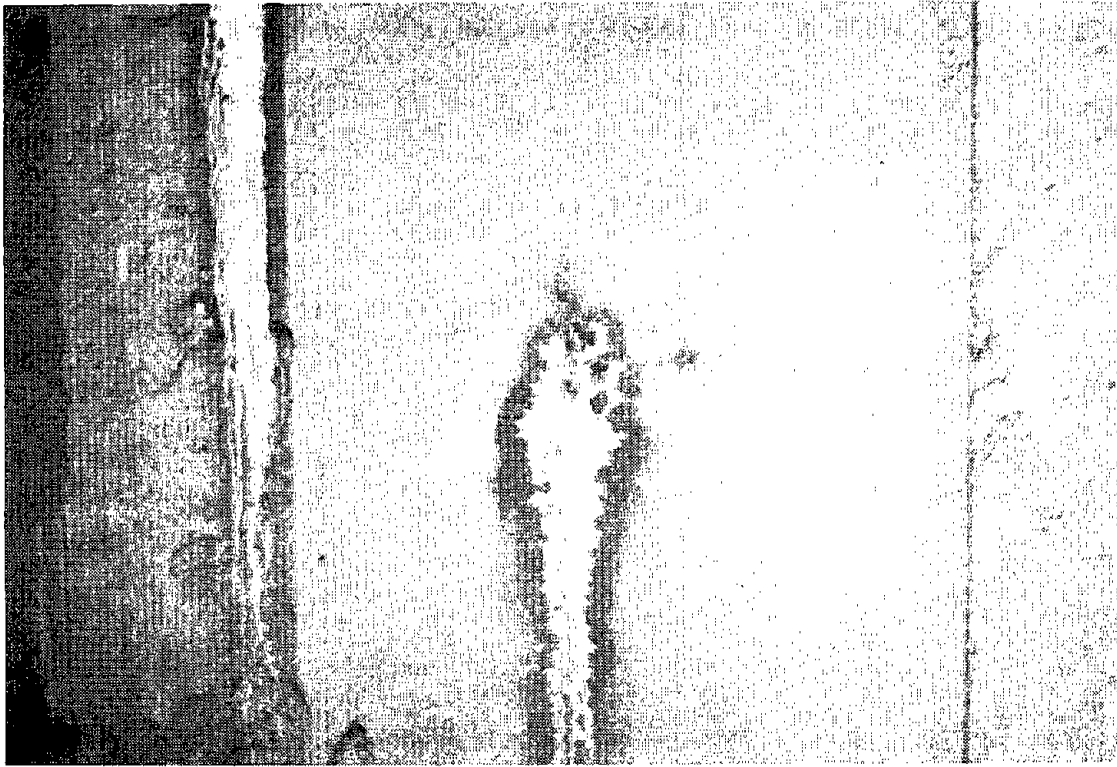
FIGURE 9.7 LEAKS THROUGH SHRINKAGE CRACKS

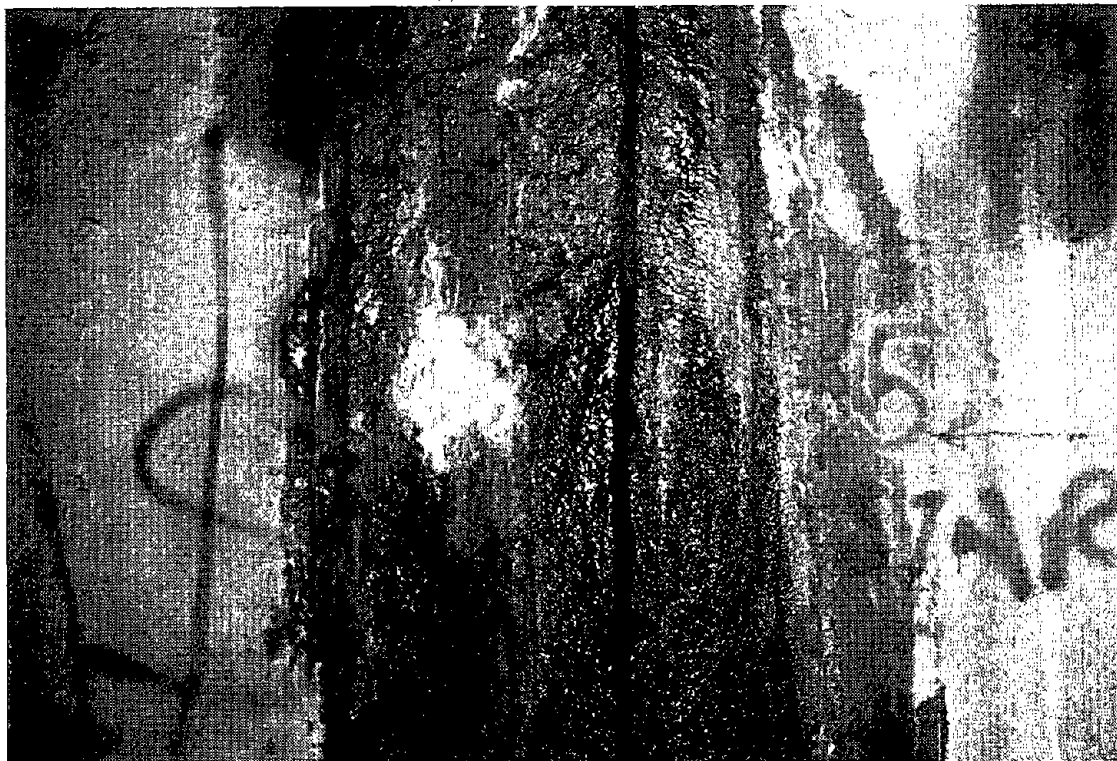
FIGURE 9.8 LEAKS THROUGH WALL JOINTS

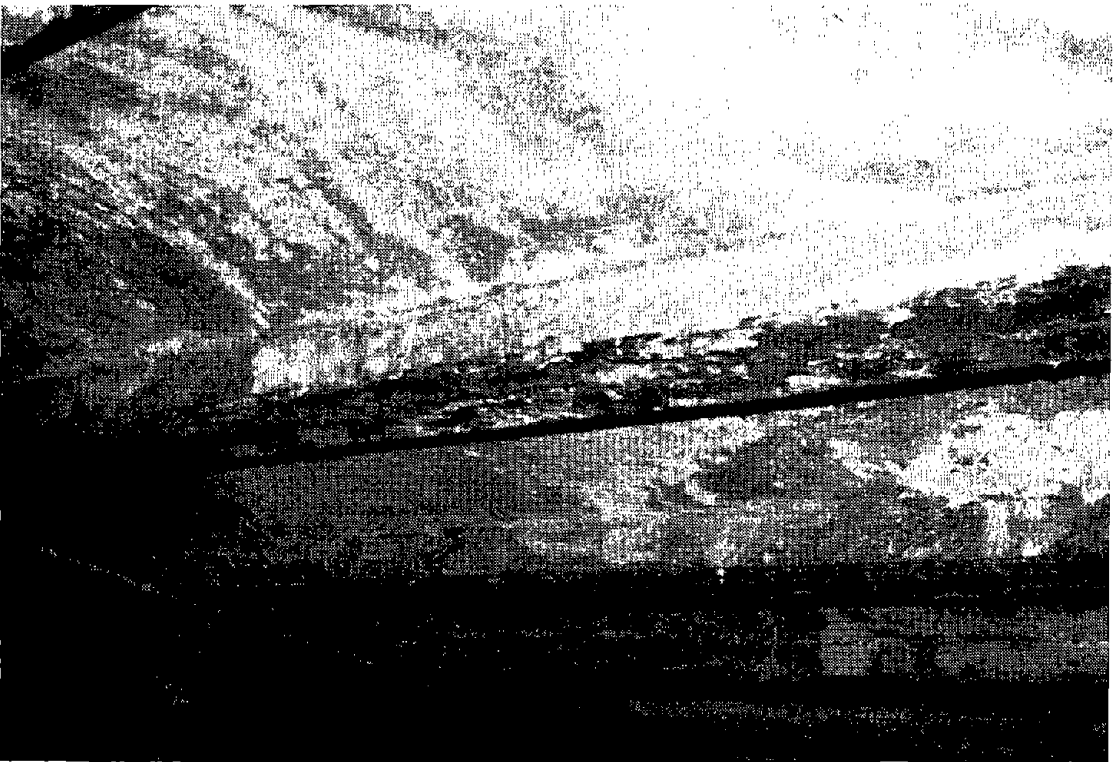
Figures 9.10 and 9.11 show a water inflow onto rail tracks and a corrosion of the arch beams.

FIGURE 9.11 CORROSION OF ARCH BEAMS (BERGEN STREET STATION)

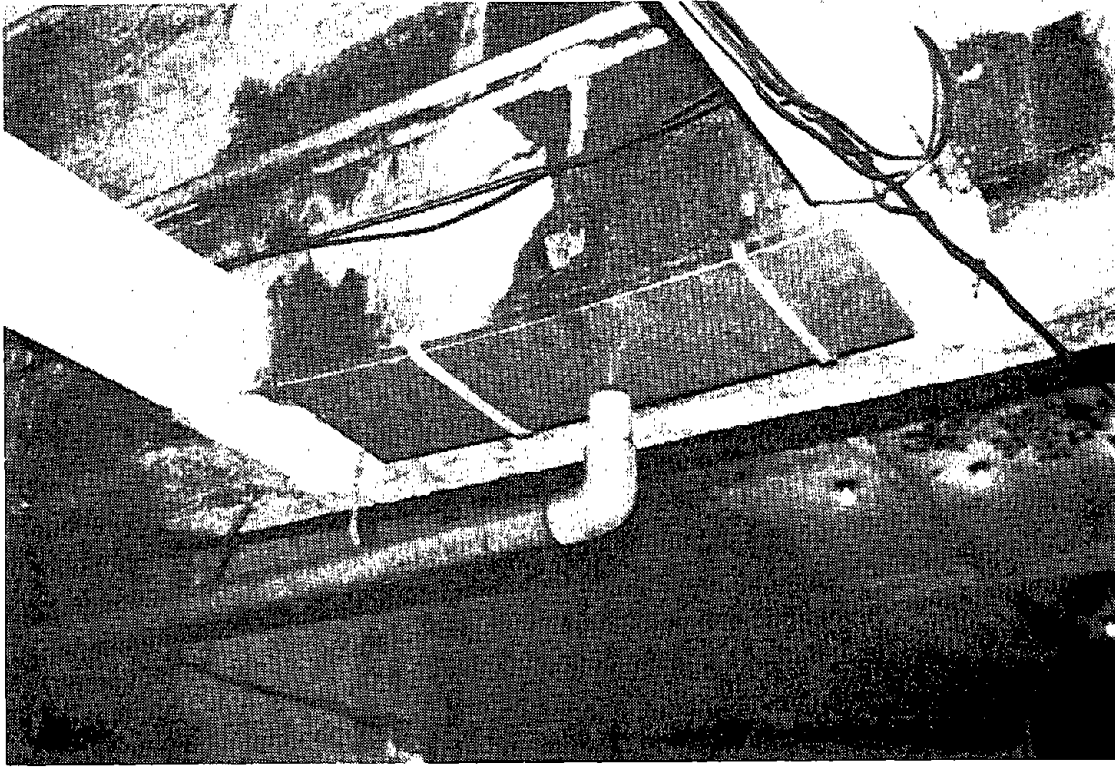
FIGURE 9.12 WATER CHANNELING (BERGEN STREET STATION)

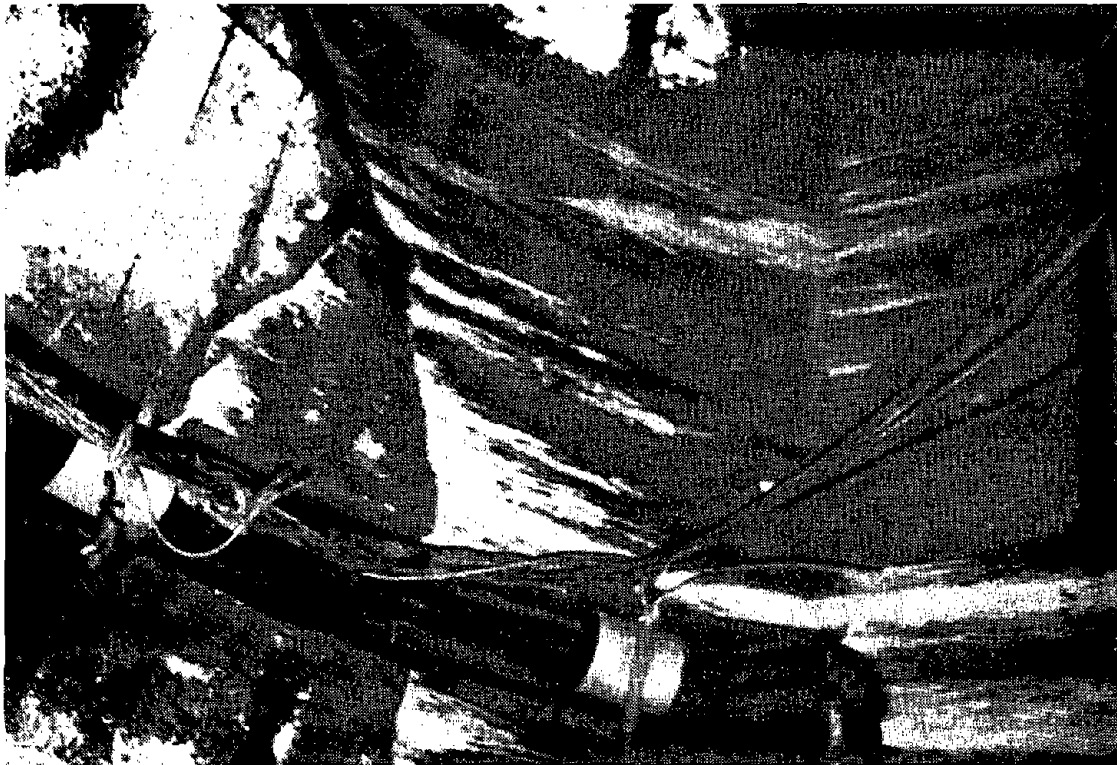
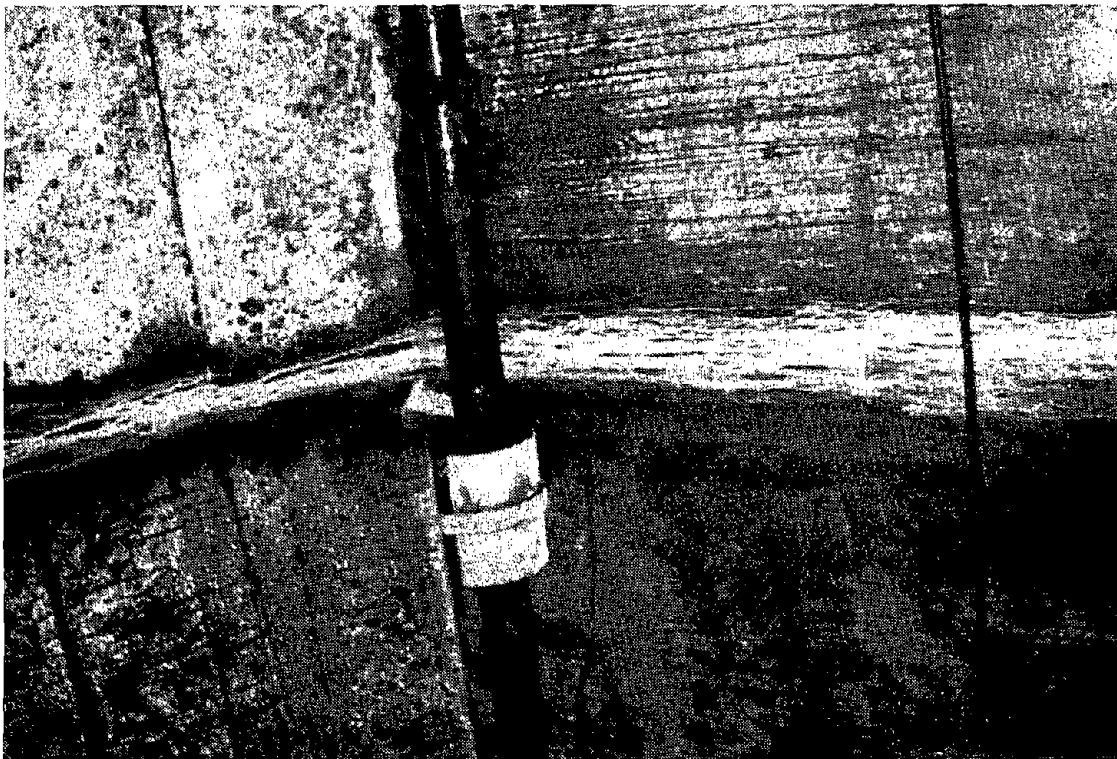
FIGURE 9.16 WATER INFILTRATION THROUGH CONSTRUCTION JOINTS

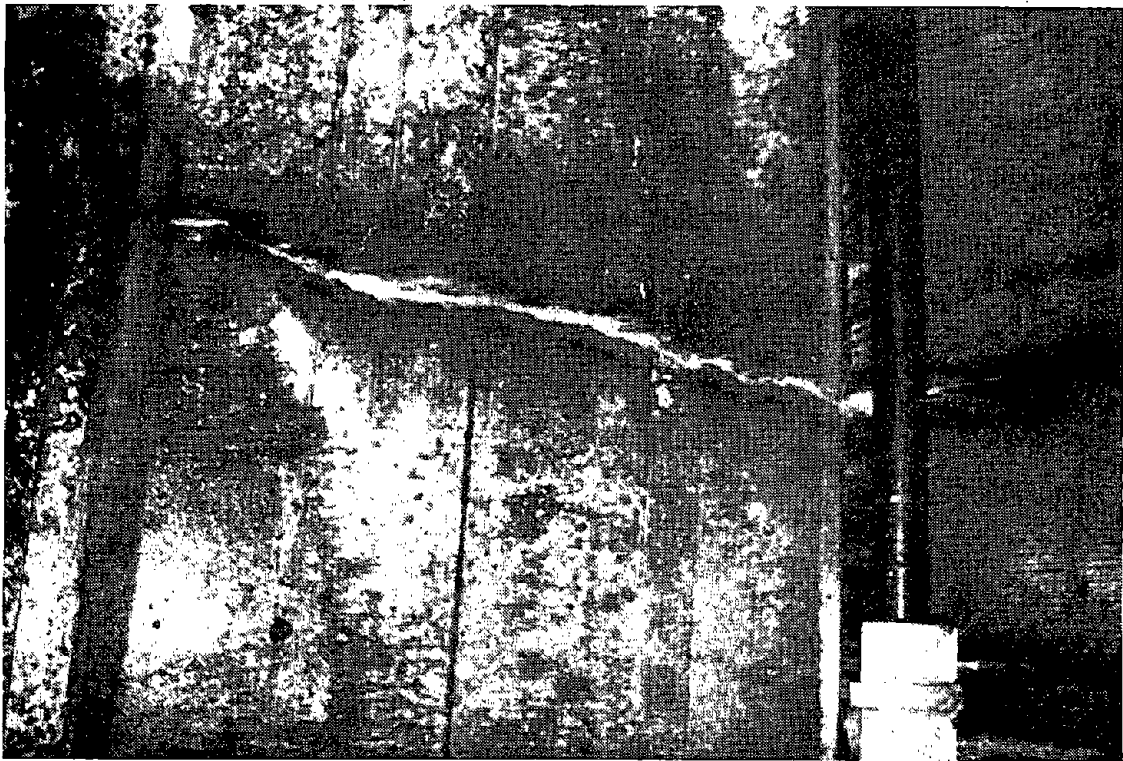
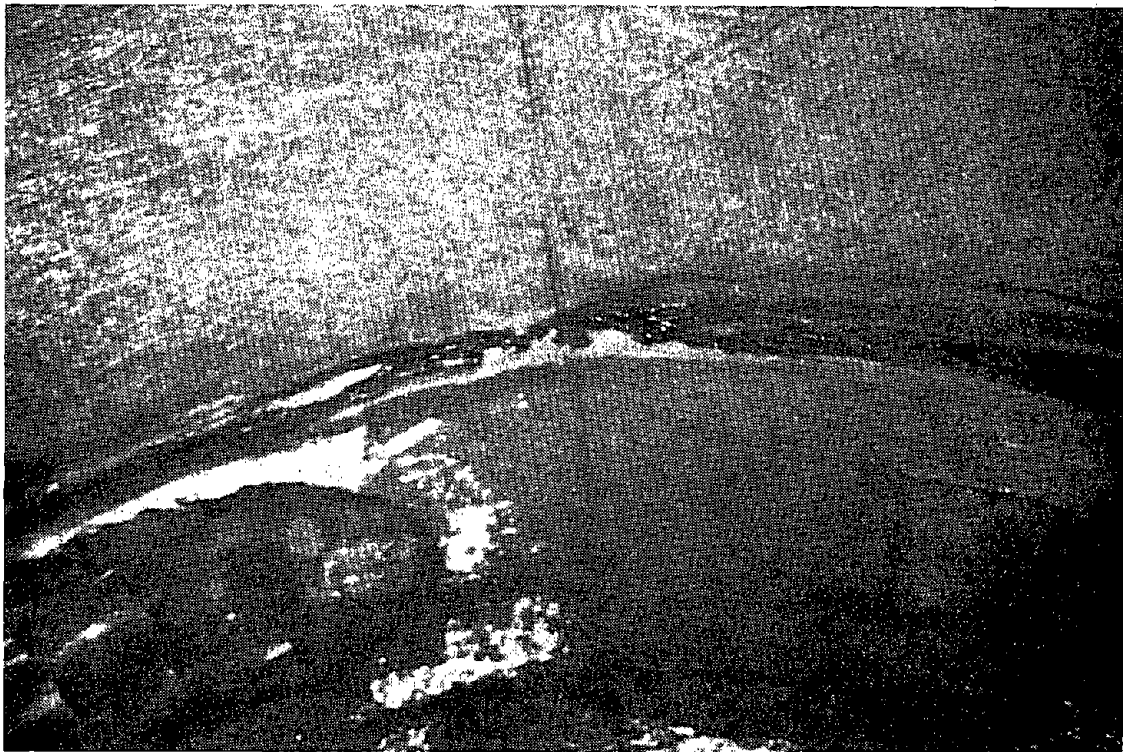
FIGURE 9.17 SHRINKAGE CRACKS (ROUTE 131-A)

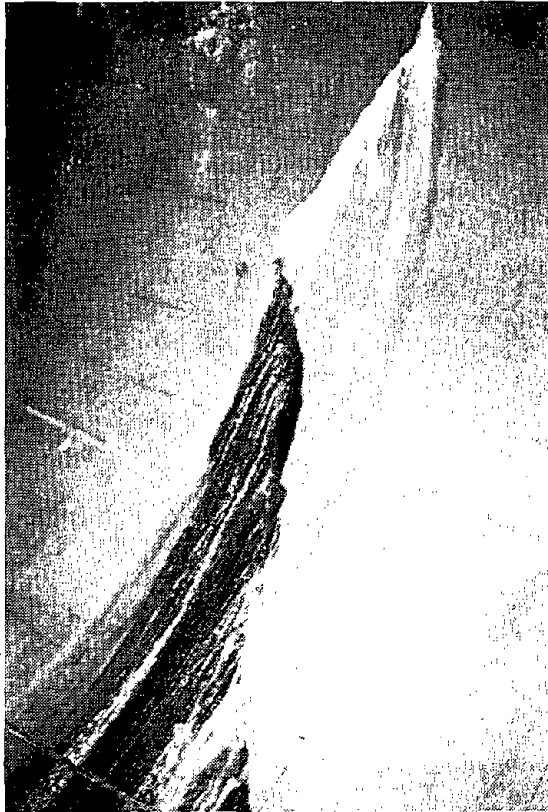
FIGURE 9.18 CALCIFICATION AROUND THE CRACKS (ROUTE 131-A)

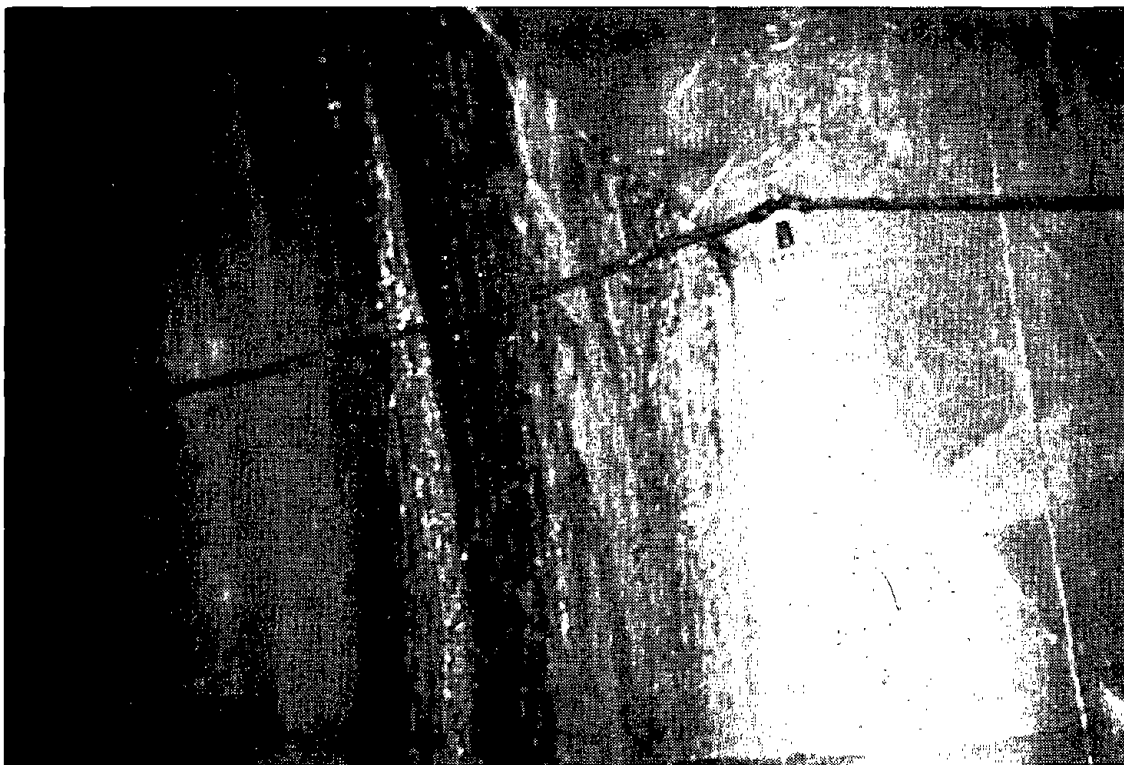
FIGURE 9.19 CALCIFICATION AND SETTLEMENTS AROUND THE CRACK AREA (ROUTE 131-A)

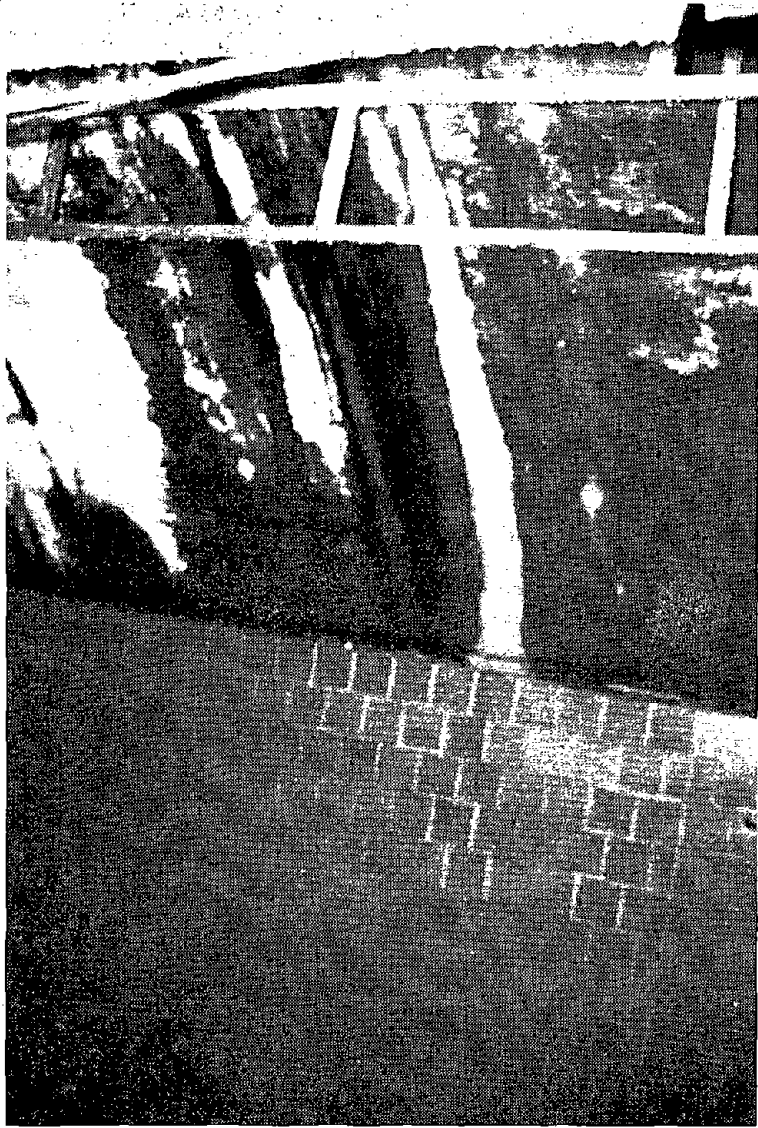
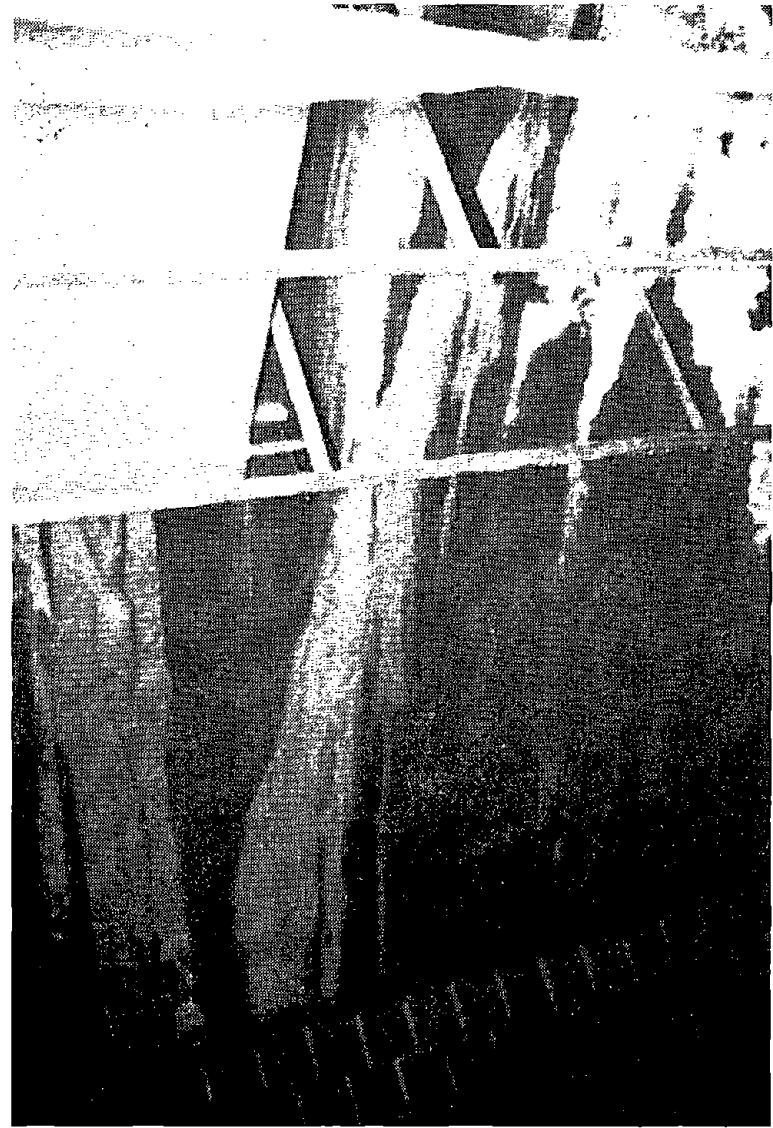
FIGURE 9.20 LEAKS THROUGH THE SHRINKAGE CRACKS BEHIND THE ARCHITECTURAL COVER (TILE WALLS)
