PROOF PRESSURE EVALUATION OF WORN PASSENGER CAR TIRE CARCASSES

S. K. Clark
R. N. Dodge
D. W. Lee
J. R. Luchini

The Regents of the University of Michigan
Ann Arbor MI 48109

NOVEMBER 1976
FINAL REPORT

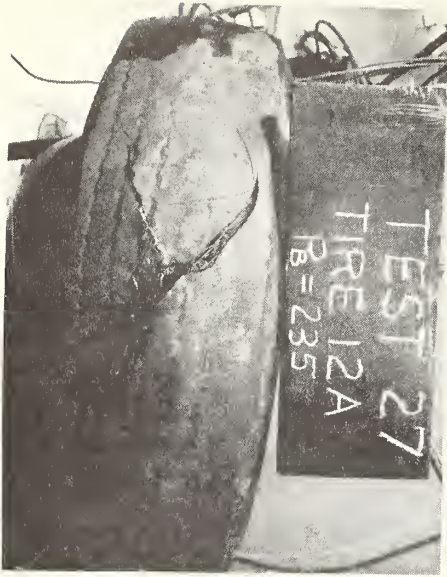
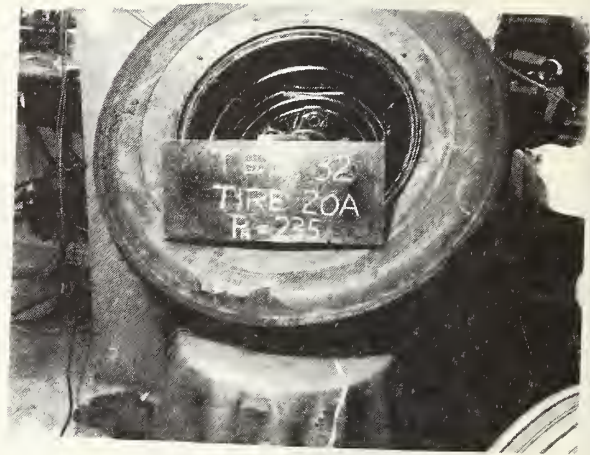
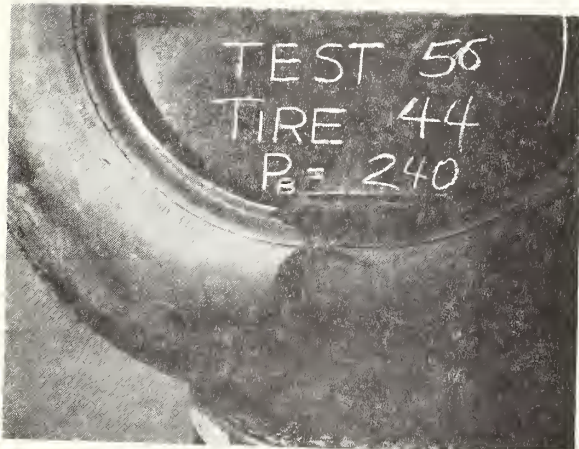
FIGURE 4. PHOTOS OF TYPICAL BURSTS

When the burst test was performed the type of failure was recorded. The failure modes were characterized as crown, shoulder, sidewall, or bead failures depending on the location of the carcass rupture. Photographs illustrating typical failures of the type mentioned are shown in Figure 4. On several occasions multiple failures occurred in a single tire, for example, both the crown and sidewalls having obvious ruptures.

Table 1 showed the distribution of failures over the various constructions considered. The trends were much more dramatic than expected. The two-ply bias tires tended to fail more regularly in the crown area, whereas the radial ply tires tended to fail most often in the bead. The other constructions were divided in modes of failure. The polyester-fiberglas bias-belted tires tended to fail most often in the crown, while exhibiting some bead failures. In contrast, rayon-rayon belted-bias tires tended to fail most often in the sidewall, while exhibiting some failures in the bead. For the four-ply tires, failures seemed to be equally balanced between bead and crown failures.

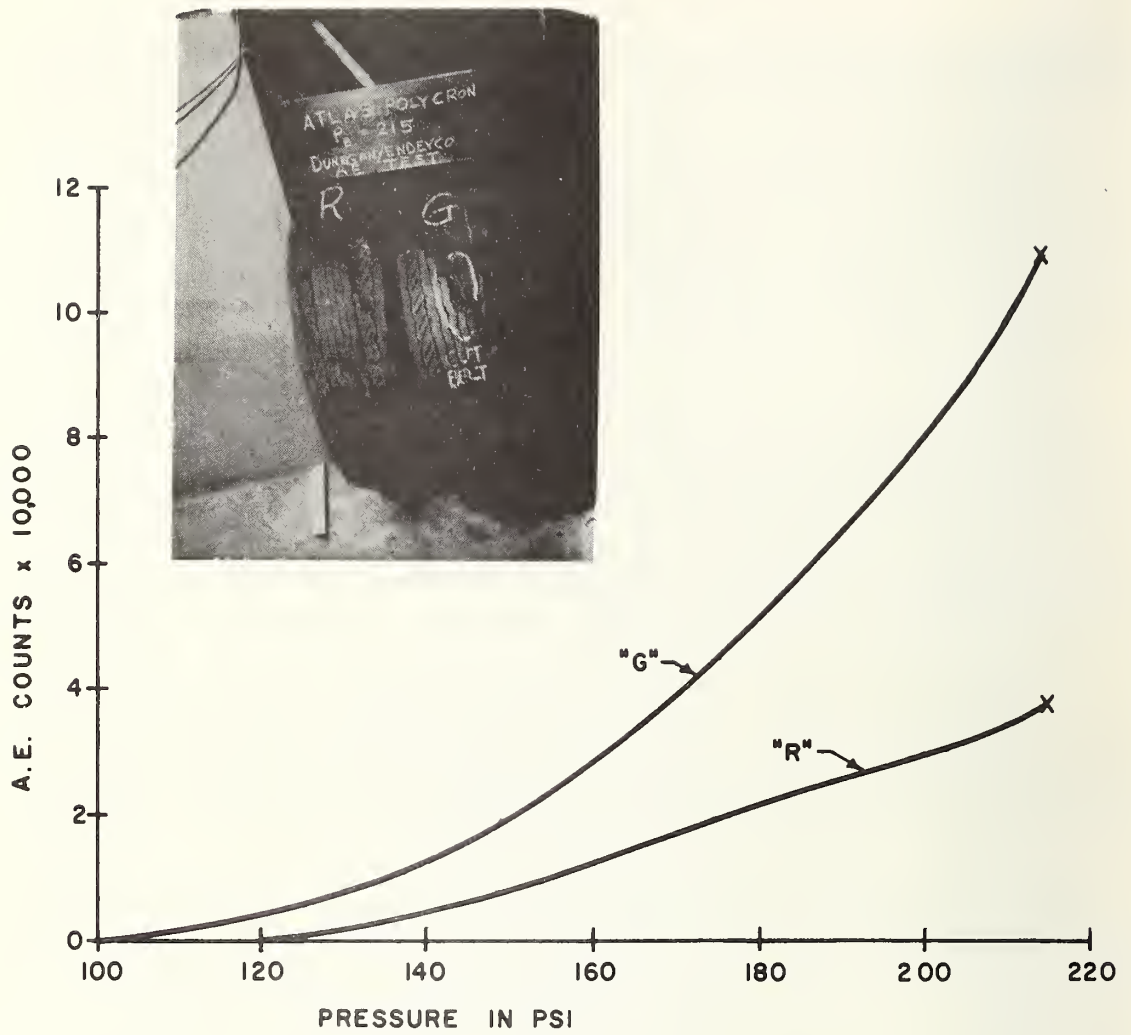
FIGURE 7. ACOUSTIC EMISSION OUTPUT FOR TWO IDENTICAL TIRES:
TIRE "R" UNDAAGED; TIRE "G" WITH CUT BELT

Two pairs of tires are of particular interest. One pair of polyester-fiberglass bias-belted tires of identical size, manufacture, and wear were burst. One tire was known to have a damaged belt. The graph of the A.E. output from the two tires in Figure 7 shows the damaged tire (marked "G") began A.E. at a lower pressure and produced more than twice the A.E. of its mate. Although the failures were identical, it should be noted that both tires would have withstood hydrostatic pressurization even though one was clearly damaged.

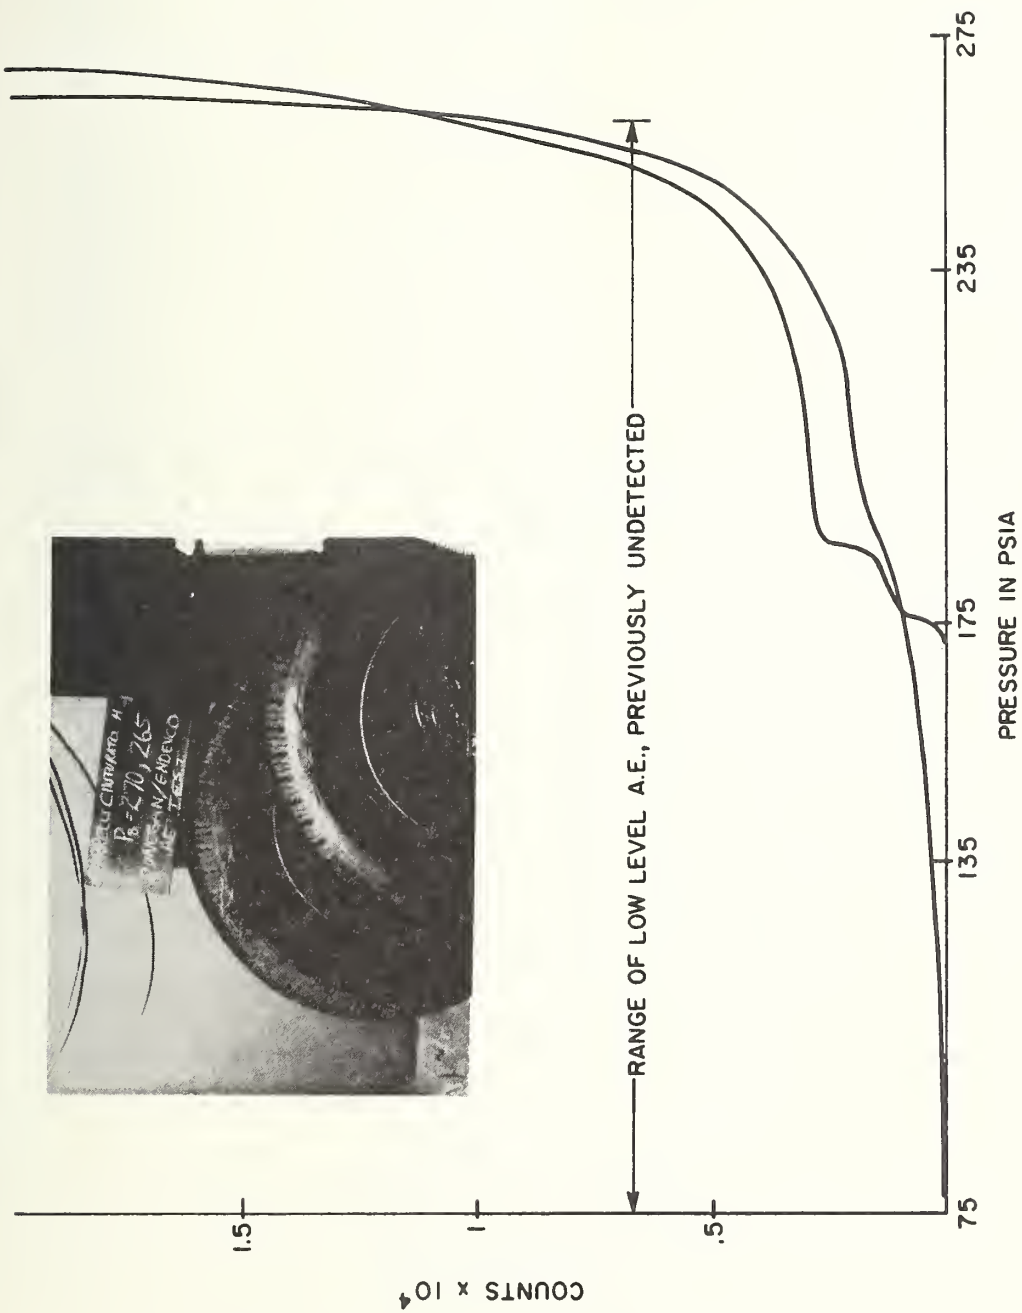
FIGURE 8. ACOUSTIC EMISSIONS VS. PRESSURE LEVEL FOR RAYON-RAYON RADIAL TIRES USING COMMERCIAL ACOUSTIC EMISSION SENSOR

The other pair of tires were of radial ply construction, which had shown characteristically low level emission hardly discernible above the noise level. With the commercial equipment at high gain, curves were produced which exhibited a sharp "knee" just before failure. These are shown in Figure 8. However, it was clear that there were random bursts of A.E. at low pressures and not simply a continuous curve produced by a constant noise level. Note also the similarity of the A.E. curves in Figure 8 and the fact that both tires failed in the sidewall at almost the same pressure.

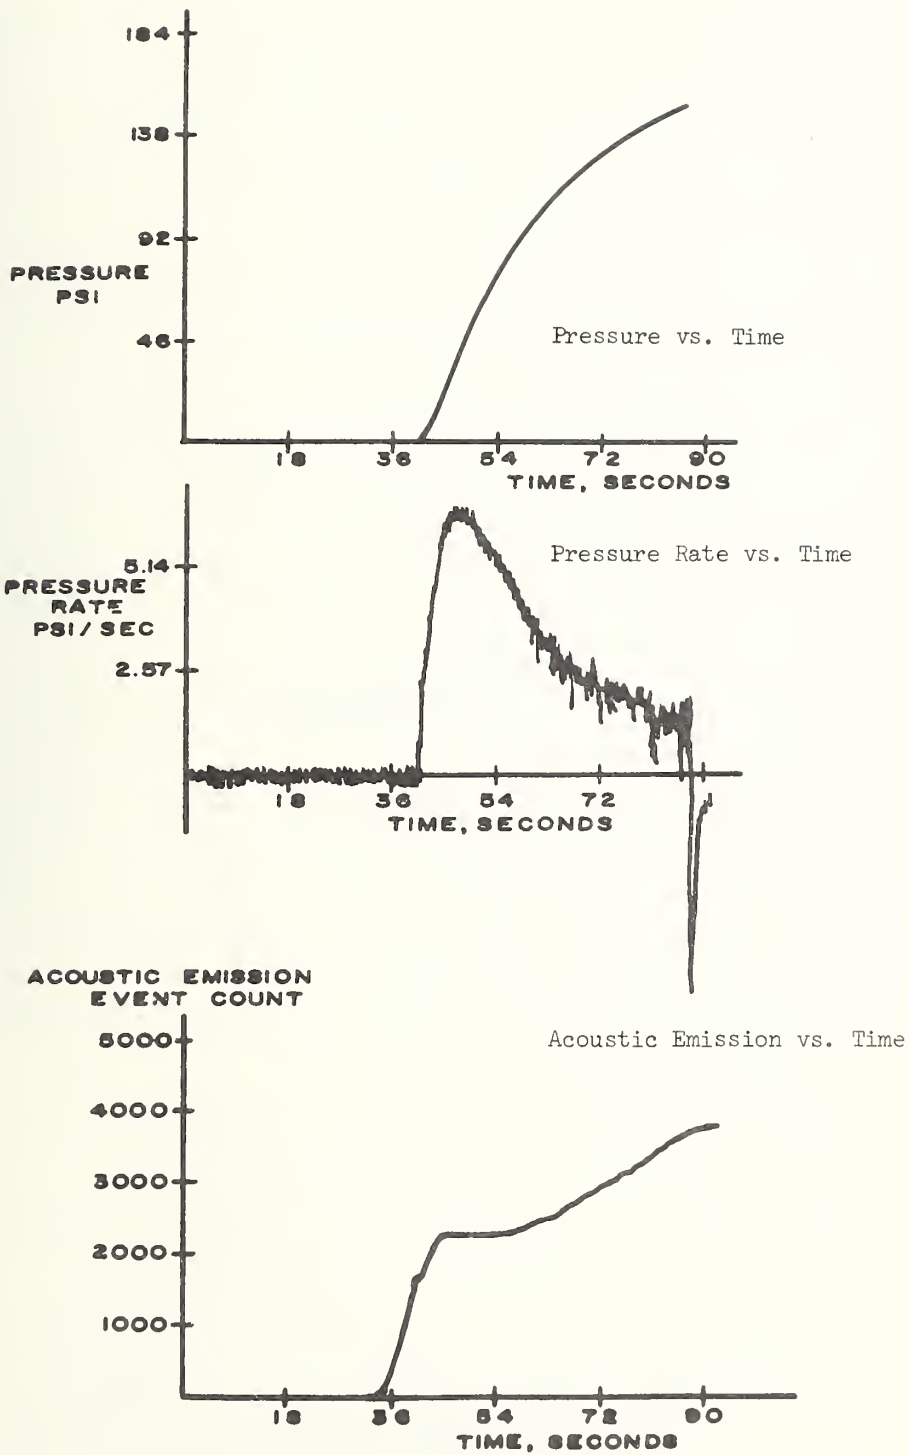
FIGURE 10. DATA FOR A GLASS BELTED F78 X 14—RECAPPABLE

These tires were processed through the rebuilt, semiautomatic pressurization system, each tire pressurized until it burst. Pressure-time, pressure rate-time, and acoustic emission-time plots were recorded for each tire. A typical set of data from these tests is shown in Figure 10 for a tire considered to be recappable. A similar set of data is shown in Figure 11 for a tire of exactly the same construction and manufacturer, with a known flaw, a plug in the tread. An examination of this data and several similar sets show essentially no correlation between tire quality and P-t, \dot{P} -t, or AE-t diagrams. These diagrams seemed similar whether the tire had been damaged or whether it had not been damaged.

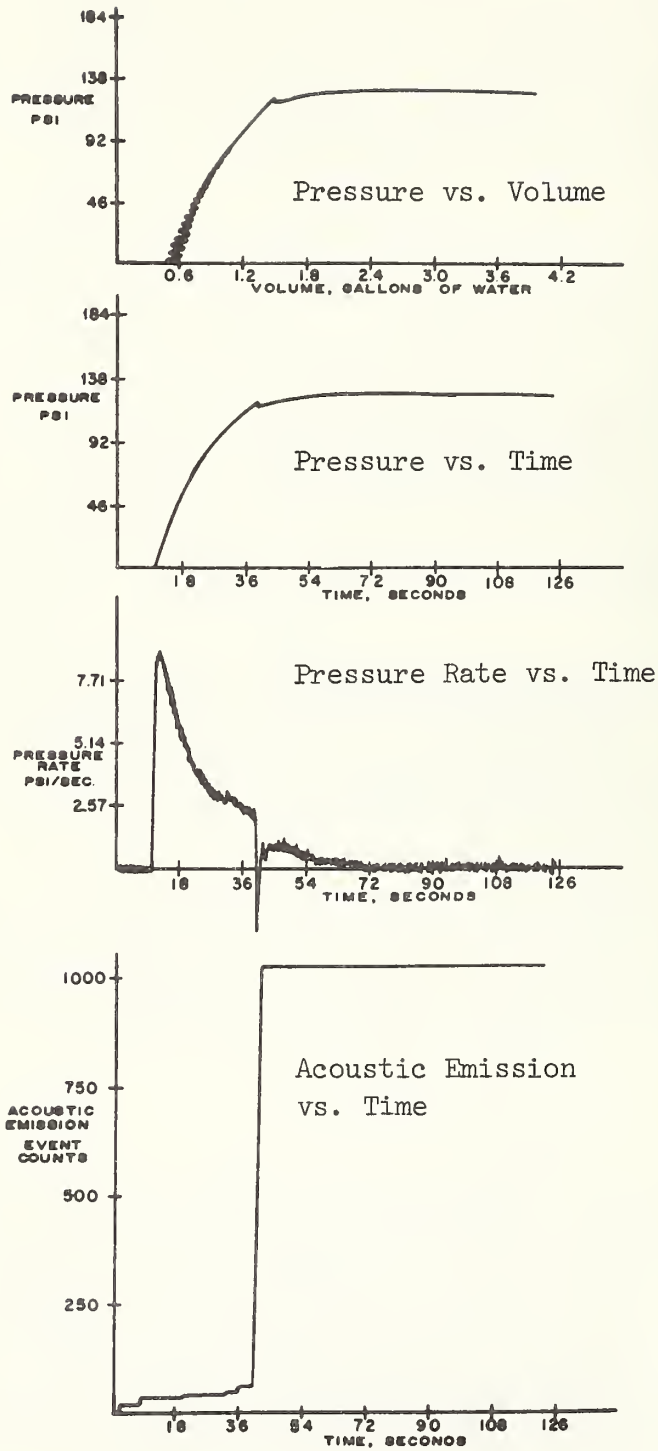
FIGURE 12. DATA FOR 6.45 X 14 TWO-PLY POLYESTER—LEAK

The sets of data shown in Figures 12 and 13 illustrate the only flaw that seems detectable from these records, a leak in the tire. The tire in Figure 12 developed a leak about 120 psi while a similar tire shown in Figure 13 had no flaws. As can be seen from these two figures the plots for the tire with the leak are distinctly different than those for the tire with no leak. Also it is of interest to note that all of the plots in Figure 12 clearly indicate the occurrence of the leak.
