FTA-MA-26-0031-94-1
DOT-VNTSC-FTA-94-9

Detectable Warnings: Testing and Performance Evaluation at Transit Systems

Final Report
November 1994

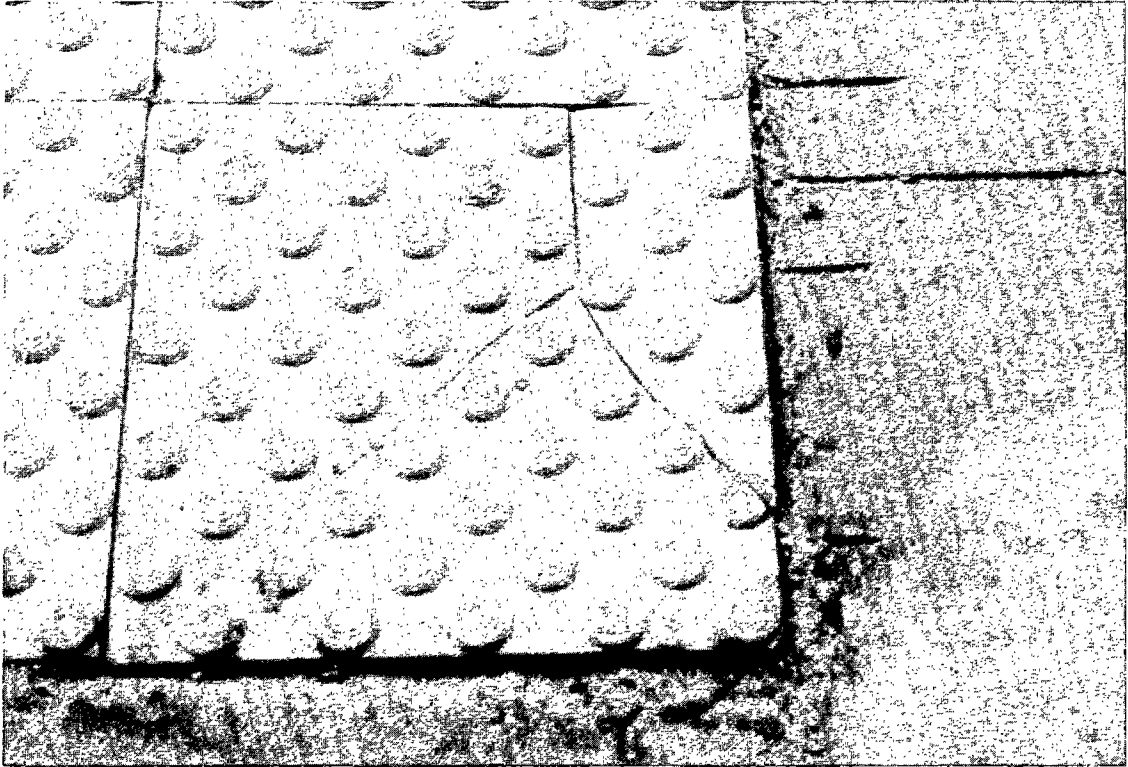
Figure 3-3 shows a portion of the installation of Transpo's Step-Safe at Orient Heights. One tile has cracked and is no longer bonded to the platform.

Figure 3-3
Transpo Industries: Step-Safe
Installation at MBTA Orient Heights Station Illustrating Cracked Tile
(Photo Taken after 167 Exposure Days)

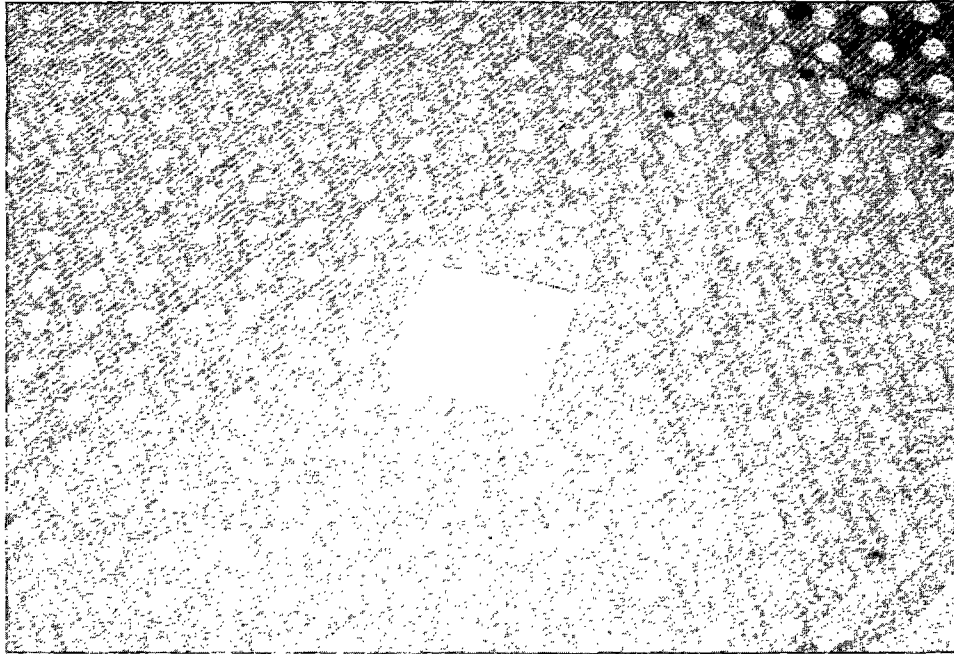
Figure 3-4
ADA Consultants: Alert Mat
Installation at GCRTA Brookpark Station Illustrating Change From Original Color
(Sample Piece in Center of Photo)
(Photo Taken After 201 Exposure Days)

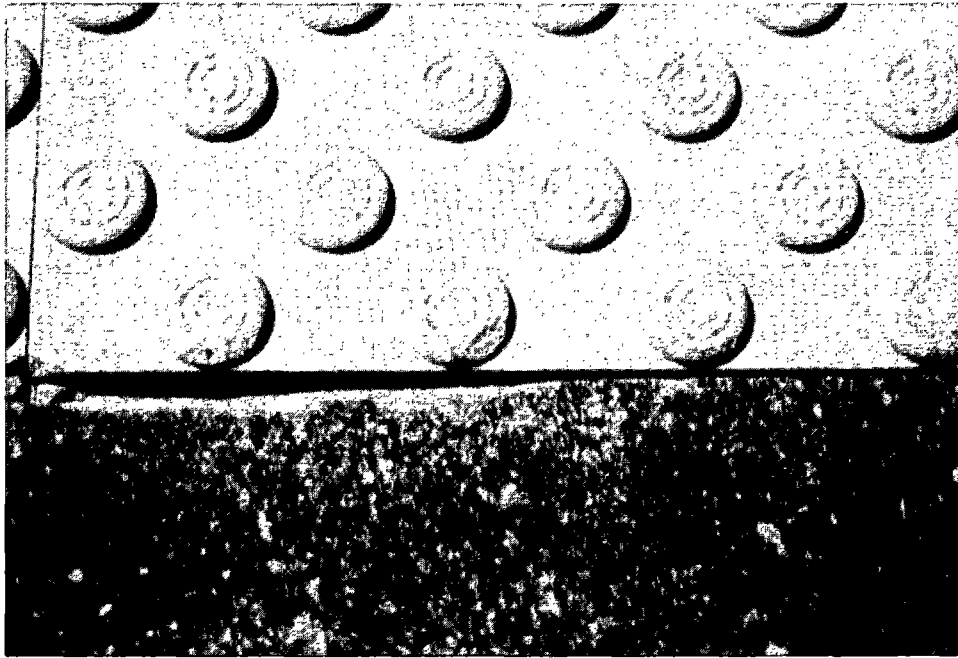
Figure 3-5
Transpo Industries: Step-Safe
Installation at GCRTA Triskett Street Station Illustrating Chipped Domes
(Photo Taken After 200 Exposure Days)

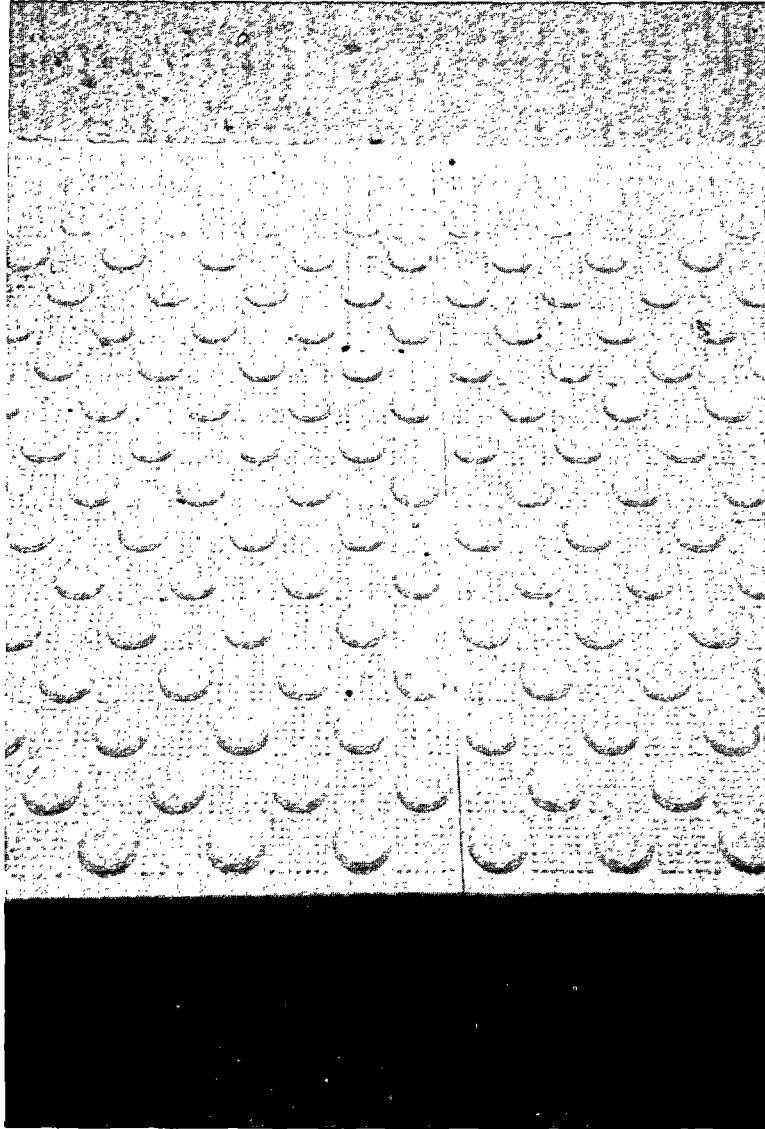
Figure 3-7
Engineered Plastics: Armor-Tile
Installation at SEPTA Bethayres Station Illustrating
Small Accumulation of Dirt and Sand
(Photo Taken After 87 Exposure Days)
