HOLOGRAPHIC TECHNIQUES FOR NONDESTRUCTIVE TESTING OF TIRES

Contract No. DOT-TSC-NHTSA-72-4
April 1972
Interim Report

U.S. DEPARTMENT OF TRANSPORTATION
NATIONAL HIGHWAY TRAFFIC SAFETY ADMINISTRATION
WASHINGTON, D.C. 20590

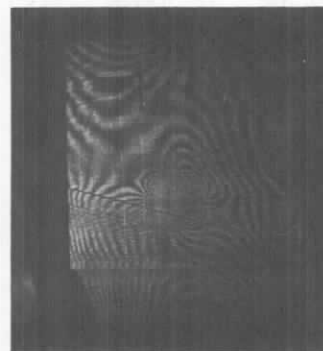
Figure 3. Holographic Interferogram of Rubber/Cord Specimen with Ply Separation

Figure 2 shows an interferogram of a specimen with no defects. Only gross fringes from creeping rubber are visible. Figure 3 is a specimen with a separation in the central area. Concentric rings show the location and size of a separation. The fringe density is an indication of the severity of the separation.

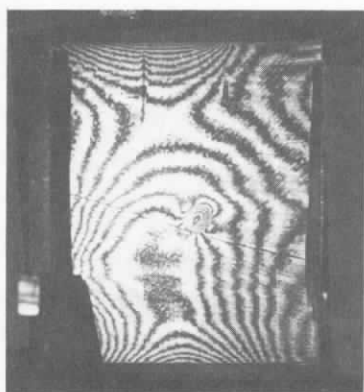
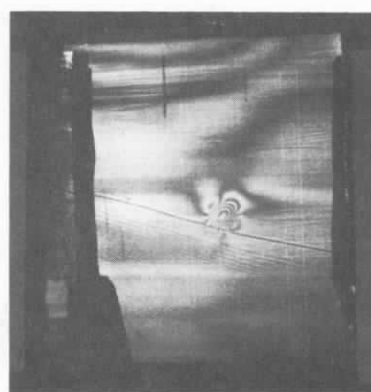
Figure 4 The Effects of Relaxation Time on a Rubber/Cord Specimen with a Separation Defect

Fringes generated by creeping rubber can add spurious fringe information and should be minimized if possible. Our study showed that for the rubber/cord specimens, 30 minutes relaxation time minimized creep fringes to the point where defect investigation could be performed. Figure 4 shows two interferograms of a specimen that was allowed to set for different time periods before holographing. Figure 4a shows the fringe pattern generated by a 1/2 inch separation in the center of a rubber/cord specimen surrounded by a fringe pattern generated by creeping rubber. This specimen was allowed to relax for one hour before holographing. Figure 4b shows an interferogram of the same specimen taken after it was allowed to relax for 72 hours. The time between

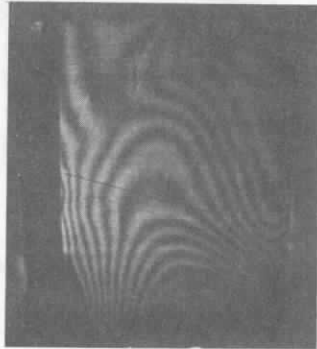
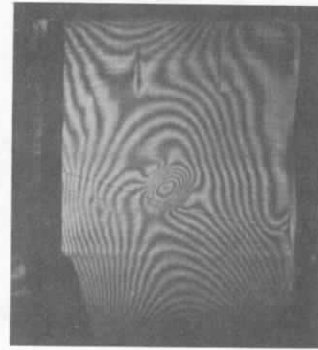
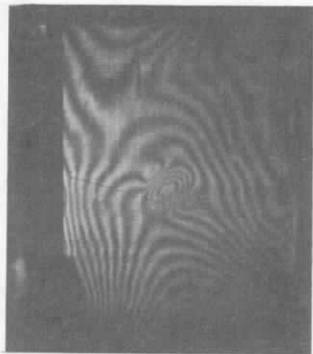
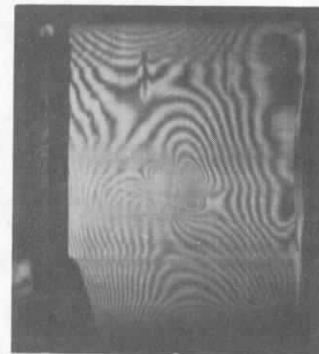
Figure 5: Pressure Effects on Holographic Interferograms of a Rubber/Cord Specimen

The optimum differential straining pressure required to expose the sub-surface anomalies varied with separation size and with sample thickness. The amount of differential vacuum applied to a defective rubber/cord sample has an effect on the surface displacement and therefore on the fringe signature of that particular defect. Figure 5 shows the effect of applying different vacuum straining pressures to a specimen containing a 1/2 inch diameter separation. The optimum straining pressure for this particular specimen was about 15 torr. Excessive pressures can cause excessive surface displacement and produce an interferogram which has a high unresolvable fringe density. Figure 5 shows that this was the case with the interferogram generated using a differential straining pressure of 40 torr.

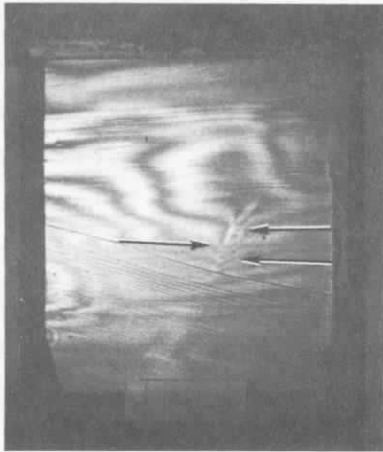
Figure 7. Holographic Interferogram of a Rubber/Cord Specimen with a Broken Cord

of the specimen could not be detected. Cords which were broken after curing by means of a plunger could be detected in some cases. Breaking cords with this technique also has a tendency to stretch and distort the specimens. Figure 7 shows an interferogram of one of these specimens. It would be difficult to predict that the fringe signature was that of a broken cord if the history of the sample were not known.

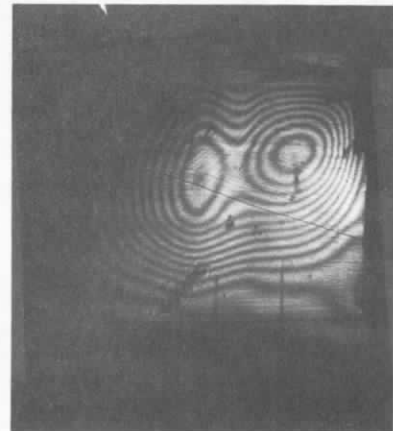
Figure 8. Holographic Interferogram of a Rubber/Cord Specimen with a Ply Overlap

Figure 8 shows an interferogram of a specimen with a ply overlapped. The overlap is located in the center of the specimen and runs vertically from the bottom edge to the top edge. The fringe pattern seems to indicate an anomaly in the area of the overlap. This type of defect seems to manifest itself as an irregularity in the gross fringe pattern rather than a localized, high fringe density pattern which is indicative of void and separations.

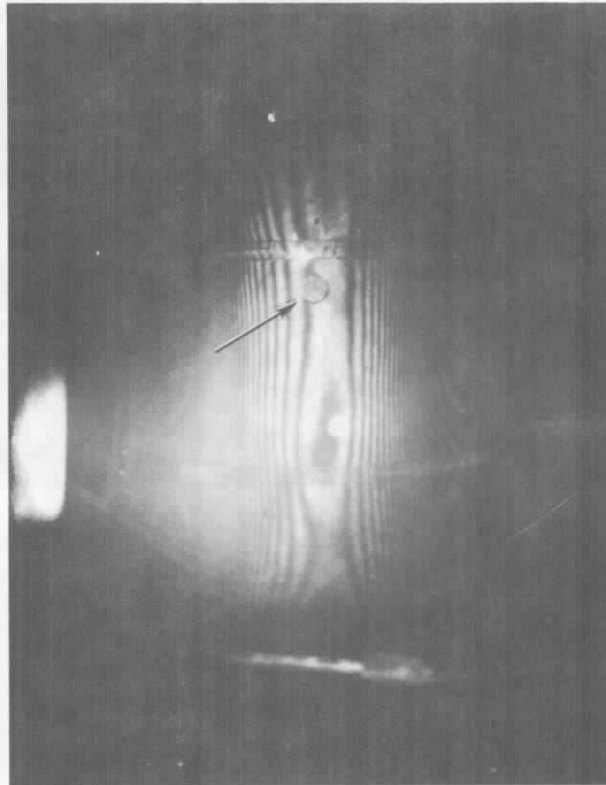
Figure 10. Holographic Interferogram of a Tire With a Separation Between the Tread and Top Belt.

Type of Defect: Each tire had three separations of 1/2", 1" and 2" in diameter between the tread and top belt.

The separation is indicated by the arrow. The fringe signature of the defect shows that the separation is circular in shape and approximately 1/2 inch in diameter. The low fringe density (7 fringes) can be an indication that the separation is not near the inner surface. This is true for this particular tire since the separation is between the belt and the tread.

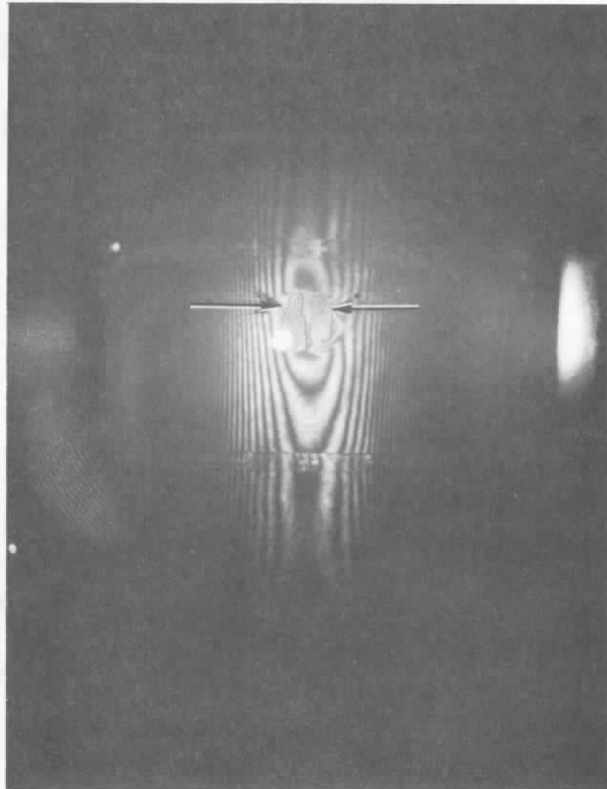
Figure 11. Holographic Interferogram of a Tire with a Separation Between the Plies and the Belt

Type of Defect: Each tire had 3 separations of 1/2", 1" and 2" in diameter between the plies and the belt.

This separation was programmed to be 2 inches in diameter. The interferogram shows that a narrow strip through the center of the separation bonded during the curing process resulting in two smaller adjacent separations as indicated by the arrow. The white spot in the photograph has no significance to the interferogram.

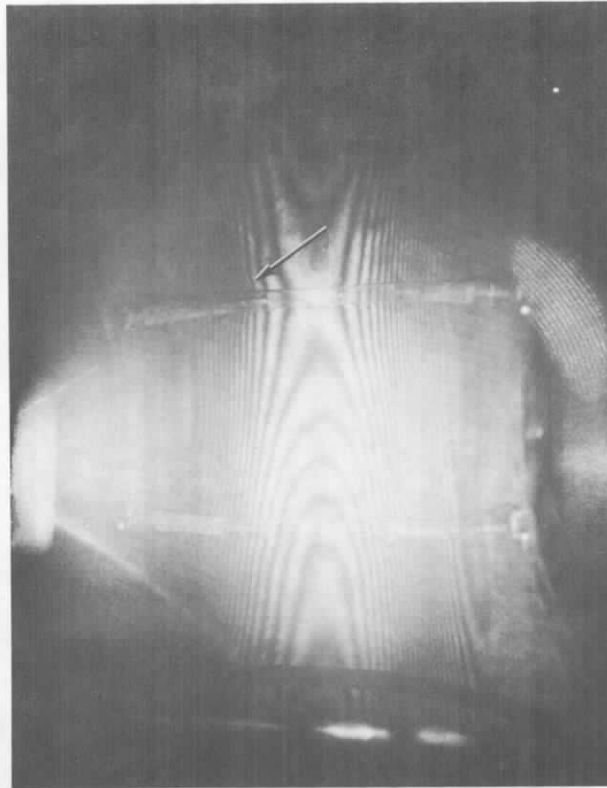
Figure 12. Holographic Interferogram of a Tire With a Separation in the White Sidewall Area

Type of Defect: Each tire had 3 separations of 1/2", 1" and 2" in diameter in the white sidewall area.

The separation location indicated by the arrow is slightly obscured by the plastic marker band. The fringe density is very high in the area of the defect and the individual fringes are not resolvable by eye in this photograph. The defect location is manifested by the termination of the gross fringe pattern in that area. The sidewall region of a tire is usually the most flexible part of the tire. Fringe signatures generated by separation located in the walls usually have a very high fringe density due to this flexibility.

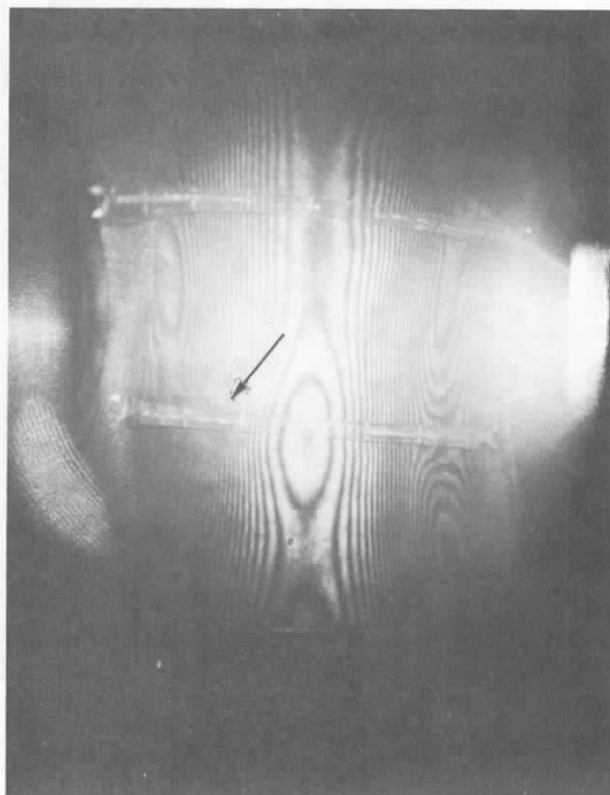
Figure 13. Holographic Interferogram of a Tire With a Separation in the Black Sidewall Area.

Type of Defect: Each tire had 3 separations of 1/2", 1" and 2" in diameter in the black sidewall area.

The separation location is indicated by an arrow and is partially obscured by the plastic marker band.

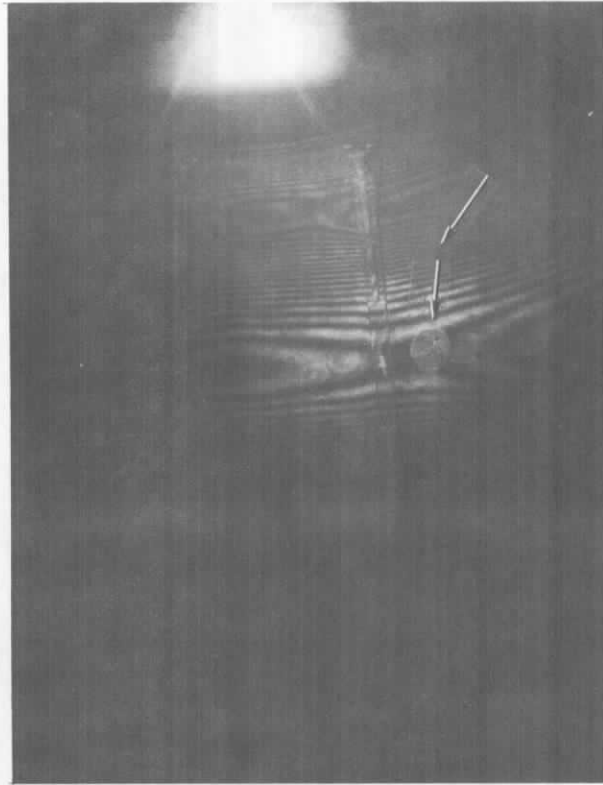
Figure 14. Holographic Interferogram of a Tire with a 1 Inch Separation in the Center of the Tread Area and a 1 Inch Separation in the White Sidewall Area

Type of Defect: 1" separation in the center of the tread area and a 1" separation in the white sidewall area. Separation were surrounded by a 12" weak-bond area.

Arrows show the location of the separations. The interferogram does not appear to have any fringe signature which could be characteristic of a weak-bond. Tires of this type are intended to be wheel tested and periodically inspected between tests for possible propagation of the separations in the weak-bond area.

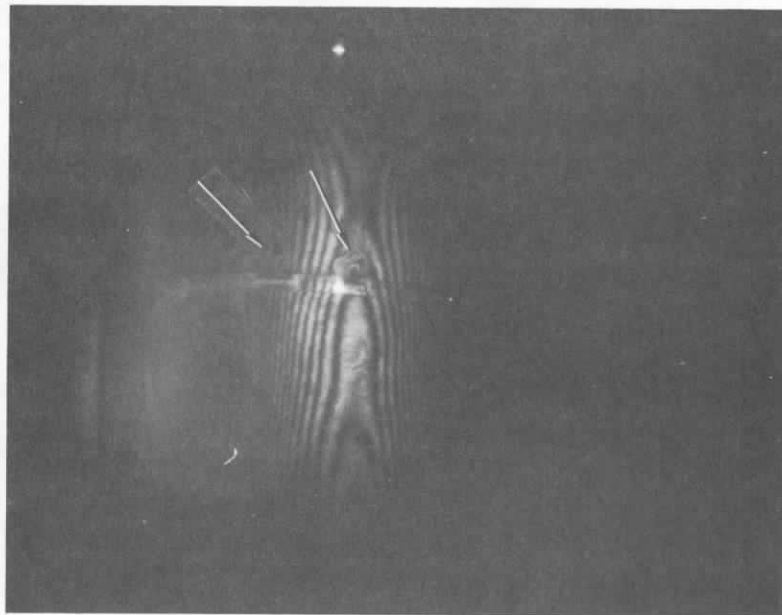
Figure 15. Holographic Interferogram of a Tire With a 1 Inch Separation in the Center of the Tread Area and a 1 Inch Separation in the Black Sidewall Area. Separations were Surrounded by a 12 Inch Weak-Bond Area

Type of Defect: 1" separation in the center of the tread area and 1" separation in the black sidewall area. Separations were surrounded by a 12" weak-bond area.

The arrows show locations of the separations. The weak-bond area was not identified.

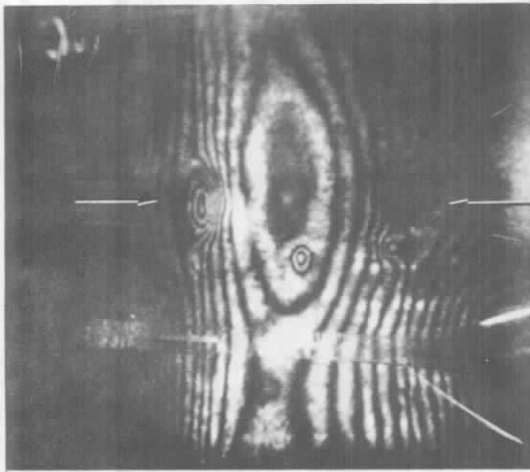
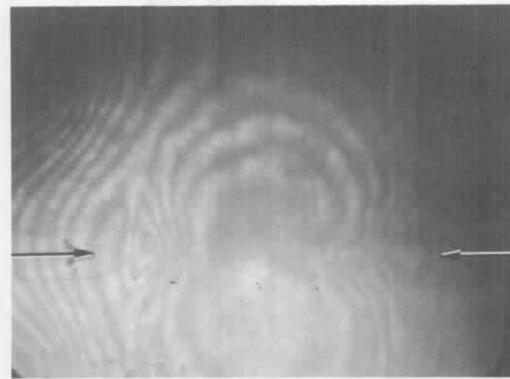
Type of Defect: Out-of-roundness from excessive rubber in the tread and shoulder area.

Results: This type of defect was detected in 2 of the 4 tires examined. (Figure 16)

The distinct fringe pattern in Figure 16a shows air voids trapped in the area of the excessive rubber. Figure 16b shows a more subtle irregularity of the gross fringe pattern in the area of the excessive rubber containing no air voids.

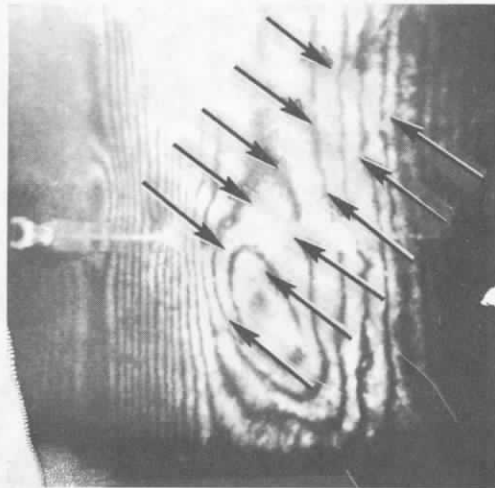
Figure 17. Holographic Interferogram of a Tire With an Overlap of 2 Inches in the Second Body Ply Extending from Bead to Bead

Type of Defect: An overlap of 2" in the second body ply extending from bead to bead. (Figure 17)

Results: 2 of the 4 defective areas were located.

The arrows in the hologram show the area of the overlap. The fringe signature of this type ply overlap is characteristically an irregularity in the gross fringe pattern and runs across the tire at approximately 45° .

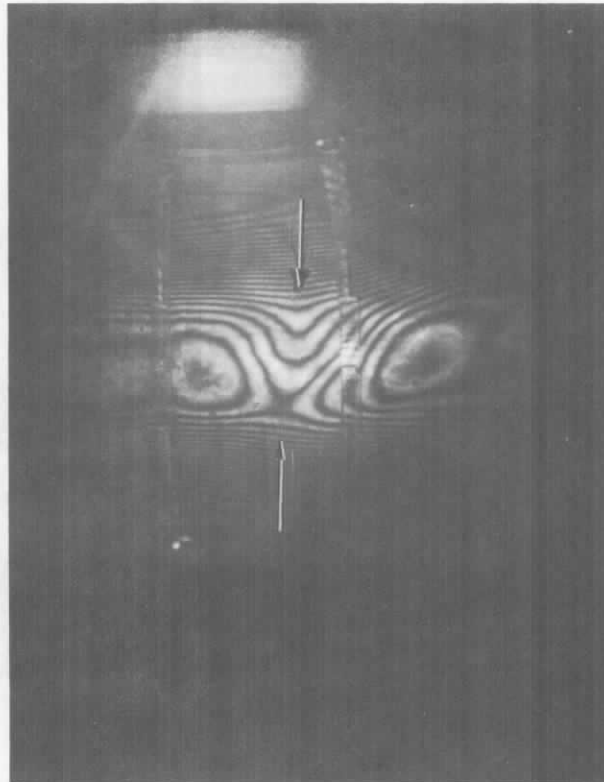
Figure 18. Holographic Interferogram of a Tire With Second Body Ply Folded Back on Itself for 1 Inch Extending from Bead to Bead

Type of Defect: Second body ply was folded back on itself for 1" extending from bead to bead.

Results: 2 of 5 of these defects were located. (Figure 18)

This type of defect can be identified by irregularities in gross fringe pattern.

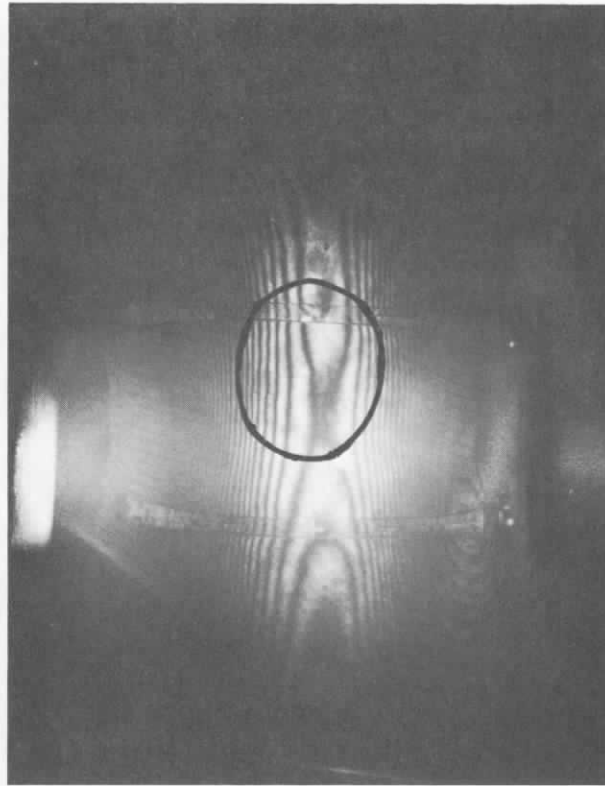
Figure 19. Holographic Interferogram of a Tire With Ruptured Cords in the Center of the Tread Area (No Defect Signature)

Type of Defect: Ruptured cords in the center of the tread area.

Results: Careful inspection gave no indication of defects in the tread area. (Figure 19)

No unusual or irregular fringe patterns could be detected in the interferogram that might indicate an anomaly in the area. An X-ray picture of the area also failed to detect the broken cords. Location of the broken cords encircled.

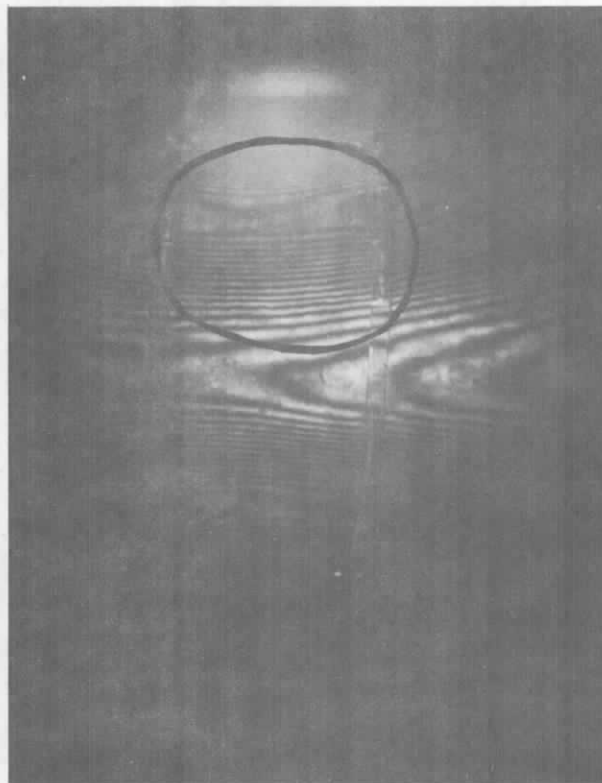
Figure 20. Holographic Interferogram of a Tire With Ruptured Cords in the Shoulder on the Black Sidewall (No Defect Signature)

Type of Defect: Ruptured cords in the shoulder on the blackwall side.

Results: Careful inspection gave no indication of defects in the sidewall area. (Figure 20)

The area in which the ruptured cord is located is circled in the hologram. No unusual or irregular fringe patterns could be detected in the interferogram that might indicate an anomaly in the area.

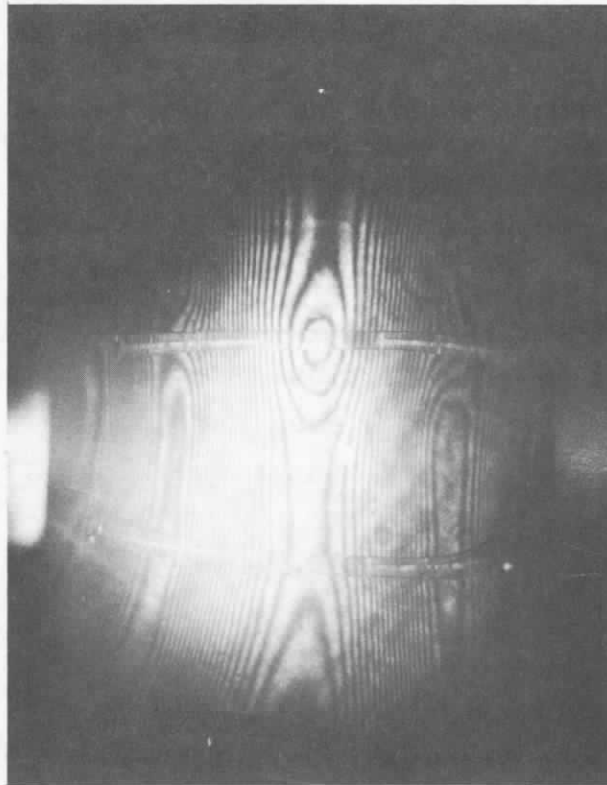
Figure 21. Holographic Interferogram of a Tire With a Permeable Tubeless Inner Liner (No Defect Signature)

Type of Defect: Permeable tubeless inner liner.

Results: No detectable defects in this area. (Figure 21)

This type of defect does not manifest a signature. Air cannot be trapped in the subsurface of the tire by this type of defect. For this reason, differential pressure straining techniques have no effect.

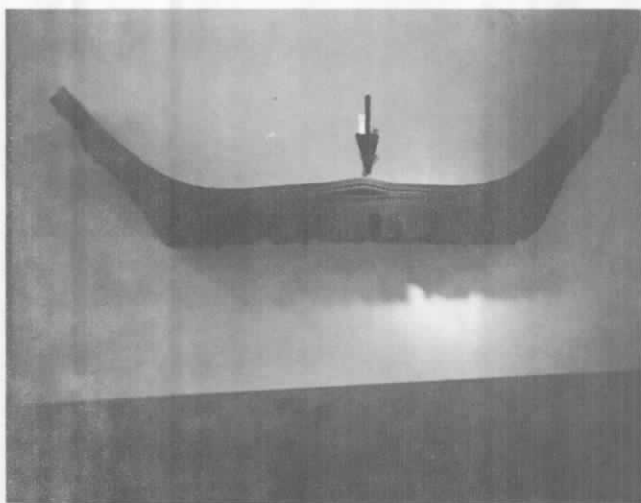
Figure 22. Section of a Tire (# ϕ 1T6061) Carcass With a Ply Separation

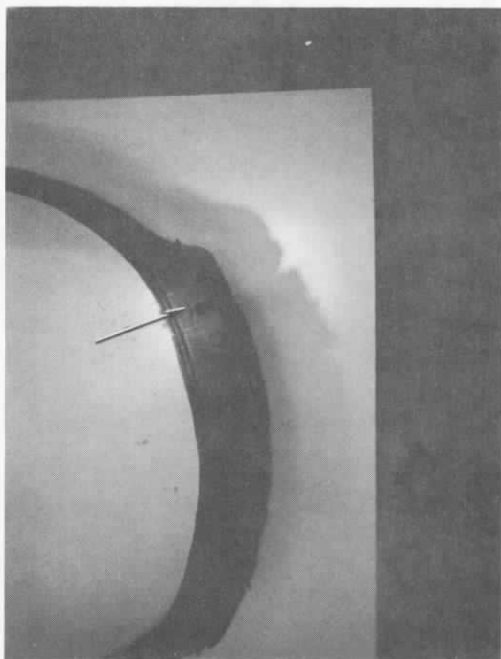
Figure 24. Section of a Tire (#ϕ1T6142) Carcass With a Tread Separation

Figure 24 shows a photograph of a section of a retreaded tire which has a separation at the junction of the new tread rubber and the old carcass rubber. This is a defect commonly found in failed retread tires. Figure 25 is an interferogram of that same portion of the tire. The arrow locates the position of the separation. Notice that the fringe signature of the separation contains only a few fringes. This is usually an indication that the separation is not near the surface exposed to holographic exposure.
