JRC2014-3824

**CRIPPLING TEST OF A BUDD M-1 PASSENGER RAILCAR:
TEST AND ANALYSIS RESULTS**

**Michael Carolan
Benjamin Perlman
David Tyrell**

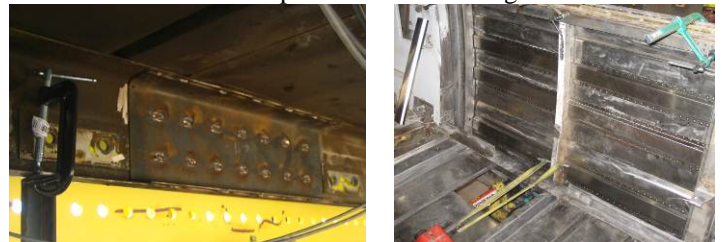
Prior to the current testing program, the M1 car was inspected by TTCL. Several areas of damage were identified, likely caused by the high-energy CEM impact test. Several repairs were made to the car prior to the first OVI test. These repairs included the installation of patches on the side sills over areas where cracks were found and the replacement of a patch of damaged sidewall with structure taken from another M1 car. Both of these repairs were made to the same area of the car, under the third window from the F-end. The replacement sidewall was only installed on the right side of the car, as only that side was damaged. Side sill patches were placed on both side sills in order to maintain a symmetric stiffness on both sides of the car. These repairs are shown in Figure 2.

Figure 2. Side Sill Patch (left) and Side Wall Patch (Right)

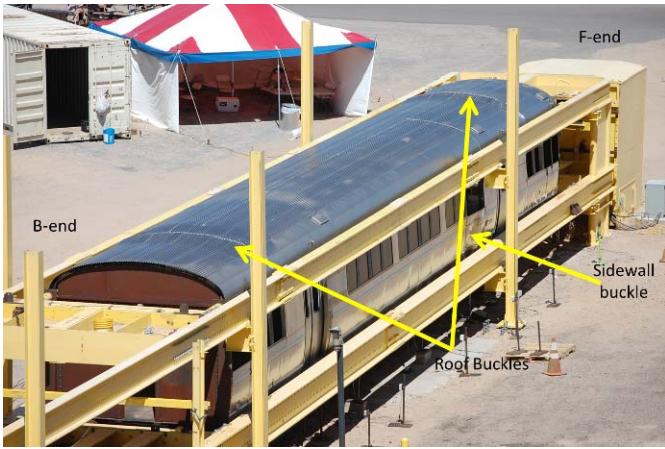
Prior to reaching the crippling load, the occupant volume experienced permanent deformation or buckling in several locations. The roof and roof rails buckled on both the F-end and B-end of the car. The center sill buckled toward the F-end of the car, while the side sills buckled at several locations along the length of the car on both the left and right sides. A post-test view of the buckled car within the test frame is shown in Figure 11.

Figure 11. Post-test Overhead View of Crippled Car

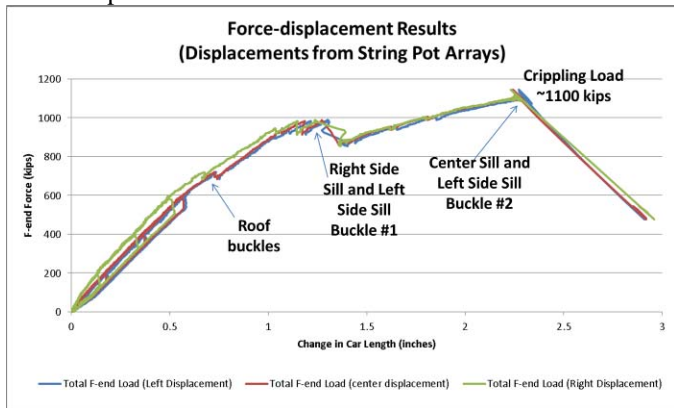
Figure 12. Force-displacement Characteristic from Test

Figure 12 includes annotations indicating the regions on the force-displacement characteristic where several buckling events occurred during the test. The timing of these events was ascertained through post-test review of the strain gage data. Post-test inspection of the car revealed several buckles to have occurred at or adjacent to strain gages. A detailed discussion of the sequence of buckling events is discussed later in this paper.

The crippling load of the M1 car in the test was approximately 1.1 million pounds. During the previous testing program, two Budd Pioneer passenger railcars were loaded to crippling using a similar test setup as the M1 test [5]. In that program, the cars buckled at 1.15 and 1.2 million pounds,

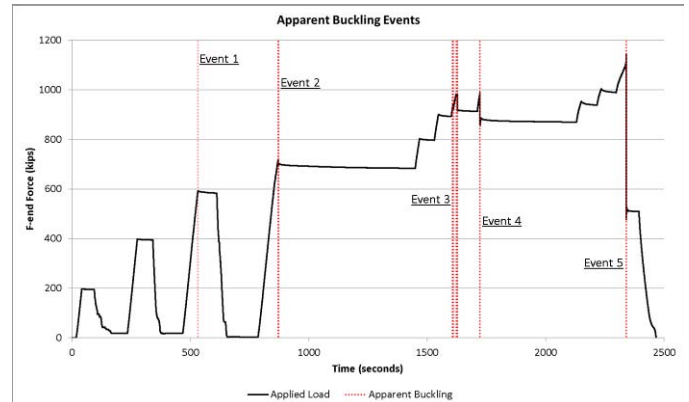
Figure 19 is a plot of the total applied force versus time over the entire load sequence during the physical test. A series of vertical lines have been added at the times corresponding to strain gage readings that indicated one or more members was experiencing buckling. Based upon the strain gage measurements, five buckling events have been identified during the loading sequence. These events have been correlated with damage noted from the post-test visual inspection of the car. From this figure, it is apparent that for events 2-4 the buckling event corresponded to a measurable drop in the total applied load.

Figure 19. Force-time History for Test with Buckling Events Indicated

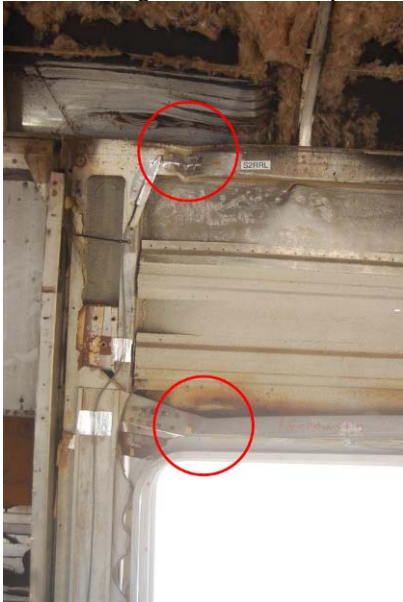
The first apparent buckling event was indicated by the strain gage on the left roof rail at cross-section 2. This is the location closest to the left roof loading location on the F-end of the car. This buckling event occurs at nearly the time when the test was paused at 600 kips, as seen in Figure 19. Because the car was subsequently unloaded, there was no immediate drop in load associated with this buckling. However, when loading resumed, the load path into the car was altered, as this location had begun to buckle. Figure 20 shows a post-test image of this

damage. This figure also shows damage to the upper window rail at the same cross-section of the car. The upper window rail was noted as having pre-existing damage, which may have contributed to the buckling behavior at this particular location.

Figure 20. Damage to Cross-section 2 Left Roof and Upper Window Rails

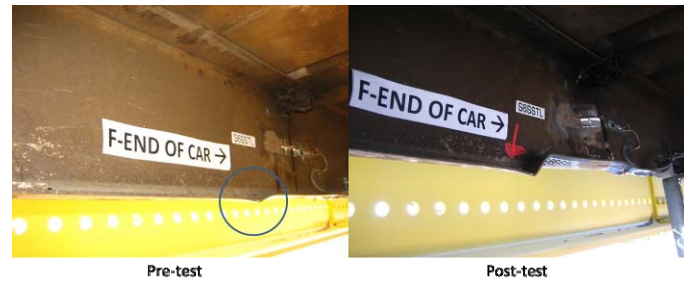
Following the third buckling event, the load began to rise as the F-end displacement was increased. The total applied load had increased to approximately 975 kips for the second time when the fourth buckling event occurred. At this time, the flange of the right side sill and flange of the left side sill buckled. The left side sill's flange buckled adjacent to an area of its web that had buckled during event 3. Figure 21 shows a pre- and post-test view of this area with the existing damage noted in the left-hand image. From the post-test photo, it is apparent that this pre-existing damage has spread during the

test, i.e. the existing damage served as an initiation site for further buckling during the test.

Figure 21. Cross-section 6 Left Side Sill Pre-test (Left) and Post-test (Right) Damage

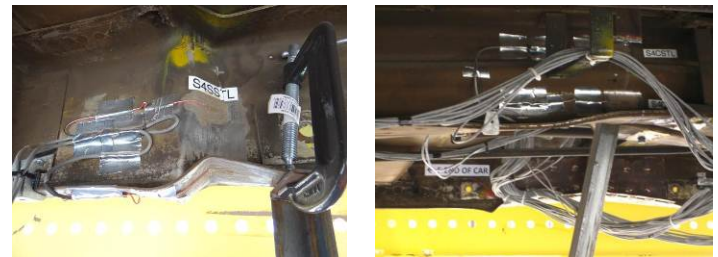
Following buckling event 4, the test was paused while the car was photographed and the instrumentation readings were examined. The load was then increased until the carbody completely crippled at a time of approximately 2340 seconds. At this time, the left side sill and the center sill experienced a near-simultaneous failure. The area of the left side sill that failed was adjacent to the region of the center sill that buckled. Both of these regions were remote from the region of left side sill that had previously buckled. This indicates that even though the left side sill had already buckled toward the B-end of the car, the side sill at the F-end of the car was still part of the load path from the F-end to the B-end. Figure 22 shows the buckled left side sill and the buckled center sill following the test.

Figure 22. Buckling to Left Side Sill (Left) and Center Sill (Right) During Event 5
