# **Seismic Damage Assessment of Rail Structures in Japan after the January 1995 Kobe Earthquake**

**Parsons Brinckerhoff Quade & Douglas, Inc.  
San Francisco, California**

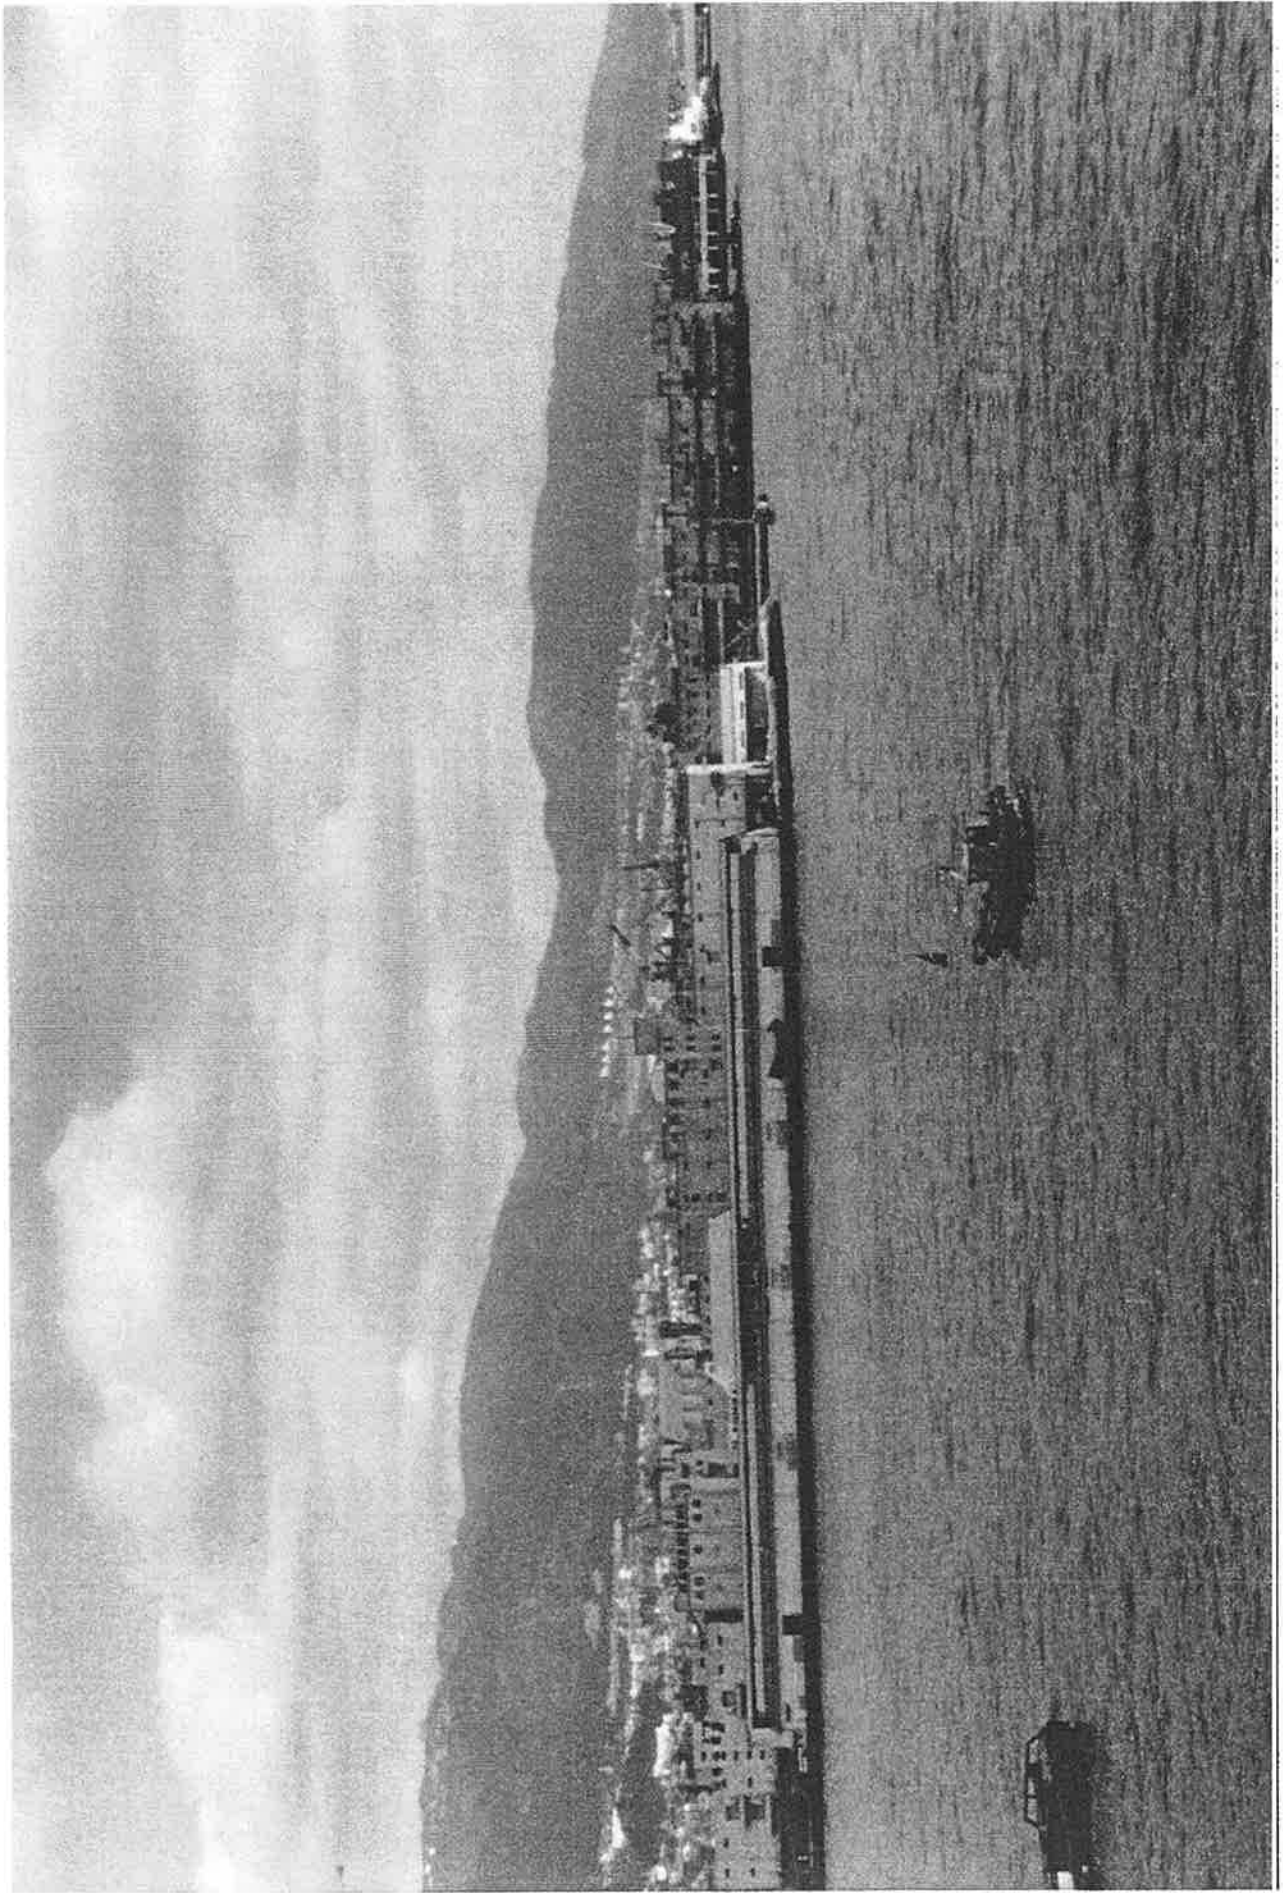
*Eastern Kobe waterfront towards Nada-ku; Much of the damage was just beyond the port facilities.*

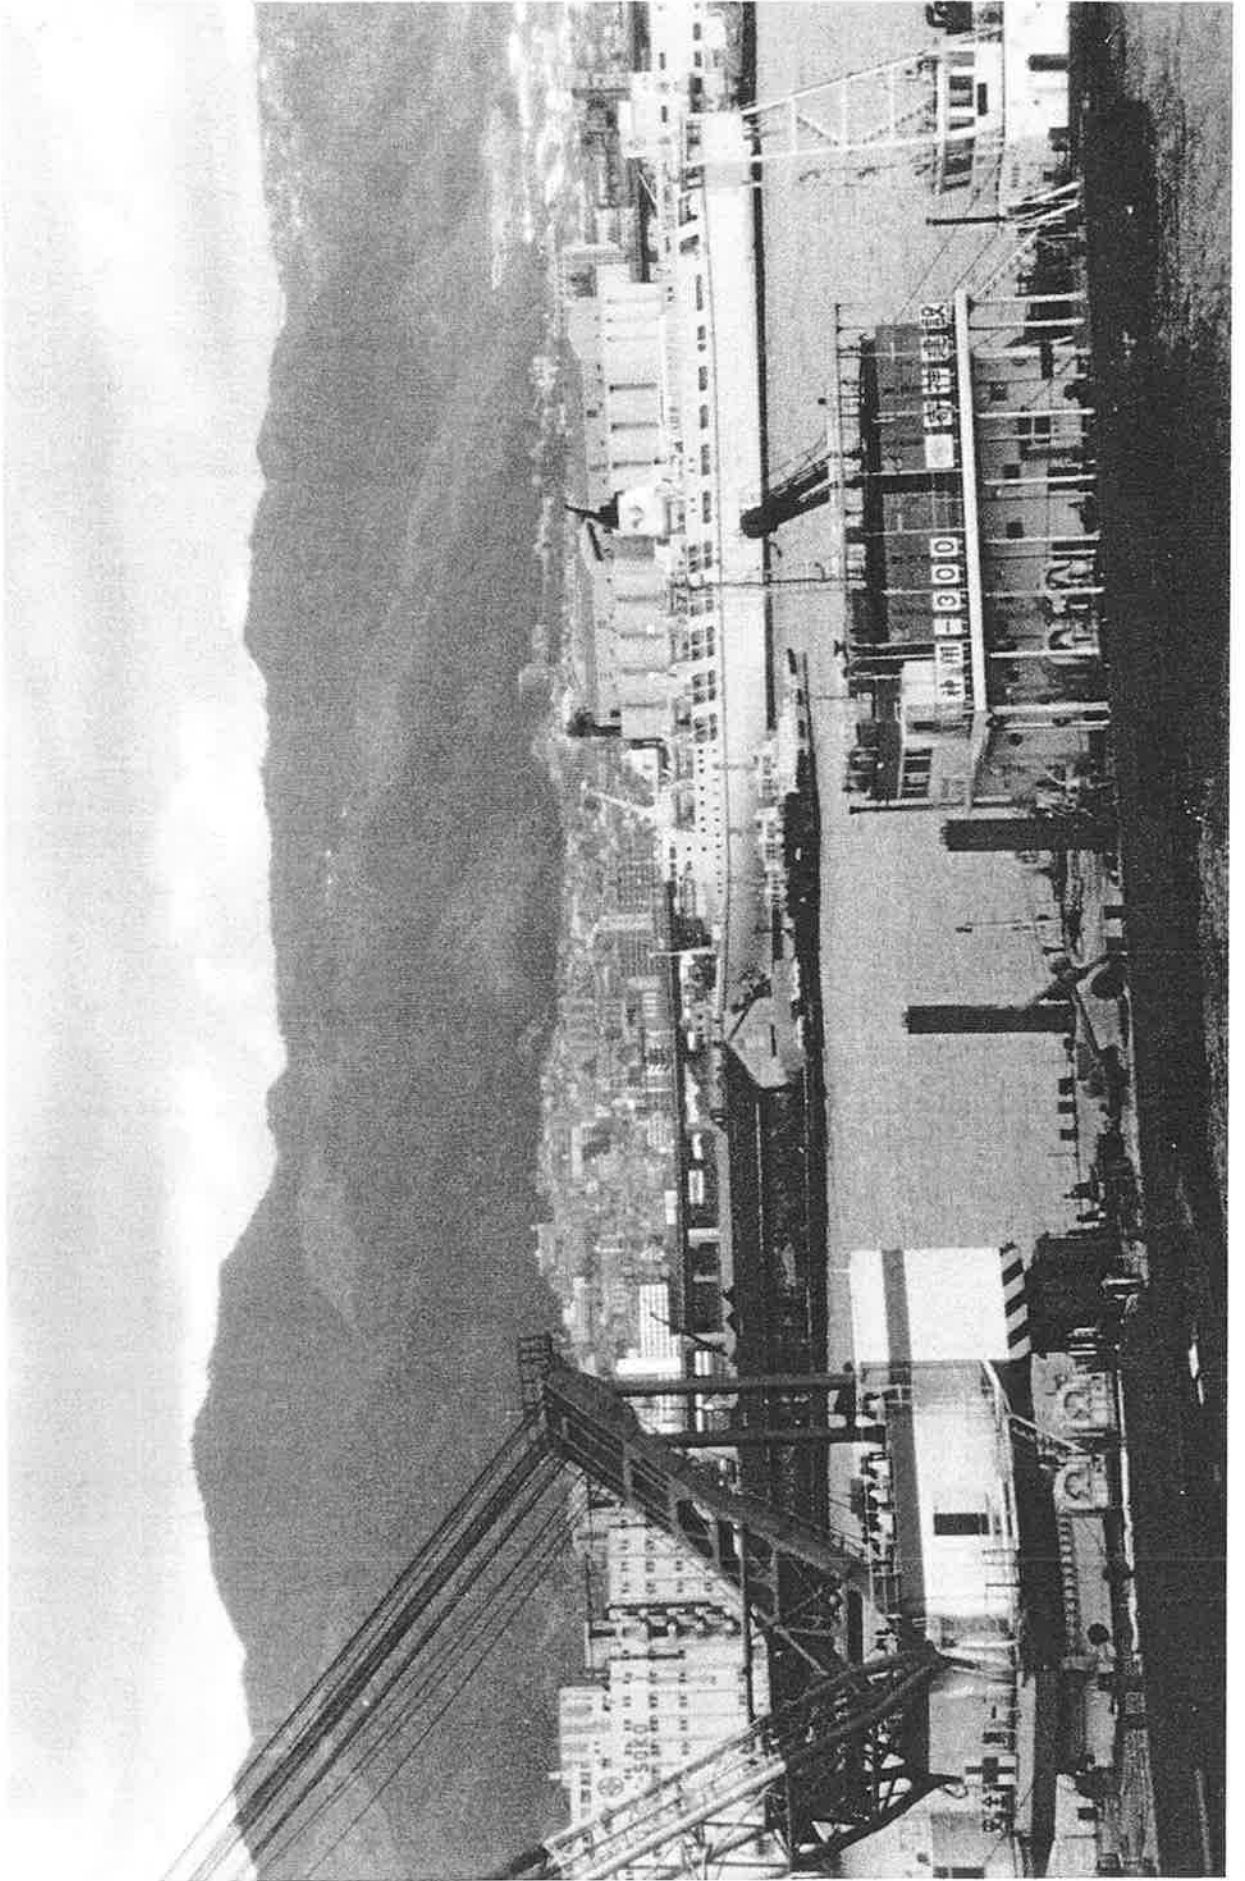
*The eastern portion of central Kobe seen from the waterfront to the hills. The rugged hills are a national park, hence all rail lines pass through this narrow corridor. The barge in the foreground is for repairing some port facilities.*

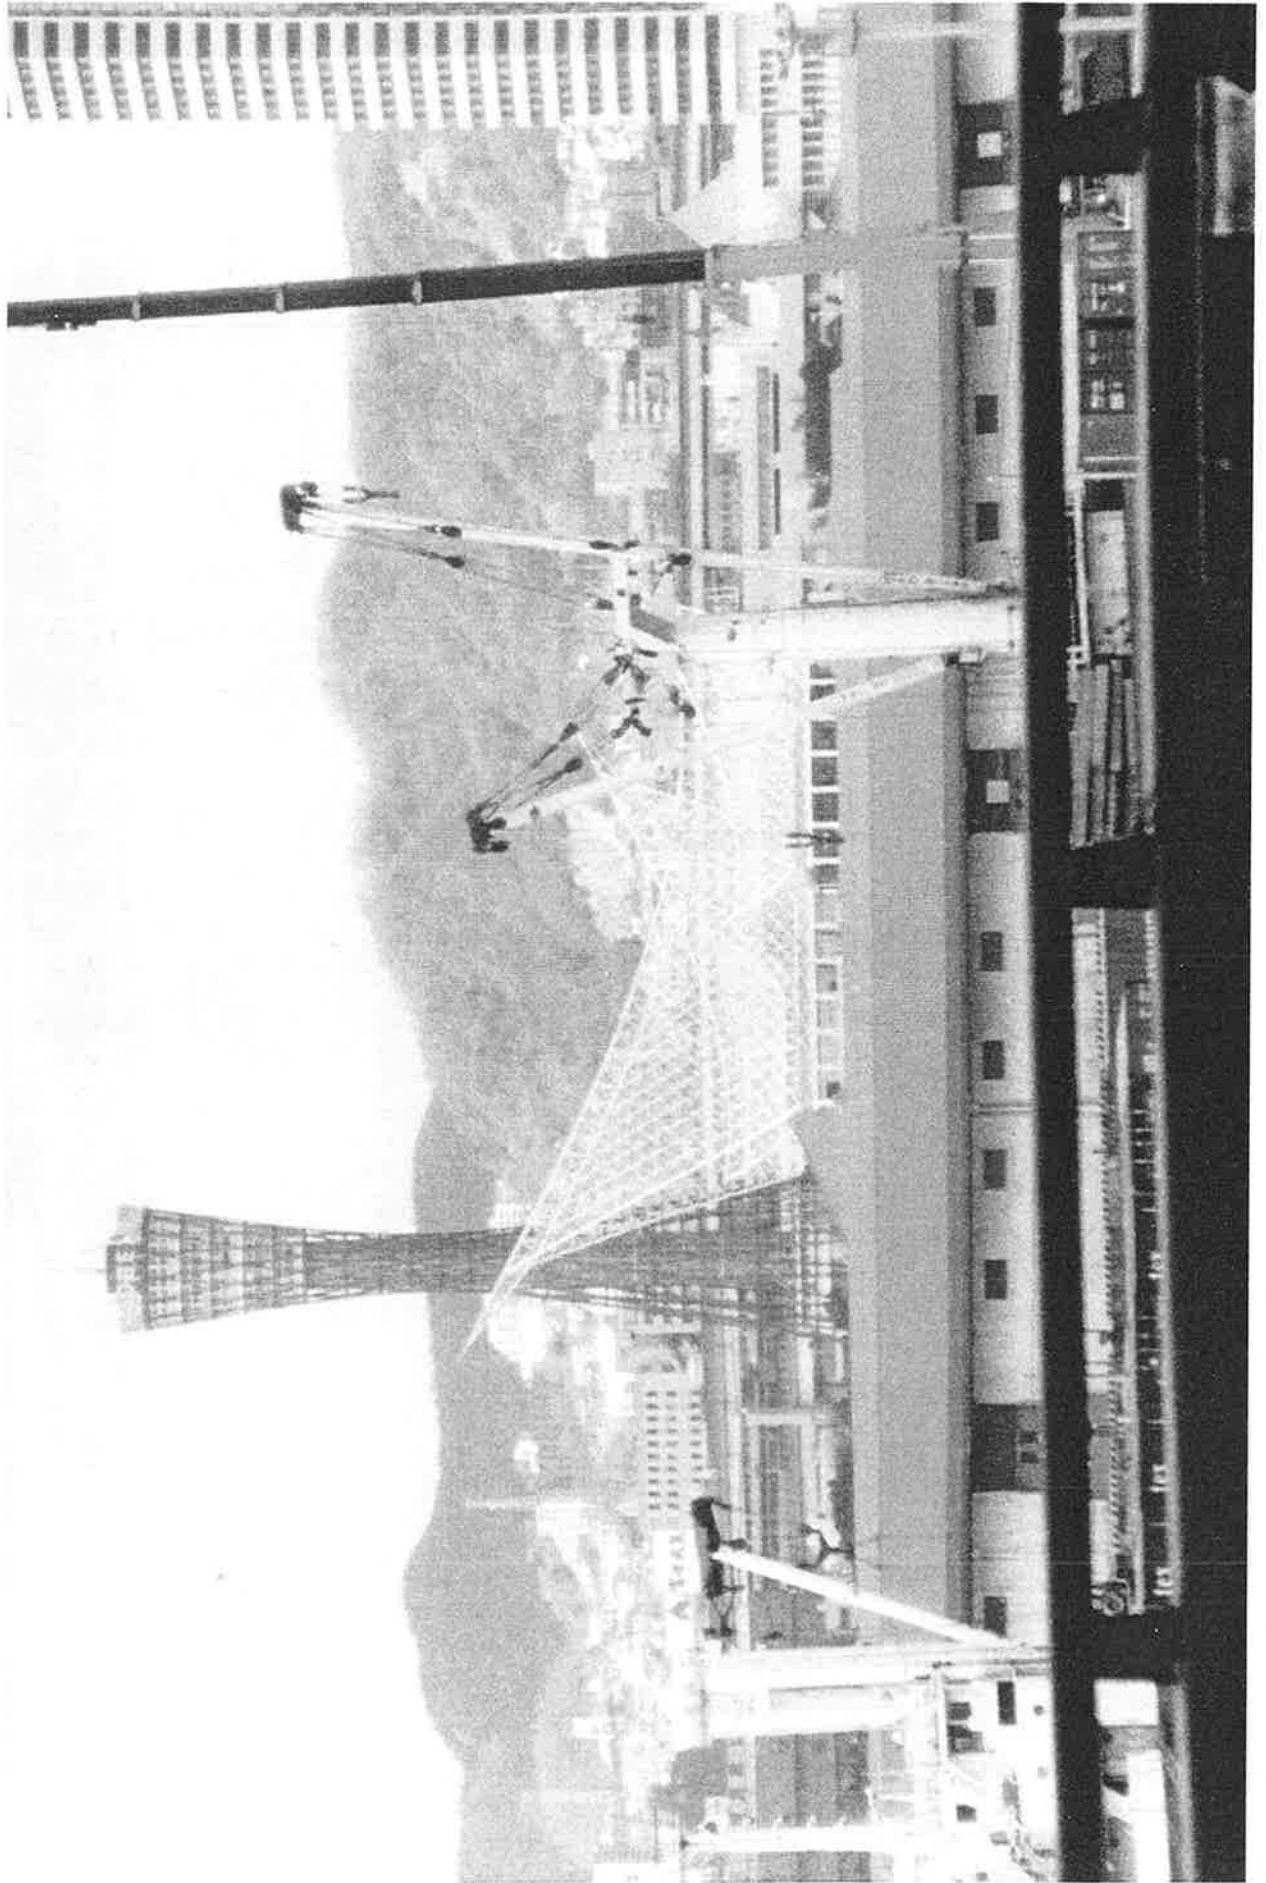
*Western Kobe towards Hyogo-ku; The tower is visible from Daikai-dori Station.*

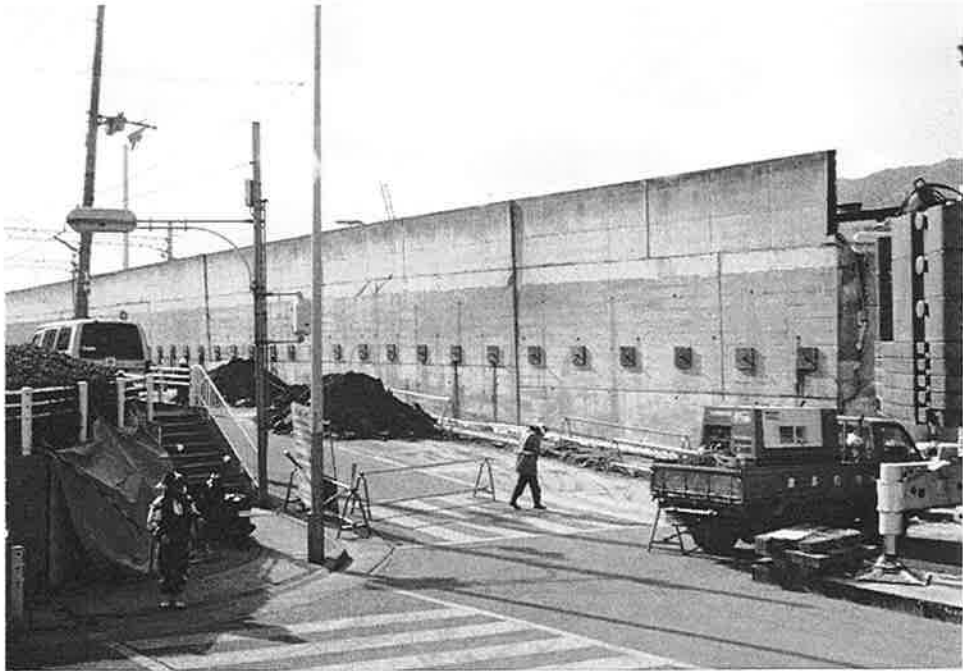
*JRT-1. This retaining wall supporting about 4 meters of fill failed, over a length of 300-400 meters.*

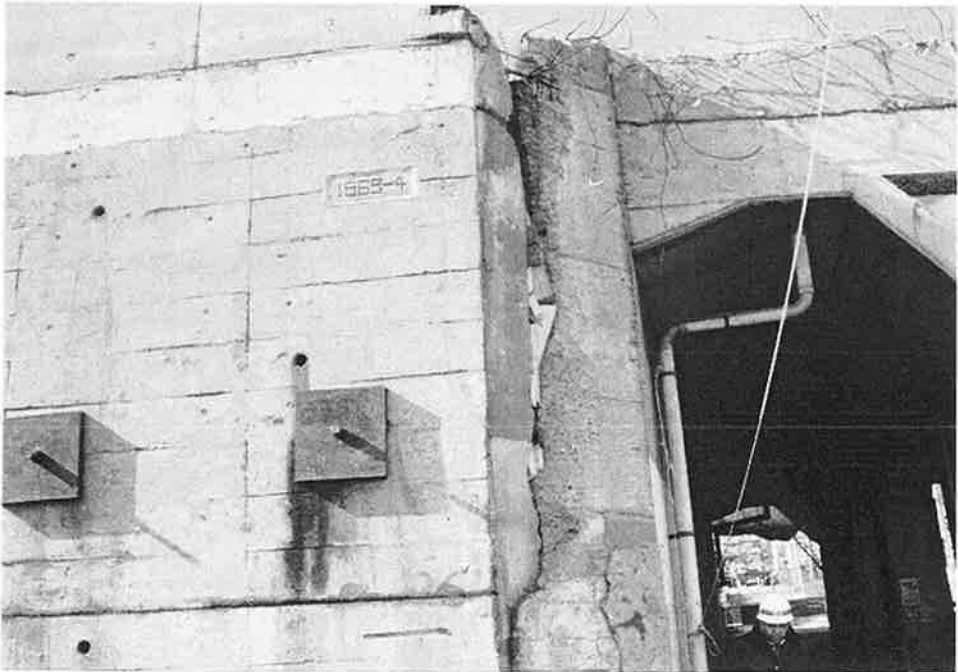
*JRT-2. The failed retaining wall opened at this abutment.*

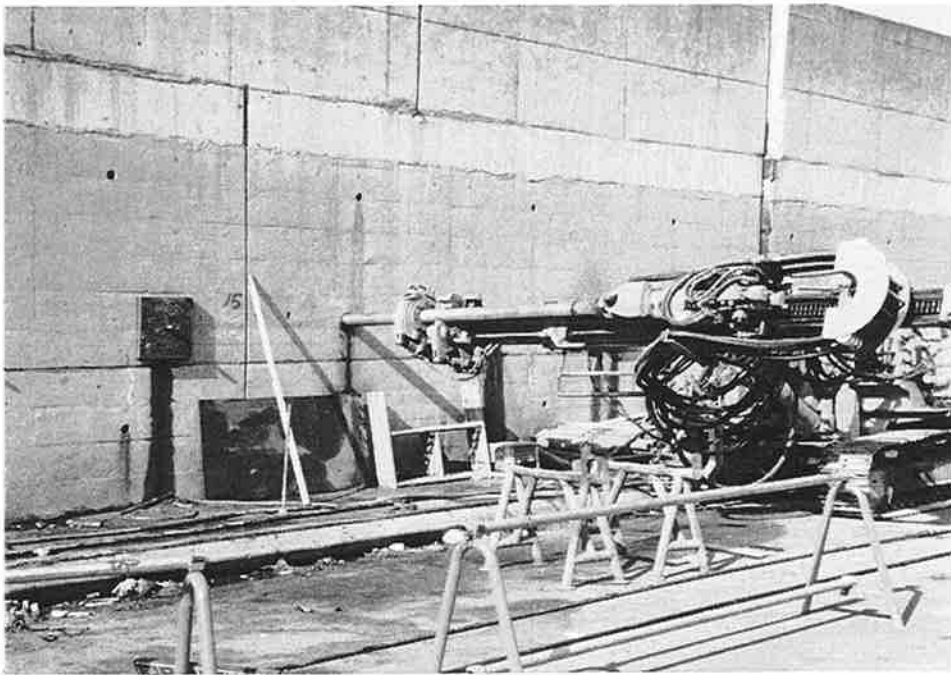
*JRT-7. The retaining walls are being repaired by coring through the wall, the embankment and the wall on the opposing side and installing high strength bars through the cored hole..*

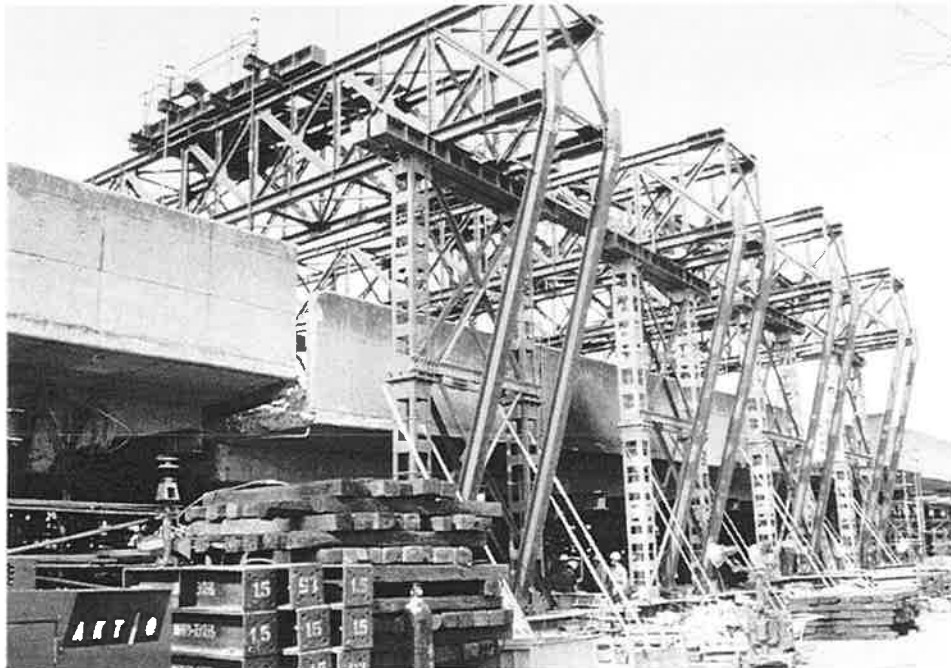
*JRT-8. This section of superstructure is being jacked into place with these jacking towers.*

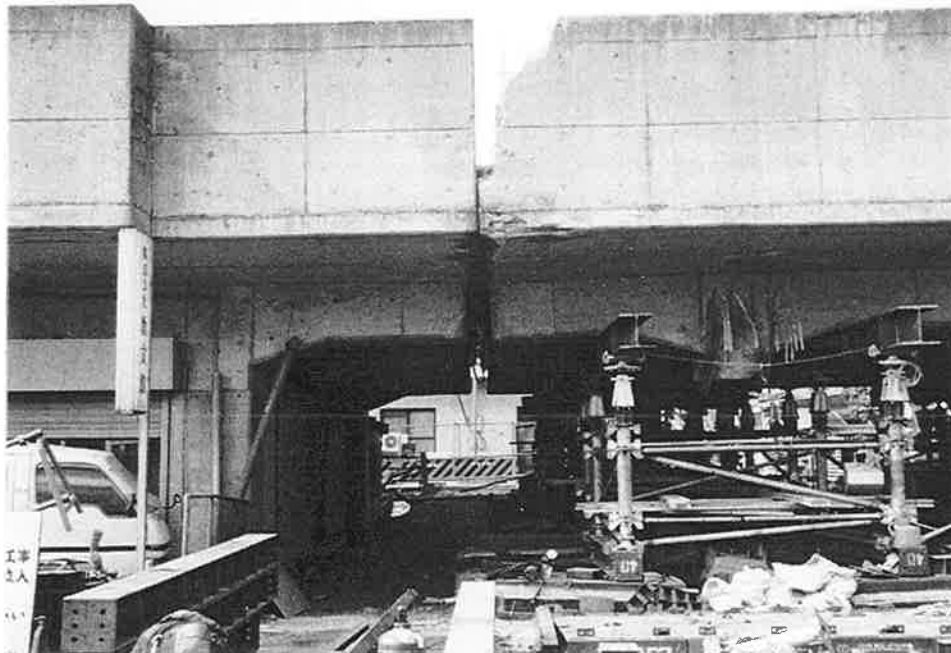
*JRT-14. A typical expansion joint at mid span. The frame on the right was severely damaged.*

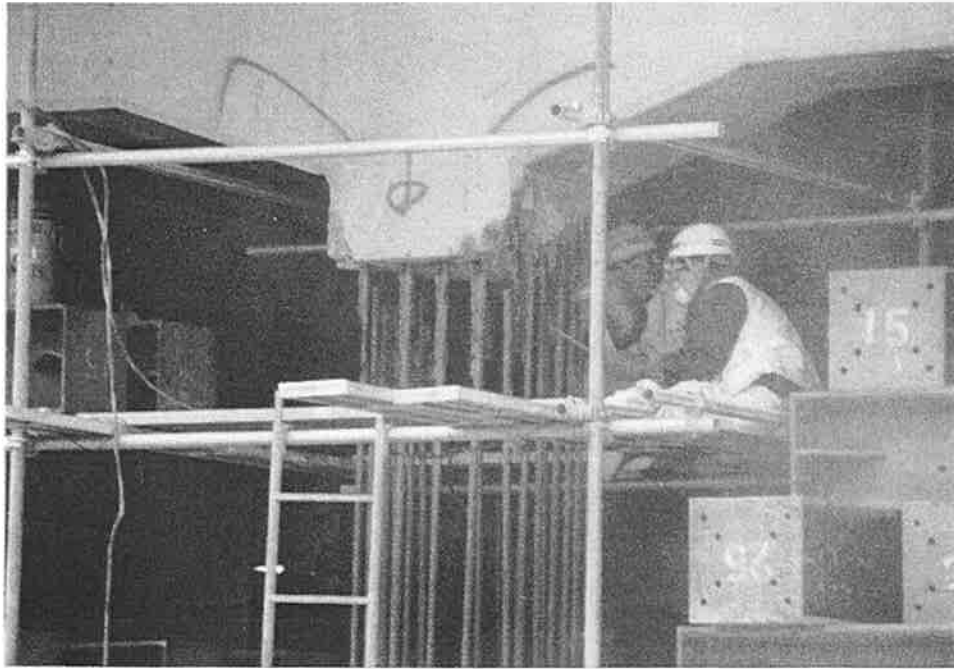
*JRT-17. New column reinforcing is being welded to existing bars to repair damaged columns.*

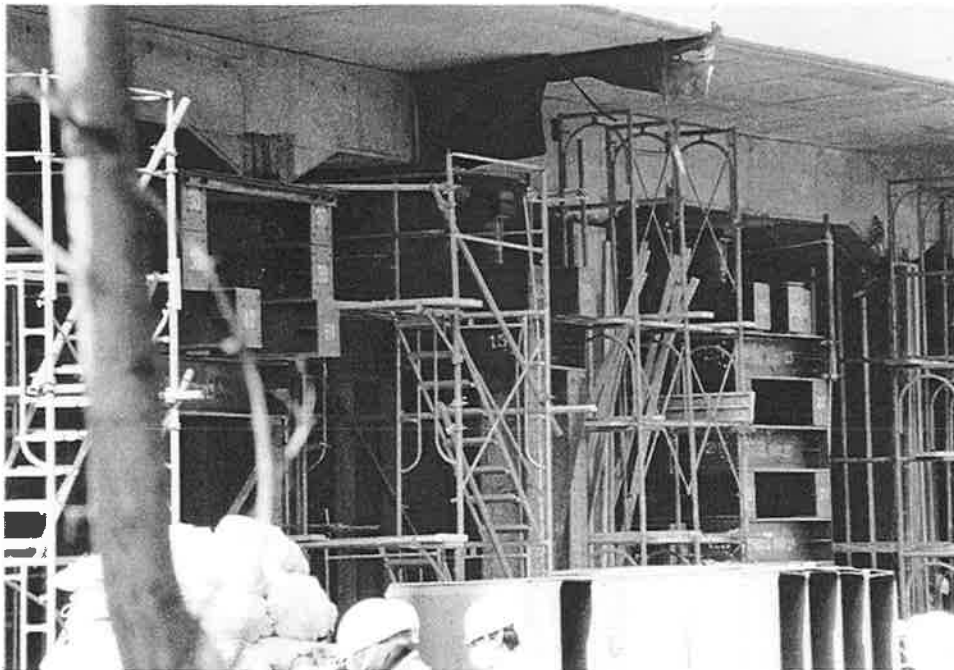
*JRT-18. Temporary supports under the viaduct while columns are replaced.*

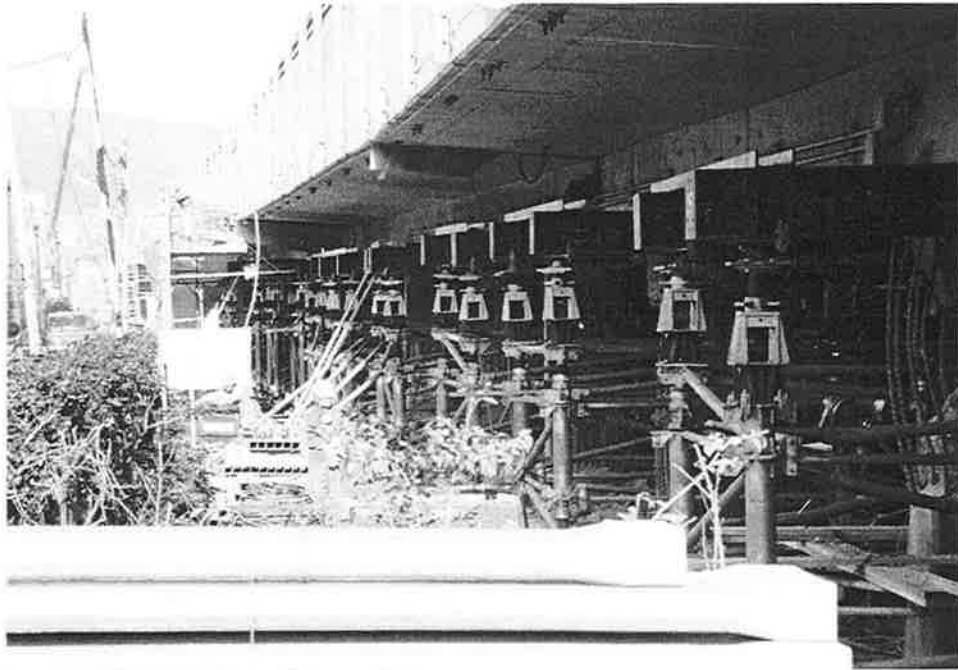
*JRT-23. Length of viaduct supported for repair.*

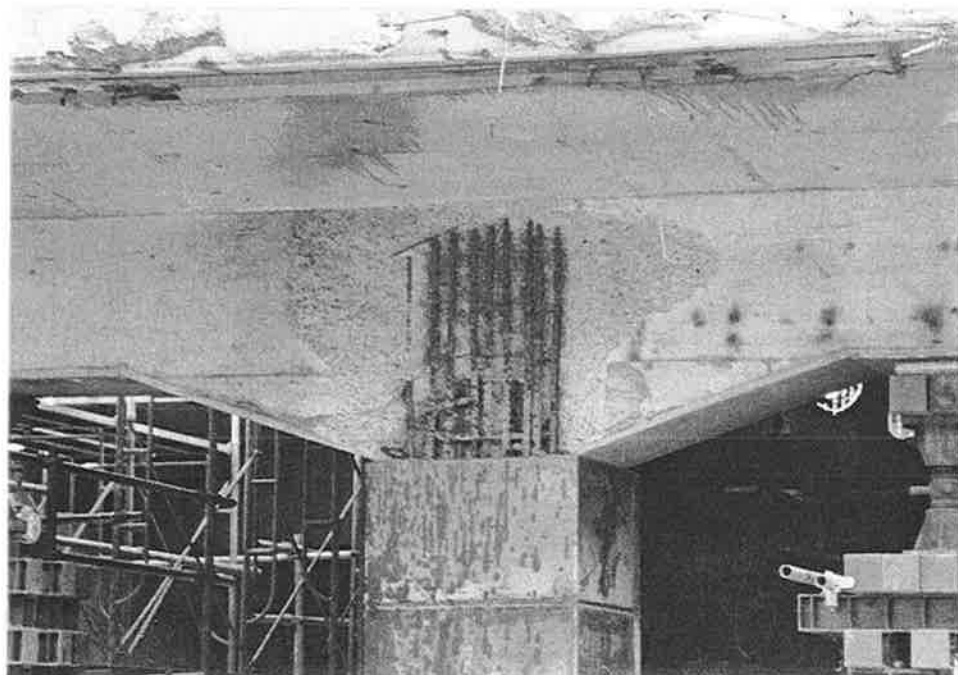
*JRT-24. The square steel plate jacket extends to the top of column. The column bars are exposed through the joint to the termination.*

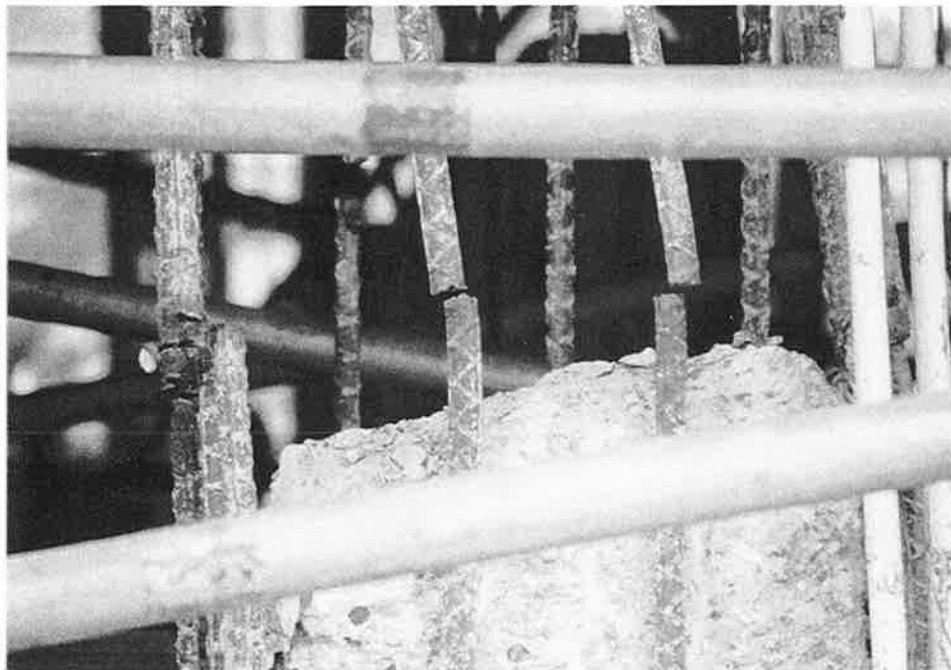
*JRT-26. The center two column bars (transverse) appear ruptured while the left side (longitudinal) bars appear to have been flame cut.*

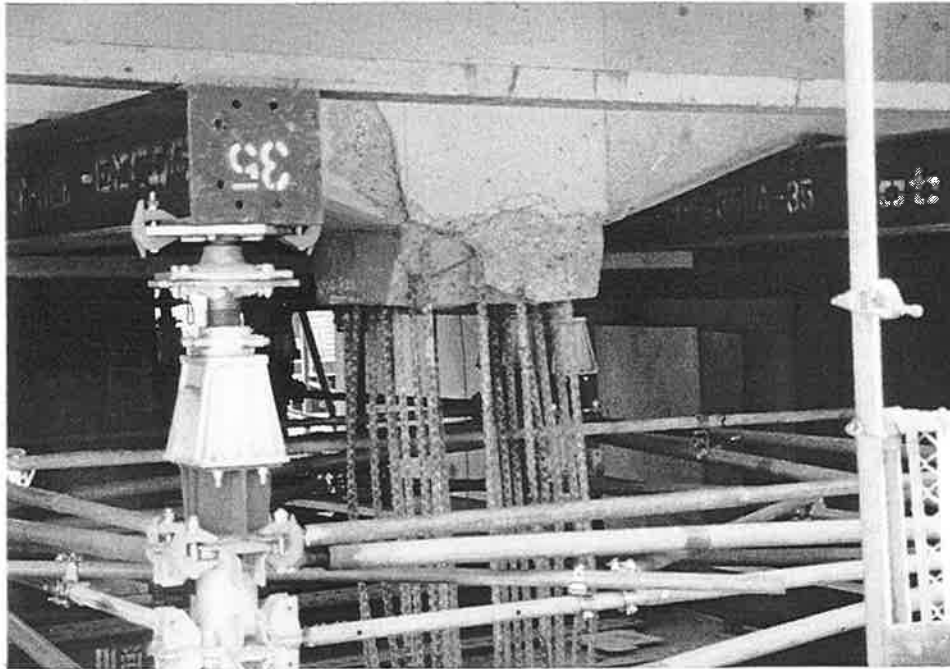
*JRT-27. These existing column rebars are being used in the repair.*

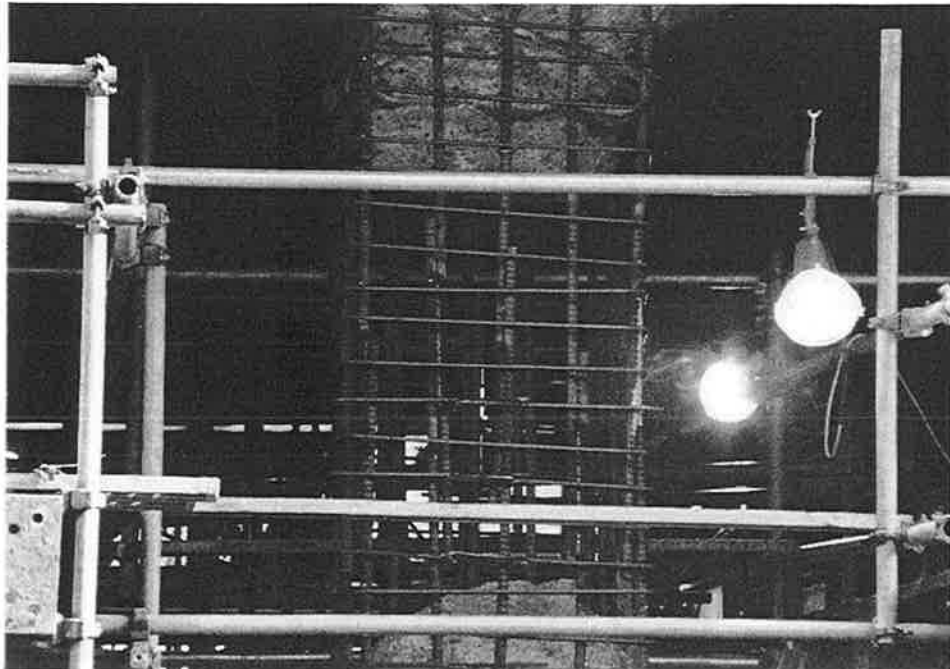
*JRT-28. Typical column repair. Note the tie spacing, splices and lack of cross ties.*

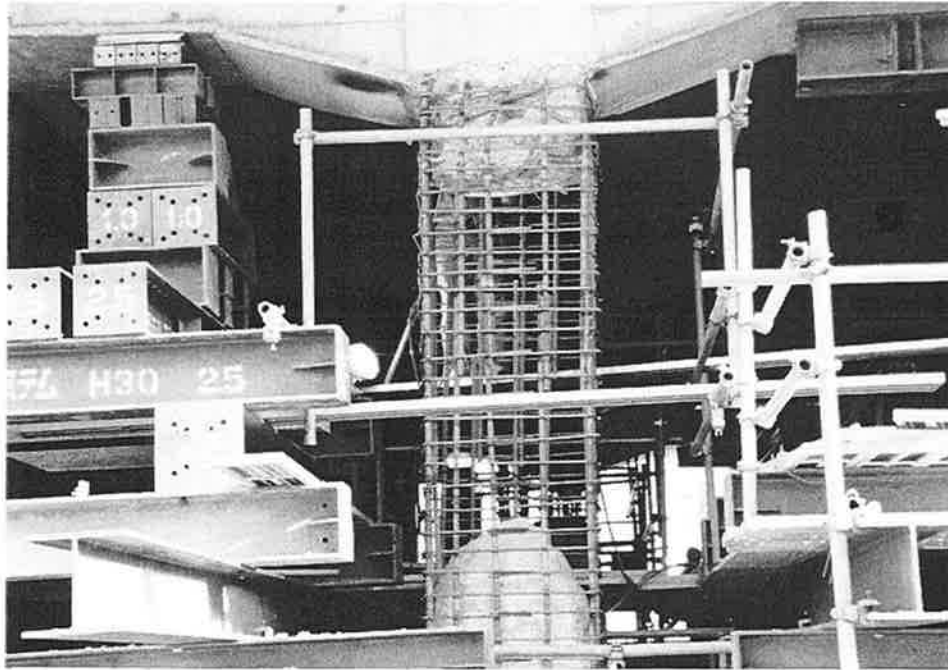
*JRT-29. Typical column repair. Note the typical supports using steel sections as cribbing.*

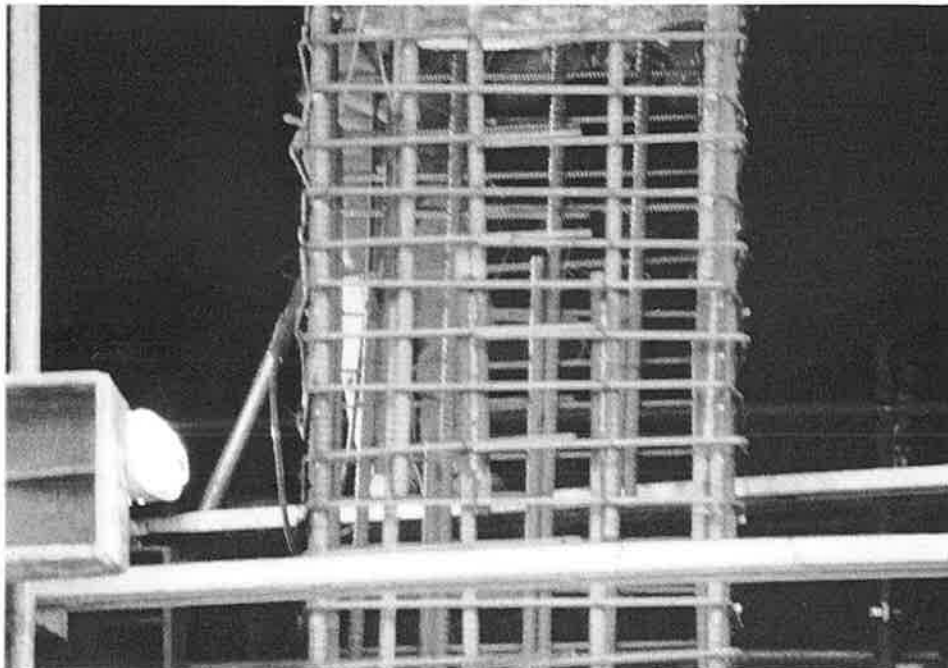
*JRT-30. Close up of reinforced column. Note the main bar splices and the tie splices.*

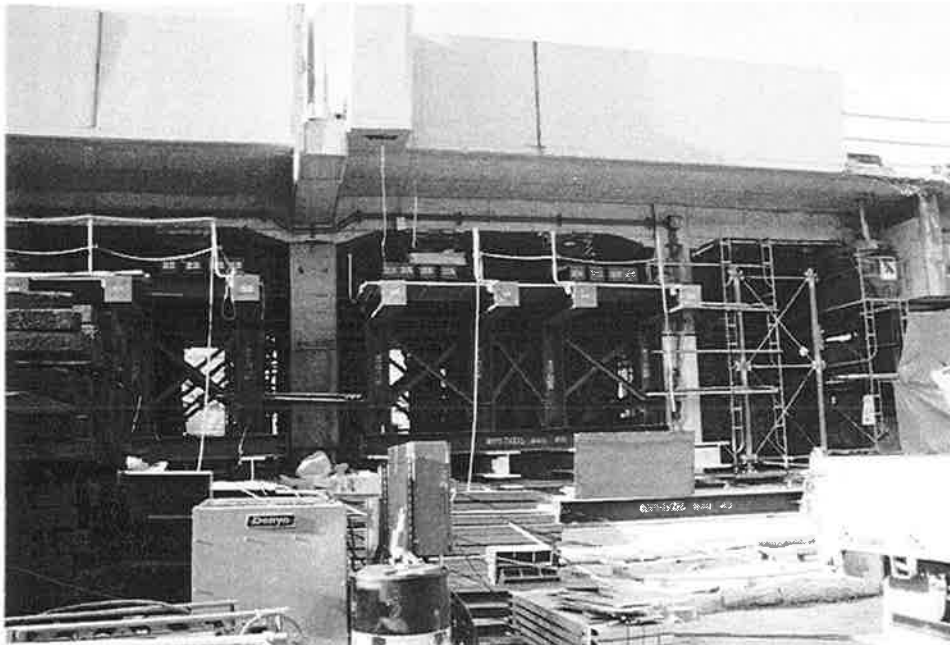
*JRT-36. More temporary supports and steel plate jacket repair.*

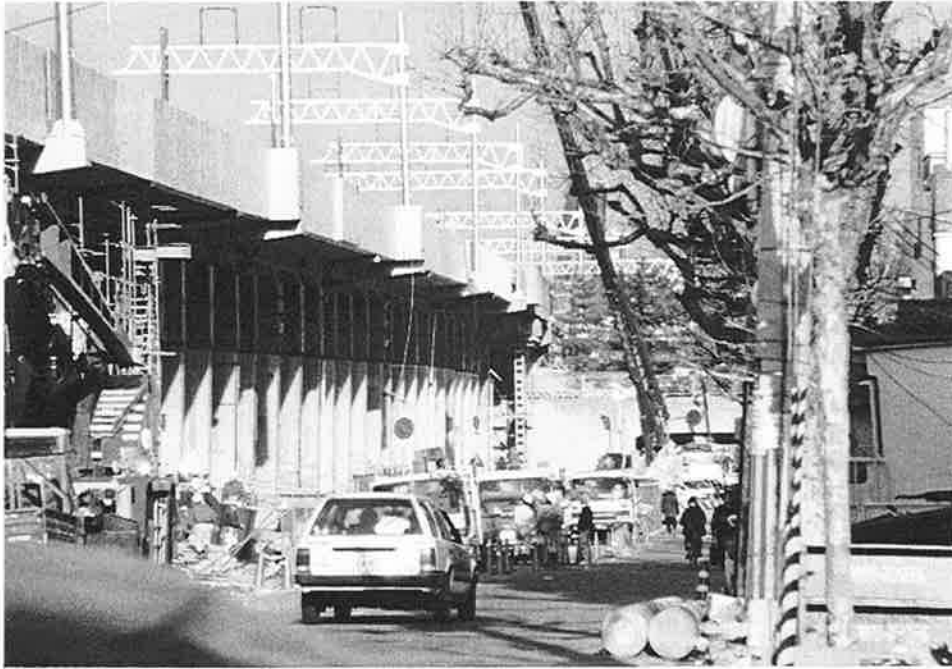
*JRT-37. Steel jacket repairs at the tops of the columns.*

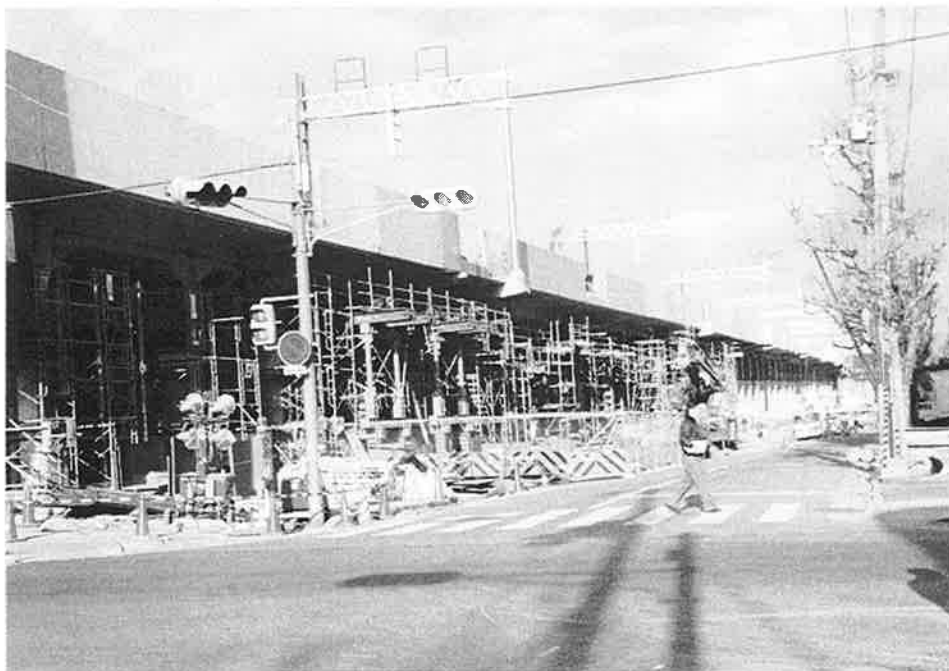
*JRT-38. Much more of the viaduct under repair.*

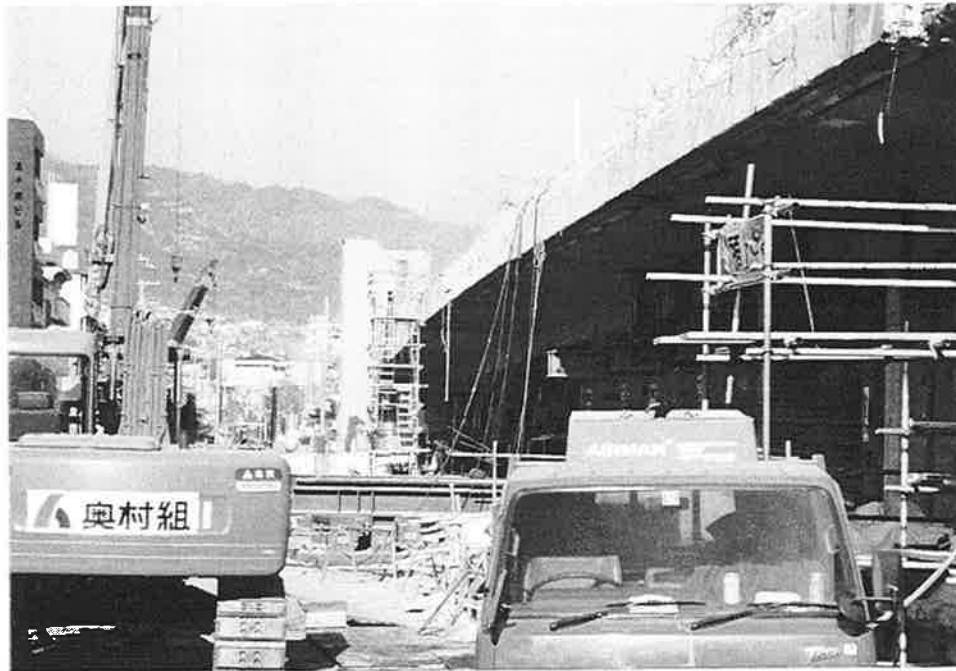
JRT-43. Viaduct under repair for more hundreds of meters.

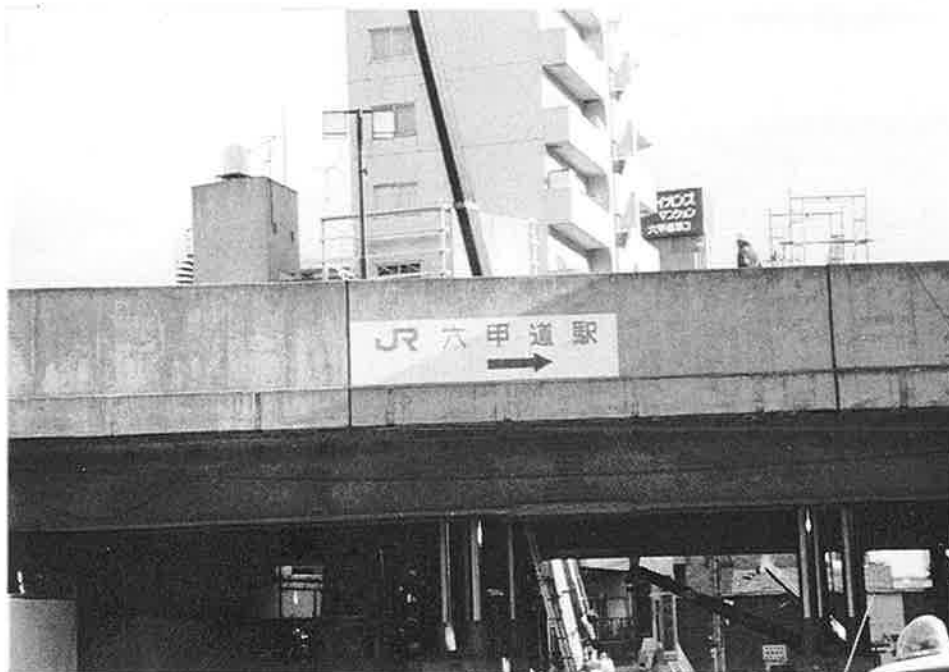
JRT-44. Sign at Rocomichi Station.

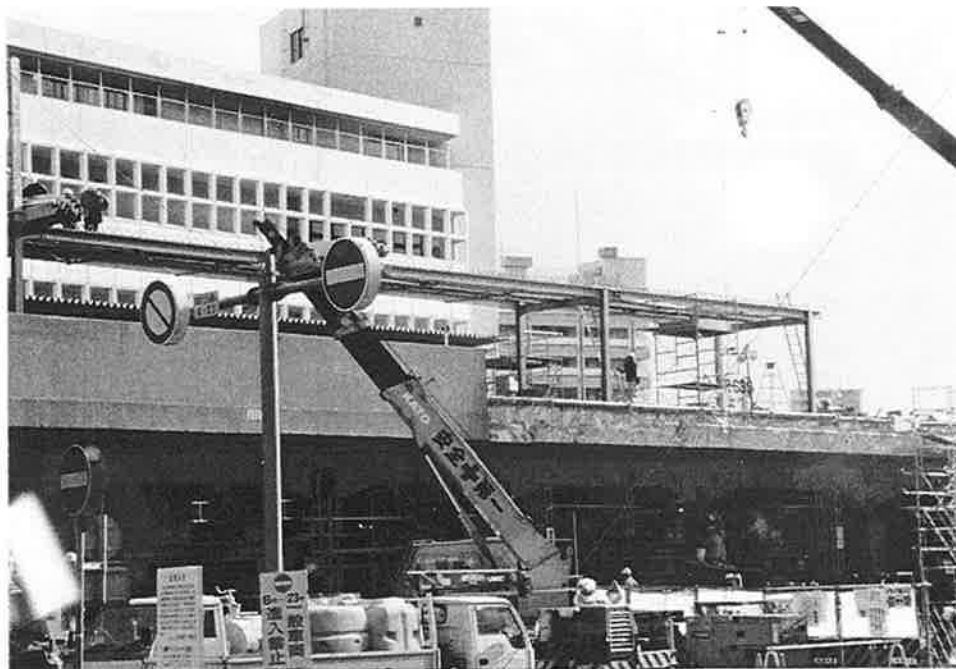
*JRT-45. Rokkomichi Station replacement.*

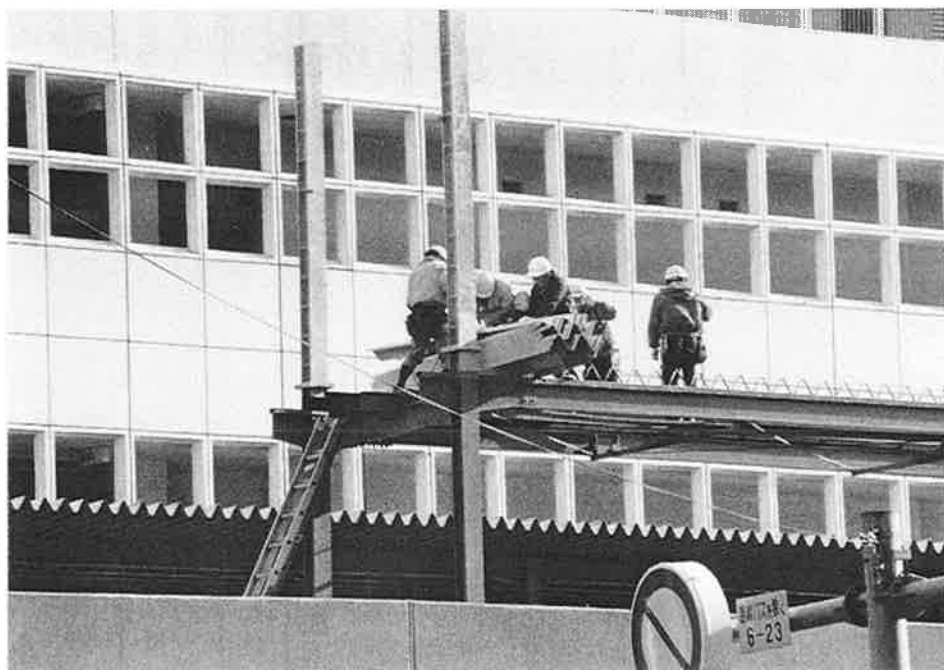
*JRT-46. Construction of the new platform for Rokkomichi Station.*

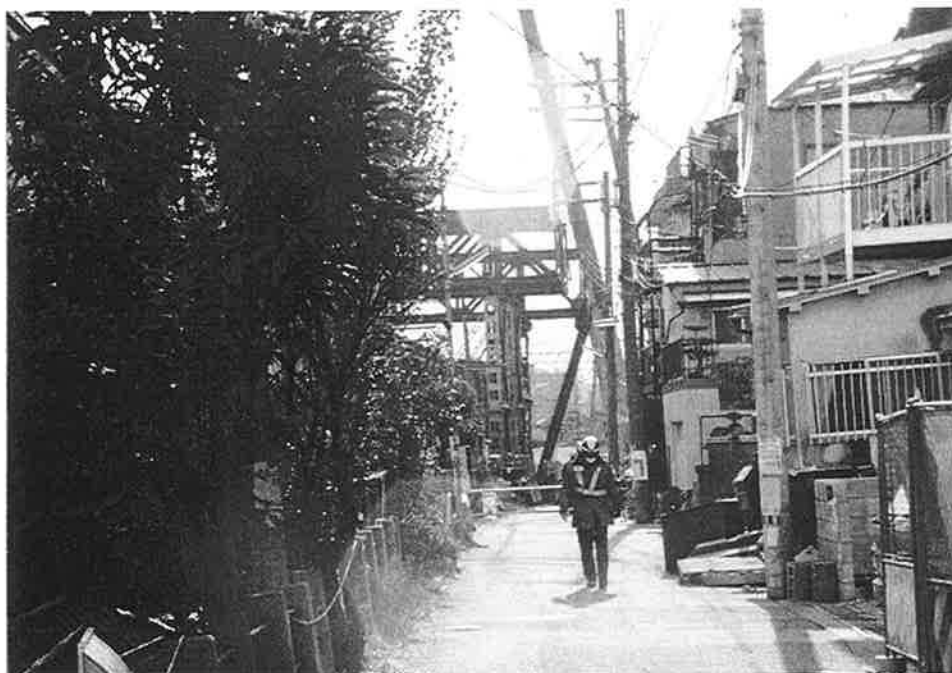
***JRT-47. Housing adjacent to the viaduct was damaged but still standing. The viaduct partially collapsed in this area. Note the jacking frames in the background.***

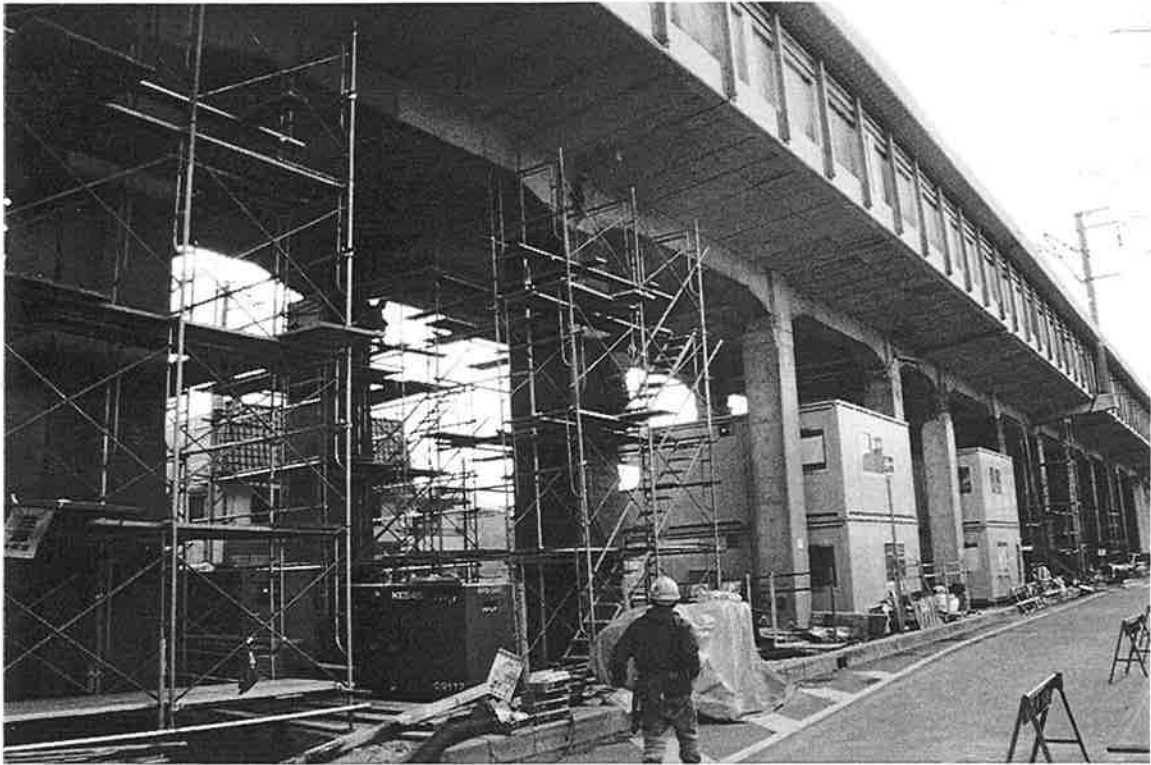
*JRS-1. Many consecutive columns were damaged.*
