# **Seismic Damage Assessment of Rail Structures in Japan after the January 1995 Kobe Earthquake**

**Parsons Brinckerhoff Quade & Douglas, Inc.  
San Francisco, California**

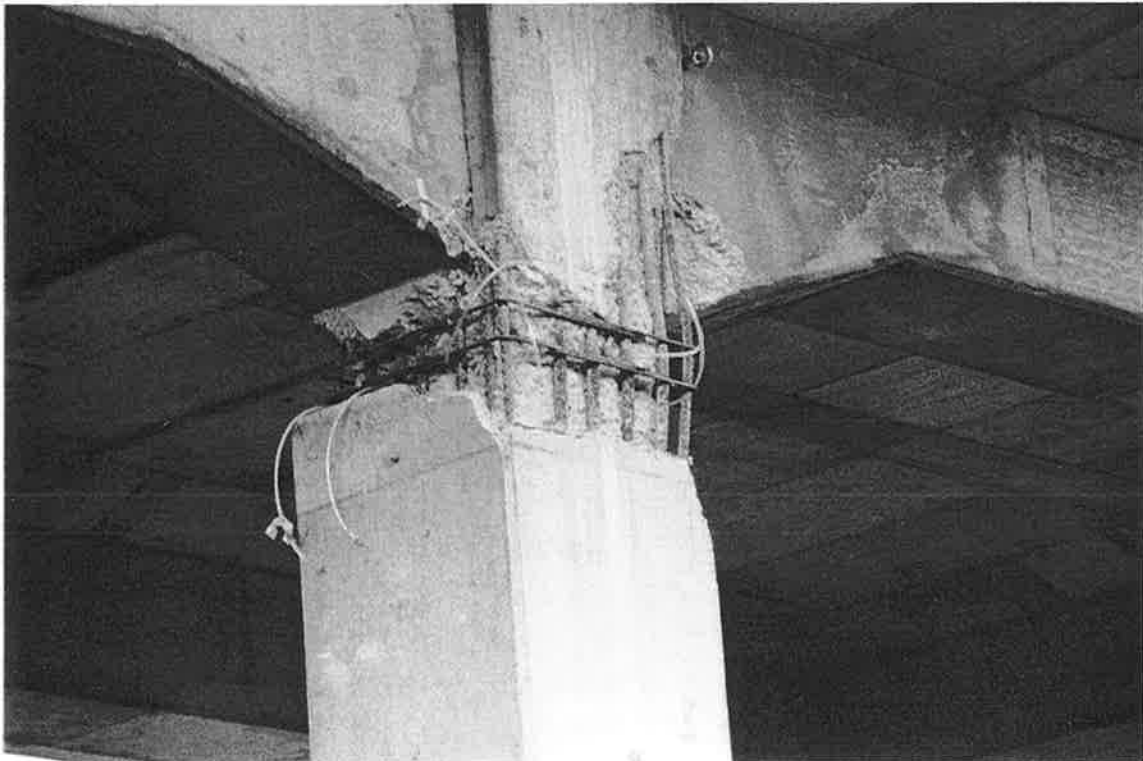
*JRS-2. Another column damaged and grouted*

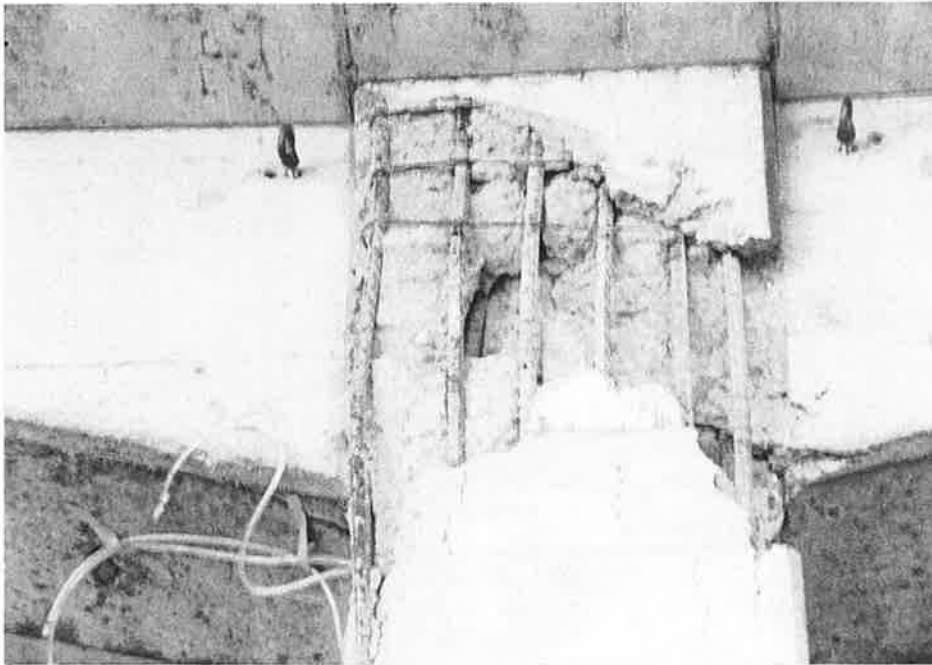
*JRS-3. Another failed top of column and joint zone*

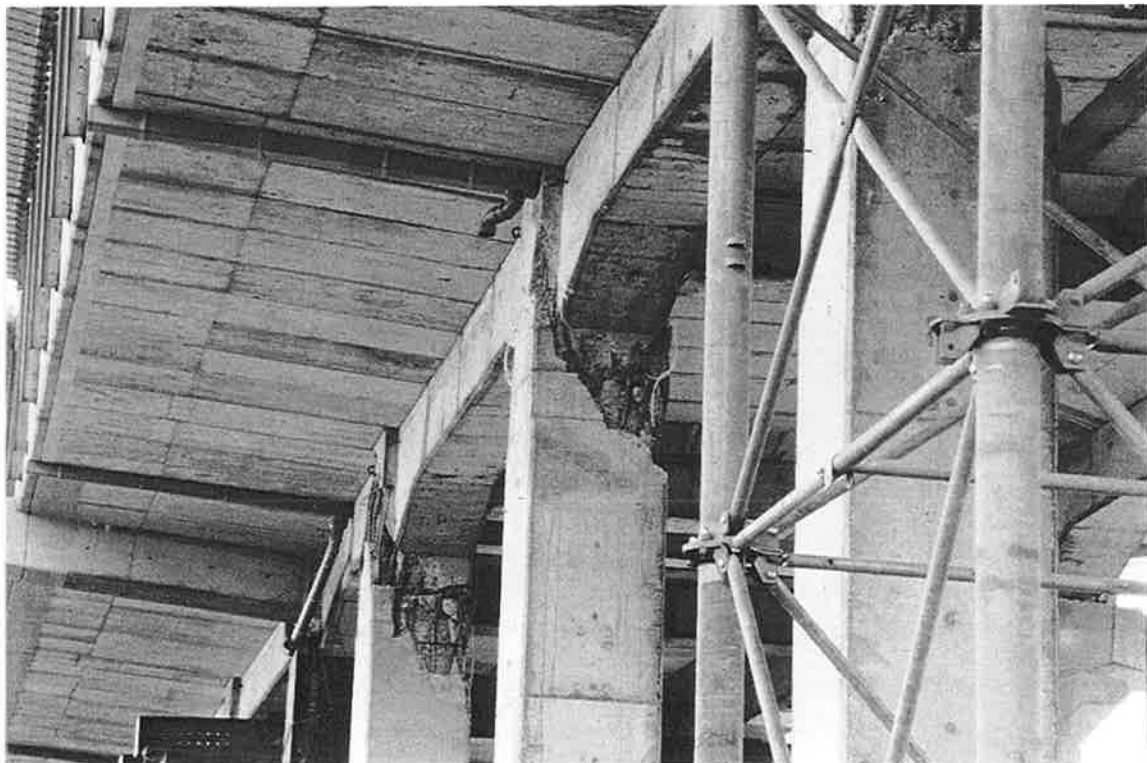
*JRS-4. These columns show primarily transverse damage, but also some horizontal spalling.*

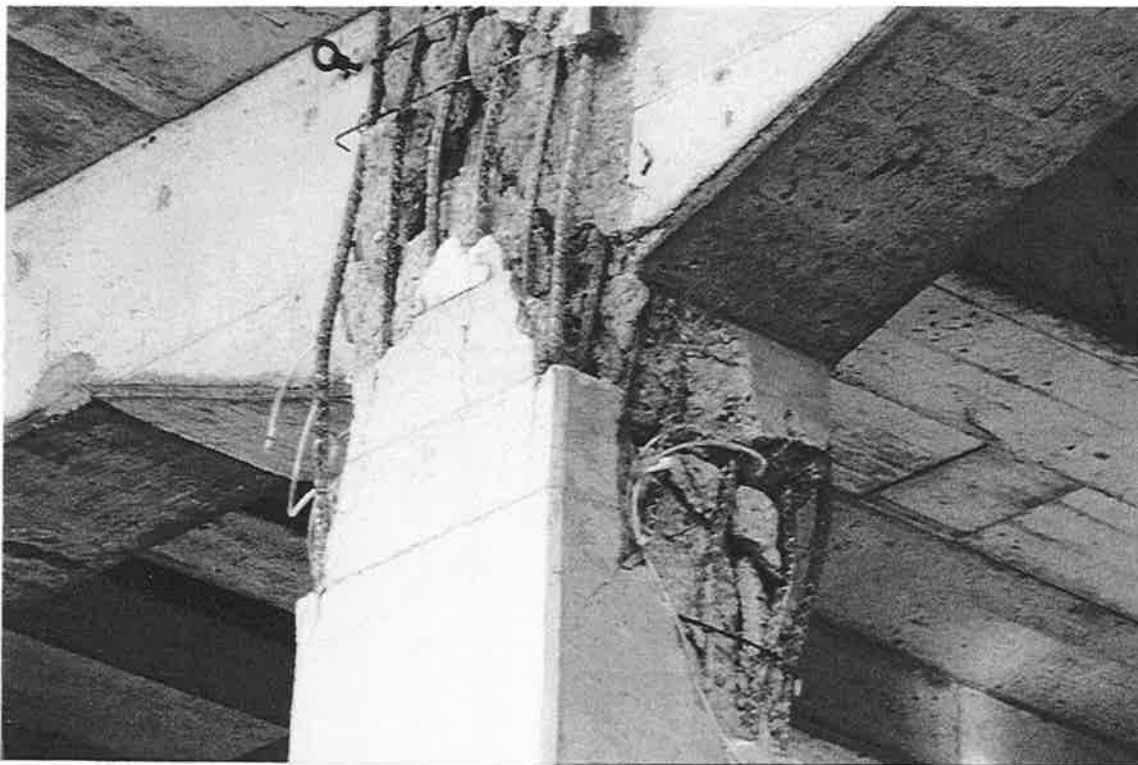
*JRS-5. Column very close to collapse with diagonal cracks through the joint zone and ties ruptured; the joint is badly deteriorated.*

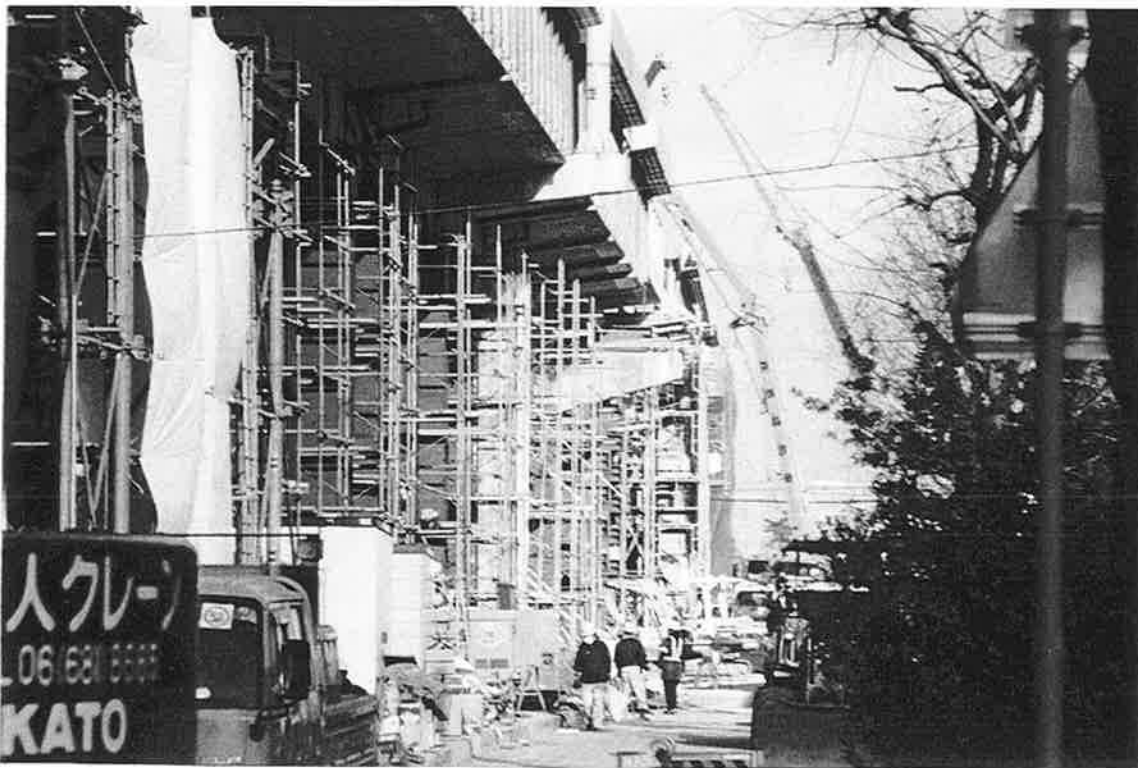
*JRS-6. A long section under repair*

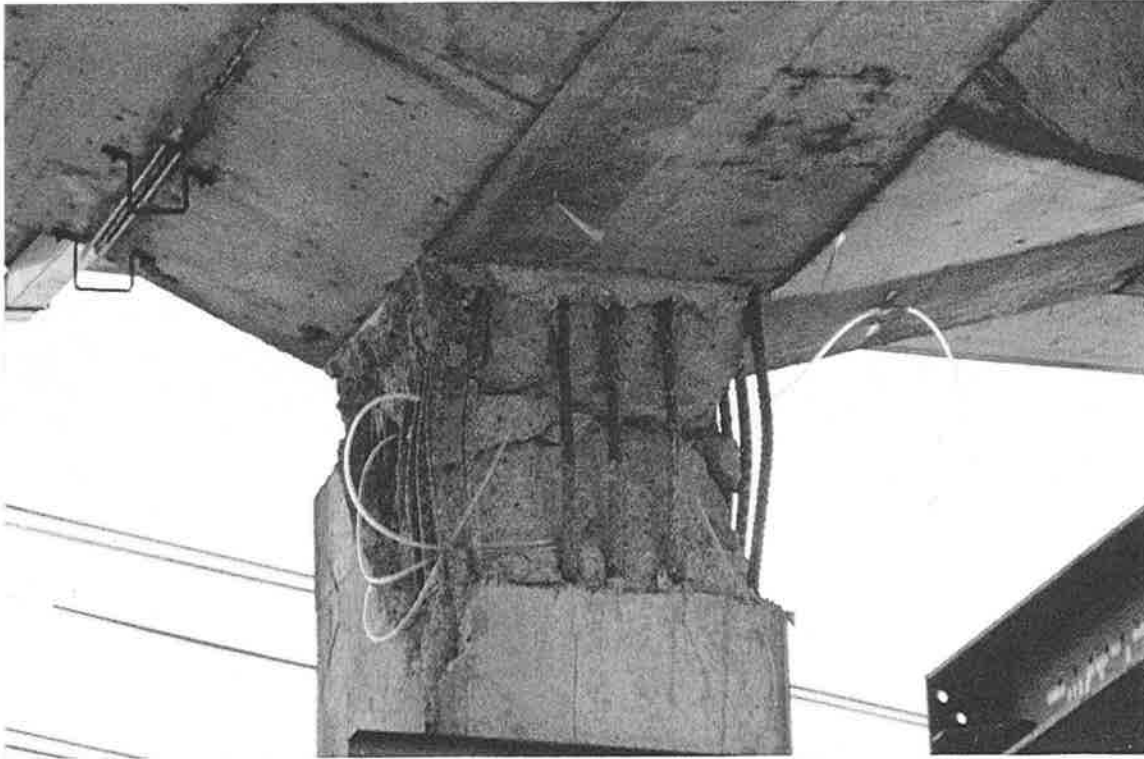
*JRS-7. Another column near collapse with buckled reinforcing ties gone with no cross ties.*

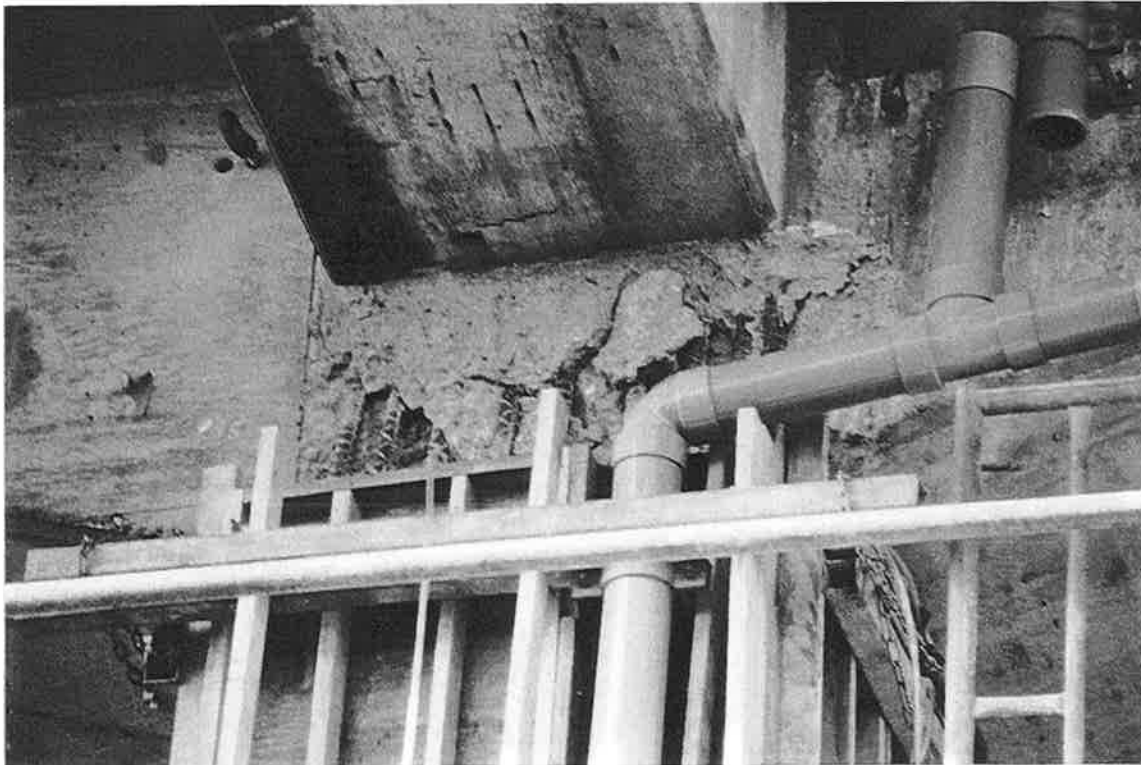
*JRS-8. The cracking in this joint is limited to the zone below the confining catenary support beam at the top of the photo and the top of the column.*

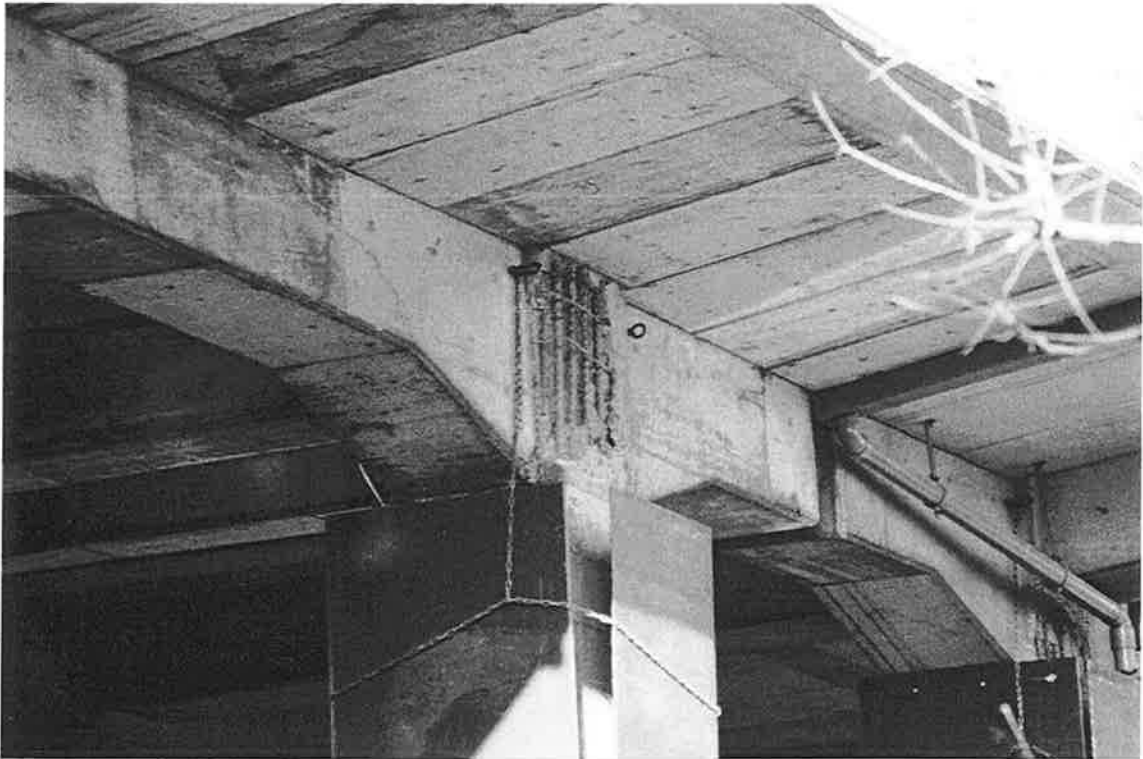
*JHS-9. A steel plate jacket installation; note the column bars exposed in a joint zone. A joint repair method was not observed. The column had almost no moment capacity in this transverse direction.*

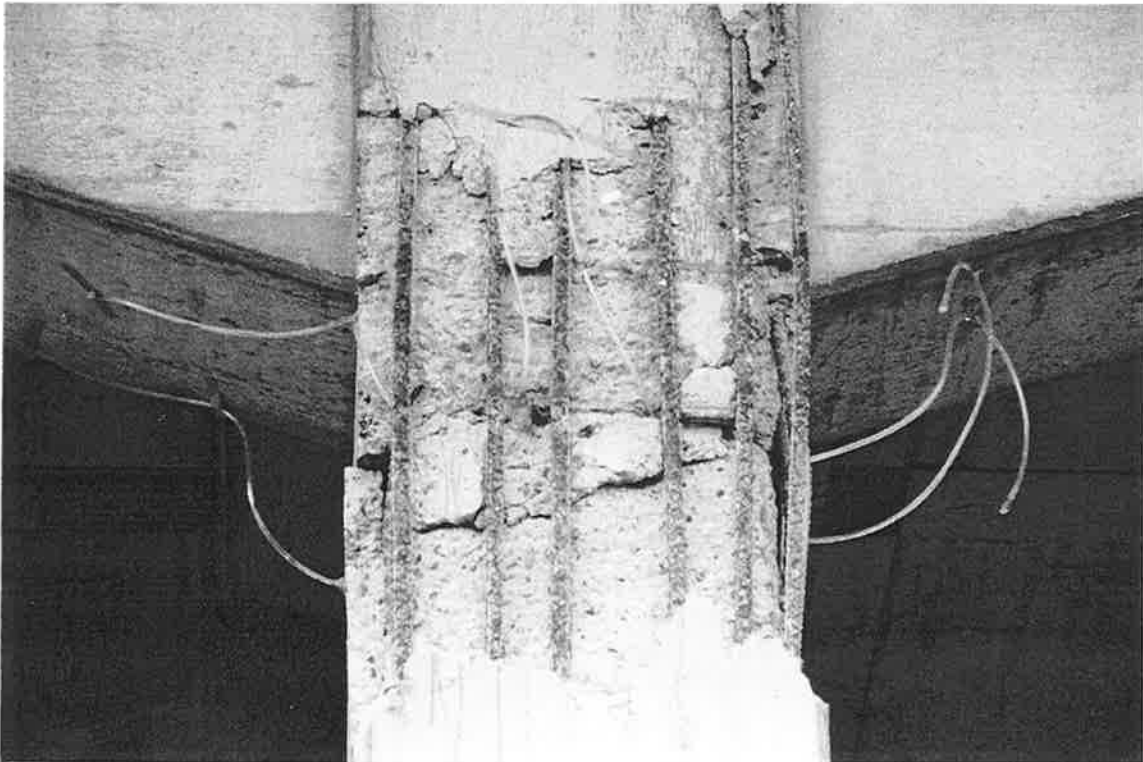
*JRS-10. Damage at the top of column and into the unconfined joint zone; the ties are no longer present. The cracks are being epoxy grouted.*

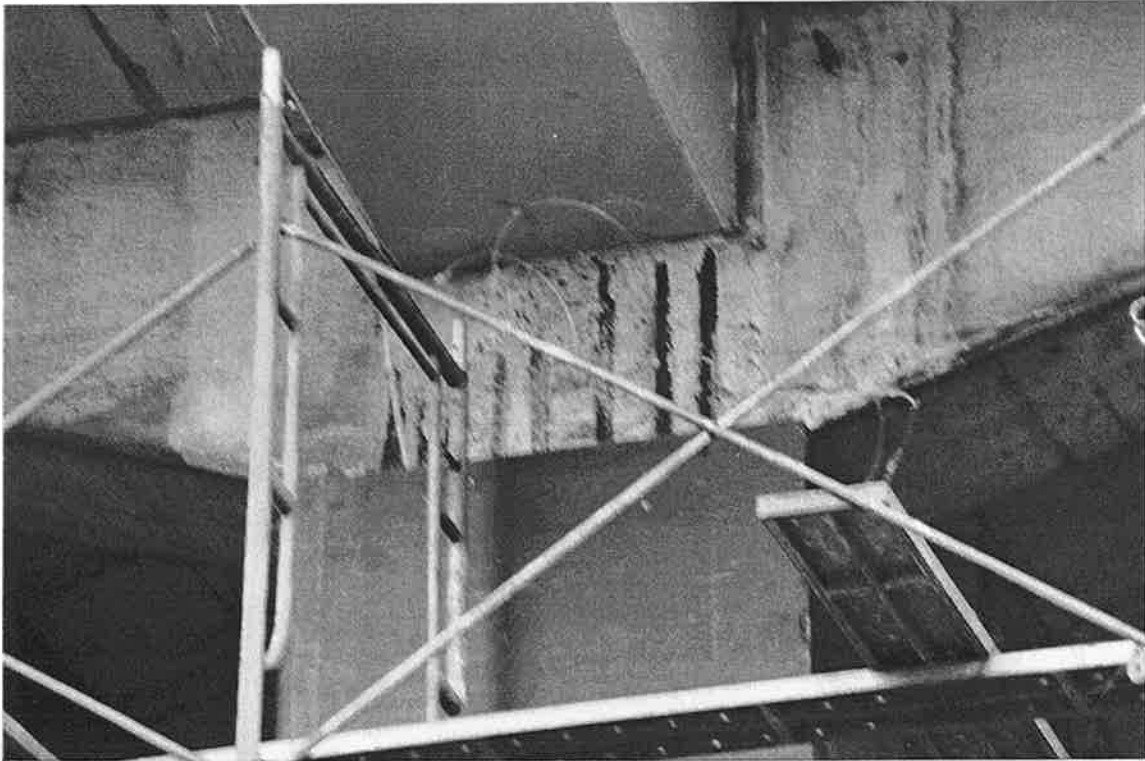
*JRS-11. Catenary support beam provides some confinement to the joint zone. The joint has degraded from the top of the column.*

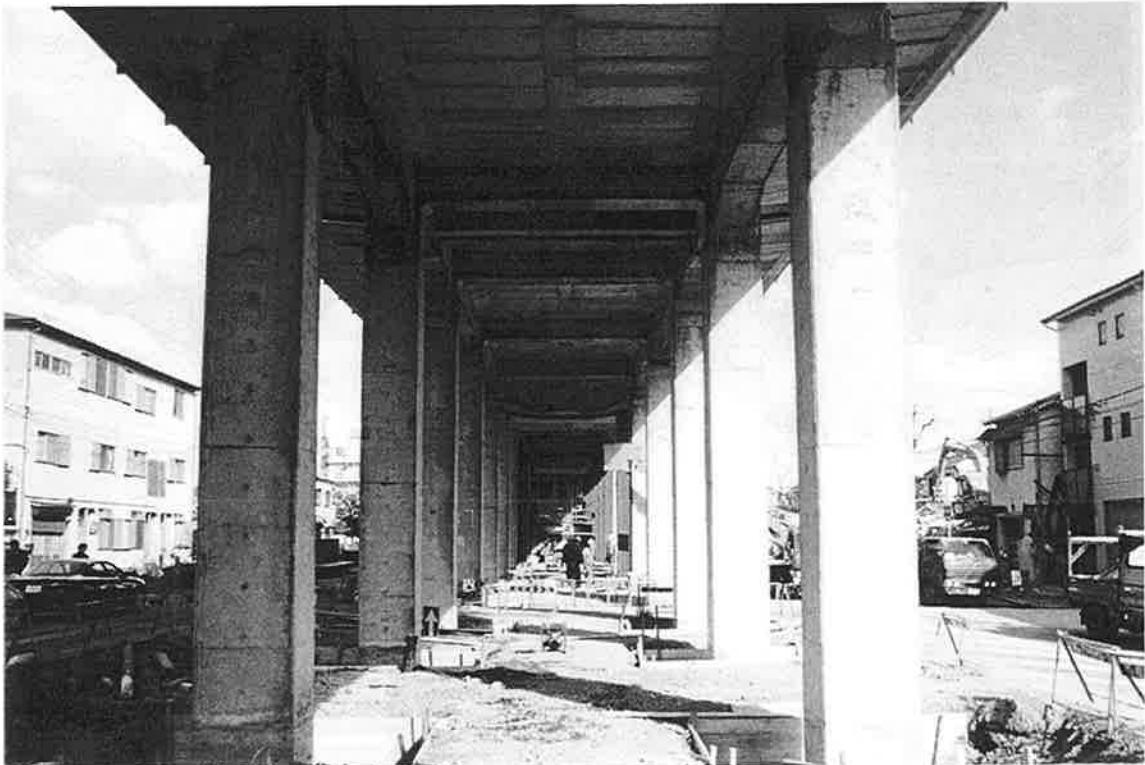
*JRS-12. Damage to the tops of consecutive column in the longitudinal direction.*

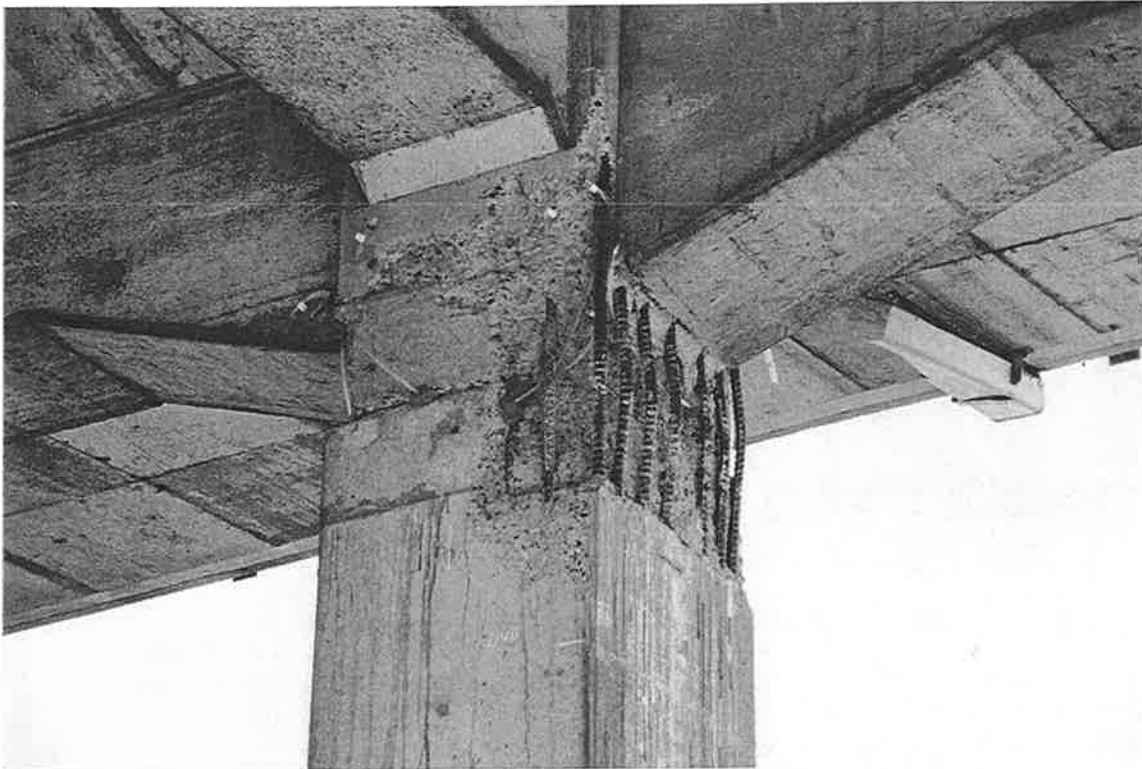
*JRS-13. Column damage in the longitudinal direction*

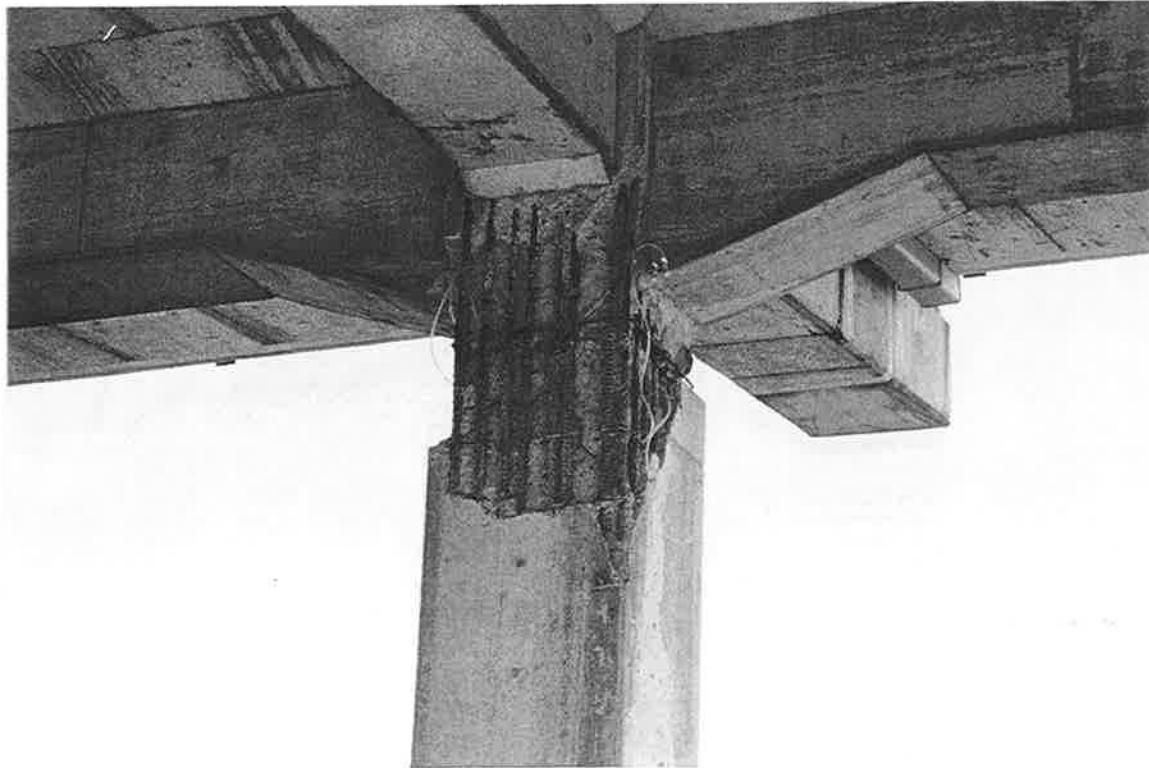
*JRS-14. Column is damaged in both directions in addition to joint damage.*

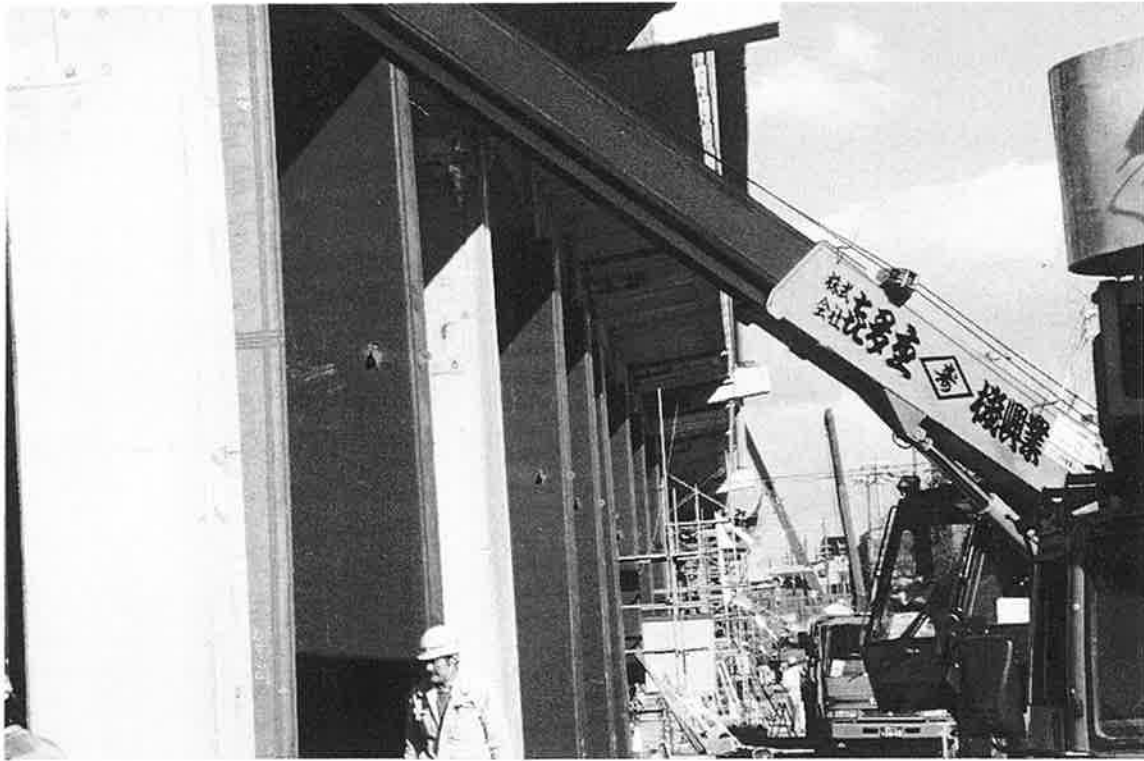
*JRS-15. Many steel jackets are installed.*

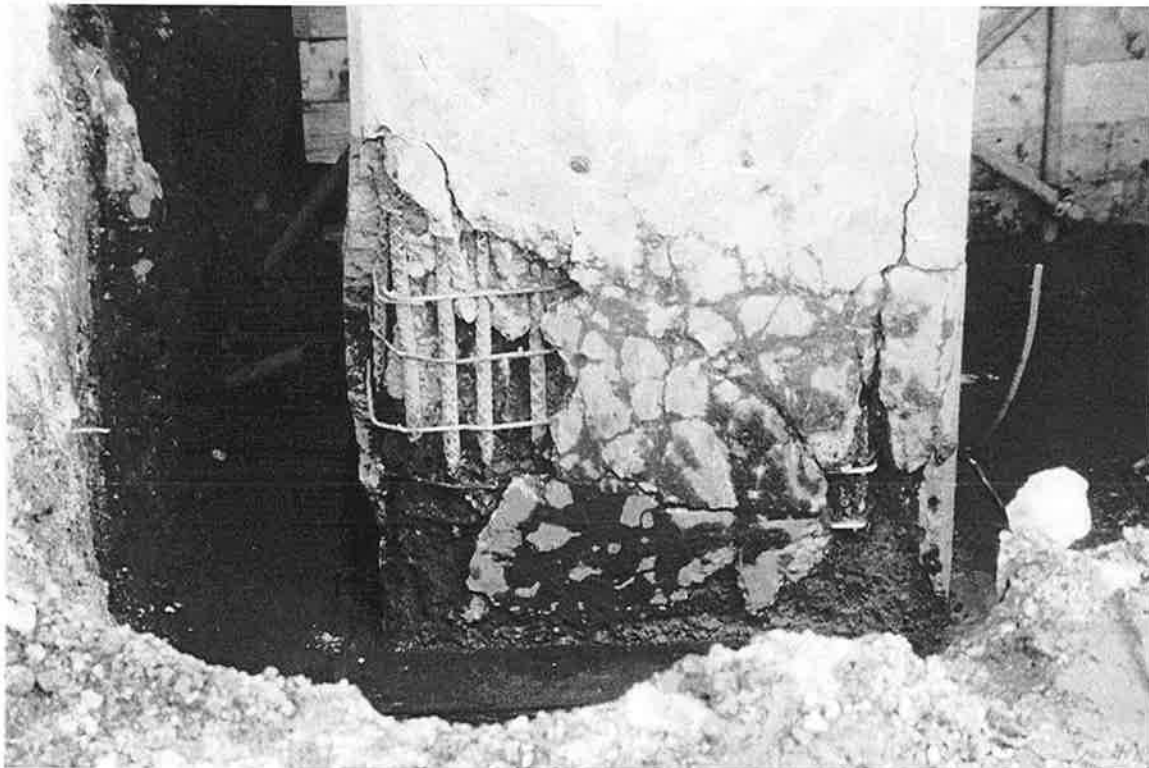
*JRS-18. Some spalling is evident at the bottom of this column. Note the tie size and spacing.*

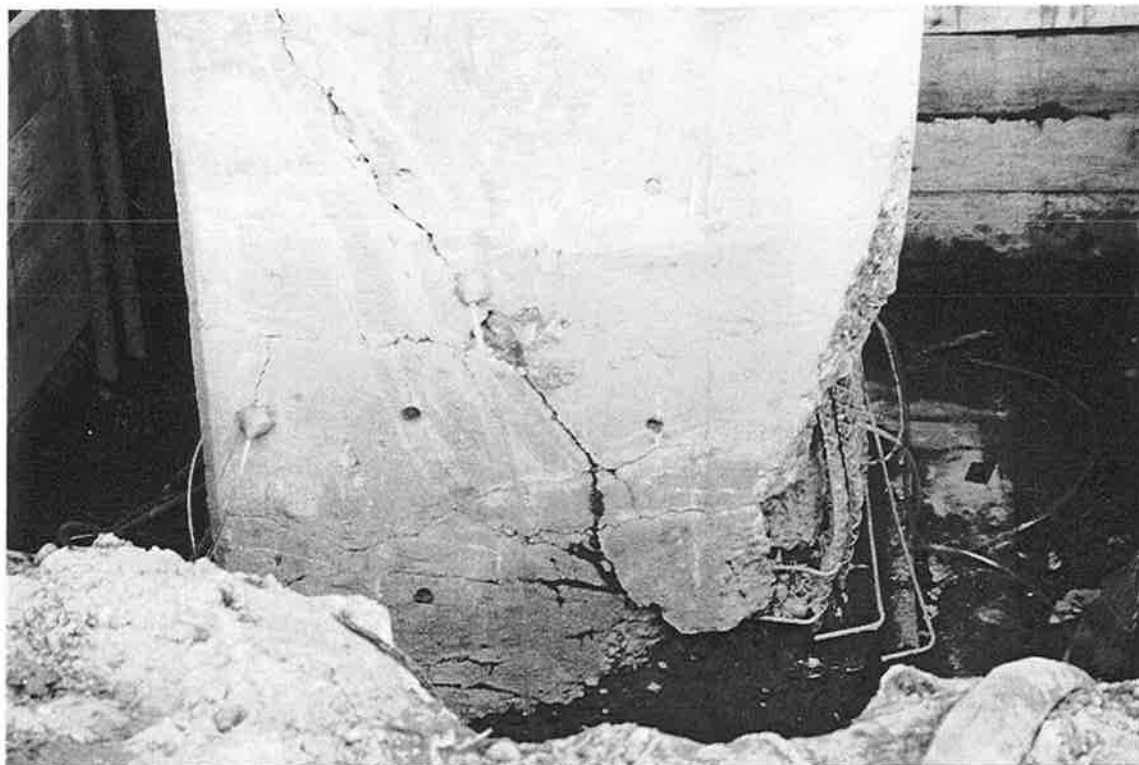
*JRS-19. This column was close to failure. The ties are opening, main bars are buckled and the shear crack is opened. Note the angle of the shear crack is more vertical than 45 degrees. Response was in the longitudinal direction.*

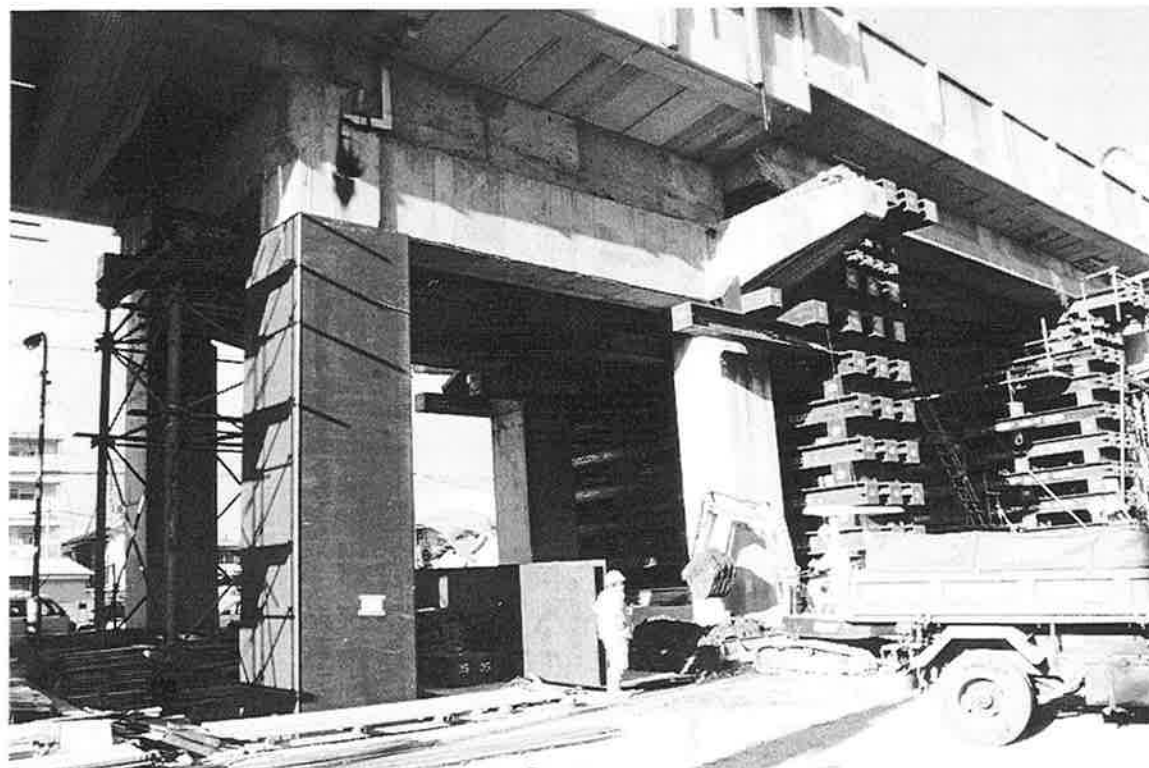
*JRS-20. The drop in span on the right was lifted off the ground and relocated on the piers. The adjacent spans were stiffened with the additional girder. Steel jackets were applied to columns.*

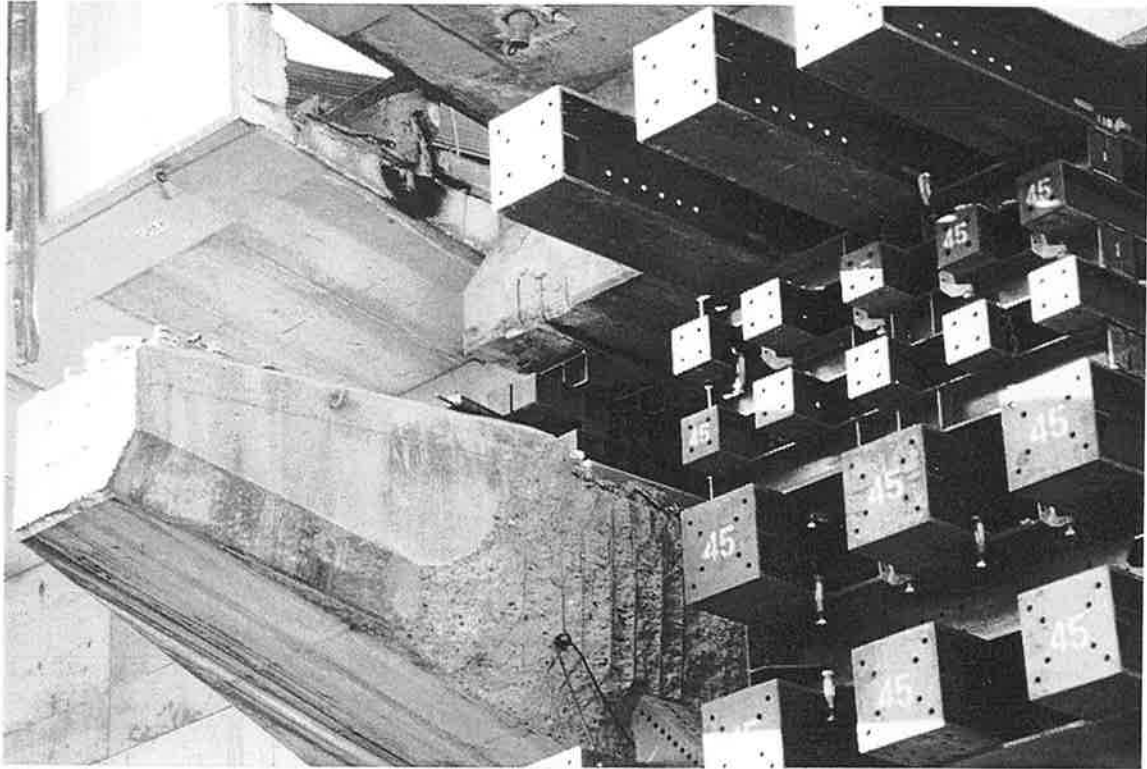
*JRS-21. The precast-prestressed concrete drop-in girder to the right is supported while the pier and adjacent span is repaired.*

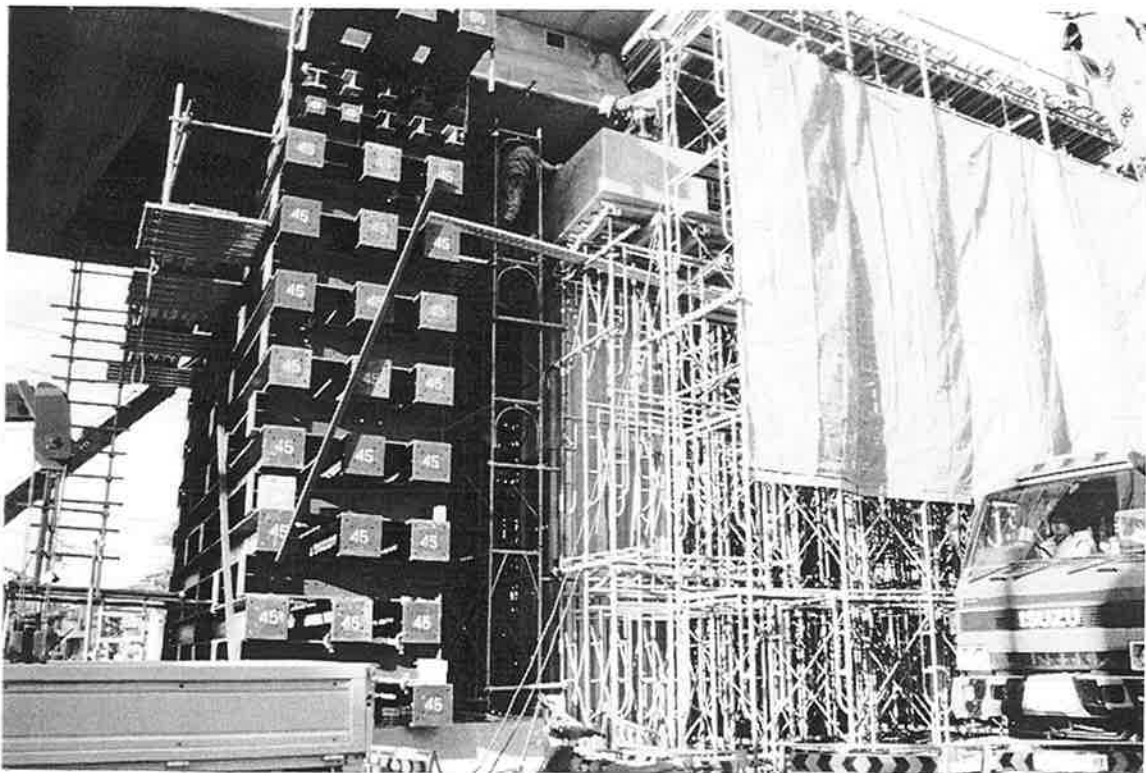
*JRS-22. Temporary supports are on the left of the drop-in span, and falsework is on the left.*

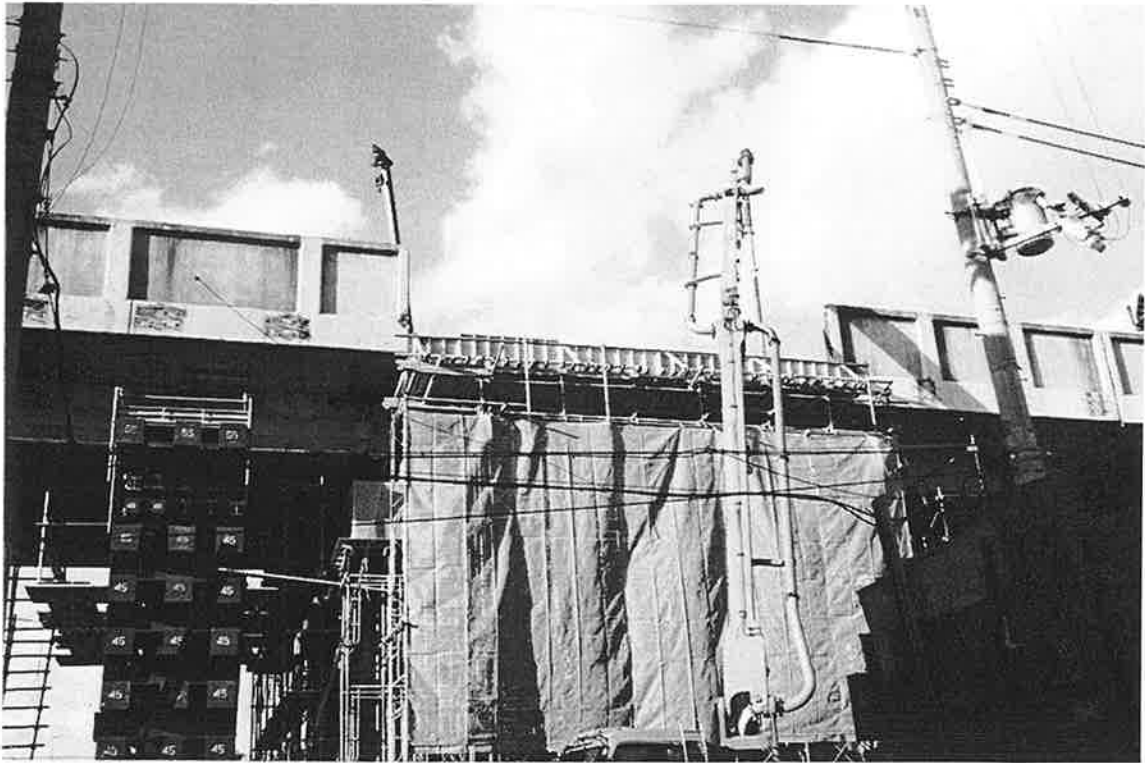
*JRS-23. The deck of this drop-in span is being replaced.*

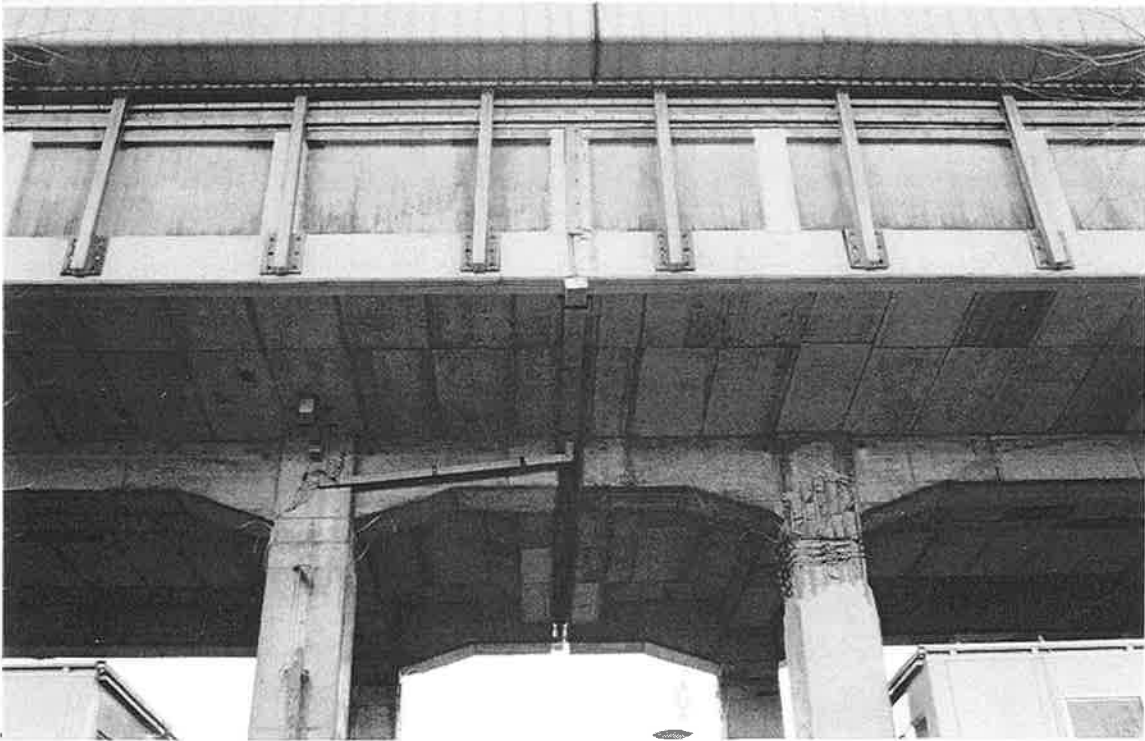
*JRS-24. An expansion joint that is typical at mid span.*

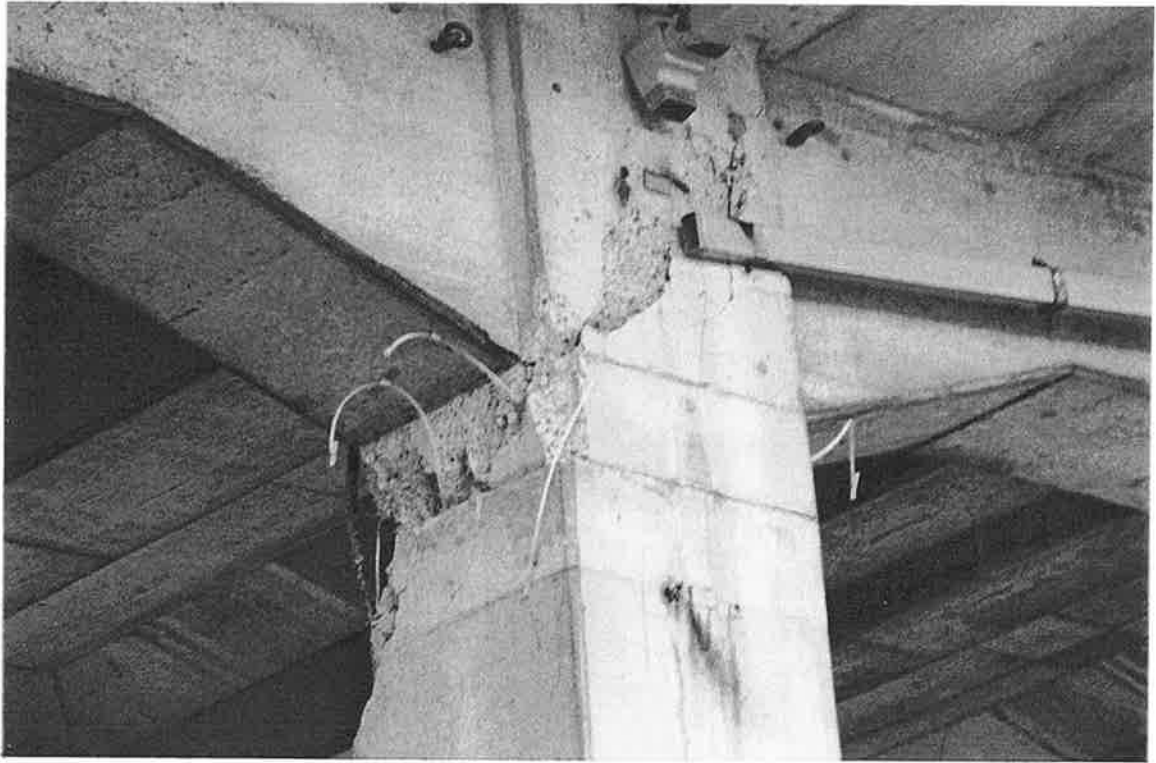
*JRS-25. The cracks have been epoxy grouted. The external spalling still needs repair.*

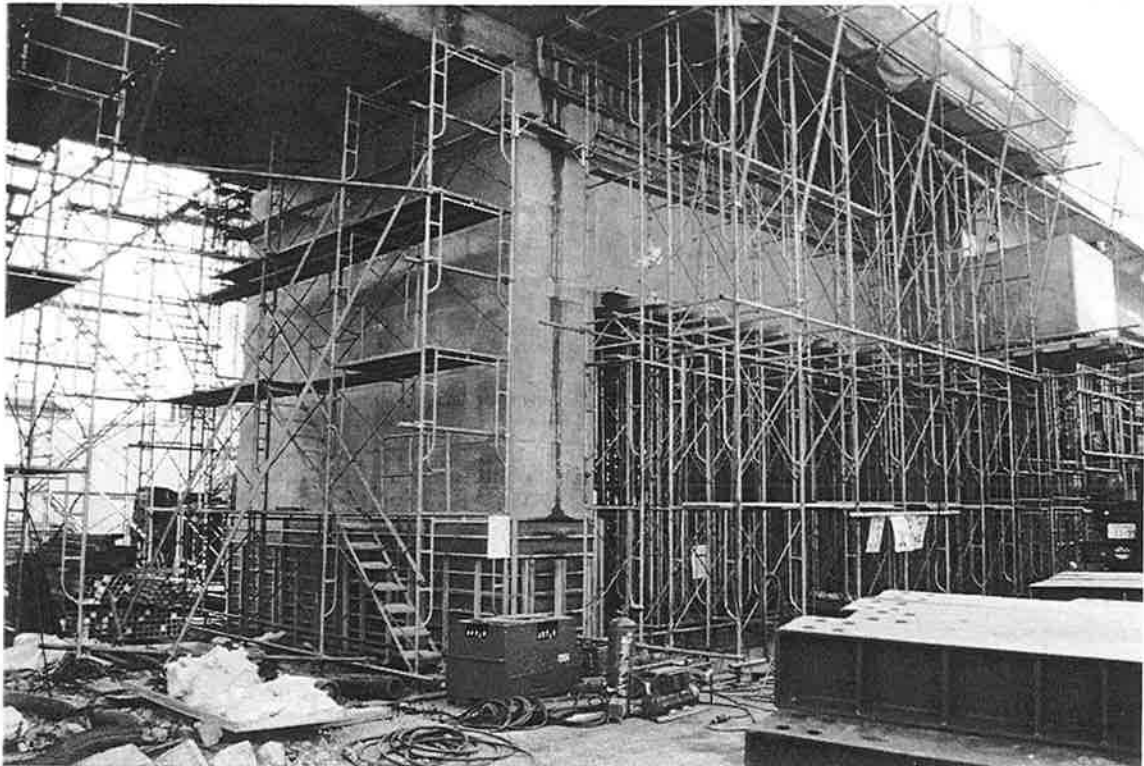
*JRS-26. A new stiffened pier to resist longitudinal forces*

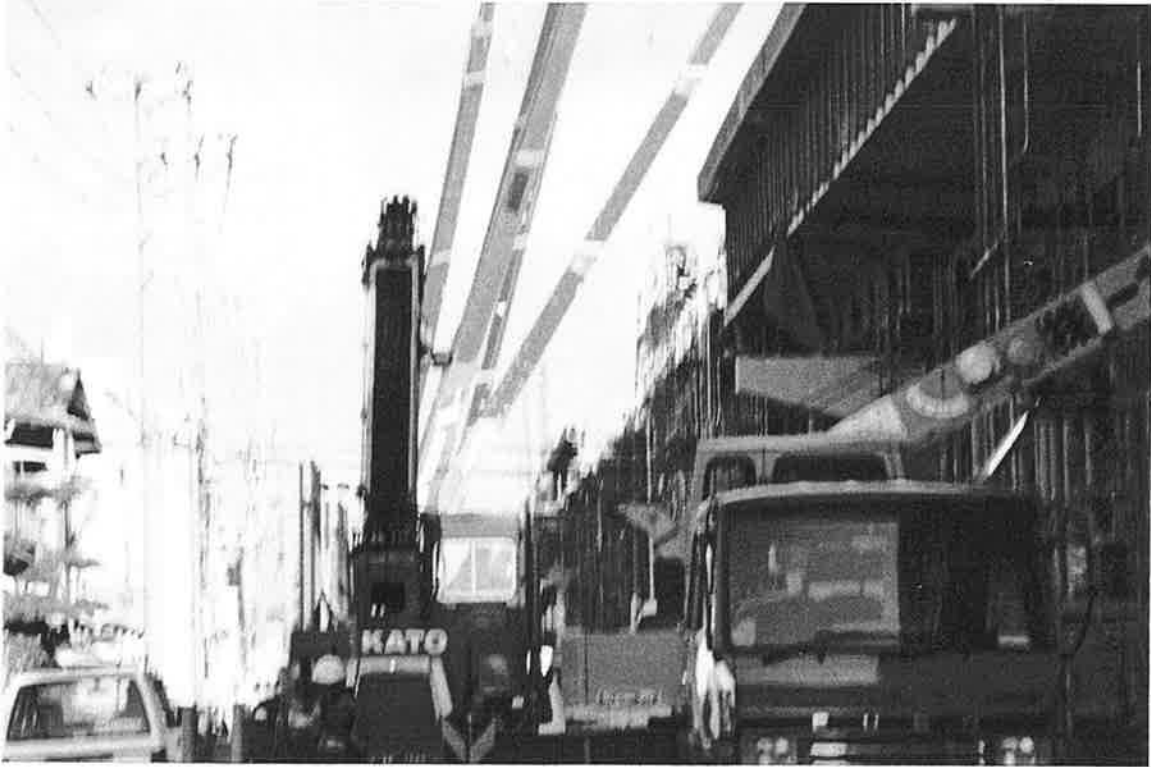
*JRS-27. More than 5 cranes are visible on this side over 200 meters of structure. The houses to the left suffered minimal damage.*

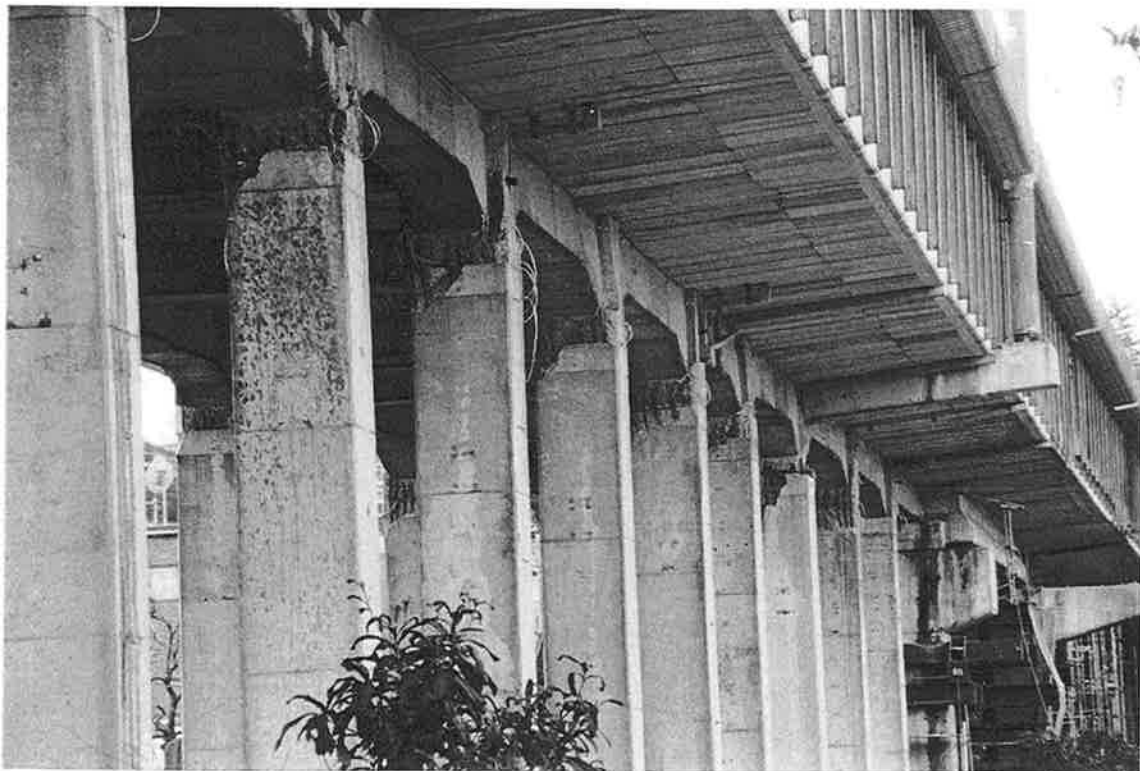
*JRS-28. Longitudinal response is shown by the damage in consecutive columns. There is minimal transverse damage.*

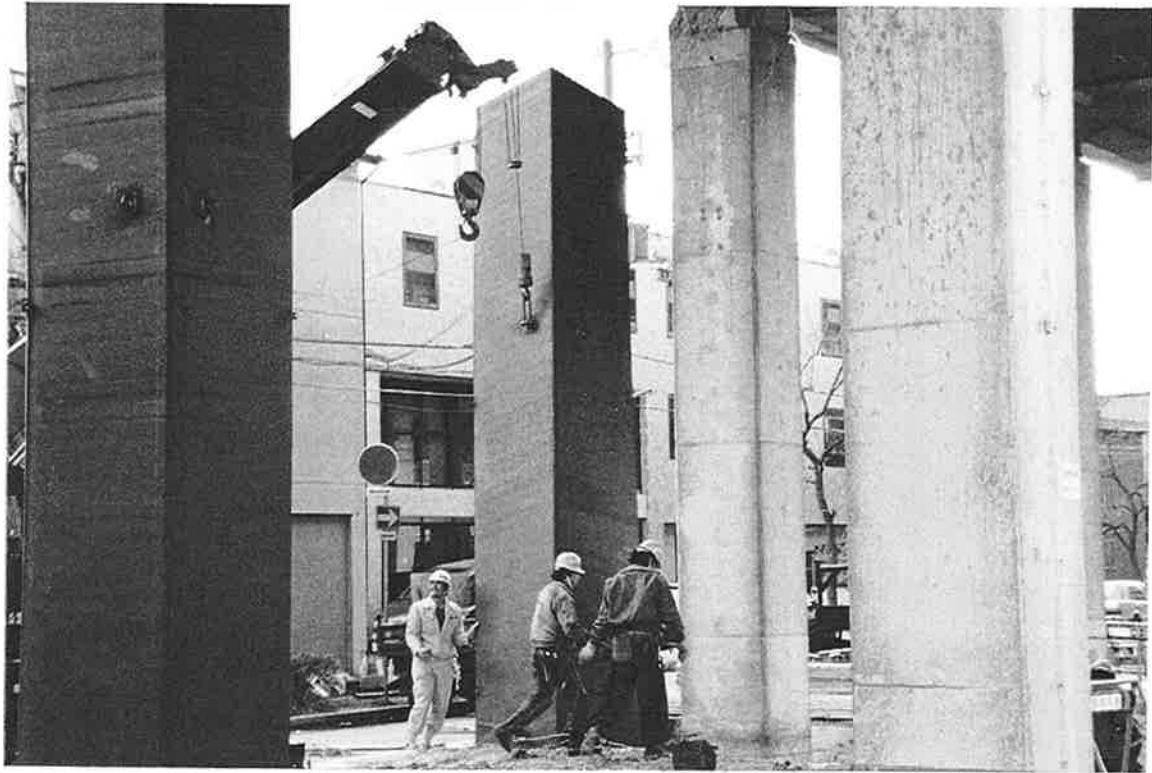
*JRS-29. Steel plate jacket installation; note damage at the top of column.*
