# **Seismic Damage Assessment of Rail Structures in Japan after the January 1995 Kobe Earthquake**

**Parsons Brinckerhoff Quade & Douglas, Inc.  
San Francisco, California**

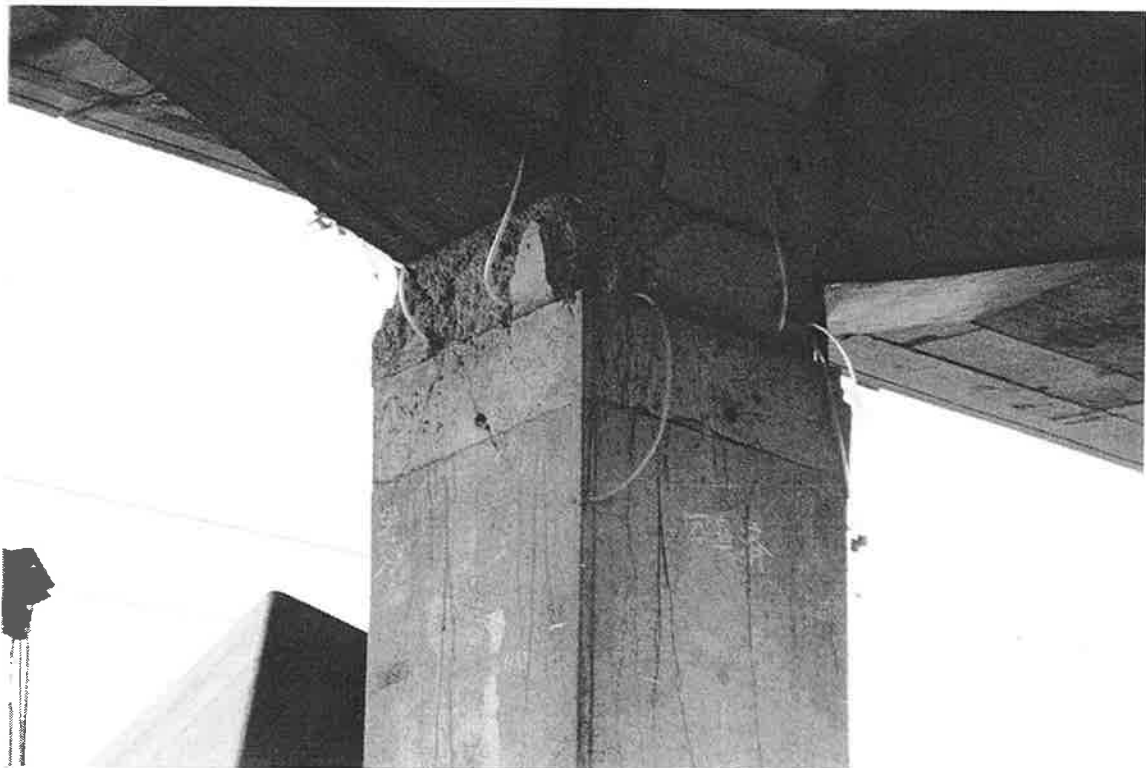
*JRS-30. A close up photo of minor longitudinal damage on the column*

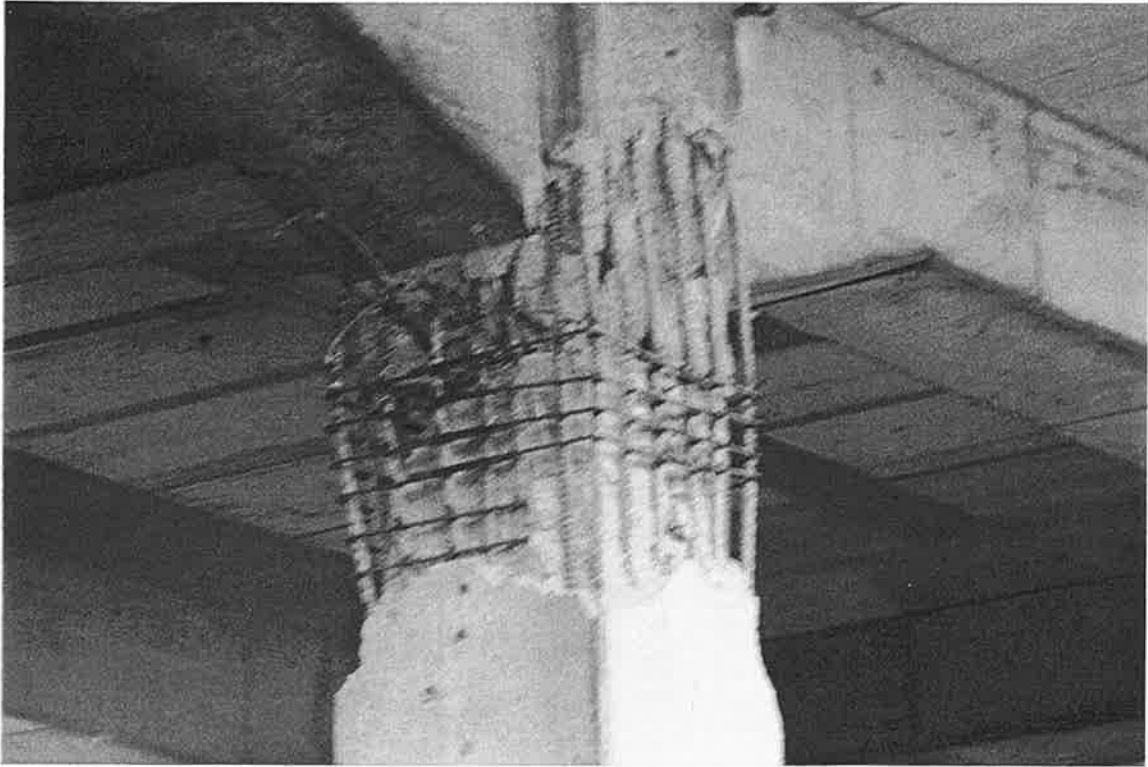
*JRS-31. Damage at top of column and into the joint; note the column ties and their spacing and their lack of cross ties*

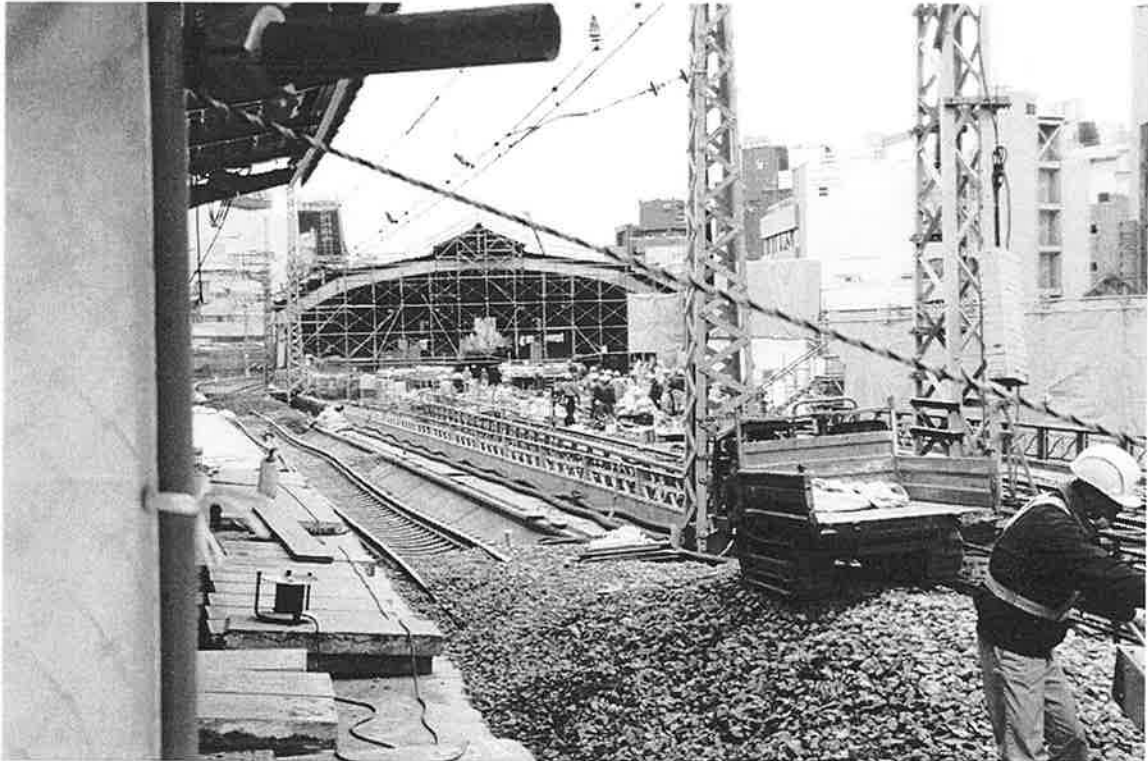
*SS-1. A train derailed as it entered Sannomiya Station from the west. The rail displacement was either caused by the derailment or it caused the derailment. The building in the background is a maintenance facility.*

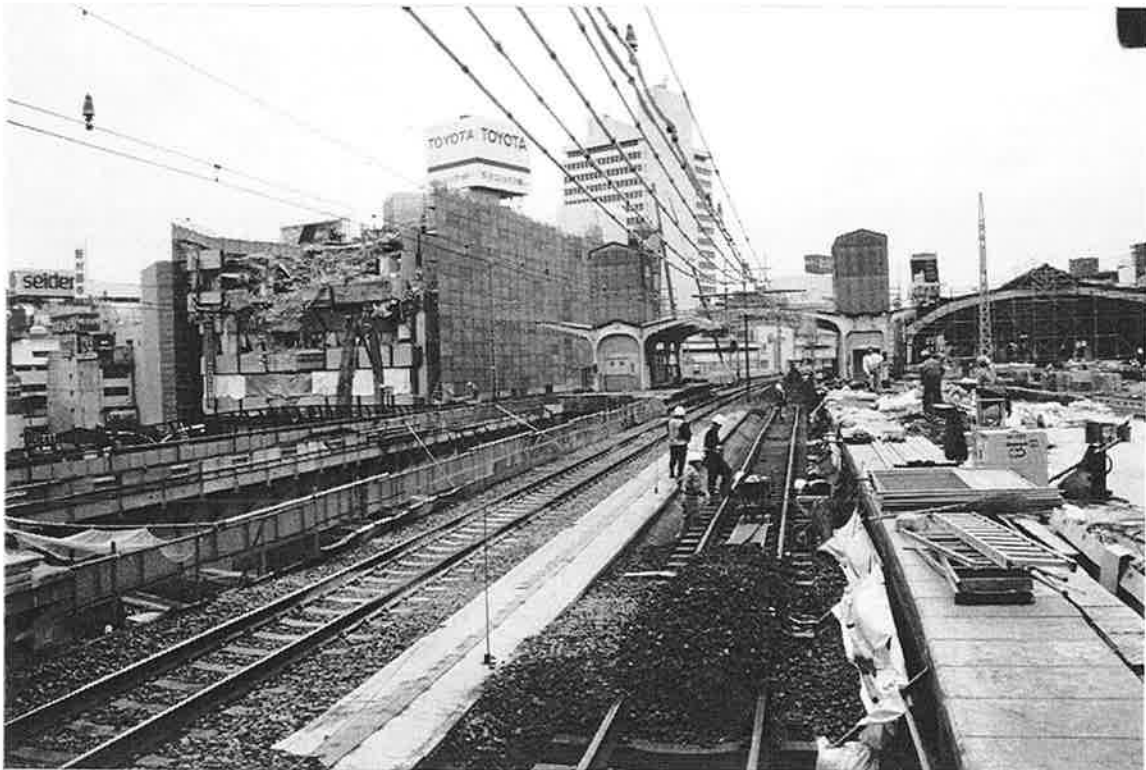
*SS-2. The ballast is being replaced and recompact on the westbound track. Note the damage to the building to the left.*

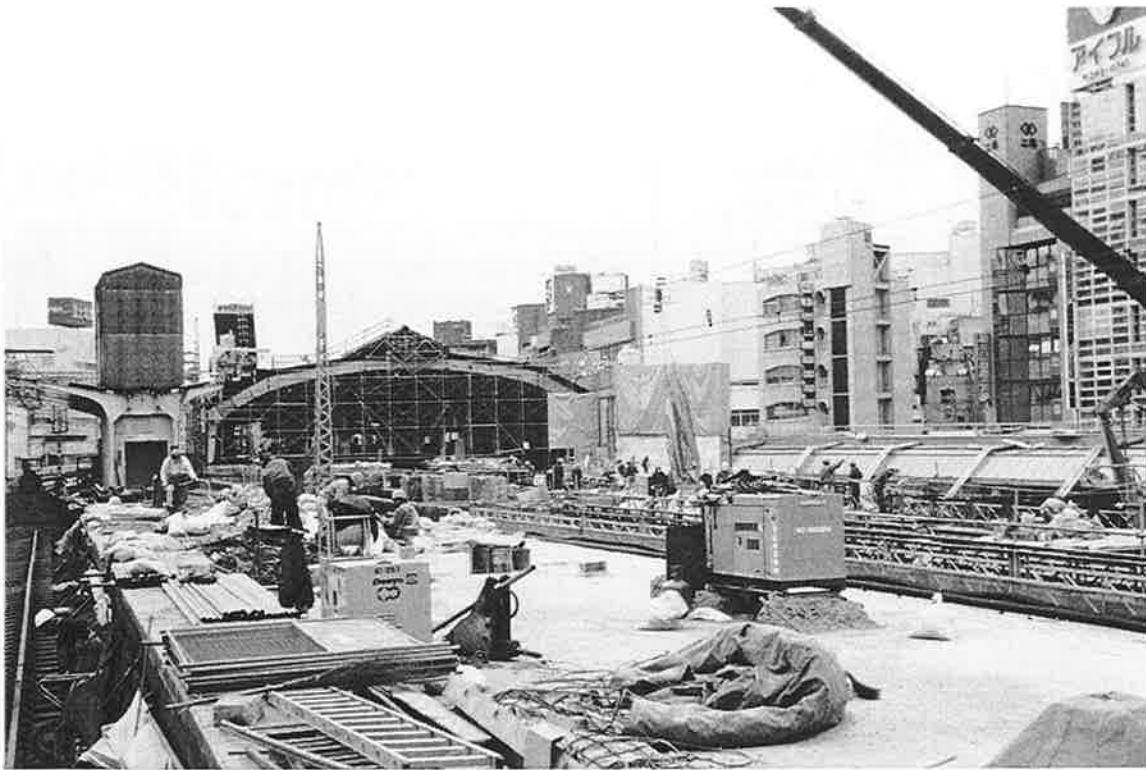
*SS-3. The ballast and trackwork has been replaced on the turnouts leading into the maintenance facility. The supporting girders fell to the street.*

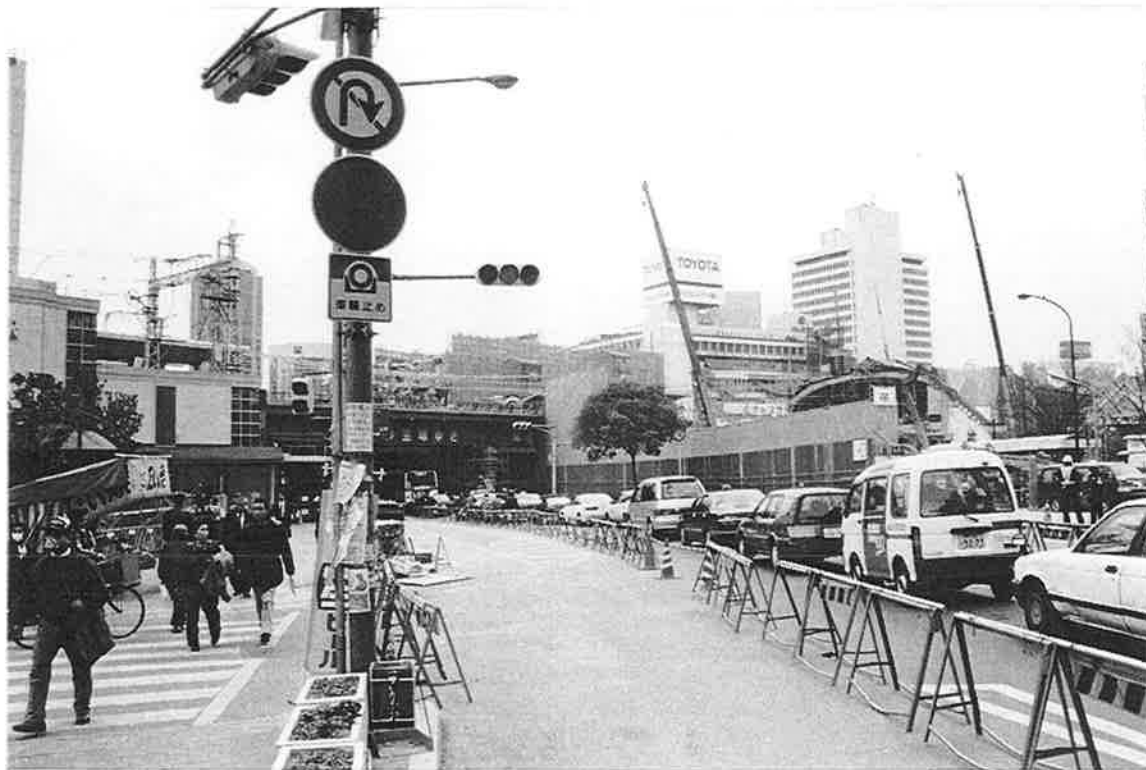
*SS-4. This area of Kobe was very heavily damaged. The JR Sannomiya Station is elevated crossing the street. The Kobe Municipal Subway Station is closed for repair behind the barriers to the far left. The Hanshin Subway was damaged below the street just beyond the bridge. The Port Island Peoplemover is down this street about 1km.*

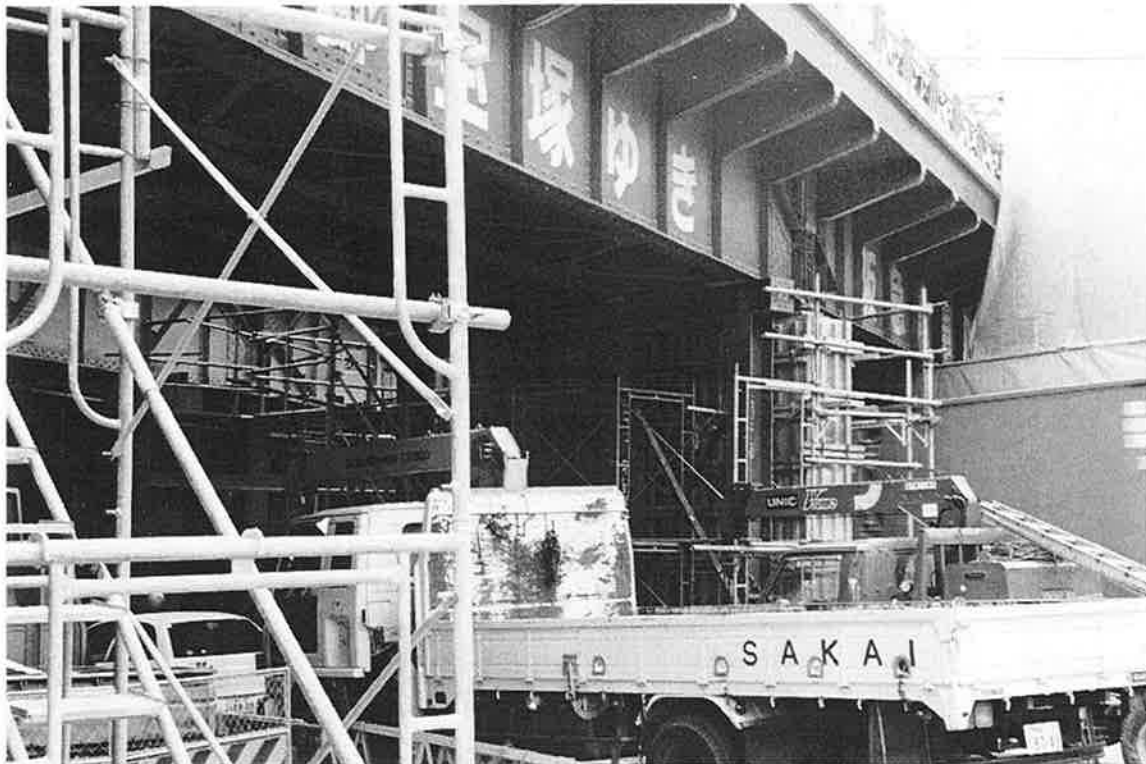
*SS-5. The new girders are supported in place while the substructure is being repaired and the trackwork above is completed.*

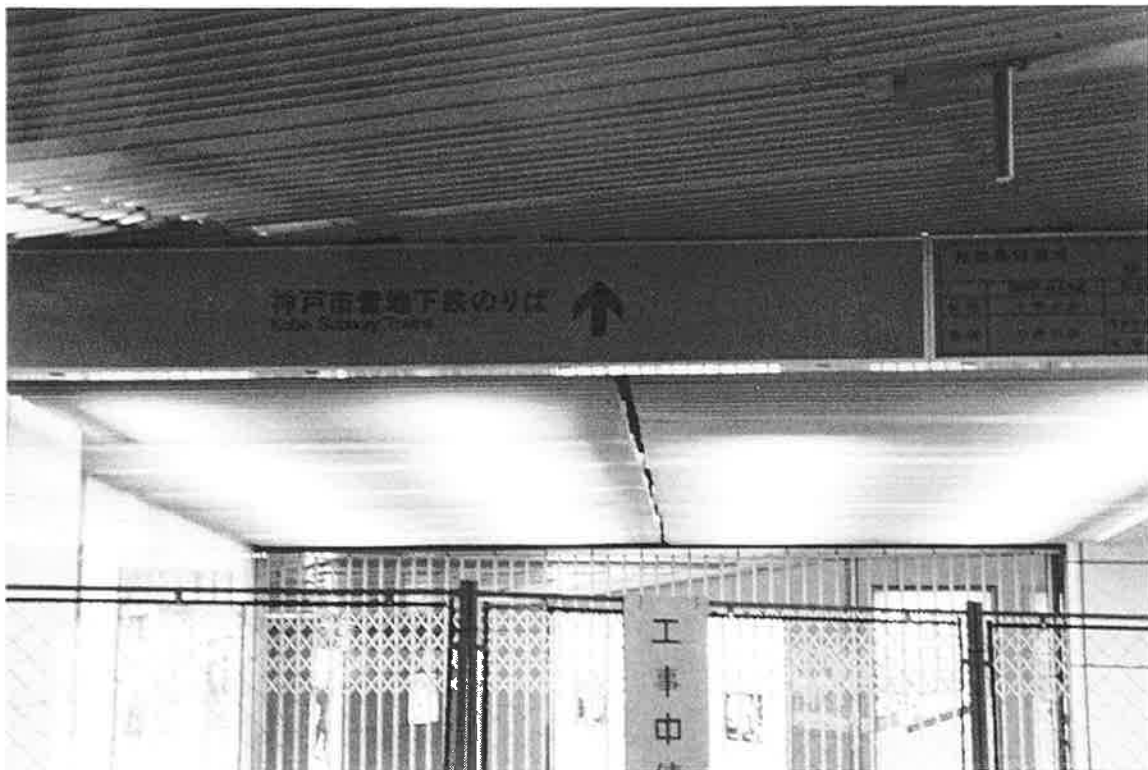
*SS-6. This access to Kobe Municipal Subway Sannomiya Station is closed.*

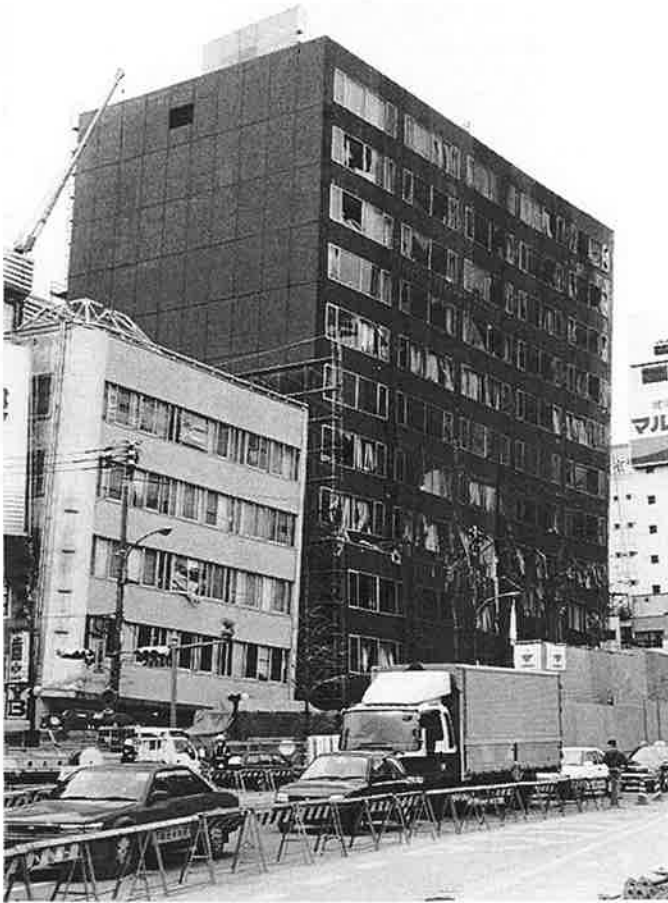
*SS-7 & SS-8. These buildings next to Sannomiya Station were also heavily damaged. The one to the left is leaning. The darker building sheared about 2 meters at the fourth floor and appears quite dangerous.*

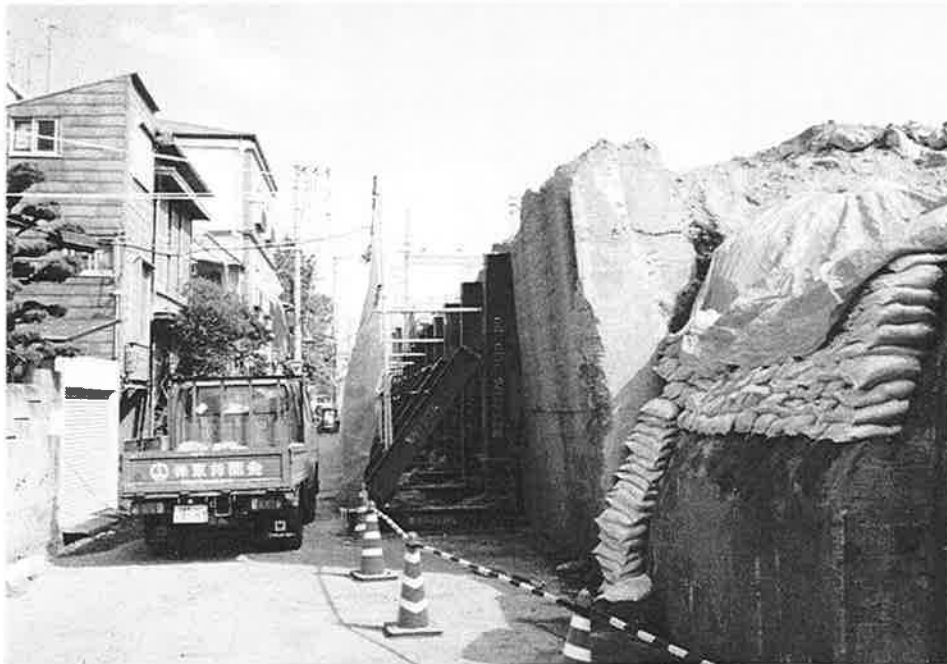
*HER-1. Retaining wall west of Mikage Station; the steel frames resist additional leaning.*

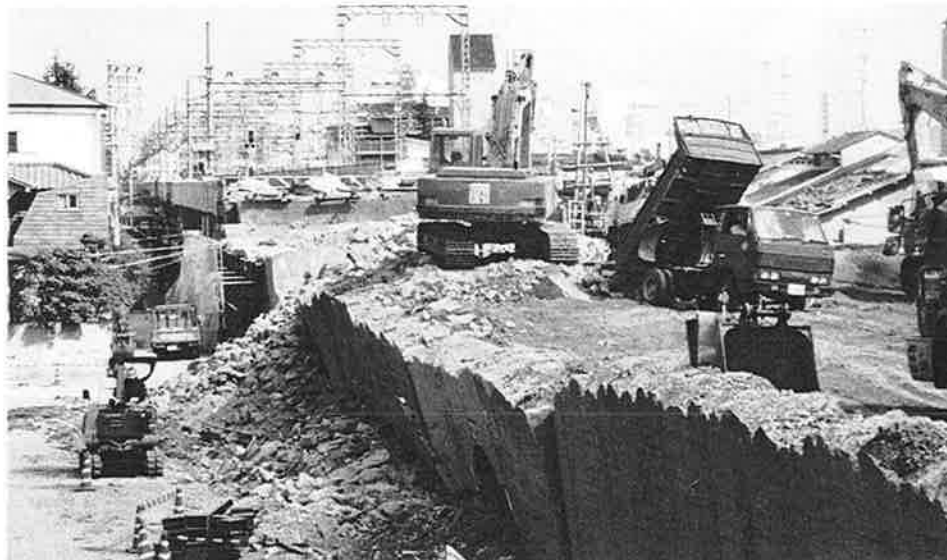
*HER-2. More failed retaining walls; the embankment is being lowered to allow replacement of the walls.*

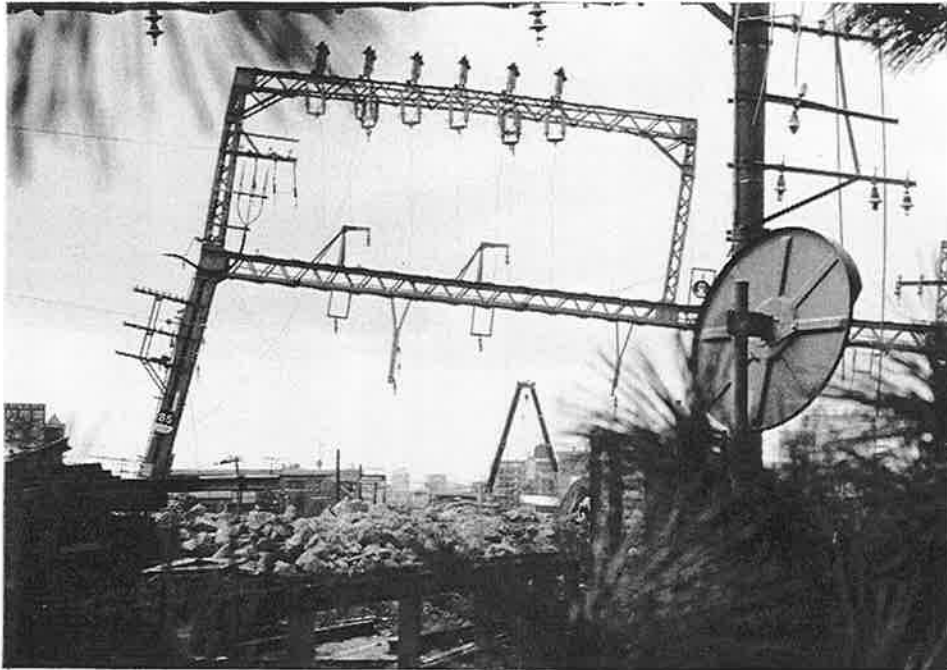
*HER-3. Just west of the failed retained embankment the damage is much more intense. A failed catenary support is in the foreground.*

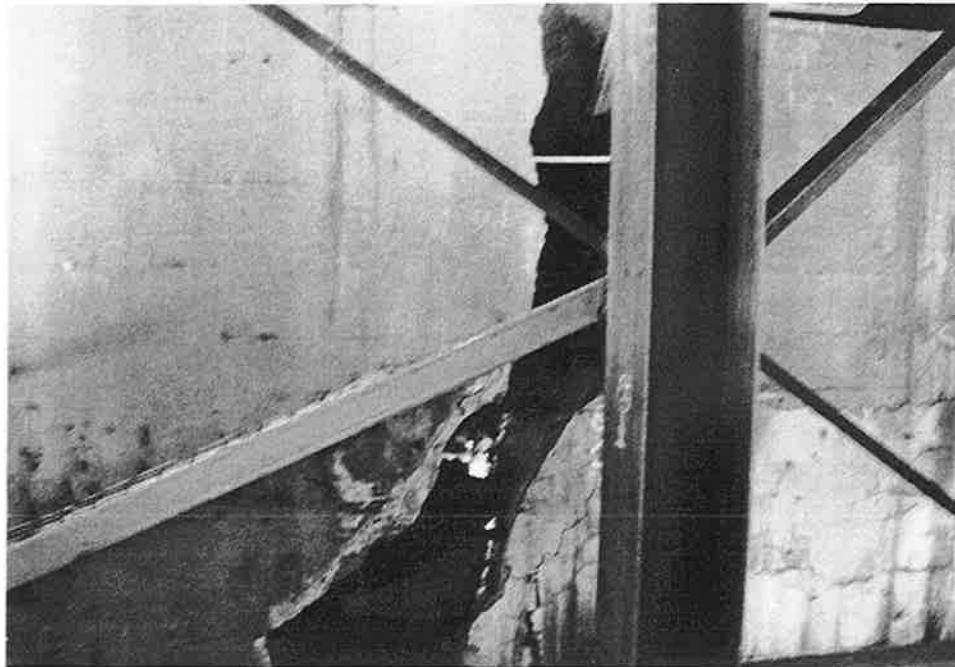
*HER-4. This 150 mm wide crack is in an abutment wall at the west end of the failed retained embankment. The steel column is supporting the superstructure of the street crossing.*

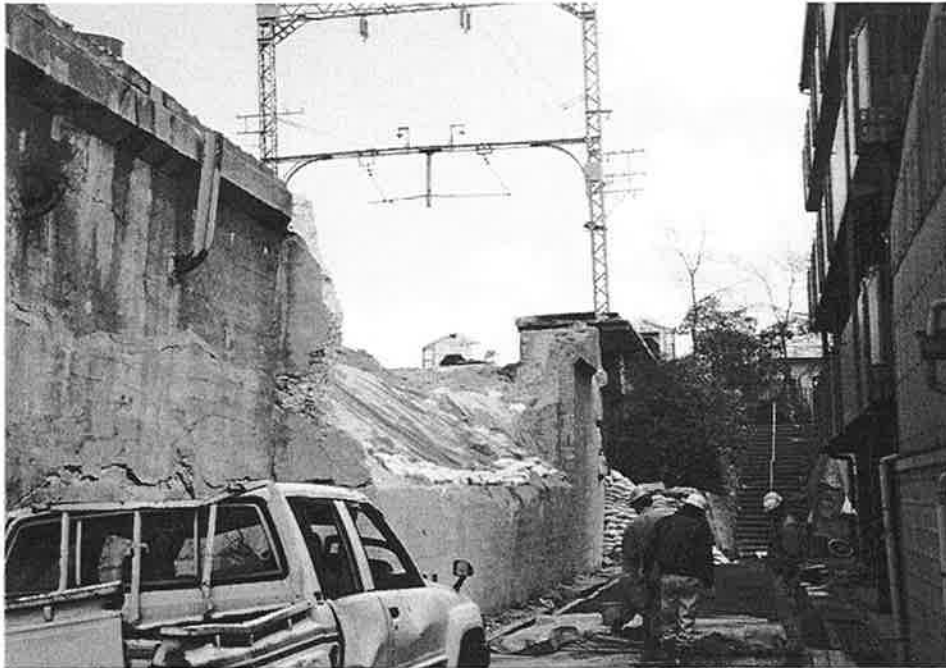
*HER-5. Another section of failed gravity retaining wall; there is another failed section above the sandbags in the background. Note the horizontal crack above the parked vehicle.*

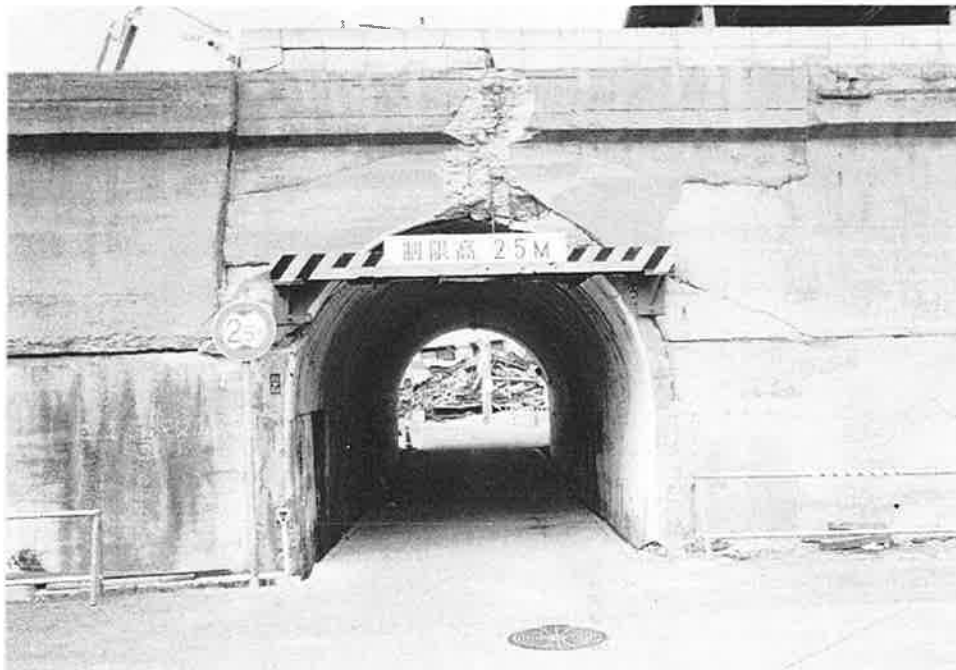
*HER-6. The crown of this arch culvert shows some distress.*

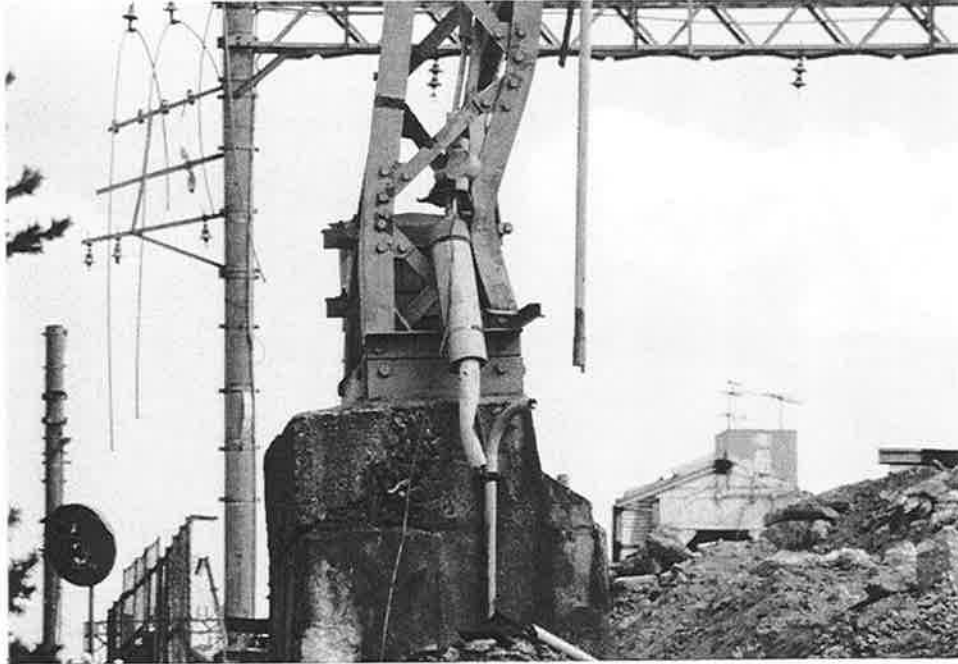
*HER-7. The column of the catenary support observed earlier has buckled.*

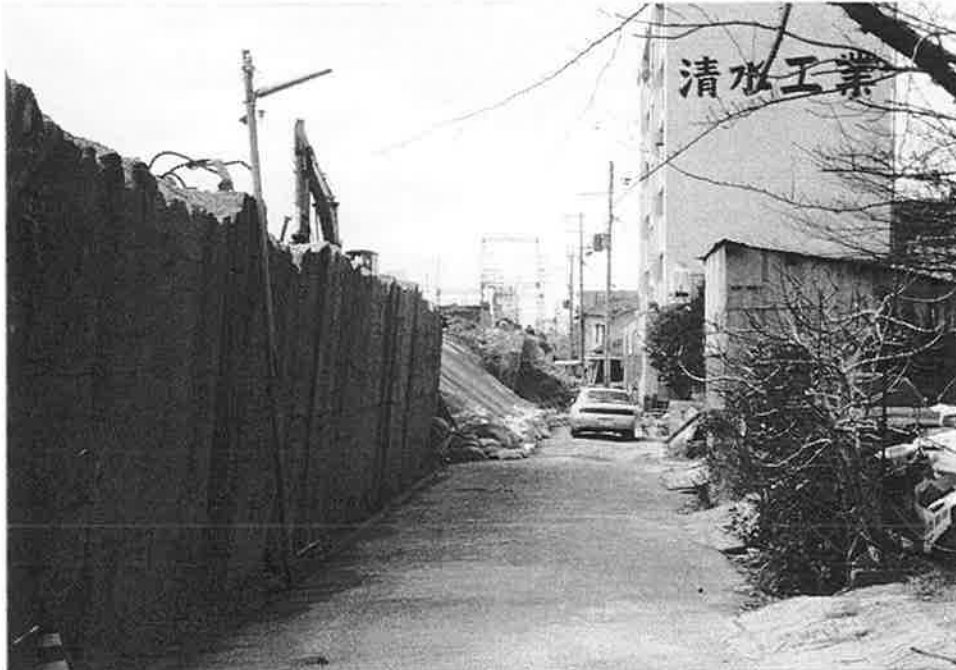
*HER-8. Another retaining wall failure*

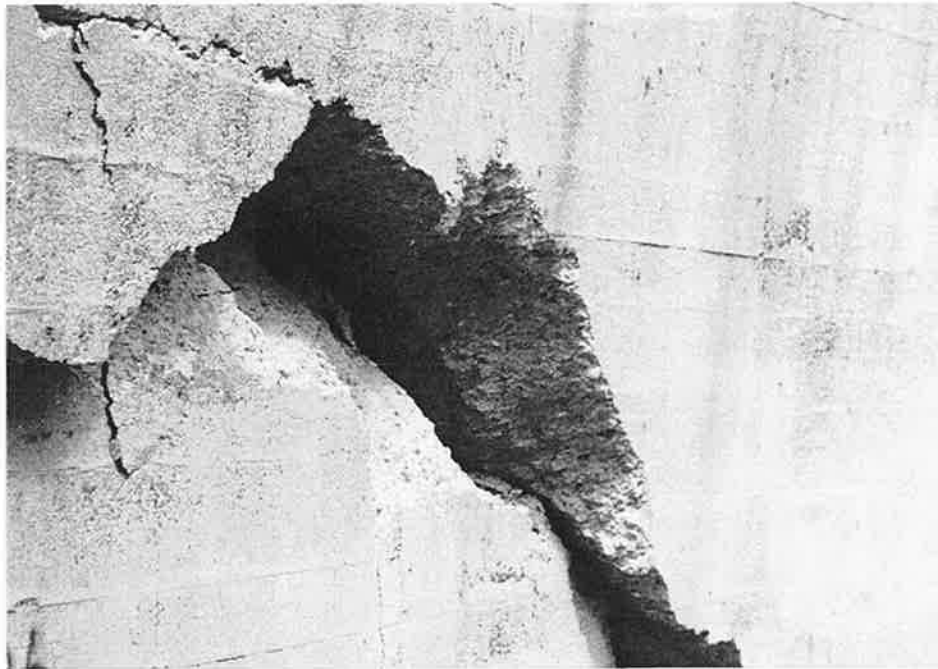
**HER-9.** *The crack in the retaining wall shows that the wall is unreinforced concrete.*

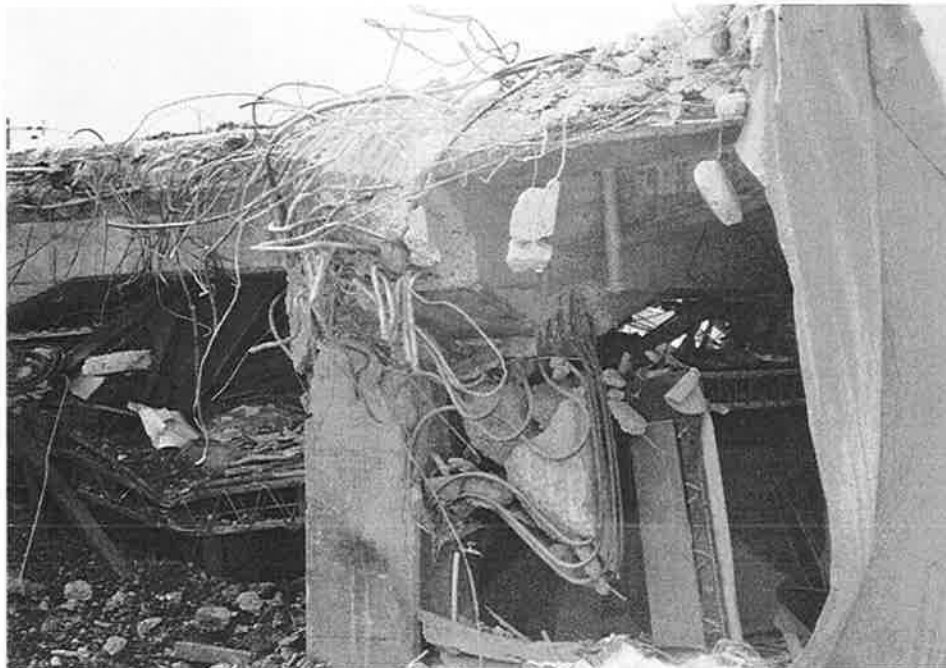
**HER-10.** *Beginning of the failed viaduct; the steel members were used for residential and commercial buildings constructed under the viaduct.*

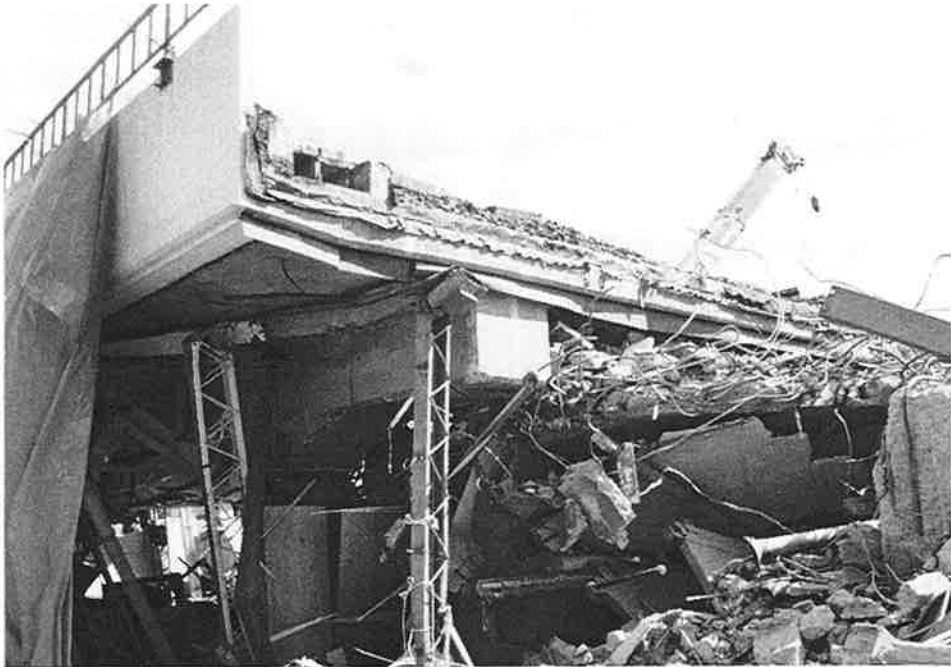
*HER-11. The viaduct collapsed to the left of the expansion joint but was destroyed to the right. The joints were located at midspan. The ballasted rail provided no restraint.*

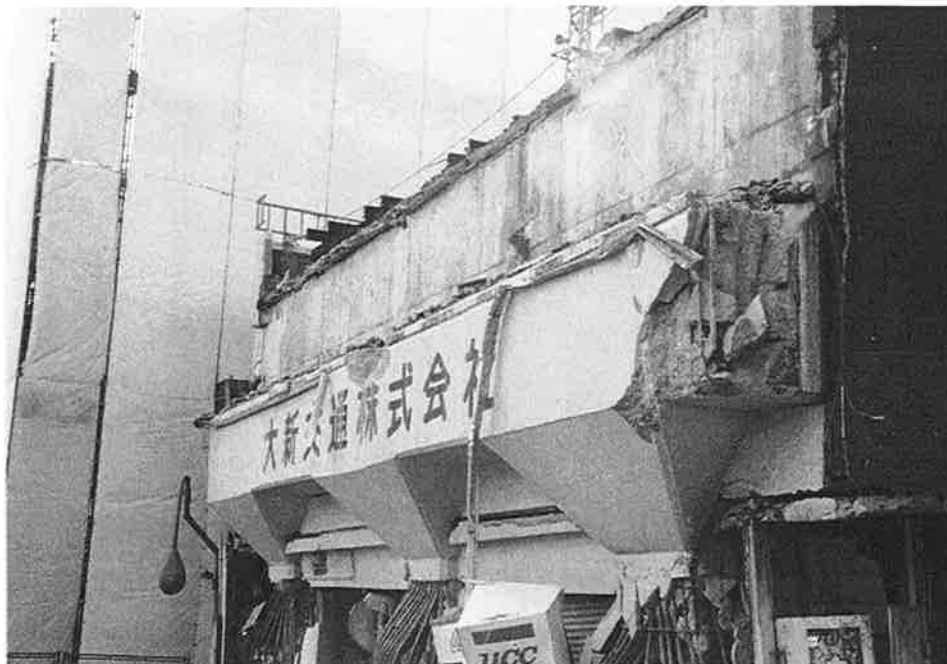
*HER-15. Same pier as already observed; the bearing ledge is 300 to 500 mm wide. Any restraint would have kept the girders up.*

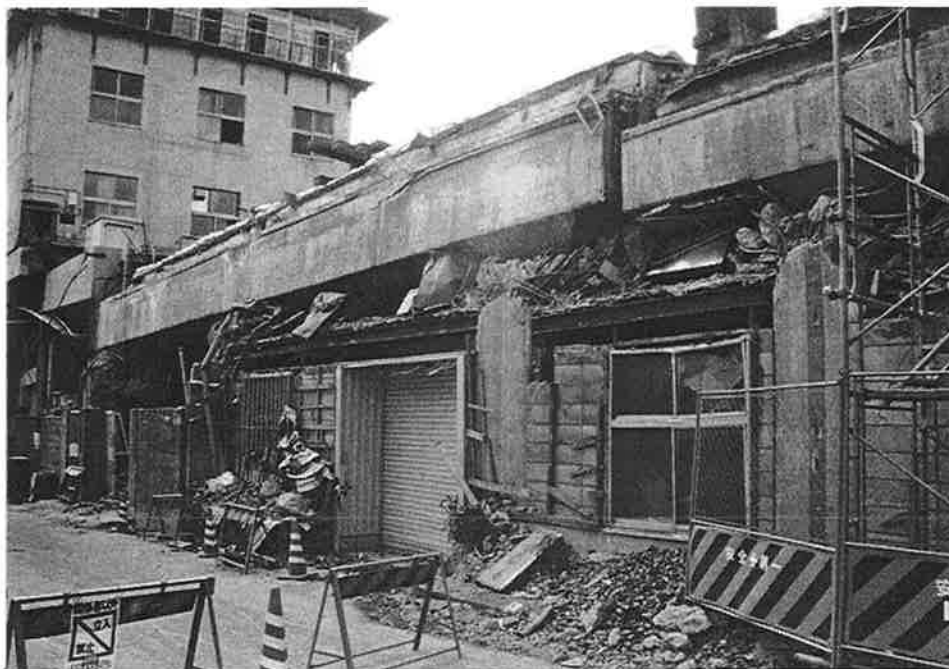
*HER-16. This section is completely destroyed above the steel beams. The steel beams were installed for secondary uses of this facility. The beams seem to have concentrated the damage at the tops of the columns. This section was some sort of siding ending at the building.*

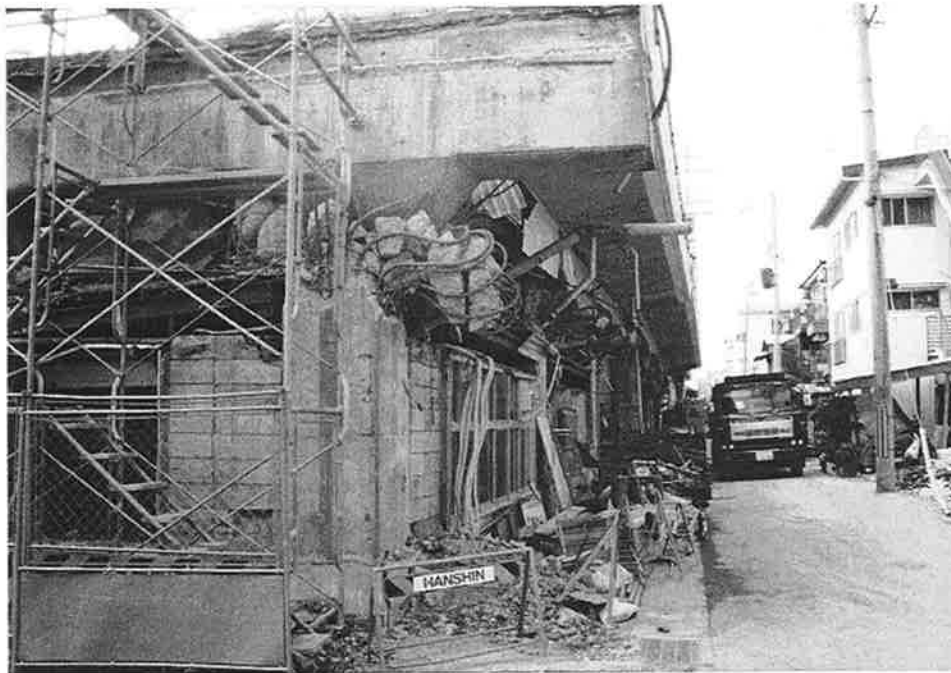
*HER-17. Another section that collapsed above the steel beams; the fore span was a steel girder street crossing that fell and was removed. The truck at the right is being used to clear rubble so construction equipment can gain access.*

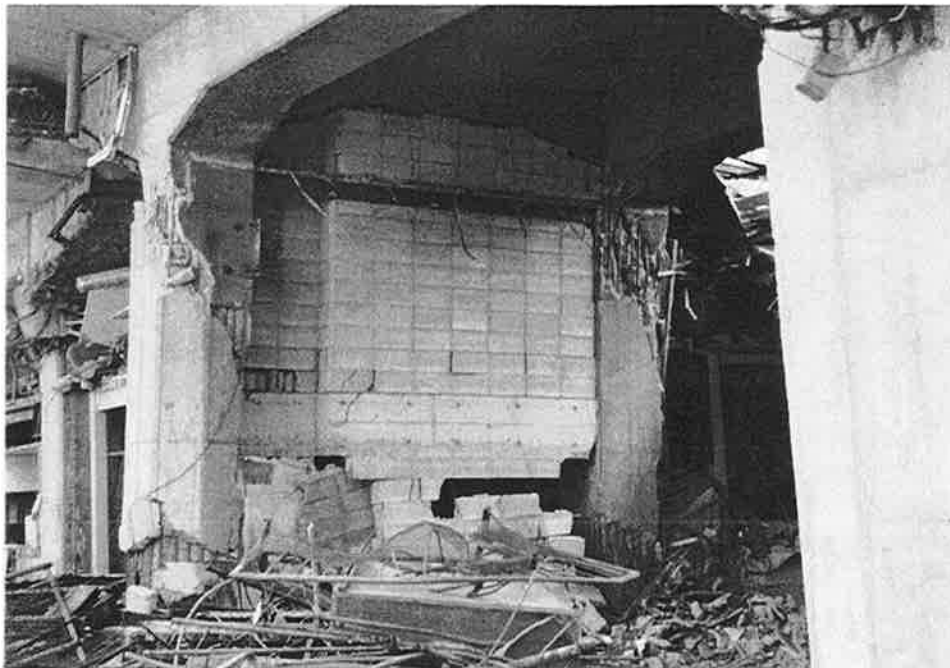
*HER-22. This unreinforced infill wall did not have adequate shear capacity. Note the shear cracks in both columns at greater than 45 degree angles and the flexure damage at the base of the columns.*

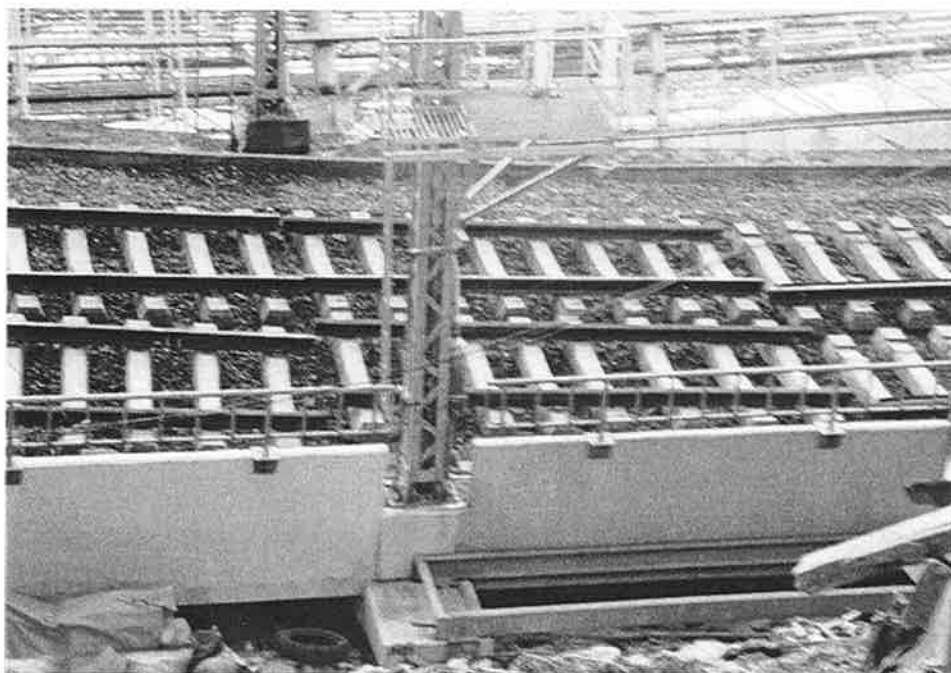
*HER-23. The parallel structure fell over with the superstructure nearly intact. The rails were cut to assist removal.*

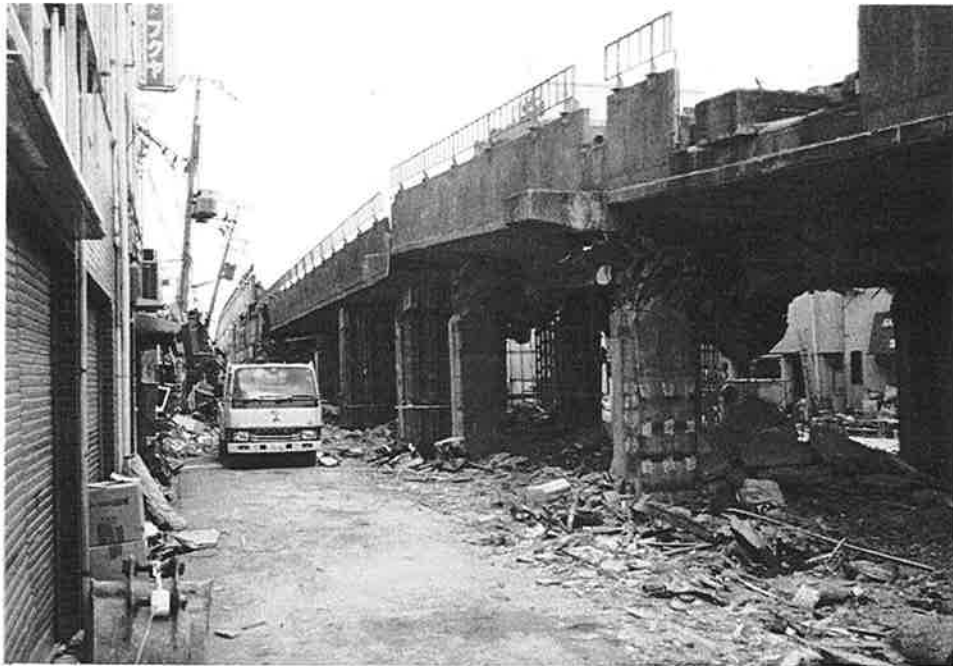
*HER-25. Broken columns and disjointed superstructure will require demolition.*

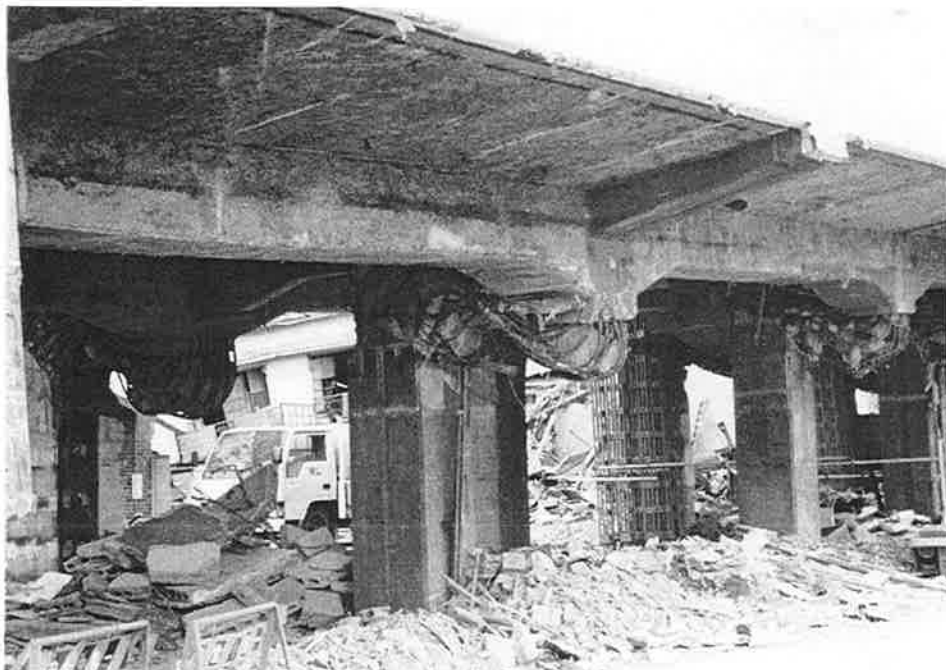
*HER-26. Another failed viaduct section; some of the debris is consistent with the additional use of the facility.*

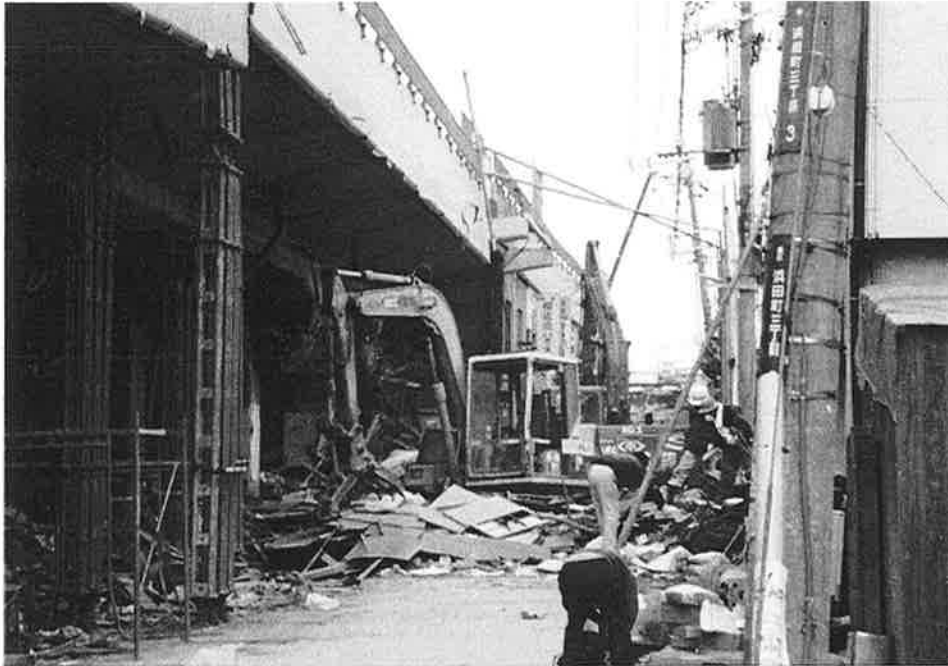
*HER-27. More damage and debris is adjacent to the viaduct.*

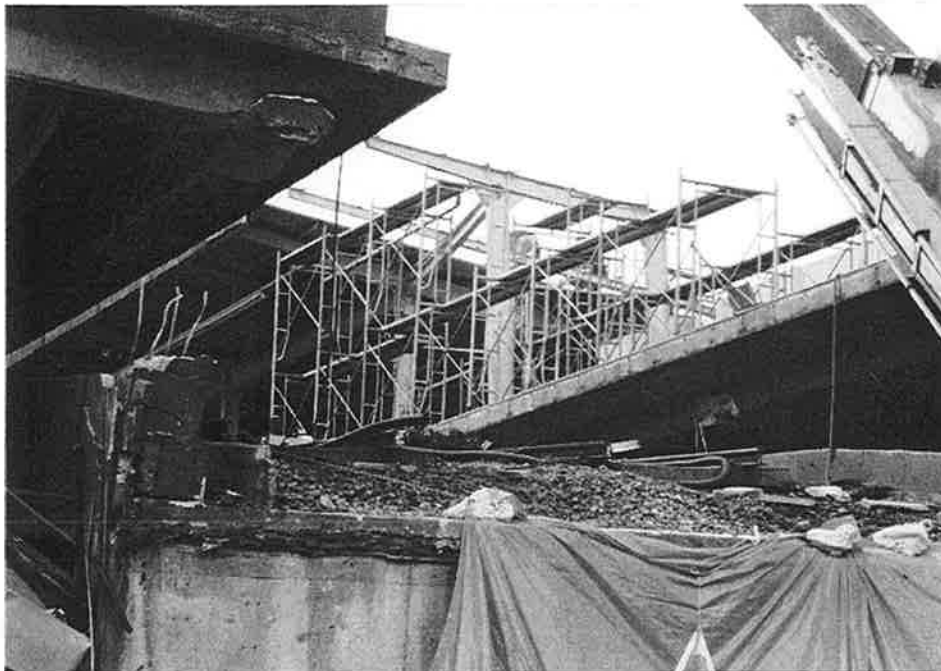
*HER-28. Demolition is underway at Shinzaike Station.*

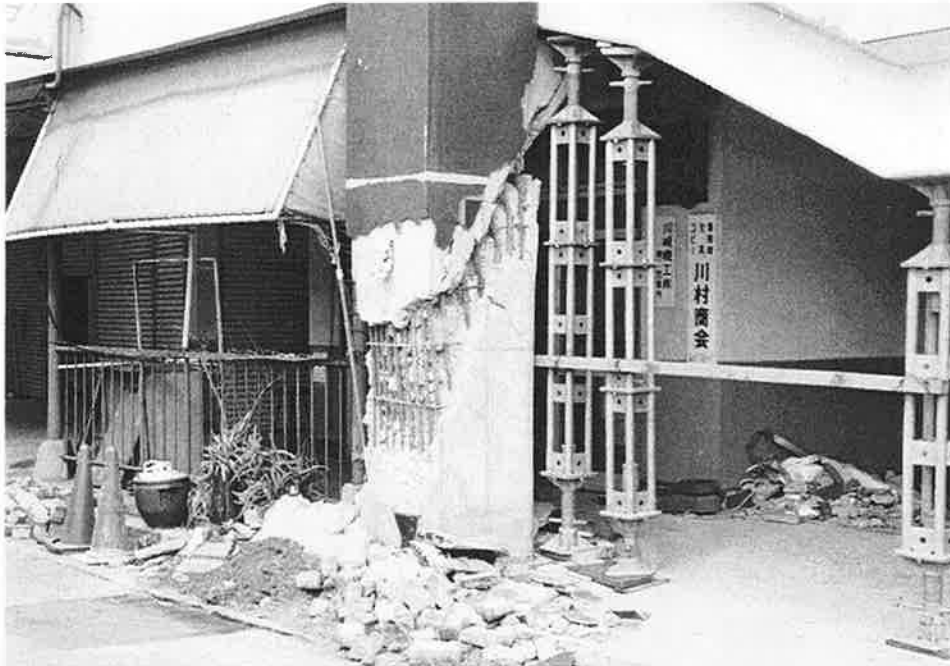
*HER-29. A severely damaged column near Shinzaike Station entrance.*

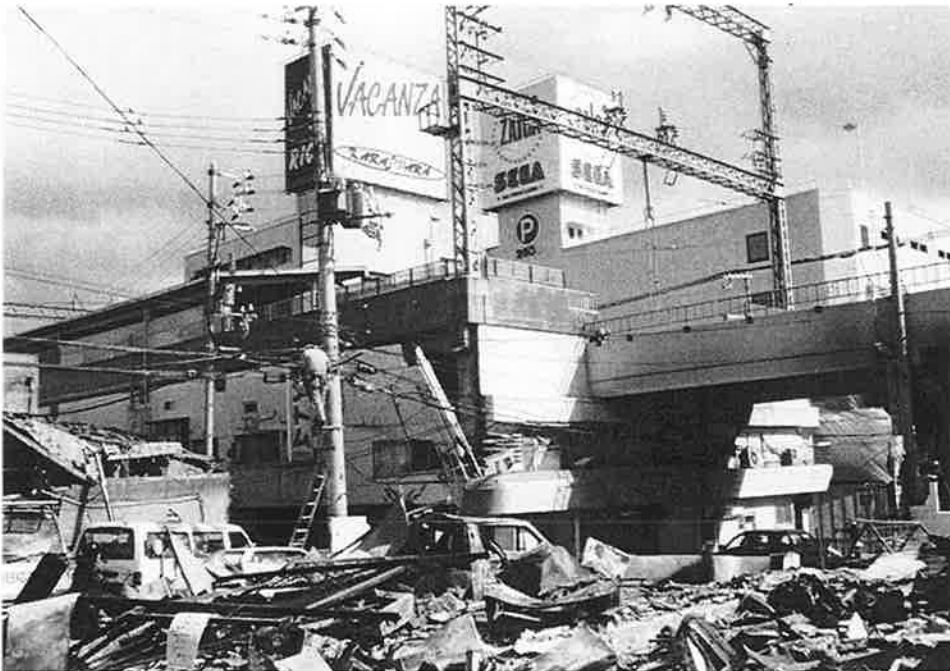
*HER-30. The damaged Shinzaike Station; note the destroyed and burned housing in the foreground and the electrician working on the power lines.*
