# **Seismic Damage Assessment of Rail Structures in Japan after the January 1995 Kobe Earthquake**

**Parsons Brinckerhoff Quade & Douglas, Inc.  
San Francisco, California**

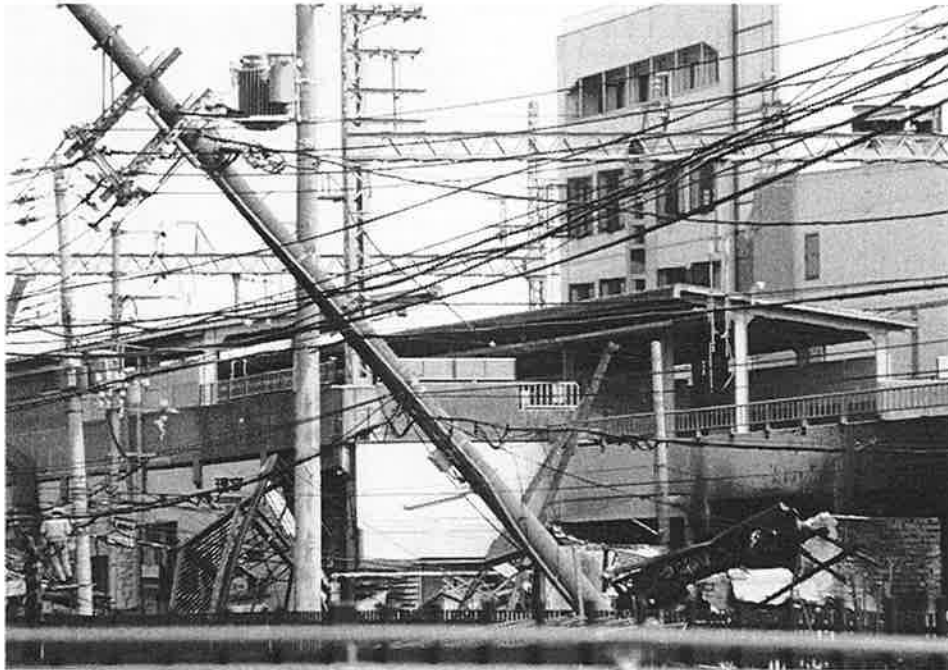
*HER-31. Close up of Shinzaike Station; over the remains of a burned up neighborhood. The leaning power pole in the foreground is typical of the infrastructure in the area.*

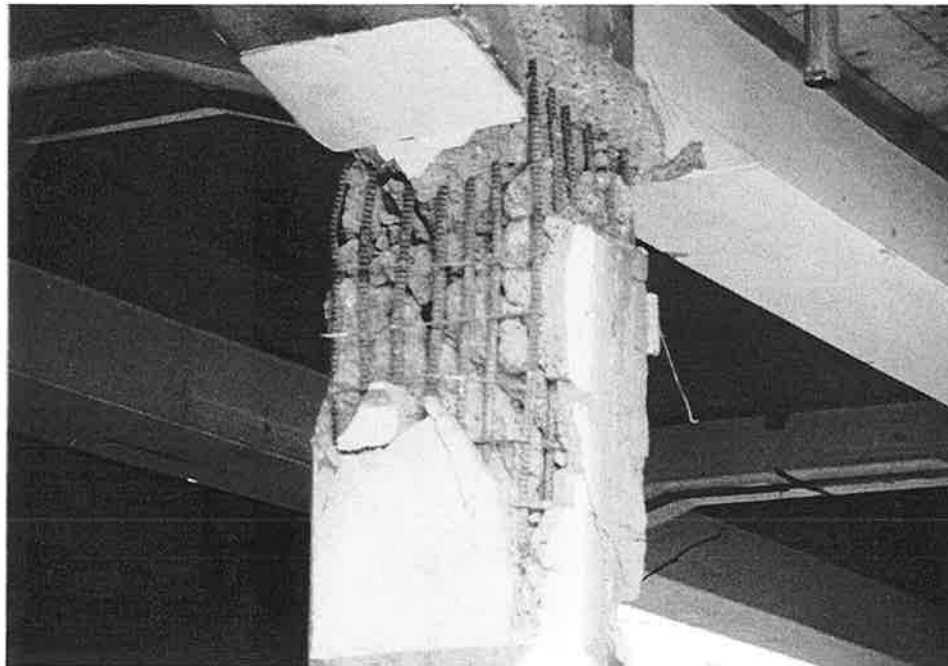
*HER-32. Damage to a column west of Shinzaike Station; major transverse shear cracking and longitudinal spalling are evident.*

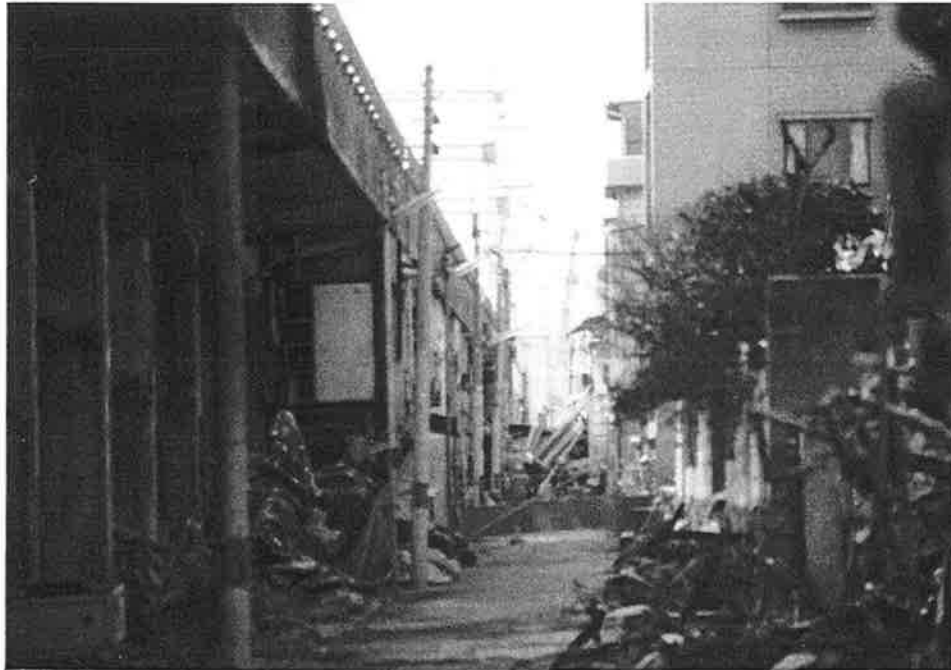
*HER-33. This barrier is visible in following photograph. There is minimal damage to the viaduct but residential damage prevents our access. This is the western limit of the viaduct damage.*

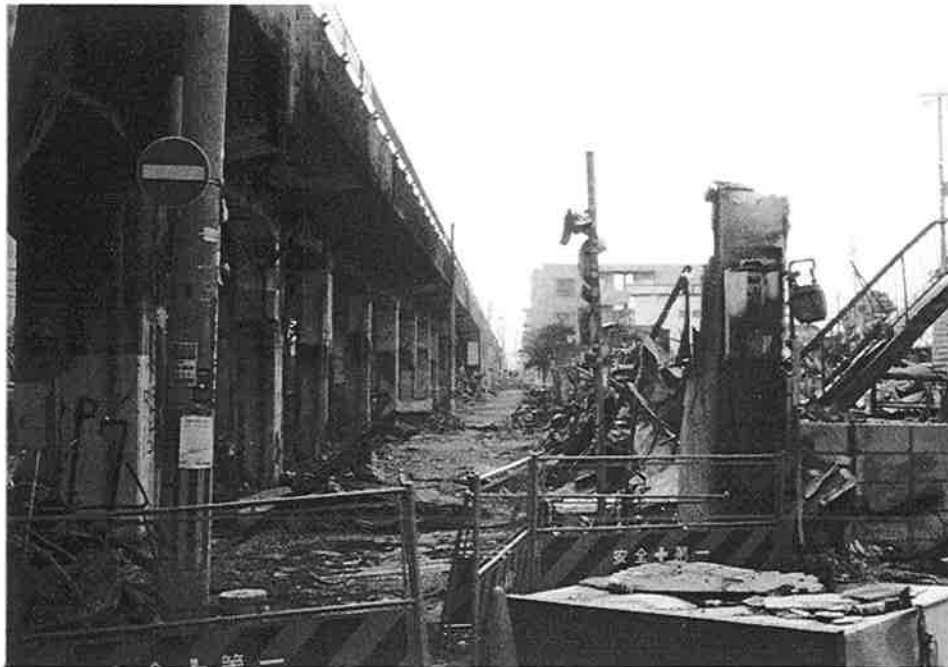
*HER-34. West of the station the damaged viaduct continues for at least another kilometer. The structure was blackened by fires that consumed many blocks. There isn't as much damage here. The structure is a little taller.*

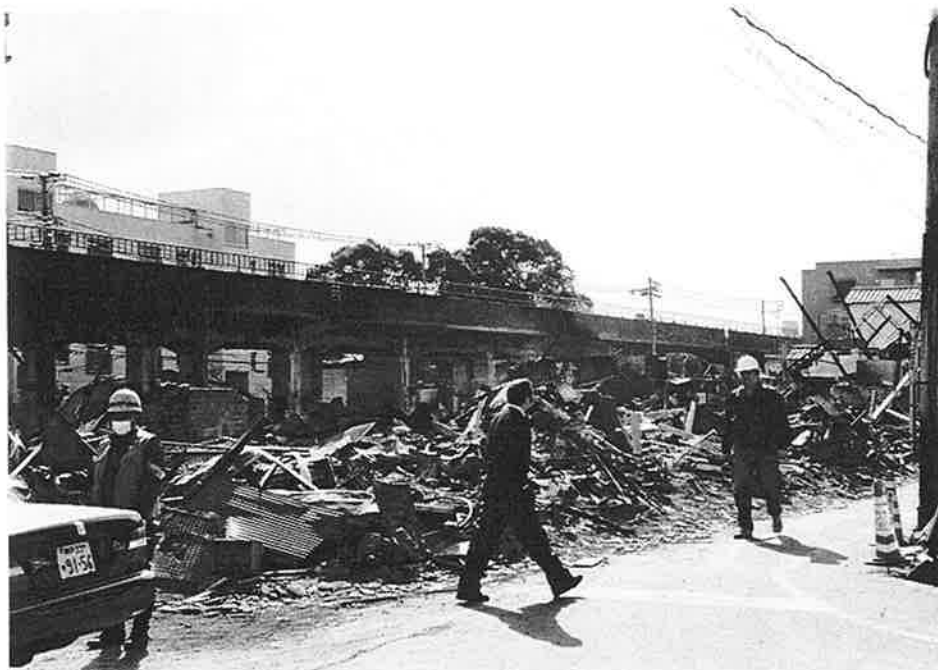
*HER-35. Viaduct is seen over the remains of a residential block.*

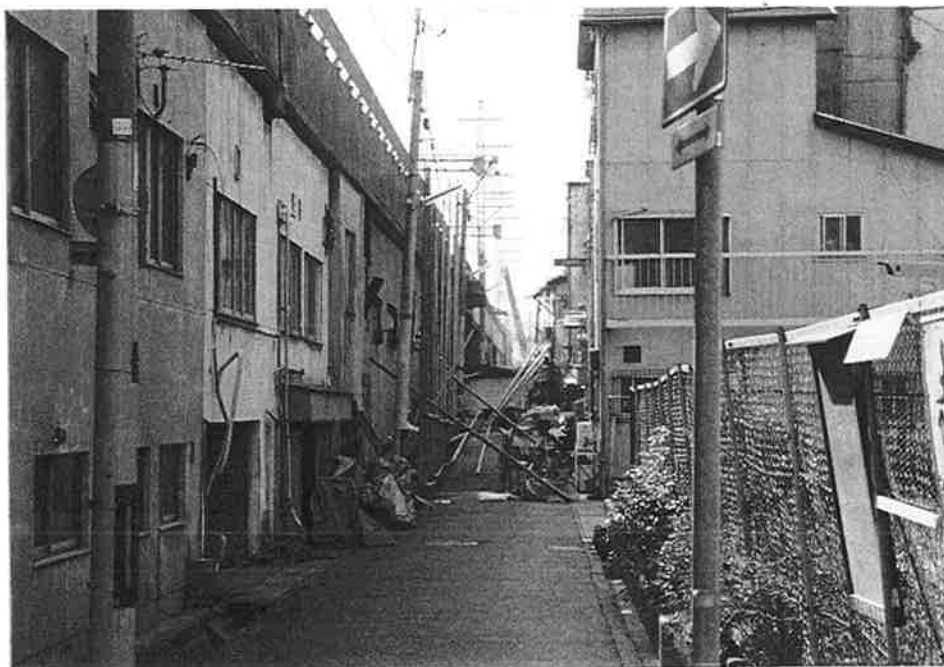
*HER-36. The viaduct to the left is undamaged, but our progress is stopped by the damage to lighter construction.*

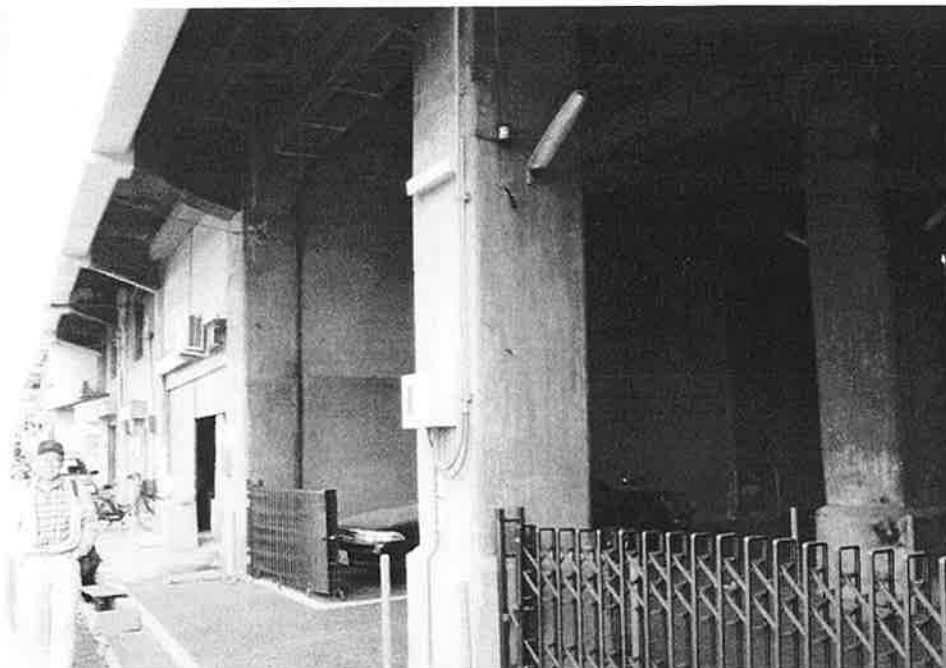
*HER-37. Substructuring adjacent to the Mikage Station is undamaged.*

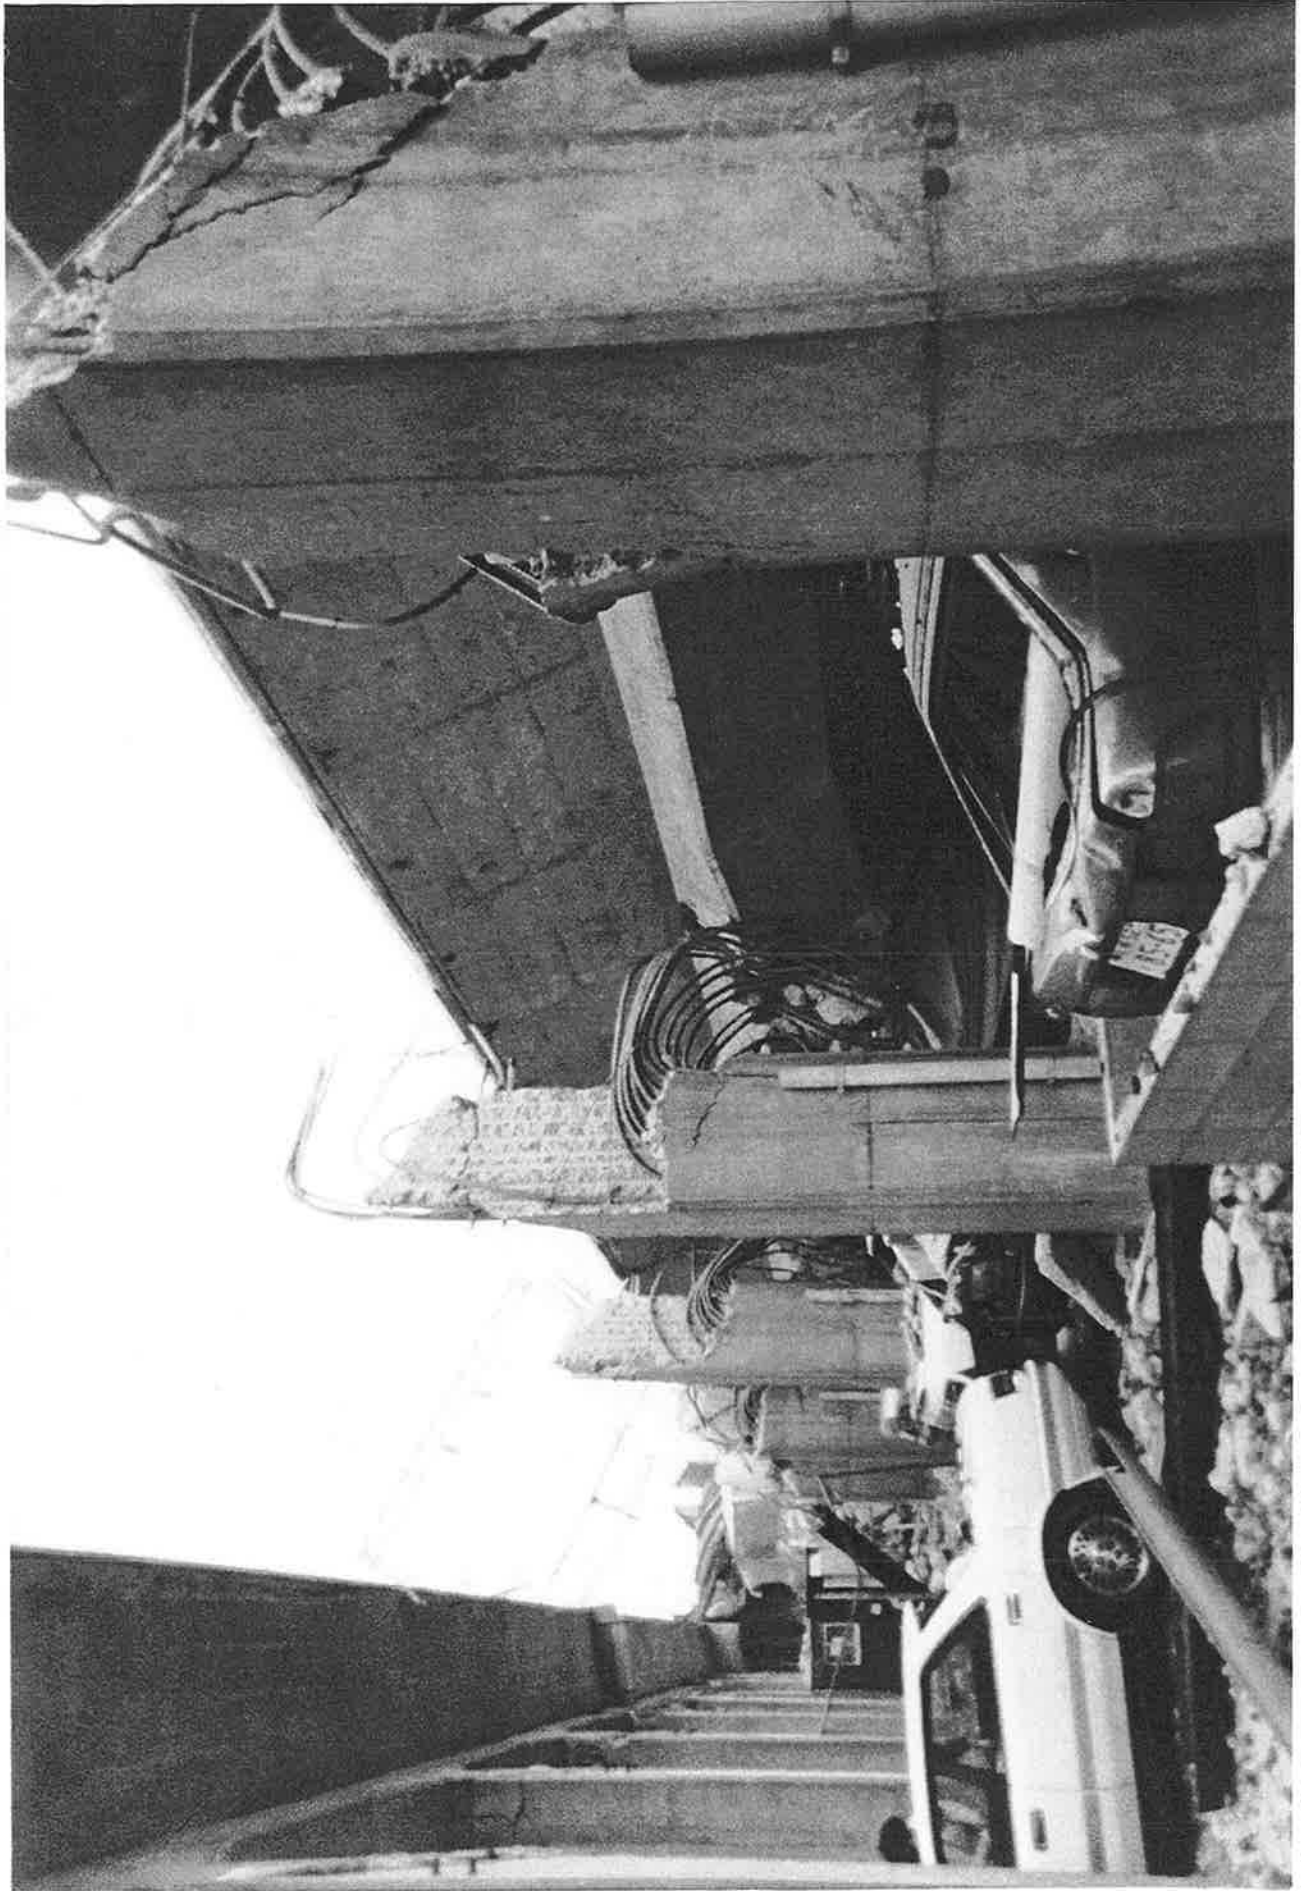
*HC-1. Hankyu parallel concrete viaducts. Northern viaduct was more heavily damaged. The joint between viaducts appears smooth and clean as there was no restraint between structures, or any pounding damage. (photo courtesy of M. Yashinsky)*

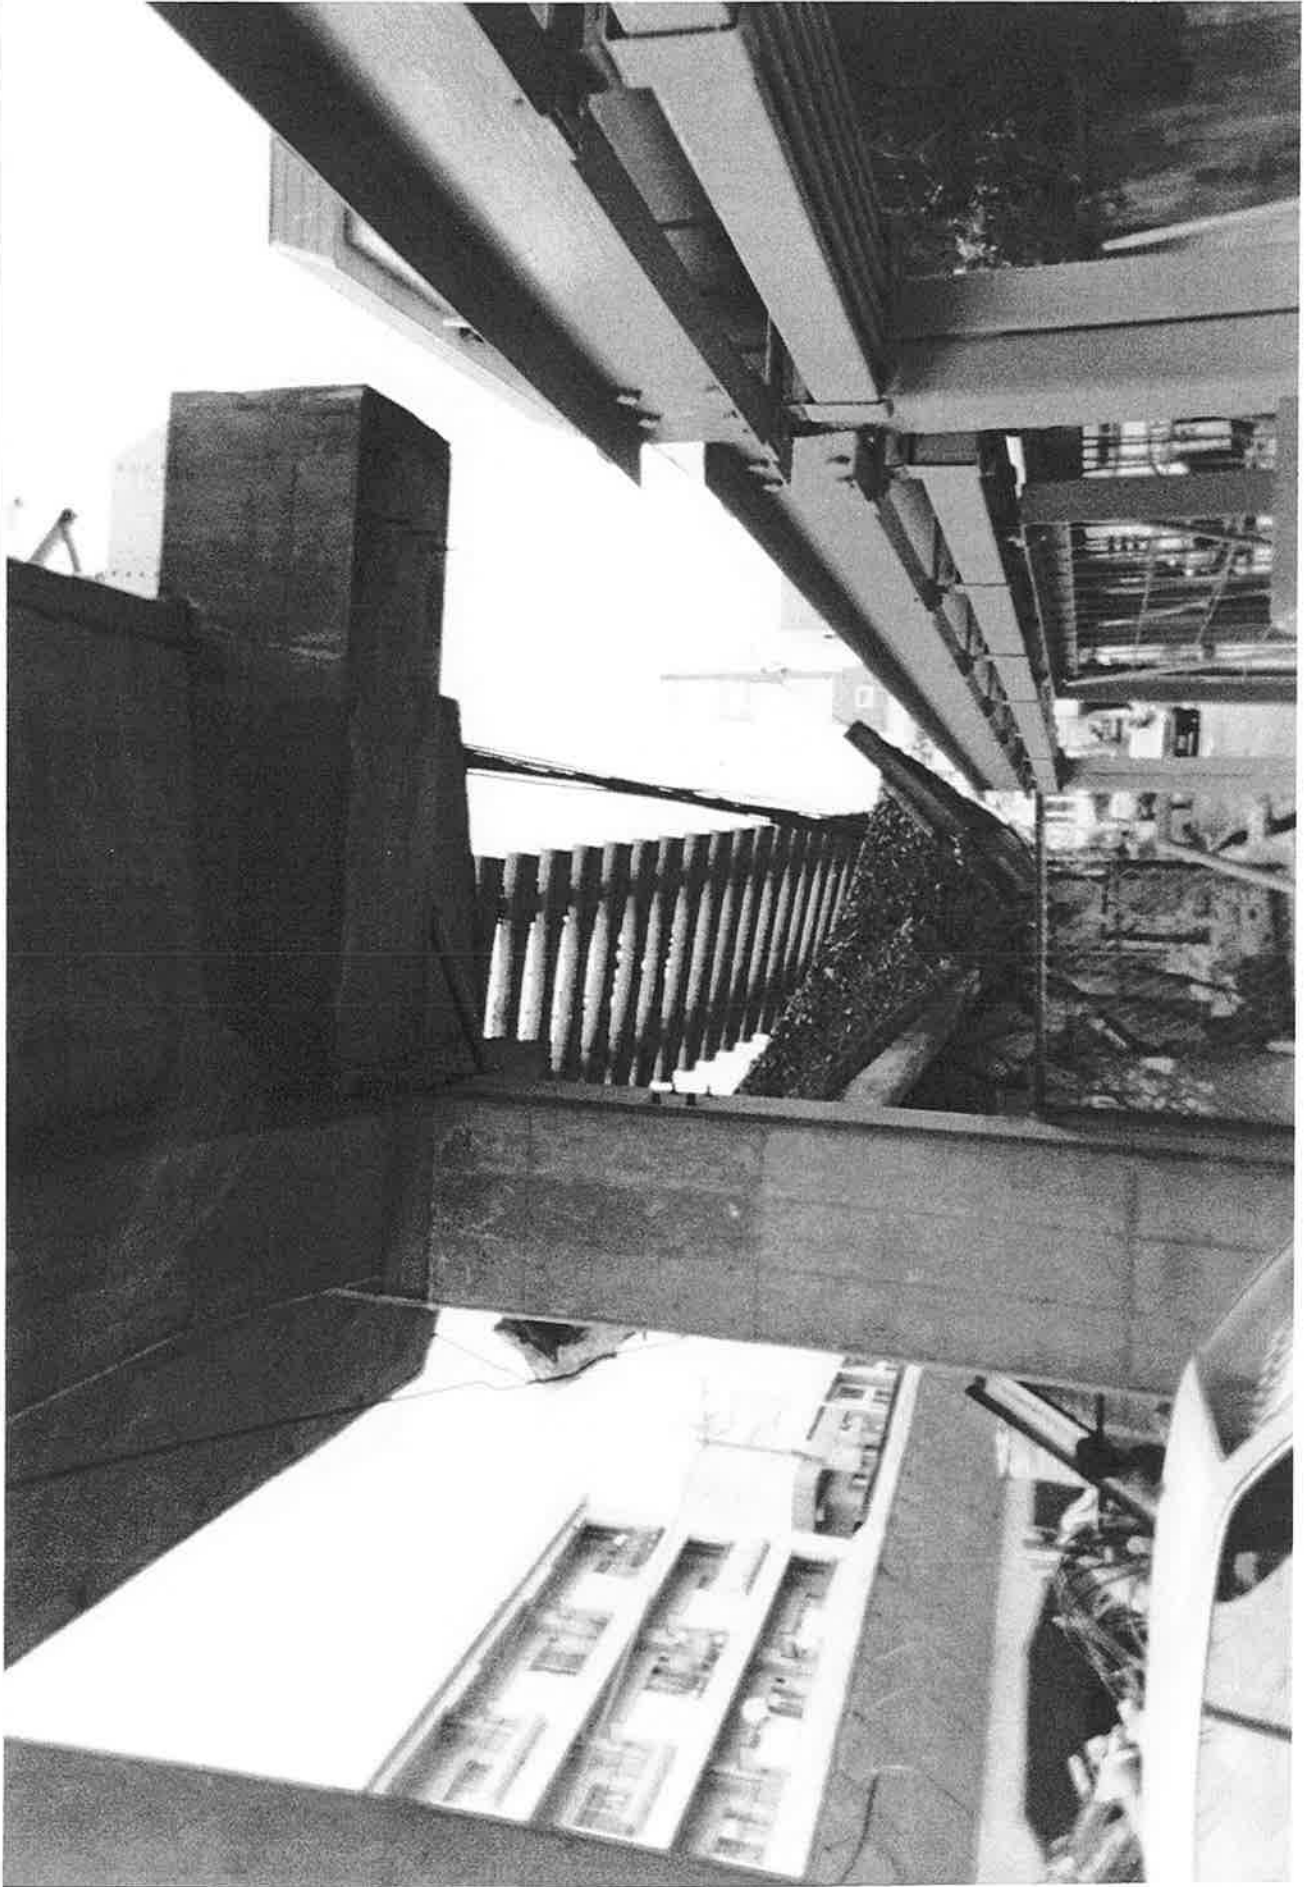
*HC-2. Once again the northern viaduct is totally collapsed. The southern viaduct is collapsed at an expansion joint. Notice the ballast and track have provided no restraint. (photo courtesy of M. Yashinsky)*

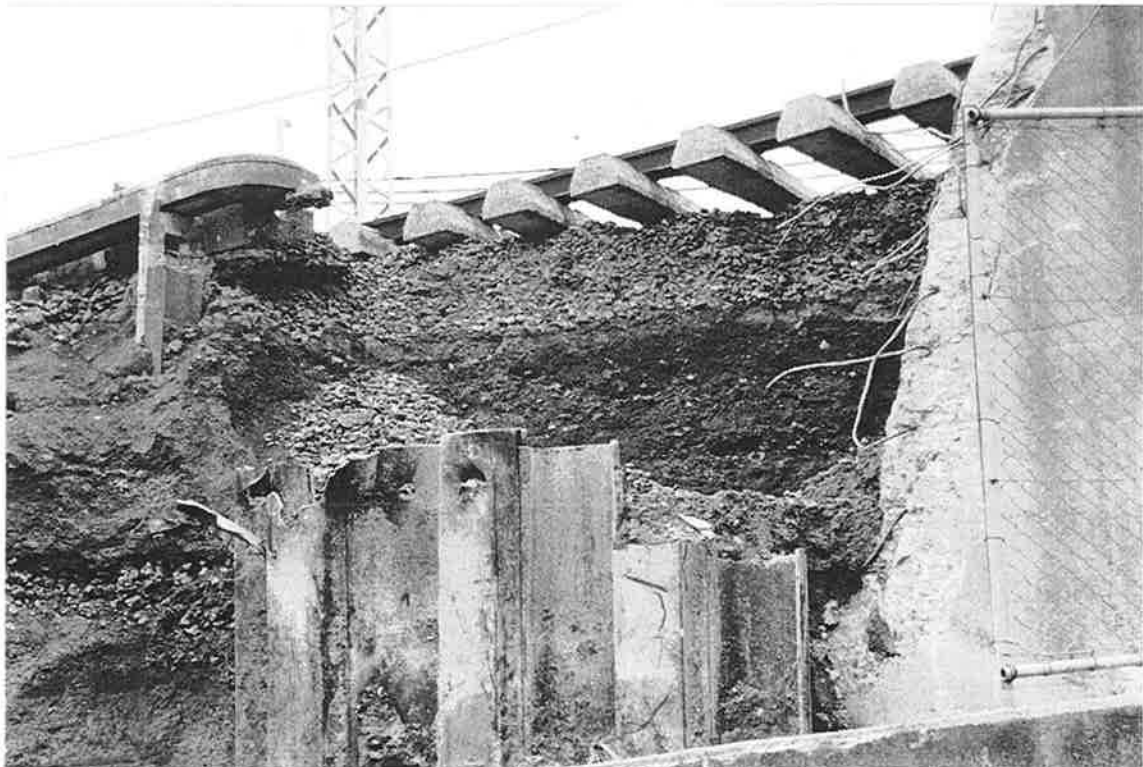
*HC-5. Embankment failure undercutting concrete ties at an abutment near Nishinomiya Station*

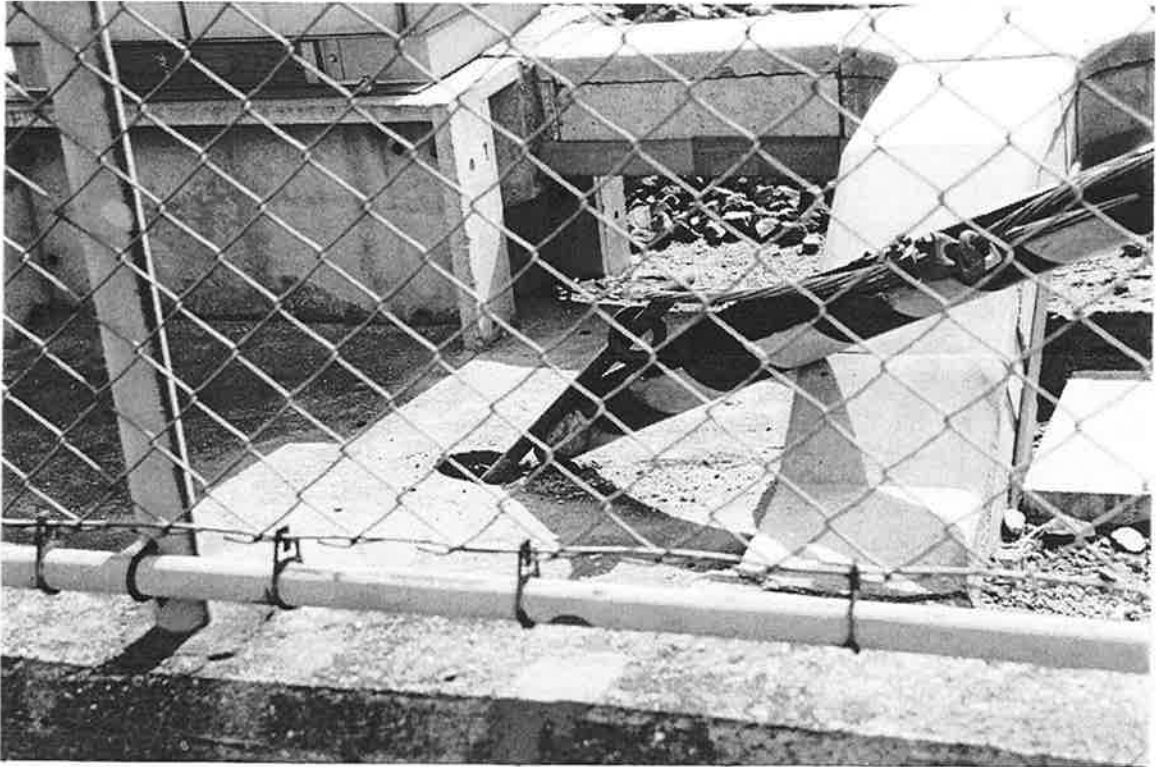
*HC-6. Anchors pulled out of this electrification support stay allow the support tower to sway freely.*

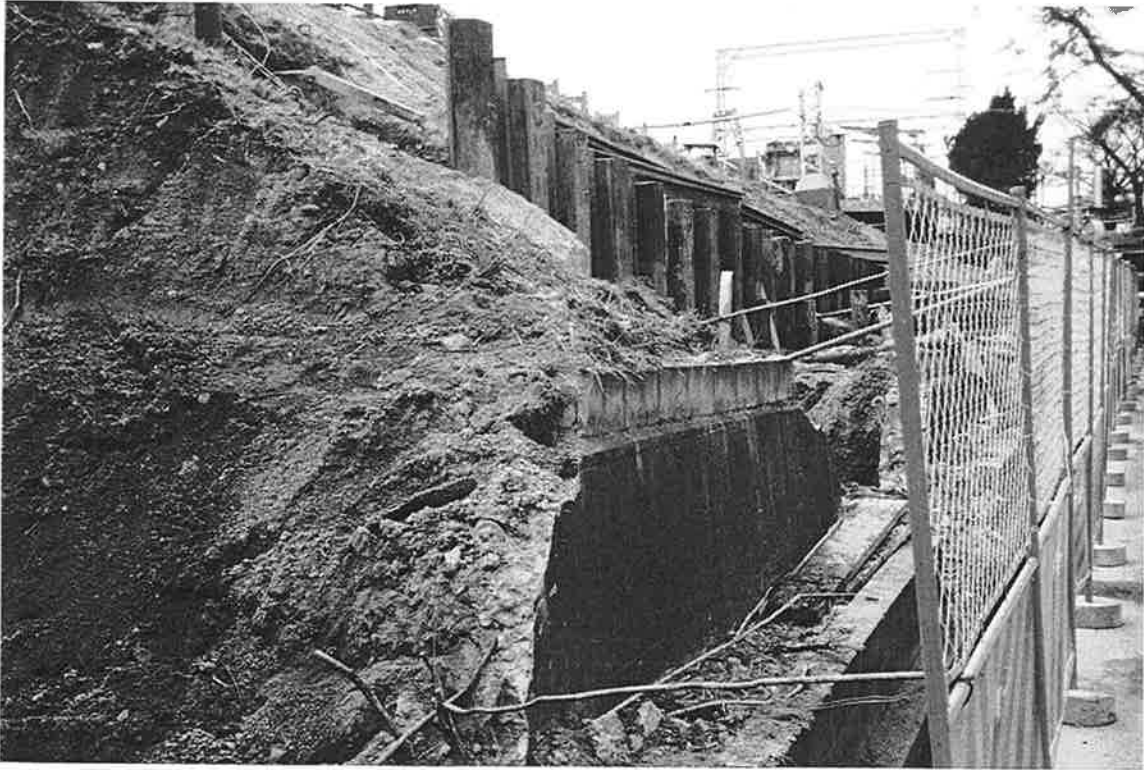
*HC-10. Failed retaining walls near Shukugawa Station*

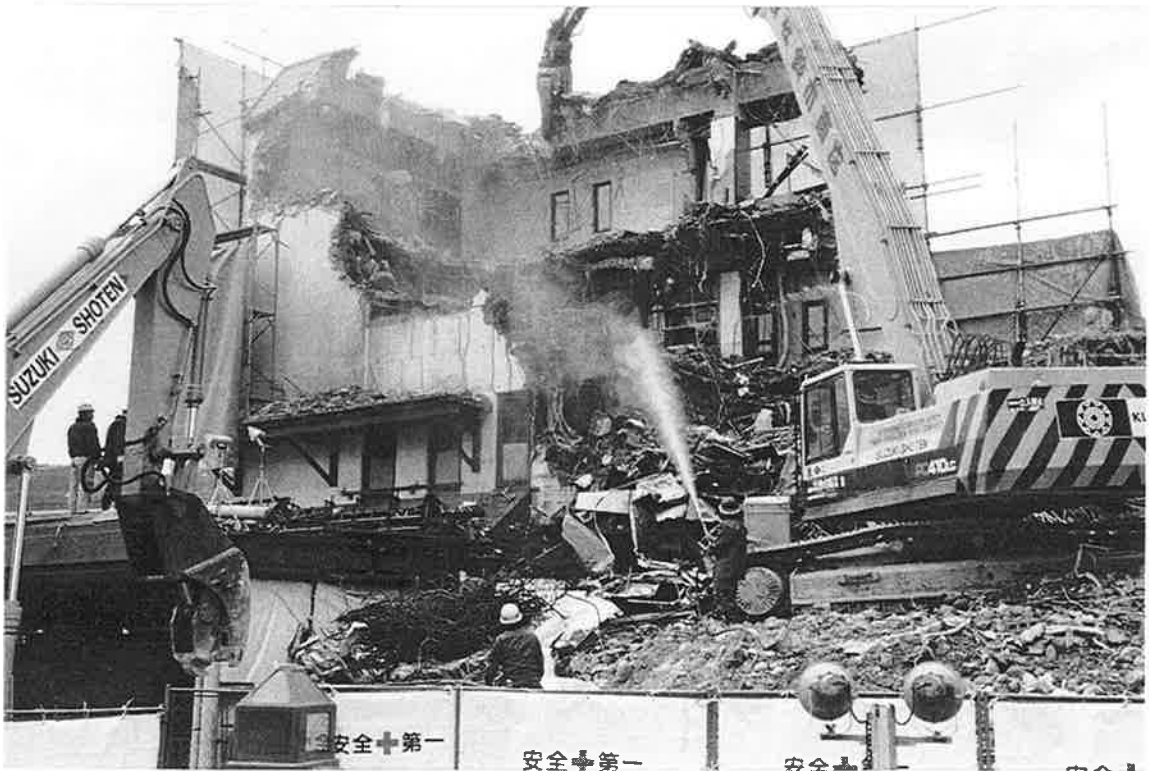
*HC-11. Shukugawa Station demolition*

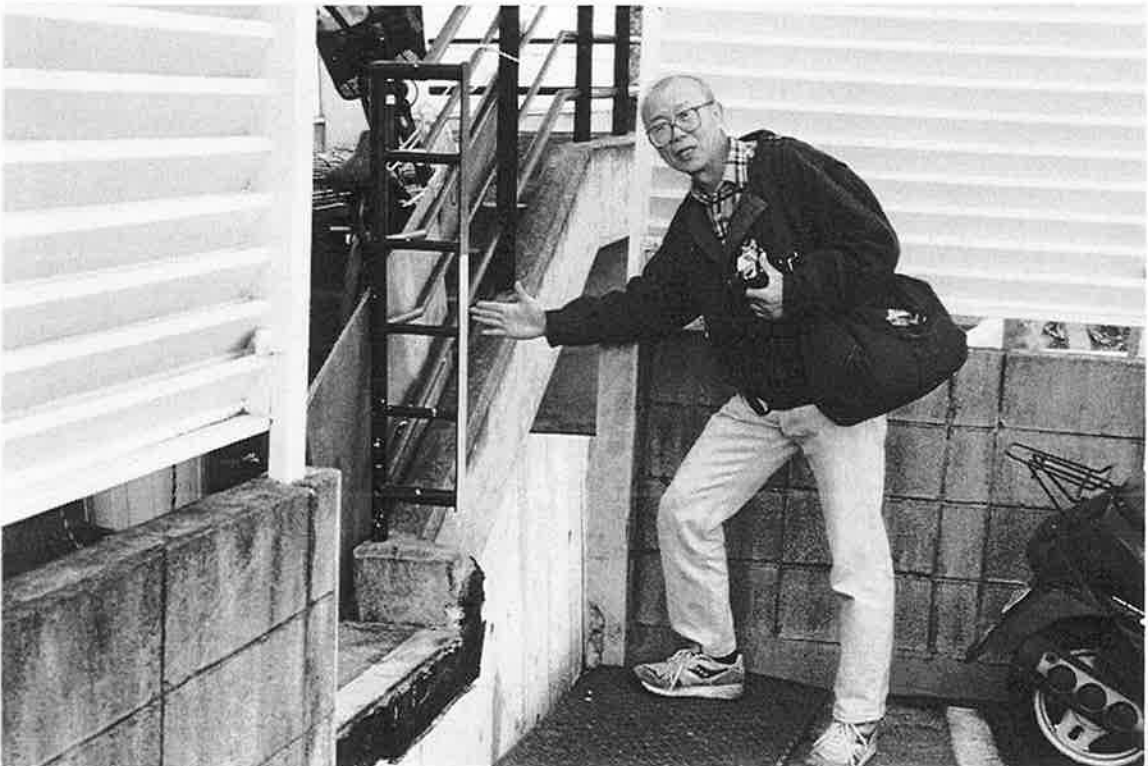
*HC-13. Kenneth Liu is demonstrating the settlement and displacement caused by the earthquake at Shukugawa Station. The settlement is nearly 300 mm and the displacement is 400 mm.*

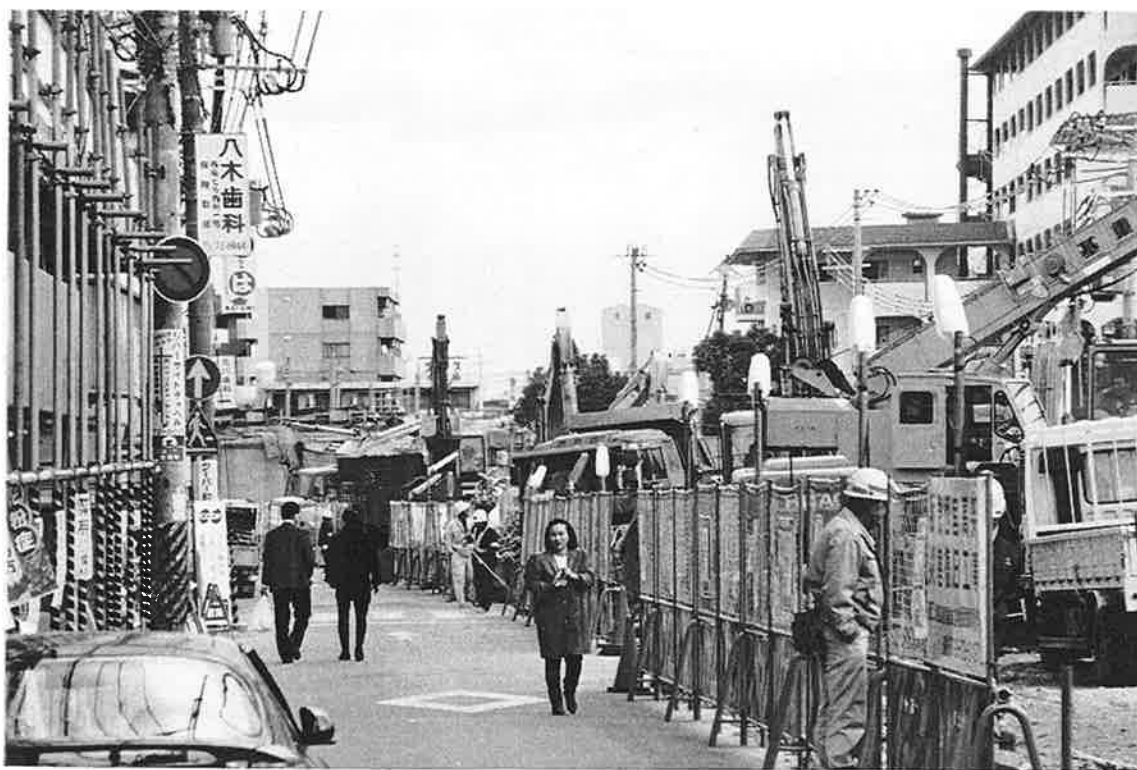
*HC-14. This very crowded new construction to replace the demolished viaduct is between minimally damaged residential and light commercial use buildings.*

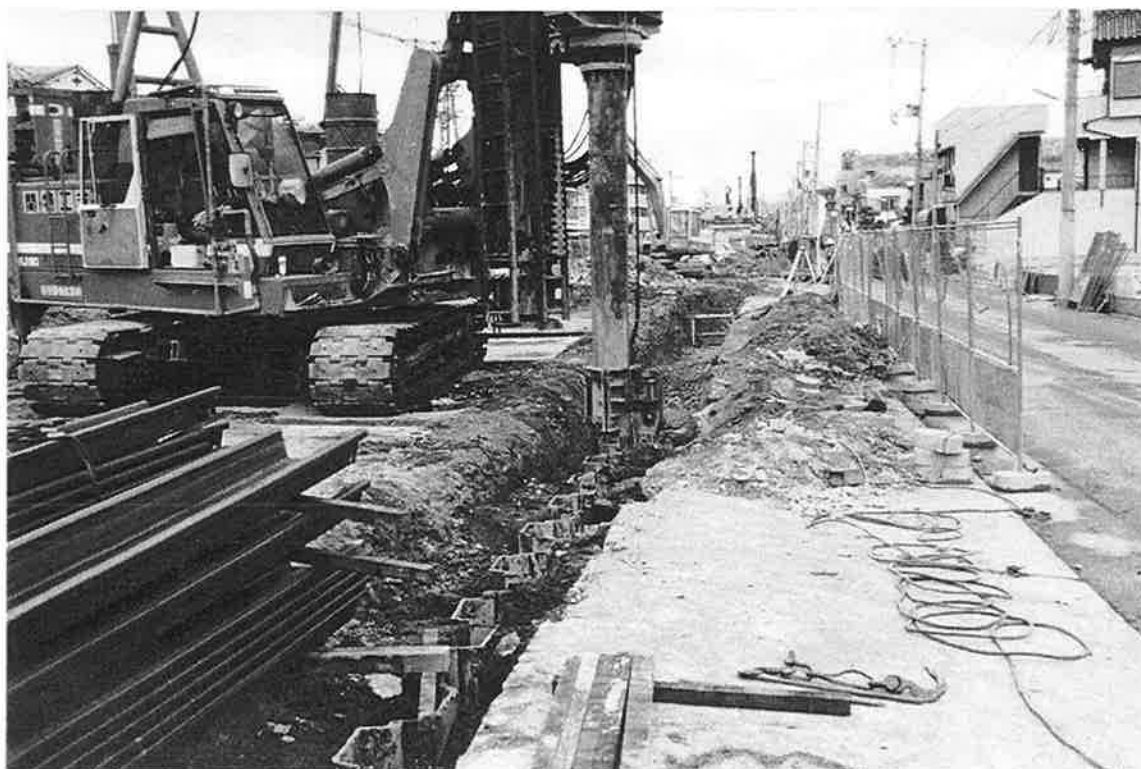
*HC-15. New sheet piles being driven on the north side of the demolished viaduct.*

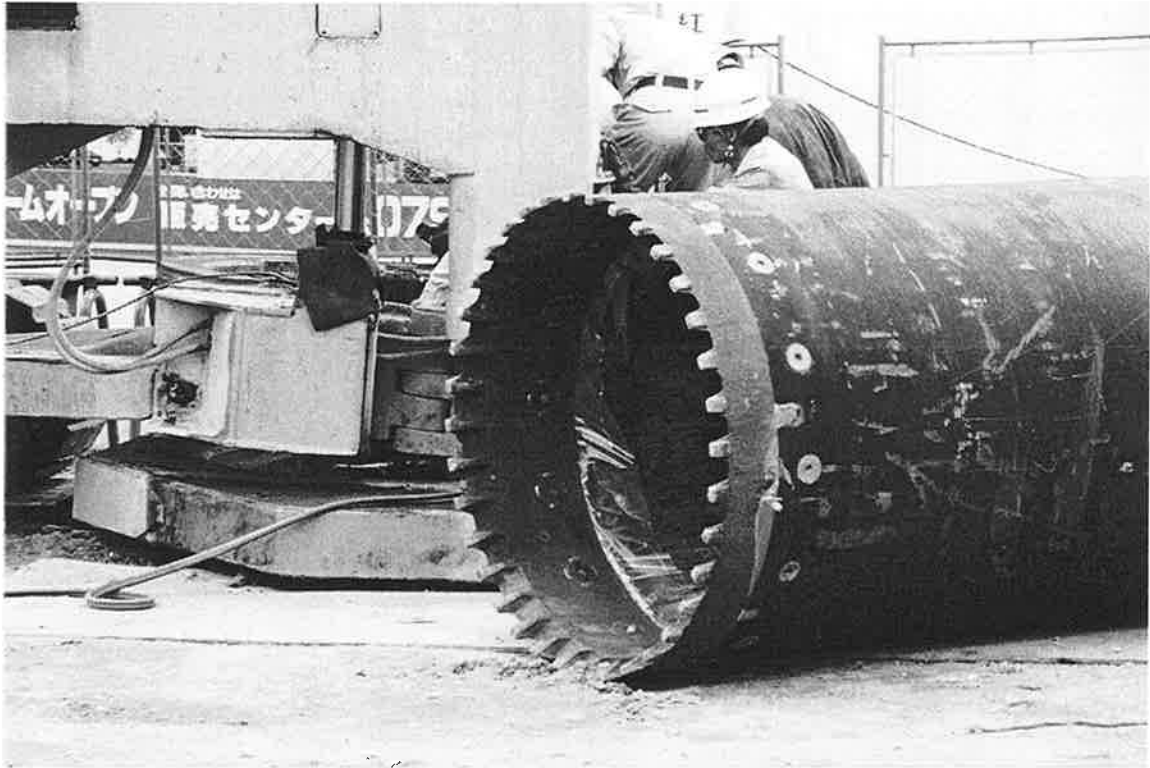
*HC-16. Foundations for the new viaduct will be about 1.3 m diameter drilled shafts. The reinforcing cages were near by.*

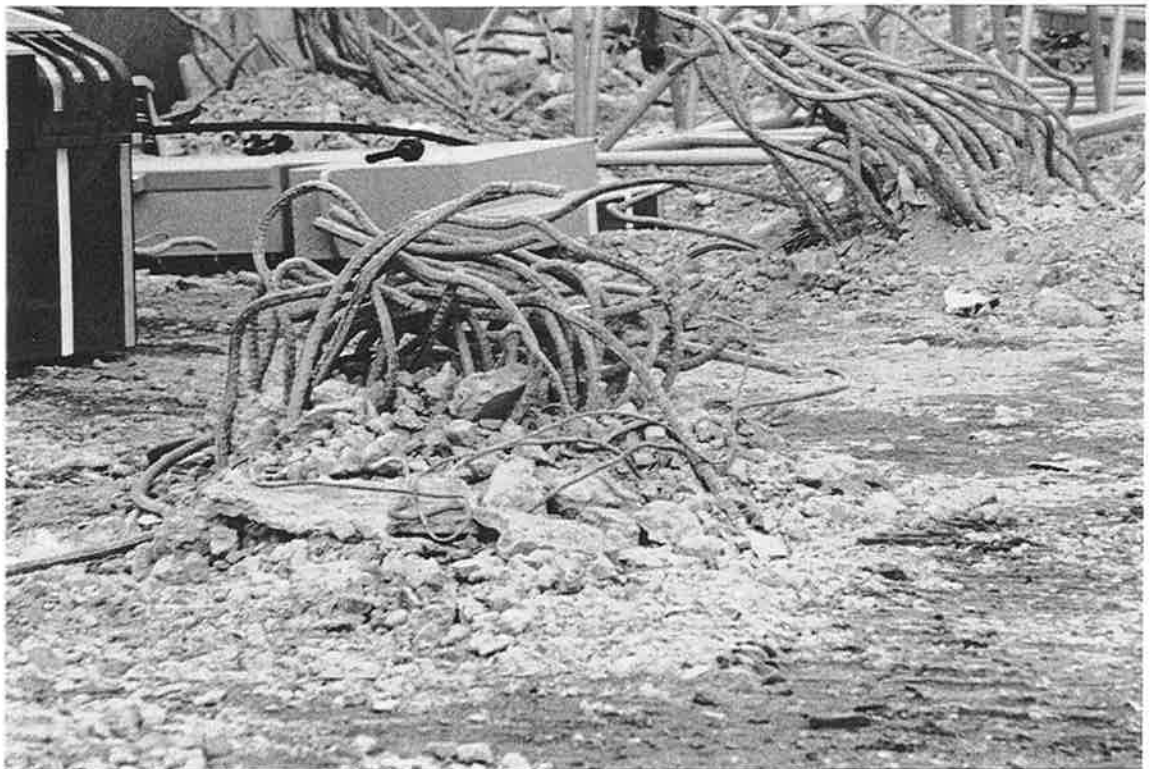
*HC-17. Remnants of the failed viaduct*

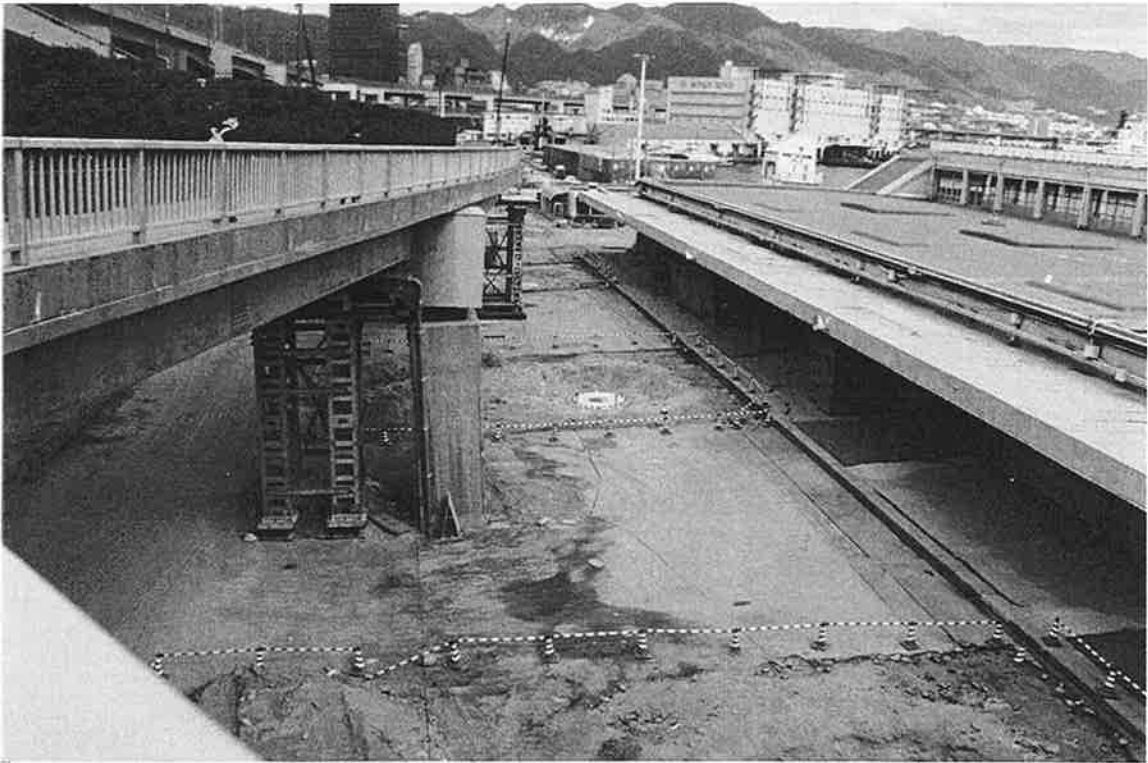
PI-5. The foundations like the bolt circle in the center are all that remain of the Port Island peplemover. A pedestrian bridge is to the left. Downtown Kobe is in the background.

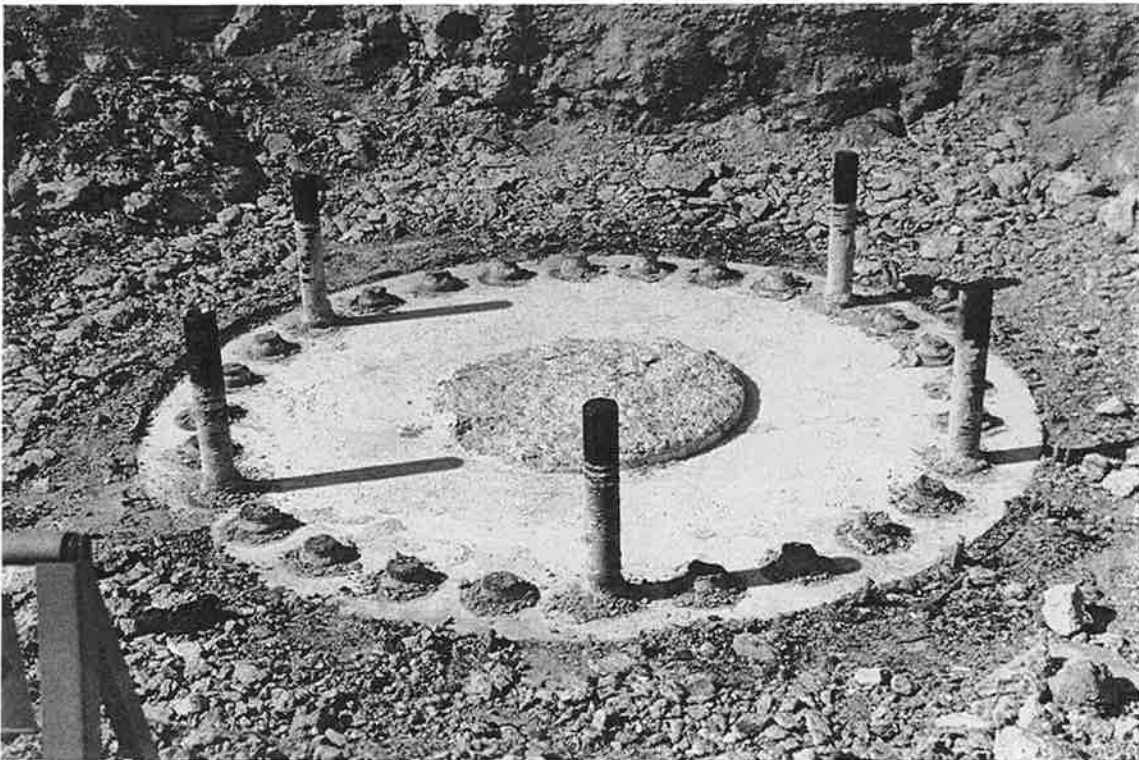
PI-6. The bolt circle remains from the peplemover pier. This indicates a circular steel column. The bolt circle is about 2 meters in diameter.

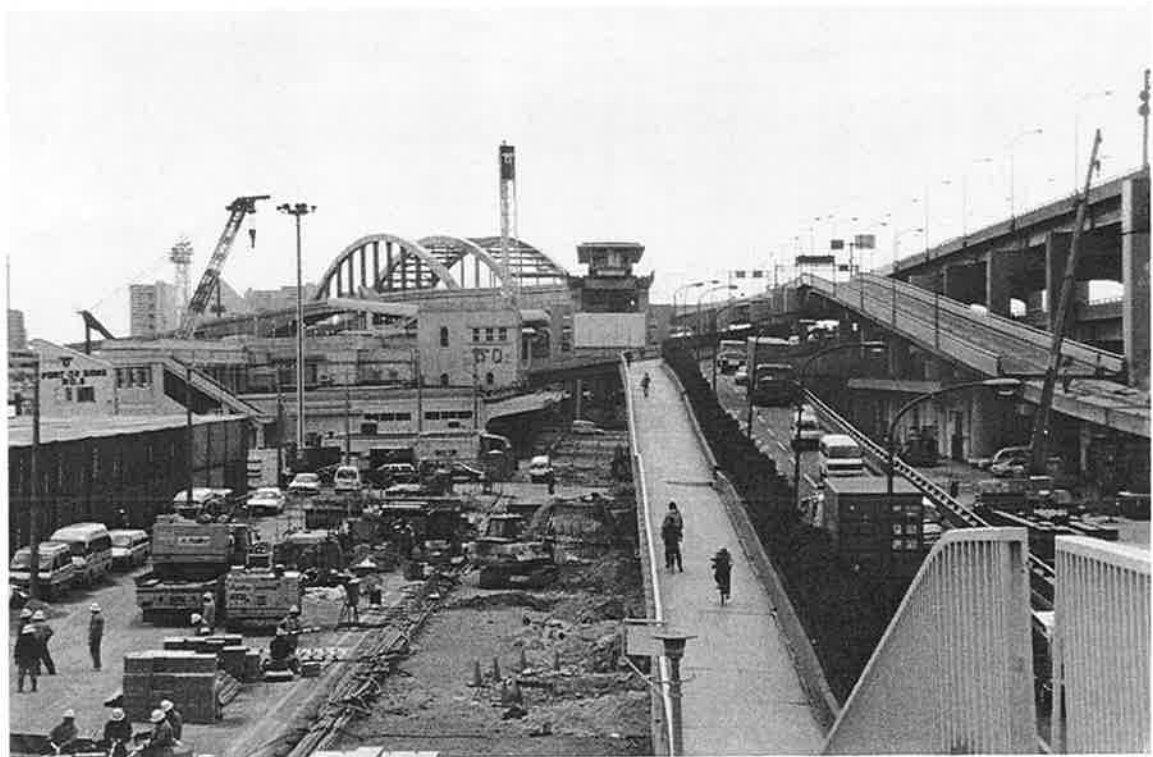
*PI-8. After a missing 300 meters, the peplemover resumes at the tower in the center. Port Island is in the background.*

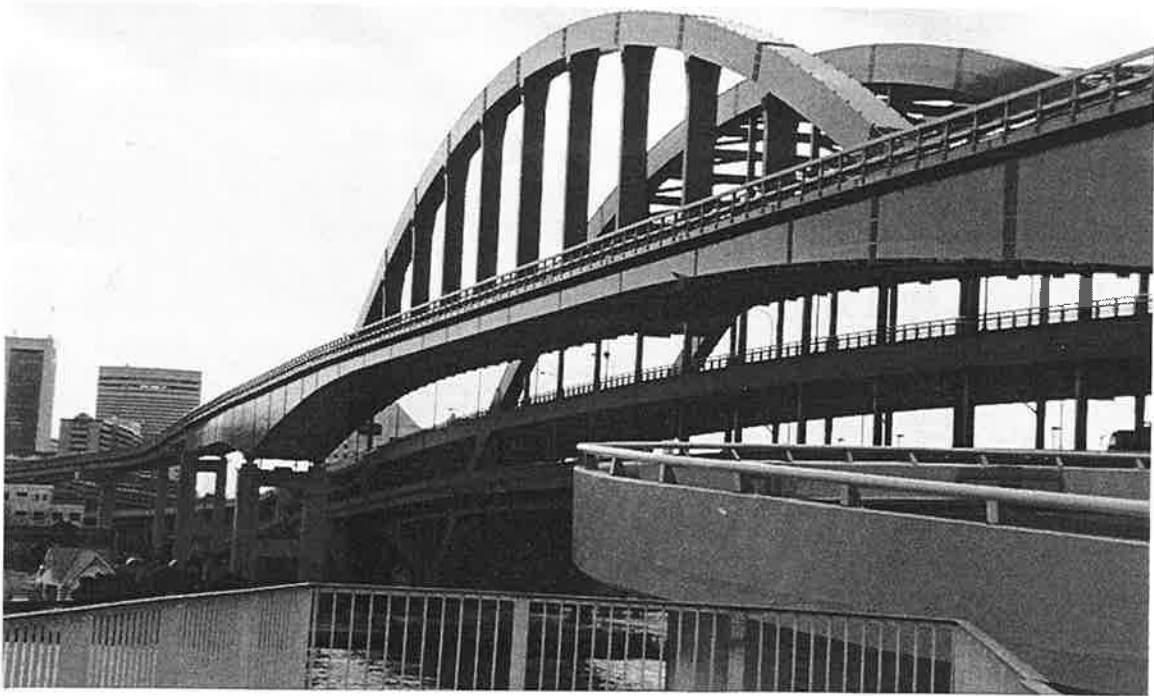
*PI-13. The single arch bridge in the foreground carried the people mover south to Port Island. It appeared undamaged. The highway bridge at the bottom right was severely damaged in the next span. The double deck arch in the background supports highway traffic.*

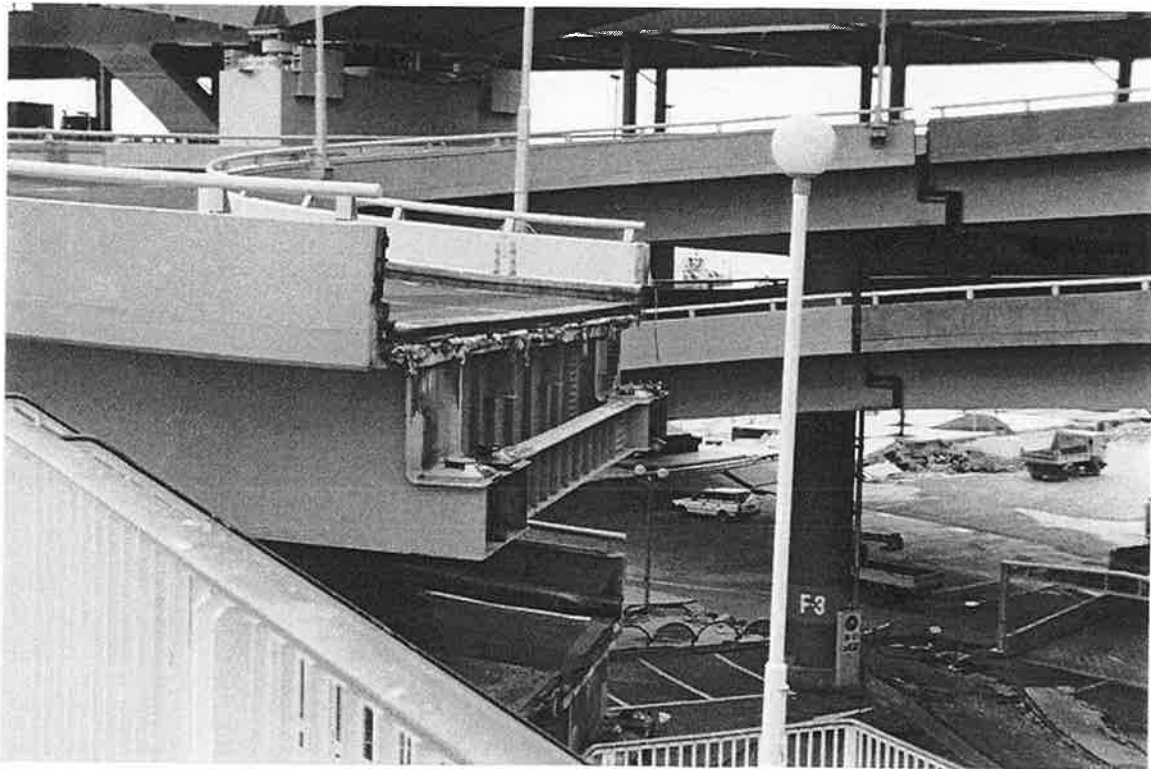
*PI-14. These spans of the double deck highway bridge fell from the short span bridge seats. The arch bridge pier is at the top.*
