# **Seismic Damage Assessment of Rail Structures in Japan after the January 1995 Kobe Earthquake**

**Parsons Brinckerhoff Quade & Douglas, Inc.  
San Francisco, California**

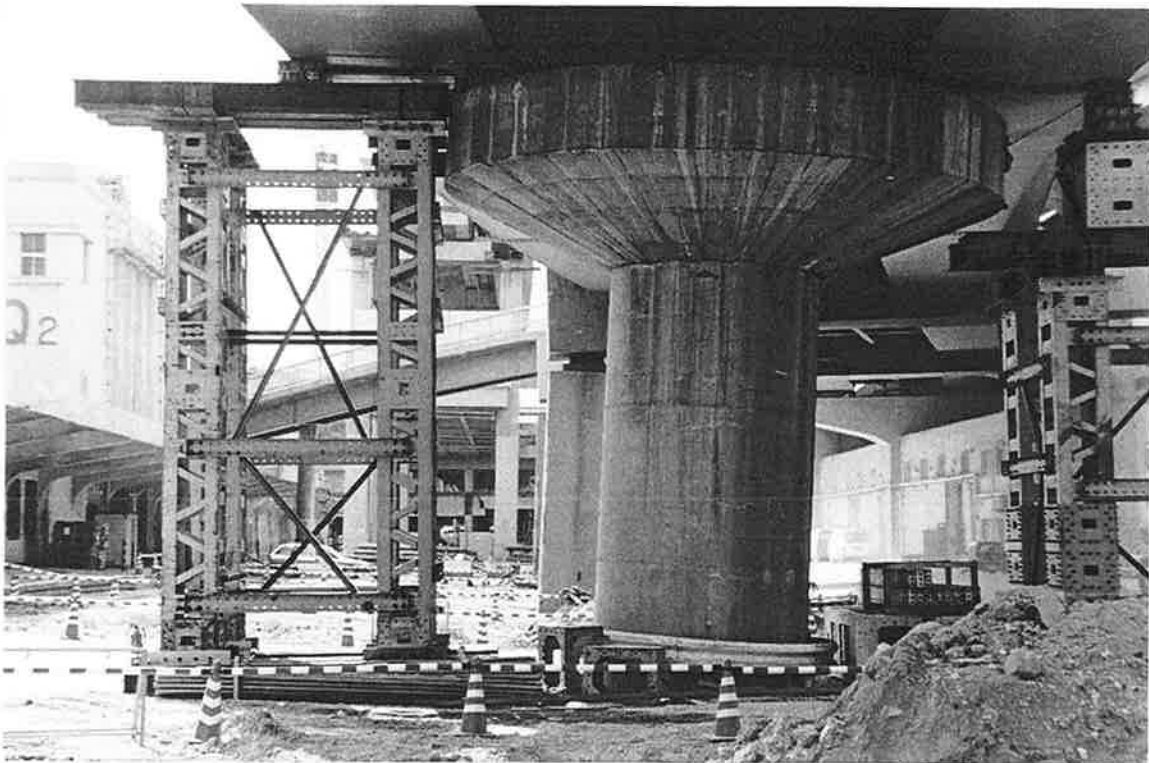
*PI-16. Adjacent to the failed peoplemover is an immense stiff pier supporting roadway and pedestrian bridges. Note the lean in the successive piers. Some foundation failure is evident.*

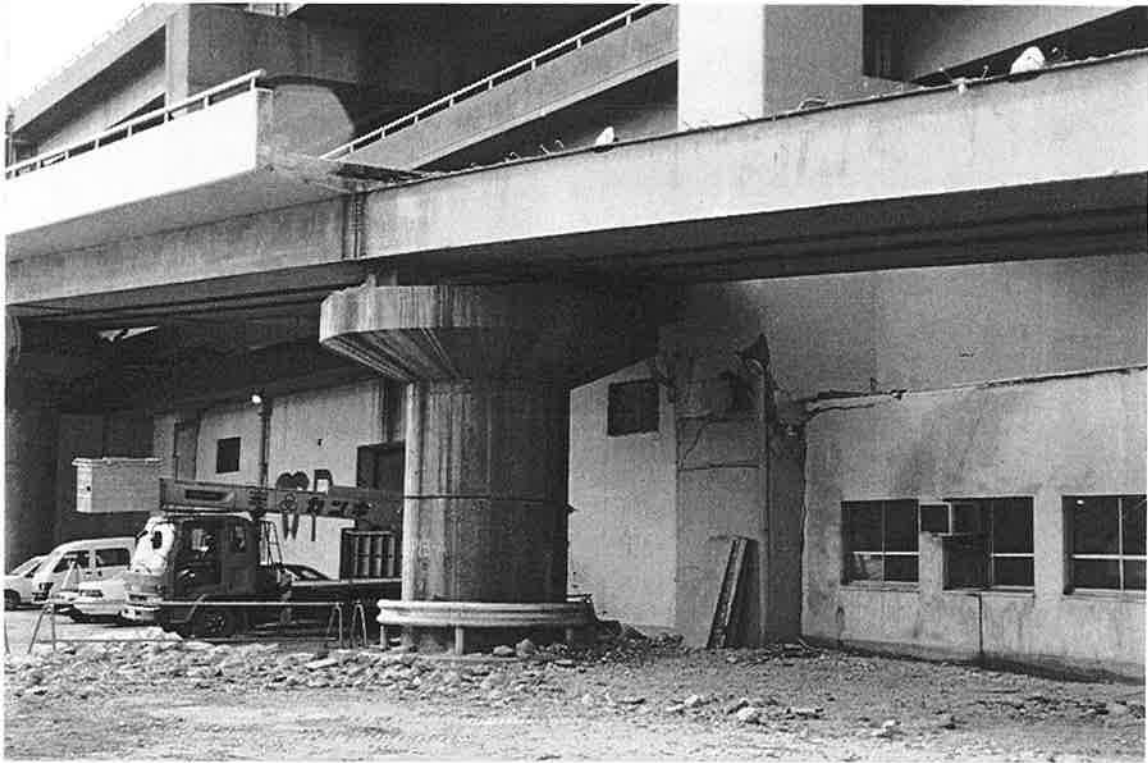
*PI-17. This highway ramp adjacent to the peplemover appears to be supported on a seismic isolation bearing. The deck was damaged here and demolished. The concrete substructure of the double viaduct sustained significant damage.*

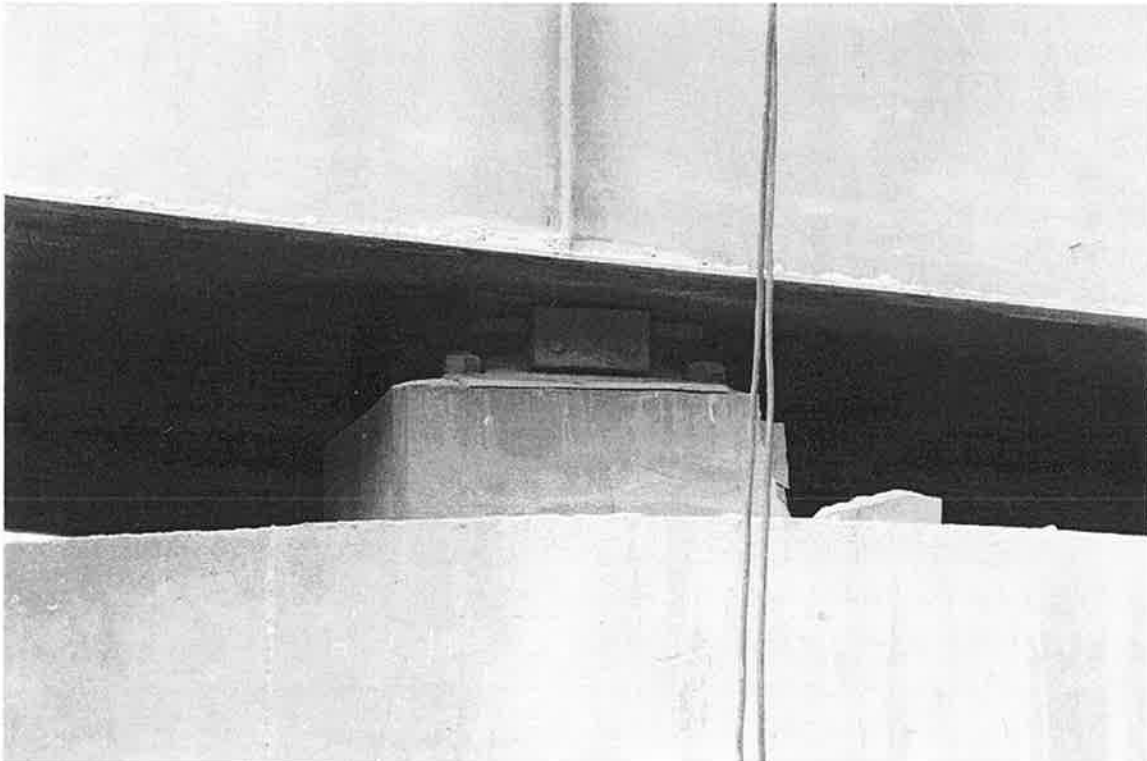
*PI-18. A close-up of the the isolation bearing*
