JRC2016-5705

CONTROLS TO ELIMINATE BROKEN RAILS IN SERVICE

Federal Railroad Administration
Washington, DC, USA

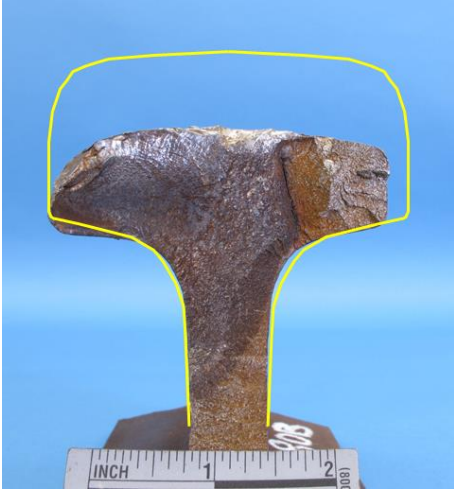
Figure 2. Worn Rail at Columbus (10)

During the NTSB's reconstruction of the rail recovered after the derailment, investigators identified 24 oxidized internal cracks that fractured during the derailment. The running surface of the rail pieces showed evidence of flaking and severe rolling contact fatigue cracks.

The faults in Figure 1 that relate to this accident are "Rail Surface Damage" and "Worn Rail" (see Figure 2). The rail surface damage prevented the critical defects from being detected by ultrasonic test equipment. The loss of rail cross-section caused high rail stresses that, combined with the critical defects, led to the broken rail.

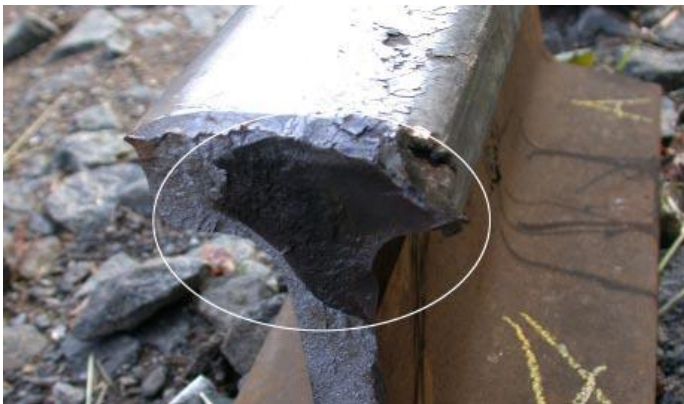
Figure 3. Broken rail and rail surface damage at New Brighton (12)

The NTSB found rail surface damage and worn rail were also the probable faults that caused the accidents at Ellicott City, Maryland on August 20, 2012 (11) and at New Brighton, Pennsylvania on October 20, 2006 (12). NTSB recommendations from these accidents led to the formation of the Rail Failure Working Group of the Rail Safety Advisory Committee. This group developed the Rail Failure Prevention Program guidance document, which was distributed to the industry on July 25, 2014 (13). This document makes recommendations to the industry; to-date it has not resulted in any changes to regulations.

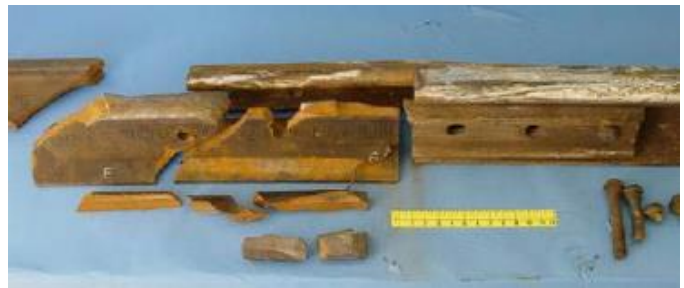
Figure 4. Reassembled Rail Joint from Painesville (16)

The NTSB determined that the probable cause of the accident involving tank cars carrying ethanol at Painesville, Ohio on October 10, 2007 was a broken rail due to installation of the wrong type of joint bar (15). This is fault “Bad Rail Joint” in Figure 1. It likely led to high rail stress causing the joint to fail from the bolt holes as shown in Figure 4.

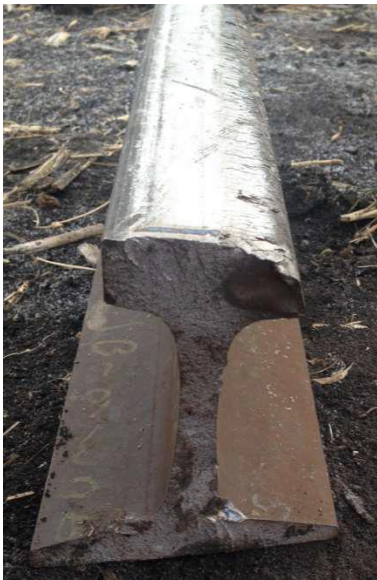
Figure 5. Rail surface damage and detail fracture at Casselton, ND

FRA preliminary investigation results determined that the primary cause of the derailment was a broken rail from the presence of a detail fracture type defect. It was also determined that an additional detail fracture failure occurred adjacent to this primary defect as a result of the accident.

The defects were suspected to be of a detectable size at time of failure. The rail specimen showed the presence of gage side oriented rail shelling and head checking (see Figure 5). It was assumed that the rail surface condition influenced the equipment detection capabilities at time of test, and the defects were not identified by the test system. The primary fault that caused this accident was assumed to be technology limitations, and failure for the inspection equipment to identify the internal rail flaws.

The probable fault that led to this derailment was “Rail Surface Damage” in Figure 1. A rail defect of critical size could not be detected due to the ultrasonic inspection being unable to penetrate the shelling and head checking on the surface of the rail.

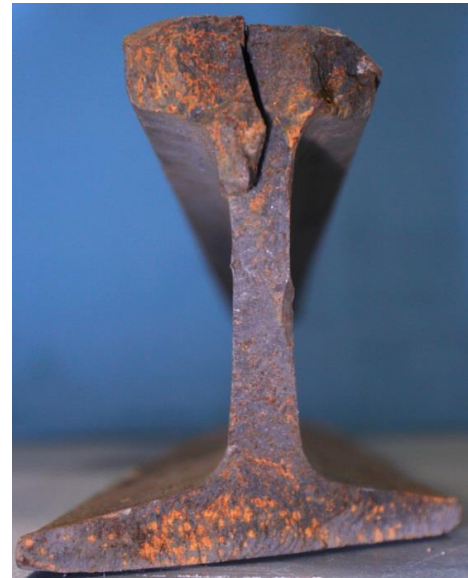
Figure 6. Vertical Split Head from the rail at Mount Carbon, WV

FRA announced the cause of the derailment to be a broken rail, resulting from a vertical split head rail defect. The defect that eventually resulted in the derailment was missed by the railroad, and its defect detection services contractor on two separate inspections in the months leading up to the accident. During a December 17, 2014 test, the test equipment recorded indications of a rail flaw at what would become the point of derailment (see Figure 6). A subsequent test, on January 12, 2015, noted a similar but more significant rail flaw indication at the same location. Despite indications of potential flaws, the operator failed to conduct a ground visual examination or hand tests to confirm the flaws as required by FRA regulations.

The probable fault that led to this derailment was “Human Error” in Figure 1. FRA published a safety advisory in November 2015 to address this issue (17).

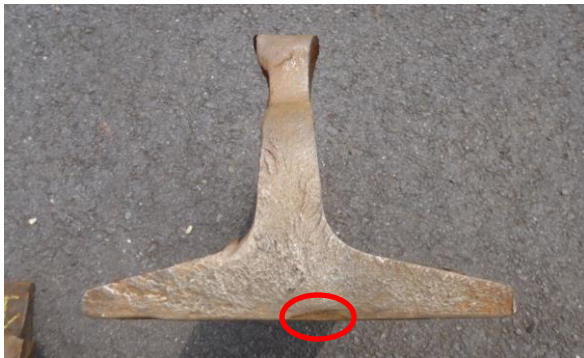
Figure 7. Rail Base Defect at New York

On May 8, 2011 an eastbound Amtrak train experienced an undesired emergency application of the train air brakes and derailed five passenger cars on a mainline track in a tunnel under New York City. The probable cause of the derailment was determined to be broken rail from crack that originated in the rail base. The crack progressed upward into the head and web area, and propagated several feet before dislodging a ten-inch portion of the rail head. The rail had been inspected for internal rail defects 63 days prior to the train accident. Figure 7 shows the accident rail which contains a base defect with a crescent, thumbnail, or semi-elliptical shape. This type of rail

base defect is more commonly found in tunnels where corrosion exacerbates the formation and growth of such defects. It illustrates the “Undetectable Defect Type” fault in Figure 1.
