Magneto-Optic Imaging Inspection of Selected Corrosion Specimens

July 1992

DOT/FAA/CT-TN92/20

1. Report No. DOT/FAA/CT-TN/92/20		2. Government Accession No.		3. Recipient's Catalog No.	
4. Title and Subtitle MAGNETO-OPTIC IMAGING OF SELECTED CORROSION SPECIMENS				5. Report Date July 1992

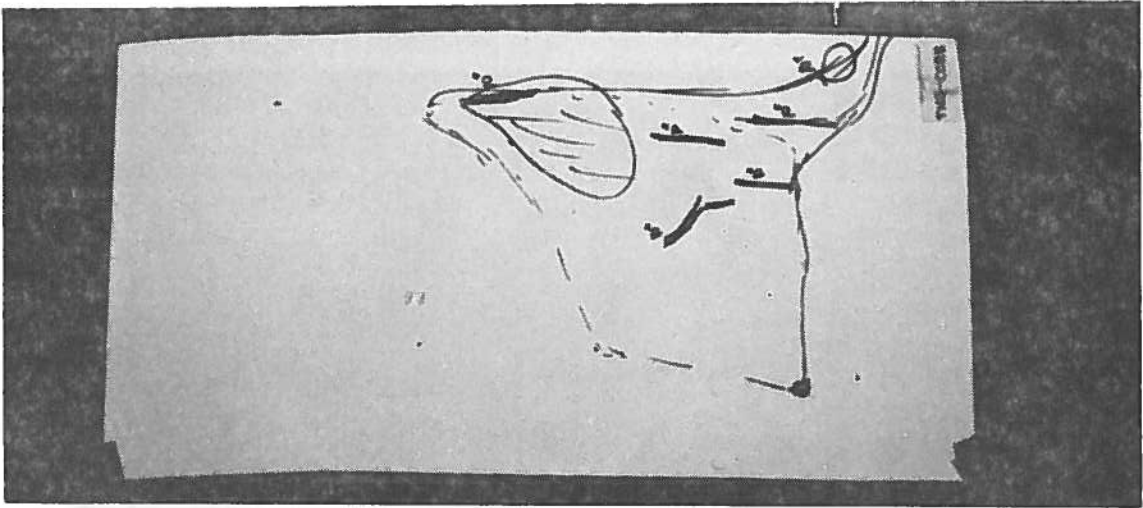
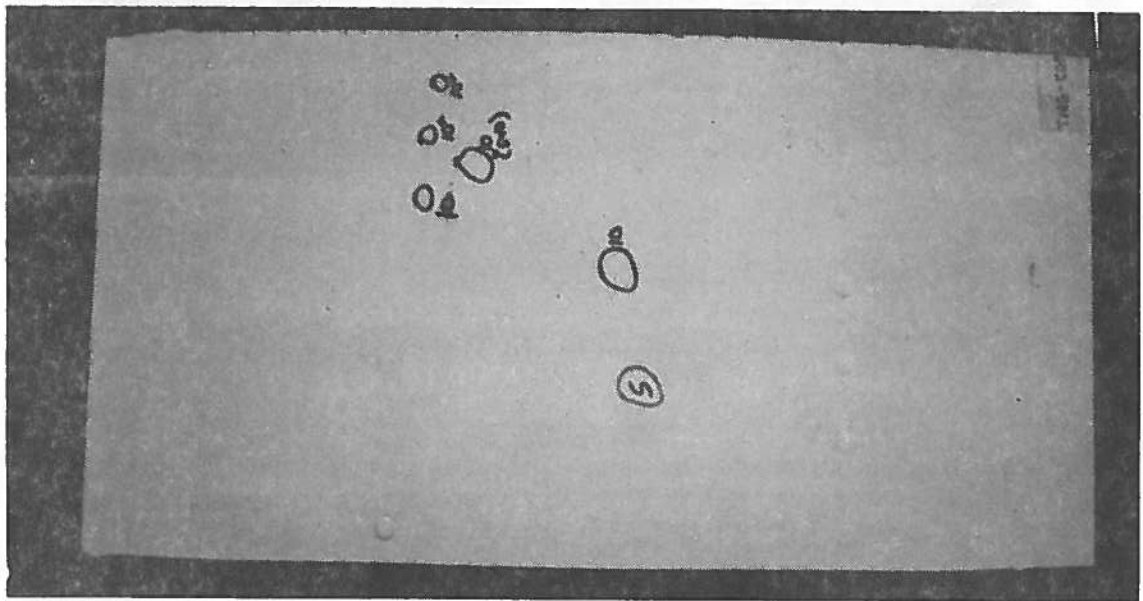
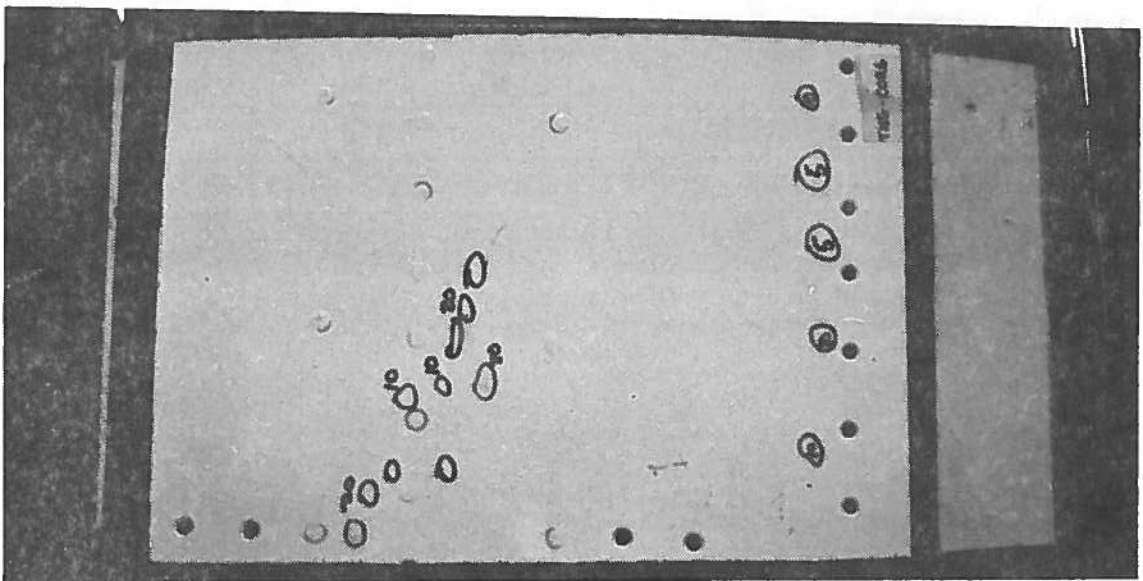
test piece perturbs the magnetic field and distorts the magneto-optic image. (A similar effect is introduced by magnetic material in the case of eddy current scanning.) The extent of corrosion was recorded on each panel surface, using an erasable marker. Personnel were requested to use the marker to circumscribe corrosion having a depth of 10 percent or greater of panel thickness, and to estimate and mark whether its depth was 10 percent, 20 percent, or 30 percent and greater (Figure 1).

Figure 1 Examples of test panels containing subsurface corrosion, detected by MOI.

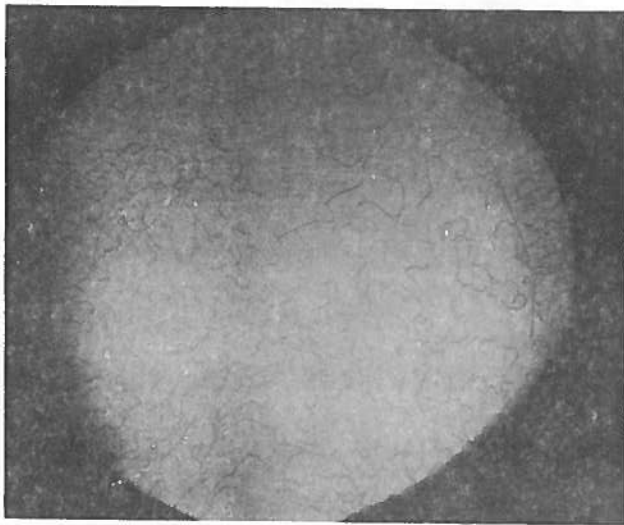
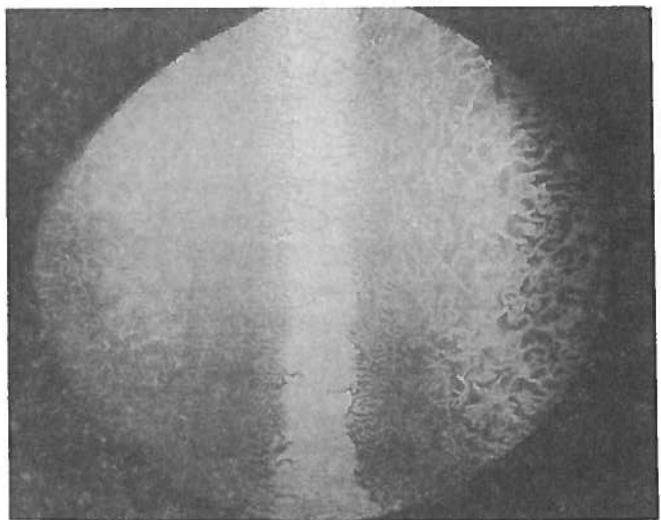
WARNING: IF THE FREQUENCY SETTING IS TOO LOW, A BRIGHT LINE ON A DARKER BACKGROUND WHICH IS CENTERED ON THE IMAGE AREA, WILL APPEAR (see Figure 2b). THIS IS NOT AN IMAGE OF CORROSION, AND GENERALLY DOES NOT MOVE WHEN THE IMAGING HEAD IS SCANNED. THE FREQUENCY MUST BE INCREASED UNTIL THIS FEATURE IS MINIMIZED OR ELIMINATED. WHEN LOWER FREQUENCIES ARE USED, IMAGES OF THE SUBSTRUCTURE MAY BECOME VISIBLE. HOWEVER, THE REGULAR PATTERN EXHIBITED BY THIS SUBSTRUCTURE EASILY DISTINGUISHES IT FROM THE GENERALLY IRREGULAR CORROSION IMAGES.

Figure 2. The appearance of the image for a correct and typical setup condition for corrosion, shown in the figure on the left, and the appearance of the image when the frequency is set too low, shown on the right. The dark side bands are a result of too deep a penetration of the eddy current excitation.

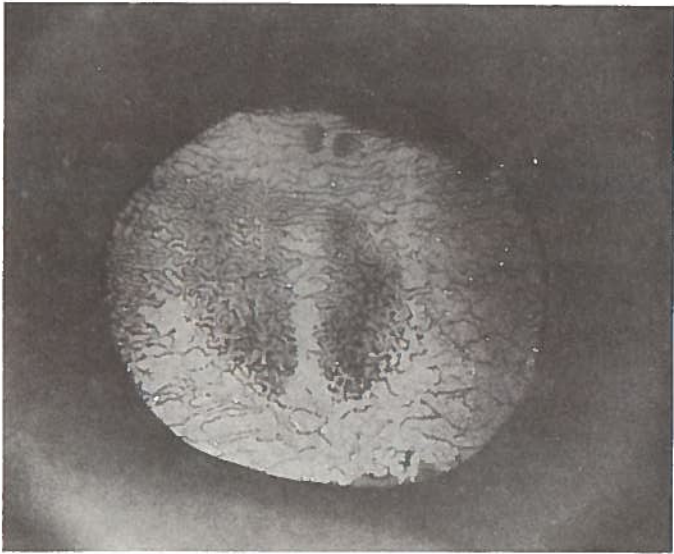
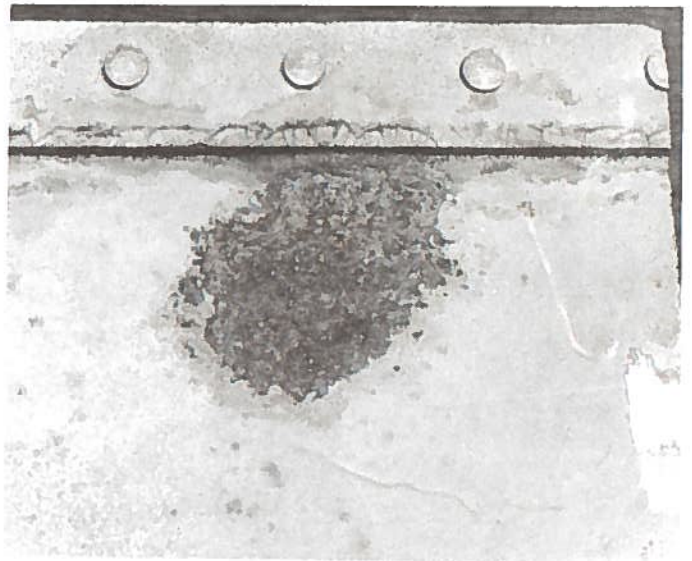
Figure 3. An image of corrosion, left, in an aluminum panel removed from an older airplane, right. The image is bookmatched or mirrored from the actual photo of the corrosion because it was obtained from the opposite side of the panel.
