DOT/FAA/AR-95/51

Nondestructive Inspection of Piper PA-25 Forward Spar Fuselage Attachment Fitting

September 1995

Final Report

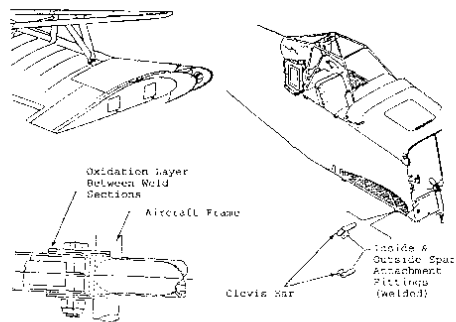
FIGURE 2. LOWER ATTACHMENT FITTING BAR AS ASSEMBLED IN THE PRESENT CONFIGURATION. FIGURE WAS TAKEN FROM AD95-21-12.

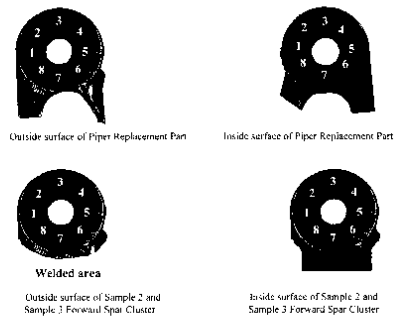
FIGURE 10. ILLUSTRATION OF THE EIGHT ULTRASONIC MEASUREMENT LOCATIONS FOR VARIOUS SAMPLES. SAMPLE 1 LOCATIONS WERE SIMILAR.
