NATIONAL TRANSPORTATION SAFETY BOARD

AIRCRAFT ACCIDENT REPORT

GROUND SPOILER ACTIVATION IN FLIGHT/HARD LANDING
VALUJET AIRLINES FLIGHT 558
DOUGLAS DC-9-32, N922VV
NASHVILLE, TENNESSEE
JANUARY 7, 1996

Abstract: This report explains the ground spoiler activation in flight and subsequent hard landing of ValuJet Airlines flight 558, N922VV, a Douglas DC-9-32 at Nashville International Airport, Nashville, Tennessee. The safety issues discussed in the report include the adequacy of ValuJet's operations and maintenance manuals, specifically winter operations nose gear shock strut servicing procedures; the adequacy of ValuJet's pilot training/crew resource management training programs; flightcrew actions/decisionmaking; the role of communications (flightcrew/flight attendants/operations/dispatch/air traffic control); ValuJet's flightcrew pay schedule; Federal Aviation Administration (FAA) oversight of ValuJet; and the adequacy of cockpit voice recorder (CVR) duration and procedures. Safety recommendations concerning these issues were made to the FAA and ValuJet Airlines.

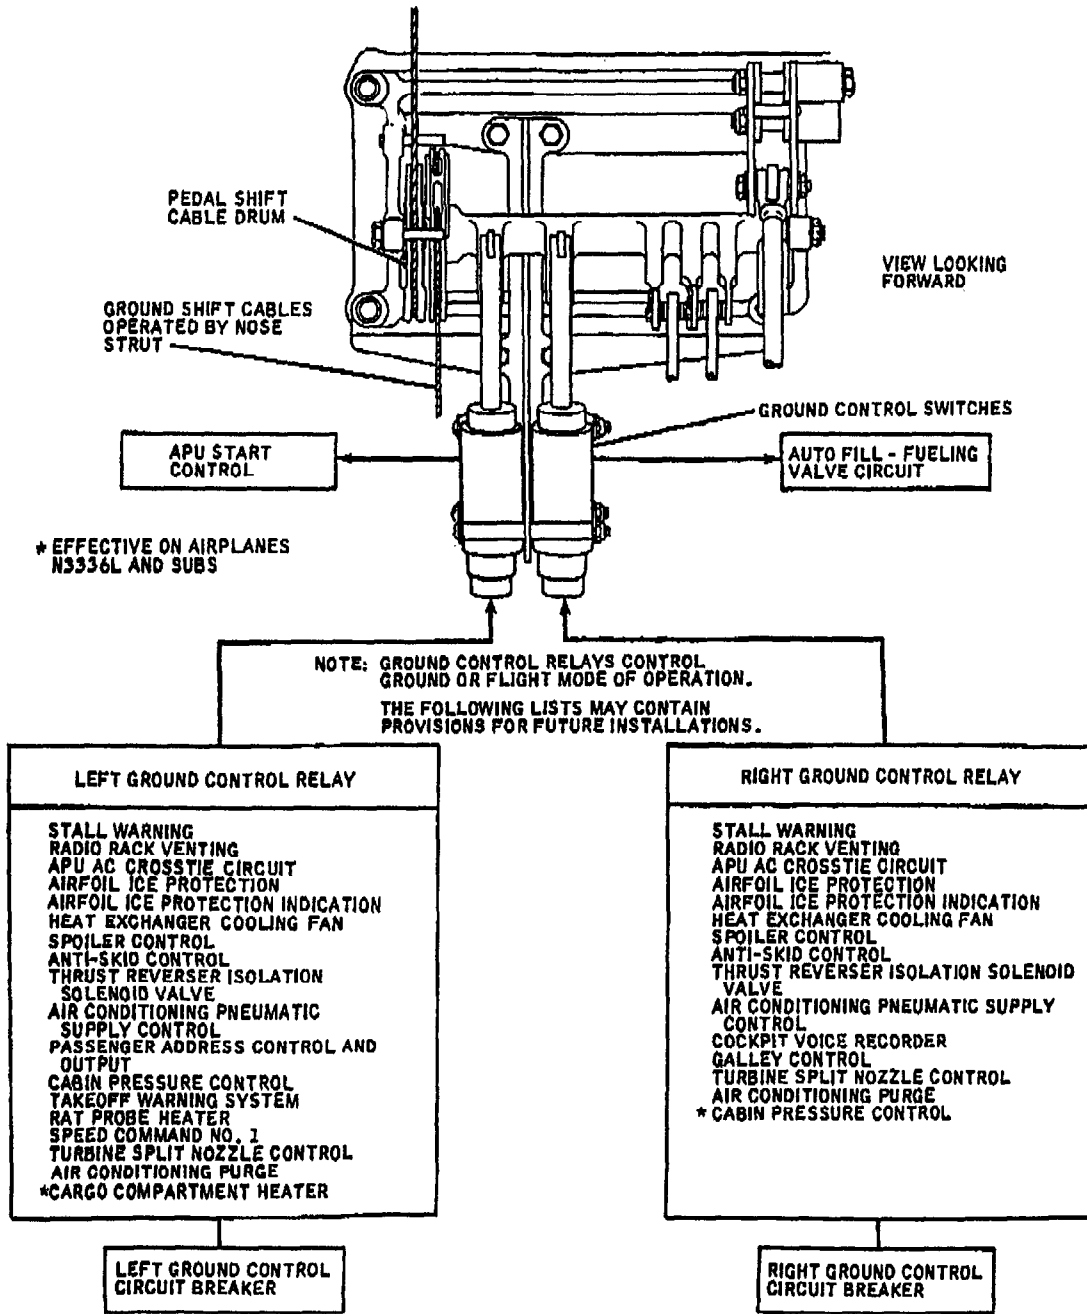
Figure 2—DC-9 Ground Shift Mechanism

The ground shift mechanism, which is actuated by nosegear shock strut extension/compression, controls whether certain aircraft systems operate in the ground or flight mode.²¹ When the nosegear shock strut is compressed by the weight of the aircraft, the ground shift mechanism causes those aircraft systems to be operated in the ground mode. When the nosegear shock strut is extended after takeoff, it triggers the ground shift mechanism,

According to Douglas representatives, when the nosegear shock strut is underserviced/underinflated, strut extension after liftoff may not be sufficient to activate the ground shift mechanism to shift the aircraft systems into the flight mode and release the gear lever anti-retraction mechanism. Douglas representatives indicated that this is a commonly reported occurrence during cold weather operations. They stated that Douglas had issued numerous service bulletins (SBs) and all operator letters (AOLs) describing the anomaly and recommending maintenance procedures to avoid underserviced/underinflated nosegear shock struts during cold weather operations.²³

It is likely that the nosegear shock strut did not extend far enough to actuate the ground shift mechanism because it was underserviced/underinflated for the cold/winter weather conditions. The en route portion of the flight proceeded uneventfully. When the airplane was about 100 feet above the ground during the approach to Nashville, the pilots reset the ground control relay circuit breakers, thereby unintentionally shifting the airplane systems from the flight mode to the ground mode. The ground spoilers subsequently extended in flight, and the airplane descended suddenly, impacting the ground in the runway approach light area.

Accordingly, the Safety Board believes that ValuJet should develop, immediately, a more extensive and accurate winter operations manual, with corresponding adjustments to maintenance procedures, to reflect the manufacturer's cold weather nosegear servicing procedures. Further, because no airline is exempt from encountering a range of weather extremes, the Safety Board believes that the FAA should require all airlines to review their operations and maintenance manuals and, if necessary, adjust or expand these manuals to reflect the manufacturer's recommended cold weather nosegear servicing procedures.
