AIRCRAFT ACCIDENT REPORT

UNCONTROLLED FLIGHT INTO TERRAIN
ABX AIR (AIRBORNE EXPRESS)
DOUGLAS DC-8-63, N827AX
NARROWS, VIRGINIA
DECEMBER 22, 1996

Adopted: July 15, 1997

Notation 6822A

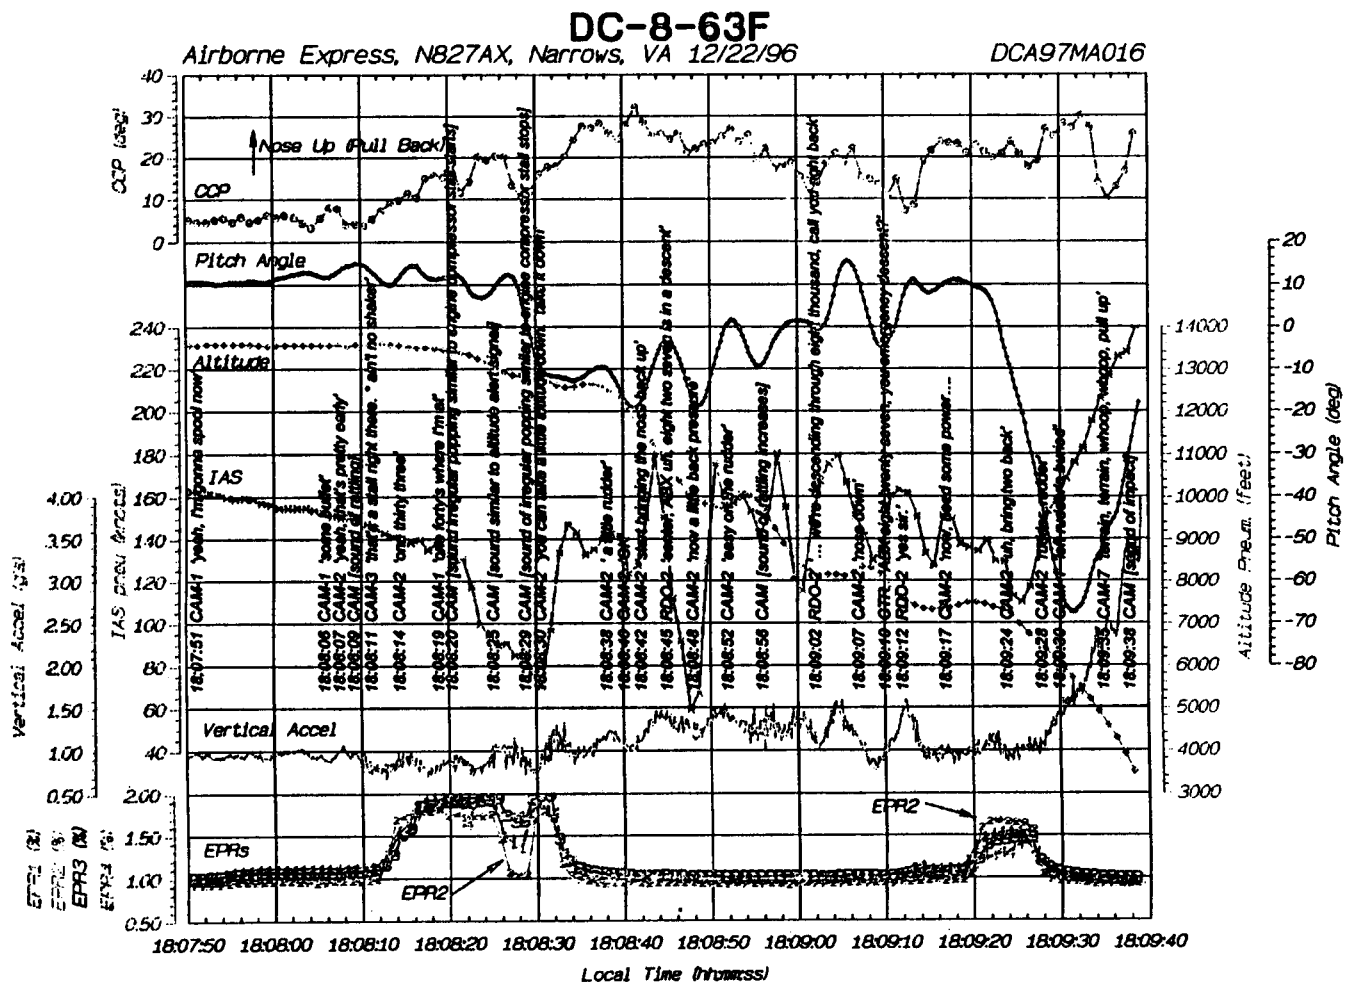
APPENDIX C—EXCERPTS FROM THE FLIGHT DATA RECORDER

FDR data indicated that for about 14 seconds after the flight engineer noted the stall indication (at 1808:11) and through the time that the first roll excursion began at 1808:25, the airplane remained pitched nose up between 7 degrees and 14 degrees. CCP values ranged from about 5 degrees aft when the stall was noted to 20 degrees aft at 1808:25. During this period, the airplane's airspeed decayed from 145 knots to about 120 knots (the FDR was providing erratic airspeed indications below 126 knots, and was indicating about 90 knots). FDR data indicated that the airplane's pitch attitude then decreased from about 11 degrees above the horizon at 1808:25 to 12 degrees below the horizon at 1808:35. Thirteen seconds after the stall was called, vertical acceleration forces began to increase and remained (with minor fluctuations) consistently more than 1 G (with a maximum of 1.5 G) until impact.
