## **AIRCRAFT ACCIDENT REPORT**

**WHEELS-UP LANDING  
CONTINENTAL AIRLINES FLIGHT 1943  
DOUGLAS DC-9 N10556  
HOUSTON, TEXAS  
FEBRUARY 19, 1996**

**Adopted: February 11, 1997  
Notation 6804**

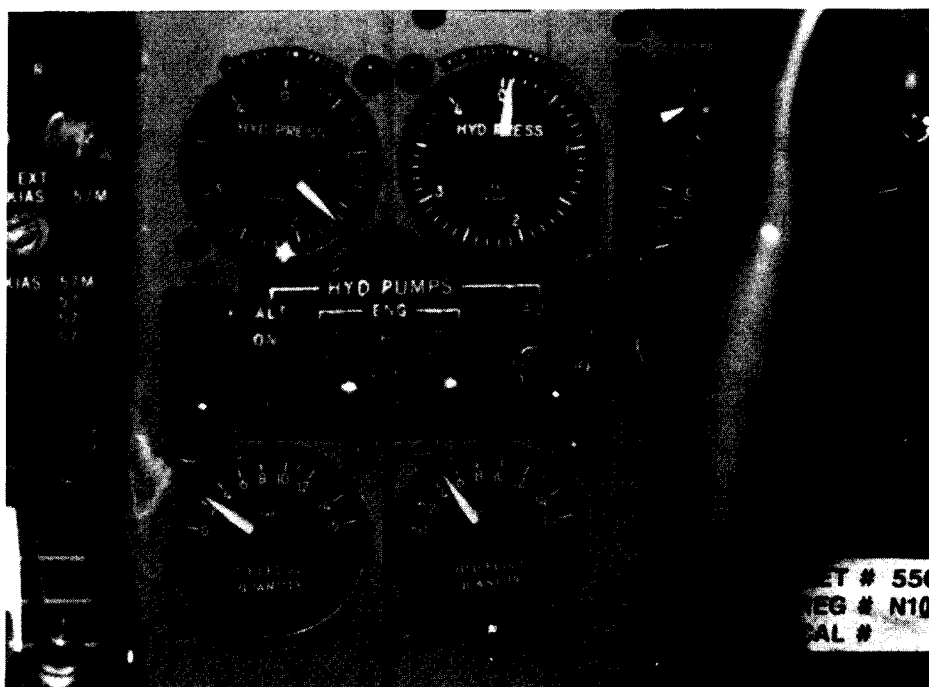
Figure 1 – Hydraulic switch panel.

**Bottom Photo - Photo of accident airplane's hydraulic switch panel in low pressure configuration (see section 1.12).**

Examination of the cockpit revealed that the landing gear handle was in the down position and the flap handle was set to 50°. The left and right engine-driven hydraulic pump switches were in the "LOW" position, and the ALT and AUX hydraulic pump switches were in the "OFF" position. The left hydraulic system gauge indicated 1,600 psi, and the right gauge indicated 0 psi (refer to figure 1). The safety wire on the GPWS flap override switch was found broken; however, the switch was not in the "OVRD" position.

The evidence indicates that the airplane's hydraulic system was not configured for landing. Because the hydraulic system remained in the low pressure mode, hydraulic pressure was not available to lower the landing gear and deploy the flaps. The flightcrew failed to detect this configuration error and continued its approach into Houston. Comments on the CVR and postaccident statements by the flightcrew indicate that both pilots recognized that the flaps did not deploy after the flaps were selected to 15°, but the flightcrew did not determine the cause of this problem or execute a go-around.
