**97-18-01 BELL HELICOPTER TEXTRON:** Priority Letter issued on August 19, 1997. Docket No. 97-SW-30-AD.

Applicability: Model 204B, 205A, and 205A-1 helicopters, with tailboom vertical fin spar, part number (P/N) 205-032-899, 205-030-846, or 205-030-851, all dash numbers, installed, certificated in any category.

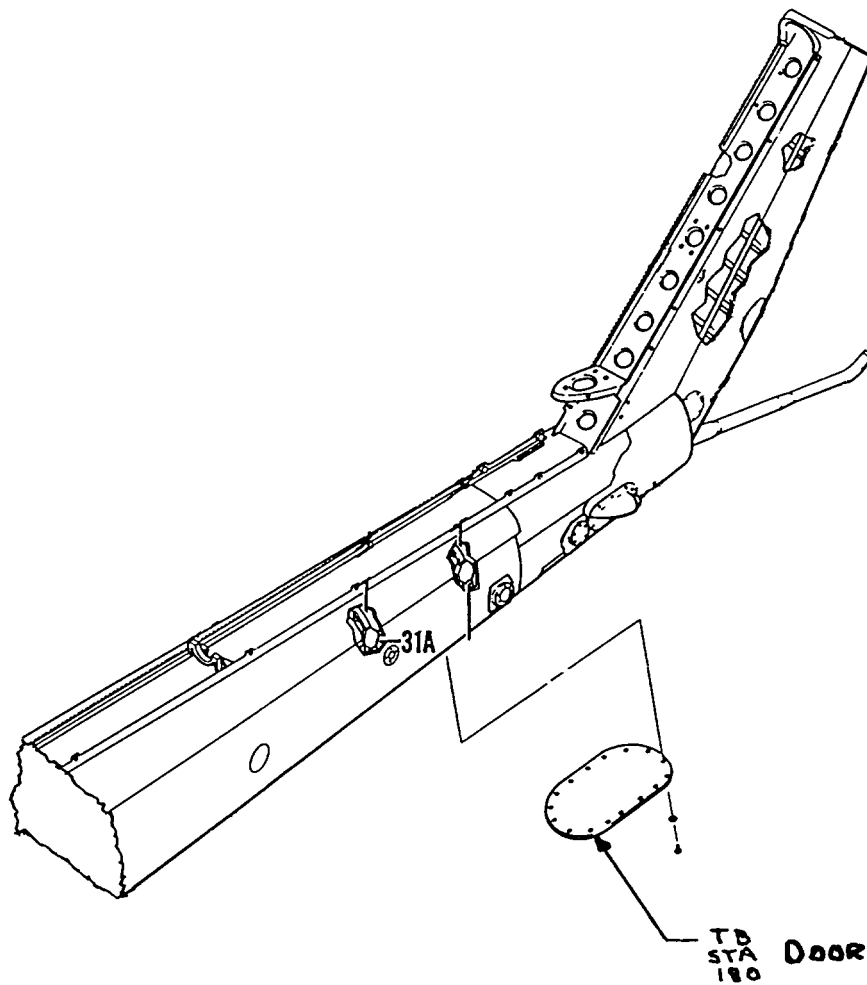
Fig. 1  
AD 97-18-01

(1) Remove the lower aft tailboom inspection door, located at tailboom station 180 (see Figure 1).

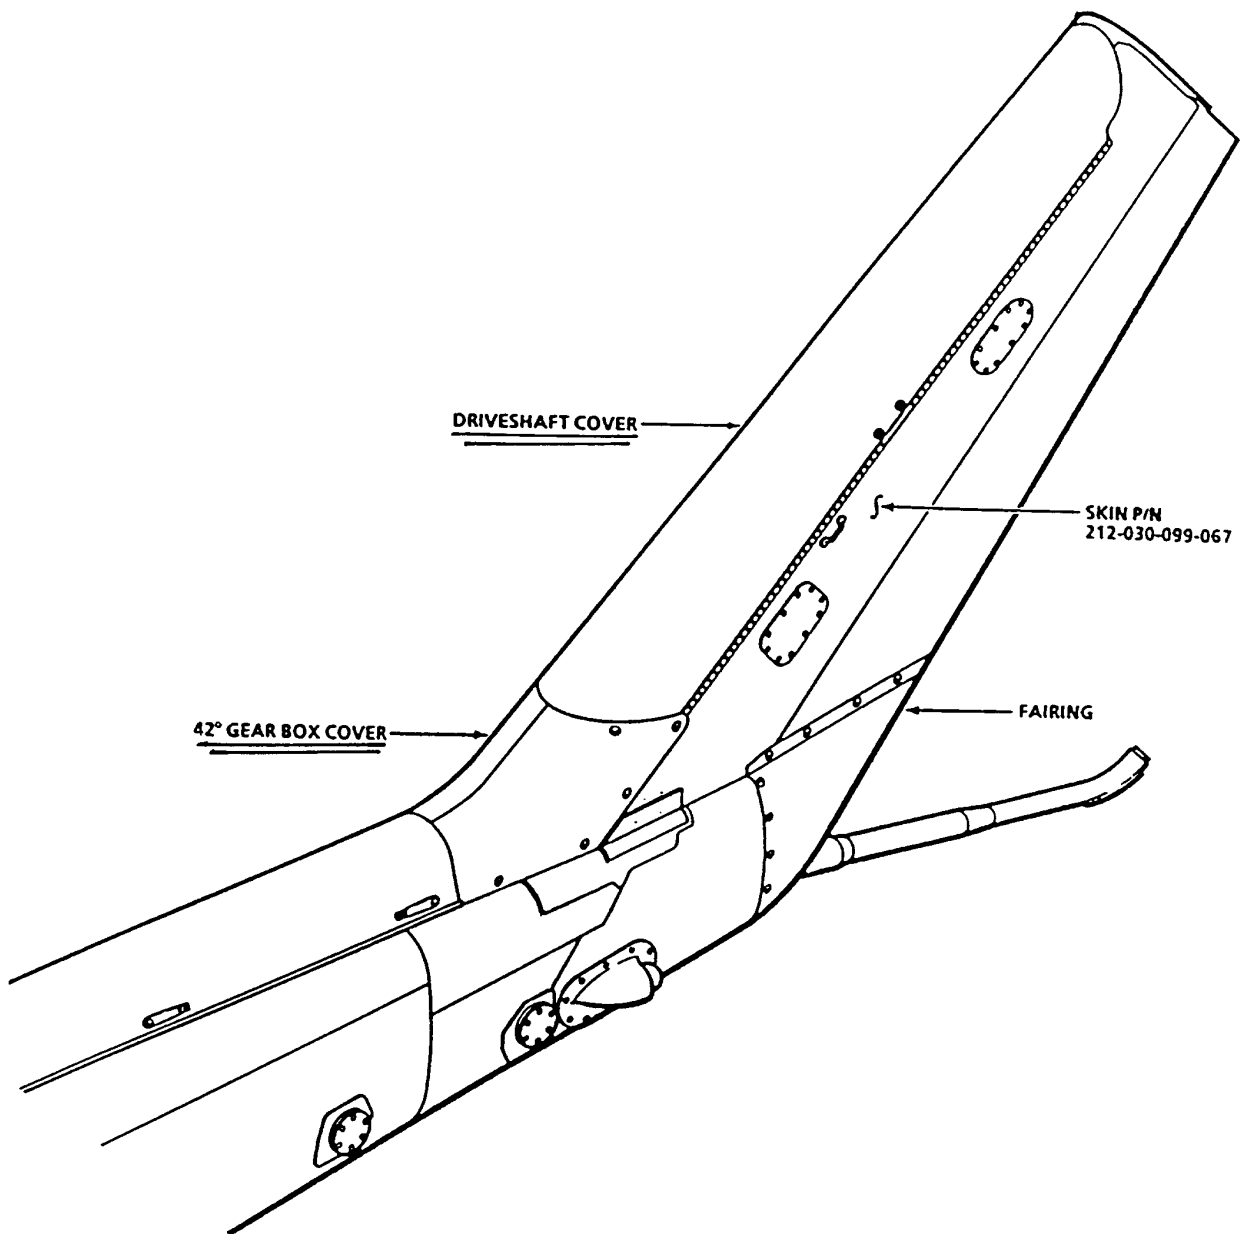
Fig. 2

(2) Remove the 42° gearbox cover and open the drive shaft cover on the vertical fin spar (see Figure 2).

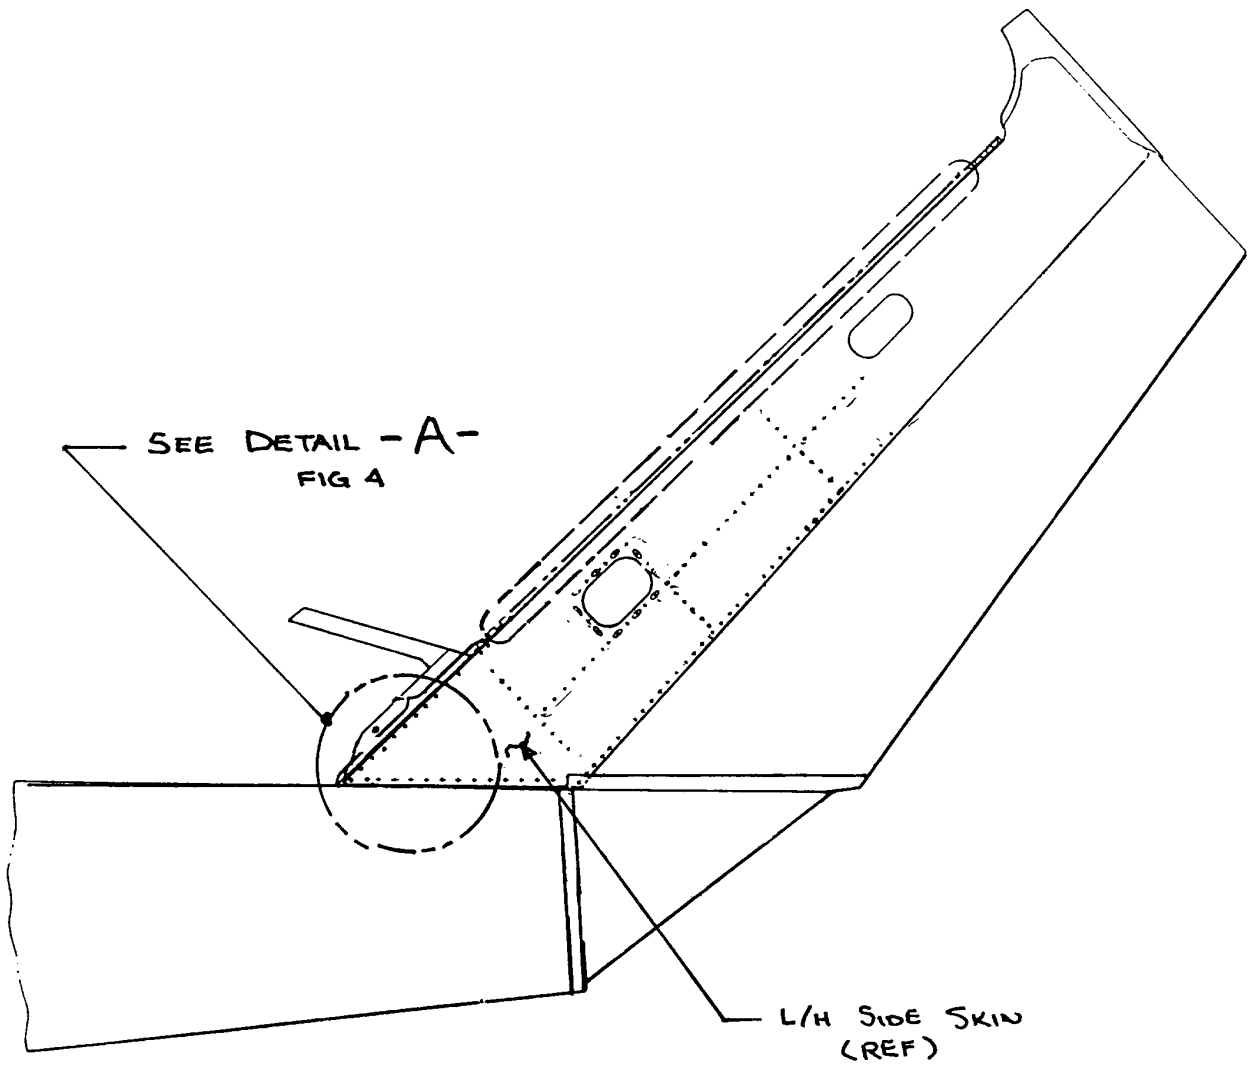
FIG 3 VIEW LOOKING INSD  
L/H SIDE

(3) Remove the clip, P/N 212-030-099-091, and the radius block, P/N 212-030-099-095 (see Figures 3 and 4). Remove the first four rivets from the bottom of the vertical fin spar left-hand side skin and retainer, P/N 205-032-851-045. Cut and remove the vertical fin spar left-hand side skin as shown (see Figure 5). CAUTION: Extreme care must be taken when drilling the side skin to ensure the vertical fin spar assembly is not damaged.

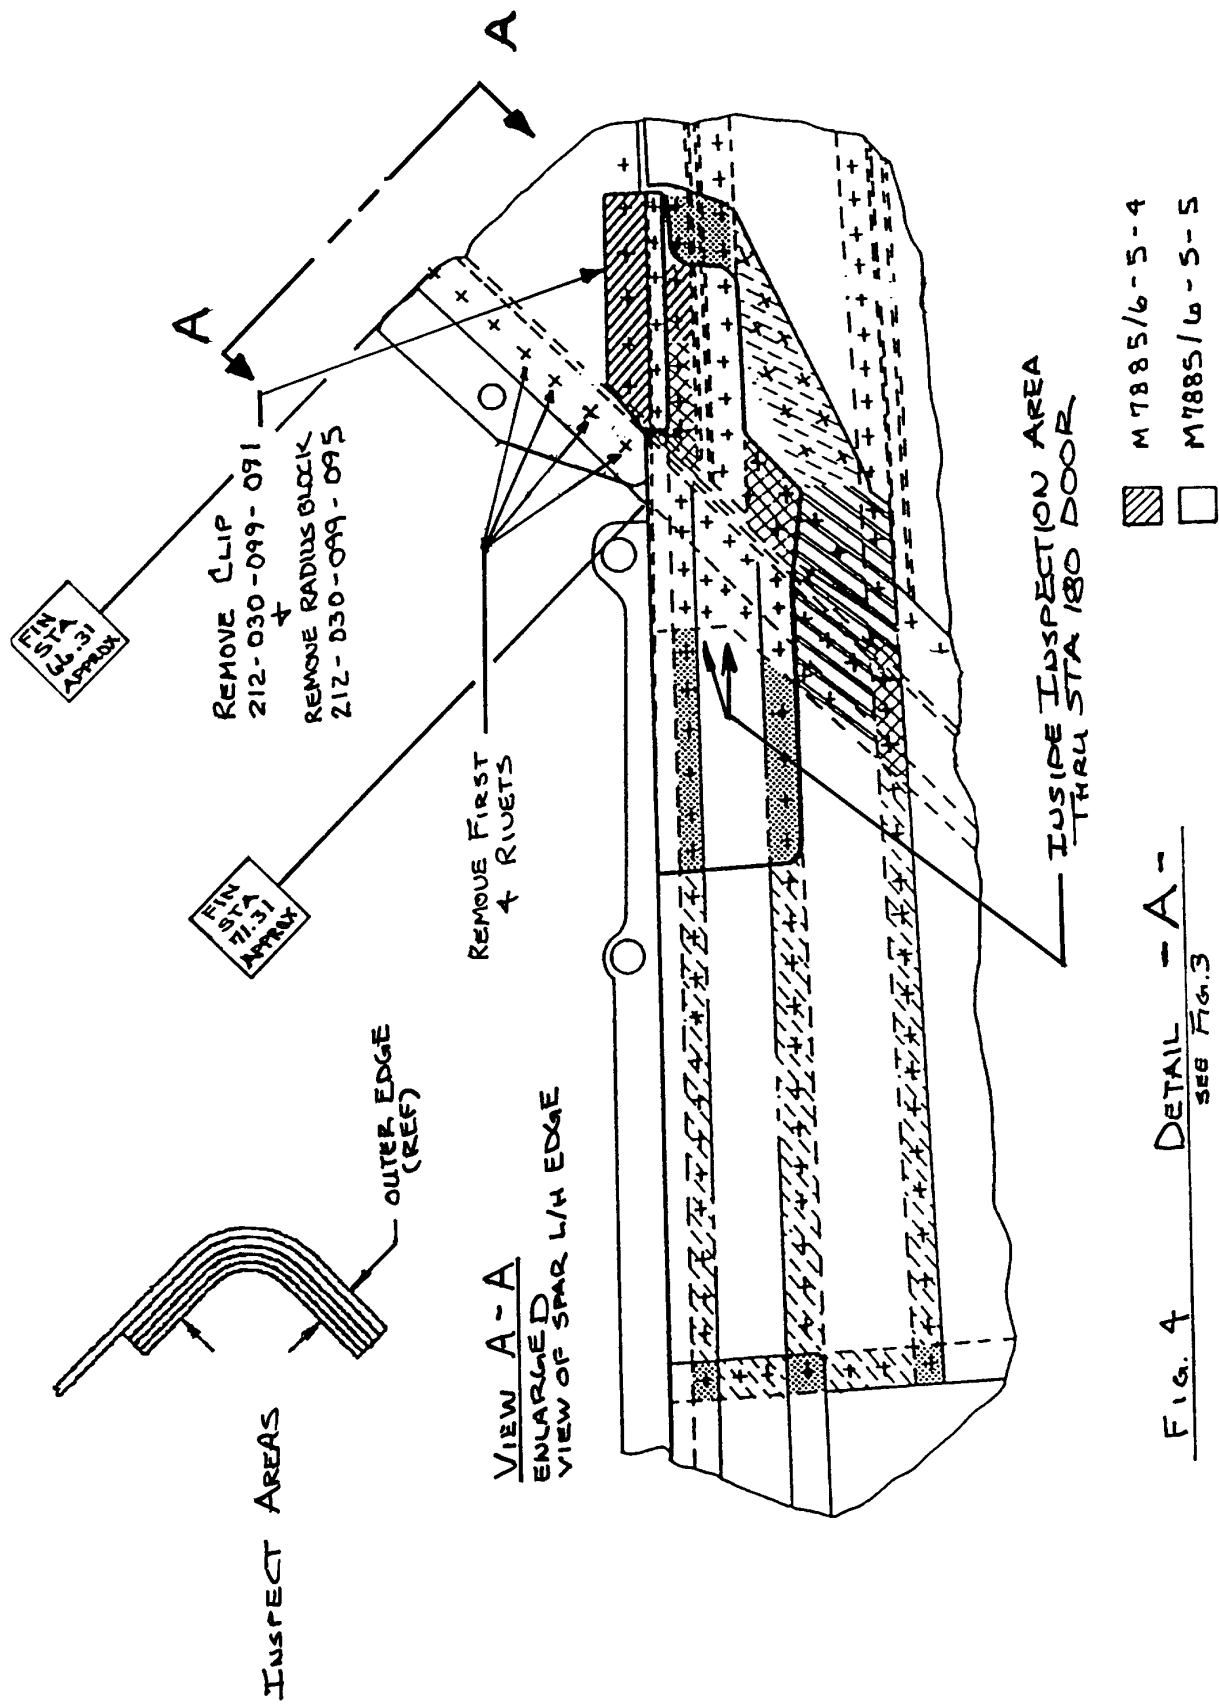
(1) Through the lower aft tailboom inspection door, using a bright light and an inspection mirror, inspect the vertical fin spar assembly adjacent to the tailboom top skin on the forward side, paying special attention to the left-hand edge and the adjacent surfaces (see Figure 4).

(2) In a ventilated work area, clean all surfaces to be inspected with a cloth dampened with aliphatic naphtha or an equivalent cleaning solvent. Using a bright light and a 10x magnifying glass, inspect the vertical fin spar assembly adjacent to the tailboom top skin, on the inboard and outboard sides, the vertical edge, and the two open rivet holes. Using a bright light and a mirror, inspect the aft side of the vertical fin spar in the same area. Special attention must be given to the left-hand edge of the vertical fin spar and any adjacent surfaces between fin station 66.31 and 71.31 (see Figure 4).

(7) Reinstall the clip and radius block (see Figure 4).

(3) If any crack is discovered on the vertical fin spar as a result of the inspection specified in paragraphs (b)(1) or (b)(2) of this AD, replace the vertical fin spar assembly with an airworthy vertical fin spar assembly before further flight.
