Events Leading to This Priority Letter AD

97-12-06 CESSNA AIRCRAFT COMPANY: Priority Letter issued on June 6, 1997. Docket No. 97-CE-35-AD.

Applicability: Model 172R airplanes, serial numbers 17280001 through 17280081, certificated in any category.

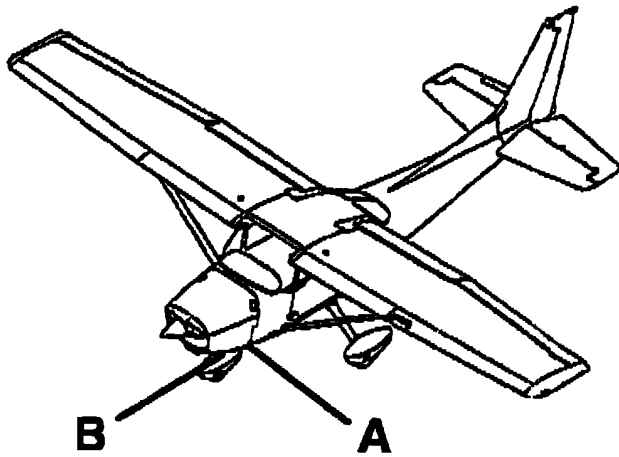
Engine Lower Cowling Modification
Figure 1

To prevent the cowling from rubbing against the gascolator drain valve or the tailpipe, which could result in fuel loss and engine stoppage, accomplish the following:

(2) If no evidence of rubbing is found, repeat the check in paragraph (a) before each flight, and within the next 10 hours time-in-service (TIS) after receipt of this AD, modify the gascolator and cowling area in accordance with Figure 1 of this AD.

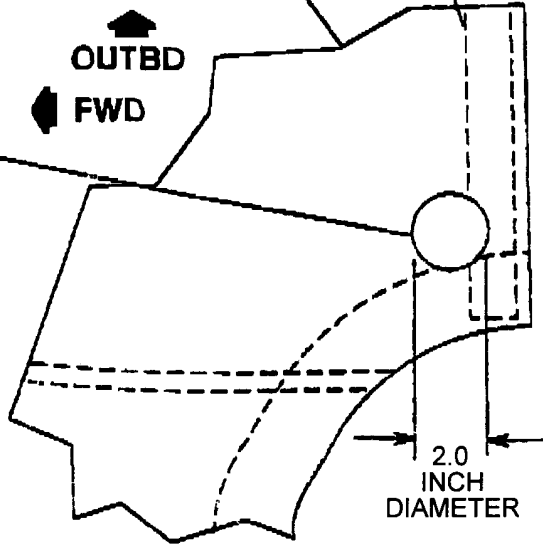
DETAIL A
VIEW LOOKING DOWN

This priority letter AD results from an occurrence of fuel loss on a Cessna Model 172R airplane. The fuel loss was severe enough to force an emergency landing. Investigation of the occurrence reveals that the cowling knocked the gascolator drain valve off the gascolator.

Further examination of the design of Model 172R airplanes shows that this condition exists when the tailpipe vibrates, during some starting conditions, into the cowling. The cowling then rubs against the gascolator drain valve, knocking the gascolator drain valve off the gascolator, and causing fuel to drain from the airplane at an extremely high flow rate. This results in engine stoppage with consequent forced landing or crash landing.

ENLARGE HOLE AROUND THE FUEL STRAINER DRAIN VALVE TO 2.0 INCHES DIAMETER (CONCENTRIC). THE NEW HOLE WILL CUT INTO THE CHANNEL JUST AFT OF THE ORIGINAL HOLE ABOUT 0.50 INCH.
