Research
Paper
FPL-RP-570

Field Performance of Timber Bridges

16. North Siwell Road Stress-Laminated Bridge

James A. Kainz

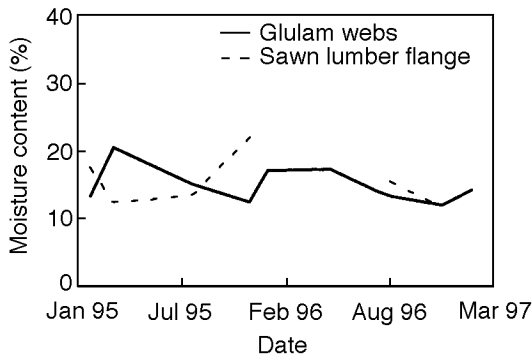
The average trend in electrical resistance moisture content readings is shown in Figure 15. As shown, there are slight variations between the readings for the glulam webs and the sawn lumber flanges. At the beginning of the monitoring period, the glulam web moisture content was approximately 12.5%. During the monitoring period, the moisture content exhibited seasonal changes of $\pm 5\%$. At the end of monitoring, the moisture content was approximately 15%. The sawn lumber flange moisture content was slightly higher at the start of monitoring at approximately 17%. During the first year of the monitoring, the sawn lumber flange moisture content varied similarly at $\pm 5\%$. Readings were not taken during the second half of the monitoring period except during the final quarter of 1996. Near the end of the monitoring period, the sawn lumber flange moisture content was approximately 12.5%. Both the glulam webs and the sawn lumber flange were installed at a moisture content less than the recommended value of 19%.

Figure 15—Average trend in electrical resistance moisture content readings.

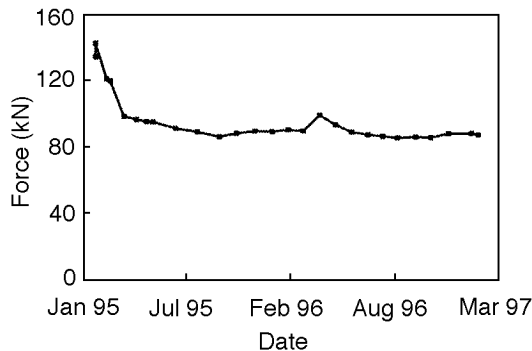
Figure 16—Average bar force from load cells installed after the third bar tensioning.

The average bar force based on load cell readings is shown in Figure 16. At the third stressing, all bars were tensioned to 142 kN (32,000 lb), which corresponds to a 848 kPa (123 lb/in²) interlaminar stress. Two months later, the bar force decreased to 98.2 kN (22,100 lb) or 579 kPa (84 lb/in²). The rate of loss declined, and the bar force then remained relatively stable for the remainder of the monitoring period. At the conclusion of monitoring, the average bar force was 87.6 kN (19,700 lb), which corresponds to a level of 490 kPa (71 lb/in²) interlaminar compression stress.

The observed bar force loss is most likely the result of stress relaxation in the sawn lumber flange laminations. Stress relaxation is a time-dependent phenomenon caused by the long-term compressive force of the steel bars acting on the wood microstructure. In the design of stress-laminated bridges, it is assumed that the bridges will lose approximately 60% of the interlaminar compression over the life of the structure as a result of stress relaxation. The stress relaxation behavior of this bridge was similar to previous monitored bridges (Wacker and Ritter 1995; Ritter and others 1995, 1996). However, the amount of stress relaxation in the North Siwell Road bridge was affected by the wood moisture content. Recent monitoring completed on a bridge installed with a moisture content greater than 19% (Kainz and others

Following the final design bar tensioning, the bridge lost approximately 47% of the bar force introduced to end at 87.6 kN (19,700 lb), which corresponds to 490 kPa (71 lb/in²) interlaminar compression stress. This decrease in bar force was most likely attributable to transverse stress relaxation in the wood laminations. The acceptable bar force level at the end of monitoring is a result of retardation of the stress relaxation rate caused by the low moisture content in the wood laminations. The introduction of a high initial bar force level that resulted in a high interlaminar compressive stress also contributed to the acceptable ending bar force performance of this bridge. To maintain this performance, bar force should be checked as part of the routine inspection program.
