**ADIEM II END TERMINAL FOR
CONCRETE BARRIER**

Final Report

**Experimental Features
Project #96-01**

Oregon Department of Transportation

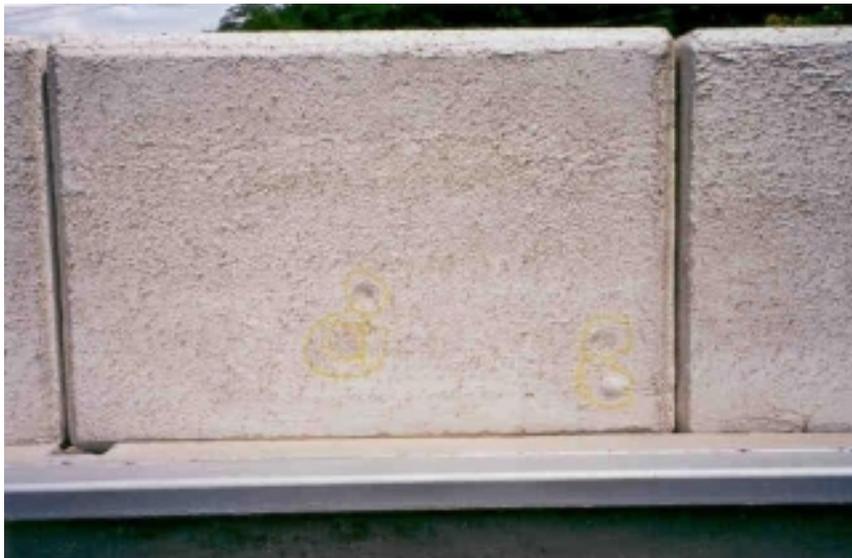
Figure 3.1: Soft Spots on Crushable Block

A second inspection was made of the ADIEM II on May 28, 1998. This inspection consisted of visual observations, photographs and a "touch test" for soft spots. Only one soft spot was visible. This spot, which was reported on the first inspection, had increased in size. Other spots were found by touch. When a moist or soft spot was found, the area was defined by pressing hard with the thumb until the soft area was outlined. All but two of the blocks had at least one soft spot. Block 10, the block closest to the barrier, had the most soft spots with 5.

On September 9, 1998, a SYRO, Inc. representative made repairs on the crushable blocks on both north and southbound lanes. Most of the soft spots were dug out and refilled with a grout made for the ADIEM II system. After a half-hour cure time, the grouted areas were coated with Acrylink, a product from Isothermal Protective Coatings, Inc. used for coating roofs. Other soft areas were not grouted, but covered only with Acrylink. The repairs are described in a field report (see Appendix B). New coating was only applied to the repaired areas because, according to the SYRO, Inc. representative, the remaining coating was considered adequate to protect the module. The resulting appearance (see Figure 3.2) was not acceptable to ODOT, so further repairs were made, as described in the Section 3.4.

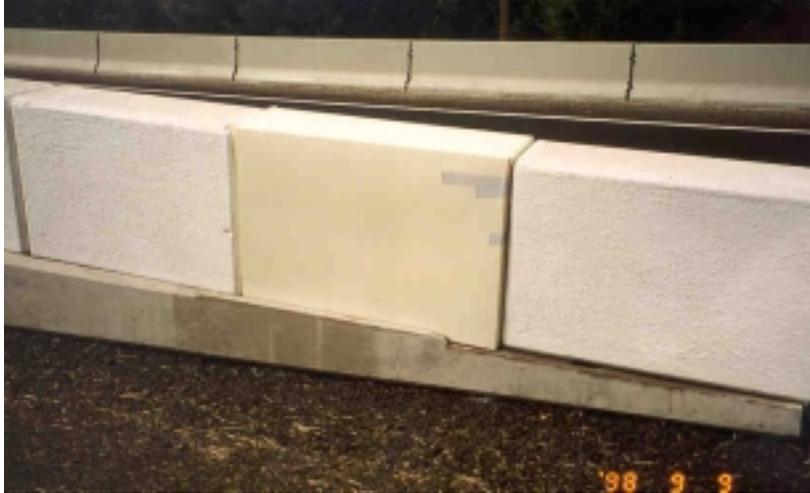
Figure 3.3: Waterproof Cover on Block

A polypropylene plastic corrugated cover, developed by SYRO, Inc. to prevent water intrusion, was installed on one block of the southbound ADIEM. The installation was difficult because there was no clearance between the blocks. A better installation method would require removal of the blocks from the base, attaching the cover, and then re-installing the blocks onto the base. The color of the cover was yellow, which contrasted with the white coating of the other blocks, as seen in Figure 3.3.

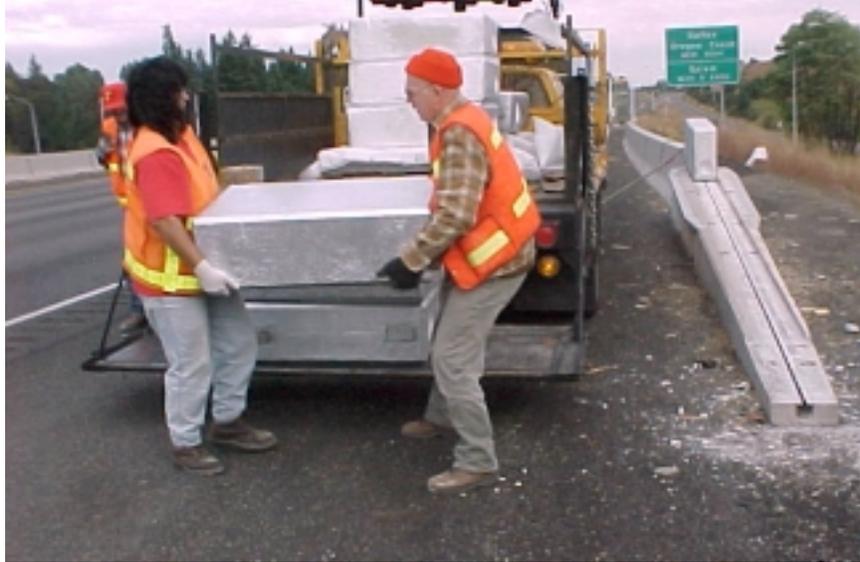
Figure 3.4: Workers Install New Blocks

On October 5, 1999, new crushable concrete modules were installed at the northbound ADIEM II system. A Trinity, Inc. representative was on hand to oversee the removal of the old blocks and replacement with new. Two ODOT maintenance workers completed the task in two hours (see Figure 3.4). As with the initial installation, the blocks had to be loaded, unloaded and installed by hand, without equipment which could damage the blocks or coating. To transport and replace 10 blocks, workers had to lift or move an 81.5 kg weight approximately 60 times, raising concern about the stresses to workers backs. Appendix C contains the detailed report.

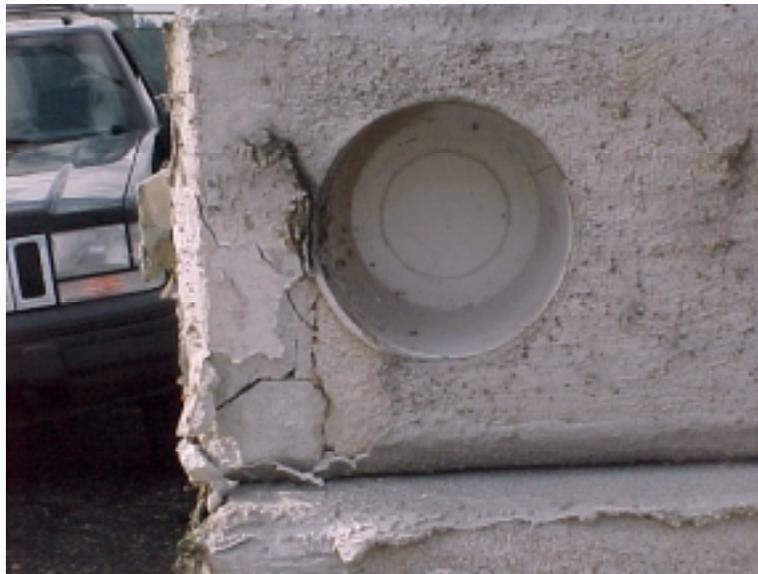
Figure 3.5: Cracks in a Block Removed in 1999.

The concrete bases of two of the blocks were crumbled, and pieces of concrete in the tracks made removal of the blocks difficult. Deep cracks were found on one block when it was removed from the base. These cracks were near one of the plastic inserts in the block (Figure 3.5).

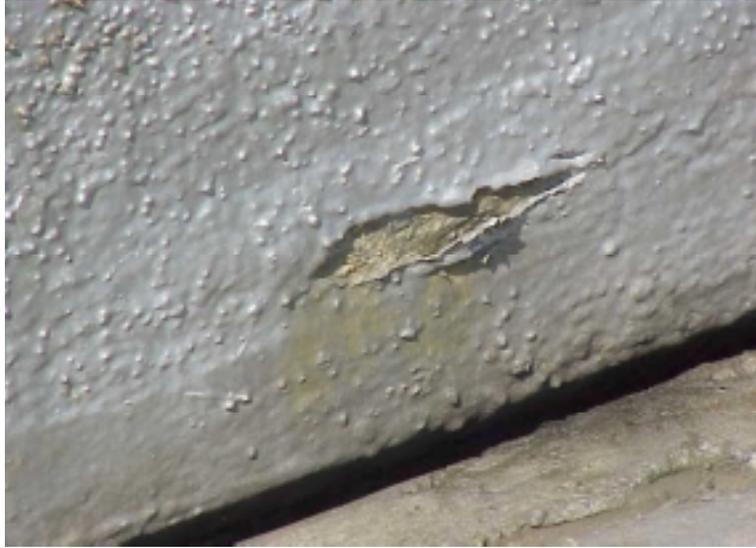
Figure 3.6: Tear in Garna-Thane Weatherproofing on Block

In April of 2000, a brief inspection was made of the ADIEM II system. The southbound modules were showing some bubbling and soft spots. There was a tear in the covering in one of the new modules in the northbound lane (Figure 3.6).

Though the new Garna-Thane covering appears to be less susceptible to weather, the concerns remained about the high level of maintenance required to protect the lightweight concrete.

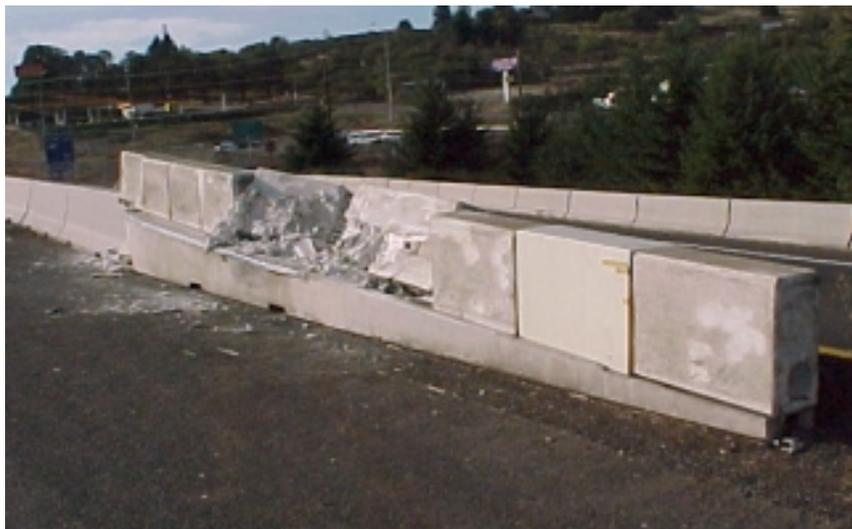
Figure 3.7: Damage from Vehicle Impact.

In October 2000, the southbound ADIEM was hit by a vehicle, with several blocks damaged. The impact, to the 4th, 5th and 6th blocks, also visibly damaged the 7th and 10th blocks (see Figures 3.7 and 3.8). The 10th block, nearest to the concrete barrier, was pushed onto the barrier approximately 0.33 m. Because no responsible party could be determined (the vehicle left the site and did not file an accident report), details about the accident are not available. The system apparently worked as designed, with the blocks absorbing the impact.

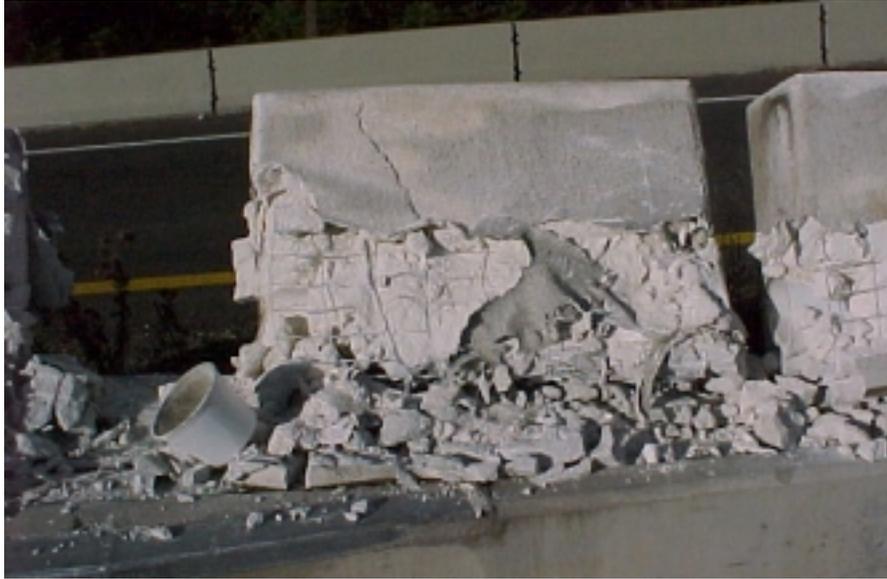
Figure 3.8: Blocks Crushed by Impact

District crews reported that the damaged blocks were difficult to remove, as the reinforcement was twisted. They also said the removal and reinstallation was slowed by debris in the track. The crew replaced the damaged blocks with blocks that had been removed from the northbound ADIEM installation the previous year. The blocks showed signs of deterioration due to moisture. Crews also noted damage to the coating on undamaged blocks that may have been caused by debris thrown by motorists or flung from vehicle tires.

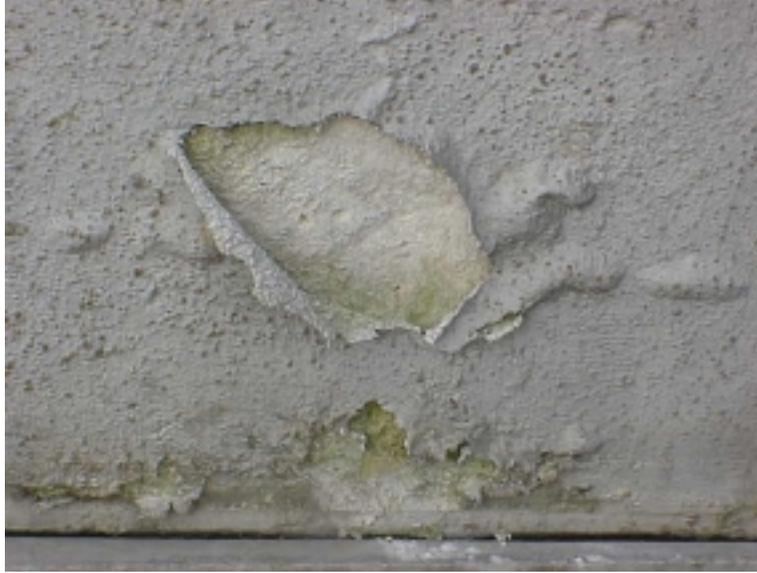
Figure 3.9: Example of Weatherproofing Condition on Southbound Blocks

A final inspection of the ADIEM system, on January 31, 2001, included both the north- and southbound installations. Figure 3.9 shows an example of the severe peeling and bubbling of the coating which was found on several blocks on the southbound system. These blocks were coated with Acrylink. Where exposed, the concrete had soft spots and crumbling areas.

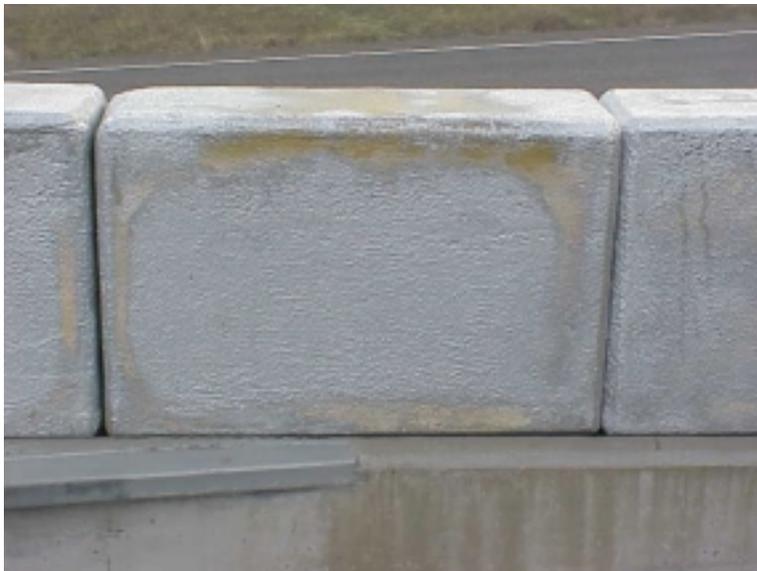
Figure 3.10: Typical Block on Northbound Installation

The blocks on the newer, northbound installation were in much better condition, but were beginning to show slight bubbling and cracking (see Figure 3.10). Because the installation was fairly new, inspectors agreed that the Garna-Thane weatherproofing also appeared inadequate for long term protection of the blocks from moisture intrusion.

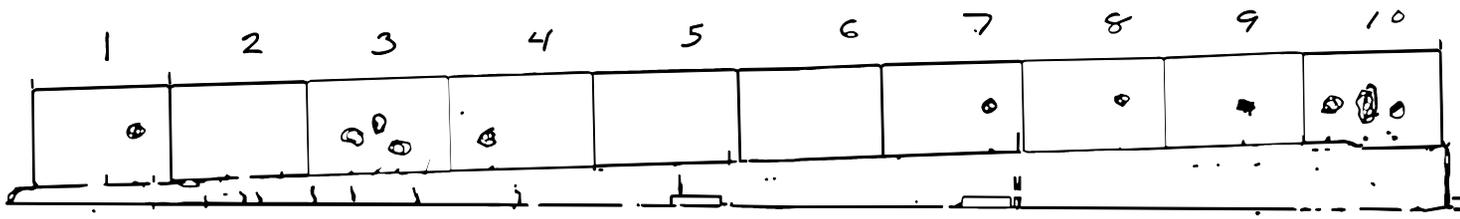
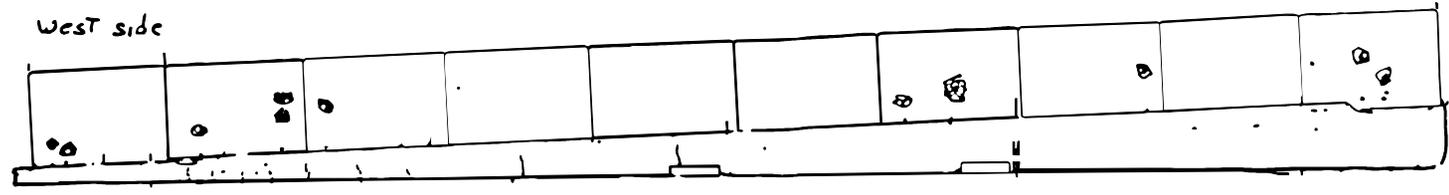
Soft spots noted May 28

Stress cracks in the base

Soft spots on the crushable blocks and stress cracks in the base plotted on the diagram of the ADIEM II

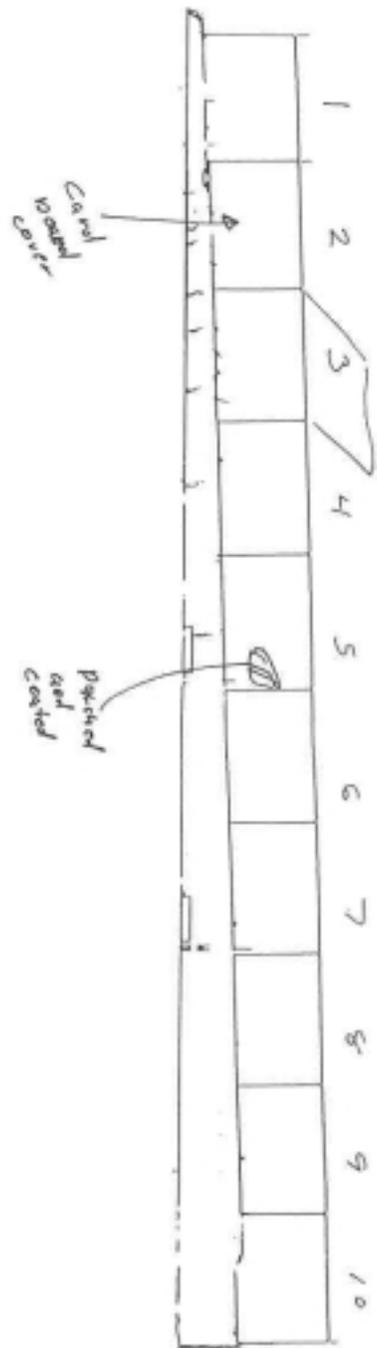
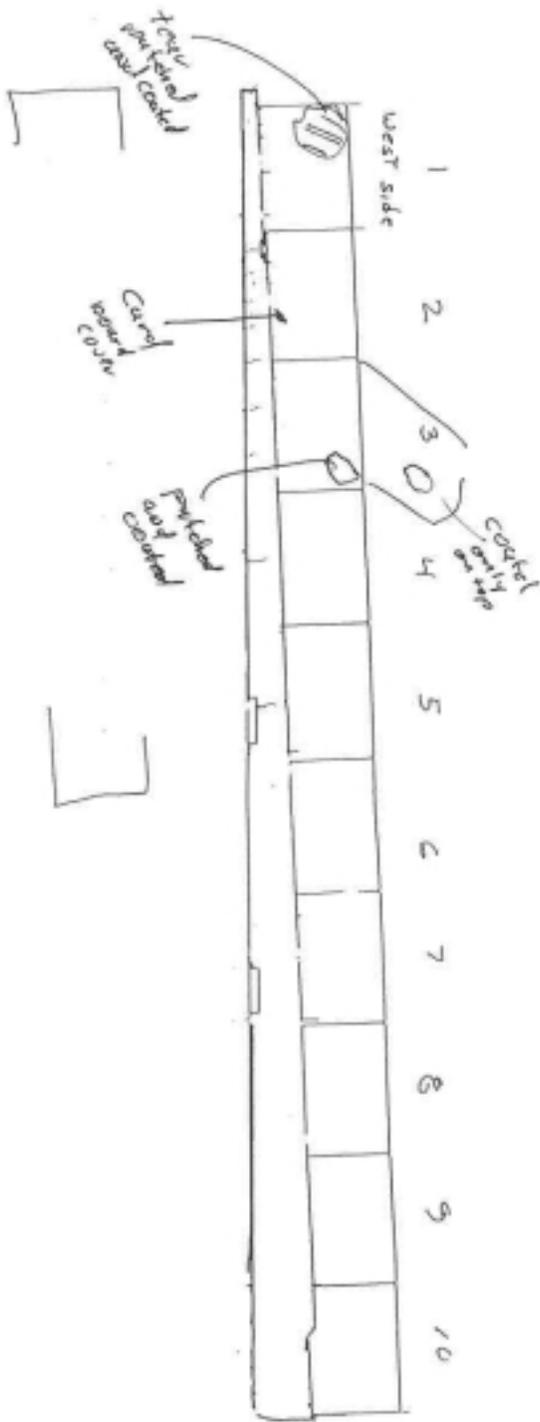
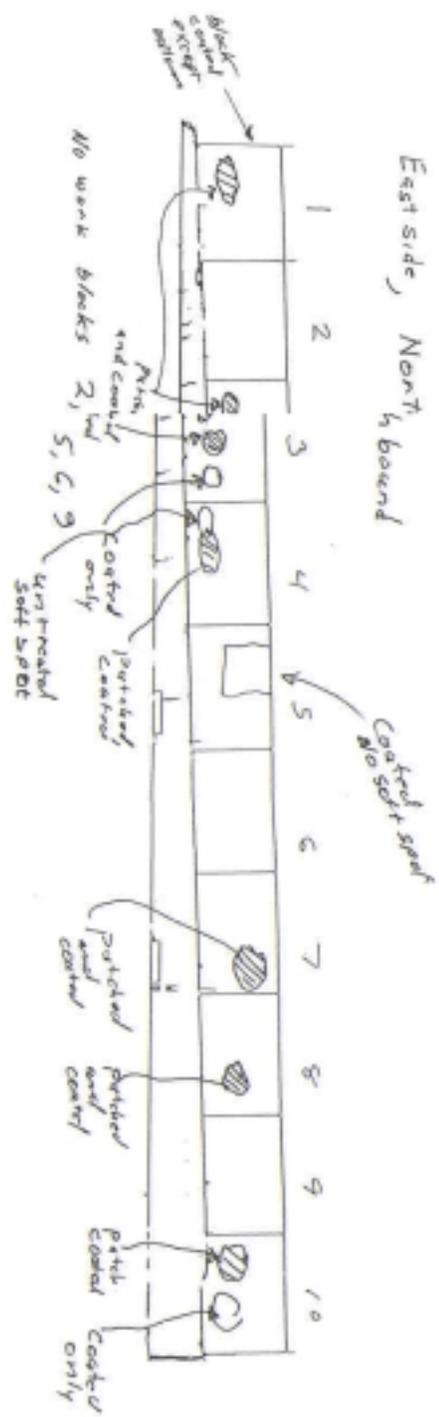
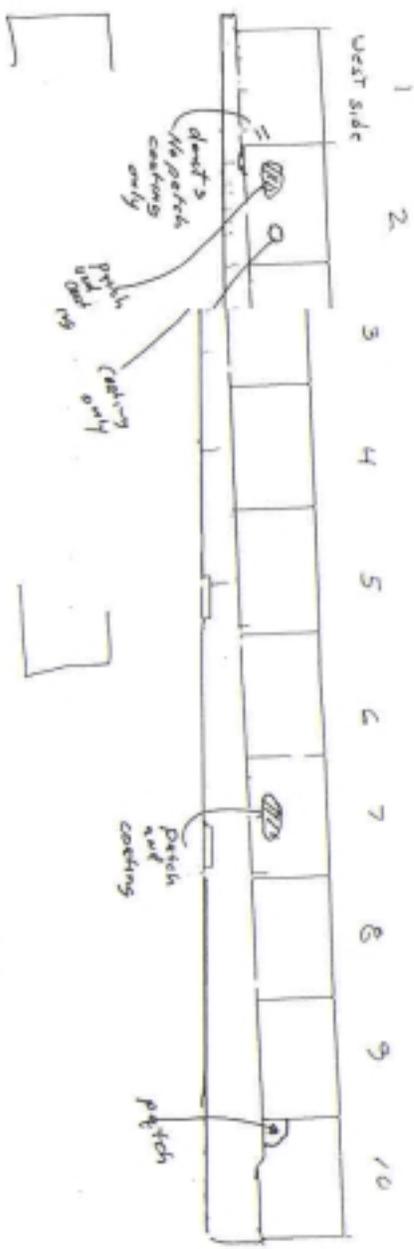
On September 9, 1998 Don Gripne, a consultant for SYRO, made repairs on the crushable blocks at both the northbound and southbound ADIEM II Units on the above mentioned project. Several soft spots were found in the northbound unit in May of 1998. The southbound unit, which was installed in August of 1998, also had a few soft spots and one tear in the coating. SYRO elected to dig out the soft spots and fill the holes with grout and re-coat the grouted surface rather than replace the blocks. (See attached drawings)

NO repair blocks 3, 4, 5, 6, 8, 9

repaired areas SEPT 9, 1998.

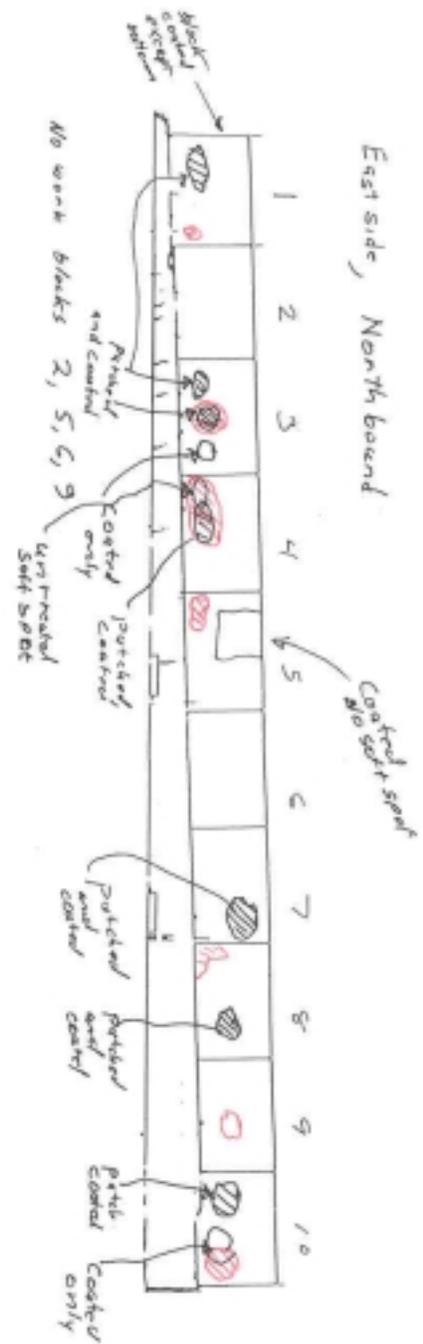
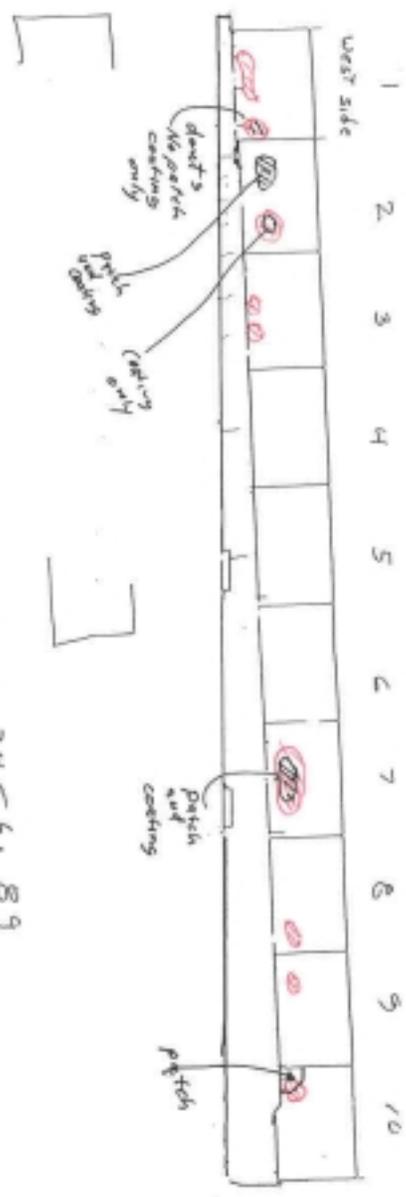
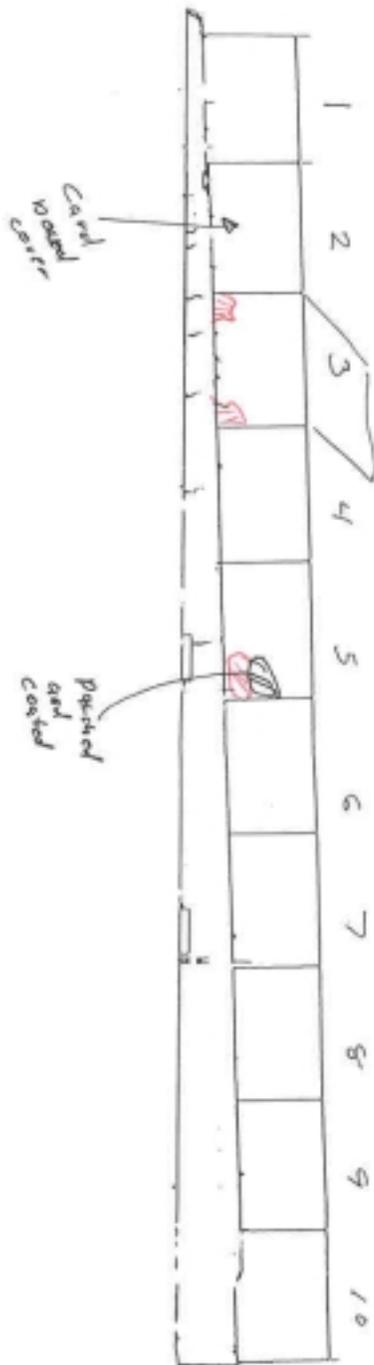
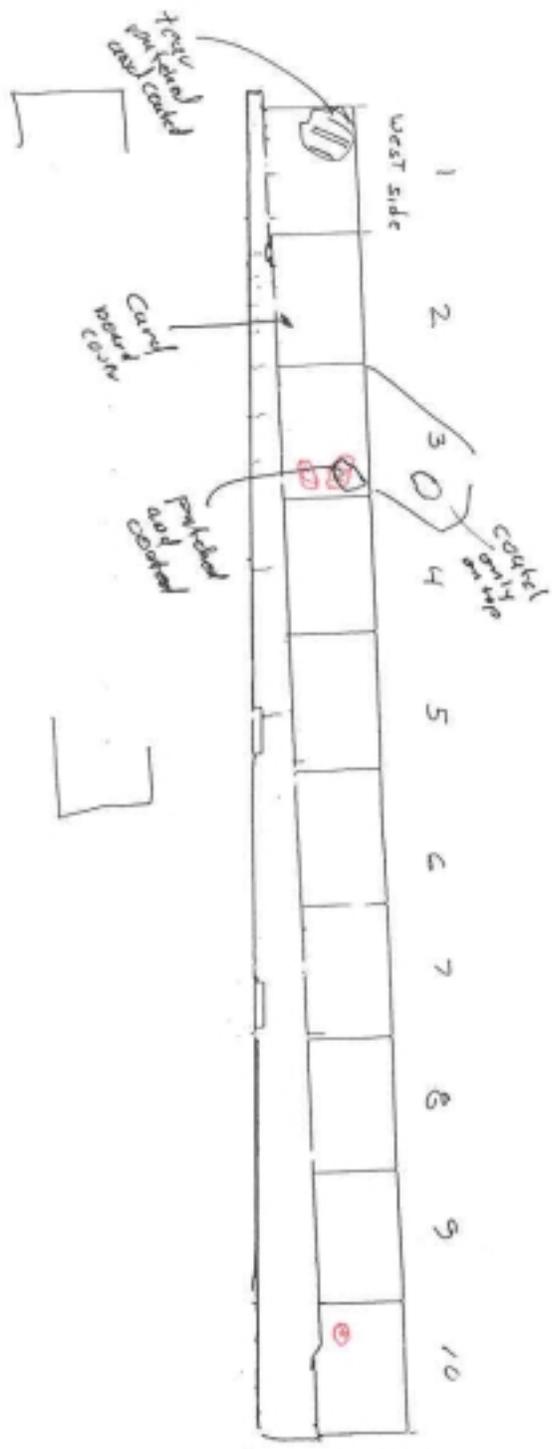
On April 22, an inspection was made on both the northbound and southbound ADIEM II units on the above project. Several soft spots were found in the northbound unit while the southbound unit, which was installed in August of 1998, only had a few soft spots. Some of these spots were in the same general area as the ones found in 1998. A few new ones were also found. The general appearance of the blocks was only fair because some were stained. The cardboard covered block on the southbound unit was still in tact and looked good. The base still looked the same as on previous inspections. See attached drawings for details.

No repair blocks 3, 4, 5, 6, 8, 9

Repaired areas Sept 9, 1998.

Self Seals April 22, 1999
