# TRAFFIC SIGNAL INVENTORY PROJECT

FINAL REPORT

Sponsored by the Iowa Department of Transportation  
CTRE Management Project 00-67

JUNE 2001

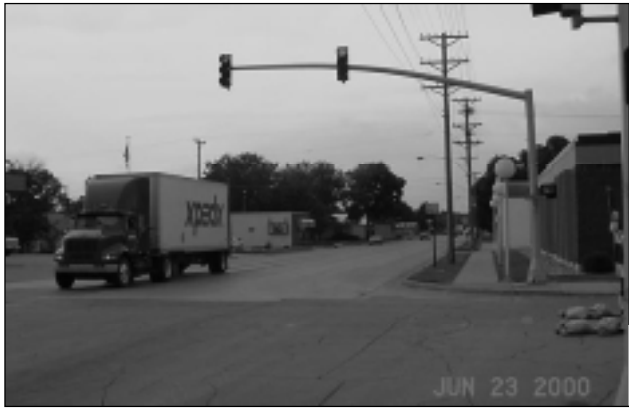
**Figure 1 South Leg of Intersection 01**

MUTCD: Neither of the traffic signals have backplates on any of their signal heads (see Figure 1). This is especially critical on the overhead mast arms signals on the state highway (which is an east-west street). There were no timing sheets in the cabinets.

Standard Practice: The Superior Street approaches have signal indications on the mast arms only. There are no pole-mounted signals for these approaches (see Figure 1). The Prospect Street approaches have only pole-mounted signals (no mast arms).

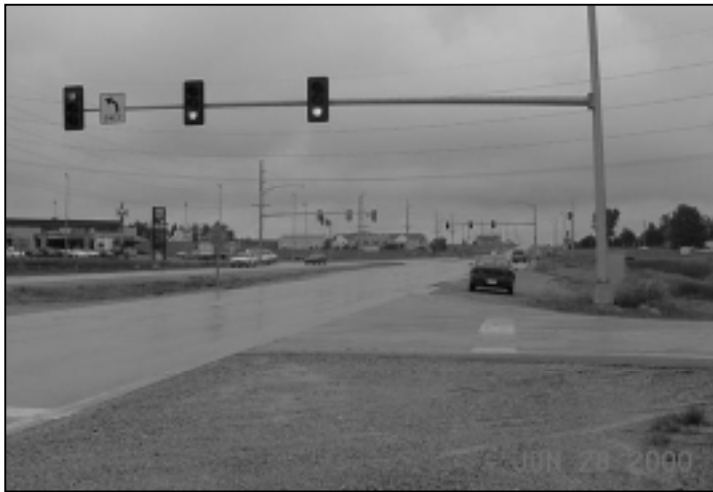
**Figure 2 North Leg of Intersection 04**

Standard Practice: There were not redundant left-turn signal heads for the protected left-turn phase. All signal heads are mast-arm mounted (see Figure 2).

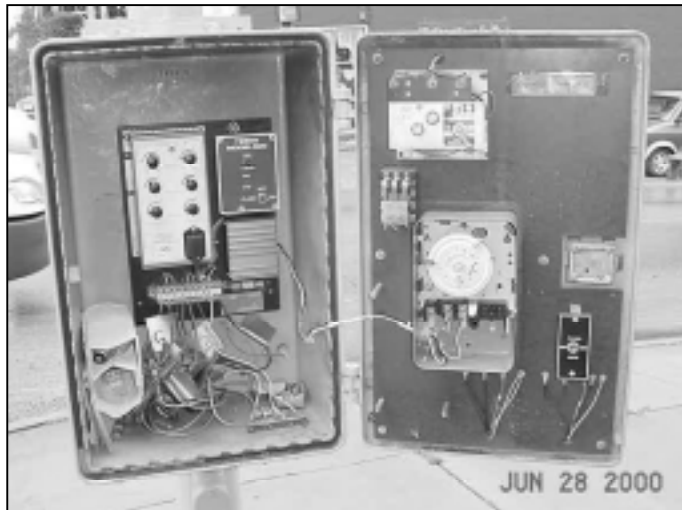
**Figure 3 Controller Cabinet for Intersection 05**

Operations: The controller is fairly obsolete (see Figure 3). The city may want to look at upgrading the equipment and possibly making the intersection semi- or fully actuated. In the meantime, the cycle length of 80 seconds may be able to be shortened without causing any delay at the intersection.

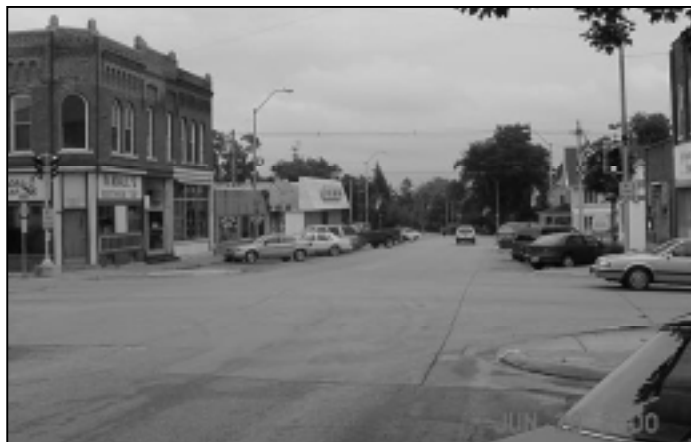
**Figure 4 East Leg of Intersection 05**

Standard Practice: All four approaches have only pole-mounted signals (no mast arms). As shown in Figure 4, the target values of the signals may not be optimal due to other visual clutter in the driver's field of view.

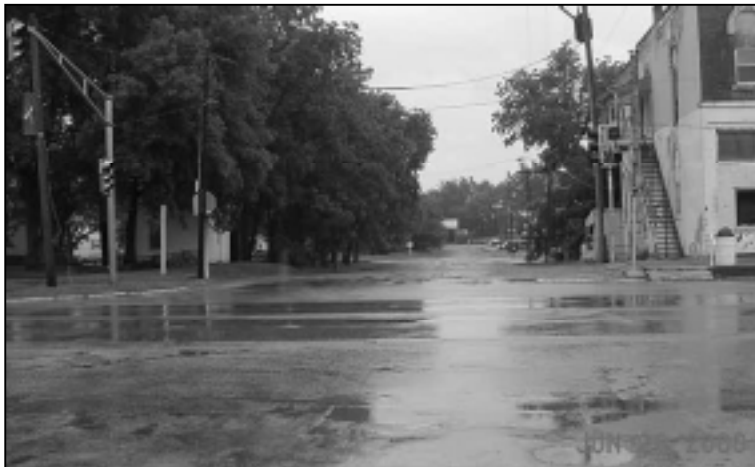
**Figure 5 West Leg of Intersection 06**

signal. Highway traffic has a constant green indication and side street traffic has a flashing red indication until a pedestrian button is actuated (see Figure 5). During the pedestrian movement, both highway and side street traffic face a solid red indication. The signal is controlled by an electro-mechanical controller. The dial rests at a “home” position until a pedestrian button is actuated.

**Standard Practice:** The operation at this intersection is highly unusual. The Iowa DOT should look closely at either changing the operation of the signal or removing it completely.

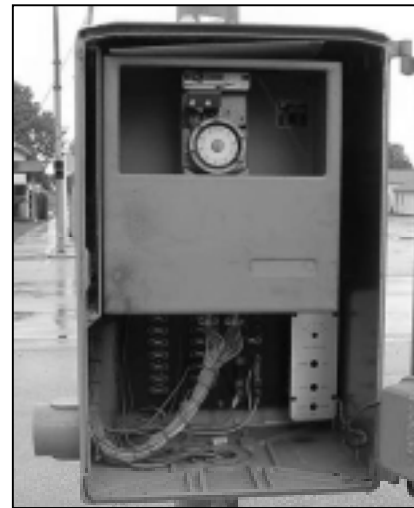
**Figure 6 Controller Cabinet at Intersection 06**

**Operations:** The controller is fairly obsolete (see Figure 6). If the signal is in fact warranted, the City may want to look at upgrading the equipment and possibly making the intersection semi- or fully actuated with three-section vehicular indications on all four approaches. For an unfamiliar driver, approaching the signal on the side street may cause some confusion.

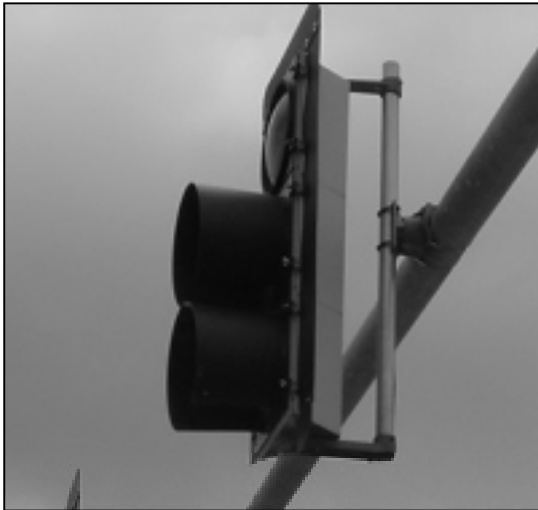
**MUTCD:** There was at least one vehicle indication visor missing at each of the three signals (see Figure 7) and there were numerous overhead backplates that were damaged and in need of replacement. The red clearance intervals were too short at all three intersections. The pedestrian clearance interval was too short at the East Jefferson intersection. None of the traffic signals have indications for pedestrians on all legs of the intersection.

**Figure 7 Missing Visor on Mast-arm Signal at Intersection 10**

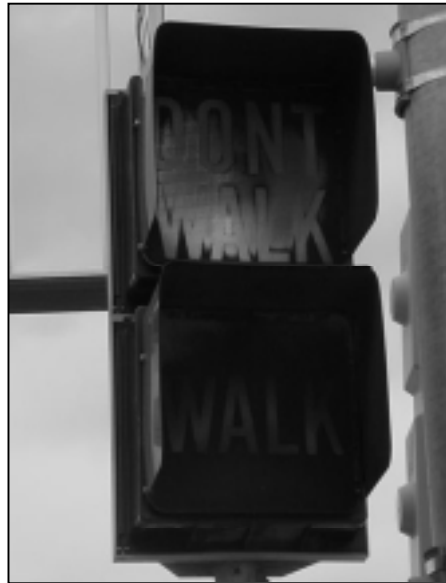
Operations: At least one “Don’t Walk” lens needs to be replaced at each of the three signals (see Figure 8). The signals do not appear to be operating in a coordinated fashion despite their close proximity to each other. The left-turn phases at the Jefferson and Franklin intersections may be unwarranted. The intersection design is fairly unusual. The west legs of both the Jefferson and Franklin intersections have angle parking in the middle of the street.

**Figure 8 Don't Walk Lens at Intersection 10**

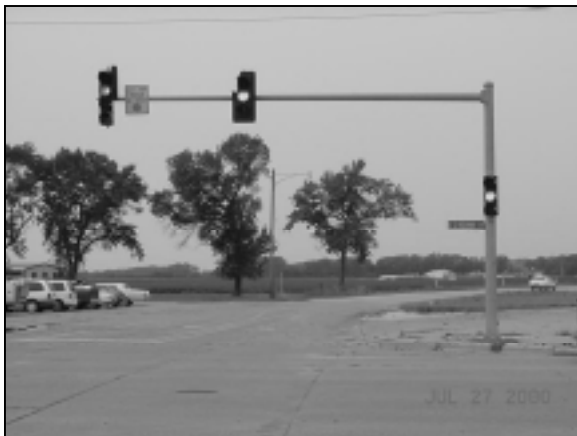
Operations: Numerous backplates at the Sheridan intersection were in need of replacement (see Figure 9). There were also many dim lights at both the Sheridan and commercial driveway intersections. All three cabinets were very dirty and needed their filters replaced (see Figure 10). Timing sheets either did not exist or were not current at all three locations. The left-turn phase at Sheridan may not be warranted.

**Figure 9 Damaged Backplates at Intersection 14**

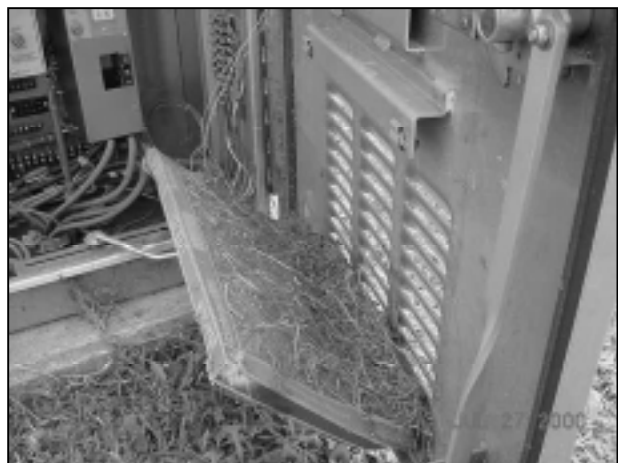
**Figure 10 Dirty Filter at Intersection 14**

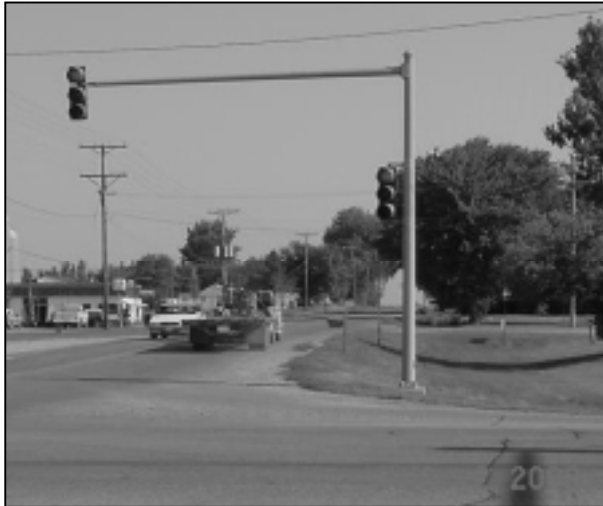
**Figure 11 Missing Backplates at Intersection 17**

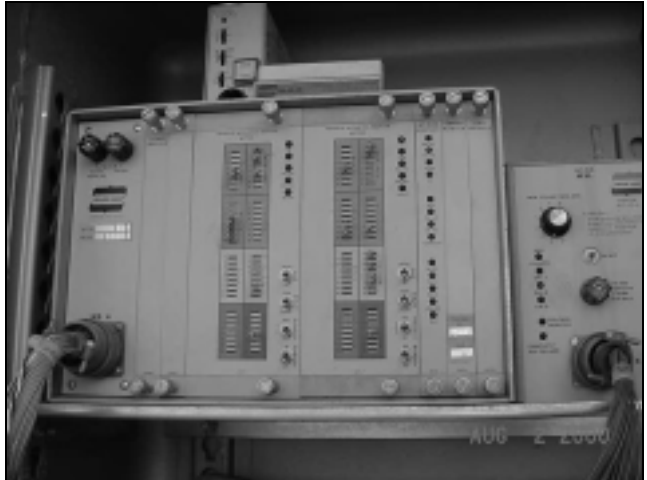
**Figure 12 Controller for Intersection 17**

Operations: There was no timing sheet in the cabinet. The controller is very outdated (see Figure 12). Recommend upgrading to a more state of the art controller.

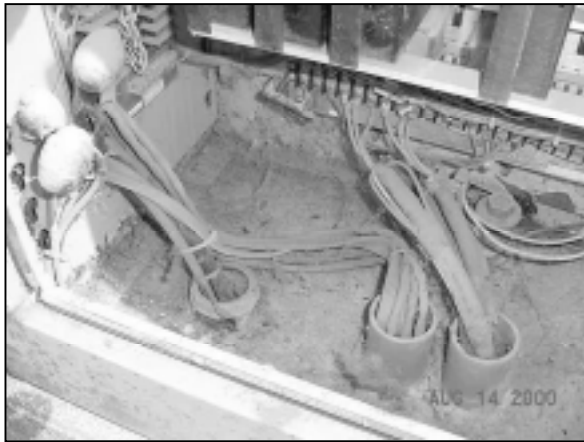
**Figure 13 Dirty Cabinet at Intersection 20**

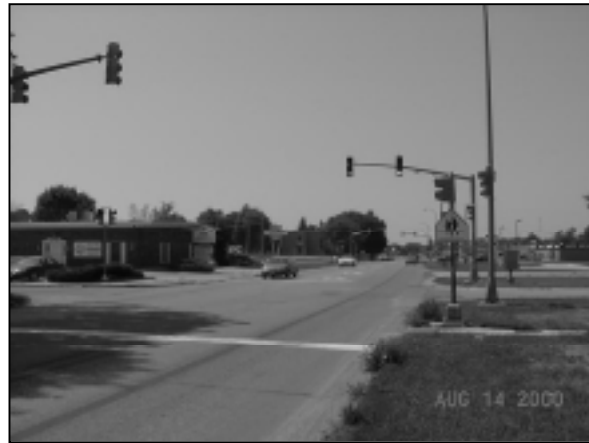
**Figure 14 Missing Crosswalks at Intersection 26**

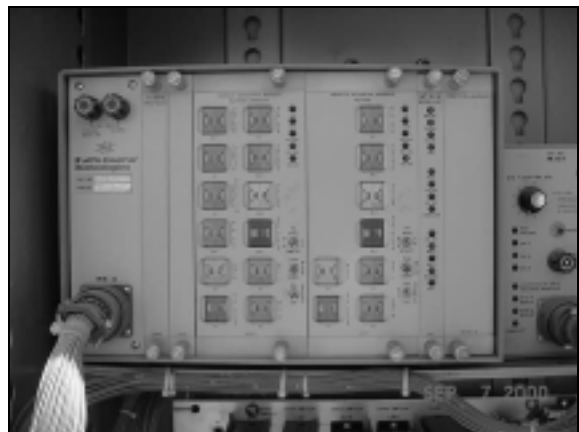
**Figure 16 Controller at Intersection 33**

None of the intersections had current timing sheets in the cabinet. Most cabinets were in need of cleaning. The controller at the commercial driveway is out of date and needs to be replaced (see Figure 16).
