COST-EFFECTIVENESS OF GEOTEXTILES

Review of Performance in Alaskan Roads

Final Report

**September 1989
Revised February 1991**

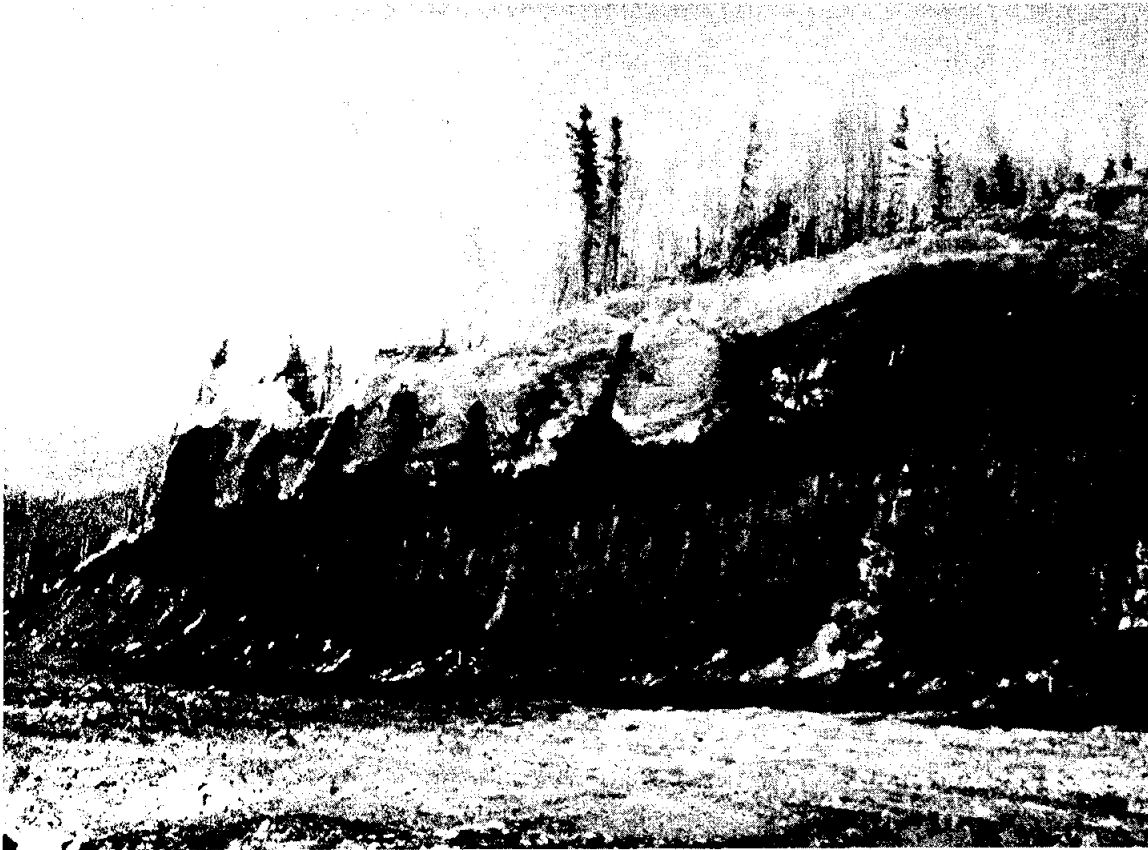
Photo 1. Massive ground ice in permafrost

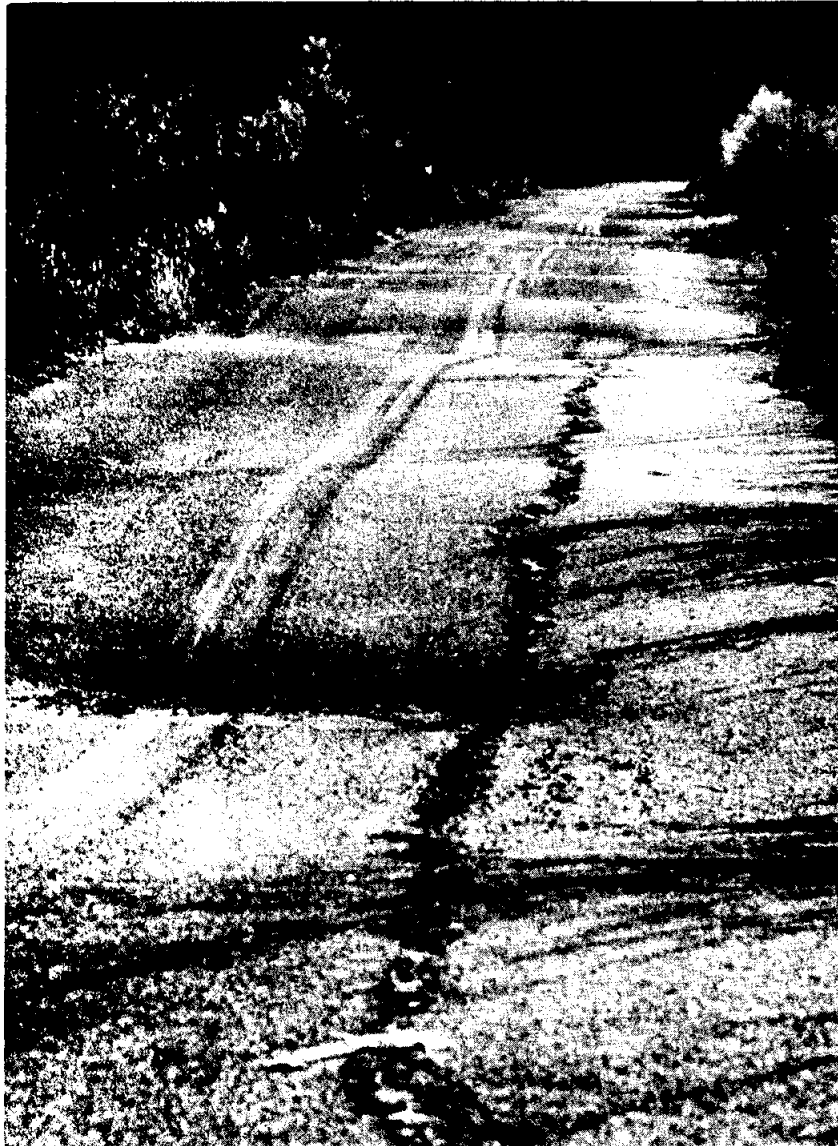
The road surface roughness which develops (Photo 2) results in the need for frequent and costly road maintenance work to level the dips and to re-create a level surface. Under the worst permafrost conditions, maintenance may be required several times a

Photo 2. Road roughness resulting from thaw settlement

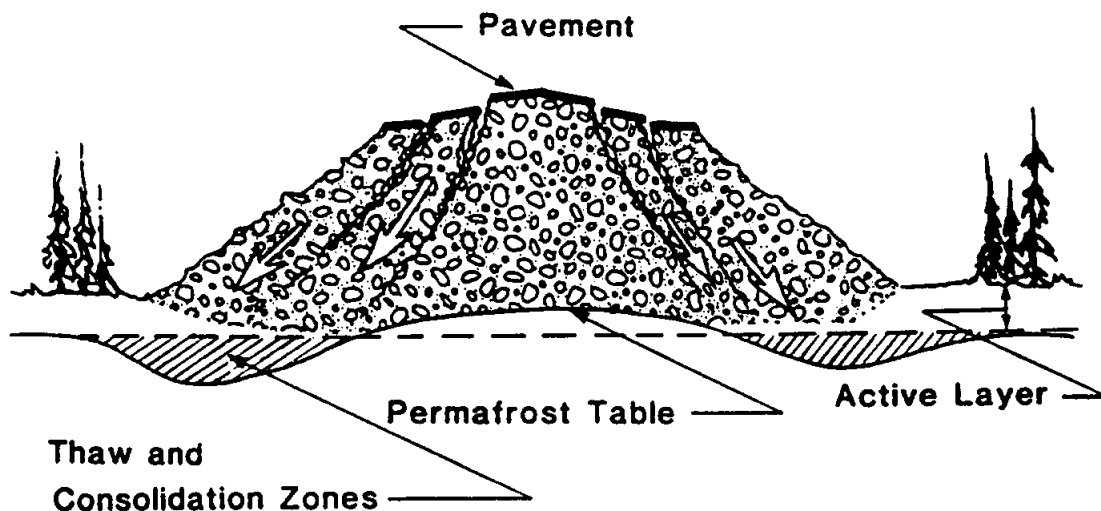
Figure 1. Roadway slope failures caused by thawing permafrost

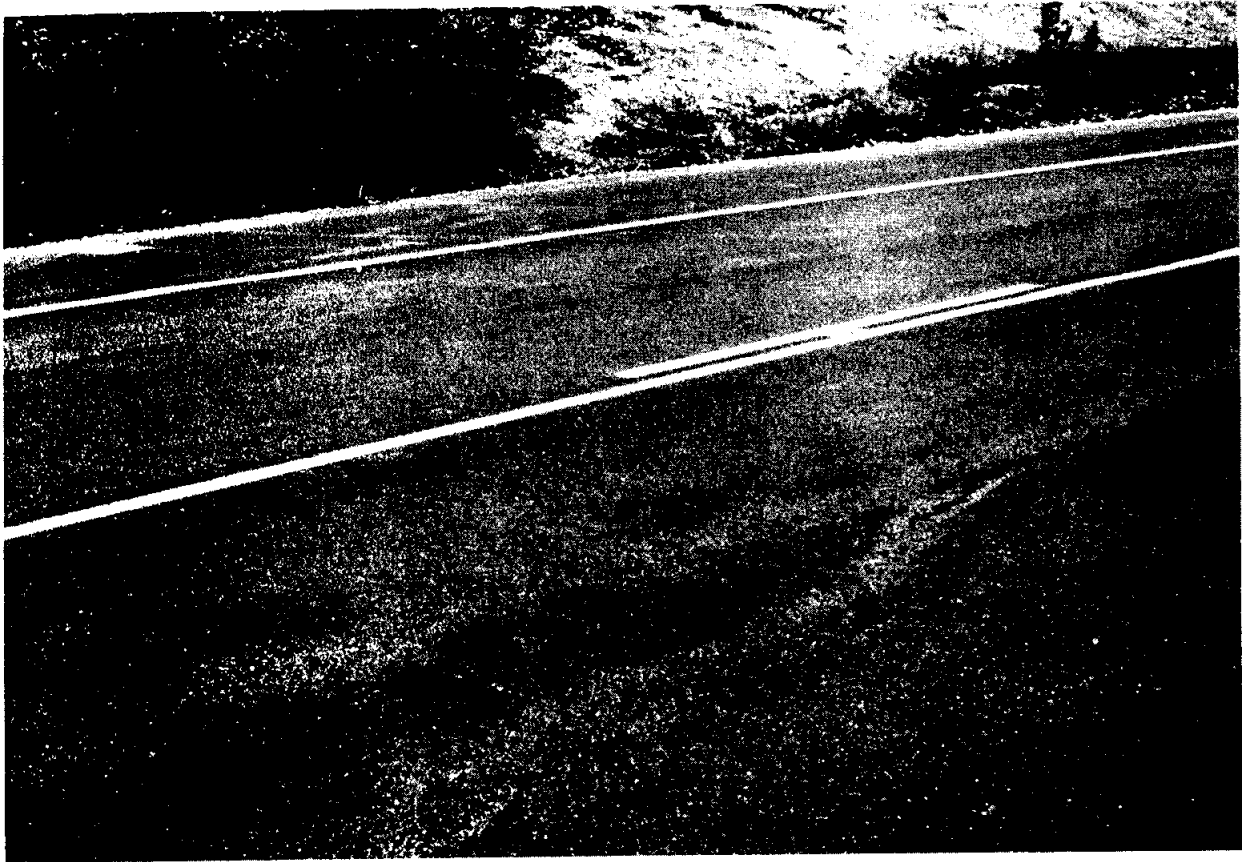
A similar example was seen on the second southernmost geotextile section placed on the Parks Highway, Little Coal Creek to Middle Fork project. Here a single layer of geotextile (again Propex 2002) was placed in 1985. By the next year a longitudinal crack extended through the southern boundary of the section with no difference apparent between the treated and untreated areas. The area is shown in Photo 4, taken one year after paving. Two years after paving the crack reached over 100 feet into the geotextile section (and 80 feet outside of it).

Photo 4. Longitudinal crack one year after paving. The paint at the edge of pavement and on centerline marks the end of a geotextile section. The photo was taken on the Parks Highway near Little Coal Creek.

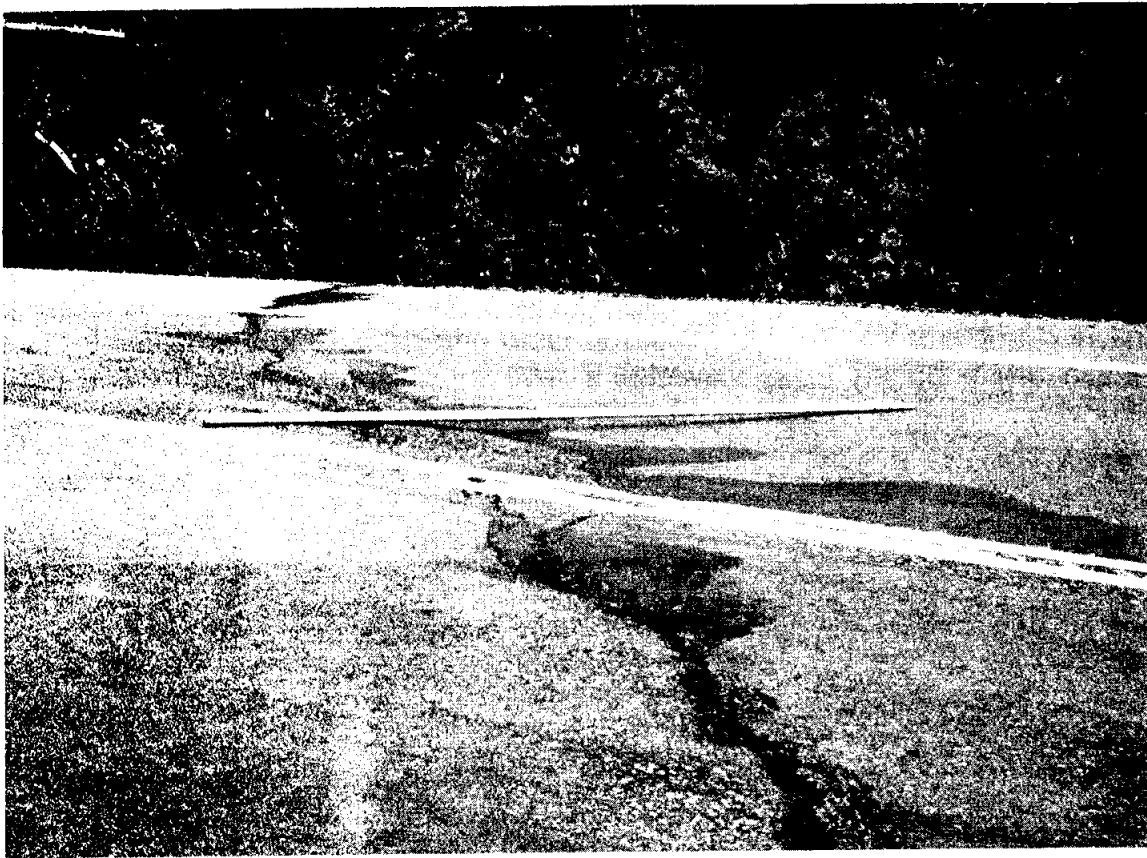
A major crack near milepost 88 of the Tok Cutoff had appeared by 1986 in a three layer geotextile section placed in 1984 (see Photo 5). This was not a longitudinal crack; instead it extended diagonally across the road embankment. While not a longitudinal crack, it appeared to result from a similar cause, a loss of support in the foundation soils. In this case the loss of support appeared to occur on the fill side of a cut/fill transition.

In 1987, this failure zone was excavated to inspect the geotextile. By this time the settlement was so severe that a gravel patch had been placed over the area. The upper geotextile layer was torn across its entire width at the crack. The other two layers were partially torn and were severely strained elsewhere. Damage to the geotextile was greater near the center of the roadway than near the edges. The geotextile installation was clearly not strong enough to prevent the failure at this location. There was no evidence that the installation had even slowed the progress of the failure by any substantial amount.

Photo 5. Crack in a 3 layer geotextile section two years after construction. The photo was taken in 1986 near milepost 88 of the Tok Cutoff Highway.

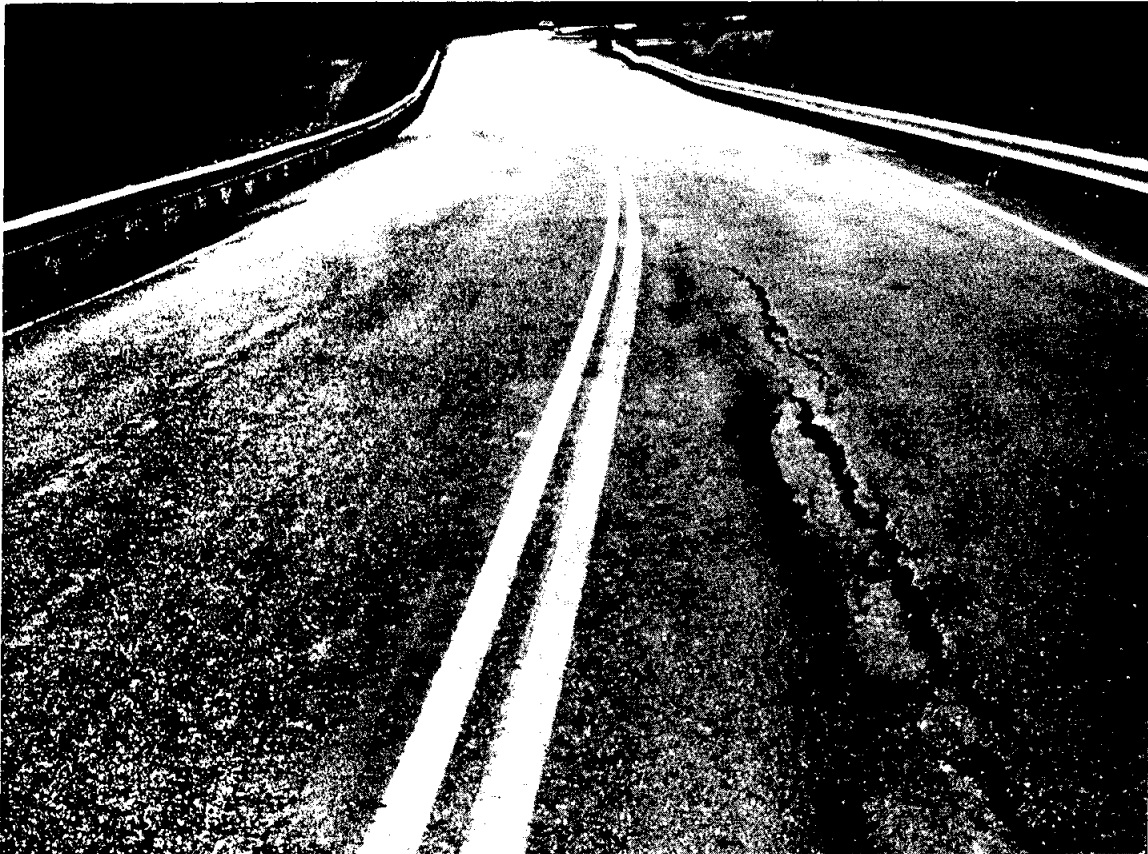
Photo 6. A five layer section on Chena Hot Springs Road starts even with the wheel lying against the right guardrail. Longitudinal cracking and patching end at about this point, but settlement dips continue (note the sharp dip in the right guardrail).

Unfortunately, there is no evidence that geotextiles have had this effect in any of the installations examined for this study. Photograph 6, for example, shows a section of the Chena Hot Springs Road where five layers of a relatively low strength geotextile (Tympar 3401), spaced about nine inches apart, were installed in 1980. Severe dipping in the road can be seen in both the road surface and in the guardrail. The geotextile does not appear to have had any beneficial influence on the differential settlement at this site. It does appear, however, that the installation has arrested a severe longitudinal crack in the roadway at the site. This effect is discussed elsewhere in this report.

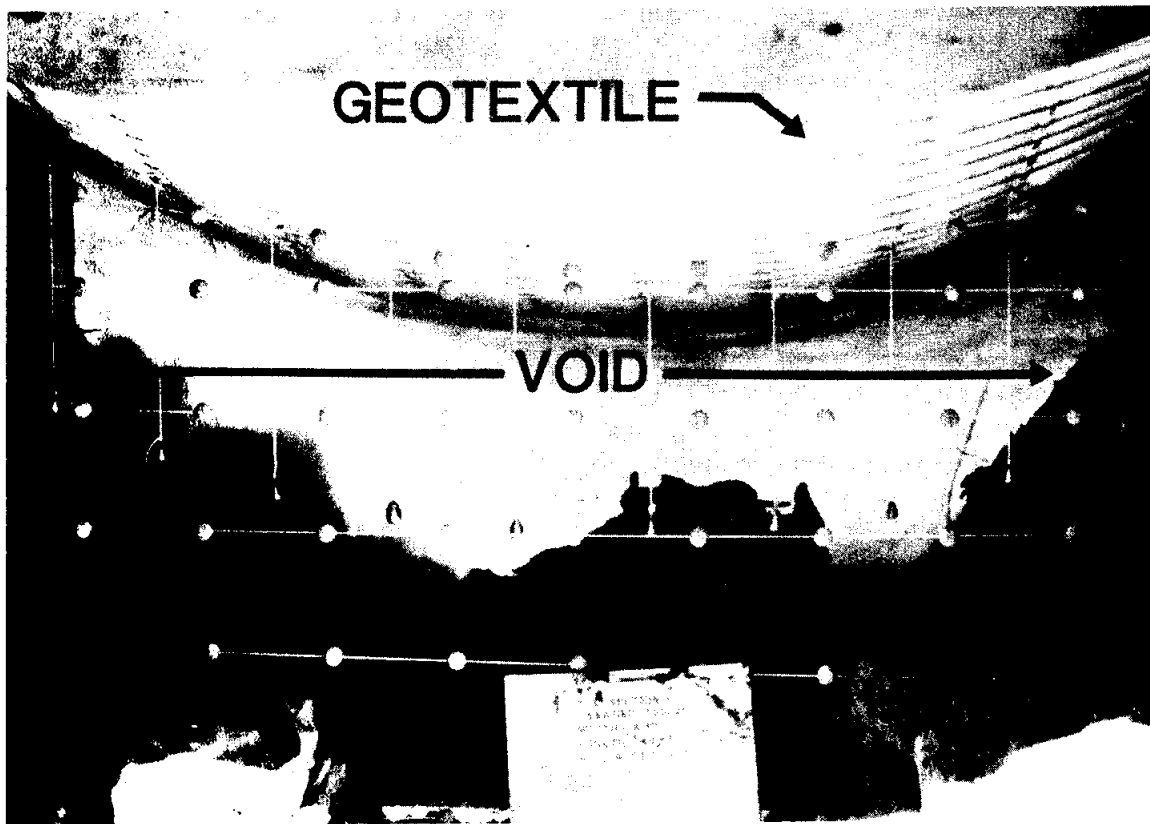
Photo 7. High strength geogrid supporting 3 feet of fill across a six foot void. The photo is of one of a series of experiments by Dr. Tom Kinney of the University of Alaska Fairbanks.

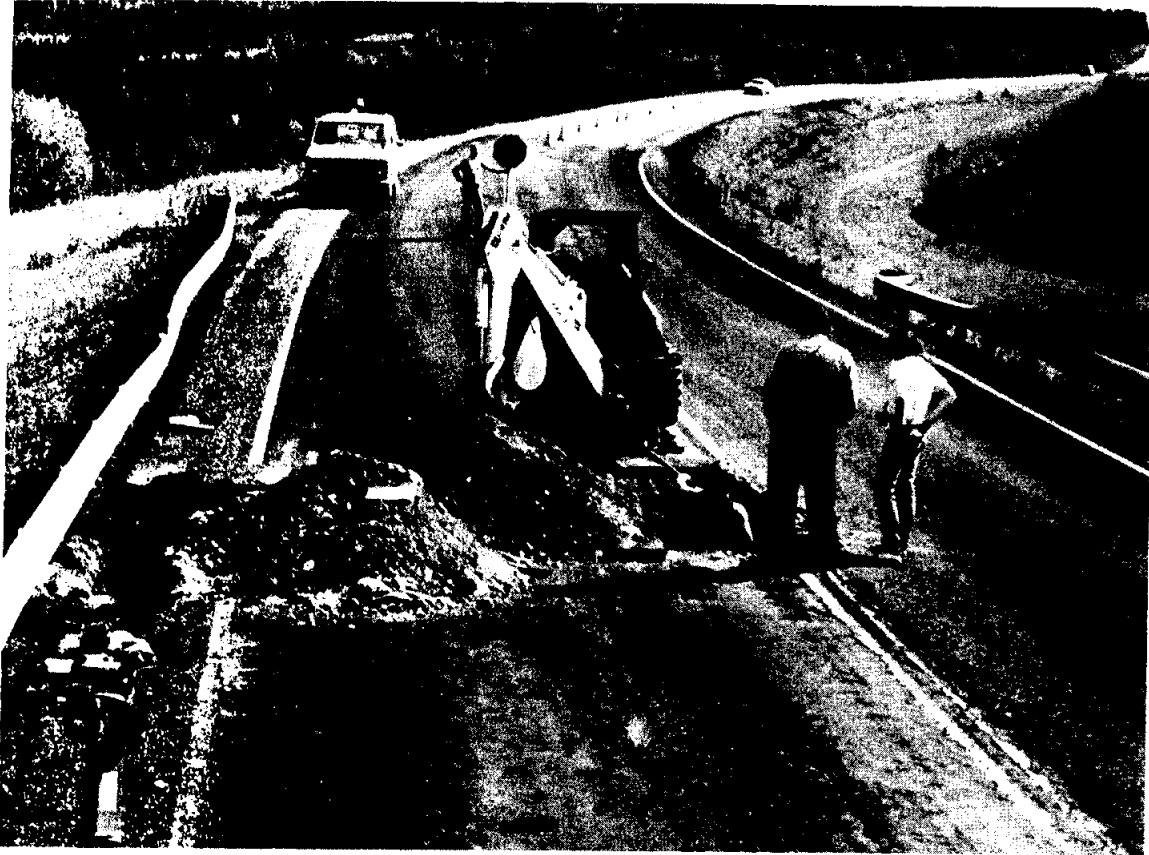
In June 1987, an excavation was made with a small backhoe in the center of the road to expose this end of the geotextile installation (see Photos 8 and 9). Although the as-built plans indicate a vertical geotextile wall at the end of the section (which would have required temporary form work to build), what was found was a stepped or terraced configuration of layers. The planned wrapping or folding over of the ends of the geotextile was missing on two of the layers. The thicknesses of the gravel between geotextile layers also did not conform to the as-built plans, although this may be a result of construction difficulties at the ends. Farther into the section the layers may be spaced as indicated in the plans.

The exposed geotextile was in good condition. It was not torn or noticeably deformed. The geotextile was punctured in some places by stones in the fill, however. The fill material was clean, rounded alluvial sand and gravel, with few or no sharp edges or fractured faces. There were no visible cracks in the fill. The geotextile, then, did not appear to be "bridging" over voids in the fill.

Photo 8. Excavation of 5 layer section on Chena Hot Springs Road, June, 1987.

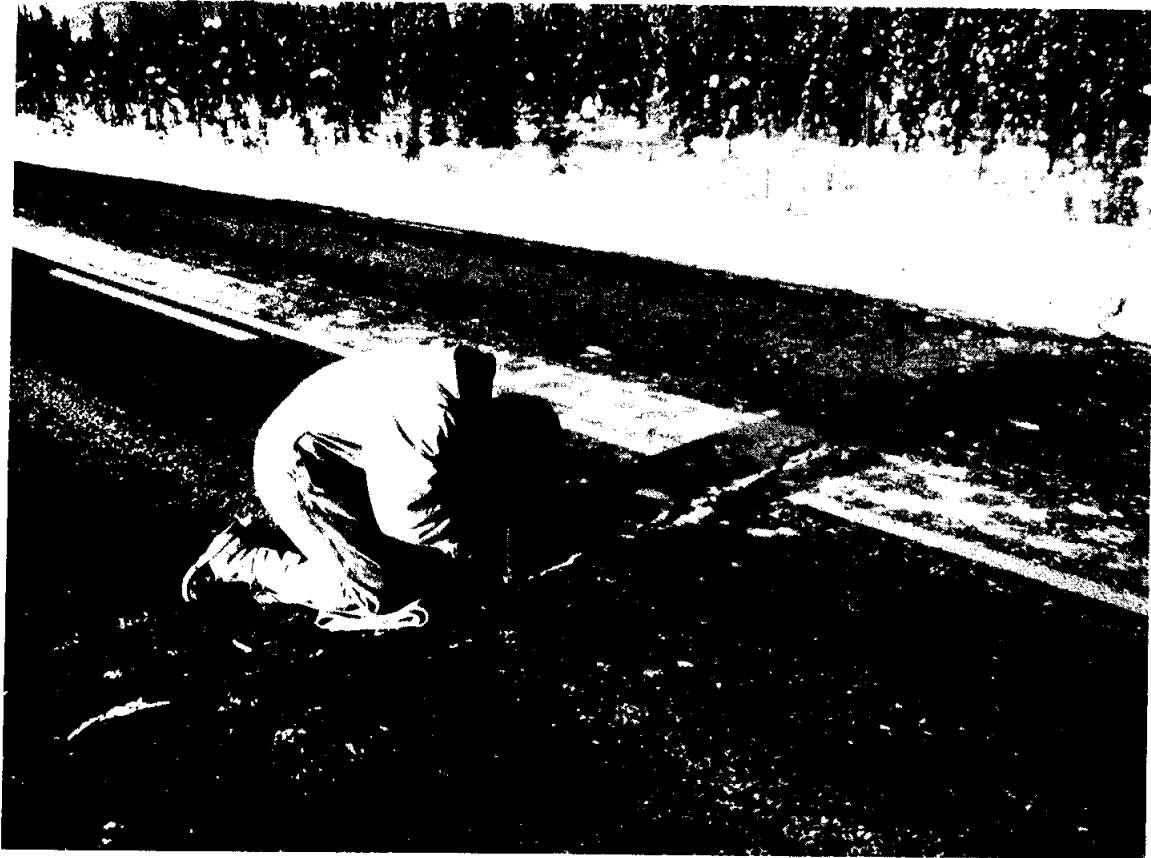
Photo 10. An inspector looks into a thermal crack using a fiber-optic borescope. The geotextile at this location was torn, as was usually the case at thermal cracks.
