**A FIELD STUDY OF PCC
JOINT MISALIGNMENT
NEAR FERGUS FALLS, MINNESOTA**

Final Report

Thomas R. Burnham, P.E.

May 1999

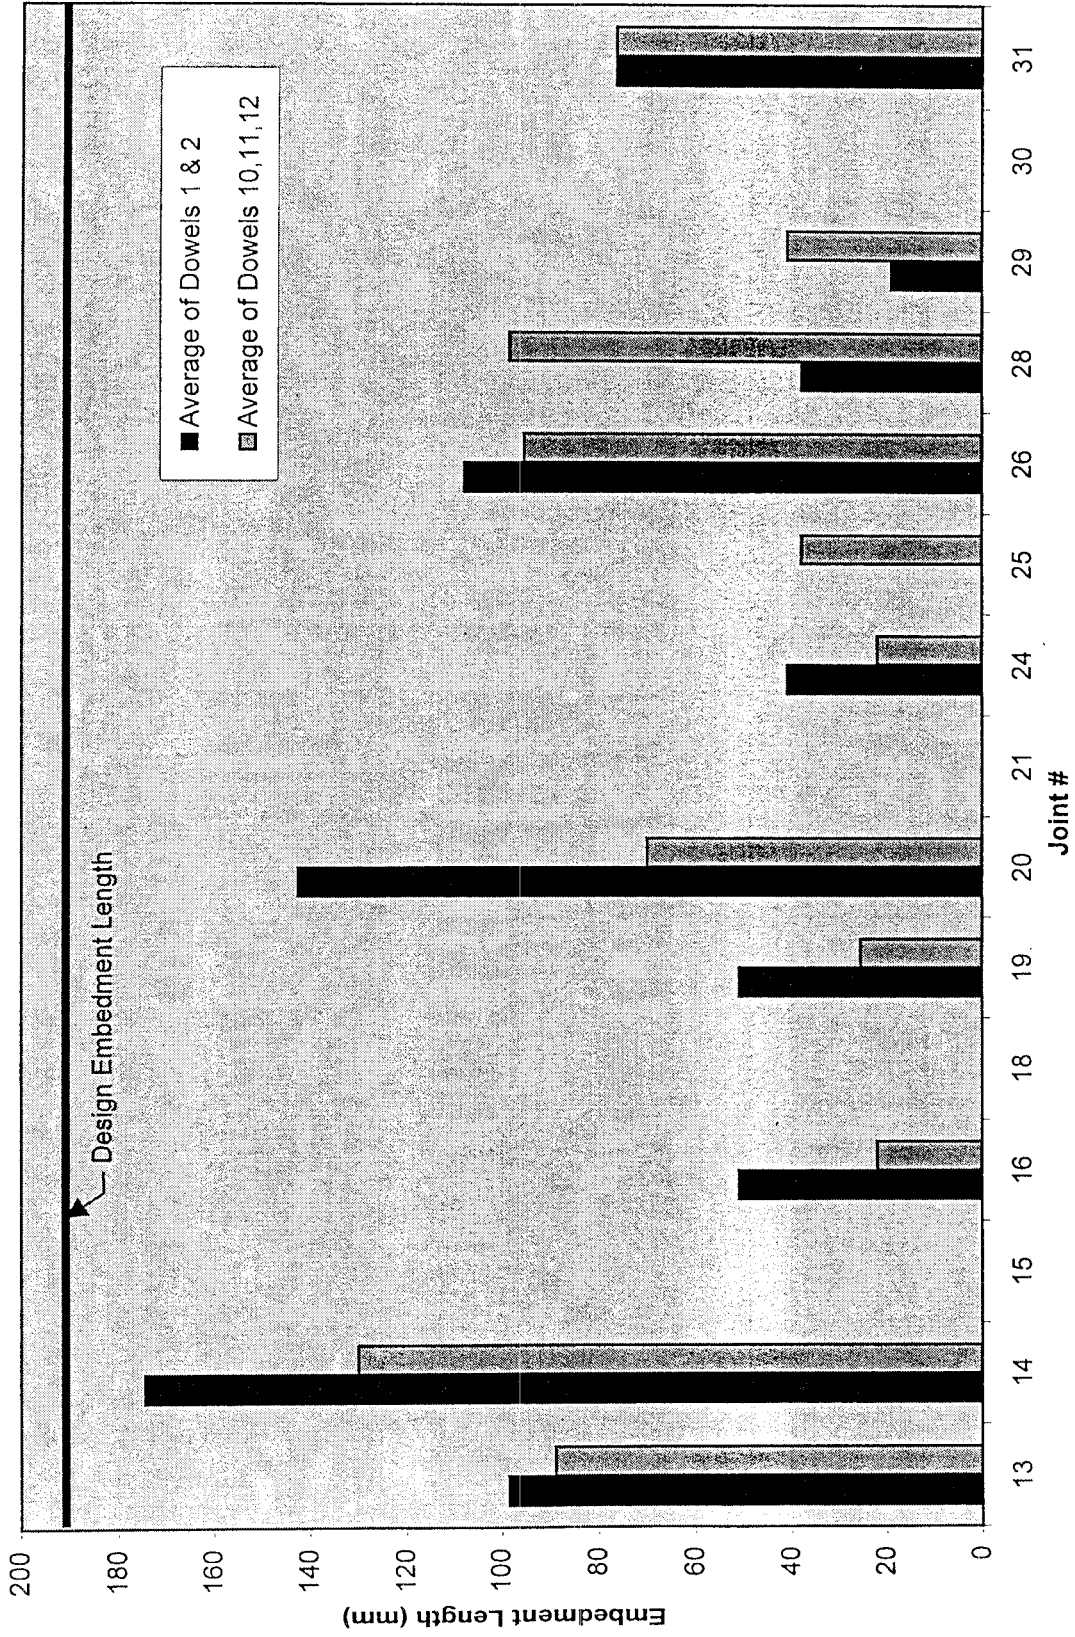
Figure 3. Dowel bar embedment lengths

Based on the longitudinal measurements, dowel bar embedment lengths were determined. Table 1 clearly shows the large variation in embedment lengths found. Positive embedment values correlate to lengths on the approach panel side (see Figure 2). Figure 3 shows embedment lengths graphically. Note that embedment lengths greater than 356 mm (14 in) or less than zero are shown as zero on this graph.

Ten of the selected joints were found to have dowel embedment lengths less than or equal to 51 mm (2 in). Of those ten, five had no dowels spanning the joint. See Appendix A for copies of the field data collection sheets.

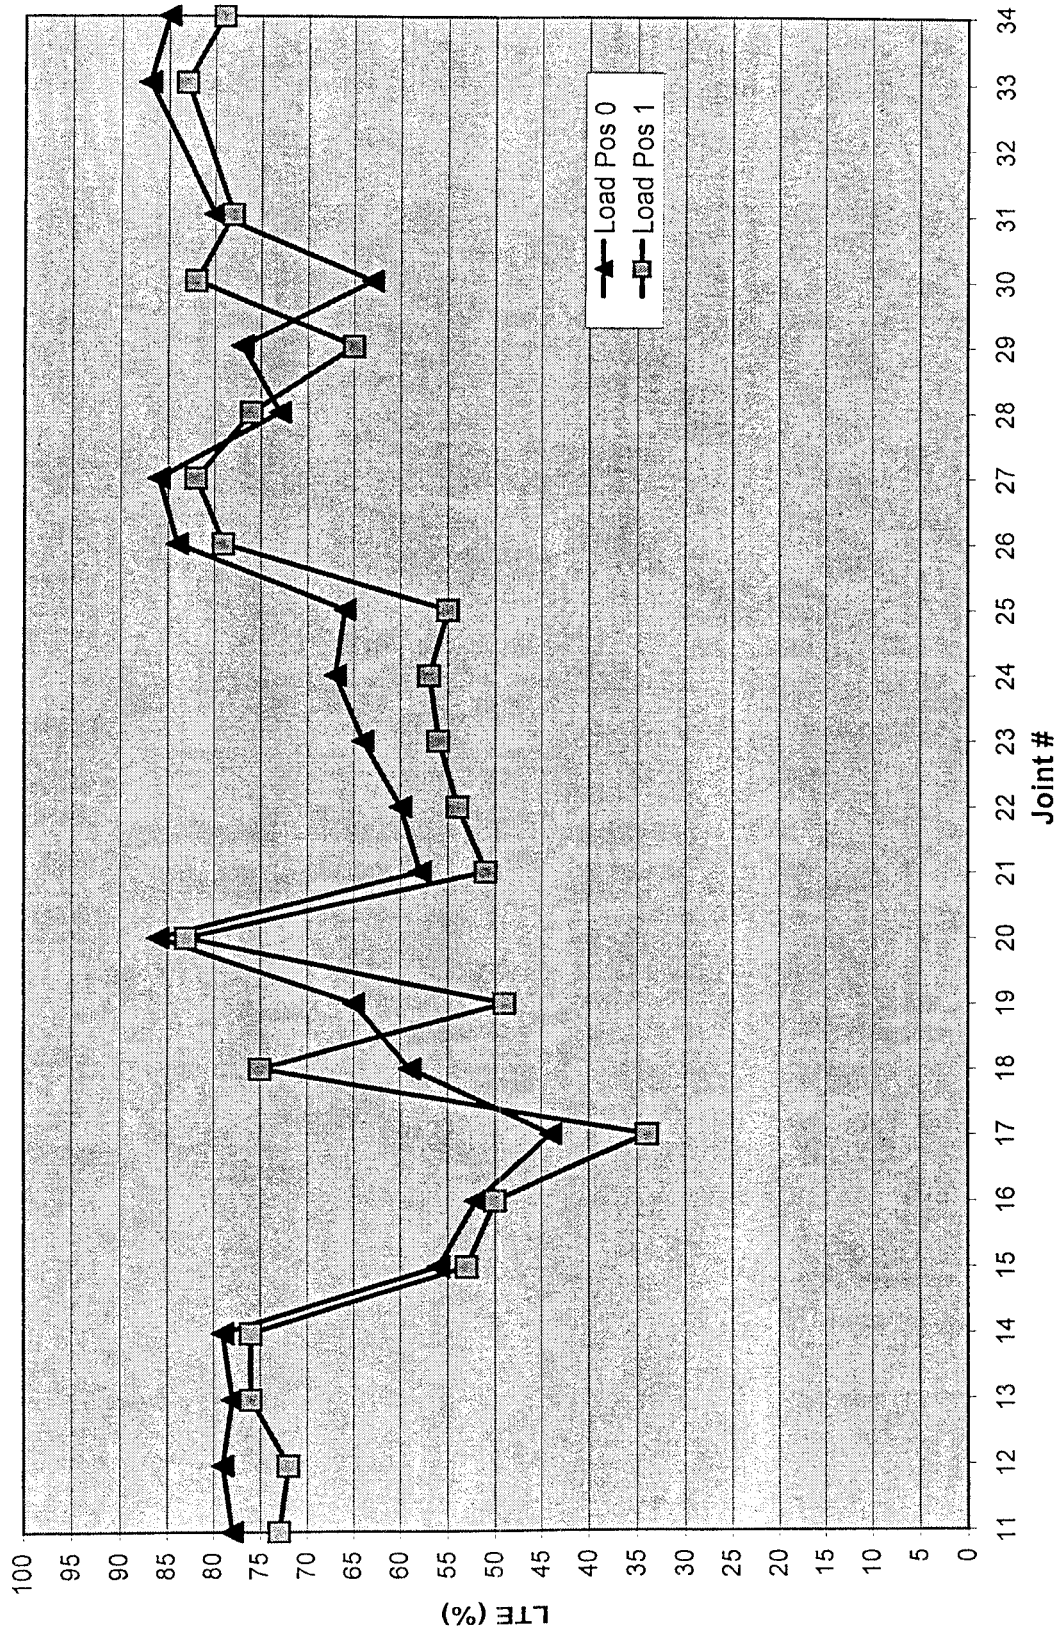
Figure 5a. Load Transfer Efficiency - Near Dowel #1

The LTE values found ranged from 30 to 87%. Figures 5a and 5b show LTE versus joint number for dowel locations #1 and #12 respectively.

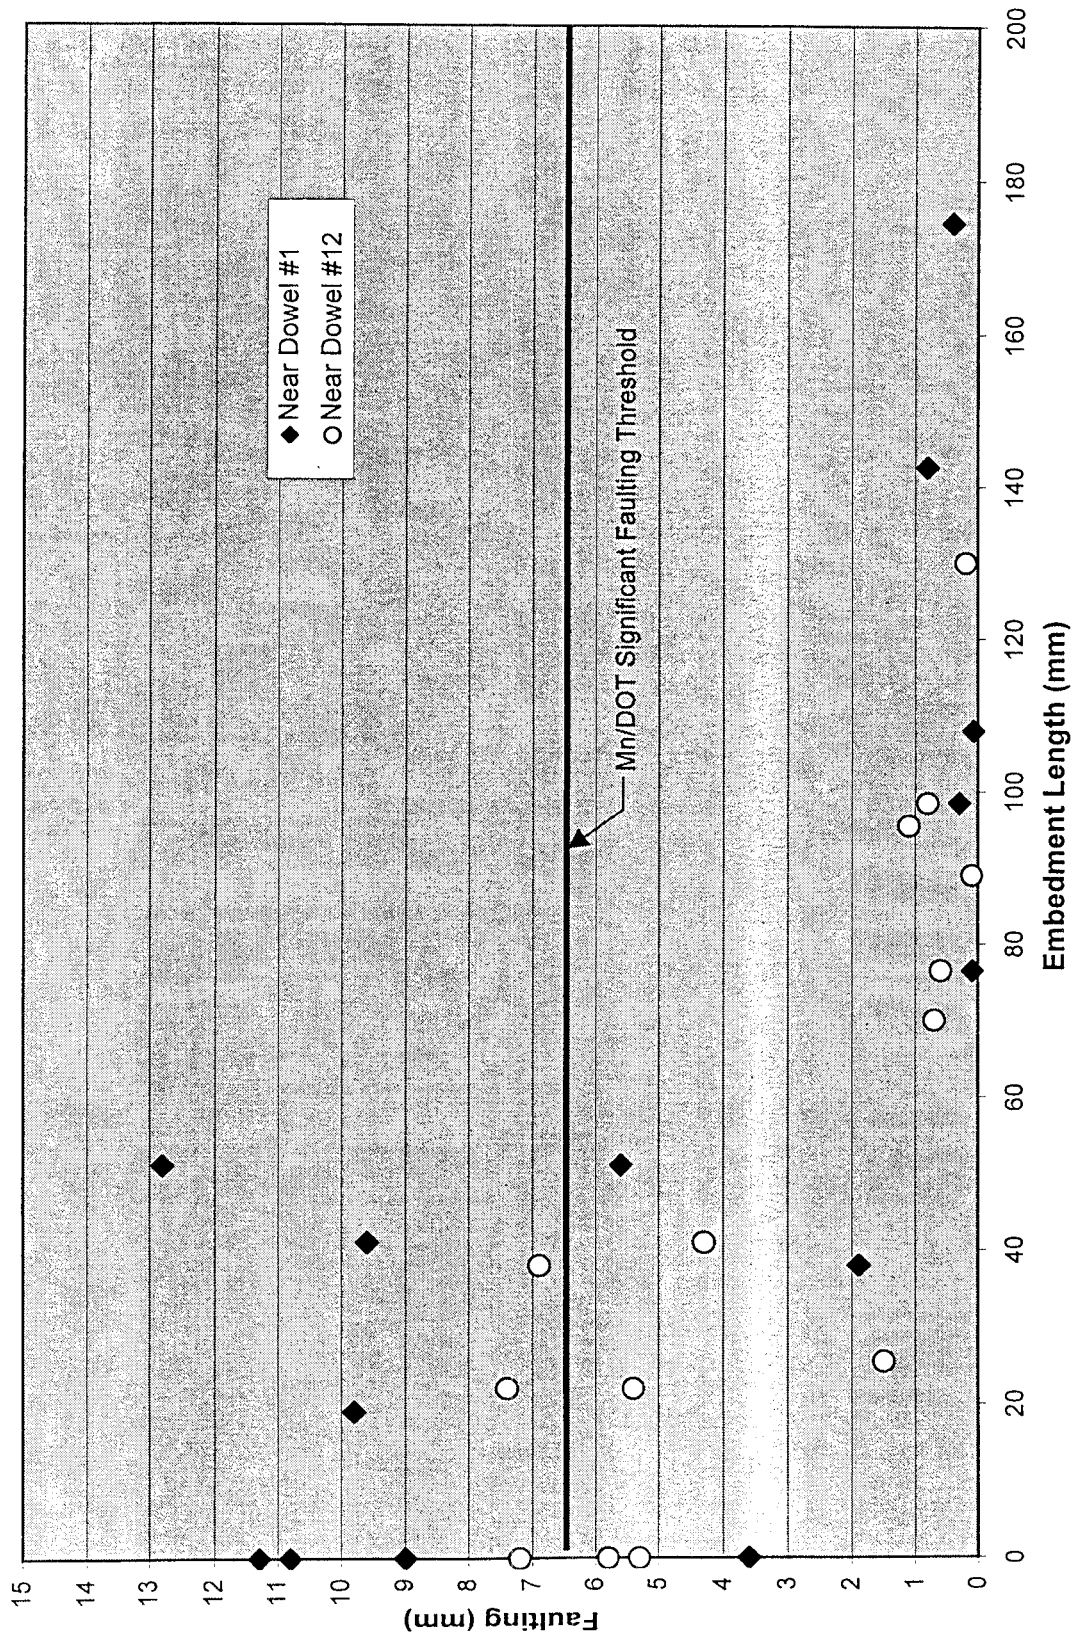
Figure 6. Embedment Length versus Joint Faulting

Figure 6 shows a comparison of dowel bar embedment length versus faulting for the selected joints. From the graph, it appears in this case that significant early faulting occurs when embedment lengths are less than 64 mm (2.5 in). The Minnesota Department of Transportation (Mn/DOT) considers faulting to be significant if it is greater than 6.4 mm (0.25 in) [2].

One must be careful not to immediately conclude that the minimum embedment length required is only 64 mm (2.5 in). Not only must there be tolerances for proper location of the dowels relative to the joint (during construction), but the results presented here are for a 12 year

old pavement (relatively new). State-of-the-art design guides recommend an embedment length of 6 times the diameter of the dowel [190 mm (7.5 in) for this case] for adequate contribution to long term load transfer [3].

No significant difference in faulting behavior was observed between dowel #1 (near shoulder) and dowel #12 (near centerline) locations.

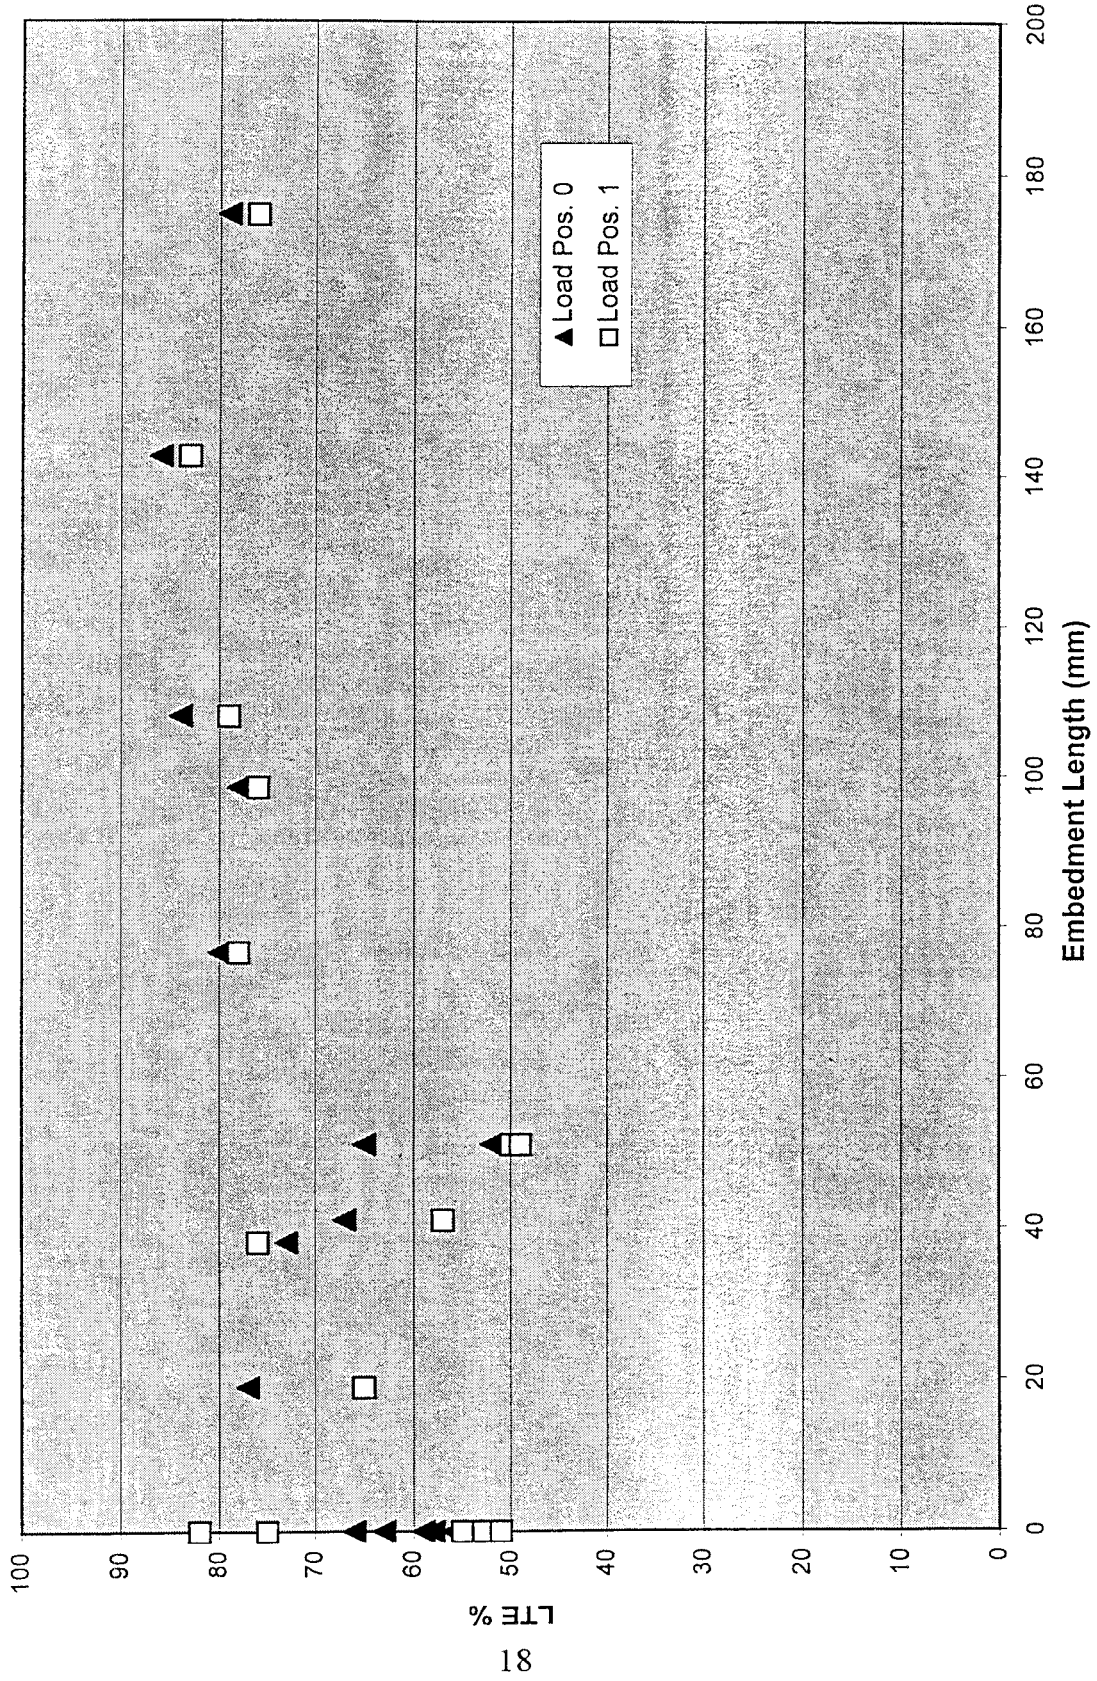
Figure 7a. Embedment length vs load transfer efficiency - Near Dowel #1

Table 4, and Figures 7a and 7b, show a comparison of embedment length and load transfer efficiency (LTE) for the selected joints. As observed in Figure 6, it appears an embedment length less than 64 mm (2.5 in) results in significantly lower (and more variable) LTE values. As in the previous comparison, caution must be taken in that this is only a 12 year old pavement. More importantly, LTE values can be strongly affected by the temperature and moisture gradients present at the time of FWD testing. Due to the lack of any instrumentation to measure these effects (other than surface and air temperatures obtained by the FWD machine), the values presented were not adjusted accordingly.

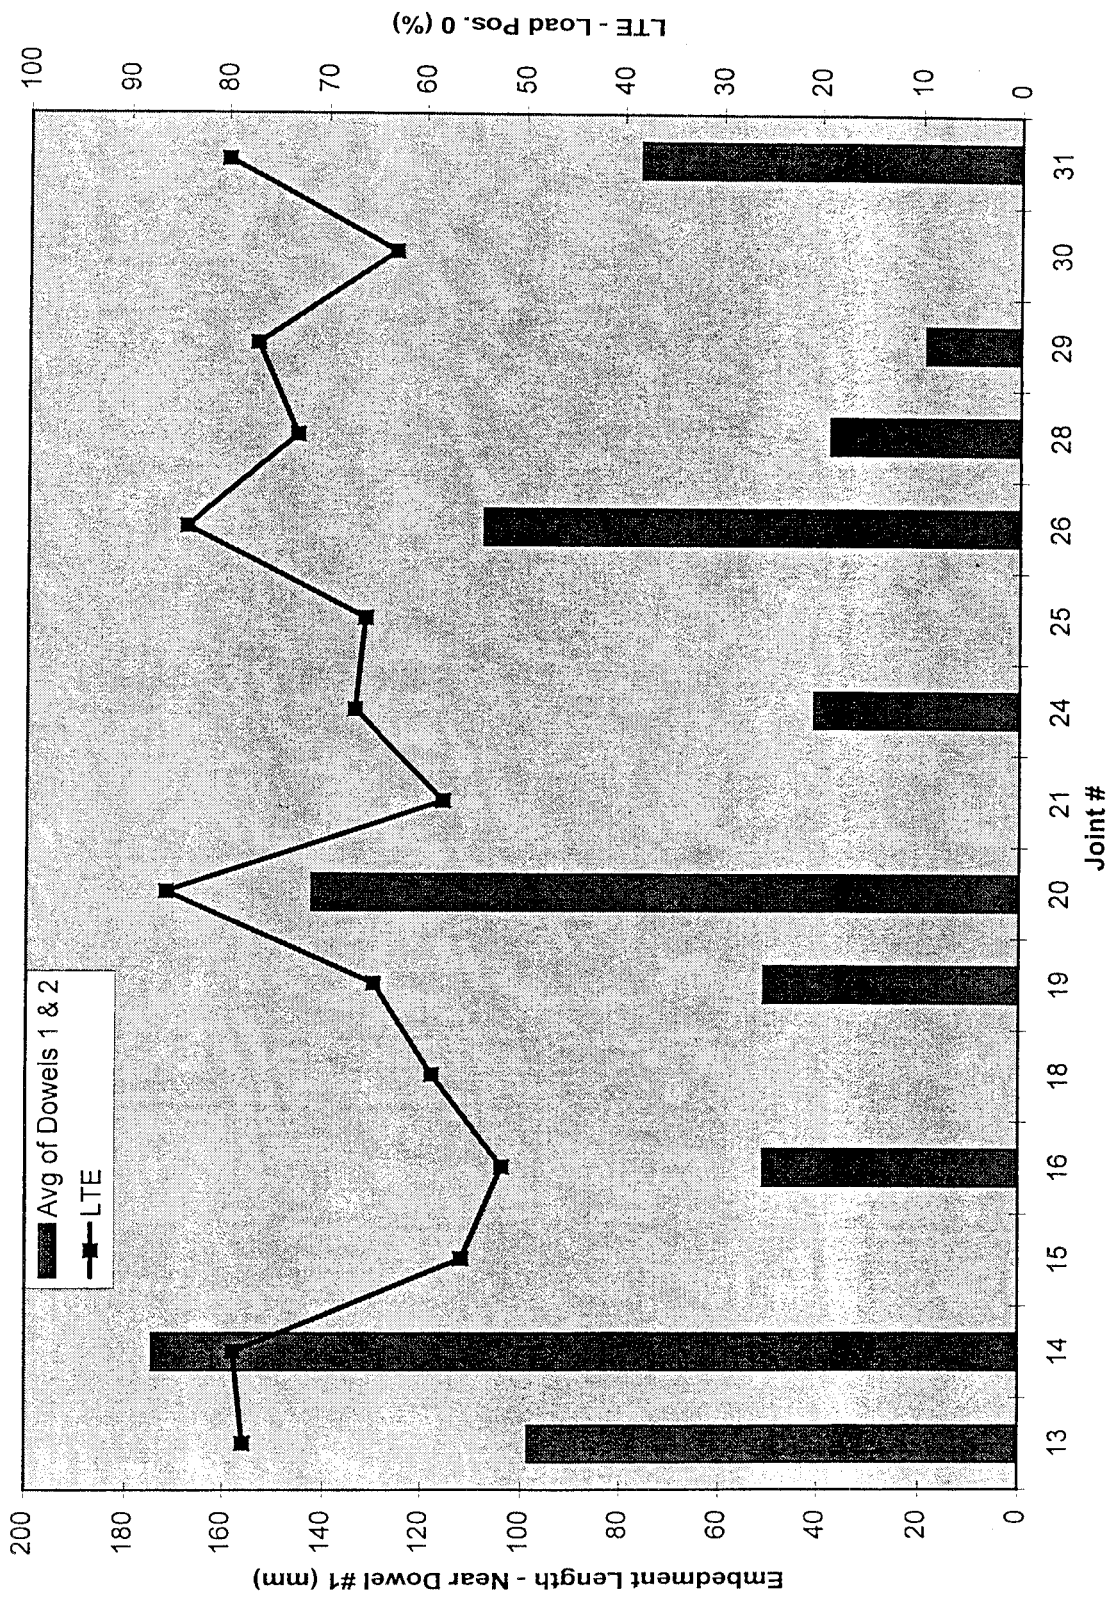
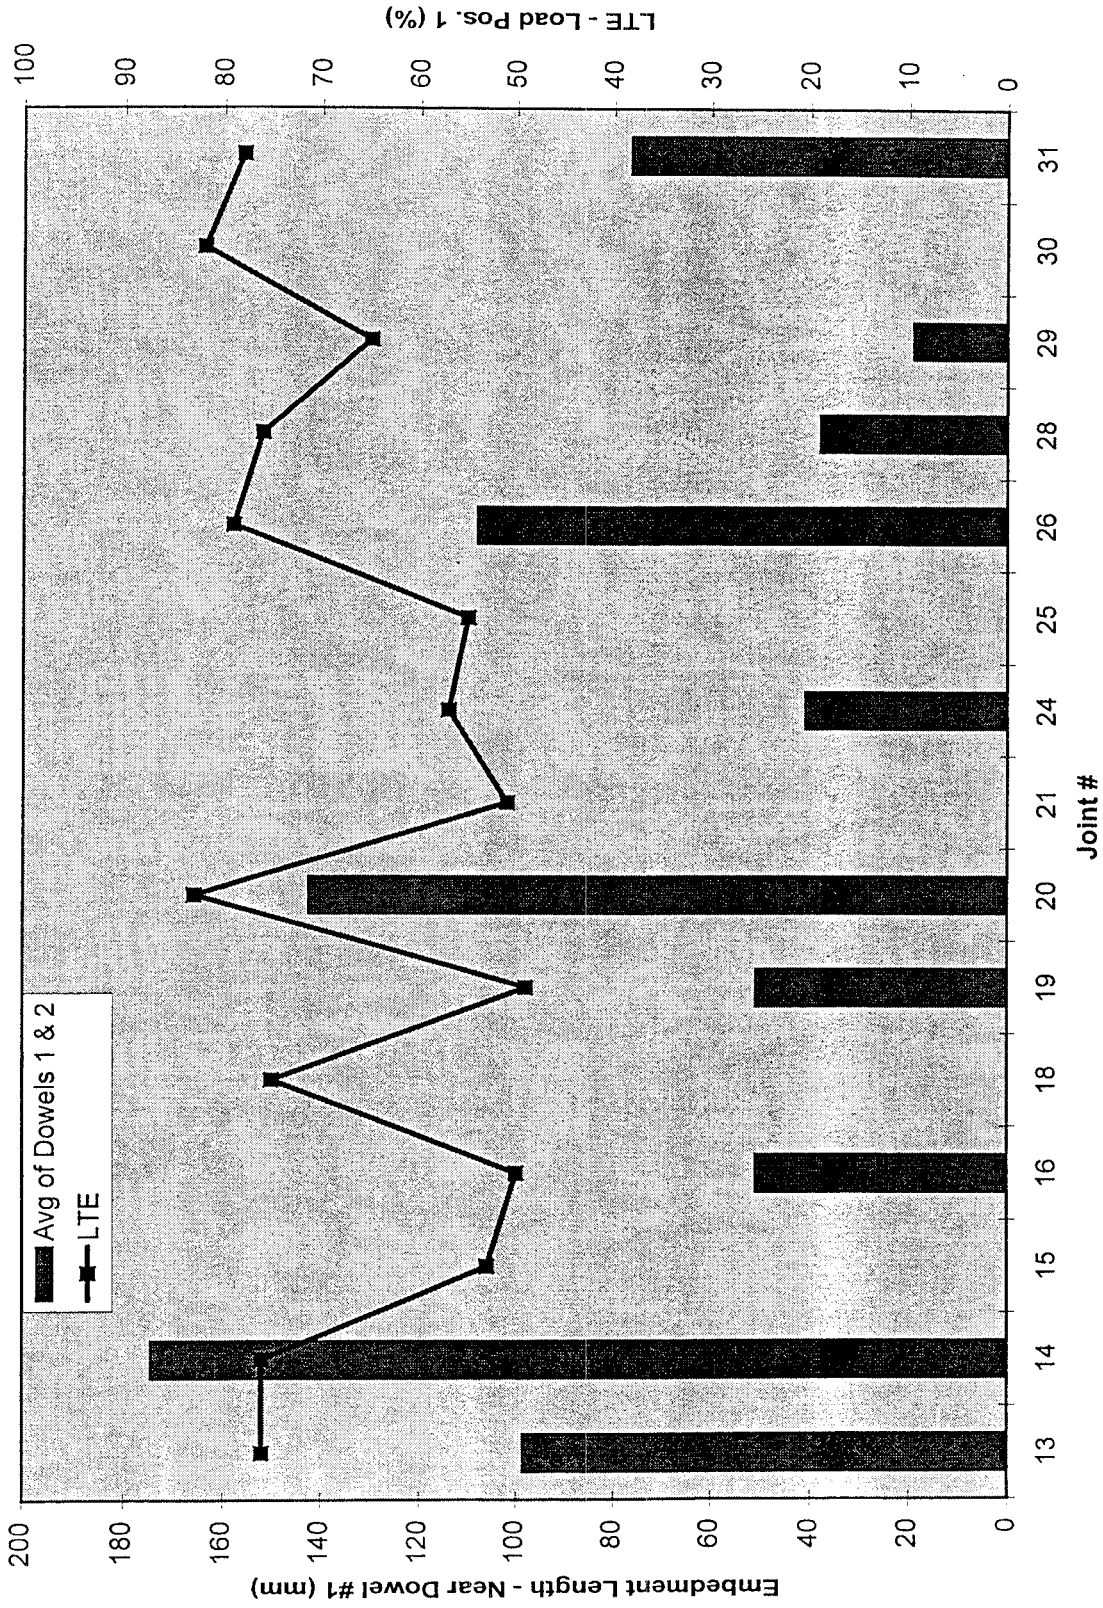
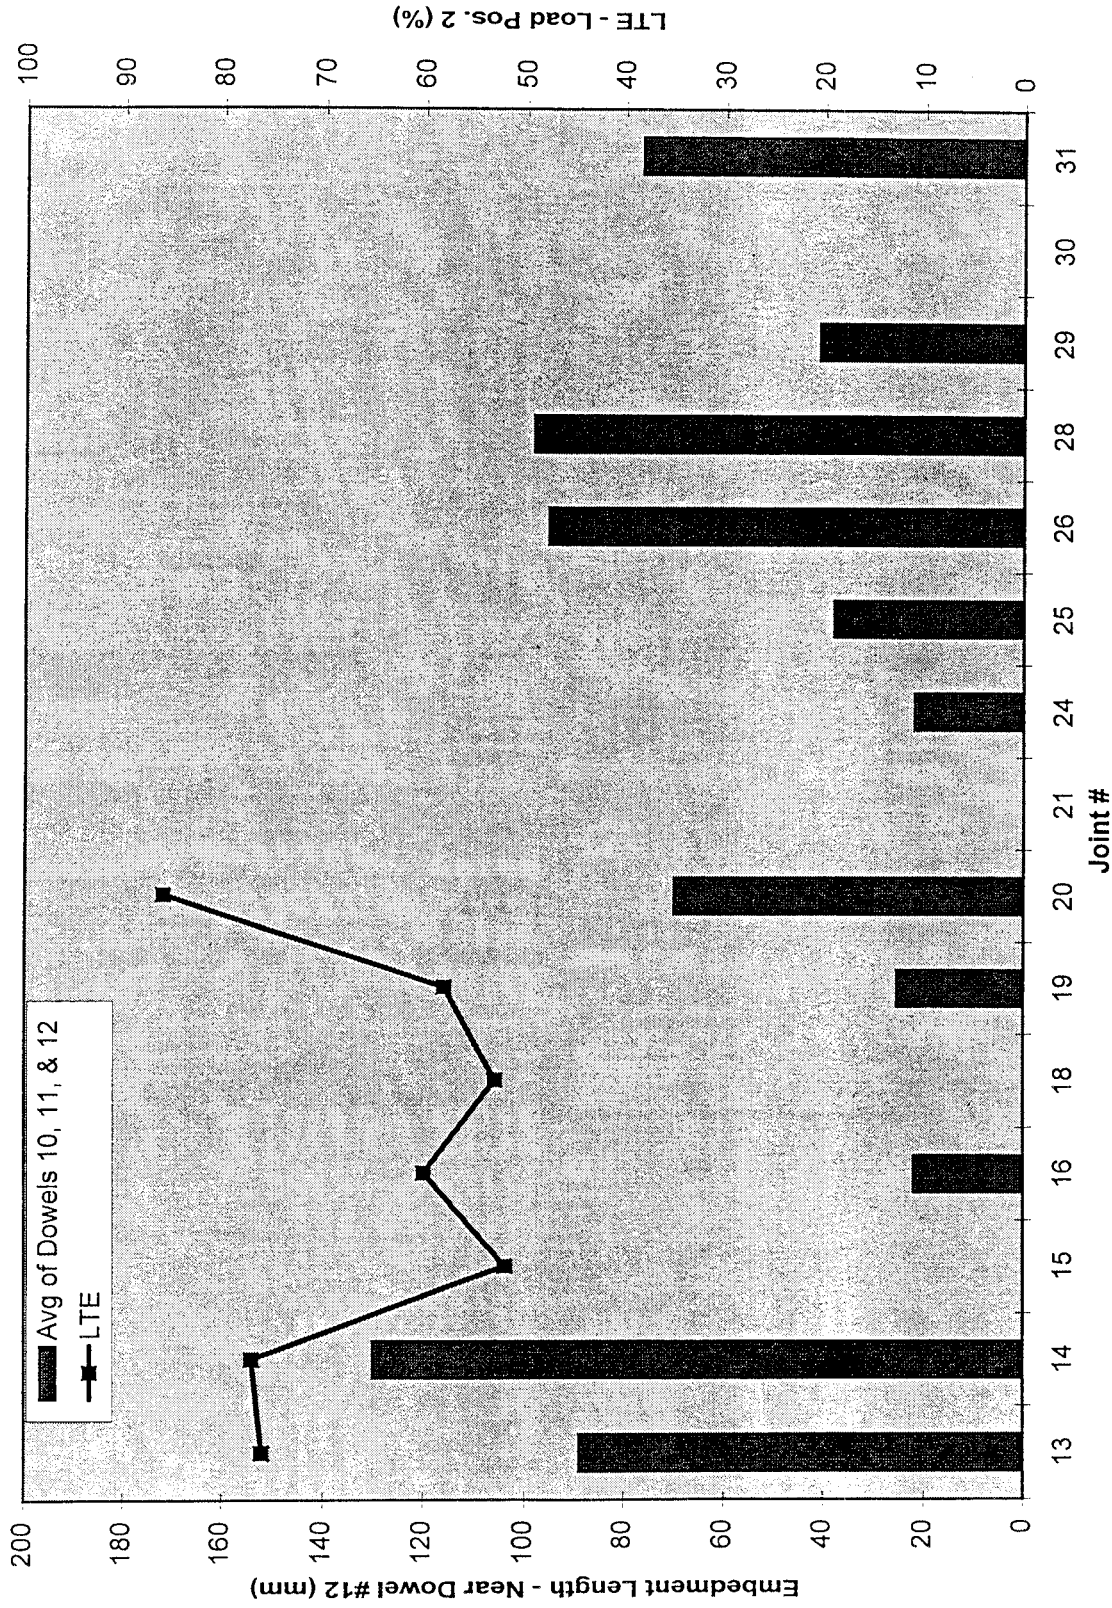
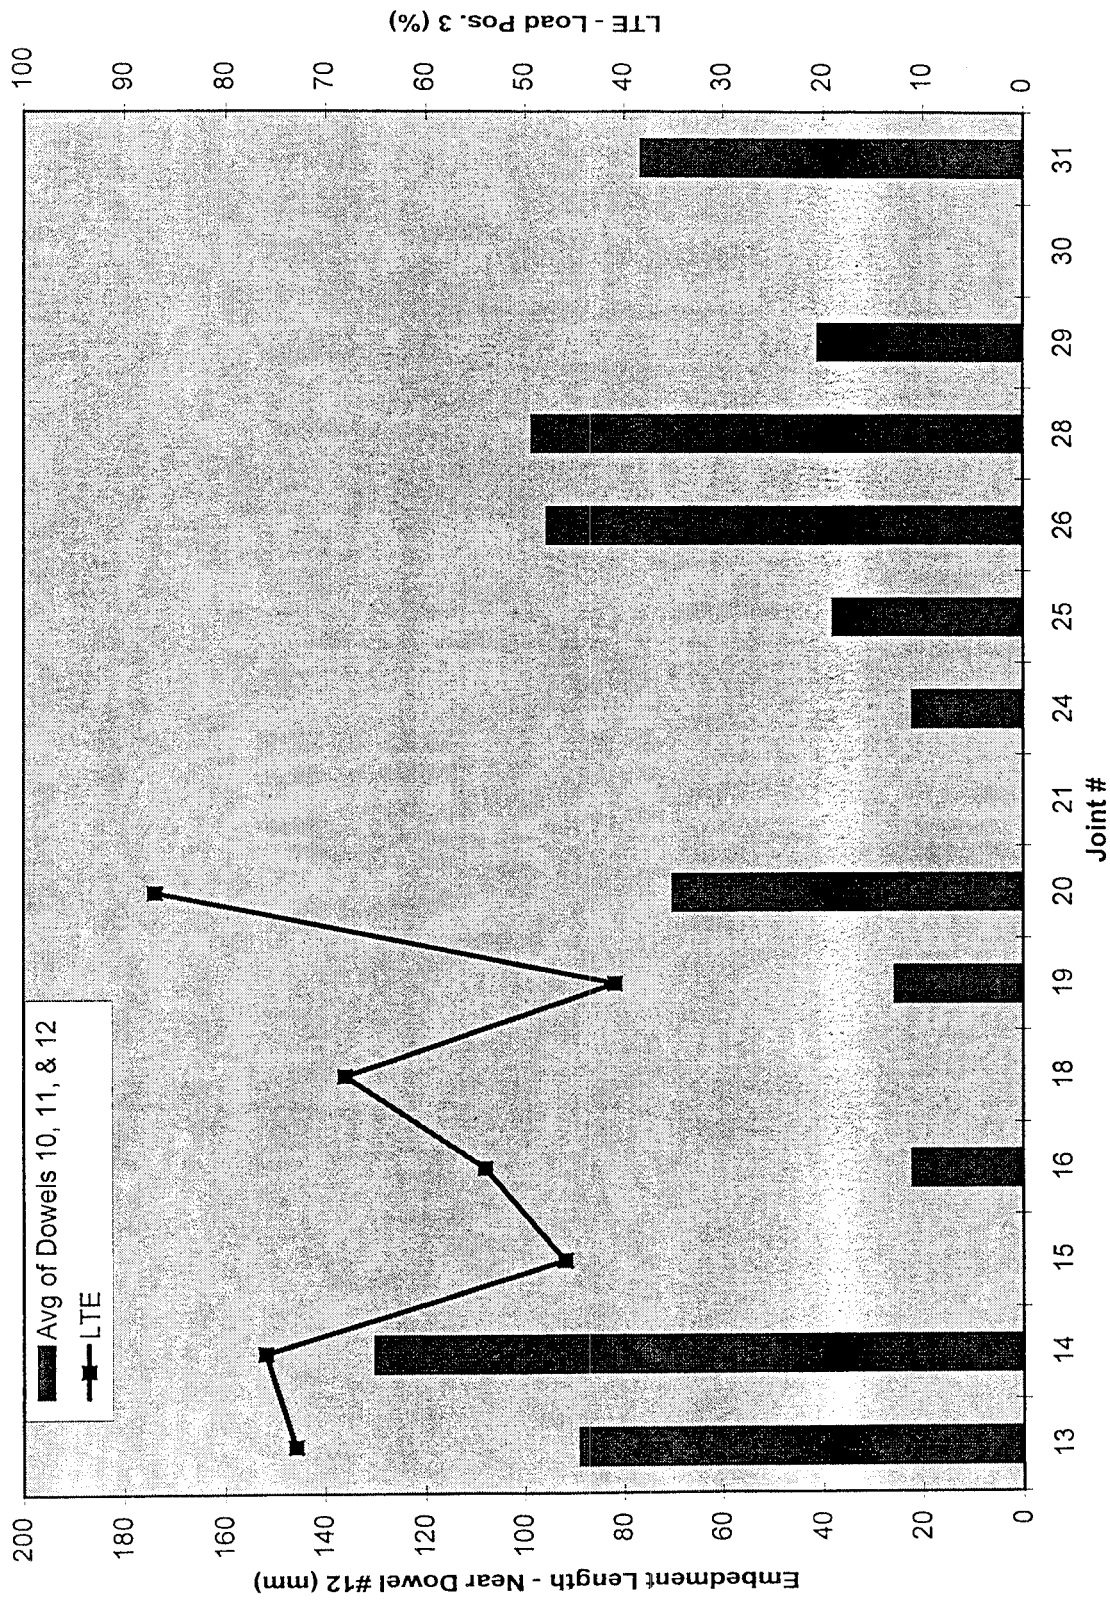
Figures 8a thru 8d demonstrate how the embedment length and LTE at each load position varies for each joint under investigation. Qualitatively, the behavior is as expected, with higher embedment lengths resulting in higher LTE values. LTE values for the leave side of the slabs (load positions 1 and 3) show more variability than the corresponding approach side.

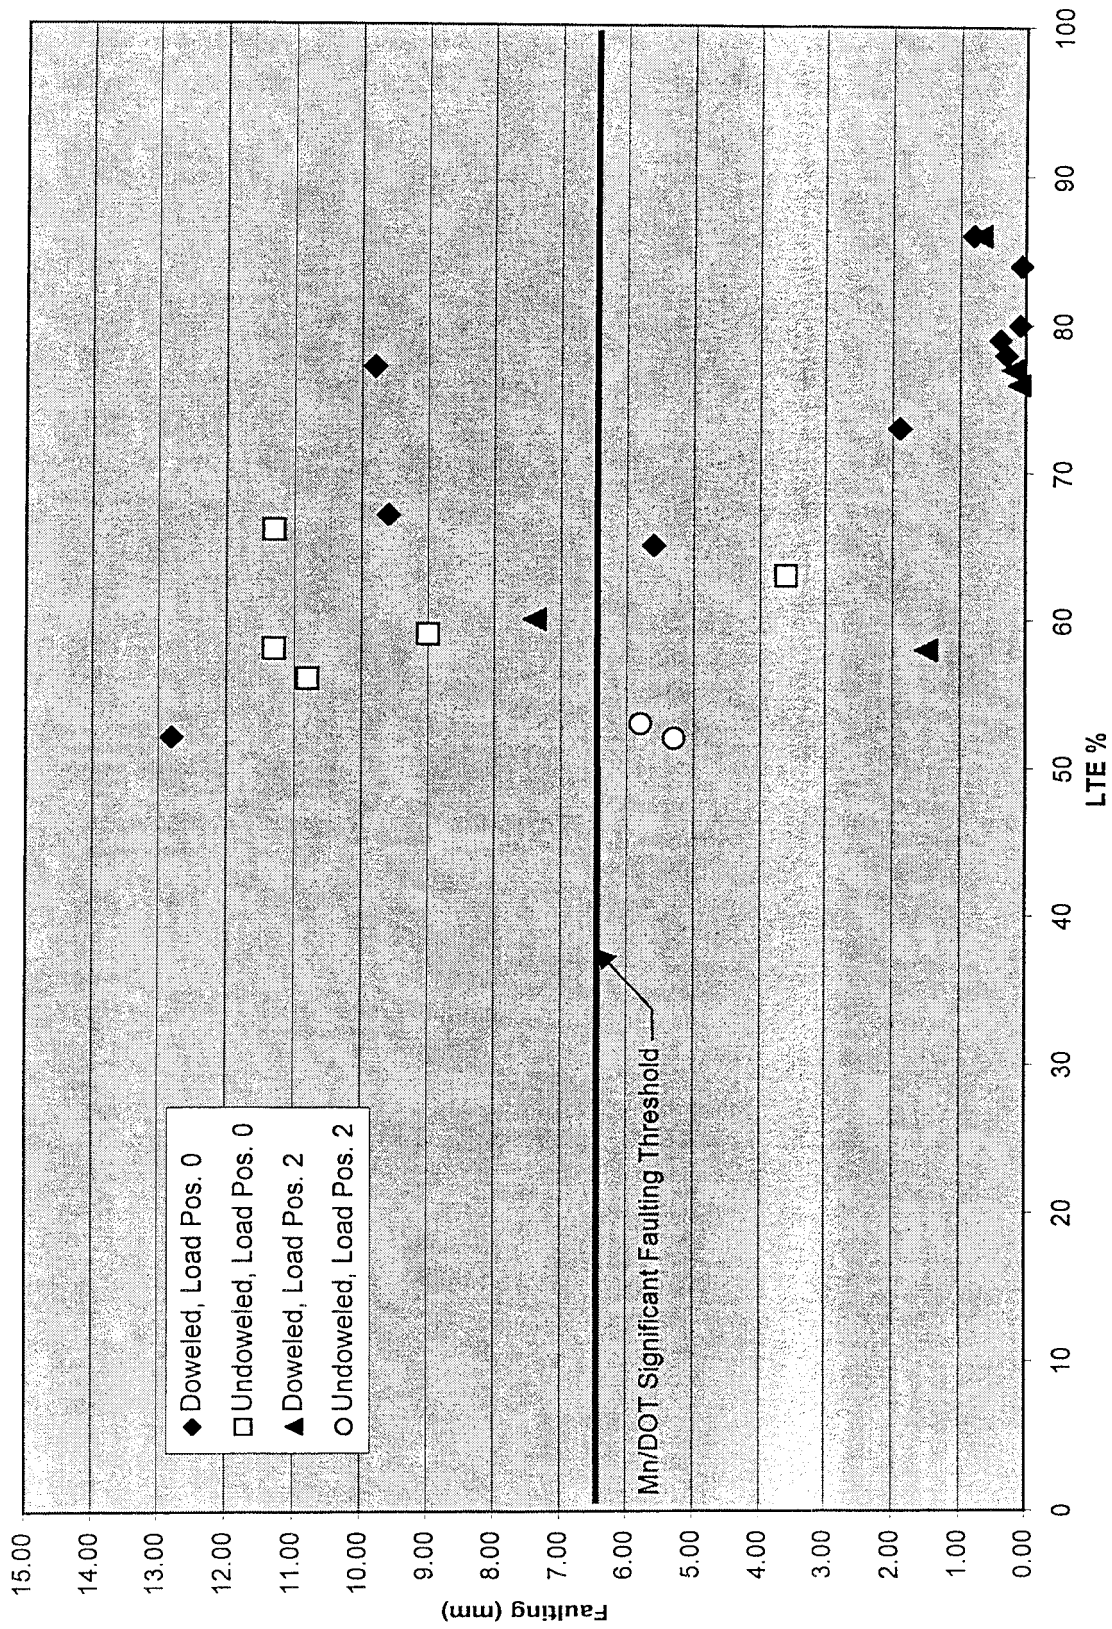
Figure 9a. LTE versus joint faulting - Approach panel side

Figures 9a and 9b show a comparison of LTE and faulting for the selected joints. As might be expected, declines in LTE result in increased faulting. Note that data points from what may be considered "undoweled" joints [less than 25 mm (1 in) embedment length] all exhibit significant faulting after only 12 years of traffic.

Since several of the joints investigated can be considered undoweled, the heavy truck traffic on this pavement will accelerate the faulting of these joints. To slow the degradation of the joints, one recommendation might be the installation of retrofit dowel bars. This could restore a good portion of the load transfer efficiency necessary for long term joint performance. The length of this distressed area makes it highly suitable as a test section for evaluating the effectiveness of retrofit dowel bars.
