National Transportation Safety Board
Washington, D.C. 20594

Safety Recommendation

Date: July 13, 1999

In reply refer to: A-99-51 through -54

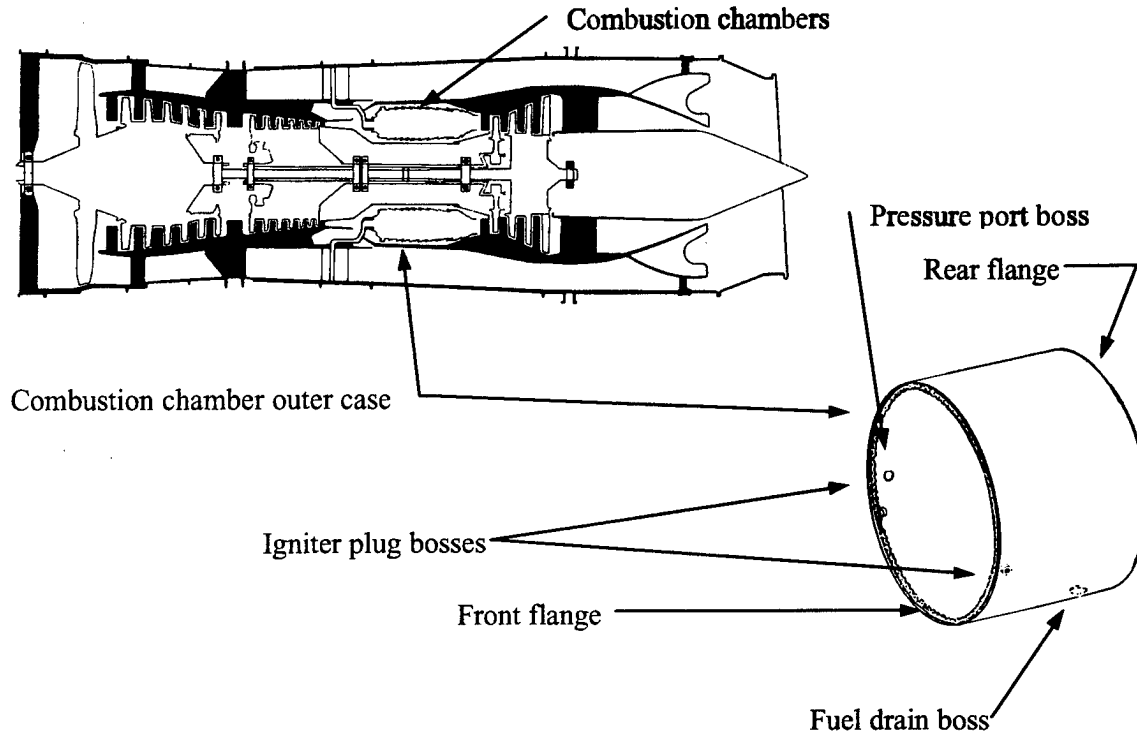
The CCOC is a barrel-shaped structure that houses the combustion chambers and contains four circular-shaped bosses, mounted on which are two igniter plugs, a pressure port, and a fuel drain (see figure 1). The ruptured CCOC was assembled in six pieces: the front flange³ and body, the four bosses, and the rear flange. The front flange and body of the case and the four bosses were made of AMS [Aerospace Material Specification] 5613 410 stainless steel,⁴ and all of the

Figure 1. JT8D-200 engine cross section showing the location of the CCOC, and an enlarged view of the CCOC showing the location of the bosses and the case's front and rear flanges.

The ruptured CCOC was examined at the National Transportation Safety Board's materials laboratory. This examination revealed a fatigue fracture that had multiple origins along the weld on the exterior side of the fuel drain boss. The fracture had propagated about 150° around the boss and then axially, about 1½ inches forward and ½ inch rearward. The fatigue striations indicated that the crack had existed for approximately 1,340 cycles before the CCOC ruptured. The fracture originated from a mechanically thinned area of the boss' flange that had grinding marks consistent with previous work. The measured thickness of the boss flange adjacent to the fatigue fracture was 0.080 inch; however, the fuel drain boss' engineering drawing required a thickness of 0.099 to 0.109 inch.

Require that all Pratt & Whitney JT8D-1 through -17AR and JT8D-200 engines have a one-piece, integral boss combustion chamber outer case (CCOC) installed at the next shop visit that the engine's CCOC becomes accessible. (A-99-51)
