RAILROAD ACCIDENT REPORT

COLLISION OF AMTRAK TRAIN 304-26
WITH A HIGHWAY VEHICLE AT A
HIGHWAY-RAIL GRADE CROSSING
MCLEAN, ILLINOIS
SEPTEMBER 26, 1999

**NTSB/RAR-01/03
PB2001-916303
Notation 7385
Adopted September 18, 2001**

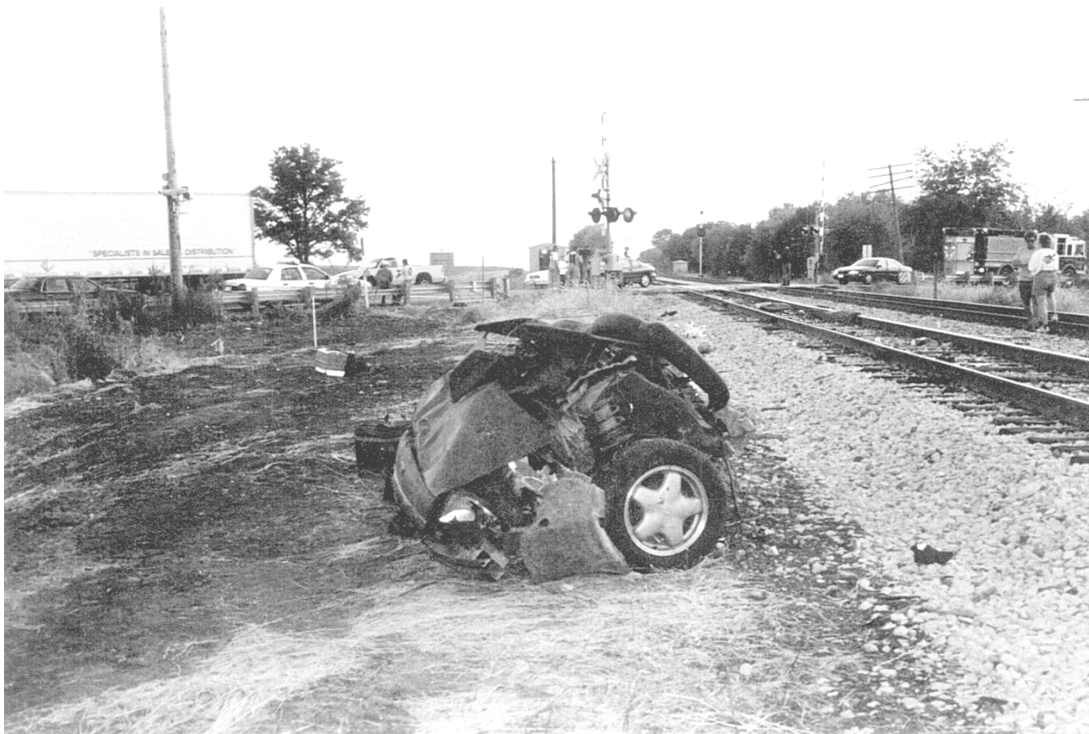
Figure 1. Postaccident scene showing rear of the destroyed vehicle.

The automobile separated into two parts as a result of the impact. The front portion of the automobile became lodged on the front of the locomotive, while the rear portion came to rest about 203 feet north of the crossing and 7 feet east of the railroad tracks. Both automobile occupants were ejected from the vehicle. According to State police reports, windshield obstructions and radio volume settings could not be determined due to the induced damages to the automobile. No brake light lamp filaments from the automobile were available for testing due to collision damage.

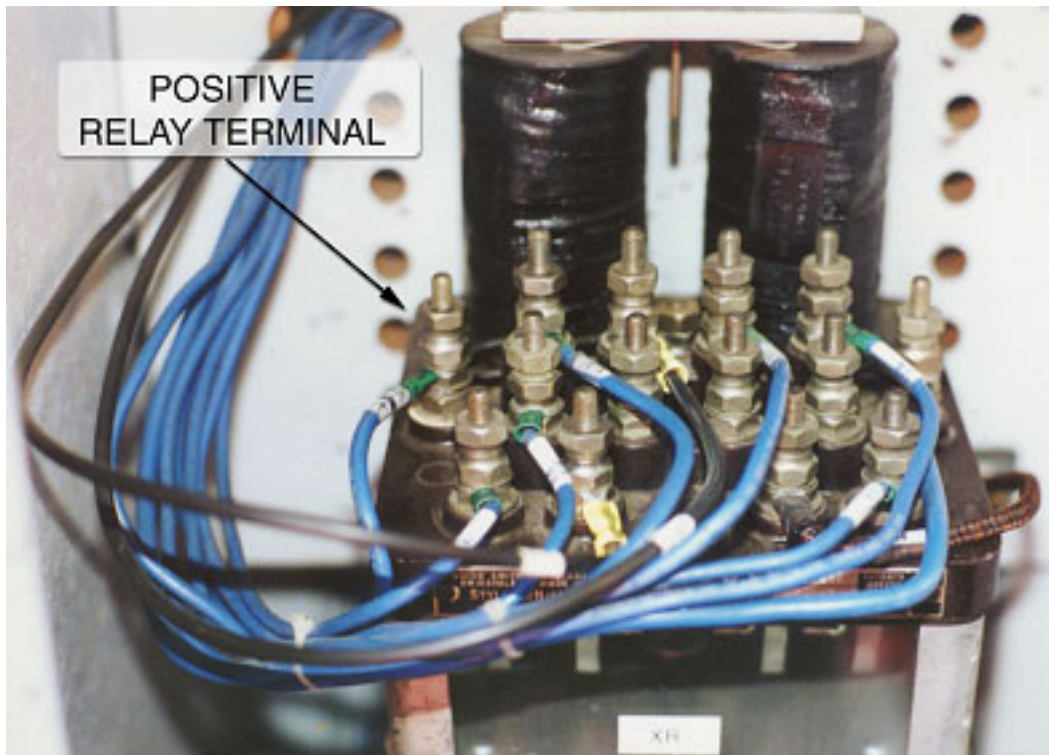
³ The *crossing control relay* is the control circuit relay that initiates the crossing warning devices.

Figure 2. Crossing control relay.

The manager of signal maintenance stated that he found a 4-foot piece of blue wire on the floor of the signal case when he first entered. The wire had eyelets on both ends, but one of the eyelets was broken and missing a piece. He stated that he then checked the crossing control relay but did not find the missing piece of the eyelet on any of the relay terminals. The manager of signal maintenance further stated that he removed the original event recorder module to protect the recorded accident data and placed a spare event recorder module in the grade crossing predictor unit. FRA inspectors arrived on scene later that evening and began testing the crossing equipment.

A signal maintainer had recalibrated the railroad grade crossing predictor at the U.S. Route 136 grade crossing about 2:18 p.m. on the day of the accident. When it is operating normally and without intervention, a crossing control relay is energized unless its associated crossing warning system detects the approach of a train. When the crossing detection system detects a train, it automatically de-energizes the crossing control relay, which causes the crossing's flashing lights and gates to activate. The signal maintainer stated that in the hours preceding the accident, to avoid interrupting highway traffic while he went through the calibration process, he interfered with the routine operation of the relay by using a jumper wire to keep the crossing control relay artificially energized during the recalibration. By falsely energizing the relay, the maintainer was circumventing the crossing warning system's ability to activate the crossing's flashing lights and gates. The signal maintainer completed the recalibration of the grade crossing predictor and left the area about 4:30 p.m. Grade crossing predictor data logs showed that the crossing control relay remained energized throughout the recalibration process, after the recalibration was performed, and during the accident.

Specialized electronic rack units are available to store jumper wires on maintenance vehicles used by signal personnel. The rack units notify signal personnel when a jumper wire is missing with an audible alarm and a visual red light alarm. The vehicles used by UP signal personnel were not equipped with such units.

Some railroads provide their signal personnel with maintenance vehicles equipped with specialized electronic rack units that are designed to notify signal personnel when a jumper wire is missing from the rack with both an audible warning alarm and a visual light signal. These warning systems provide a double-checking mechanism that helps the railroad safeguard against its employees leaving jumper wires in unsafe locations.

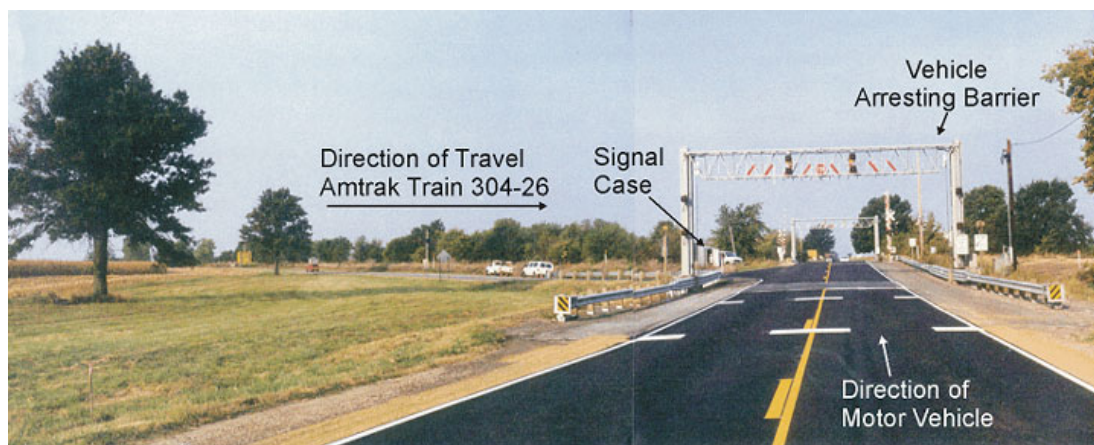
According to the American Association of State Highway and Transportation Officials, for a vehicle approaching a crossing, the driver must be able to see a train far enough along the tracks to have time to react to its presence and stop the highway vehicle before the crossing. The quadrant sight distance or “sight triangle” is formed by the distance along the roadway, the distance along the railroad tracks, and the distance along an imaginary line from the train to the highway vehicle. At the U.S. Route 136 crossing, the signal case and a small clump of low vegetation near the track were within the sight triangle. (See figure 5.)

Figure 5. View down tracks from accident vehicle's direction of travel.

According to State police reports, no tire marks from the highway vehicle were found on the pavement approaching the crossing. The video monitoring system²⁹ indicated that the brake lights on the automobile never activated as it approached the crossing.
