Whitetopping Construction And Early Performance In Illinois

**CONSTRUCTION REPORT
PHYSICAL RESEARCH REPORT NO. 144
JUNE 2002**

Illinois Department of Transportation

11. Contract or Grant No. IHR – R07	
12. Sponsoring Agency Name and Address Illinois Department of Transportation Bureau of Materials and Physical Research 126 East Ash Street Springfield, Illinois 62704-4766		13. Type of Report and Period Covered Construction Report January 1998 – December 2001

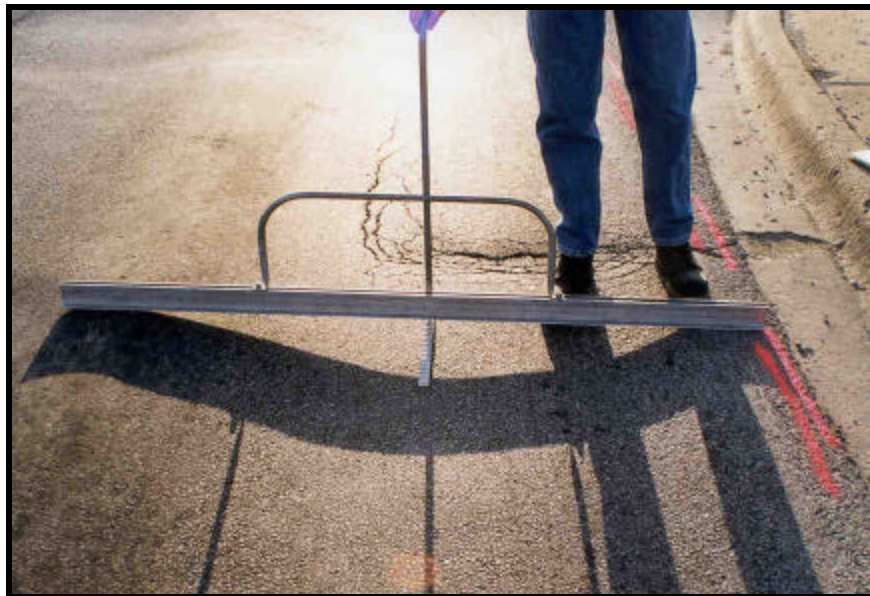
The existing bituminous concrete surface in the eastbound lanes was severely rutted and displayed a significant amount of cracking distress. The rut depth exceeded one inch in several locations of the outer wheel path, as shown in Figure 1. Cracking distresses included longitudinal and transverse cracks, as well as some minor block cracking. The existing surface was constructed in 1986, and consisted of a 1.25-inch bituminous concrete resurfacing of a previous bituminous concrete surface.

Figure 1. Existing Bituminous Pavement Rut

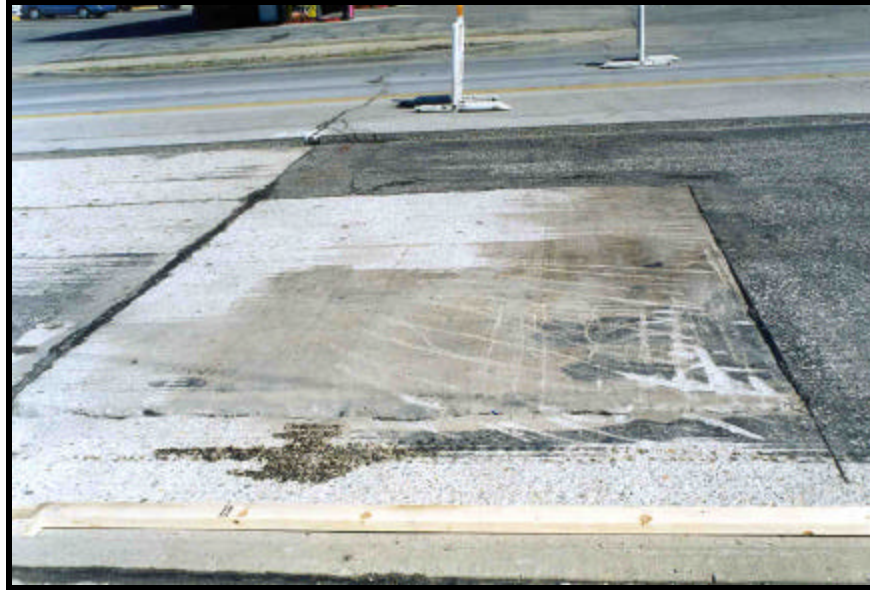
the remainder of the project is considered whitetopping. The transition from bituminous to concrete pavement is not a uniform joint, as shown in Figure 2. In addition, some small areas of the original brick pavement and the concrete widening were exposed after milling off the bituminous surface.

Figure 2. Bituminous To Concrete Pavement Transition

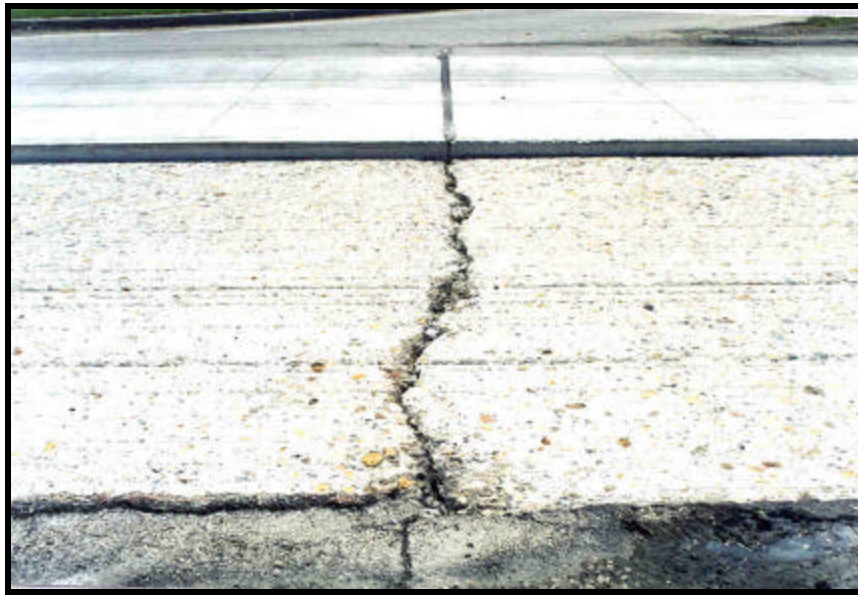
and numerous transverse cracks were discovered after the bituminous surface was milled off. The decision was made to place partial-depth and full-depth patches at some of these locations. However, all of the areas that required patching were not repaired due to a limitation in patching quantities and time constraints. The severe transverse crack in Figure 11 is one of many areas that were not patched.

Figure 11. Severe Transverse Crack That Was Not Patched

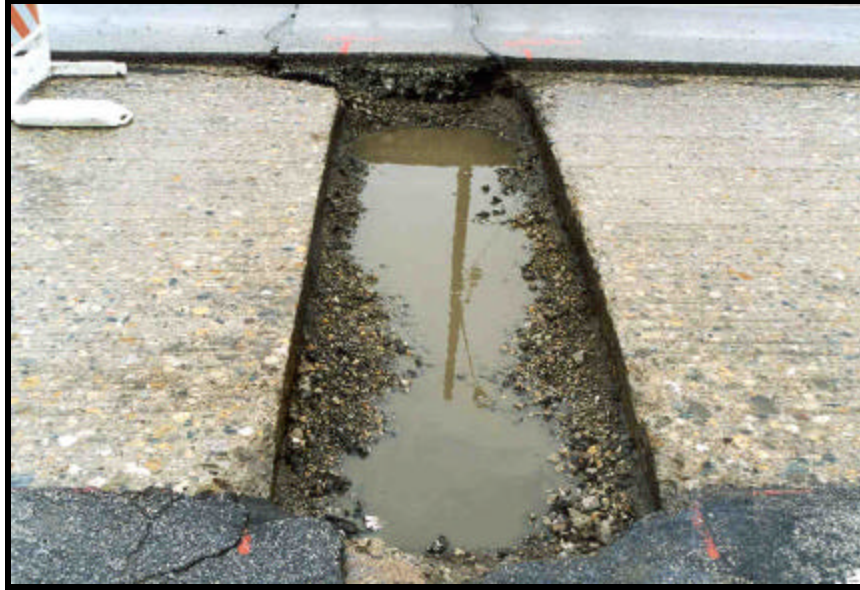
The rain that fell before the paving of the eastbound driving lane was not removed from the patch locations within this lane. This water was forced out of the patch locations by the concrete placement, and then pushed ahead by the fresh concrete. Eventually this water found a crack as an escape path, or was incorporated into the concrete mixture. Figure 12 illustrates a typical patch location that contained rainwater before paving.

Figure 12. Rain Water Within A Patch Location

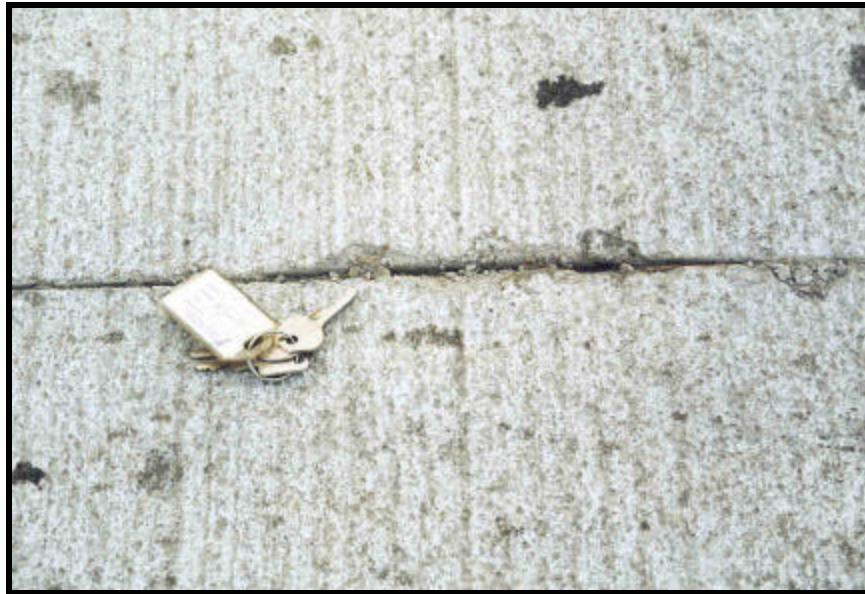
Problems were also encountered with the partial-depth saw cutting, as the contractor started to soon. Noticeable amounts of tearing and spalling occurred along several of the partial-depth saw cuts. The contractor had difficulty determining the ideal time to start the partial-depth saw cutting process. However, the consequences of shrinkage cracking from sawing too late are more severe than the tearing of the saw cuts. Evidence of the saw cut tearing may be found in Figure 16.

Figure 16. Tearing At A Partial-Depth Saw Cut

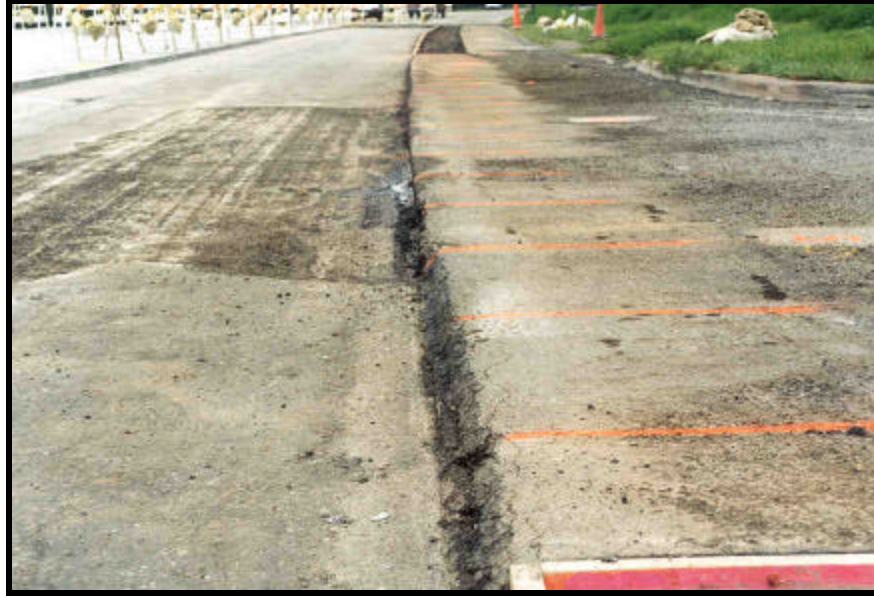
The temporary bituminous concrete ramps also created problems with traffic flow through the intersection. Several times, the traffic was redirected to an area with no ramp, which resulted in a worn-down edge on the existing pavement. This created some difficulty during paving when concrete was placed directly against the worn down edge, such as the one shown in Figure 17.

Figure 17. Worn-Down Pavement Edge

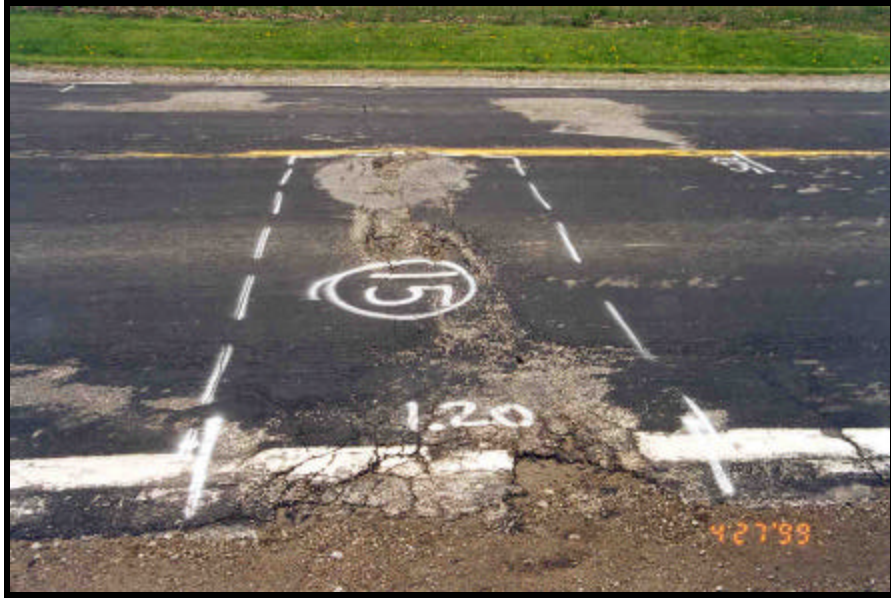
The existing bituminous concrete overlay displayed a frequent amount of transverse cracking and a small amount of longitudinal cracking. The majority of the transverse cracking was considered moderate to high in severity as shown in Figure 18. Evidence of edge deterioration was also noted throughout the length of the project. The existing bituminous concrete surface was seal coated in 1987, however the original construction date for the bituminous concrete overlay could not be determined.

Figure 18. High Severity Transverse Crack

Prior to the overlay placement, 18 partial-depth patches were placed to repair these high severity cracks. The area surrounding the crack was milled out, as shown in Figure 19, and a bituminous patch was placed. Areas of the existing bituminous overlay were also milled out at each end of the project in order to create a butt joint with the existing pavement. The entire length of the project was not milled. The concrete overlay was placed directly on the existing bituminous overlay with no added surface texture given to the bituminous overlay. However, the existing pavement was broomed and cleaned with high-pressure water before the overlay was placed.

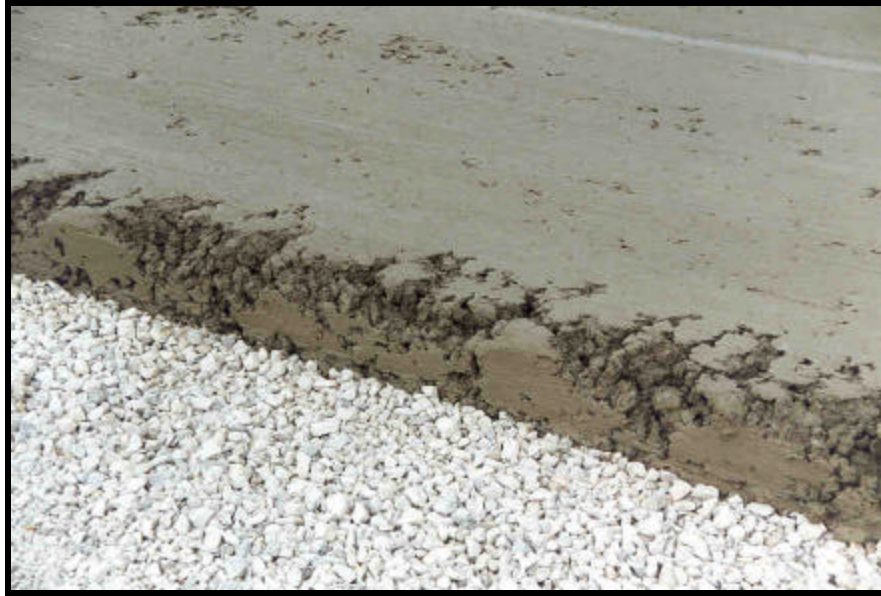
The first major problem encountered with this project occurred during the paving of stage one. Approximately halfway through this stage, the paving machine broke down and lost all grade control. Several trucks waited one to two hours before unloading due to the breakdown. This concrete was fairly dry, with low air voids, and was very hard to finish. The concrete had a honeycombed appearance as shown in Figure 21.

Figure 21. Honeycombed Appearance Of Concrete

The decision was made to remove this section and replace it. The following day, the contractor used pavement breakers and jackhammers to remove the bad concrete. The removed concrete exhibited a very good bond with the underlying bituminous concrete. In several places, especially around cracks, the bituminous material was fully bonded to the concrete and removed with the concrete overlay. The length of the removal was approximately 220 feet.

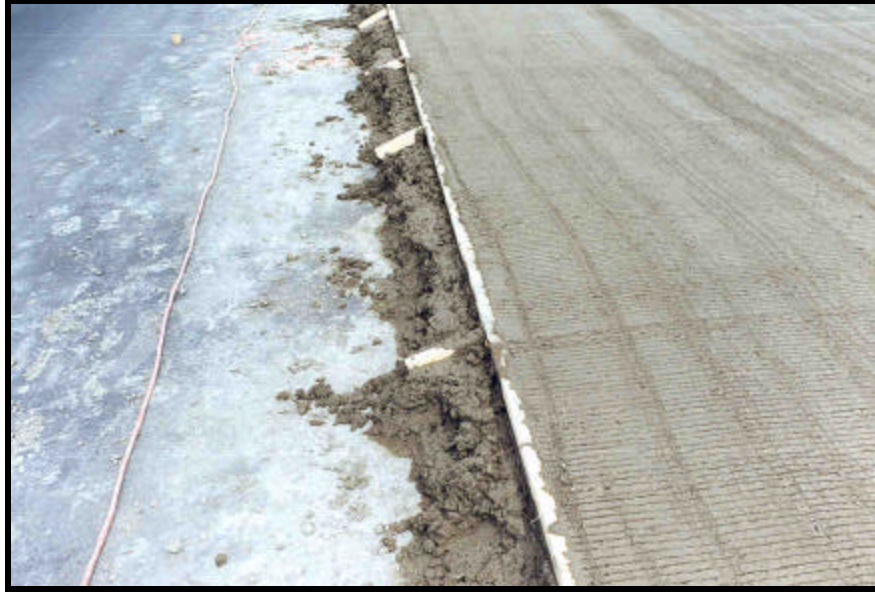
This section was formed with two-by-four lumber at the pavement elevation and hand placed. The two-by-four lumber allowed for concrete to flow out under the formwork as shown in Figure 22. This excess concrete created a lot of waste and handwork for clean up.

Figure 22. Concrete Flow Under Form Work

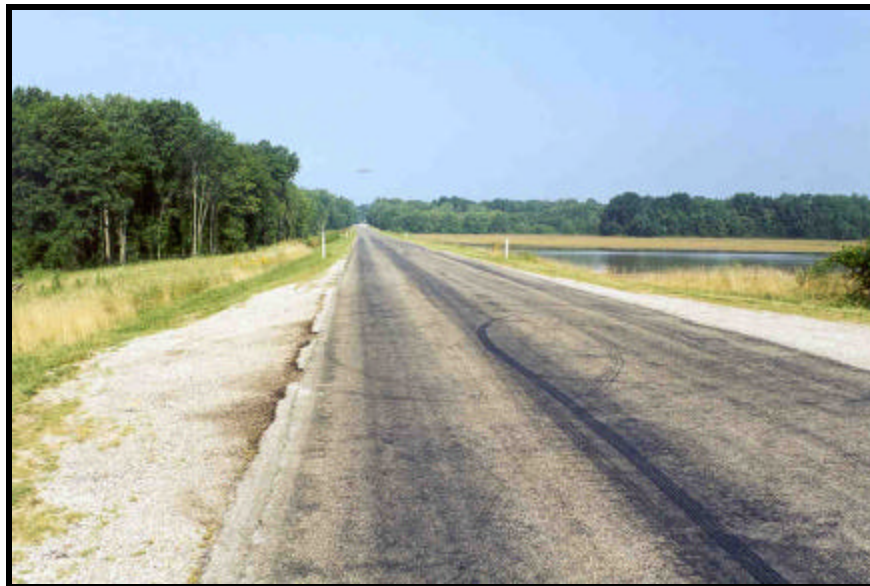
The existing low volume road consisted of a soil cement pavement with an oil and chip surface. The western most quarter of the original pavement was eight inches of soil cement constructed in 1980, while the remainder of the project was seven inches of soil cement constructed in 1960 and 1962. Prior to the whitetopping overlay, the pavement surface appeared to be in good shape. There were some minor cases of pavement edge cracking as shown in Figure 23. In addition, there were some small potholes and minor rutting noted throughout the project. Prior to overlay placement, the original surface was milled to remove these surface defects, increase the bonding surface area, and provide a level construction platform.

Figure 23. Original Pavement Edge Cracking

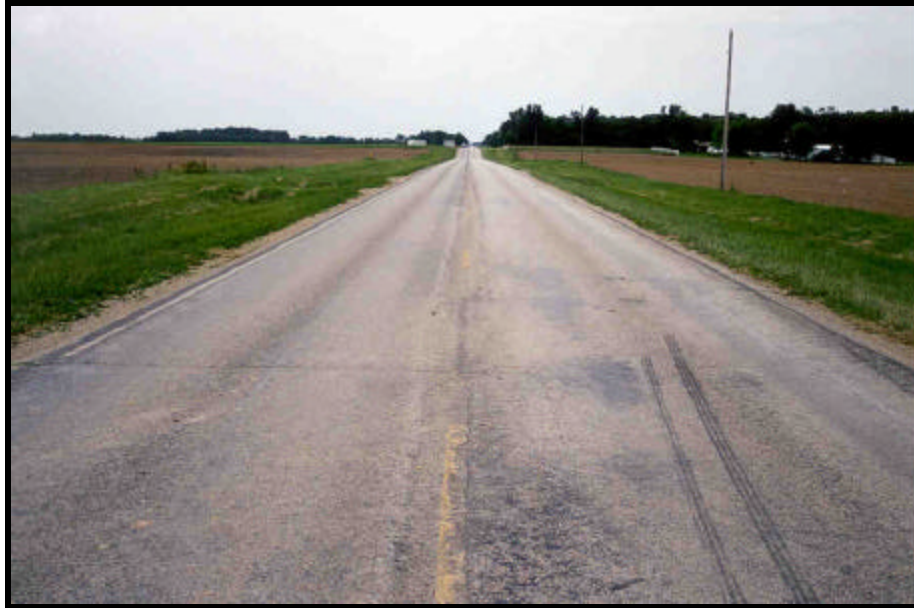
The original pavement at this location consisted of a 10-inch aggregate base with three inches of bituminous surface constructed in 1965. The project was overlaid with an additional 3.5 inches of bituminous material in 1977. The existing surface displayed a significant amount of wheelpath rutting. Longitudinal and transverse cracking were also found throughout the project length. An example of these distresses may be found in Figure 27. Three inches of bituminous material were milled from the surface prior to the overlay placement.

Figure 27. Existing Surface Distresses

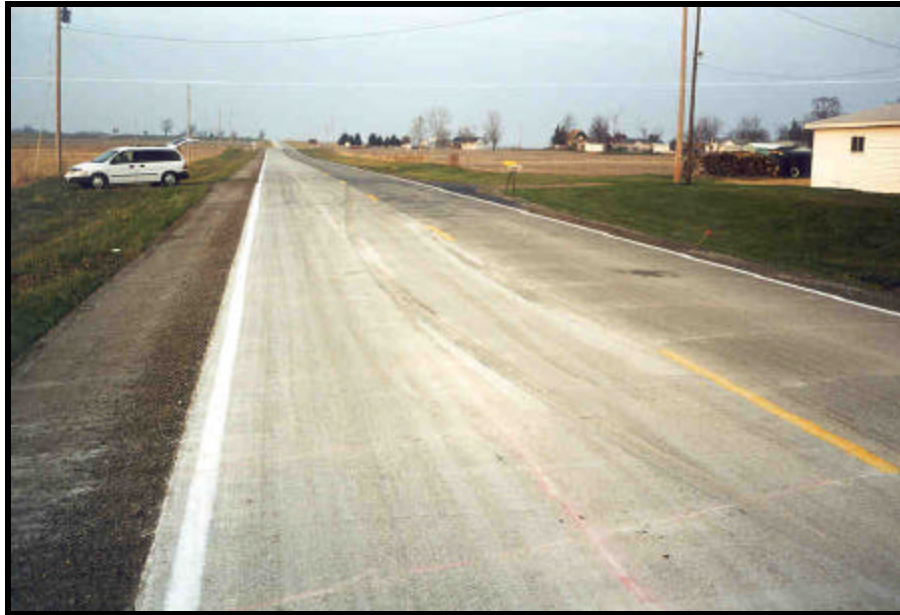
There was only one problem encountered with the construction of this project. A motorist traveled for a short distance through the non-cured pavement leaving a tire impression (Figure 29). The impression is very shallow and has not caused any problems for the traveling public.

Figure 29. Tire Impression In Finished Concrete

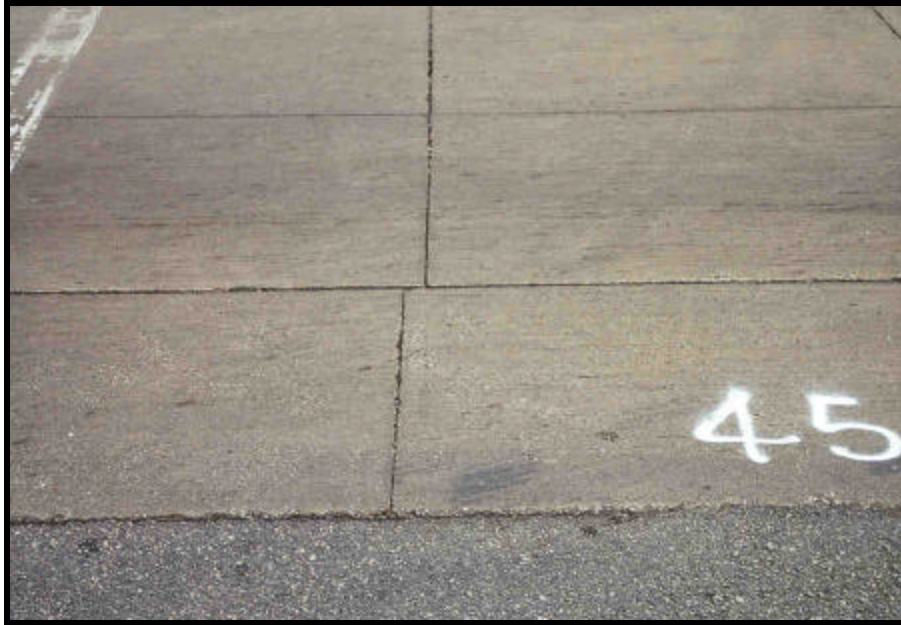
The majority of these cracks are low severity. There were seven cracks noted as moderate severity in the 2001 survey. The most common cracking pattern is a transverse mid-panel crack with a few corner breaks and random cracks. Small areas of debonding were found underneath seven panels during the 2001 survey. The longitudinal full-depth saw joint closest to the pavement edge is separating and some faulting is apparent. In addition, the panels within the driving lane appear to be shifting toward the intersection with relation to the outside row of panels. The amount of movement is approximately two inches and can be seen in Figure 30.

Figure 30. Panel Movement

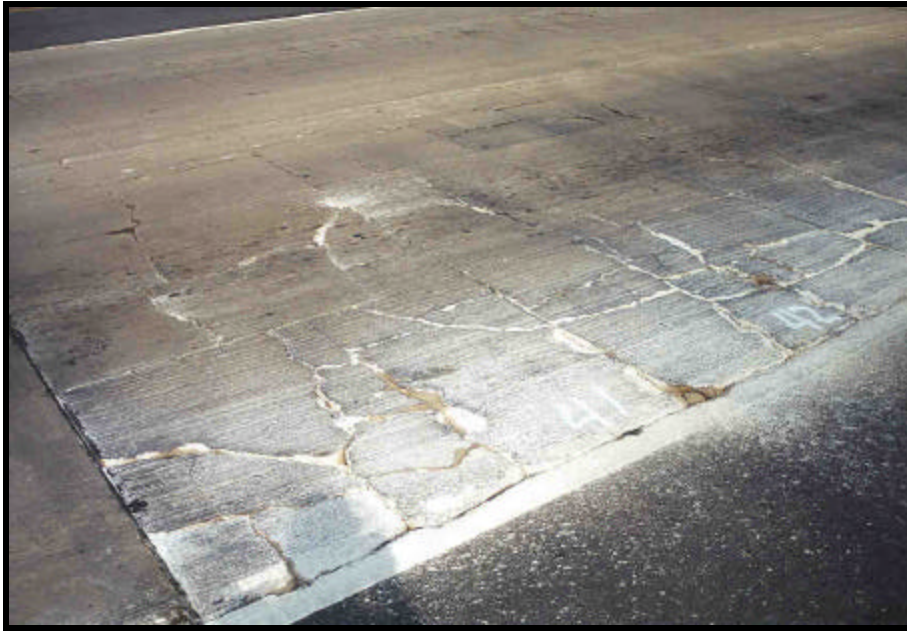
A large number of plastic shrinkage cracks were found at the west end of the westbound passing lane within a day after paving. Approximately 75 percent of the cracks listed for the 2001 survey are low severity, 15 percent are moderate severity, and 10 percent are high severity. The most common crack pattern is transverse mid-panel cracking. Seven areas of significant debonding (> 50 ft²) were found, as well as 18 isolated areas under individual panels. Several areas of significant distress and break-up have been noted at

this intersection. The worst area may be seen in Figure 31, where a significant amount of water was forced out of a partial-depth patch and in front of the concrete overlay by the paving process. This area was replaced with a full-depth patch in the fall of 2001. There has also been one partial-depth bituminous patch placed at a similar area of distress in the westbound driving lane.

Figure 31. Area Of Significant Overlay Break-Up

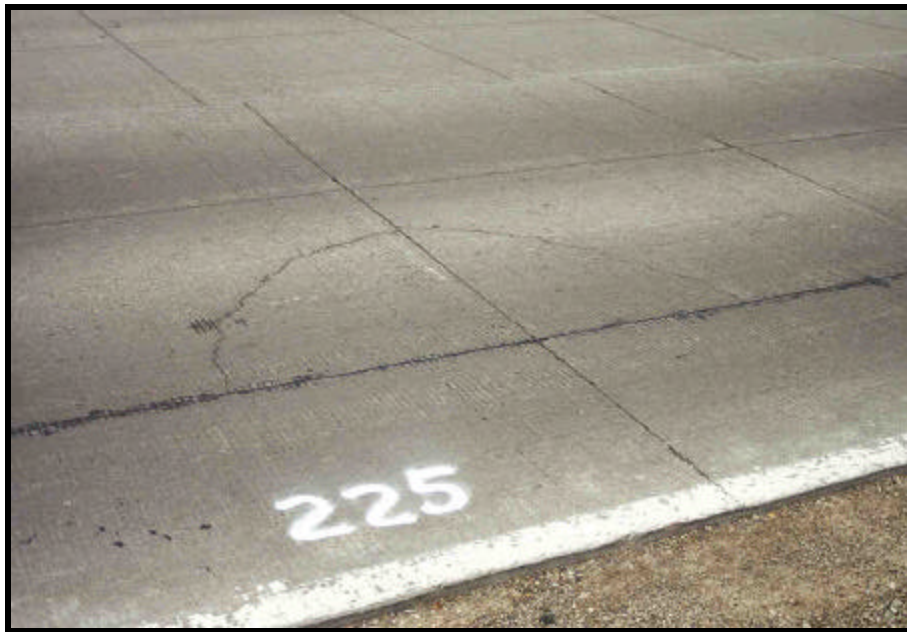
Two of the 96 total cracks for 2001 were transverse mid-panel cracks. The remaining 94 cracks were all corner breaks similar to that shown in Figure 32. All of the cracks were low severity, and there is no evidence of debonding at this time.

Figure 32. Panel Corner Break
