## EVALUATING LOAD TRANSFER RESTORATION

**DISTRICT 1**  
Mendocino County  
Route 101 – North Bound

**DISTRICT 3**  
Placer County  
Route 80 – West Bound

July 2002

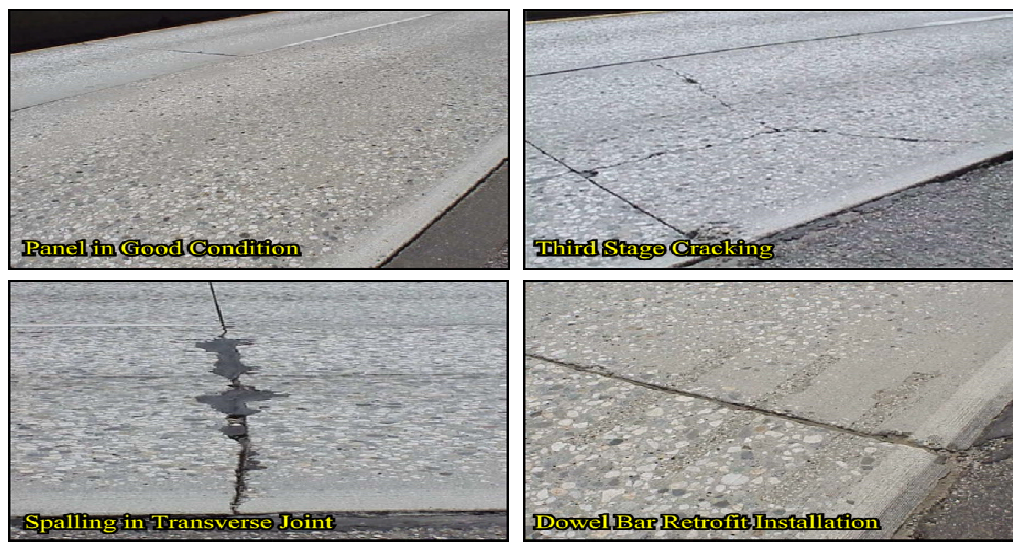
**Figure 8.** Pavement Condition - March 2001

A pavement inspection on March 27, 2001, revealed the pavement is in good condition, a few panels have third stage cracking and a number of transverse joints were spalled (Figure 8). The retrofit installations are in very good condition. The backfill grout remains intact and shows no signs of bond failure or cracking.

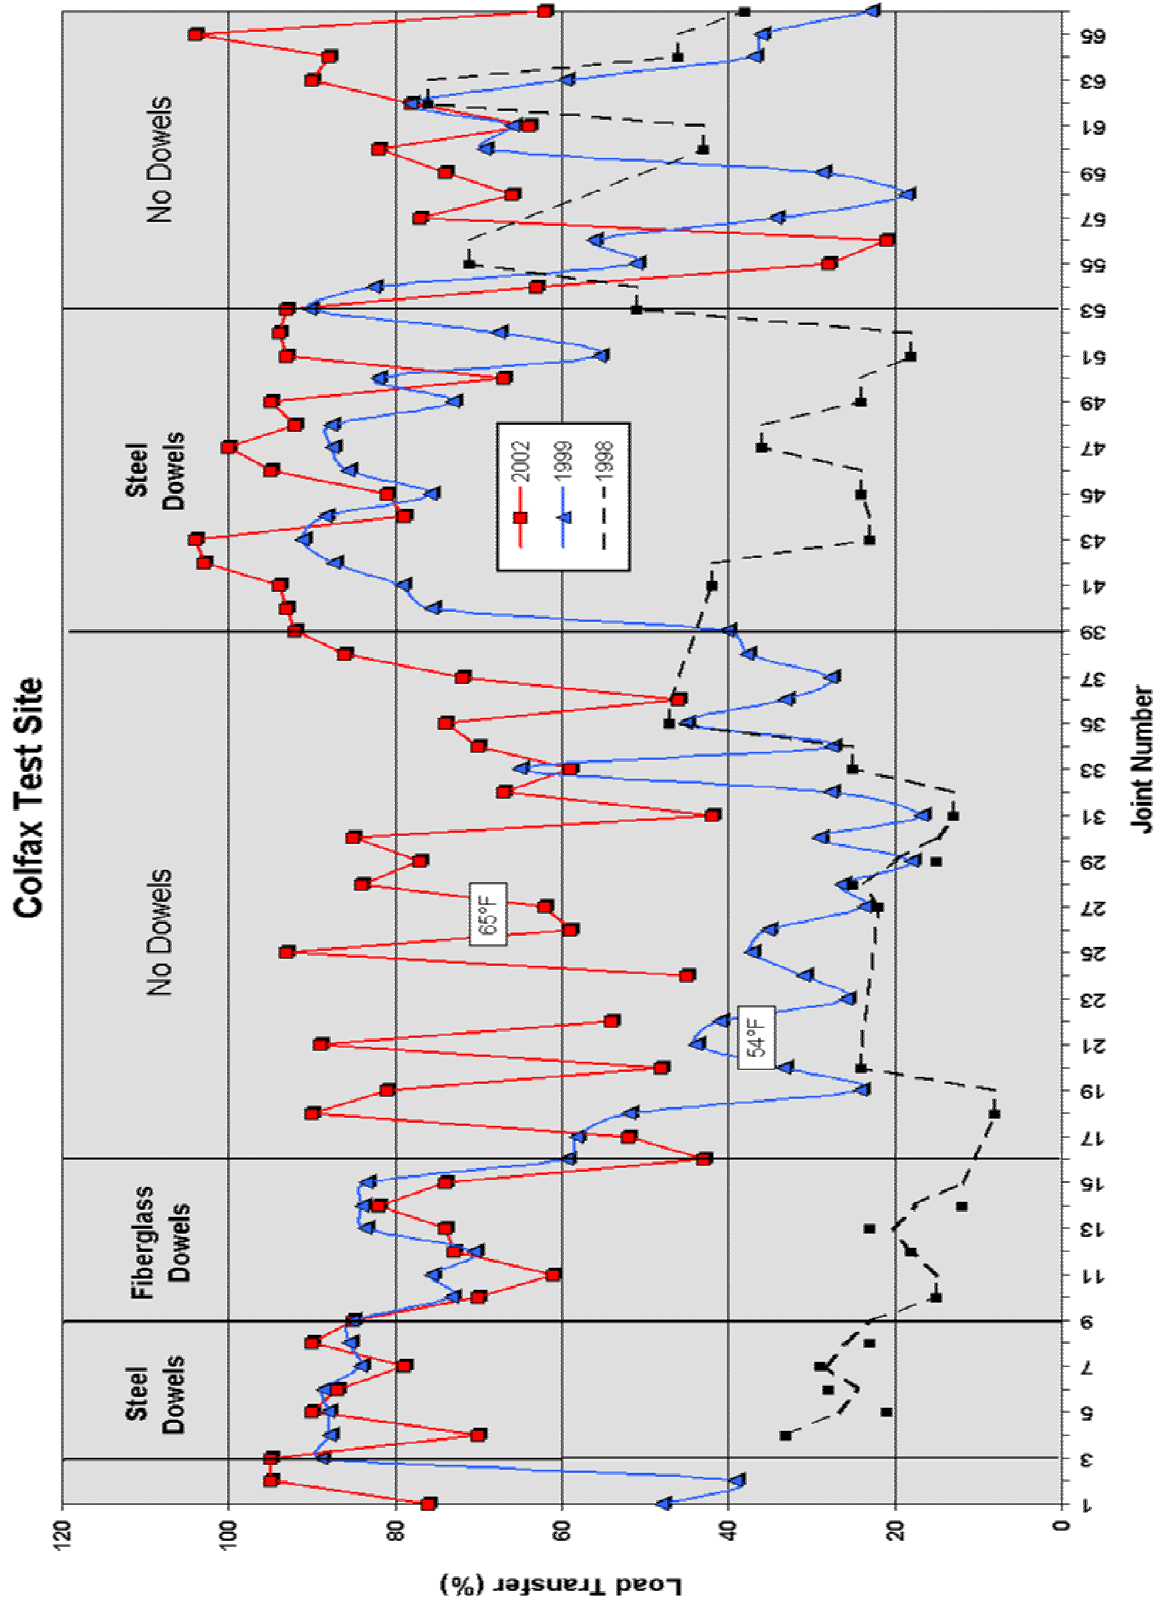
Figure 9.

Results from the FWD tests show that the average load transfer in the joints with steel dowels improved from 30 % (before the DBR) to 82% or better (Table 1). The joints with fiberglass dowels improved from 15 % to 69% or better.

At warmer temperatures, load transfer increased. Load transfer for undoweled joints was slightly greater than that of the joints with fiberglass dowels. At cooler temperatures, load transfer decreased, particularly in the undoweled joints. Load transfer in the retrofitted joints was minimally affected by the change in pavement temperature.

Figure 9 is graph representation of the load transfer values at each joint. Values in are listed in Appendix A.

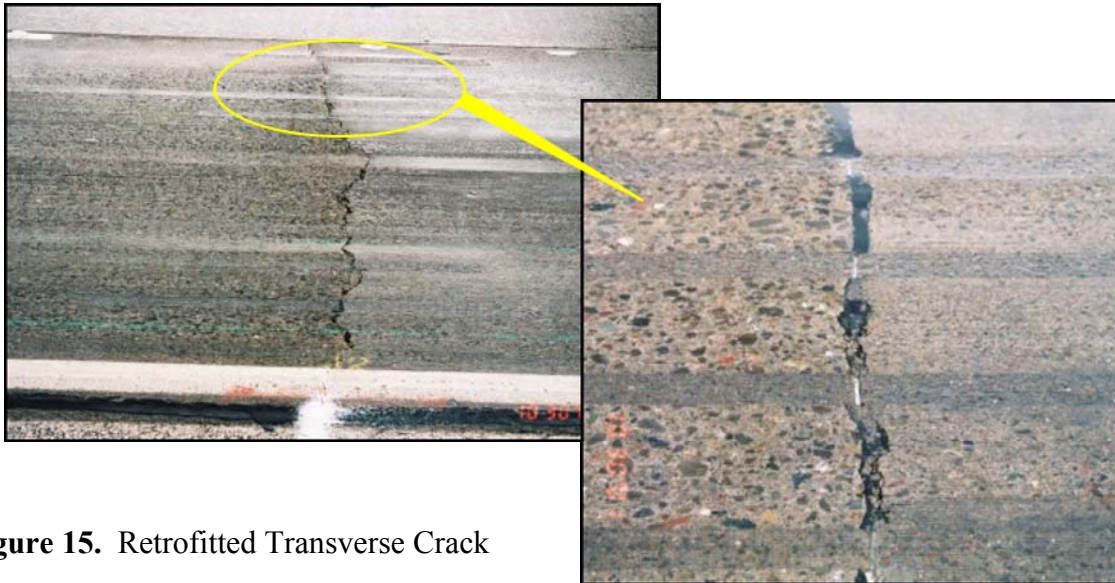
**Figure 15.** Retrofitted Transverse Crack

A pavement inspection in October 2001 revealed the retrofit installations remain intact, even after 10 months of service. The backfill grout shows no signs of bond failure, cracking, or other deterioration (Figure 15).

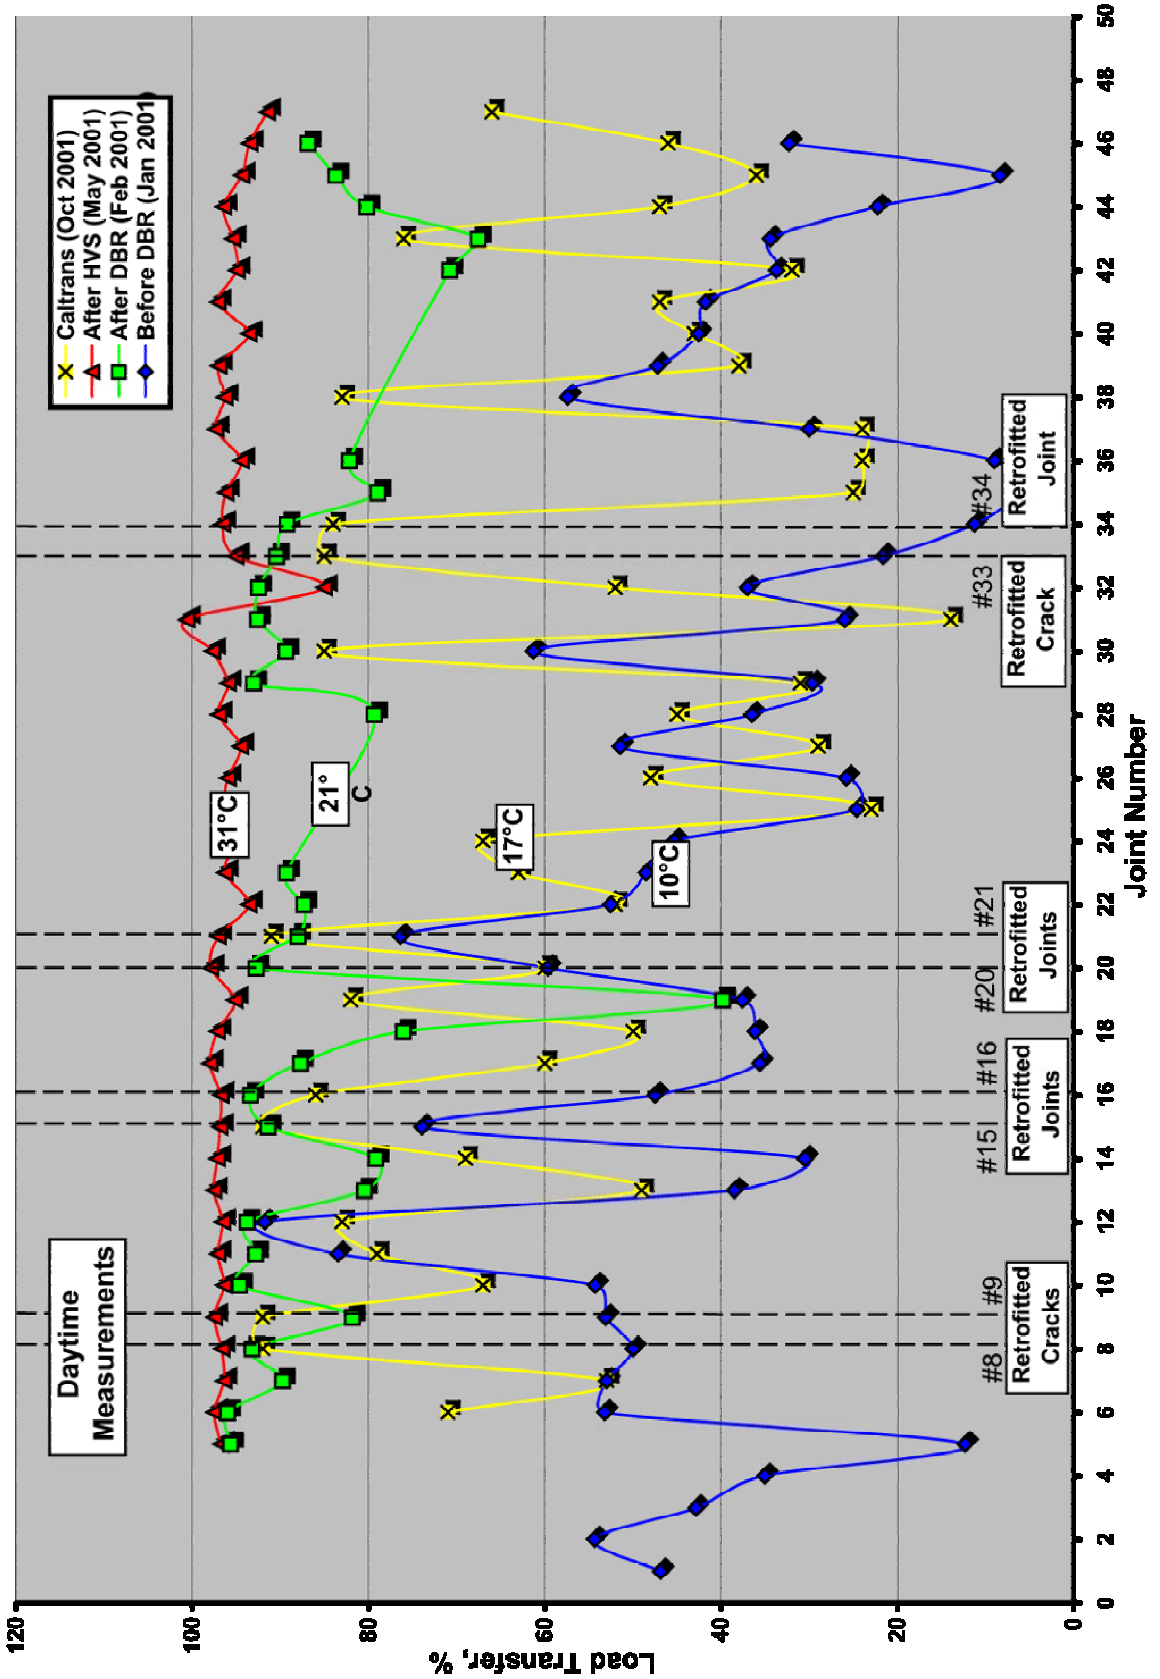
Figure 16.

Results from the FWD tests indicate that the average load transfer in the retrofitted joints/cracks improved significantly from 49.2 % (before the DBR) to 85.3% or better (Table 1) .

Again at higher pavement temperatures, load transfer increased throughout the test site. At lower temperatures, load transfer decreased, particularly in the undoweled joints/cracks. Load transfer in the retrofitted joints/cracks was minimally affected by the change in pavement temperature.

Figure 16 is graph representation of the load transfer values for each joint/crack in test section. These values are listed in Appendix A.

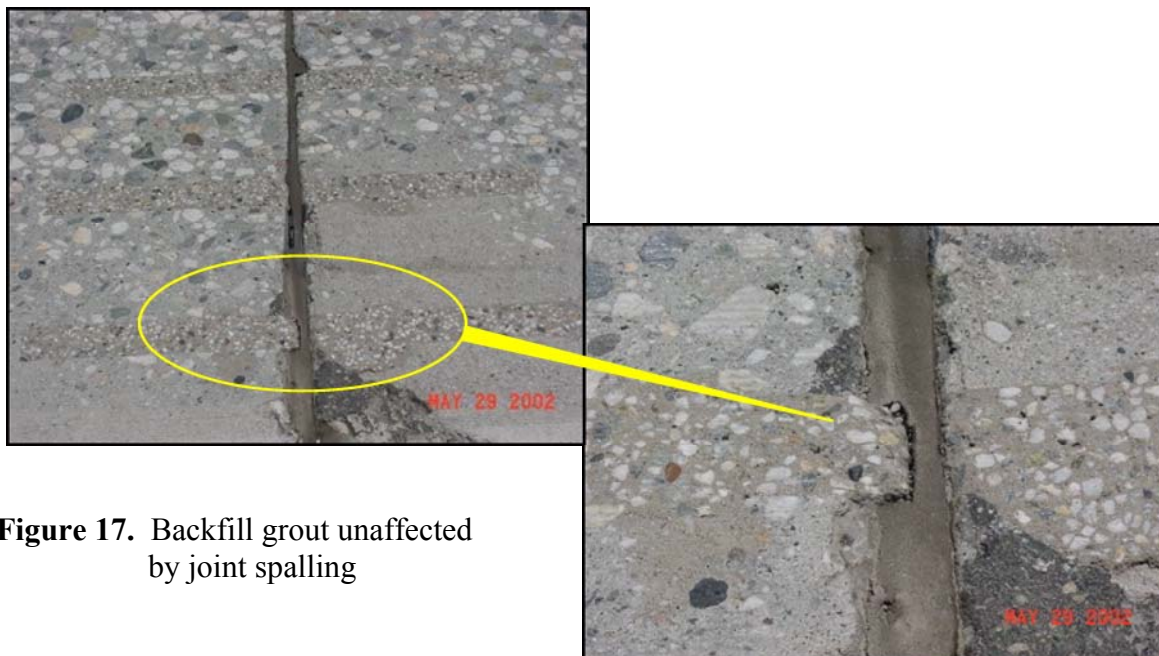
**Figure 17.** Backfill grout unaffected by joint spalling

The backfill grout used in the retrofit installations remains intact. The material shows no signs of bond failure, cracking, or other deterioration. The grout seems unaffected by the distresses occurring in the existing pavement (Figure 17).
