Interstate 15 – South Bound
PM 55.7 to PM 53.5

POST CONSTRUCTION REVIEW

DISTRICT 8
San Bernardino County
Interstate 15 – South Bound

CONTRACT NUMBER: 08-4277U4

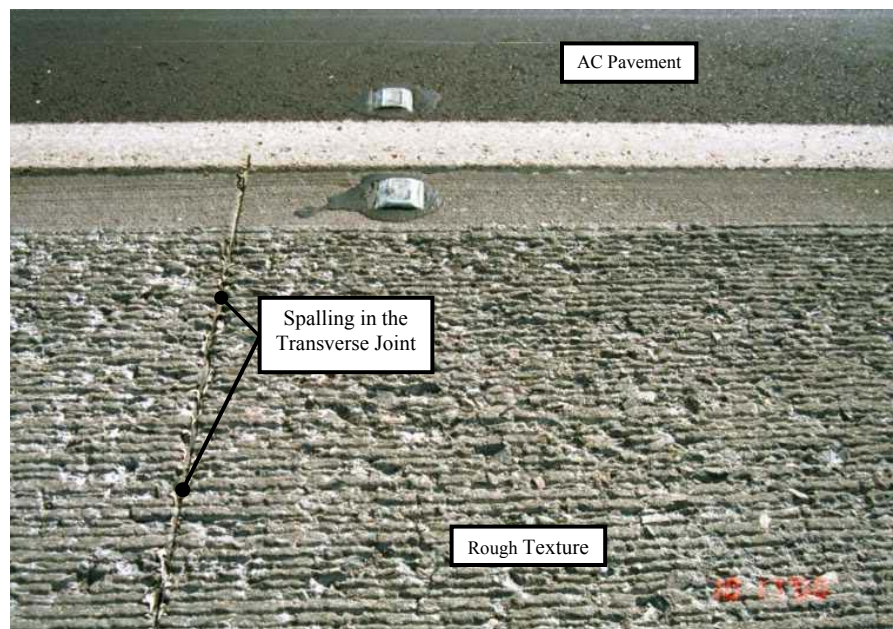
Figure 6. Exceptionally Rough Texture

Irregularities in the tined surface were found on many panels throughout the project, as shown in Figures 6 through 9.

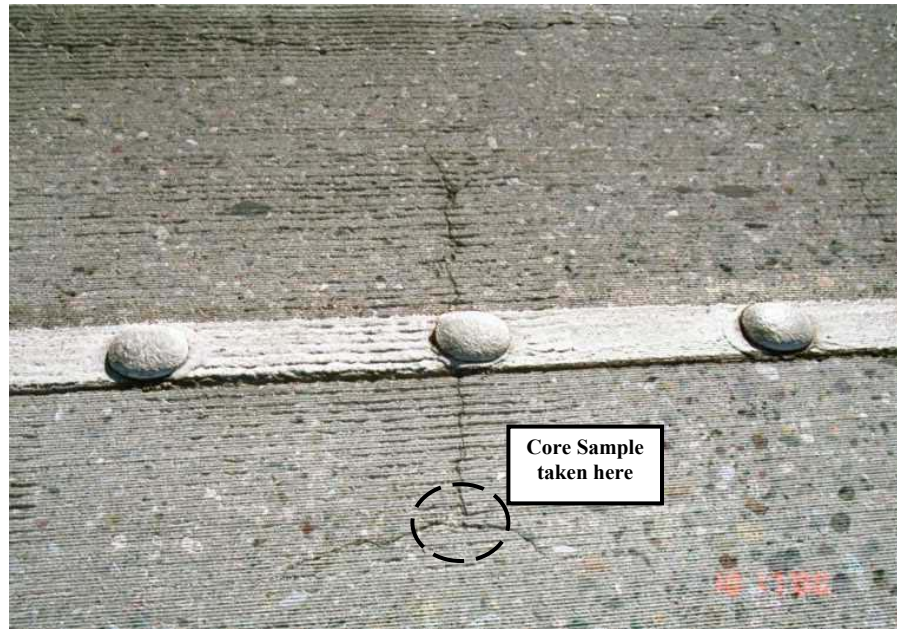
Figure 10. Crack across the Longitudinal Joint

Transverse cracks across the longitudinal joint were frequently observed. A core sample was taken over the crack to determine if it was over a tie bar and how deep it extended into the concrete (Figure 10).

The cracks across the longitudinal and transverse joints are related to poor consolidation and/or finishing of the concrete around the tie bars and dowel bars. After mechanically inserting the tie bars, the disturbed concrete was not adequately reworked and refinished. The concrete placed near the dowel bar assemblies (cages) was also inadequately worked and finished.

Future specifications should address the reconsolidation and refinishing of concrete after the mechanical insertion of tie bars.

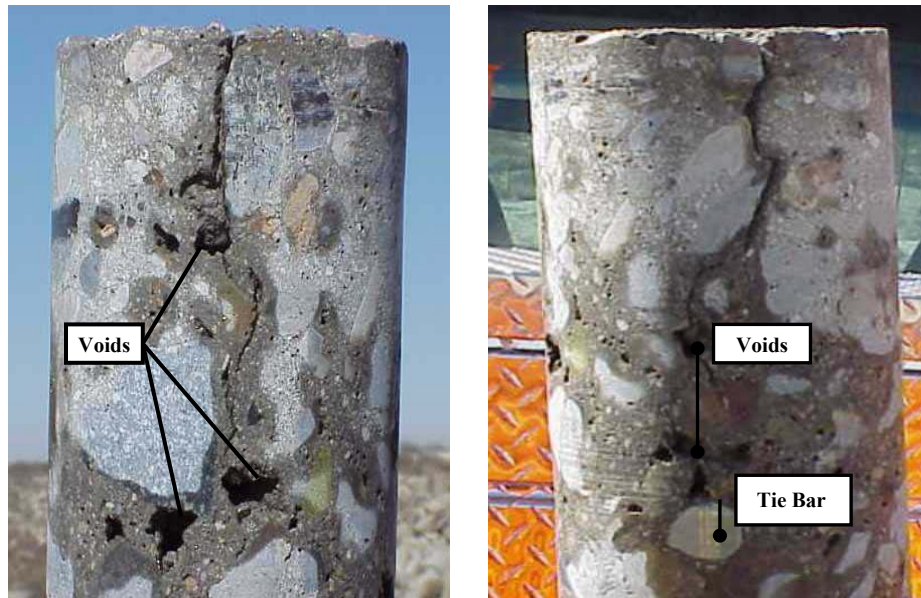
Figure 11. Core Sample

The core sample revealed the crack was over a tie bar, but did not extend full depth into the pavement section. Voids can be seen above the tie bar (Figure 11).

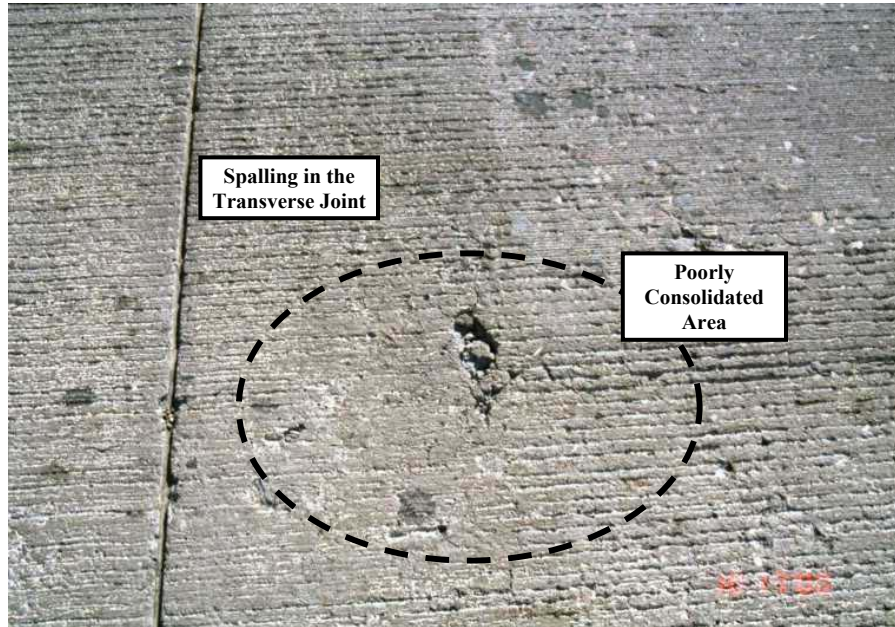
Figure 12. Suspect Surface Flaw

A surface flaw, shown in Figure 12, near a transverse joint created suspicion of poor consolidation. A core sample was taken to determine if the underlying concrete was poorly consolidated.

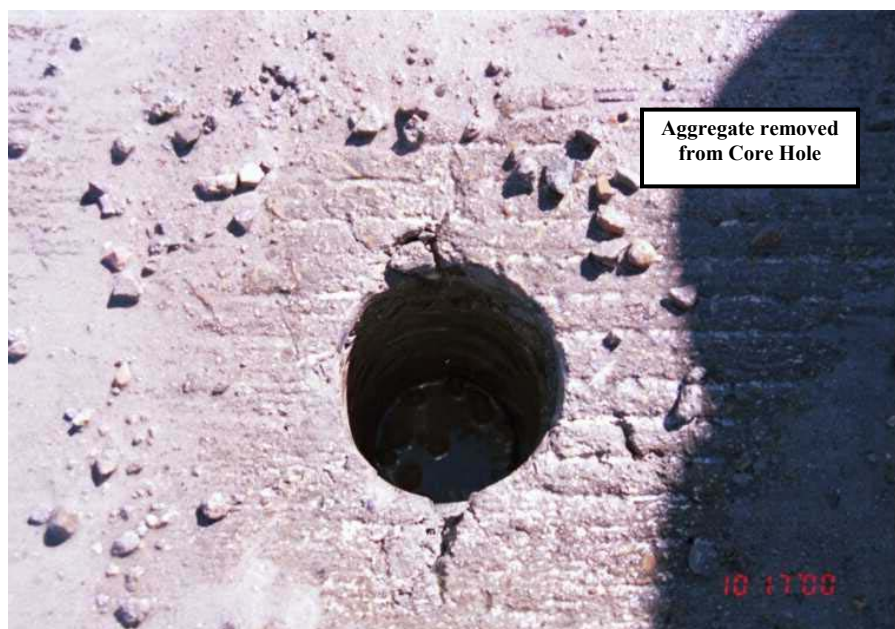
Figure 13. Core Hole

While coring, the sample crumbled. Coring was stopped momentarily to remove loose aggregate from the core hole (Figure 13).

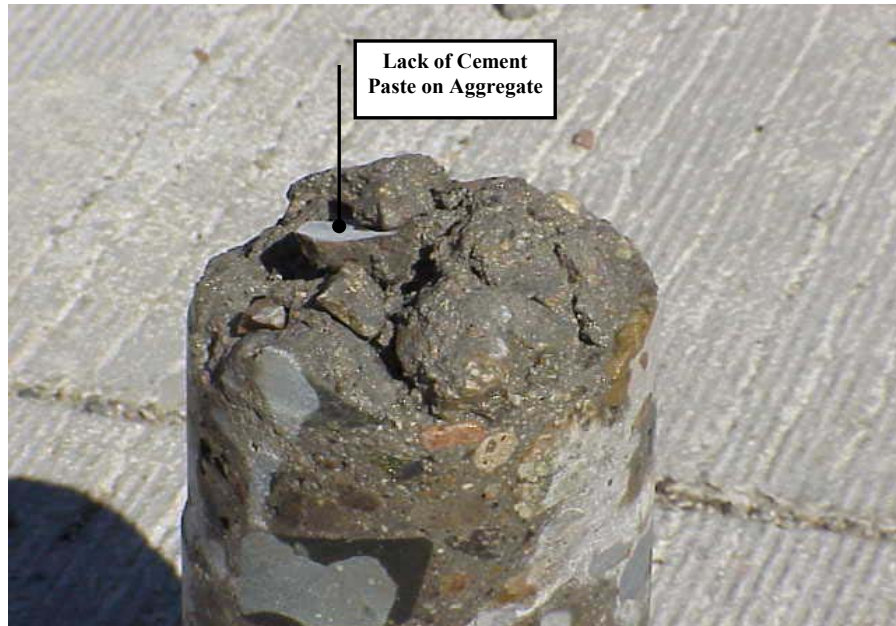
Figure 14. Remains of Core Sample

The lack of cement paste on aggregate particles was evident in the remains of the core sample (Figure 14).

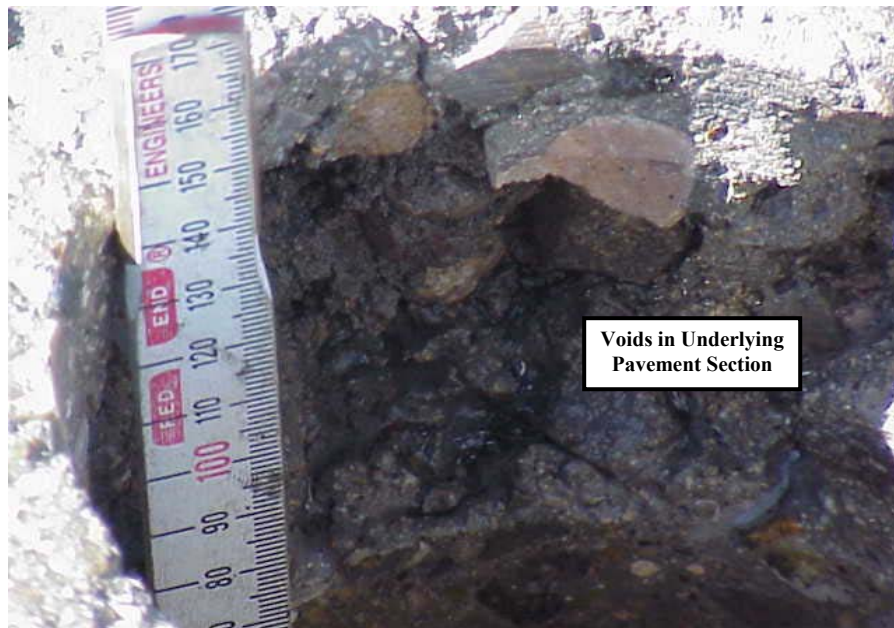
Figure 15. Core Hole Side

The core hole (Figure 15) revealed that the underlying concrete section was poorly consolidated. There were significant voids between coarse aggregate particles due to lack of mortar.

Poorly consolidated concrete entraps air and forms honeycombs and rock pockets, which weaken the pavement section. The voids found in the core samples and the underlying pavement revealed the lack of consolidation in the PCC layer. Inadequate consolidation can result from poorly proportioned concrete or poor workmanship.

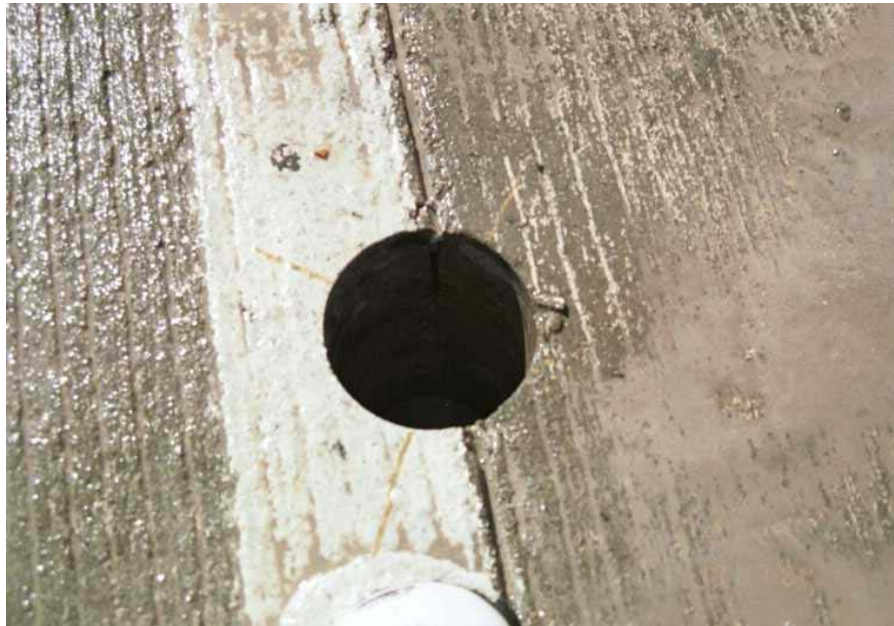
Figure 16. Core Hole - Longitudinal Joint

Core samples were taken at a saw-cut longitudinal joint and at a longitudinal crack about 0.5 m from the joint. Both were cored to determine which was functioning as stress relief for the pavement.

The core samples showed that neither extended full depth into the PCC layer, but the longitudinal crack did penetrate deeper than the induced crack at the saw-cut joint.

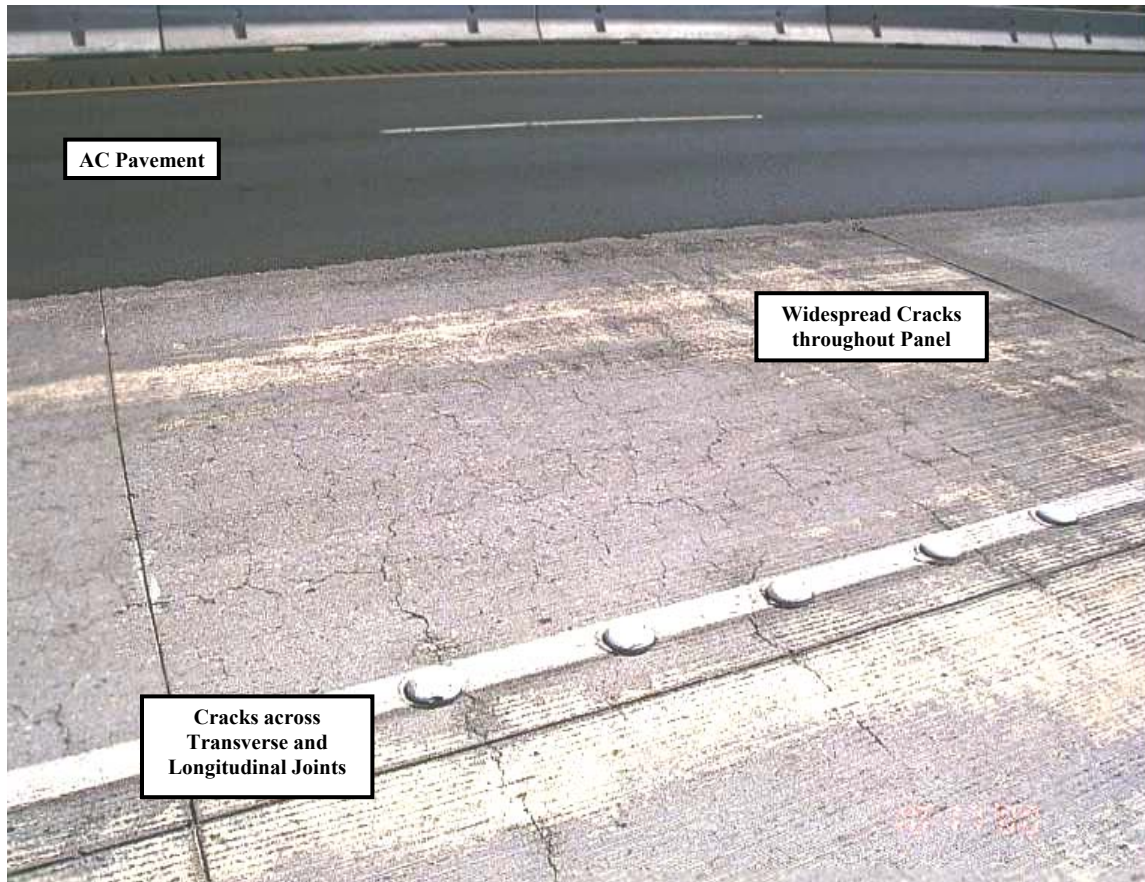
Figure 20. Southern End of Project

The southern end of the project exhibited moderate severity distresses. Many panels in this section displayed excessive cracking.

The panel shown is located in the truck-climbing lane at the southern end of the widened segment. Many panels in this section exhibited widespread cracking in the wheel path and across the longitudinal and transverse joints.

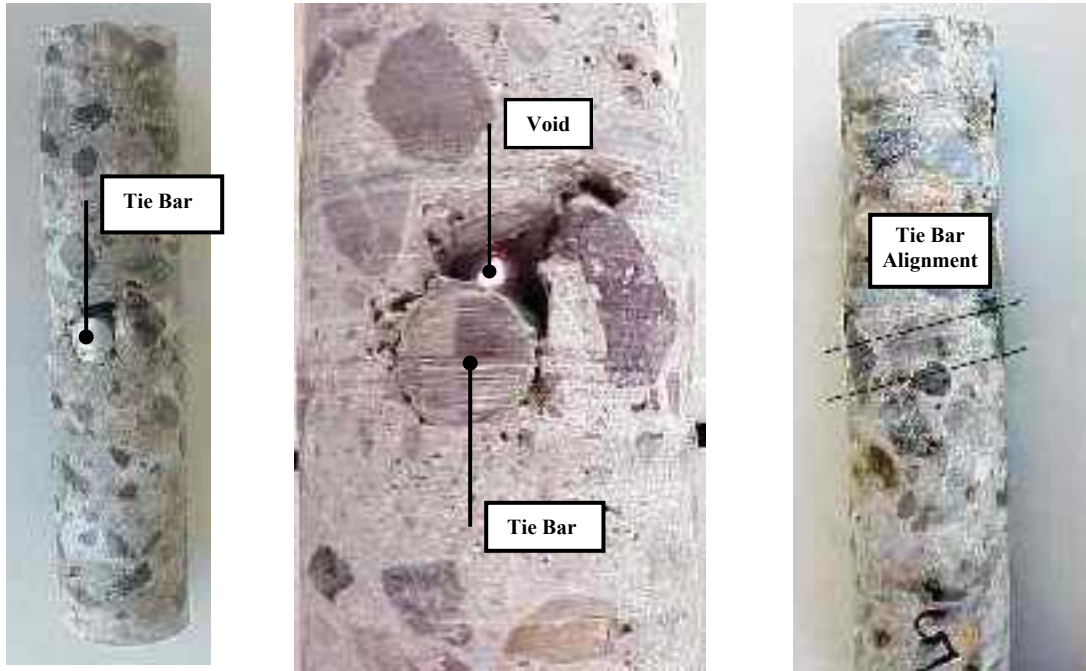
Figure 21. Core Sample, taken by Contractor

Core samples, taken by the contractor, were examined and found to have numerous voids. The core shown has a large void directly above a tie bar.
