**ARIZONA
TRANSPORTATION
RESEARCH
CENTER**

PRODUCT EVALUATION
84-06
CRAFCO POTHOLE REPAIR SYSTEM

JULY 18, 1986

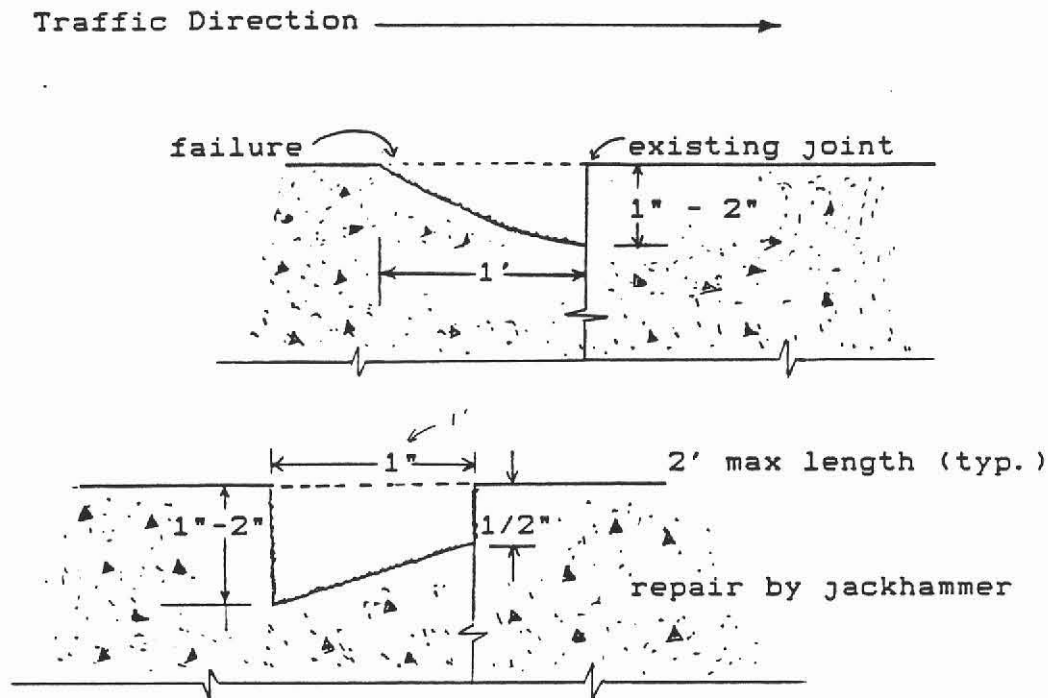
FIGURE 1 - TYPICAL JOINT FRACTURE

Conversations with District personnel indicates that a "typical" joint fracture for the concrete pavement looks like the failures shown in figure 1.

Besides the joint spalling shown in figure 1, corner breakage is the next most common pothole producer within this area. To repair these forms of potholes generally requires a 6-7 man crew limited to work hours between 9:00 a.m. and 2:30 p.m. to avoid rush hour.

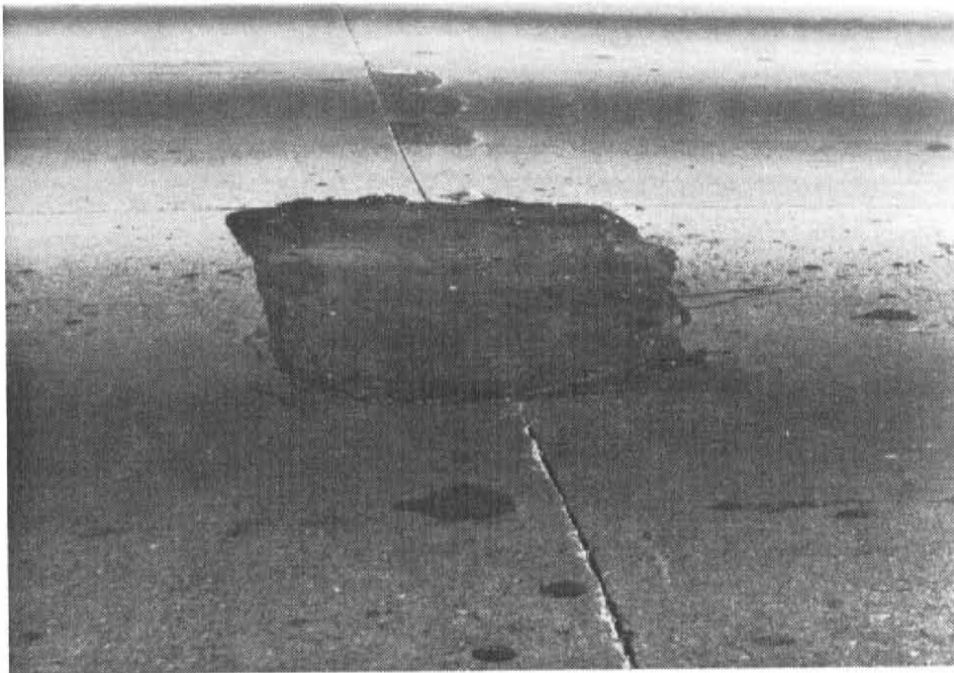
FIGURE 7 - POTHOLE NUMBER 3

that the aggregate utilized for pothole number 3 had some fines present and the Crafcop personnel attempted to segregate out the fines by hand.
