1. Report No. FHWA/TX-08/0-5210-5		2. Government Accession No.		3. Recipient's Catalog No.	
4. Title and Subtitle CRASH TESTING AND EVALUATION OF TXDOT BURN BAN SIGNS				5. Report Date December 2008 Published: August 2009

**CRASH TESTING AND EVALUATION OF
TXDOT BURN BAN SIGNS**

Report 0-5210-5
Project 0-5210
Project Title: Roadside Crash Testing Program
for Design Guidance and Standard Detail Development

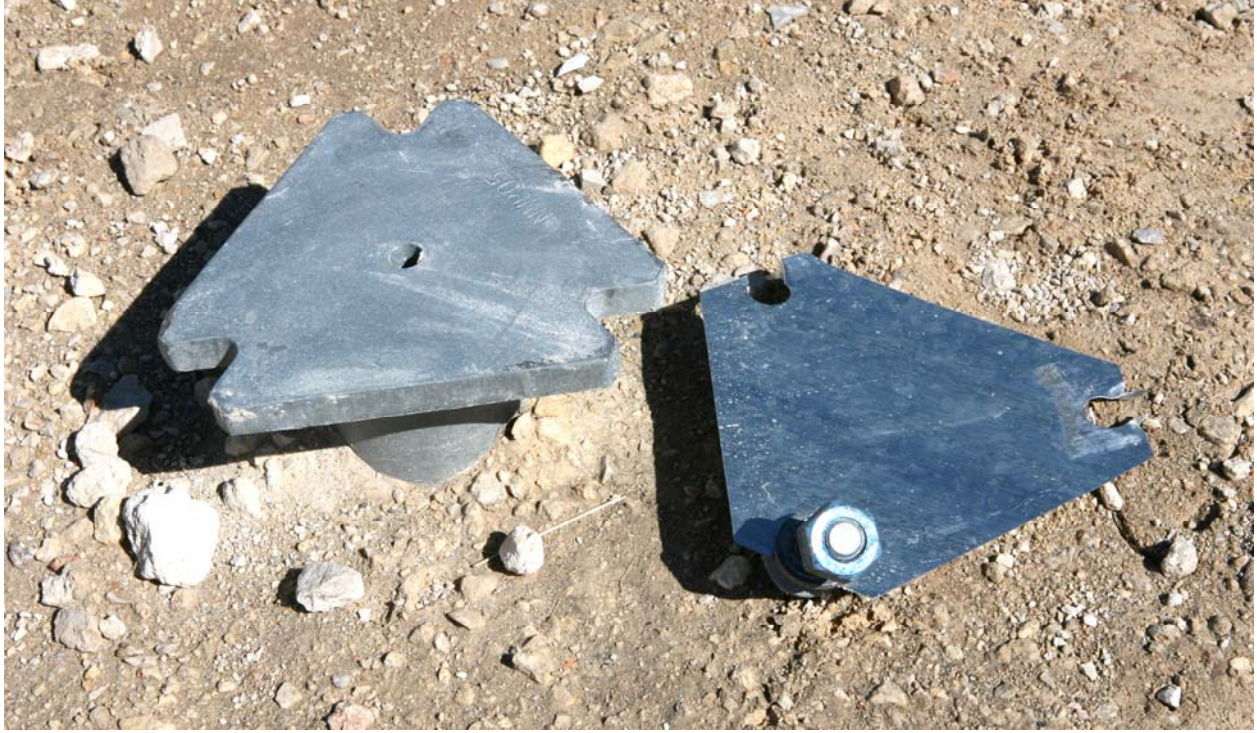
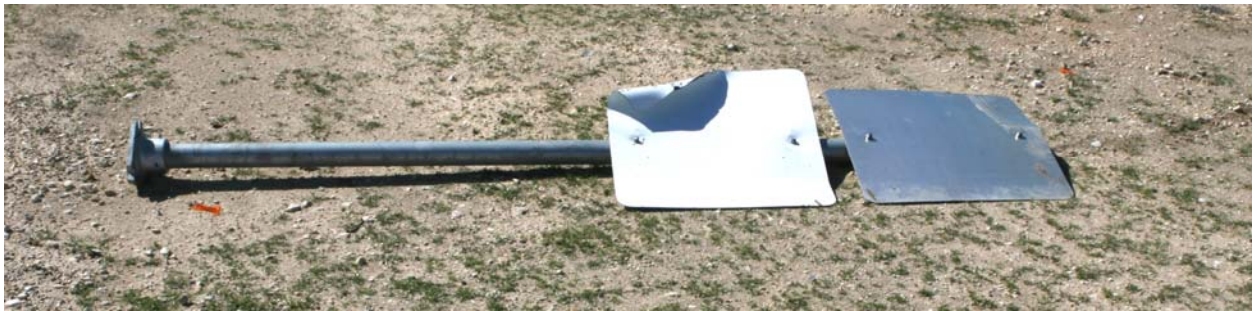
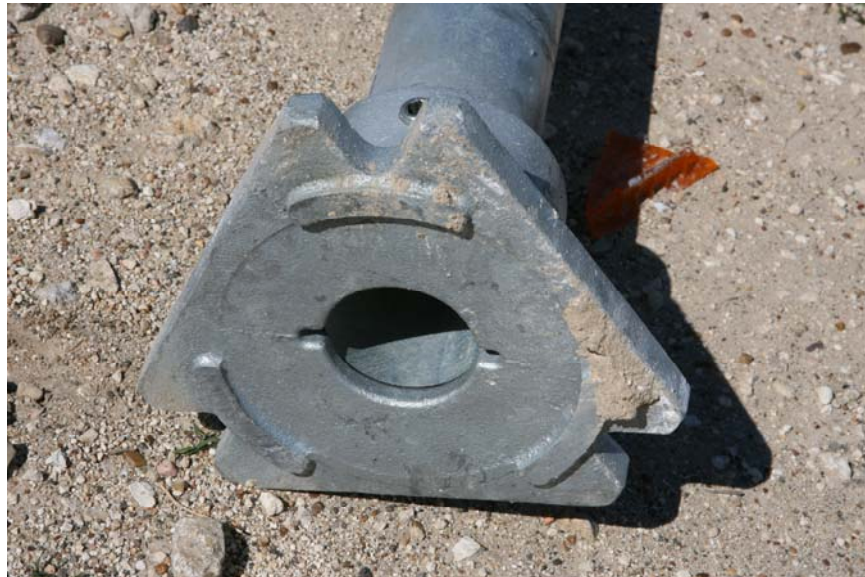
Figure 3.7. Installation after Test 452108-1.

Damage to the sign support installation is shown in Figures 3.6 and 3.7. The base showed no movement in the ground. The keeper plate and one bolt remained at the base, one bolt came to rest 12.5 ft downstream of impact, and the third was resting 57.5 ft downstream of impact. The sign panels and support came to rest under the vehicle, which came to rest 92.5 ft downstream from the point of impact.

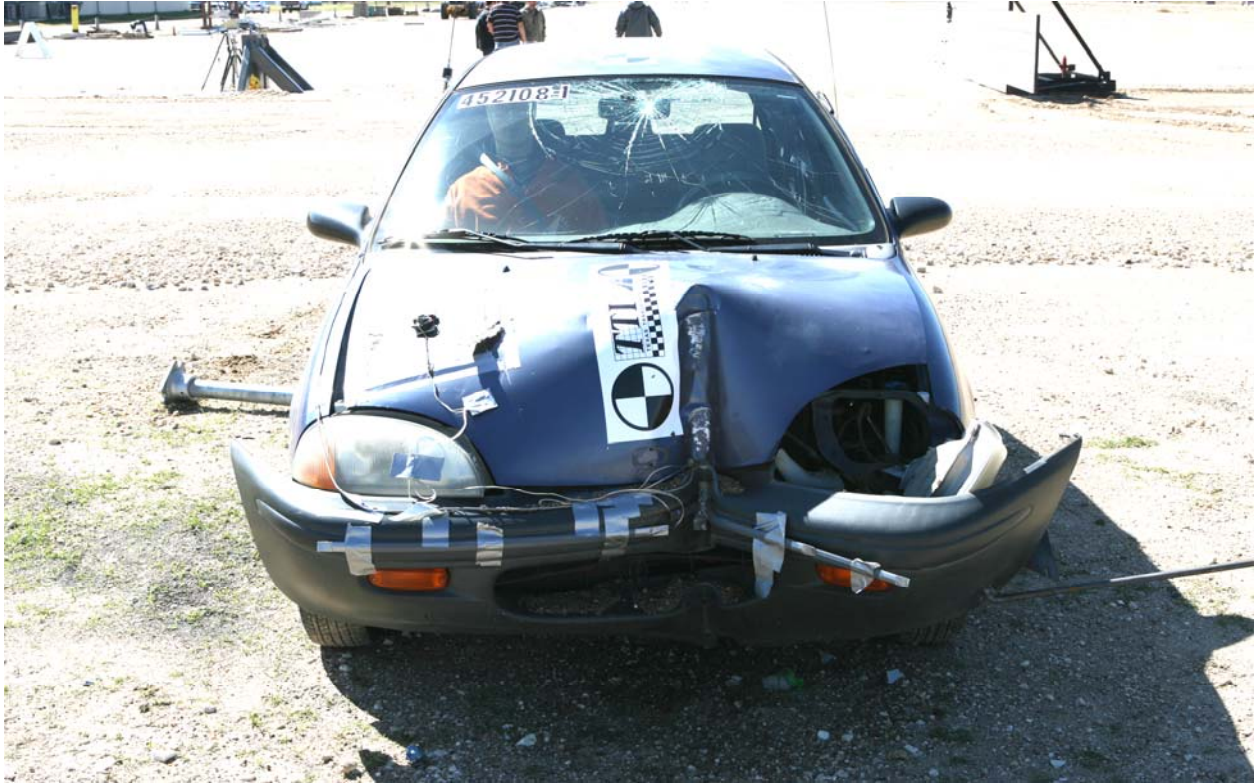
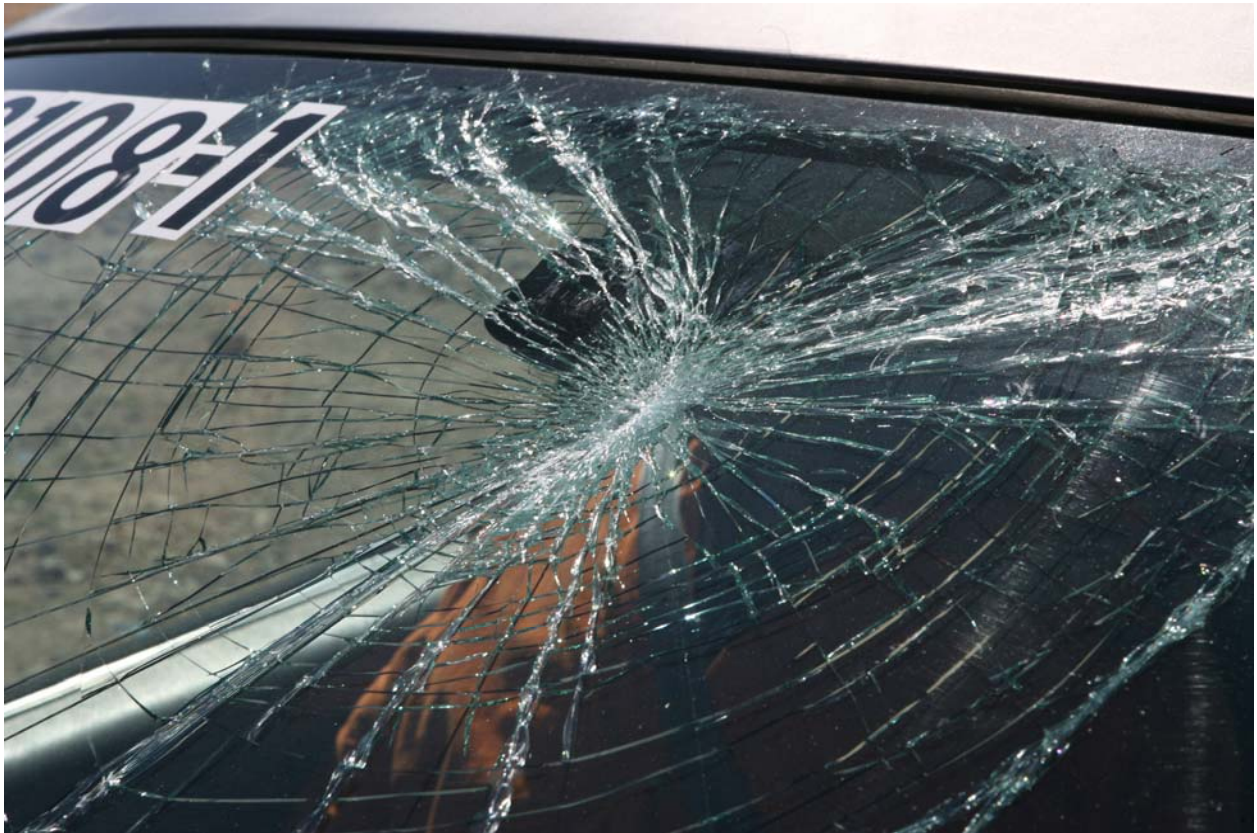
Figure 3.8. Vehicle after Test 452108-1.

Figures 3.8 and 3.9 show the damage to the exterior and interior of the vehicle, respectively. The front bumper, hood, radiator, and radiator support were deformed. The windshield was cracked near the roof line, but there was no hole. Maximum exterior crush to the vehicle was 6.3 inches on the front of the vehicle at a point 6 inches left (toward the driver side) of centerline. No occupant compartment deformation occurred. Exterior crush and occupant compartment measurements are shown in Appendix B, Tables B1 and B2, respectively.

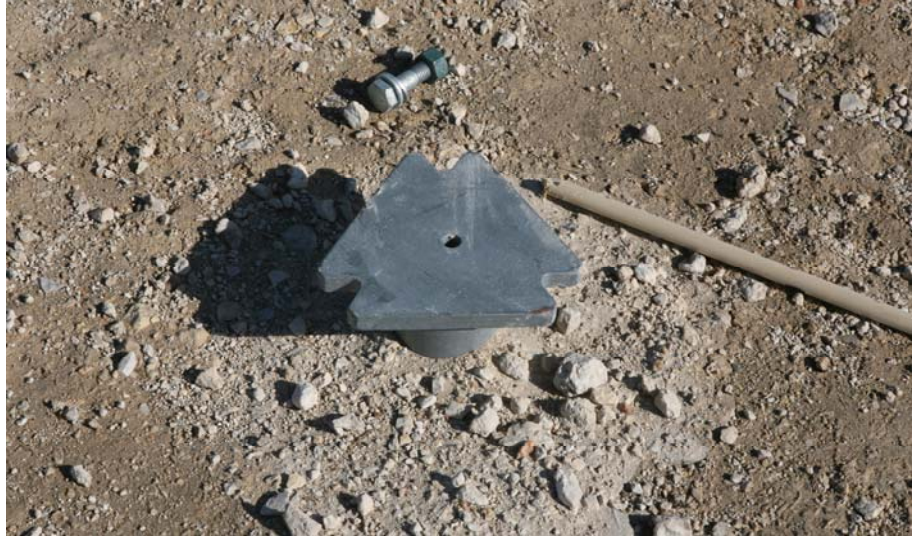
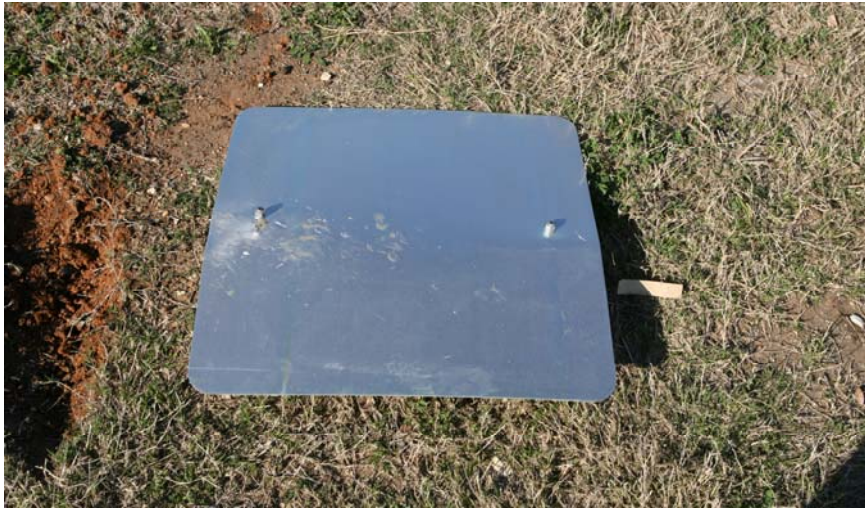
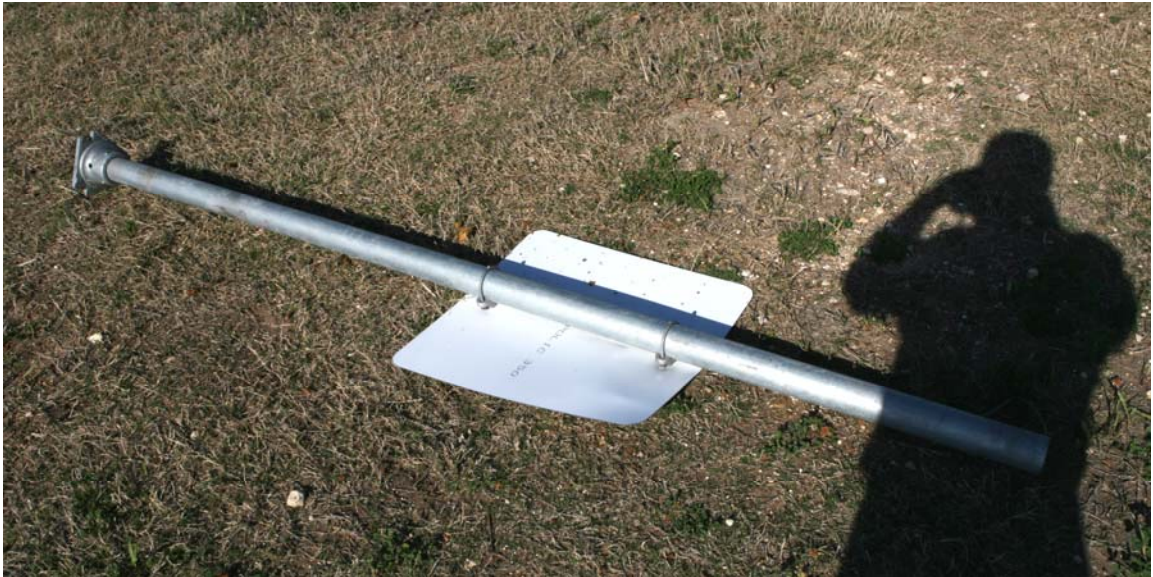
Figure 3.14. Installation after Test 452108-2.

Damage to the installation is shown in Figures 3.13 and 3.14. The base showed no movement in the ground. The keeper plate came to rest 28.5 ft downstream from impact and 30 inches to the right of centerline. One bolt remained at the base, one bolt came to rest 12.5 ft downstream of impact, and the third was resting 51 ft downstream of impact. The confirmation sign panel separated from the support came to rest near the support and confirmation sign panel, which came to rest 150 ft downstream from impact.

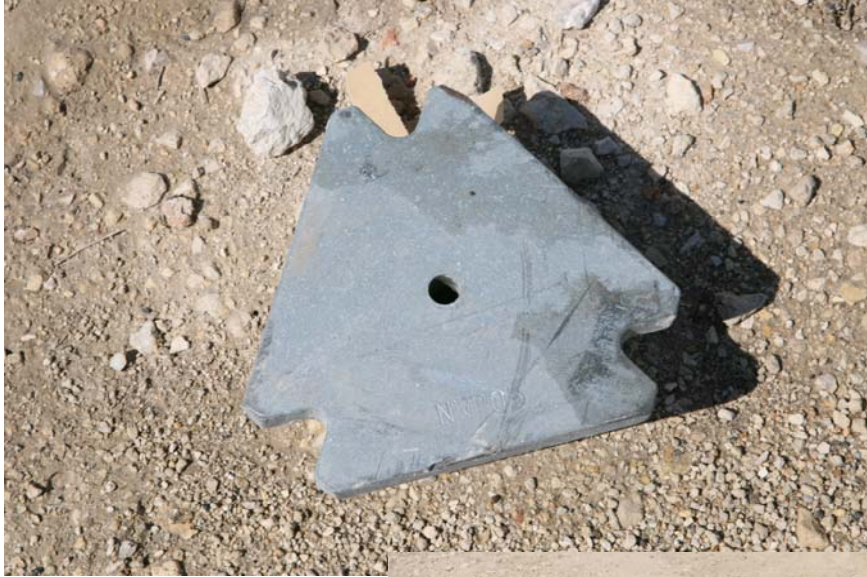
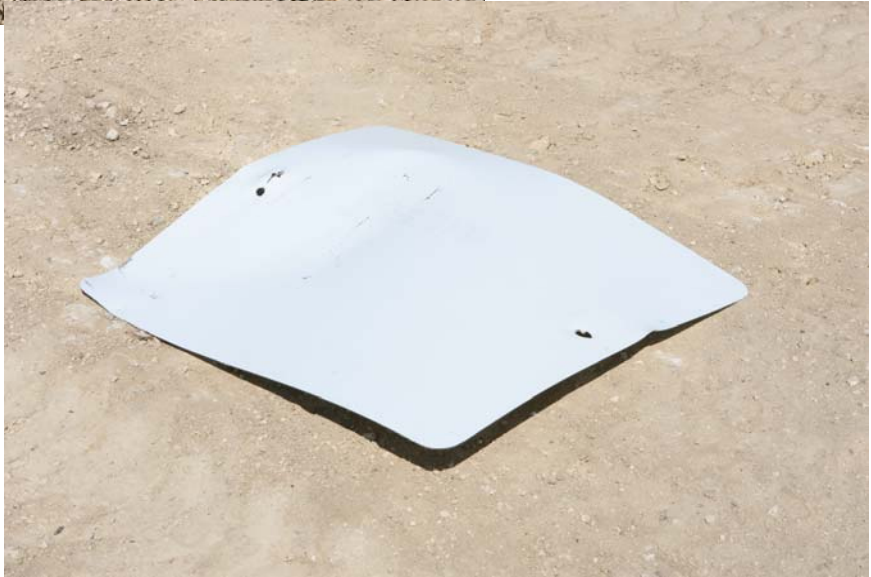
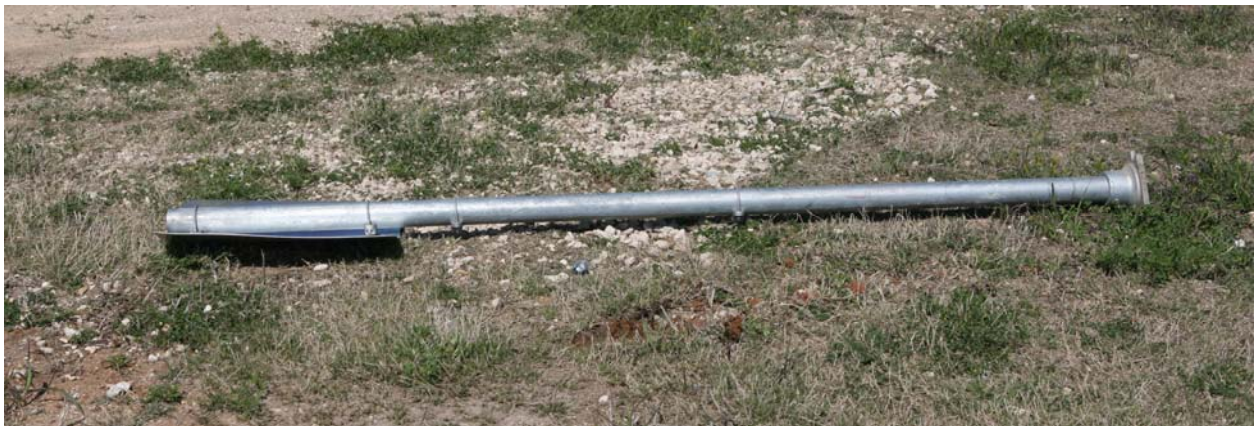
Figure 4.7. Installation after Test 452108-3.

Damage to the installation is shown in Figures 4.6 and 4.7. The base showed no movement in the ground. The keeper plate and bolts came to rest near the base. The 30 inch × 36 inch burn ban sign panel separated from the support and came to rest 58 ft downstream of impact and 28 ft to the left of centerline. The 24 inch × 24 inch confirmation sign panel and support came to rest 149 ft downstream of and directly in line with the point of impact. The brakes on the vehicle were applied 160 ft behind the test installation, and the vehicle subsequently came to rest 322 ft downstream from impact.

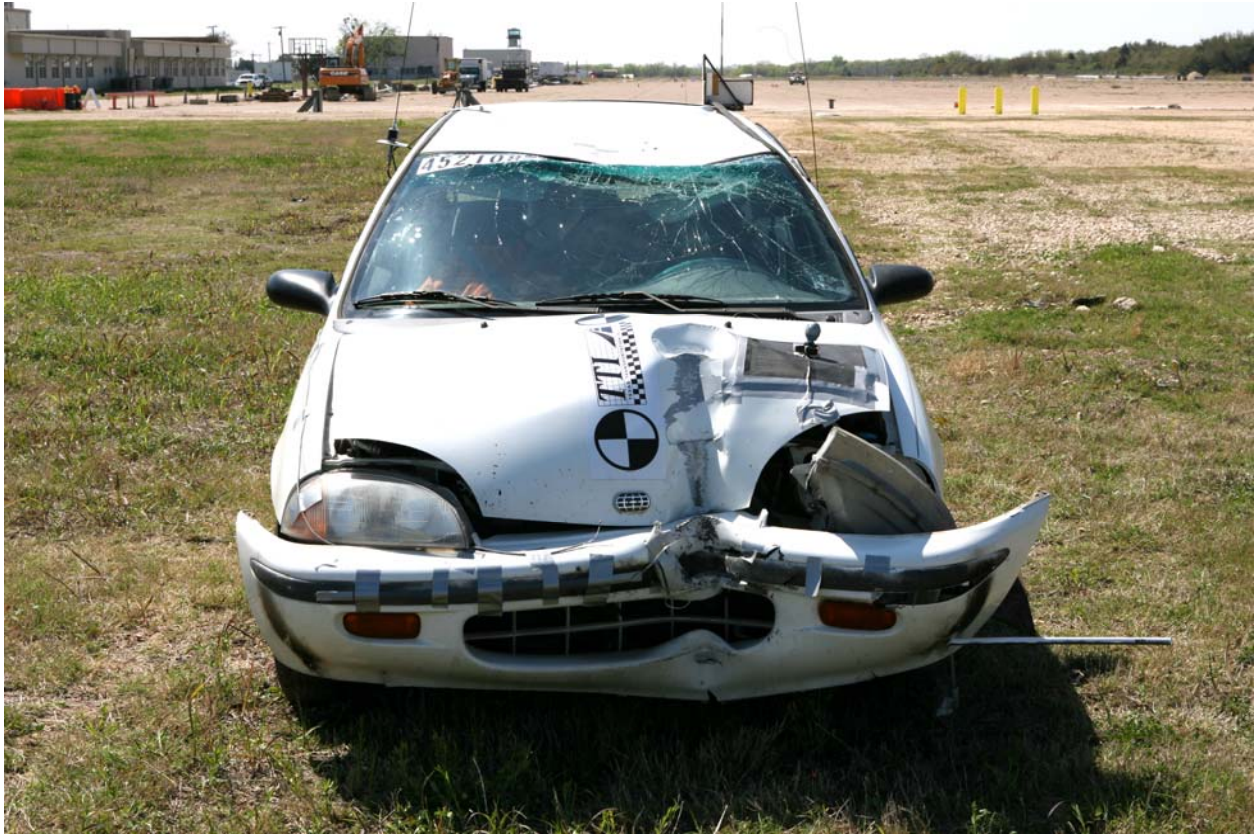
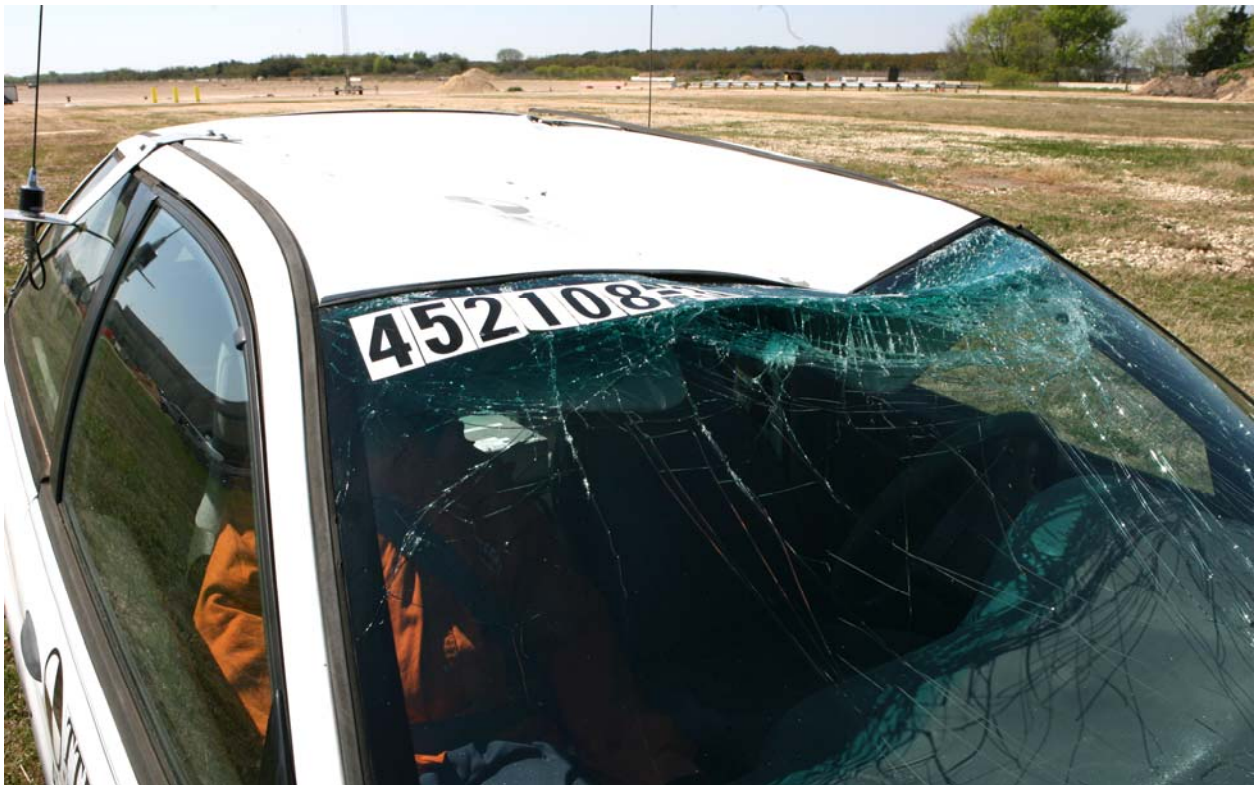
Figure 4.8. Vehicle after Test 452108-3.

Result: The detached sign support traveled with the vehicle and came to rest along the vehicle path. The support did not penetrate nor show potential for penetrating the vehicle, or to present undue hazard to others in the area. The sign panel and support deformed the roof 5.6 inches into the occupant compartment. (PASS)

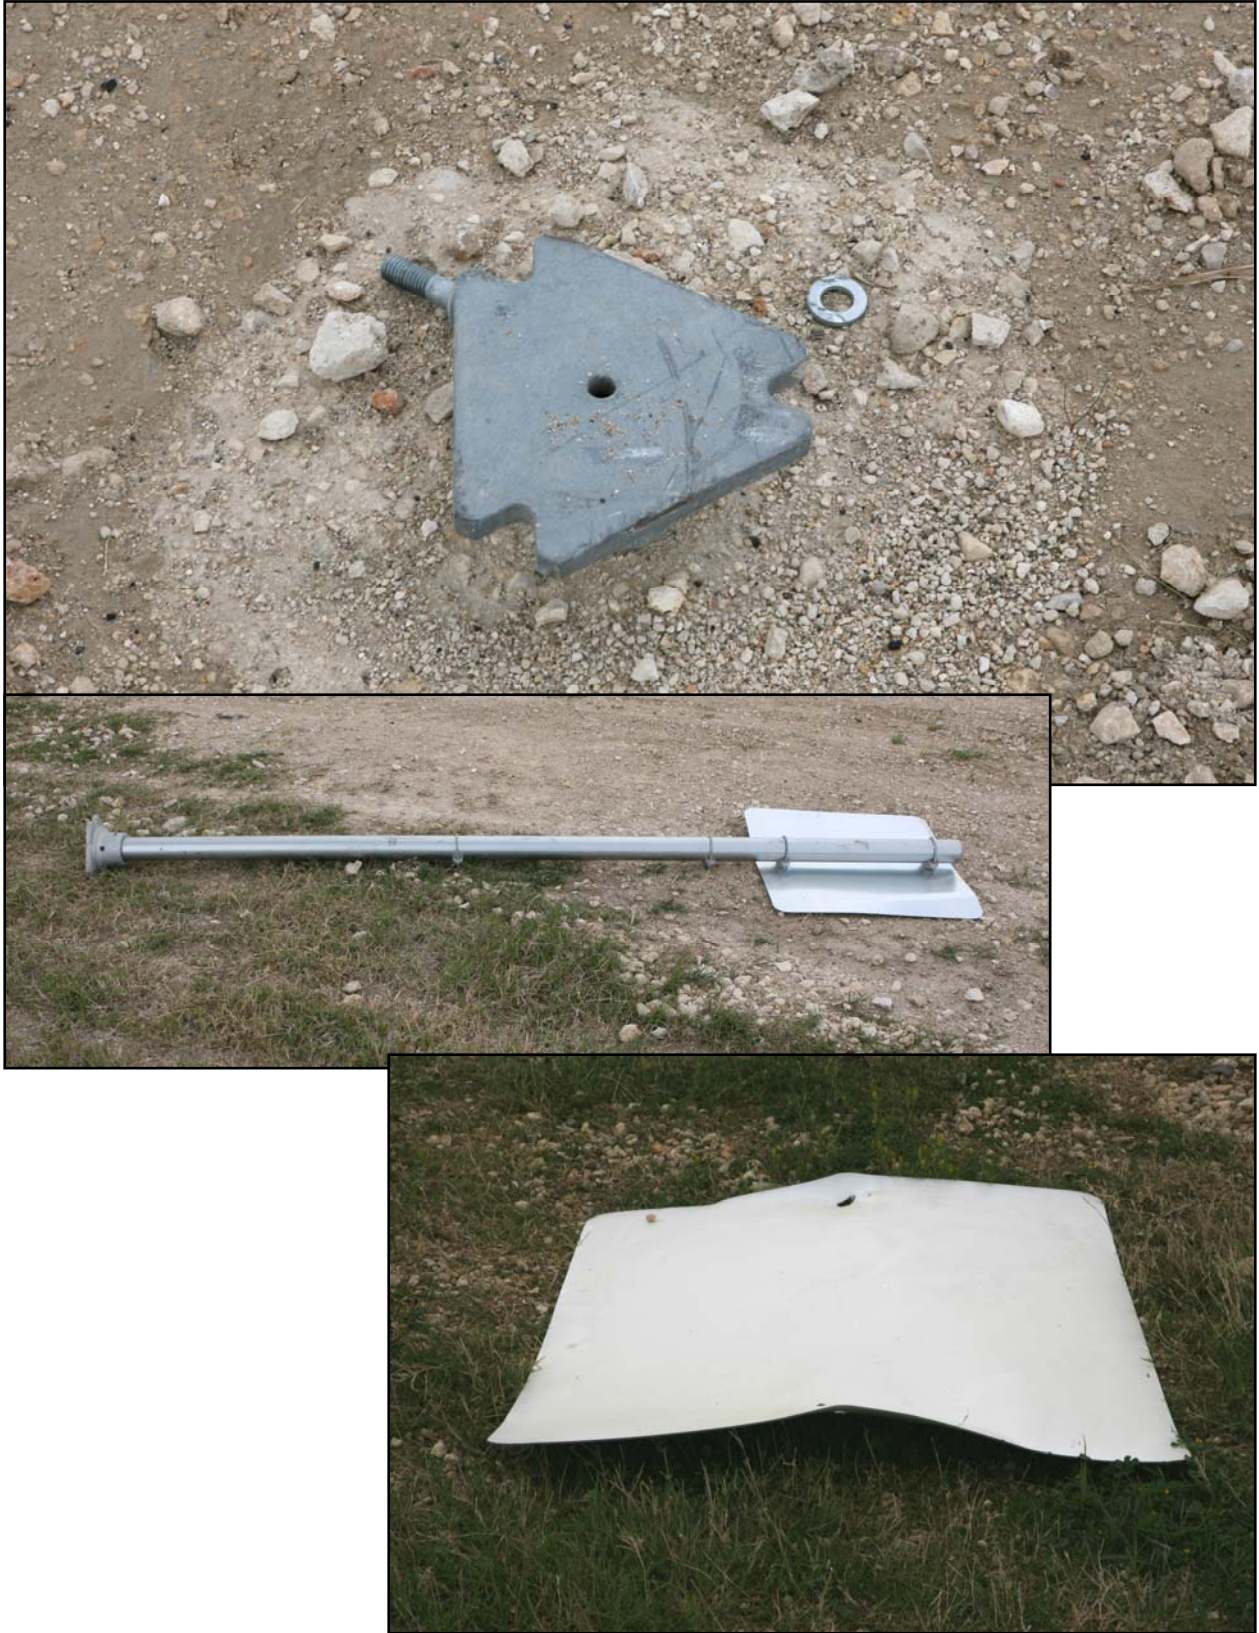
Figure 4.14. Installation after Test 452108-4.

Damage to the installation is shown in Figures 4.13 and 4.14. The base showed no movement in the ground. The keeper plate and bolts came to rest near the base. The 30 inch × 36 inch burn ban sign panel separated from the support and came to rest 71 ft downstream of impact and 9 ft to the left. The 24 inch × 24 inch confirmation sign panel and support came to rest 213 ft downstream of impact and 4 ft to the left of centerline. The vehicle came to rest 466 ft downstream and 37 ft to the left of the point of impact.

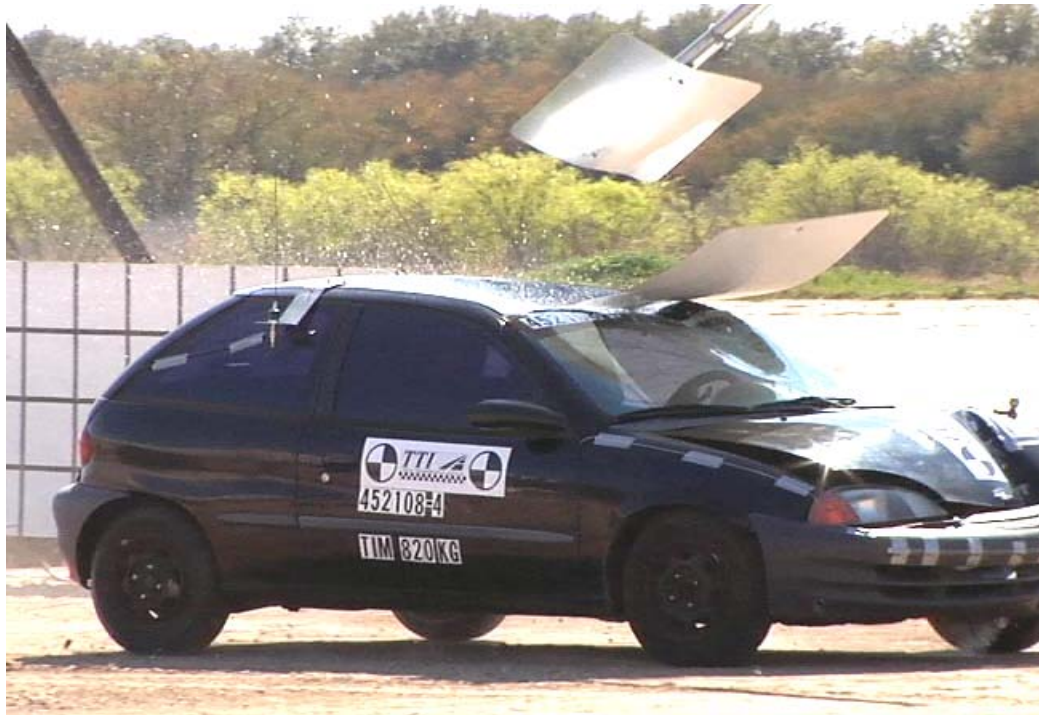
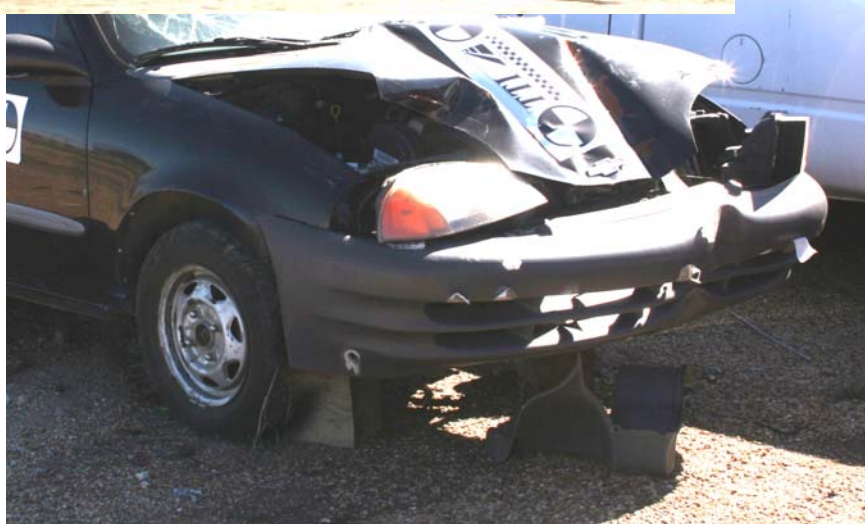
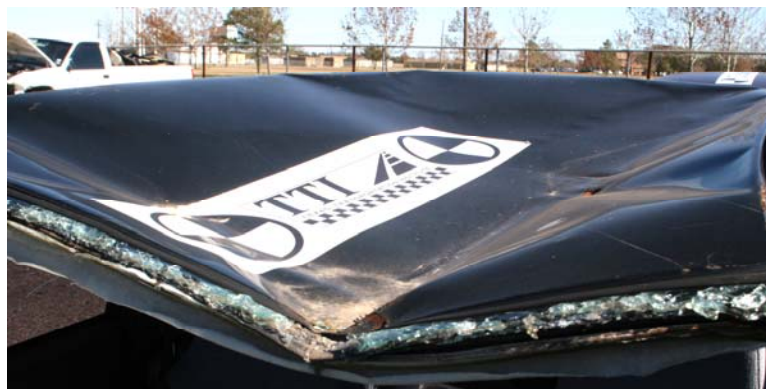
Figure 4.15. Vehicle after Test 452108-4.

Still photographs were taken after vehicle was removed from test site. Movement jarred the windshield loose from the top of the windshield/roof frame.

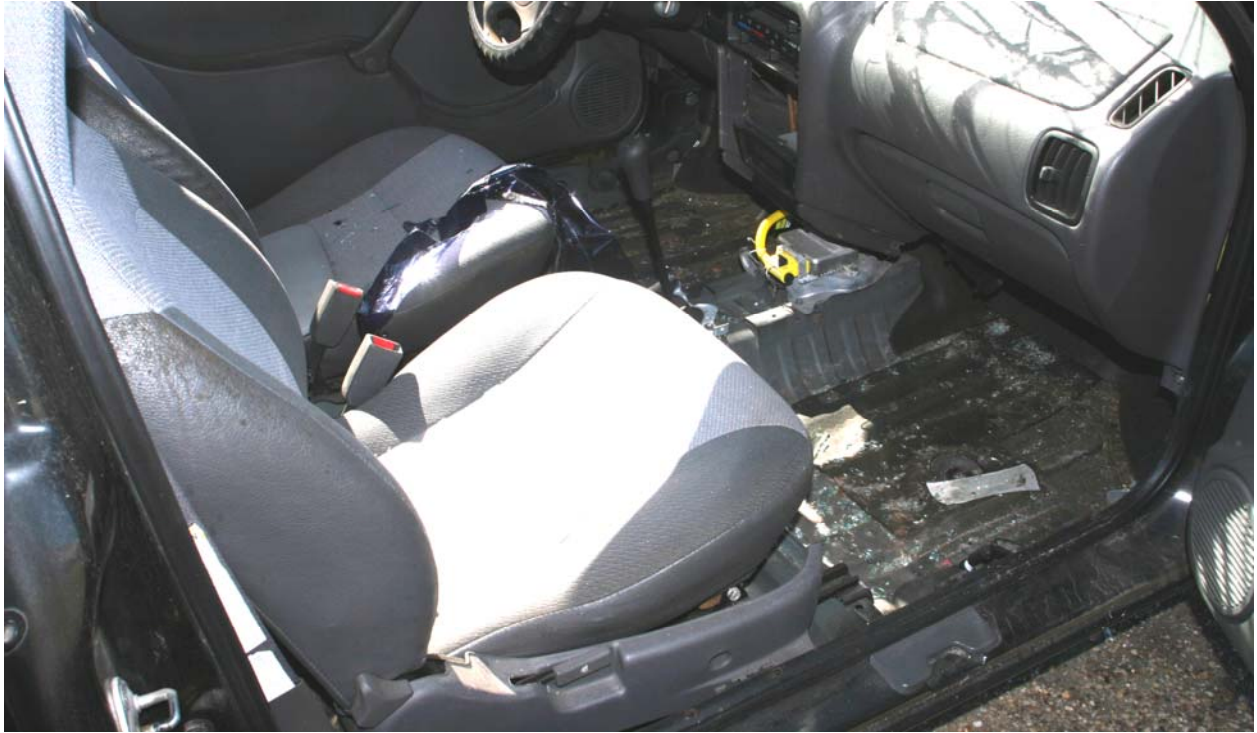
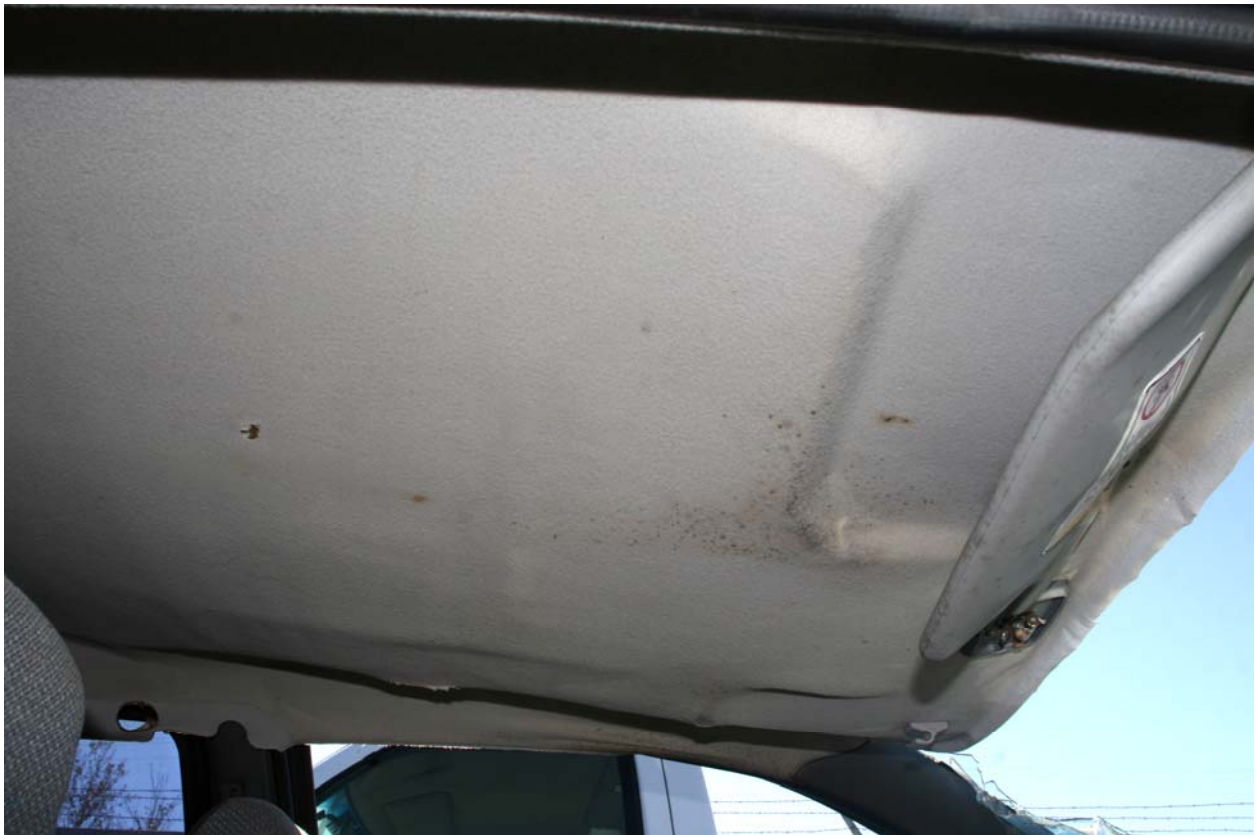
Figure 4.16. Interior of Vehicle for Test 452108-4.

NOTE: Photographs were taken after vehicle was removed from test site. Movement jarred the windshield loose from the top of the windshield/roof frame.
