# Evaluation of Rumble Stripes on Low-Volume Rural Roads in Iowa—Phase I

**Final Report  
July 2009**

**Sponsored by**  
the Iowa Highway Research Board  
(IHRB Project TR-577), the Iowa Department  
of Transportation (InTrans Project 07-304),  
the Federal Highway Administration, and  
the Midwest Transportation Consortium

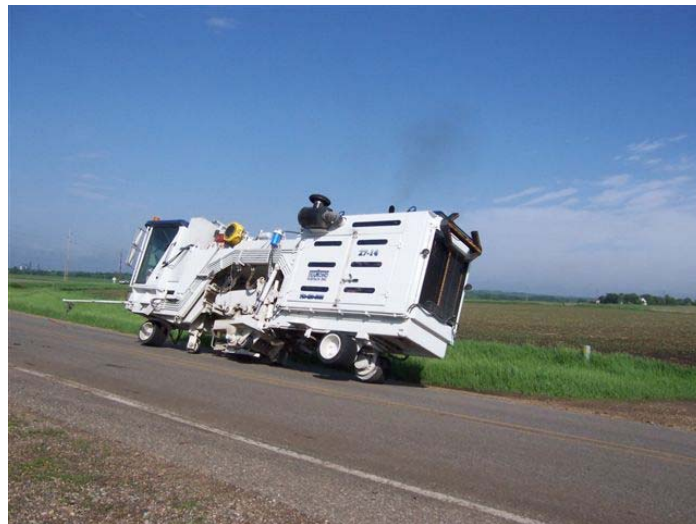
**Figure 3-11. Machine tipping on inside curve**

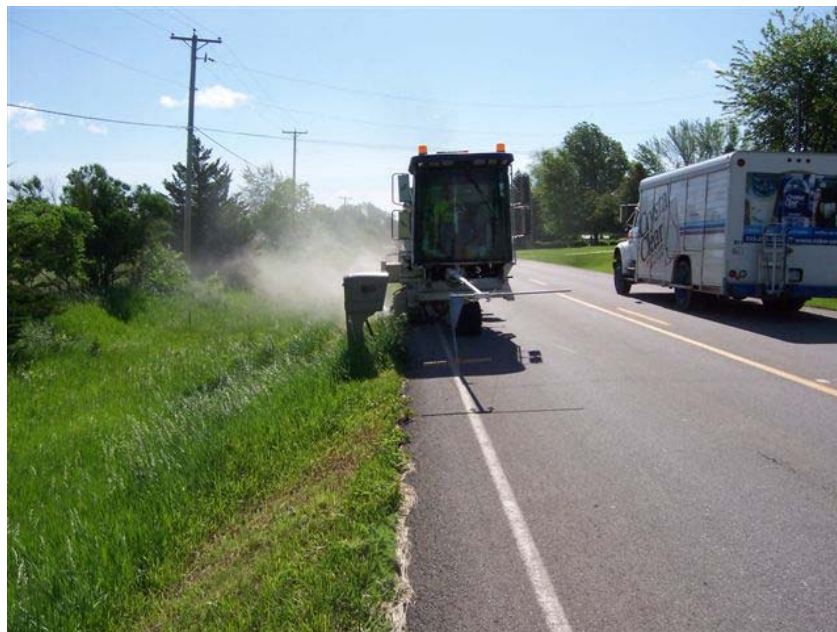
**Figure 3-13. Milling operation omitting short areas around mailboxes in Polk County**

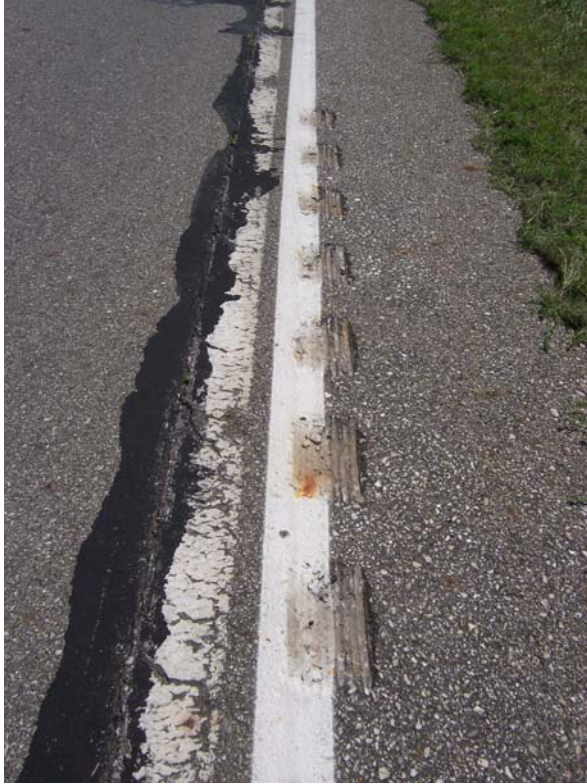
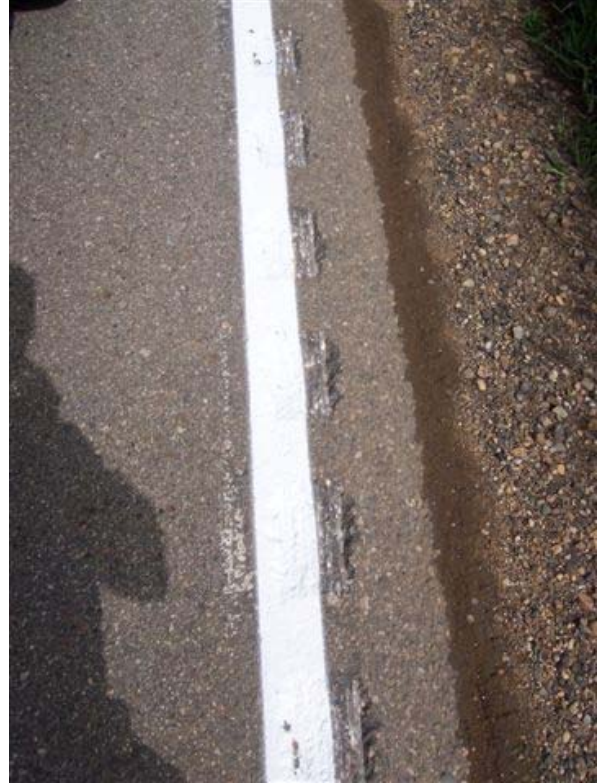
Figure 3-14 shows the difficulty in aligning the painted edge line with the milled rumble strip.

**Figure 3-14. Photos showing difficulty in maintaining painted edge line alignment within rumble stripe installation**

- There were problems maintaining horizontal consistency with distance from edge; as a result, the guidance system in the milling machine needs refinement.
- Inadequate removal of millings resulted; a compressor was added to the installation process to remove material.
- The milling machine had problems with stability around the low side of horizontal curves; those areas had to be omitted initially but were later cut with the modified Iowa Plains Signing machine.
- Breakup of edges on PCC pavement occurred when the milling operation was attempted too close to the edge.
- It was difficult to achieve the desired 5/8 inch milling depth in PCC pavement (most measured approximately 1/2 inch in depth) due to insufficient downward pressure on

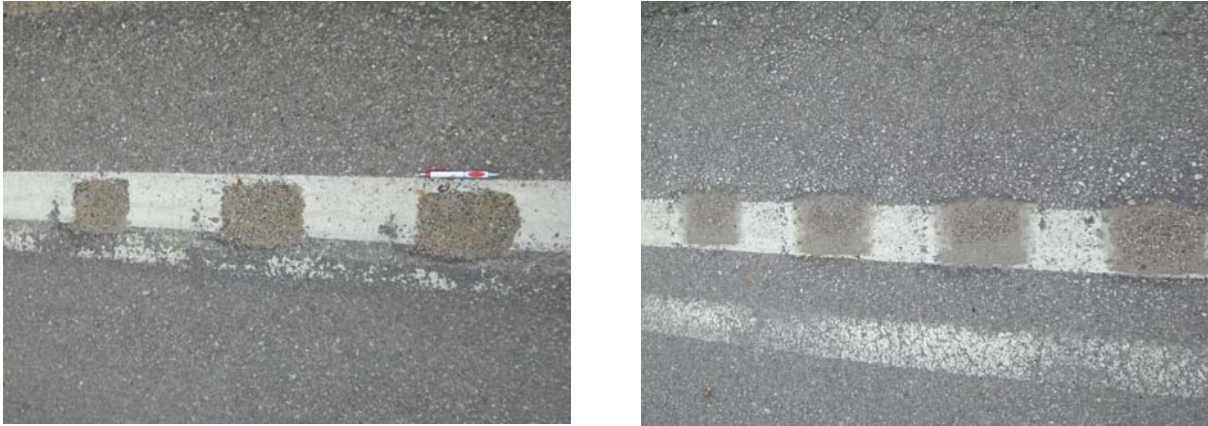
Although the appearance of the stripes seemed the same for the initial and most of the fall collections, county maintenance crews had pulled up the gravel shoulders on the Poweshiek project, filling the stripes with loose granular material. This rendered them ineffective until the paint contractor blew out the material with compressed air. Also, the spring collection period revealed that the many of the stripes had been filled or partially filled with loose gravel material,

even on the Polk County roads with paved shoulders. See Figure 5-2. This may be attributed to winter maintenance using sand (sometimes mixed with salt) on slick roads. The amount of filling seemed to be much heavier on the asphalt pavements than on the PCC pavements.

**Figure 5-2. Rumble stripes filled with sand**

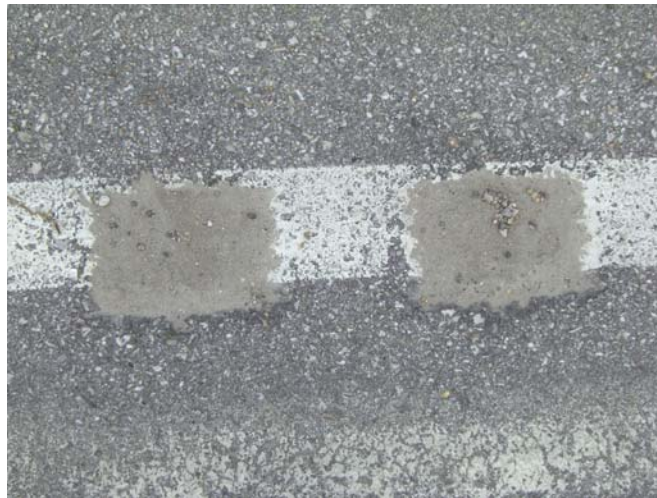
Some of the stripes, especially at the tops of hills, on straight road segments seemed to accumulate only a small amount of caked fines in the bottom of the stripe. See Figure 5-3.

**Figure 5-3. Rumble stripe with caked fines in bottom**

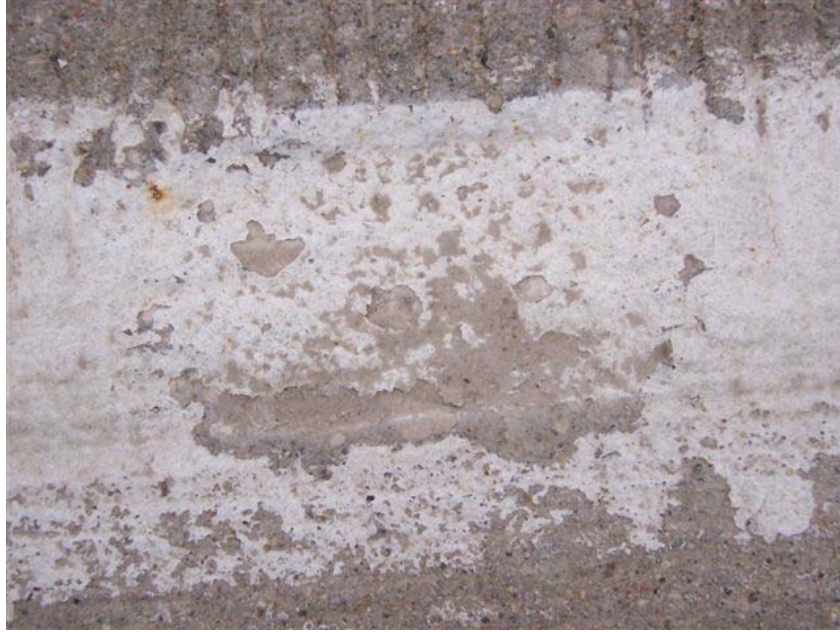
Some of the paint that was applied late in the fall (inside curve segments in Dallas/Madison, Polk, Buchanan, and Poweshiek Counties) did not seem to adhere well in the stripe area, especially on the PCC surfaces. Much of the paint was loose and had chipped away by the spring evaluation. Brooming seemed to remove most of the loosened pieces. See Figure 5-14.

**Figure 5-14. Peeling paint chips on flat area**

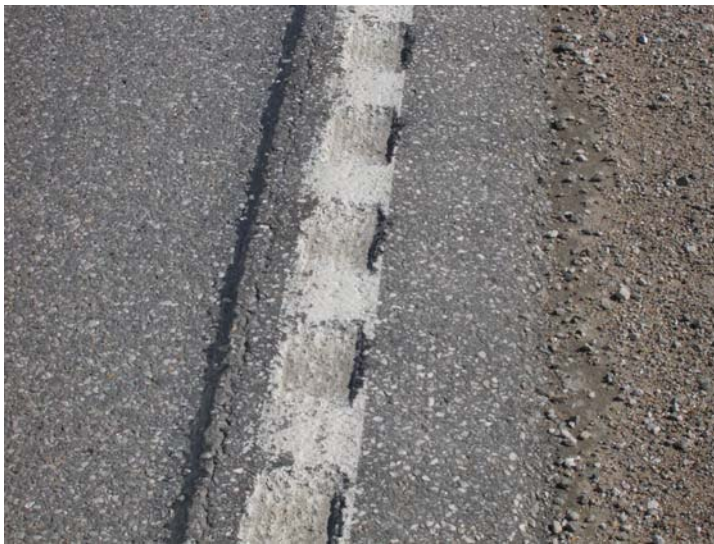
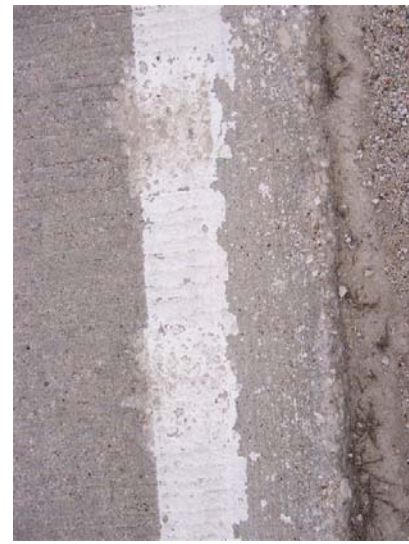
**Figure 5-15. Similar wear for rumble stripe and flat section (taken spring 2009). F-29 is on the left and P-53 is on the right.**

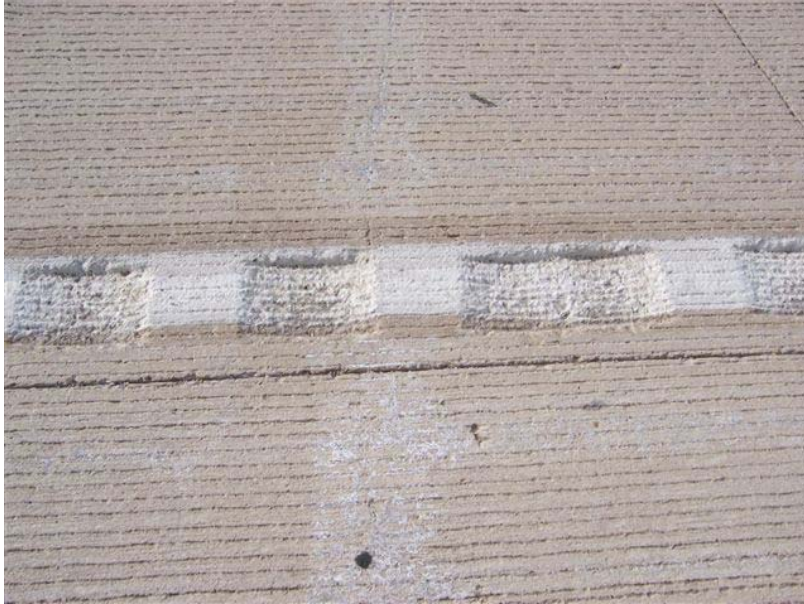
**Figure 5-16. Similar wear for rumble stripe and flat section on E-16 (taken spring 2009)**

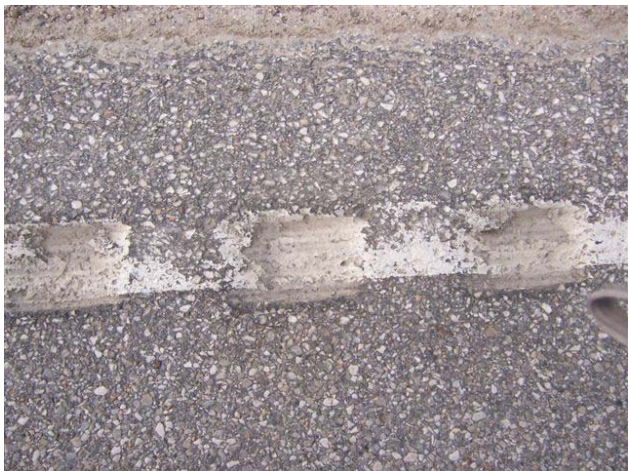
In other areas, the paint in the rumble stripe appeared to weather better and show less wear than the pavement markings on the flat portion of the roadway. Figure 5-17 shows a portion of F-29 that shows less wear in the groove than in the flat areas. Figure 5-18 shows a similar scenario for P-53.

**Figure 5-17. Another portion of F-29 showing less wear in the rumble stripe than in the flat area (taken spring 2009)**

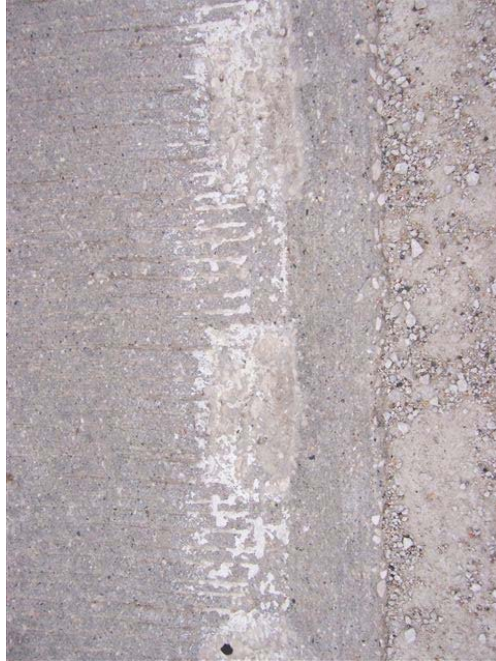
**Figure 5-18. Another portion of P-53 showing less wear in the rumble stripe than in the flat area (taken spring 2009)**

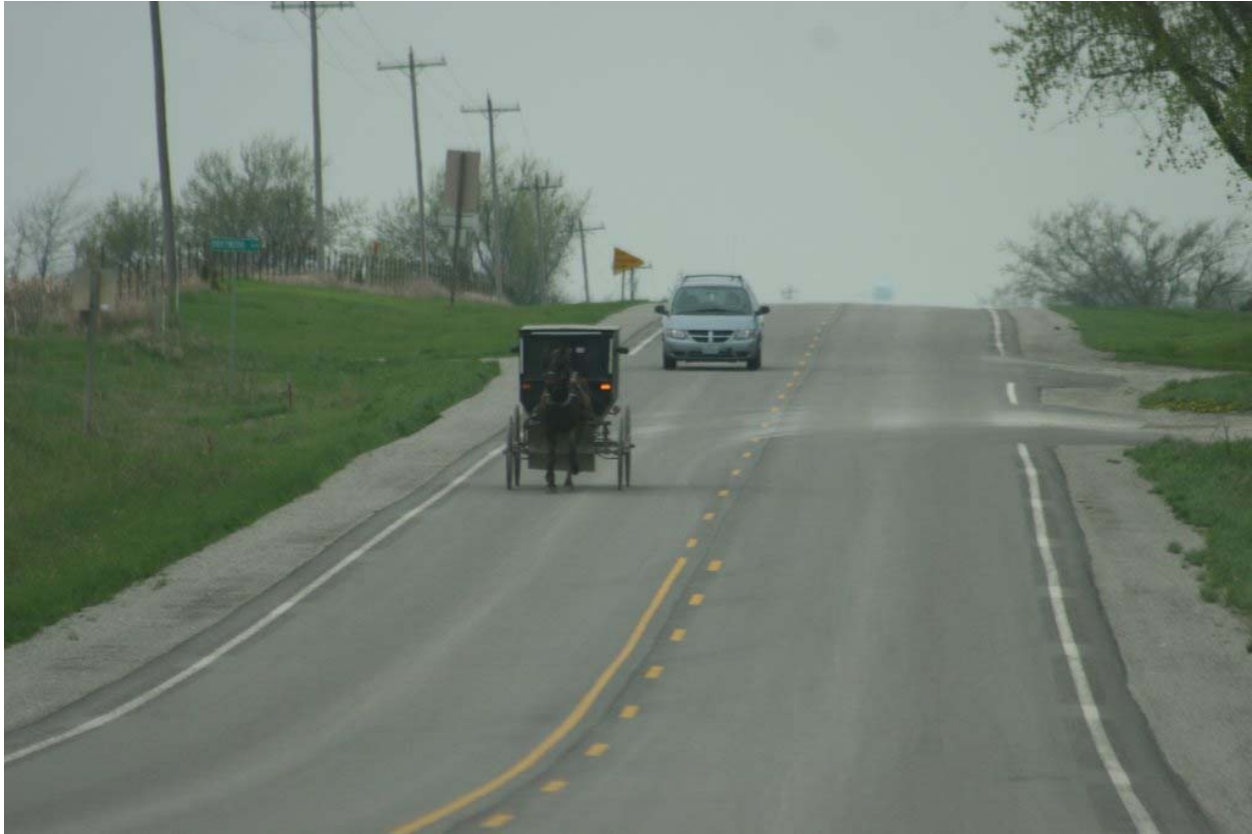
There are no test sections in Davis County as part of this research. However, rumble stripes are present along Iowa 2 in that county, as shown in Figure 5-21. As shown, the rumble strip is wider than that used along test sections. The Amish group in Davis County indicated that recently installed rumble strips were a problem for the horse and buggies. They indicated that the horses were reluctant to cross the strips and could easily injure their feet. They also indicated that the vibrations caused by rumble strips were hard on the buggies and that the buggies can

fishtail when crossing the strips. The Amish indicated that they would prefer not to have rumble strips on roadway sections that they commonly use. Note the narrow shoulders present on Iowa 2 along with the rumble strips, as shown in Figure 5-21. In this section, there is very little room for the buggies to maneuver around the rumble strips. It should be noted that the standard width for milled rumble strips on Iowa DOT roadways such as Iowa 2 is 16 inches.

**Figure 5-21. Edge line rumble strips in place along Iowa 2 (image courtesy of Neal Hawkins, CTRE)**

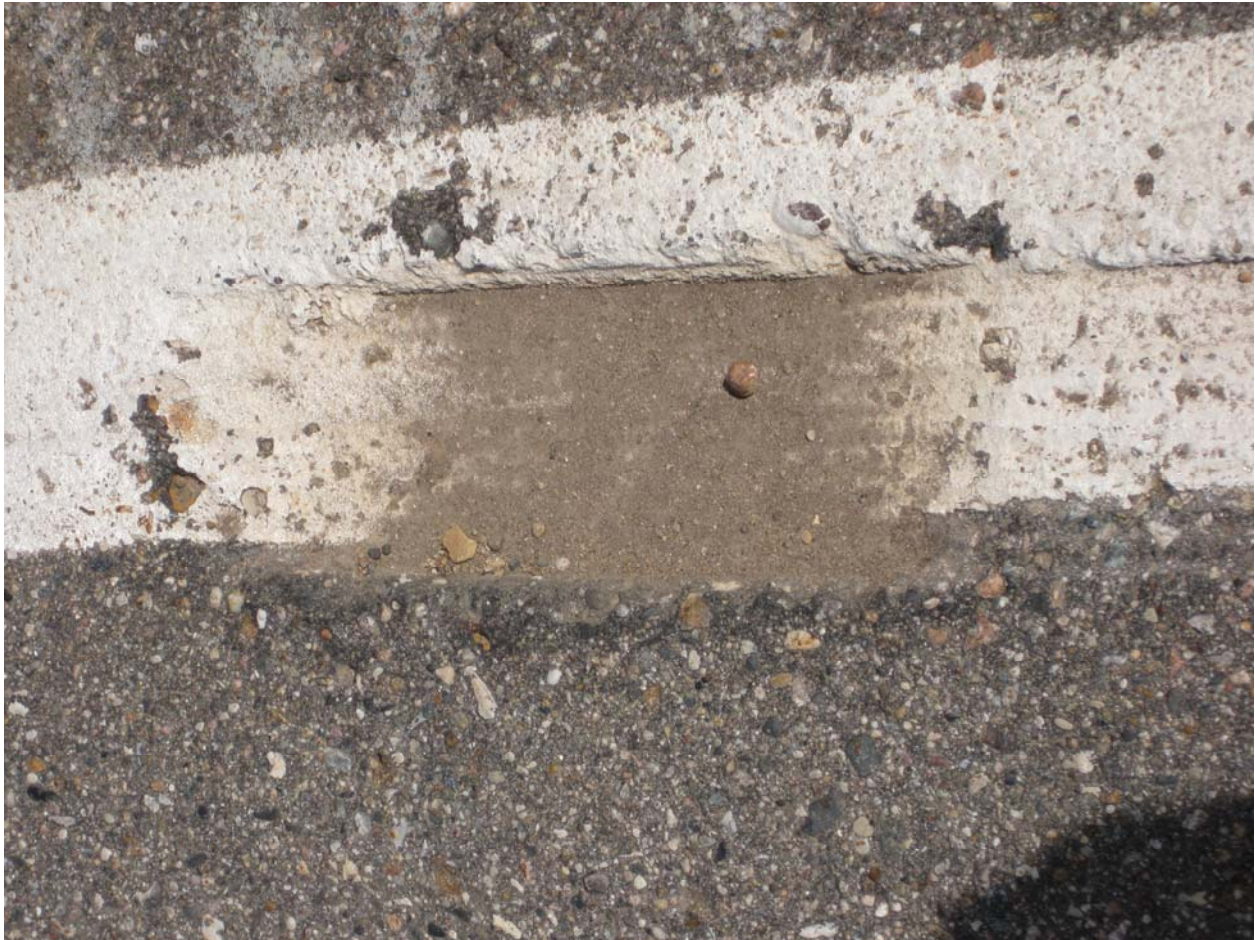
Some of the rumble strips collected an unusual amount of debris. See Figure 6-1. It was commonly believed that wind from vehicle tires would force dirt and other material from the rumble strips, leaving the area fairly clean. This was not the case on F-70 and in several other locations. This problem persisted over several seasons and was not an isolated occurrence. It is not known why this problem occurred in a few areas but not others.

**Figure 6-1. Rumble stripes on B-30 filled with debris**
