**Final Technical Report**  
TNW 2008-10  
TransNow Budget No. 61-4026 and 61-5916  
De-Bonding Cracking

**De-Bonding of Hot Mix Asphalt Pavements in Washington State:  
An Initial Investigation**

Stephen T. Muench  
Assistant Professor  
University of Washington

November 2008

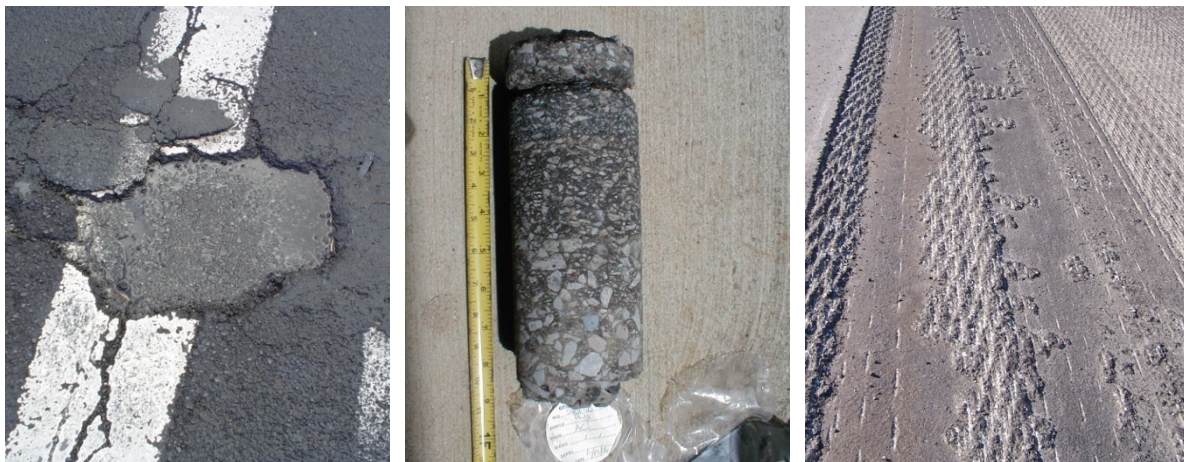
1. Shallow depth potholes in an existing pavement where the surface HMA layer has disintegrated.
2. Pavement cores that become detached at layer interfaces.
3. Areas of pavement that remain in place after milling operations but are unattached or loosely attached to the layer below.

**Figure 1: Three types of evidence for de-bonding: shallow potholes (left), detached cores (middle) and loosely attached pavement after milling (right).**

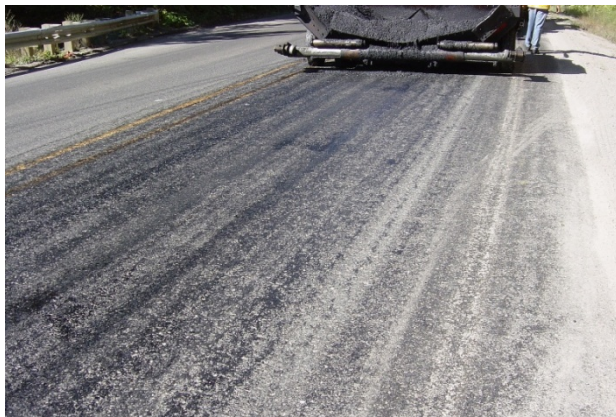
Spotty coverage SR 12

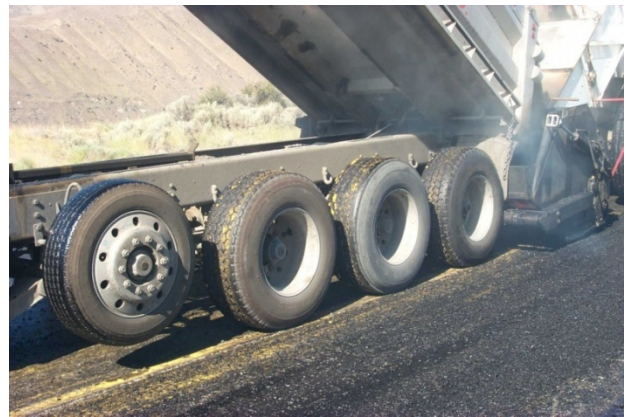
Tack pick-up on SR 2/97

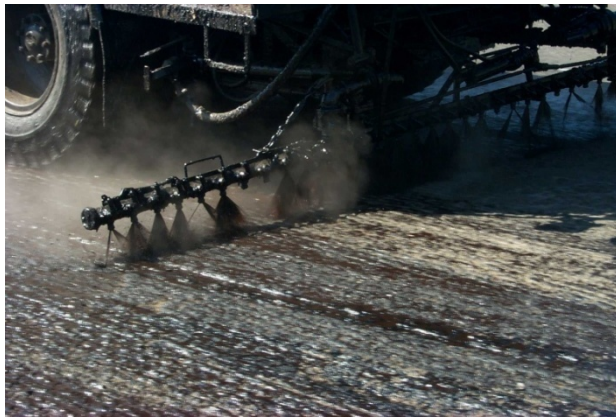
Clogged nozzles on SR 500

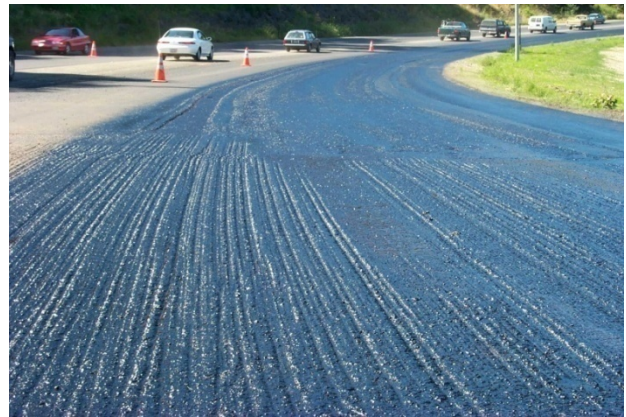
Good coverage on SR 101

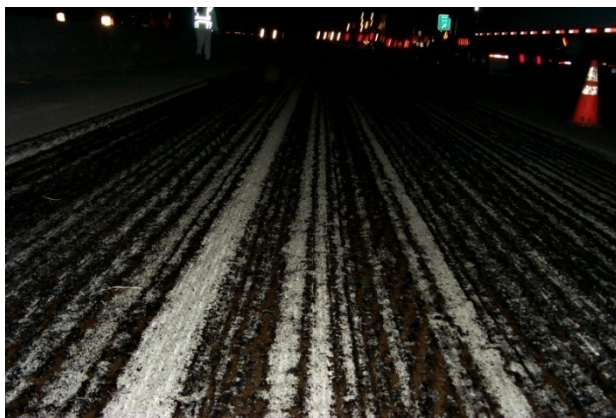
Streaky coverage on SR 5

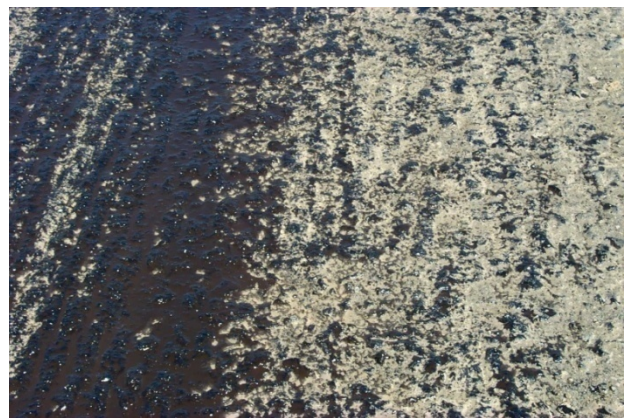
Spotty coverage on SR 500

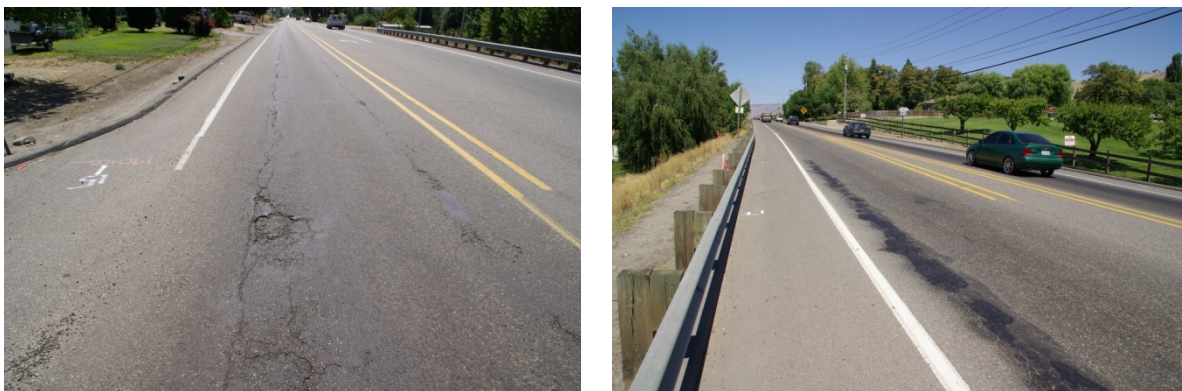
**FIGURE 10 Typical views of SR 28 before the project showing substantial wheelpath cracking and flushing.**

- The 2000 SR 28 job used a modified asphalt from Koch materials (PG 64-34) that remained quite fluid for over two days. Reports are that after two days that the mix on the shoulder could still be shoved by foot.
- The 2000 SR 28 job experienced significant distress rather quickly after it was paved. Most PRC values dropped to between 60 and 80 in one to three years after paving. Substantial flushing was also noted.

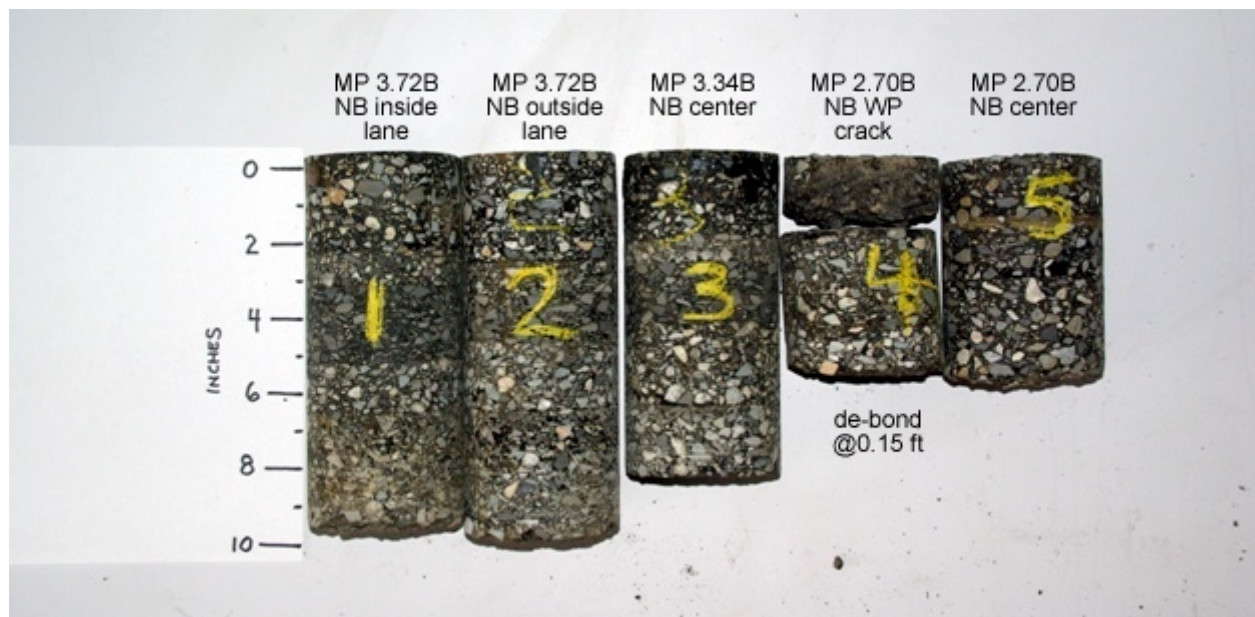
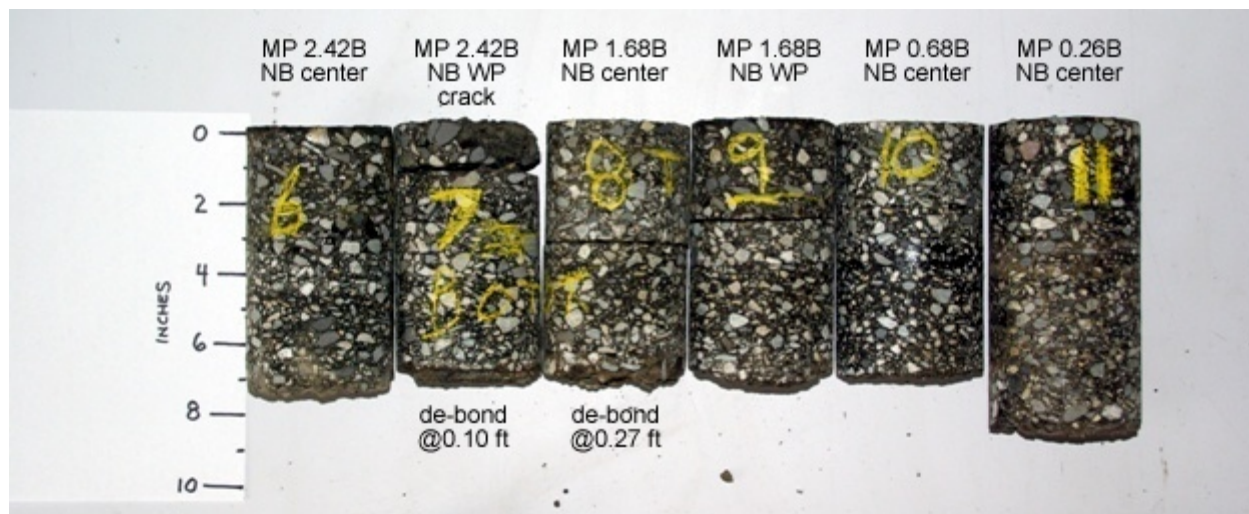
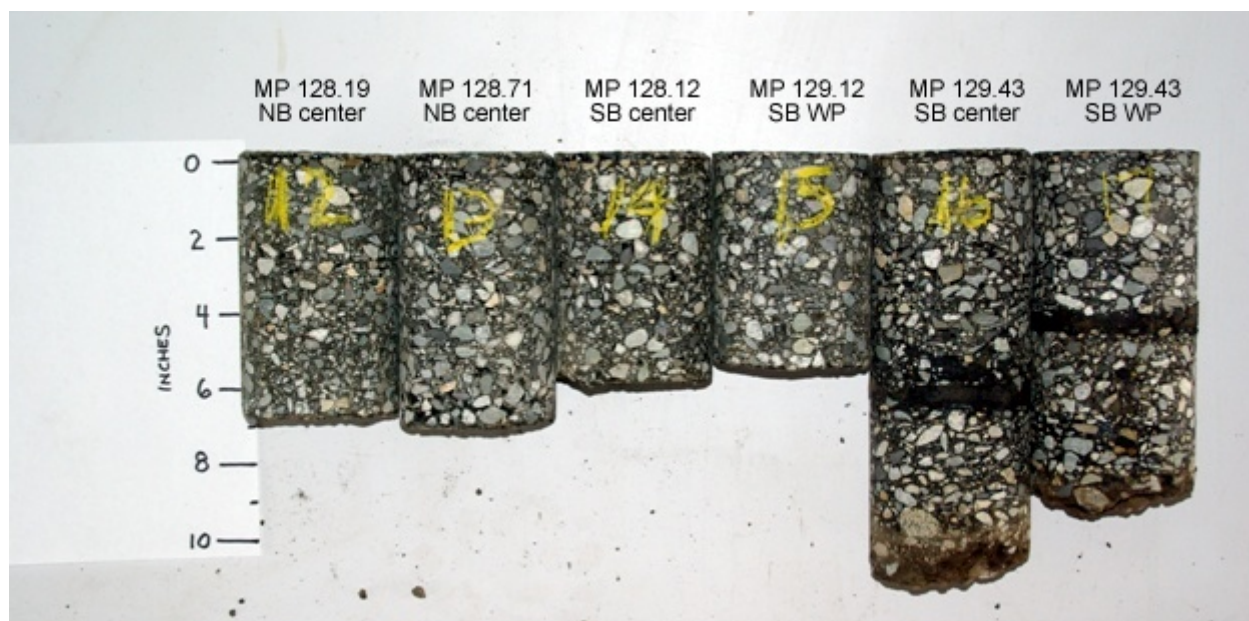
FIGURE 12: Cores from SR 28 from MP 2.70B to 3.72B. WP=wheelpath, NB=northbound, SB=southbound

**FIGURE 13: Cores from SR 28 from MP 0.26B to 2.42B. WP=wheelpath, NB=northbound, SB=southbound**

**FIGURE 14: Cores from SR 2/97. WP=wheelpath, NB=northbound, SB=southbound**

These cores tend to show that de-bonding was occurring in areas of distress (i.e., the cracked wheelpath areas). This might suggest that bonding was adequate during construction and infiltration of water through the cracks or perhaps areas of low density caused the observed de-bonding. If de-bonding where the initiator, then it would be logical to assume that at least one area of de-bonding of the top lift would have been observed in the non-cracked cores. None were.

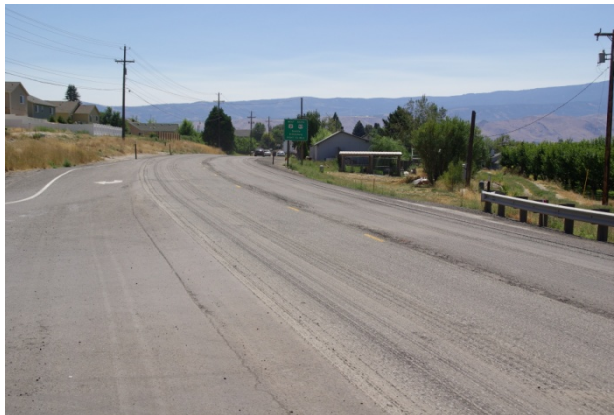
**SR 2/97 Milling.** Milled surfaces observed on 5 August 2008 on SR 2/97 showed generally good removal of this layer with some localized areas of de-bonding at what appeared to be the old longitudinal joint (Figures 15 and 16). This might suggest that perhaps infiltration of water through a porous longitudinal joint (there were no joint compaction specifications in 1994) caused the observed de-bonding. The longitudinal joint was likely intermittently cracked, however a positive determination could not be made because the project area on SR 2/97 had been covered with a bituminous surface treatment (BST) the year before. Observation of pavement condition photographs from 2007 for SR 2/97 just north of the project area showed intermittent cracking at the longitudinal joint.

**FIGURE 15: Milled surface of SR 2/97.**

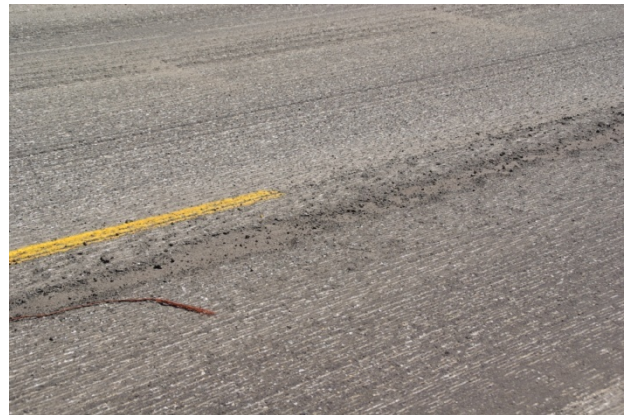
**FIGURE 16: Milled longitudinal joint area.**

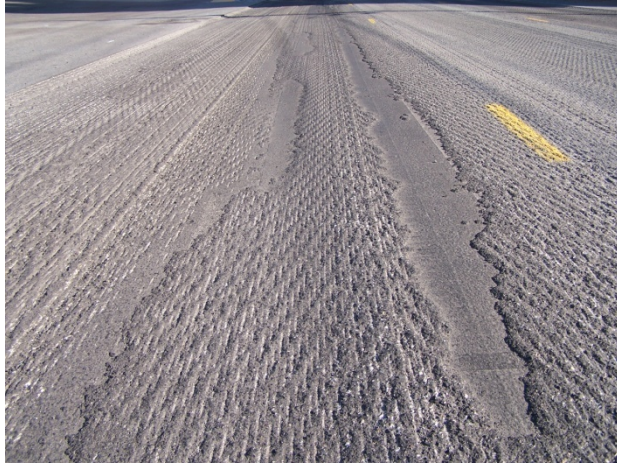
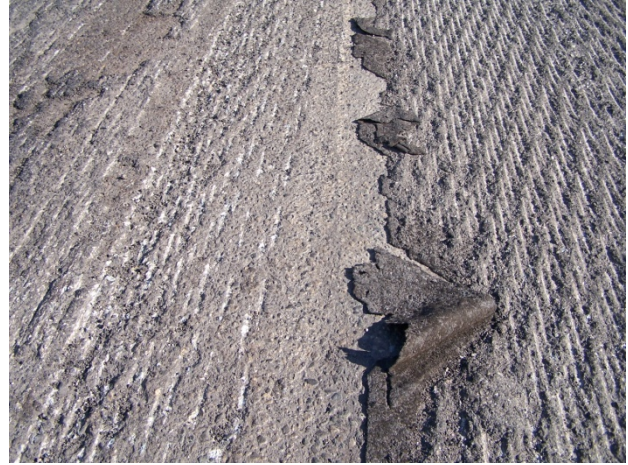
**SR 28 Milling.** Milled surfaces observed on 6 August 2008 on SR 28 showed generally uneven removal of the last overlay and revealed areas where a fabric that was placed with the previous overlay to slow reflective cracking had lifted up and de-bonded from the lower layers (Figures 17 and 18).

**FIGURE 17: Milled surface of SR 28.**

**FIGURE 18: Milled surface of SR 28 showing fabric.**

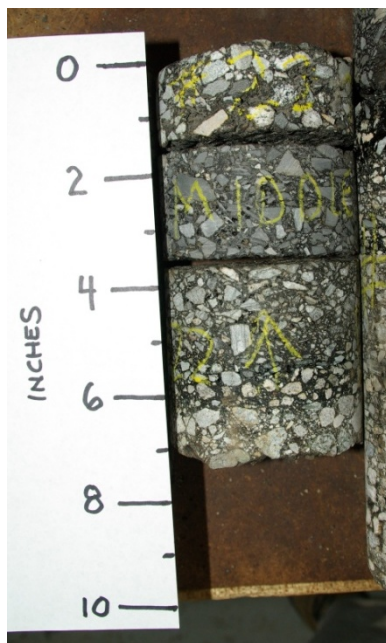
The SR 2 cores exhibited de-bonding suggesting two possible mechanisms:

FIGURE 20: Poor tack.

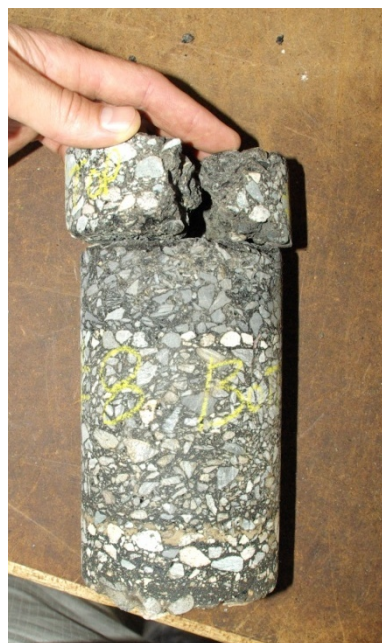
FIGURE 21: Cracked surface.

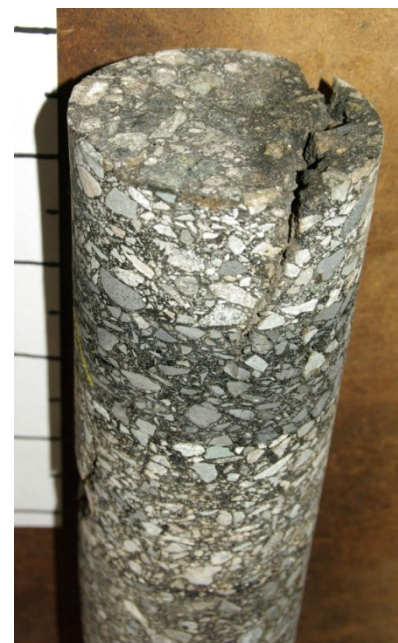
Also, some SR 2 cores exhibited classic signs of top-down cracking (Figure 22). Still other cores, reportedly taken near de-bonded cores exhibited no de-bonding or distress.

FIGURE 22: Top-down crack.

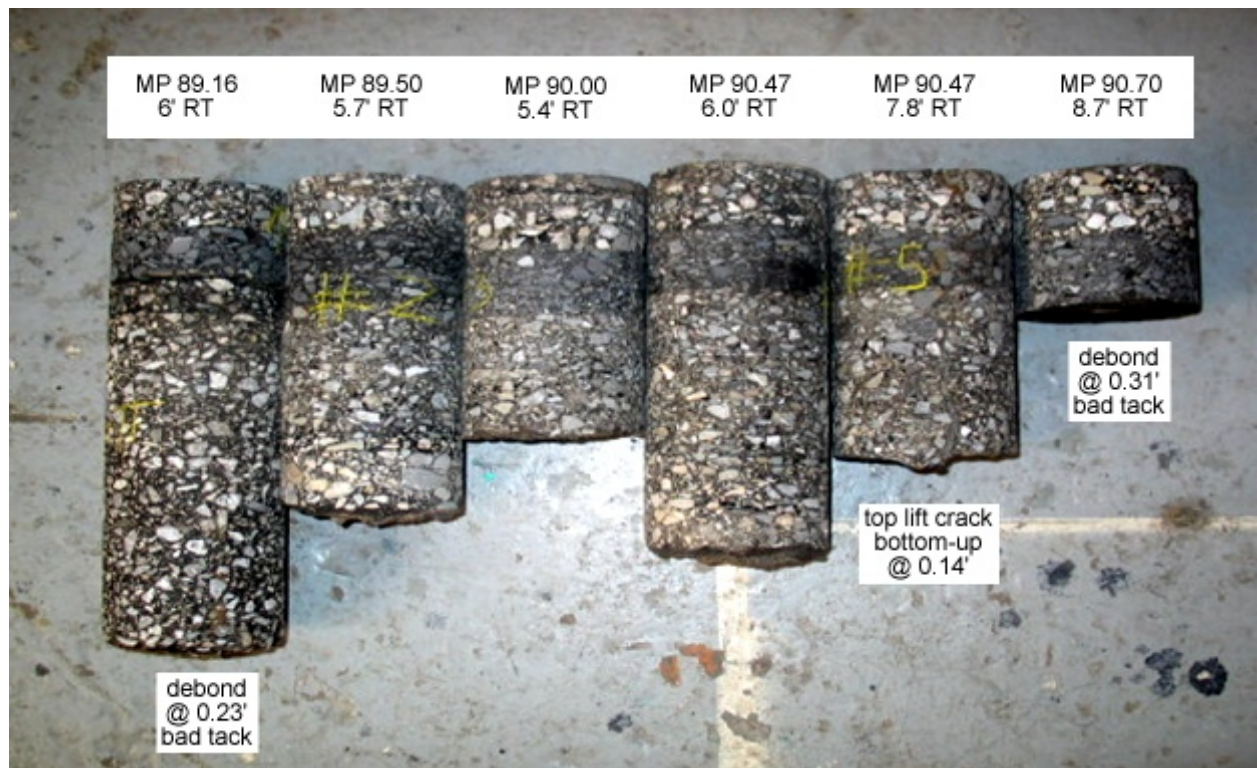
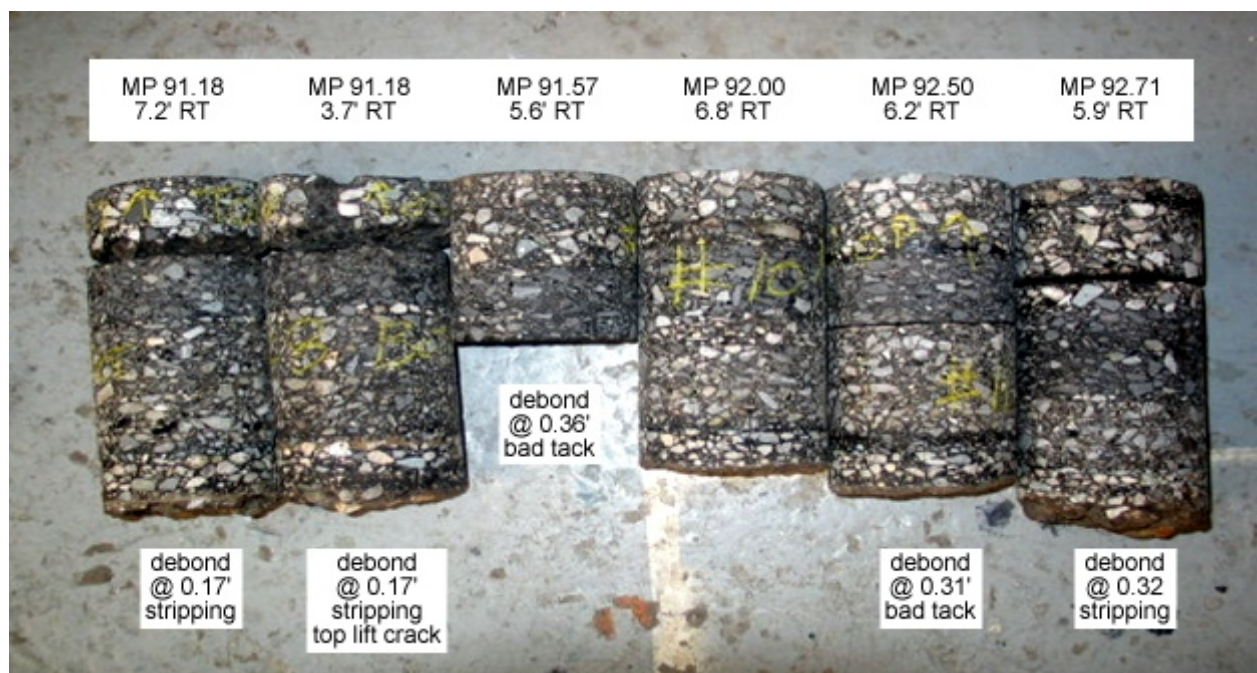
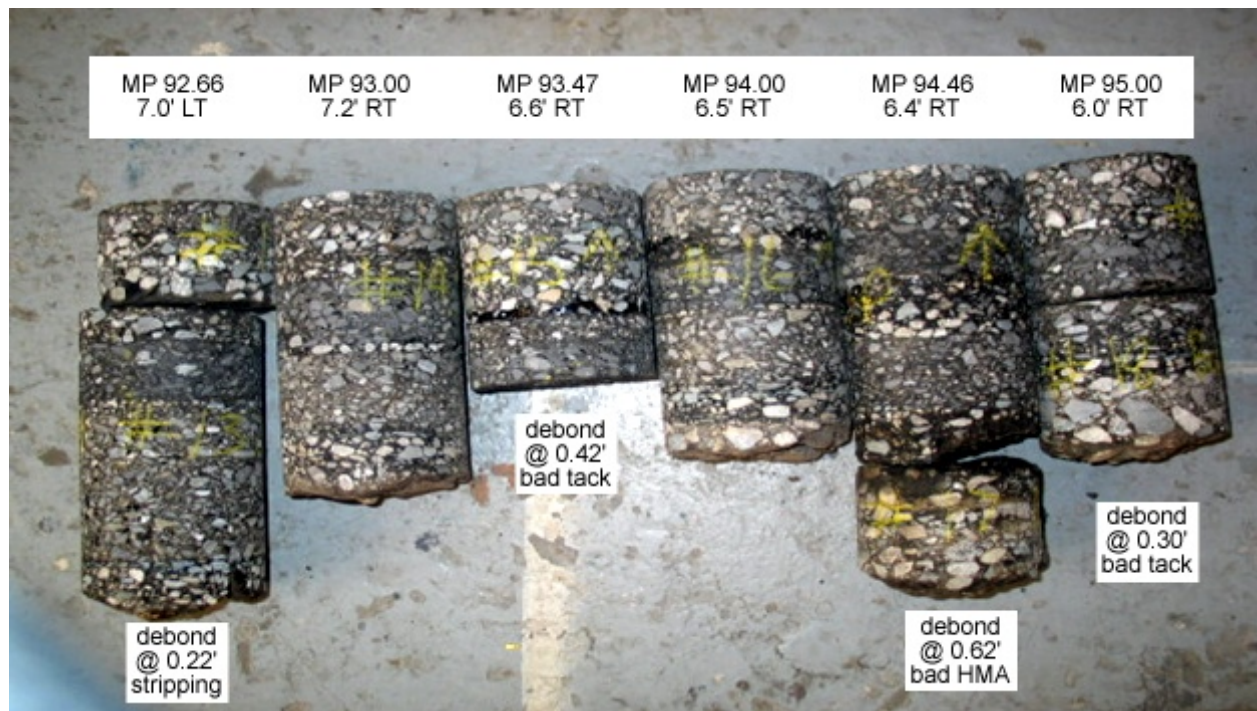
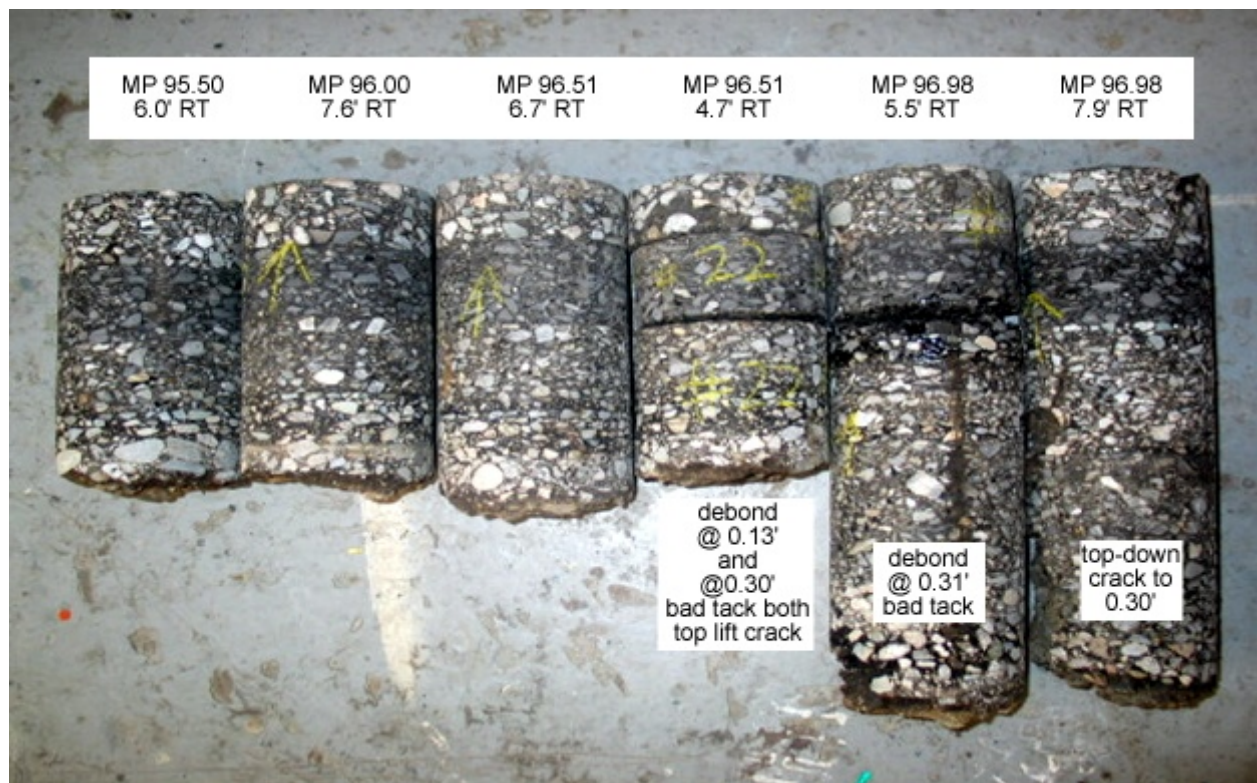
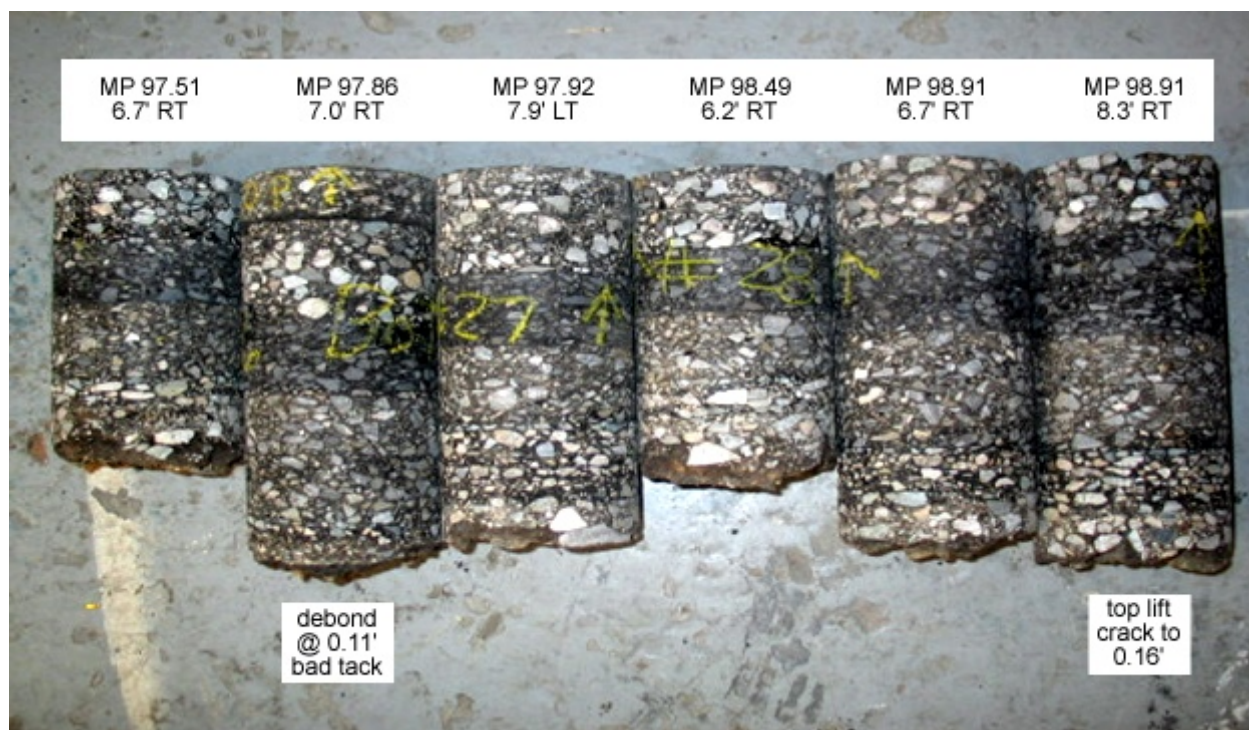
FIGURE 24: Cores from SR 2. RT = right of centerline, LT = left of centerline

FIGURE 25: Cores from SR 2. RT = right of centerline, LT = left of centerline

FIGURE 26: Cores from SR 2. RT = right of centerline, LT = left of centerline

FIGURE 27: Cores from SR 2. RT = right of centerline, LT = left of centerline

**FIGURE 28: Cores from SR 2. RT = right of centerline, LT = left of centerline**

De-bonding below about 0.55 ft is likely separation of upper HMA lifts from lower BST layers and probably does not indicate HMA de-bonding as described in this study. These cores tend to suggest that de-bonding may be widespread with 14 cores de-bonded. Many are not associated with surface cracks suggesting that poor tack coat adhesion rather than water infiltration may be the primary cause. Of note, cracks in the wheelpath cores seem to extend only to the HMA layer interface and are often associated with a companion outside-the-wheelpath core (see MP 91.18, 96.98, 98.91) that is also de-bonded.

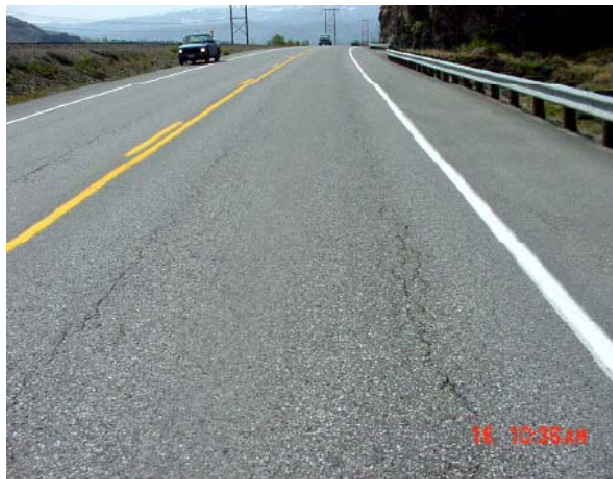
**FIGURE 30: Looking south from MP 202.50 showing wheelpath longitudinal cracking.**

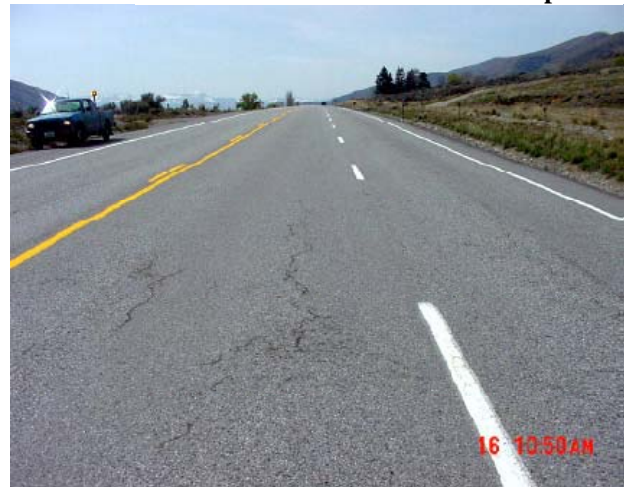
**FIGURE 31: Looking south from MP 207.37 showing wheelpath cracking.**

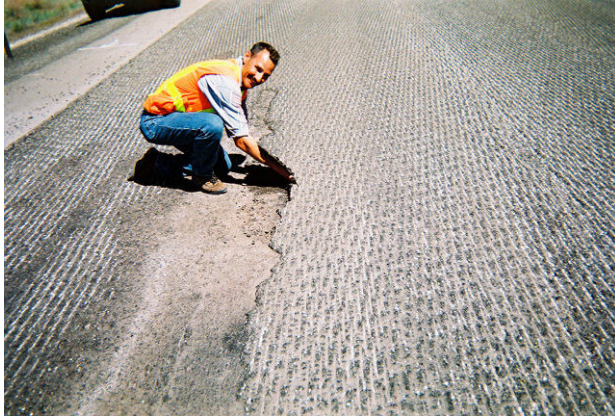
**FIGURE 33: Milled surface of SR 97A showing de-bonded area.**

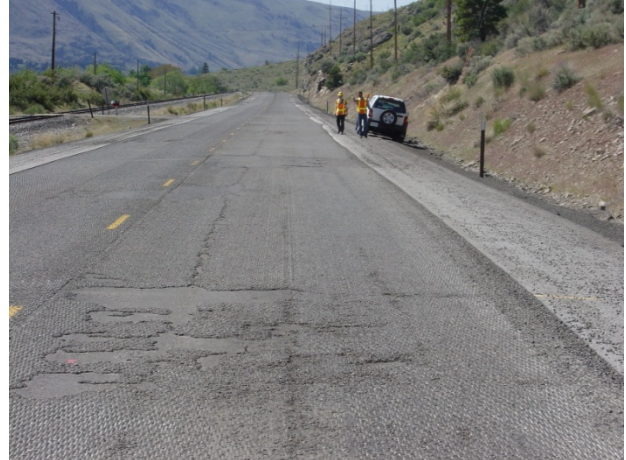
- **Gear box and auger drag streaks.** Streaks of low density HMA can form behind a paver gear box or auger drags (Figure 34) because the auger cannot place enough HMA or places segregated HMA behind these auger attachment points (Figure 35). We speculate that this low density material may have let water infiltrate in surface HMA layer, which contributed to de-bonding.

**FIGURE 34: Milled surface of SR 97A showing de-bonded area probably from construction-related temperature differentials and gear box streaking.**

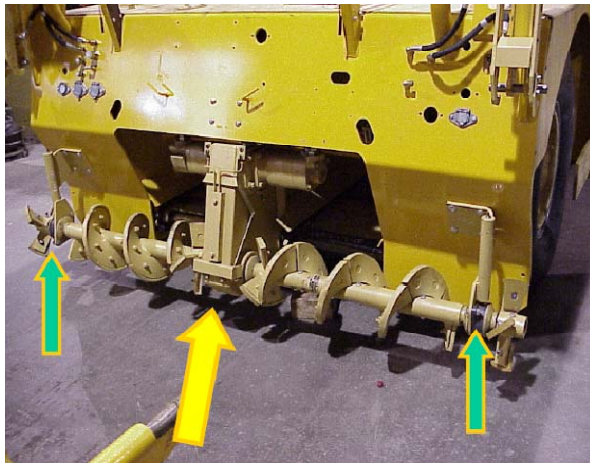
**FIGURE 35: The three parallel streaks in Figure 30 were likely caused by the low density HMA areas behind a paver's gear box (yellow arrow) and auger drags (green arrows). This low density is caused because the paver's auger cannot place enough HMA or places HMA that is segregated behind these attachment points.**
