REPORT FHWA/NY/SR-09/149

CENTERLINE (LONGITUDINAL) JOINT ADHESIVE PERFORMANCE: TWO TO THREE-YEAR REVIEW

**Centerline (Longitudinal) Joint Adhesive Performance:
Two to Three-Year Review**

Special Report 149
November 2009

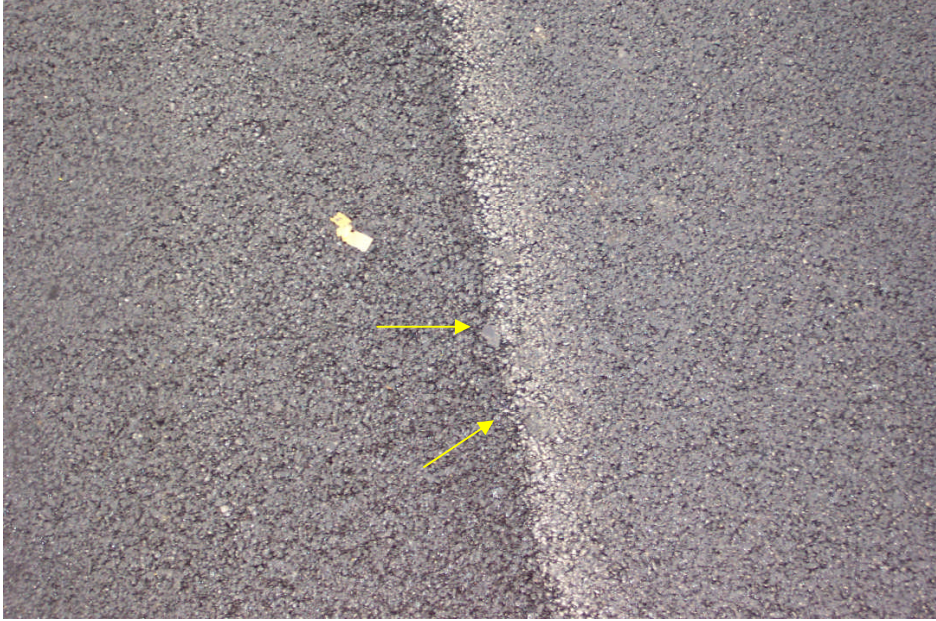
Adhesive was placed just prior to paving the second lane on all jobs except the Oswego County highways. On Routes 3 and 481, adhesive was placed the day before the second lane was paved meaning the longitudinal joint with adhesive in place was left open to traffic overnight. There appeared to be no concerns from construction or inspection personnel about leaving the joint and adhesive in this condition. When paving was done next morning, small spots (generally less than 1 inch diameter) of melted adhesive appeared at the surface along centerline in random areas, ensuring that the adhesive was being melted by the hot-mix asphalt being placed thus creating a seal along the longitudinal seam (Photo 9).

Photo 9: Adhesive Beads @ Surface After Rolling

All adhesive sites on all routes had areas at which adhesive was forced to surface during rolling. This demonstrates that during the rolling process, adhesive is forced into areas other than where it was placed thereby sealing more surface area within the seam. These areas at the surface varied in size from spots less than 1 inch diameter to beads up to 6 inches in length.

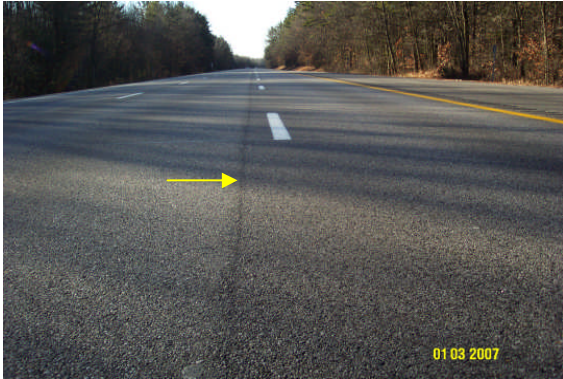
I87 was visited in January 2007 by Chris Euler and Rick Morgan (see Table 1 for locations). The entire length of the control section had a single crack (Photo 10). In the 2 inch bead section, approximately 40 percent of the centerline (Photo 11) was cracked while 80 percent of the 4 inch section was cracked (Photo 12). There are minor areas of ravelling appearing along the centerline of all three sections.

Photo 10: Crack in Control Section – I87

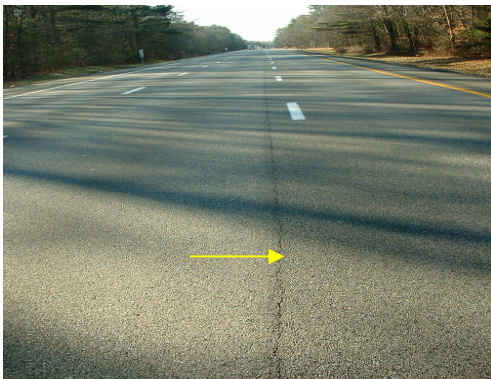
Photo 12: Crack in 4 inch Section – I87

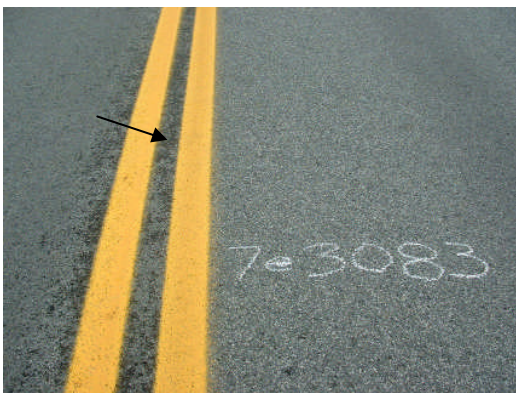
Route 7 was evaluated in September, 2006 by Rick Morgan and in January 2007 by Chris Euler (see Table 2 for locations). In 2006, the entire job was examined with approximately 20 to 25 percent of the centerline in the test sites was cracked (hairline to 1/4 inch wide, less than 3 feet to 250 feet in length, and varied depths). There were areas of ravelling along centerline in the test sites of varying lengths (similar to cracking lengths). In the control site more than 60 percent of the centerline was cracked with entire first 0.2 mile cracked. Crack widths, depths, and lengths in the remaining 0.4 mile, were similar to test sites. Areas of ravelling were also present along centerline in the control site (Photos 14 thru 16). In 2007, the test and control sections were evaluated. The test section had a single crack along 20 percent of its length while the control section had a single crack along approximately 80 percent of its length.

Photo 14: Ravelling Along Centerline – Route 7

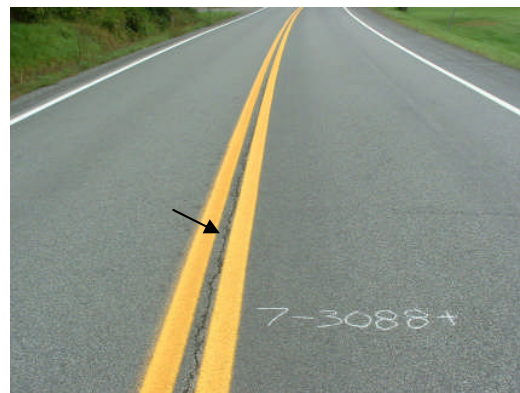
Photo 15: Cracking in Adhesive Section – Route 7

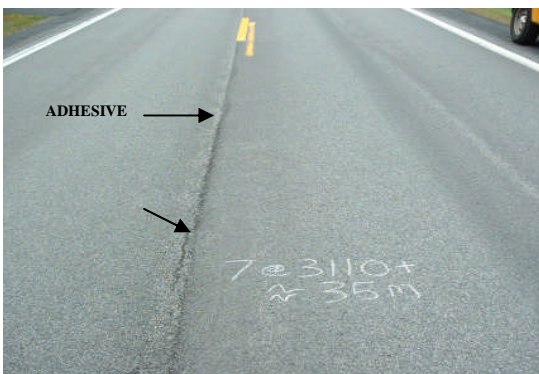
Photo 16: Cracking & Adhesive @ Surface – Route 7
