**September 2006**  
OR07.002

# **Investigation of Cause of Cracked Stringer on the Blanchette Bridge**

Prepared by Missouri  
Transportation Institute and  
Missouri Department  
of Transportation

RI05-036

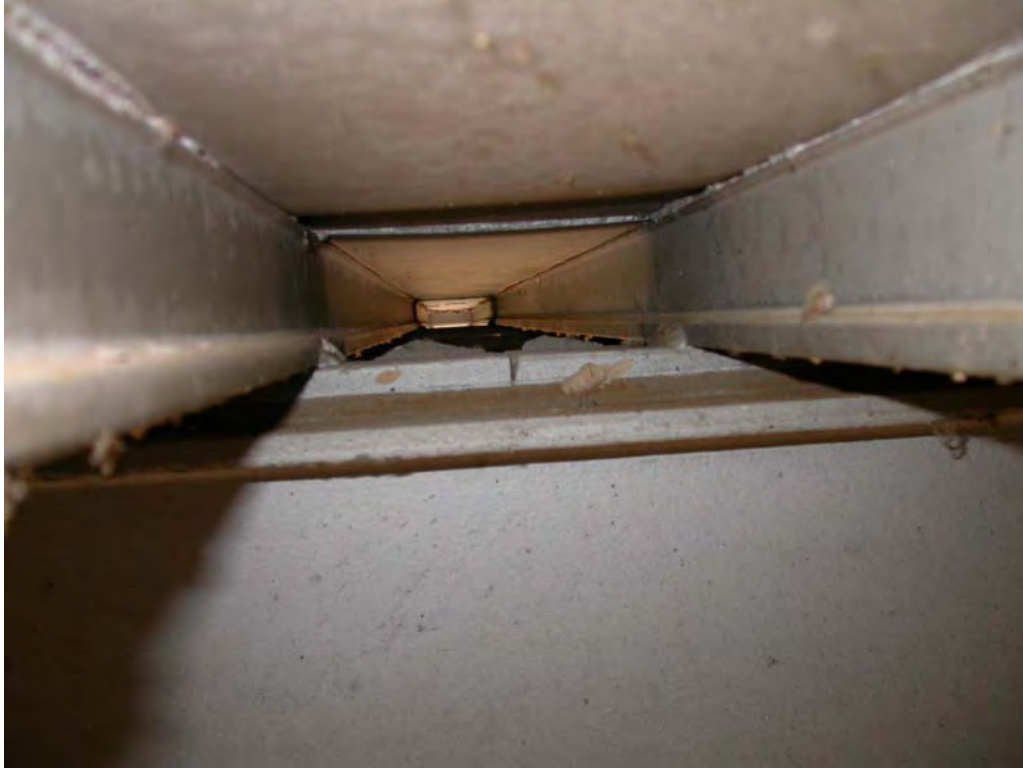
This change, as shown in Figure 2-8, prevented open butt joints from occurring in the end quarters of the stringer spans.

Figure 2-8. Transverse view of grid deck welded to shim plate on top flange of stringer in plate girder spans.

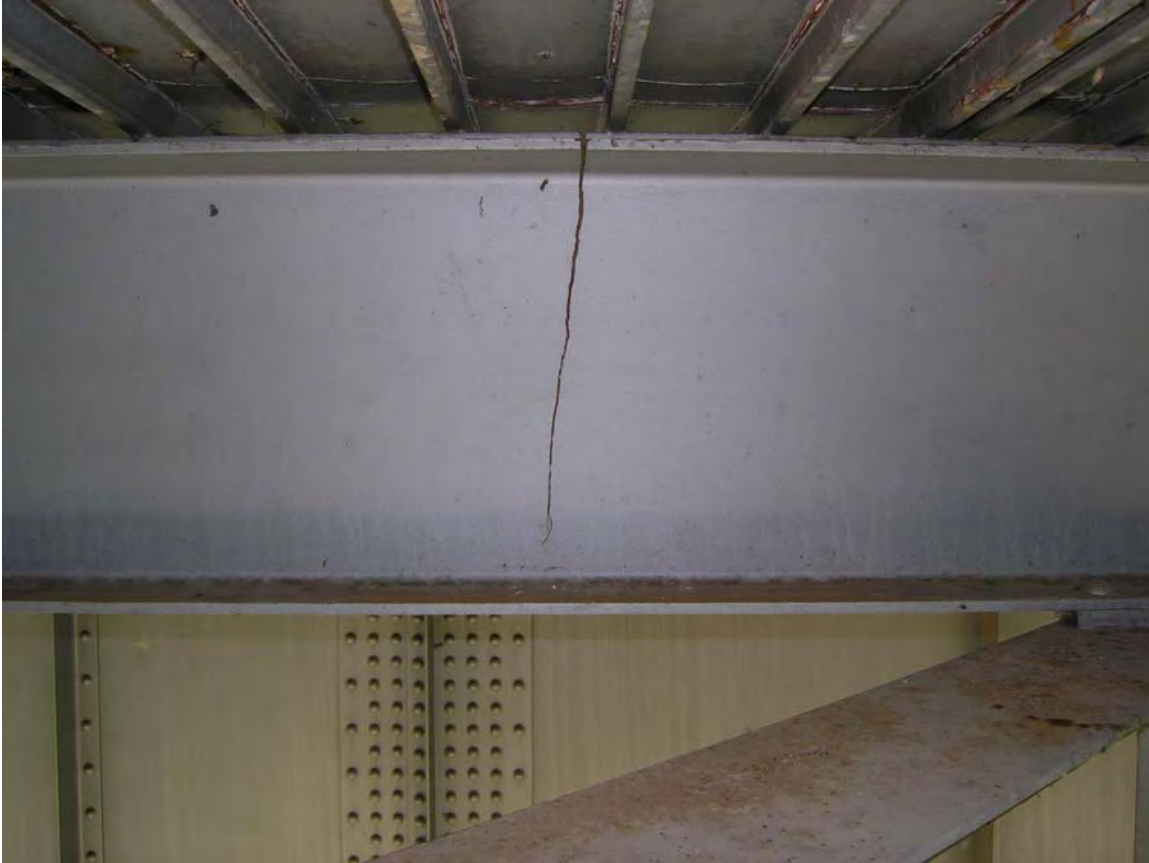
MoDOT bridge inspectors found a severely cracked stringer (see Figure 3-1) on July 19, 2005. The two inspections prior to this one were on January 29, 2003, and March 15, 2004, with no indications of any cracking at this location identified. The crack had occurred in stringer S3, between the third and fourth floorbeam west of Bent 20 in the east approach plate girder approach spans.

Figure 3-1. Cracked stringer found during 2005 inspection.

MoDOT bridge personnel repaired the crack with splice plates (see Figure 3-3). Both the top and bottom flanges and the web of the stringer were spliced.

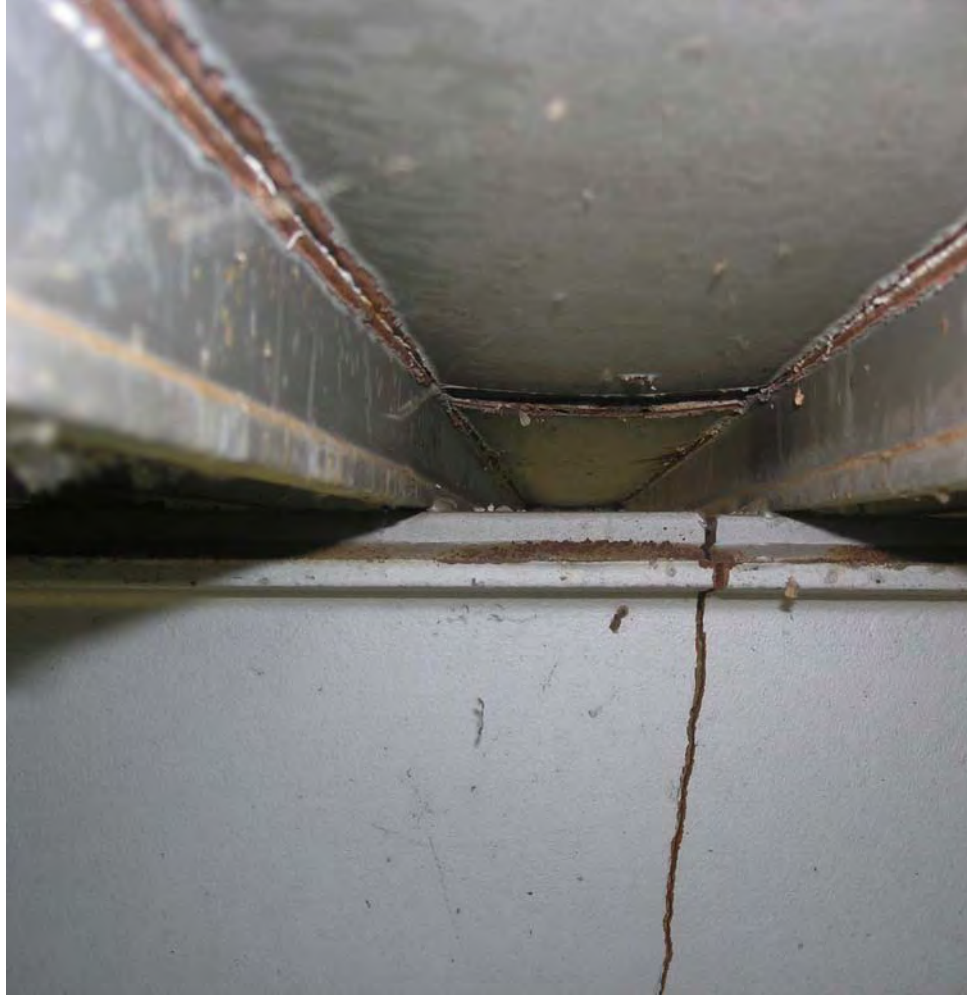
As shown in Figure 3-2, the crack initiated at the shim plate butt joint and propagated downward through the stringer top flange and web. It arrested in the bottom of the stringer web, near the top of the stringer bottom flange.

Figure 3-2. Close-up view of shim plate butt joint and crack.

The photographs show that the stringer crack remained open, with the stringer cambered upward.

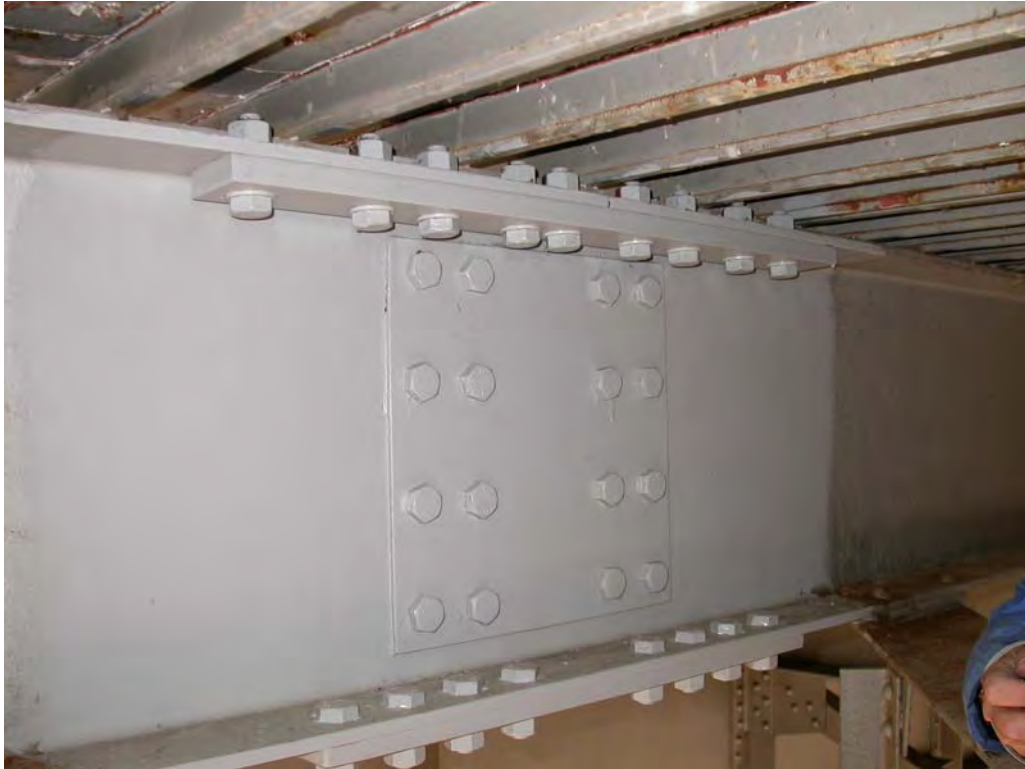
Figure 3-3. Splice repair of cracked stringer.

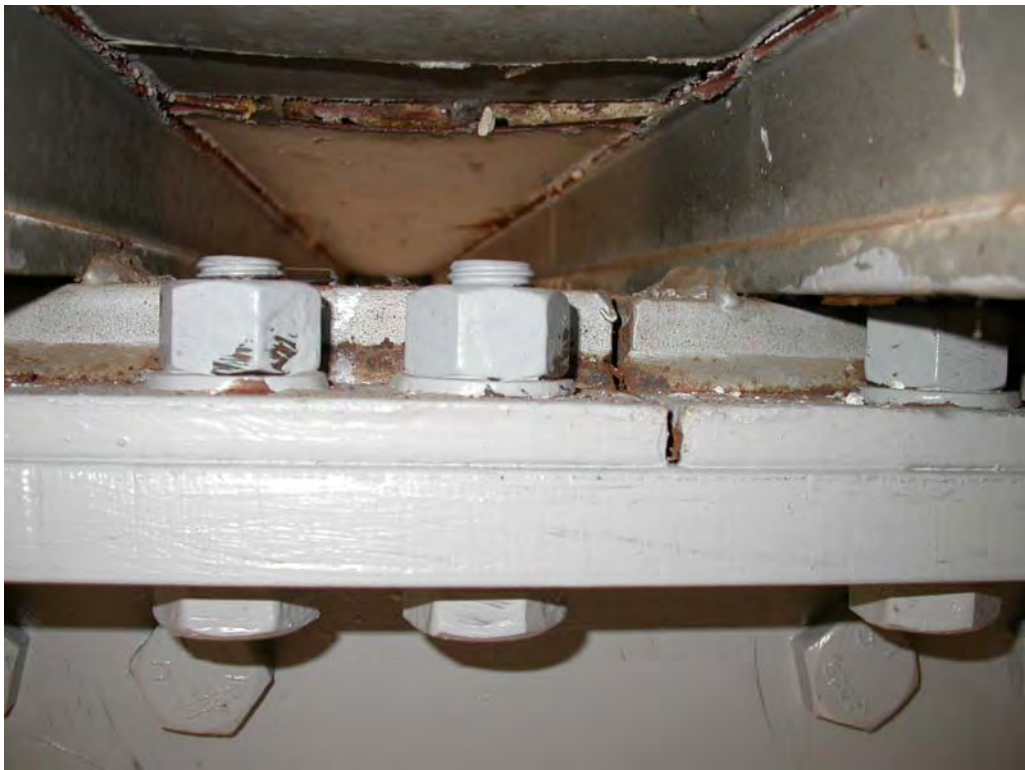
No samples were taken from the crack area at the time of repair. The crack surface was not visible following the repair, as it was covered with splice plates and paint, as shown in Figure 3-4.

Figure 3-4. Close-up view of crack area after repair.  
\*Note that fillet weld runs across shim plate butt joint.

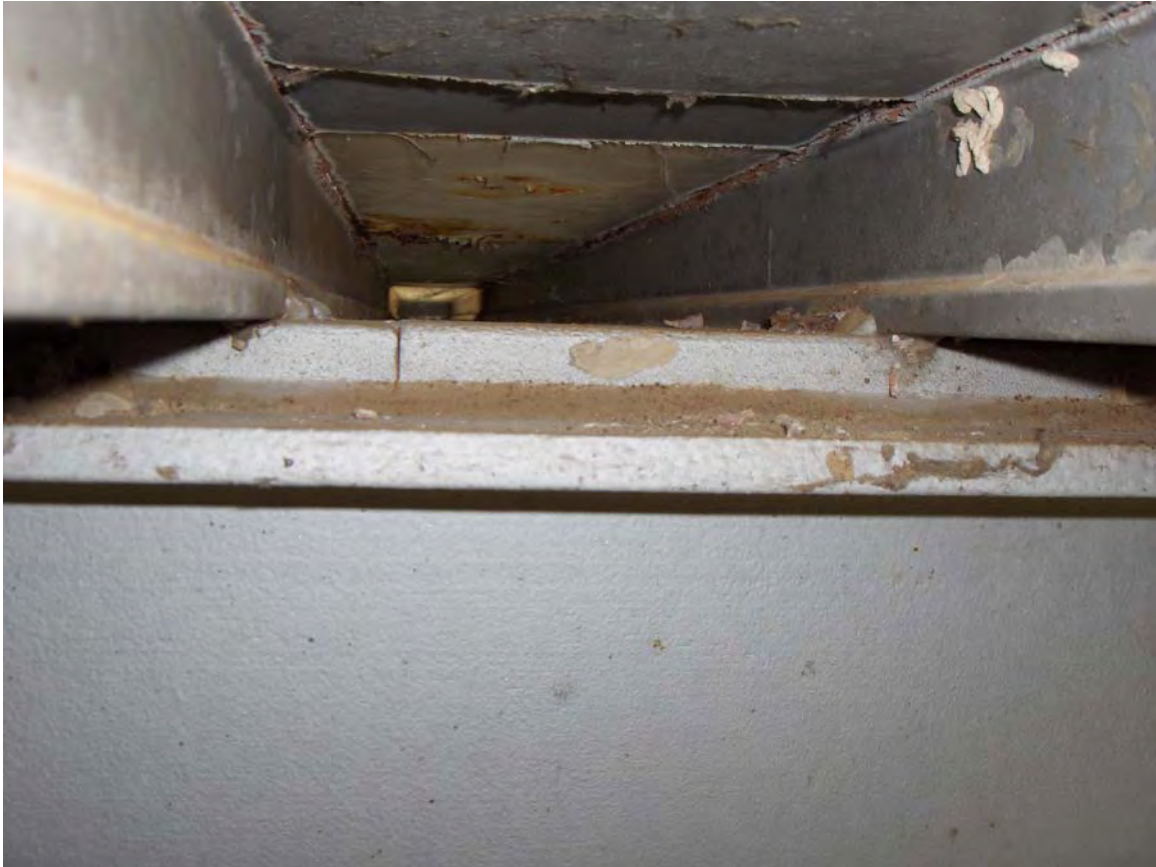
Other butt joints on the bridge have similar fillet weld treatments (see Figure 3-5). The shop drawings previously discussed show one butt joint per stringer bay between floorbeams, with an additional joint at each expansion joint. This would result in 180 shim open butt joints in the west approach spans and 300 in the east approach spans.

Figure 3-5. Similar butt joint weld detail located near cracked stringer on east approach.

1. The open shim butt joints should be retrofit or modified to eliminate the crack initiation area where the fillet welds cross the joint gaps. A suitable retrofit plan uses grinding to remove the welds for a distance of 2" in each direction from the gaps. Grinding should remove all weldment in this area. Ends of welds should be smoothly tapered to reduce stress concentrations. Following grinding, the affected

areas should be visually inspected and tested by dye penetrant or magnetic particle methods to confirm that no cracks exist in the stringer or remaining welds.

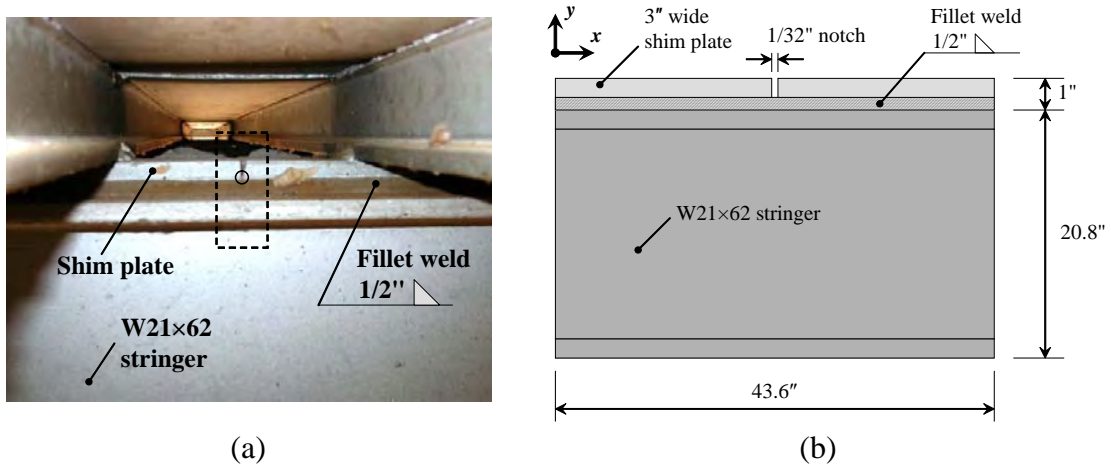
Figure 6-1. (a) Photo of typical open shim plate butt joint\*; (b) geometric characteristics of three-dimensional FE model.

\*Dashed rectangle and solid circle indicate butt joint area and stress singularity zone, respectively.

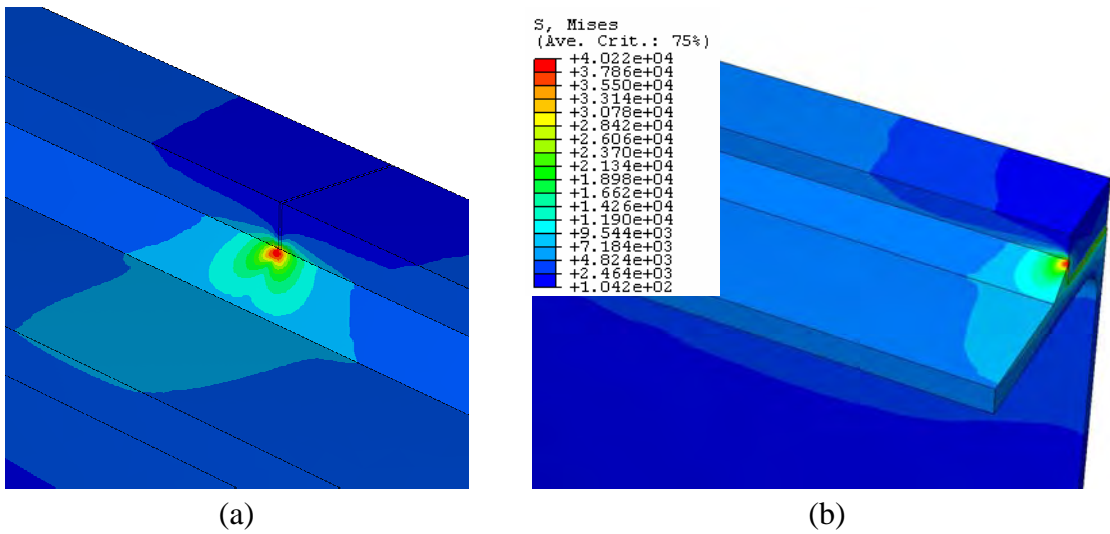
Figure 6-4. Graphical rendering of stress analysis results at given negative bending moment.

\*Sample contours of (a) Von Mises stress (in psi) at shim plate butt-joint and (b) thru-notch section view. Note stress concentration at weld tip at notch location in red.

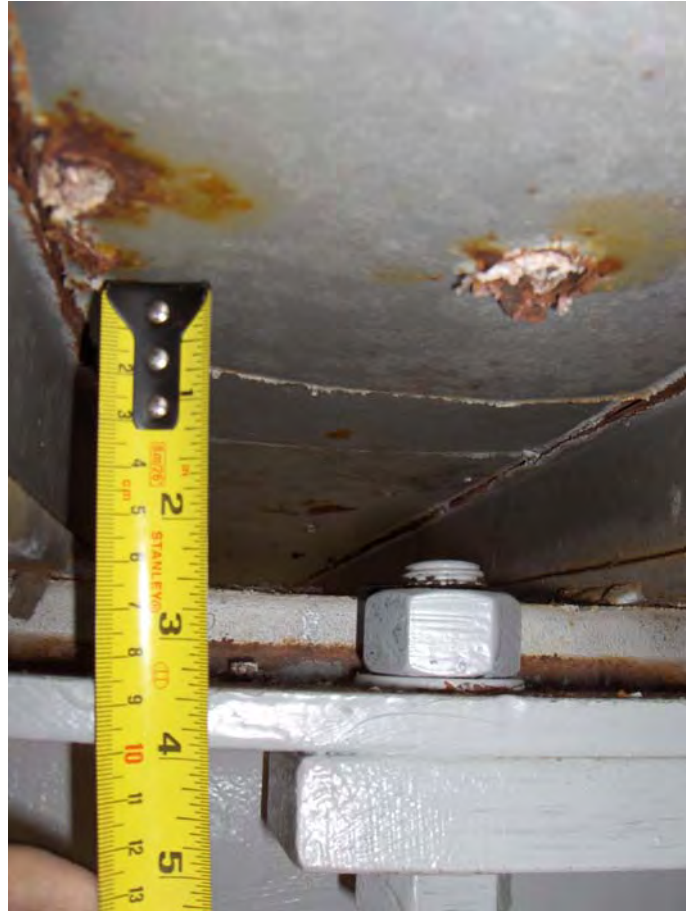
Figure 9-1. Limited space available for work on joints.

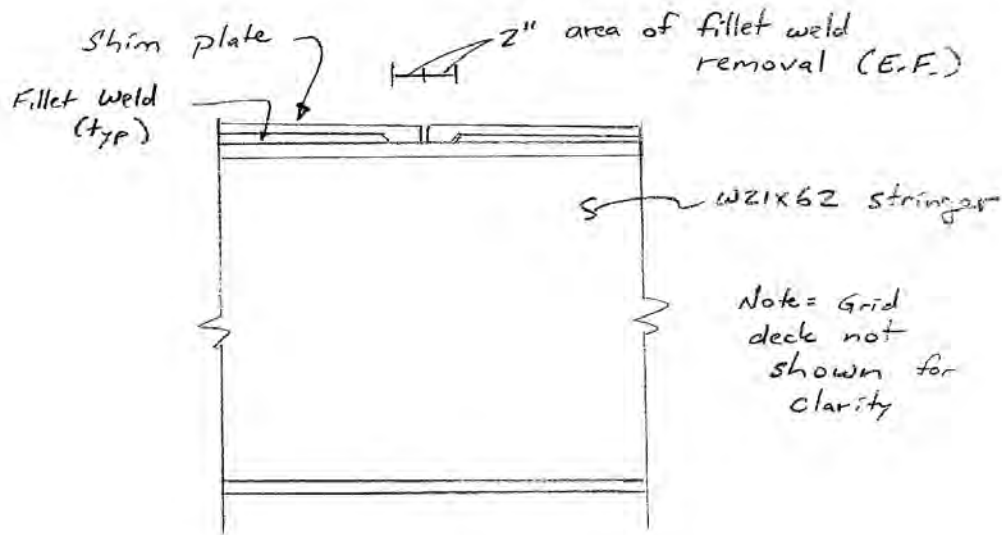
Figure 9-2. Grinding retrofit.

The purpose of grinding (see Figure 9-2) would be to remove the fillet welds in the immediate vicinity of the butt joints. The detailed structural analysis showed that removal of the welds would reduce the stress concentration effect at this location by a factor of about six. To maximize the effectiveness of this approach, grinding must remove all of the fillet weld material at the shim butt joint and leave the remaining weld ends and stringer top surface in a smooth condition. Fillet welds should be removed approximately to a distance of about 2" in each direction from the shim butt joint. The ends of the welds should be ground at a taper from full-thickness to zero at the 2" clear point. Past research has shown good results from a 1:3 taper ratio (weld thickness to length of taper) (Simon and Albrecht, 1981).
