**Report No. CDOT-2009-9
Final Report**

SHORT-TERM CRACK SEALANT PERFORMANCE AND REDUCING BUMPS AND TRANSVERSE CRACKING IN NEW HOT MIX ASPHALT OVERLAYS OVER CRACK SEALANTS

Scott Shuler

November 2009

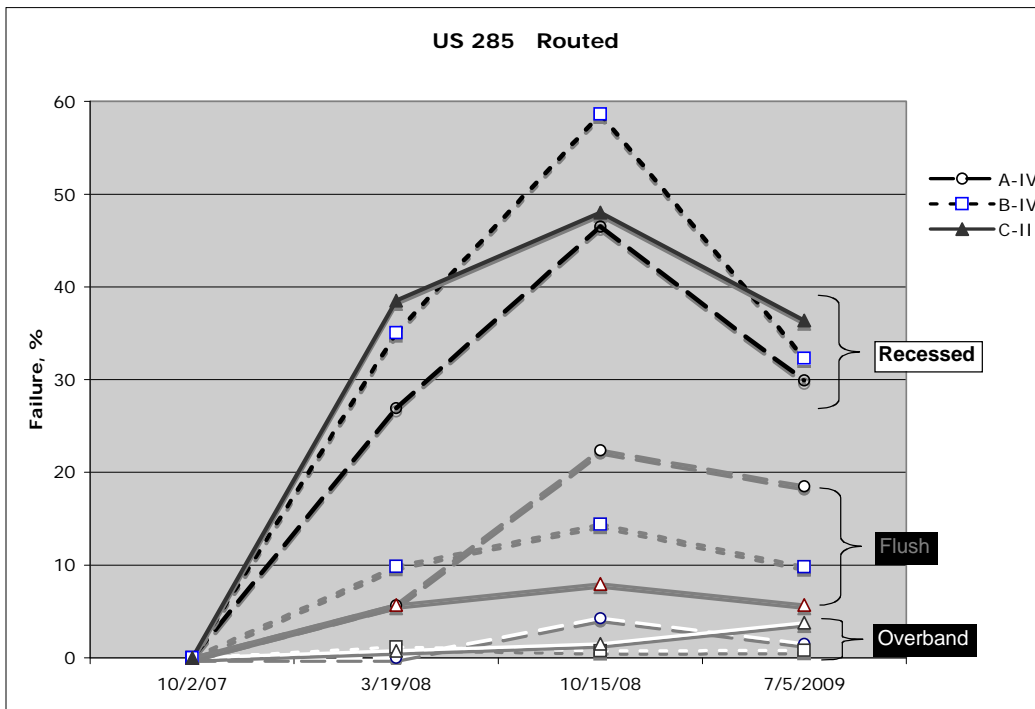
Figure 6. Sealant Performance on US285-Cracks Prepared by Routing

Analysis of the results from this study is challenging. There is variation in the data and few trends stand out consistently with the exception of one. It appears that for most of the conditions studied performance of the crack sealants has not followed a linear path of an increase in failure over time, as might be expected. Instead, the failures increased from installation in October 2007 to the first survey in March 2008, continued to increase until the second survey in October 2008, then declined at the third survey in July 2009 to levels of failure approximately equal to that observed in March 2008. There are eight exceptions to this. These are on Figure 3, where Supplier A for the flush, routed application shows a consistent increase in failure rate over time to a total of 10 percent failure and Supplier B for the flush and overband, routed application shows a consistent increase in failure rate over time to a total of 3 and 4 percent failure. Also, from Figure 4 Supplier C increases to approximately 7 percent failure for the hot air lance and recessed application. Products B and C in Figure 6 for routed and overbanded application on

US285 reach approximately 2 and 4 percent failure. And Figure 8 indicates that Supplier B reaches 15 percent failure for the air blow and overband process on US285. Supplier C reaches 4 percent failure on US350 in Figure 10 for a hot air lance and flush application and Supplier A-I has an 11 percent failure rate on US350 for the air blow and overband application shown on Figure 11.

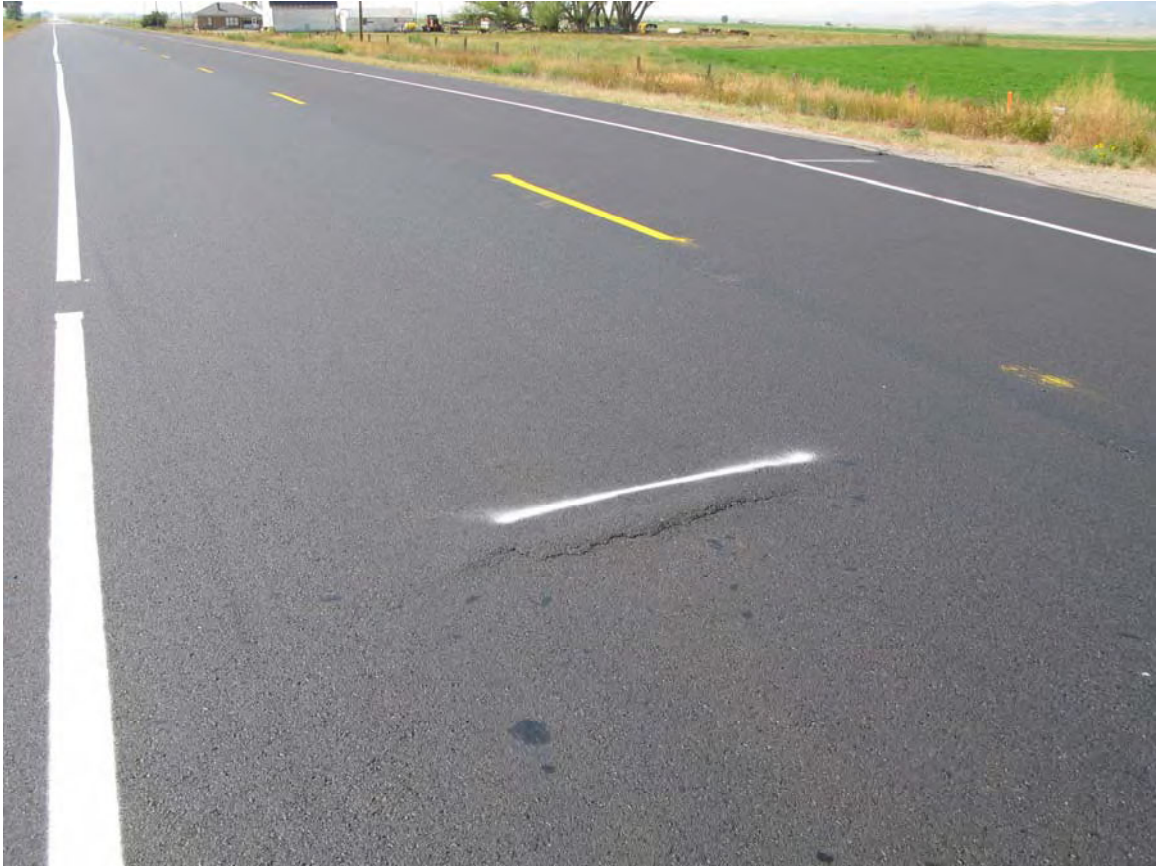
Figure 12. Bumps and Transverse Cracks at Station 150+00

Bumps and transverse cracks began to appear on the project during previous leveling course construction south of the test sections at approximately Station 150+00 as shown in Figure 12. The contractor mitigated further occurrence of this distress by changing from vibratory steel rollers in vibrating mode on breakdown compaction to pneumatic tired rollers. The vibratory steel rollers being used were a Bomag BW190AD and a Caterpillar CB534C. The pneumatic rollers were a Hypac C530AH and a Caterpillar PS150B. However, the material properties of the crack sealant used at Station 150+00 were unknown, therefore, it was not possible to conclude that the bumps and

transverse cracks in the leveling course at Station 150+00 were not material related. Therefore, an experiment was developed to determine if the bumps and cracks could be reproduced within the crack sealant test sections. The experiment was developed as shown in Table 6. Paving was northbound in the southbound driving lane and shoulder with rollers used for breakdown as shown.

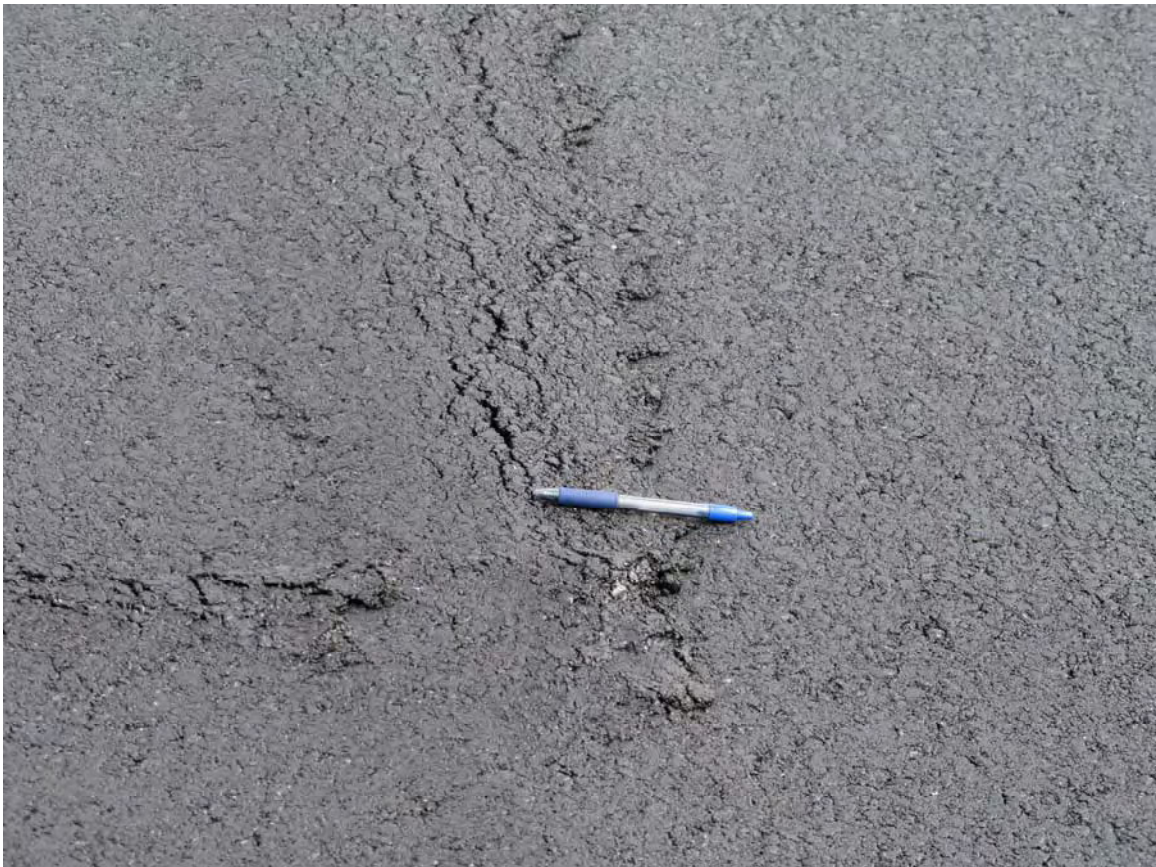
Figure 13. Bump and Transverse Cracks Over Crack 271

330 to crack 1. The experiment was repeated with some exceptions as shown in Table 7 in an attempt to create the bumps and transverse cracks witnessed at cracks 271 and 272 in the southbound lane on September 2. The first evidence of bumps and cracks occurred at cracks 271 to 275 as shown in Figure 13. These bumps were much more severe than those witnessed on September 2 in the southbound lane.

3. The bumps and transverse cracks that were created occurred two years after each of three manufacturers' crack sealants were installed on US285.
4. The severity of the bumps and transverse cracks appear directly proportional to the number of passes of steel rollers operated in vibrating mode for breakdown compaction.

The conclusions above are based on only one location . To verify that a vibrating steel roller is the cause of the bumps and transverse cracks observed, an experiment should be designed to create the effect under various circumstances. For example, it is not clear from this preliminary experiment why the cracks and bumps did not occur as frequently in the southbound lane when vibratory rollers were used on the shoulders. It is also unknown whether the thickness of the overlay in the northbound direction exacerbated the bumps and cracking phenomenon since this was the only difference between the northbound and southbound lanes.

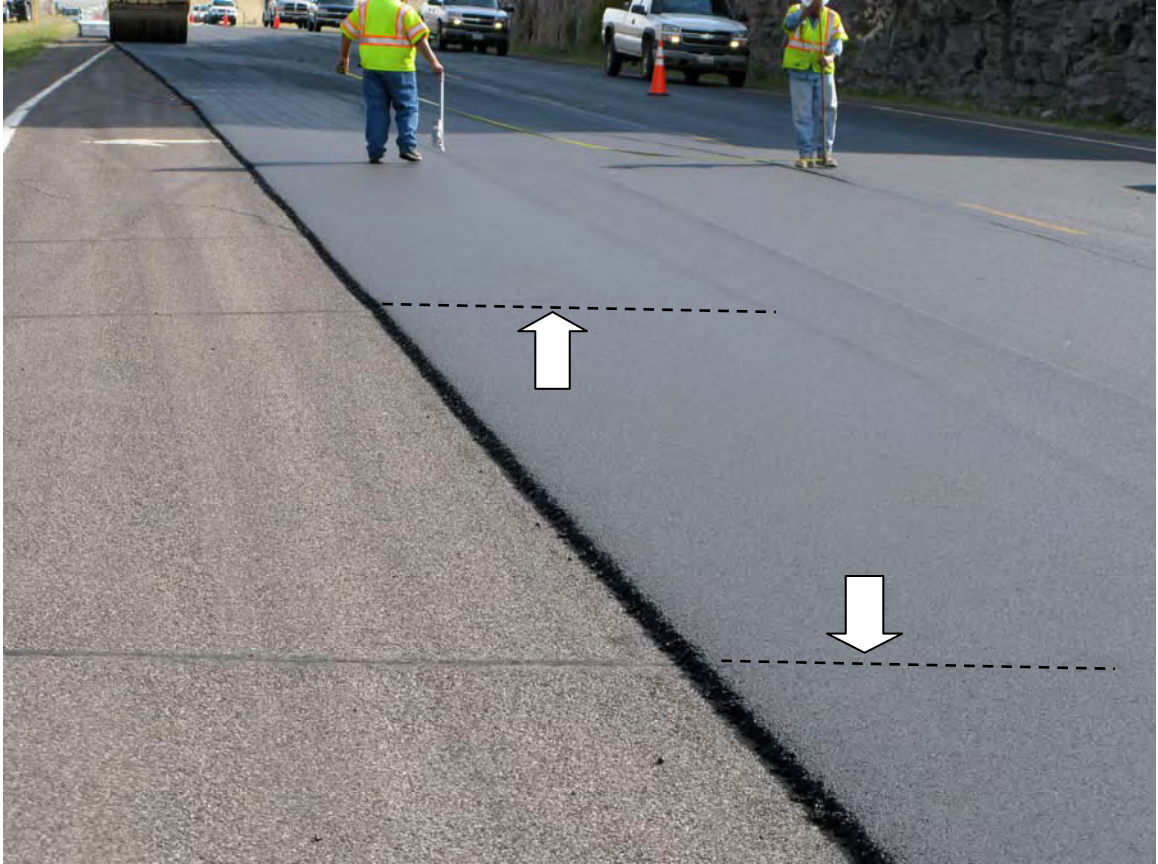
Figure 14. Bumps and Transverse Cracks Over Cracks 129, 130 and 131 Northbound

A second and third attempt to create the bumps and transverse cracks was done over cracks 199 to 204 and again at cracks 127 to 132. The results of this experiment are shown in Figures 14 and 15. The severity of the cracks and bumps appeared directly related to the number of passes of the vibrating roller. As cracks began to appear after the first pass of the roller, the contractor was reluctant to continue the experiment with additional roller passes. The severity of the cracks and bump shown over crack 271 was not observed over cracks 199 to 204 or 127 to 131 due to fewer passes of the vibrating rollers.
